Site/Project Location: Brady Wind Laydown Area

Date of Inspection: 22 June 2016

145 PU-15-690 Filed 07/22/2016 Pages: 12
Site inspection trip report - Topsoil Inspection Report
Keitu Engineers & Consultants, Inc.

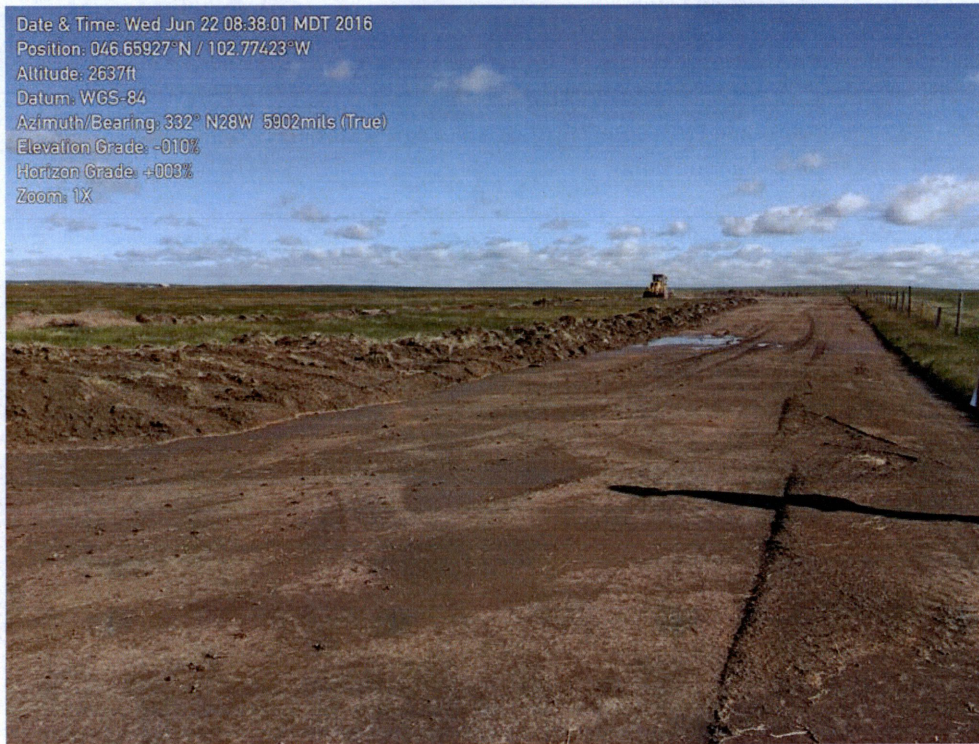
Topsoil had been removed to a depth of 4-6 inches, more topsoil was visible. Site foreman was told to go deeper to remove all topsoil up to a depth of 12 inches. Site staff agreed to continue removing topsoil.

Report Photo #1 "Topsoil removal at 4-6 inches"

Topsoil segregation was noted to be acceptable at this time, site staff agreed to remove all topsoil up to 12 inches. Equipment operator has demonstrated proficiency in topsoil removal and segregation in compliance with the Commission's Order.

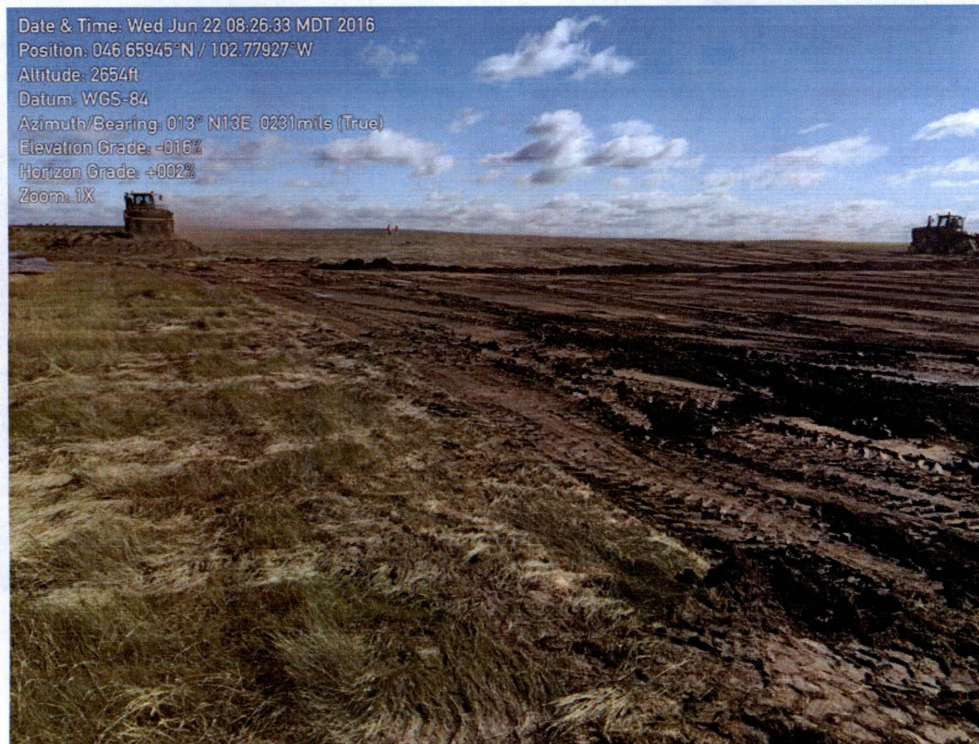
Report Photo #2 "Topsoil removal and tockpile (upper left corner)"

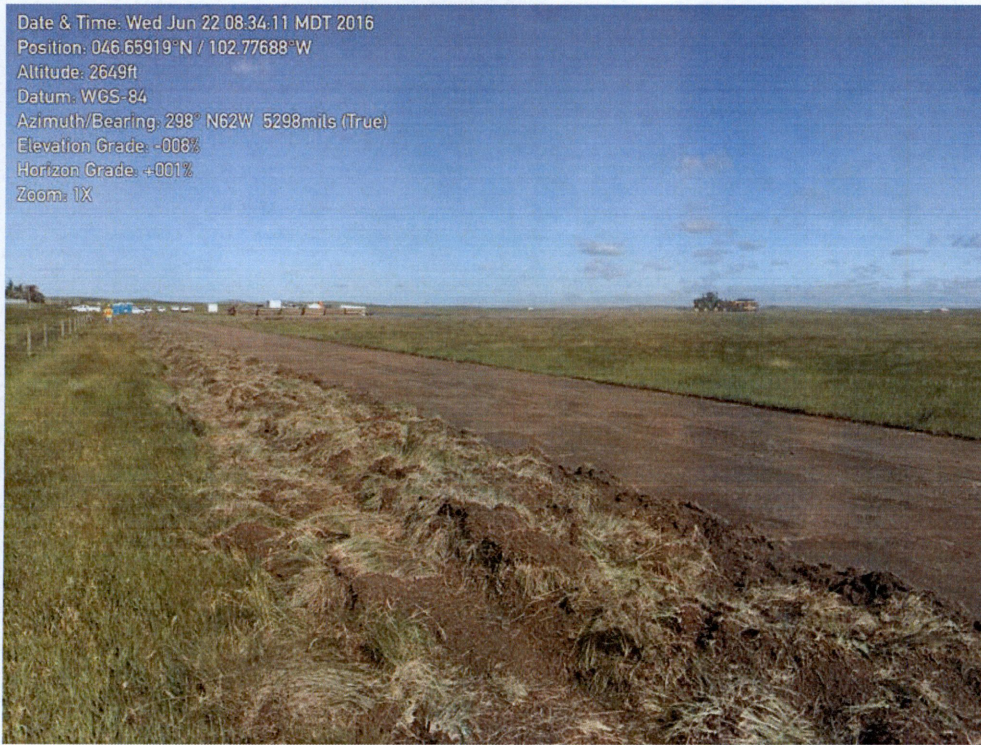
Report Photo #3 "Topsoil Removal, Parking, and Equipment Laydown"

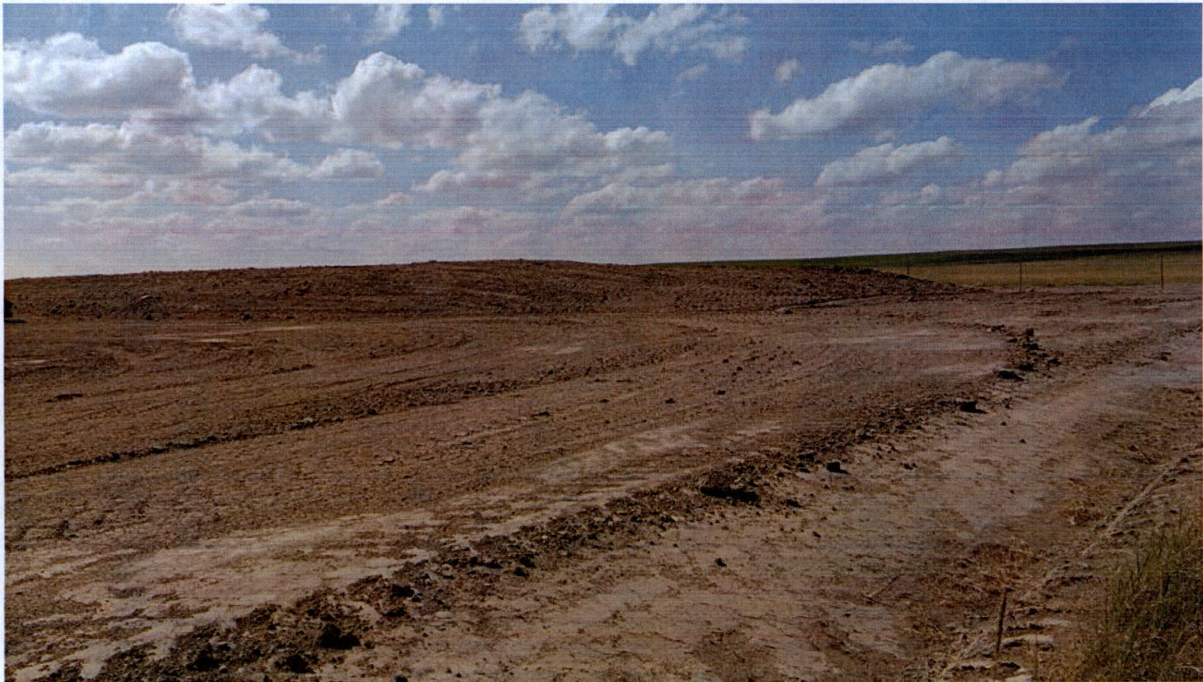
Location: 46°39'44.61"W 102°46'27.75"W

Report Photo #2 "Topsoil removal and north stockpile"

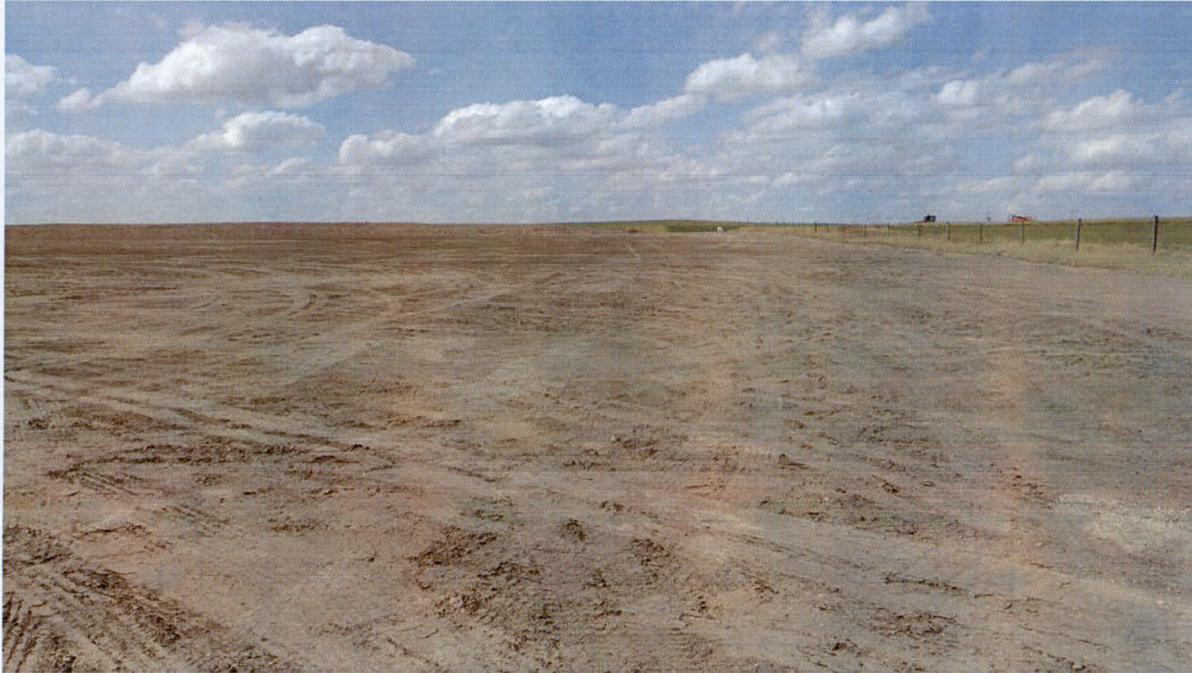
Location: 46°39'34.47"N 102°46'30.54"W

Report Photo #3 "Topsoil Removal in eastern half of site, visible subsoil"

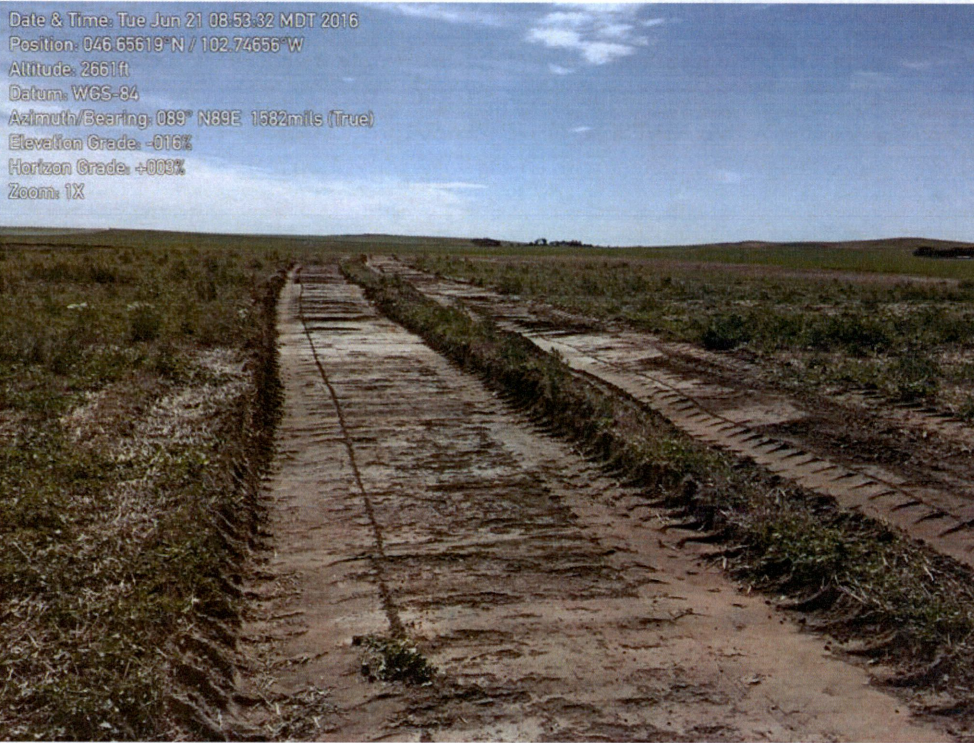
Report Photo #1 "Topsoil removal"

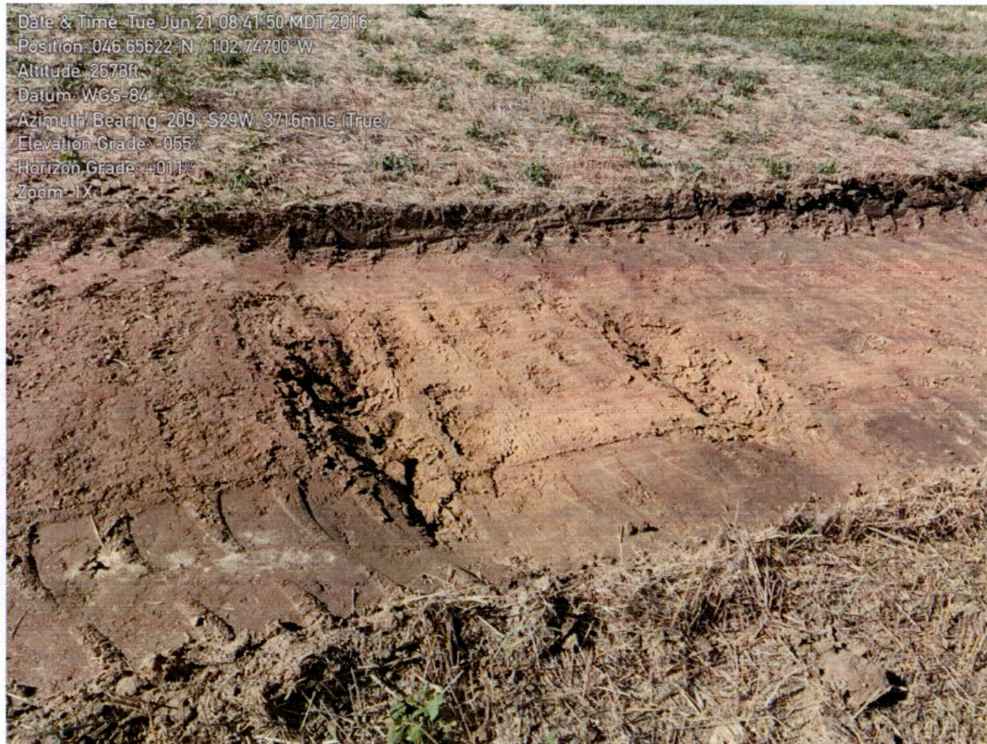
Report Photo #2 "Topsoil depth"

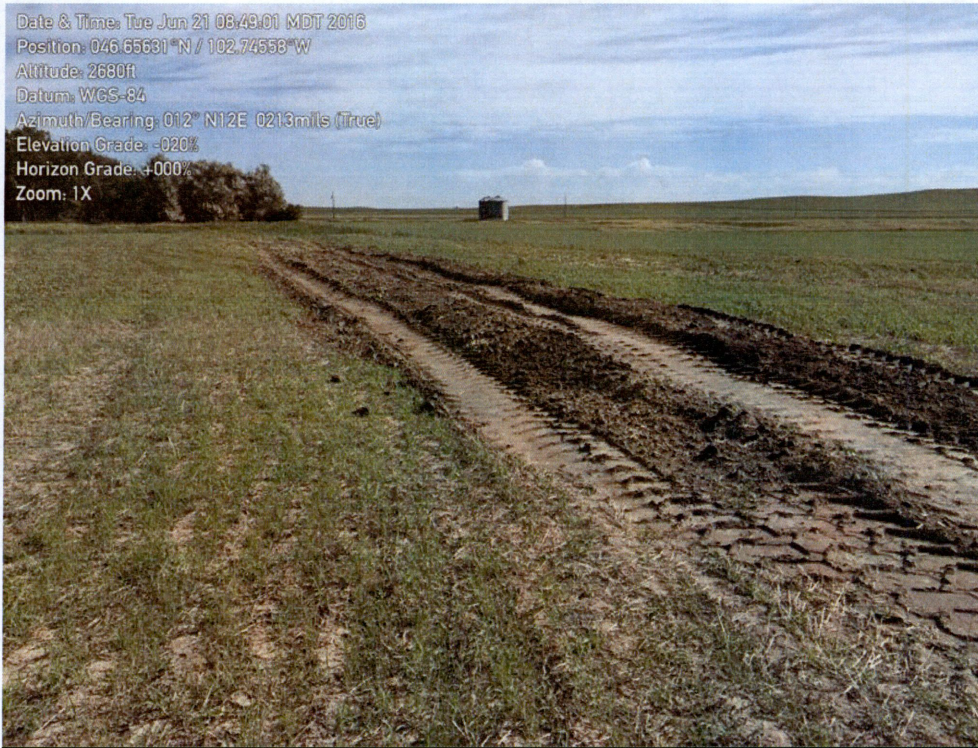
Report Photo #3 "Topsoil Stock Pile"
