Site/Project Location: Brady Wind Energy Center – Stark County **Date of Inspection:** 16 August 2016

Construction inspection focusing on (1) confirming surface disturbance/work occurring within ND PSC-approved work corridor and/or route; (2) topsoil segregation occurring; (3) vegetation removal consistent with tree & scrub mitigation plan.

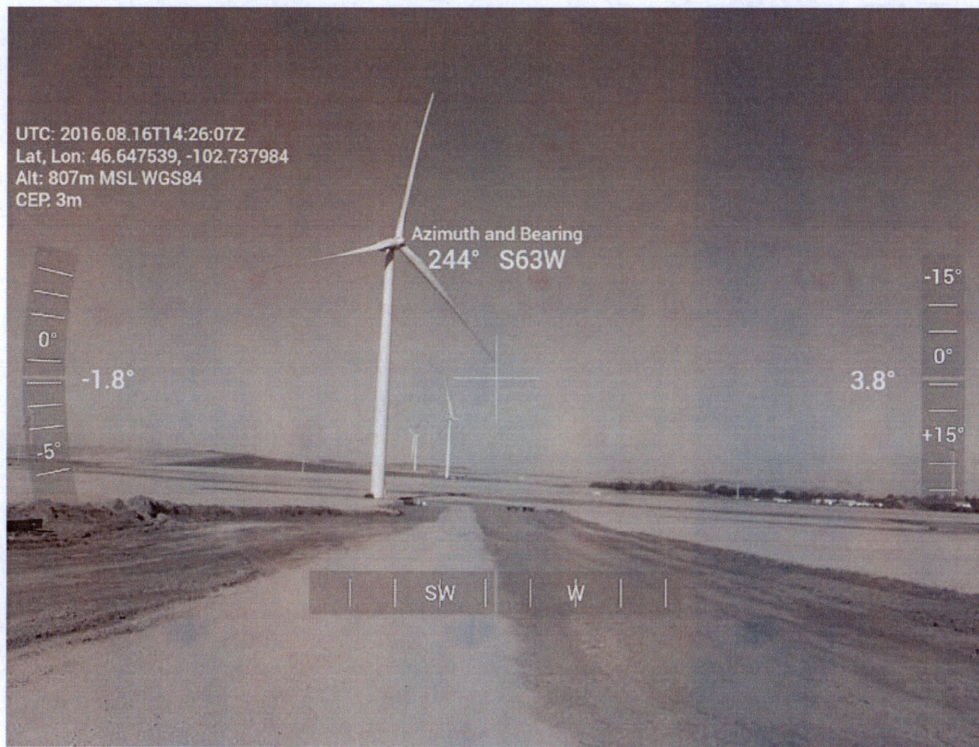
Report Photo #1 "Cement Treated Road With Windmill Construction"

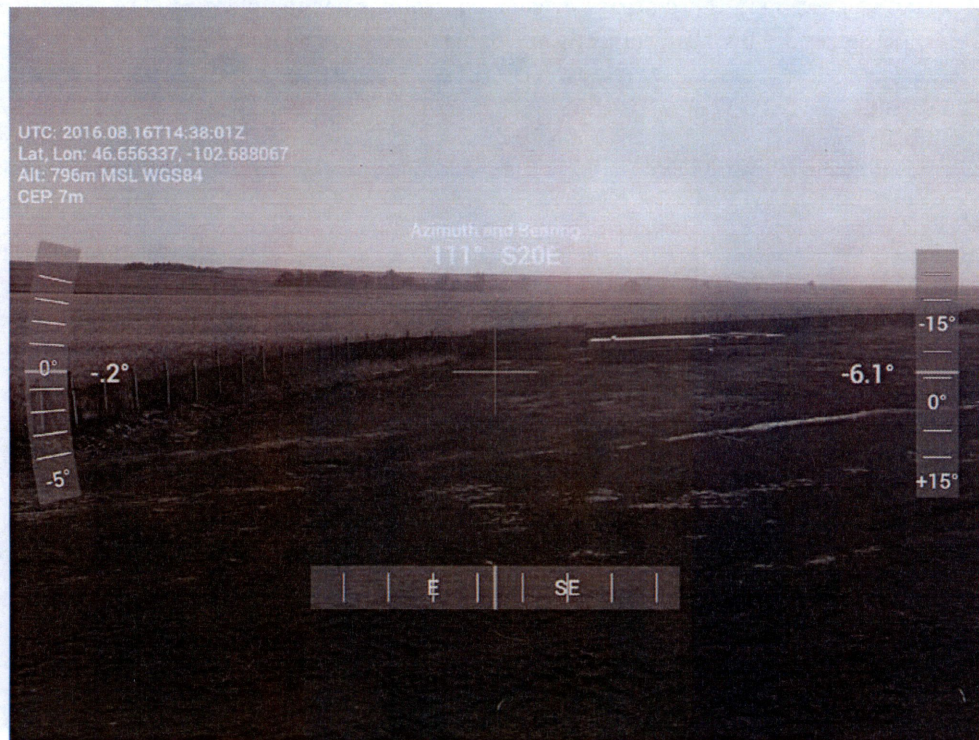
Topsoil from subsoil segregation appears adequate. Site operators stated they have been reaching 6 inches before seeing subsoil on most locations and have seen shallow topsoil on the tops of hills and deeper topsoil in the valleys. Construction crew is doing an adequate job of separating topsoil and keeping soil layers separate during construction. Turning radius improvements have been implemented on multiple locations. Crew was informed to be cautious during cleanup of gravel in road ditches as they do not want to impact the soil and the roots of vegetation in those areas. Erosion control has been implemented in disturbance areas and heavy slopes. Silt fences are installed correctly and being inspected and maintained.

Report Photo #2 "Silt Fence On Windmill Pad"
