Reclamation and Revegetation Inspection Report

Brady Wind Energy Center – Stark County
Brady Wind, LLC

ND PSC Case No. PU-15-690

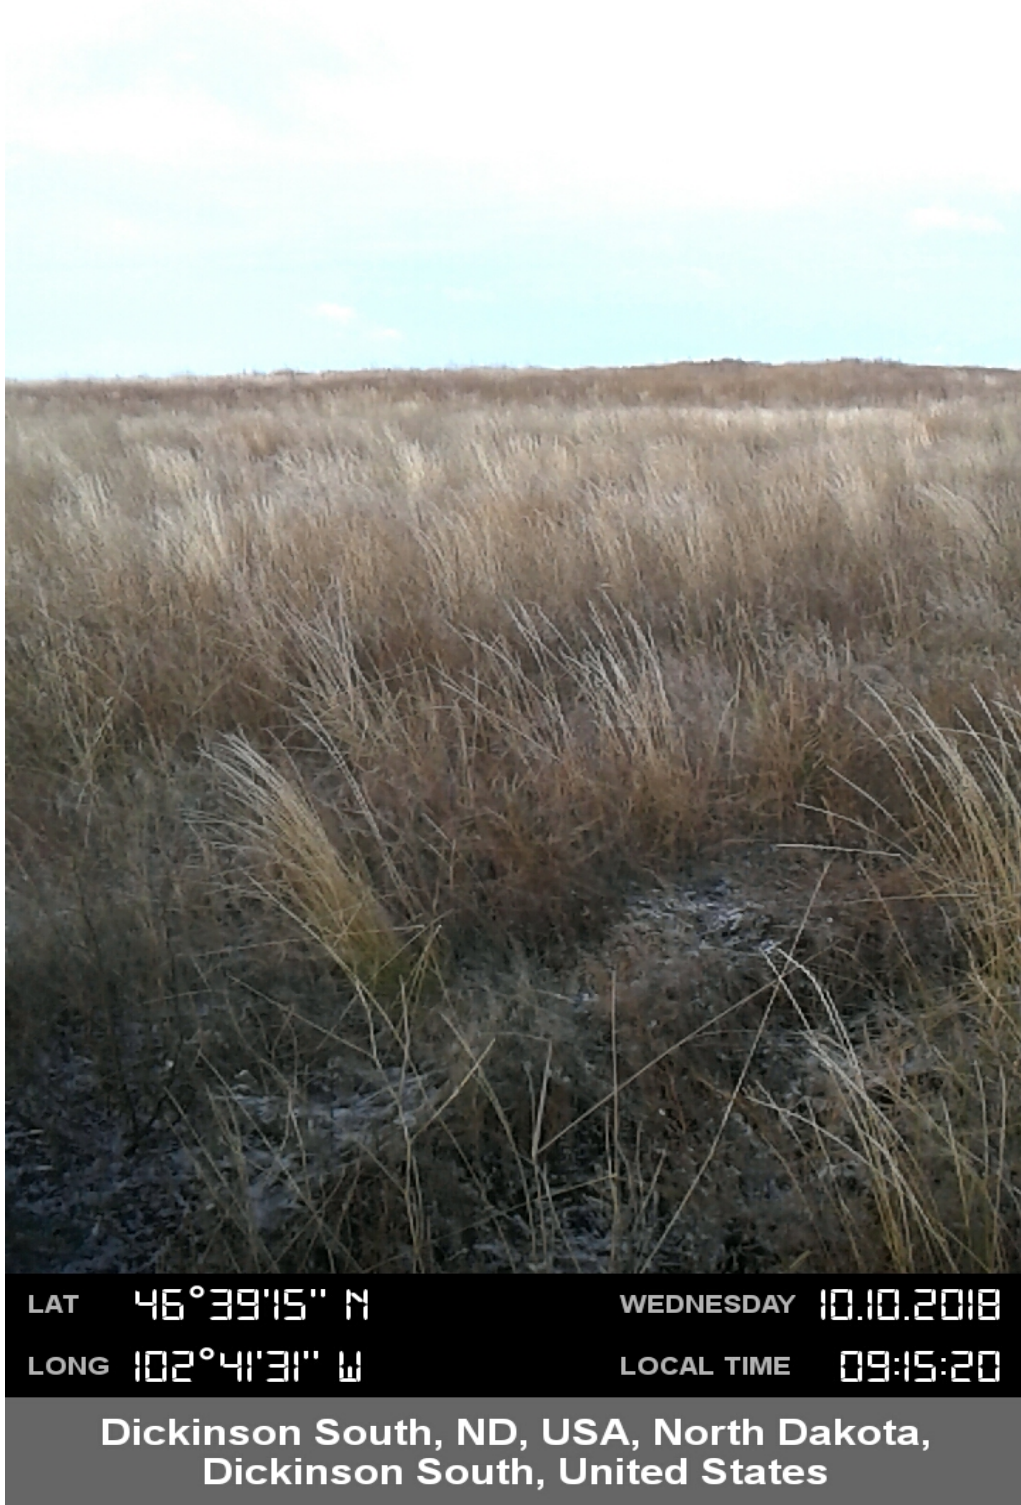
Report Photo #1: Overview of turbine construction block (T45) from East to West.

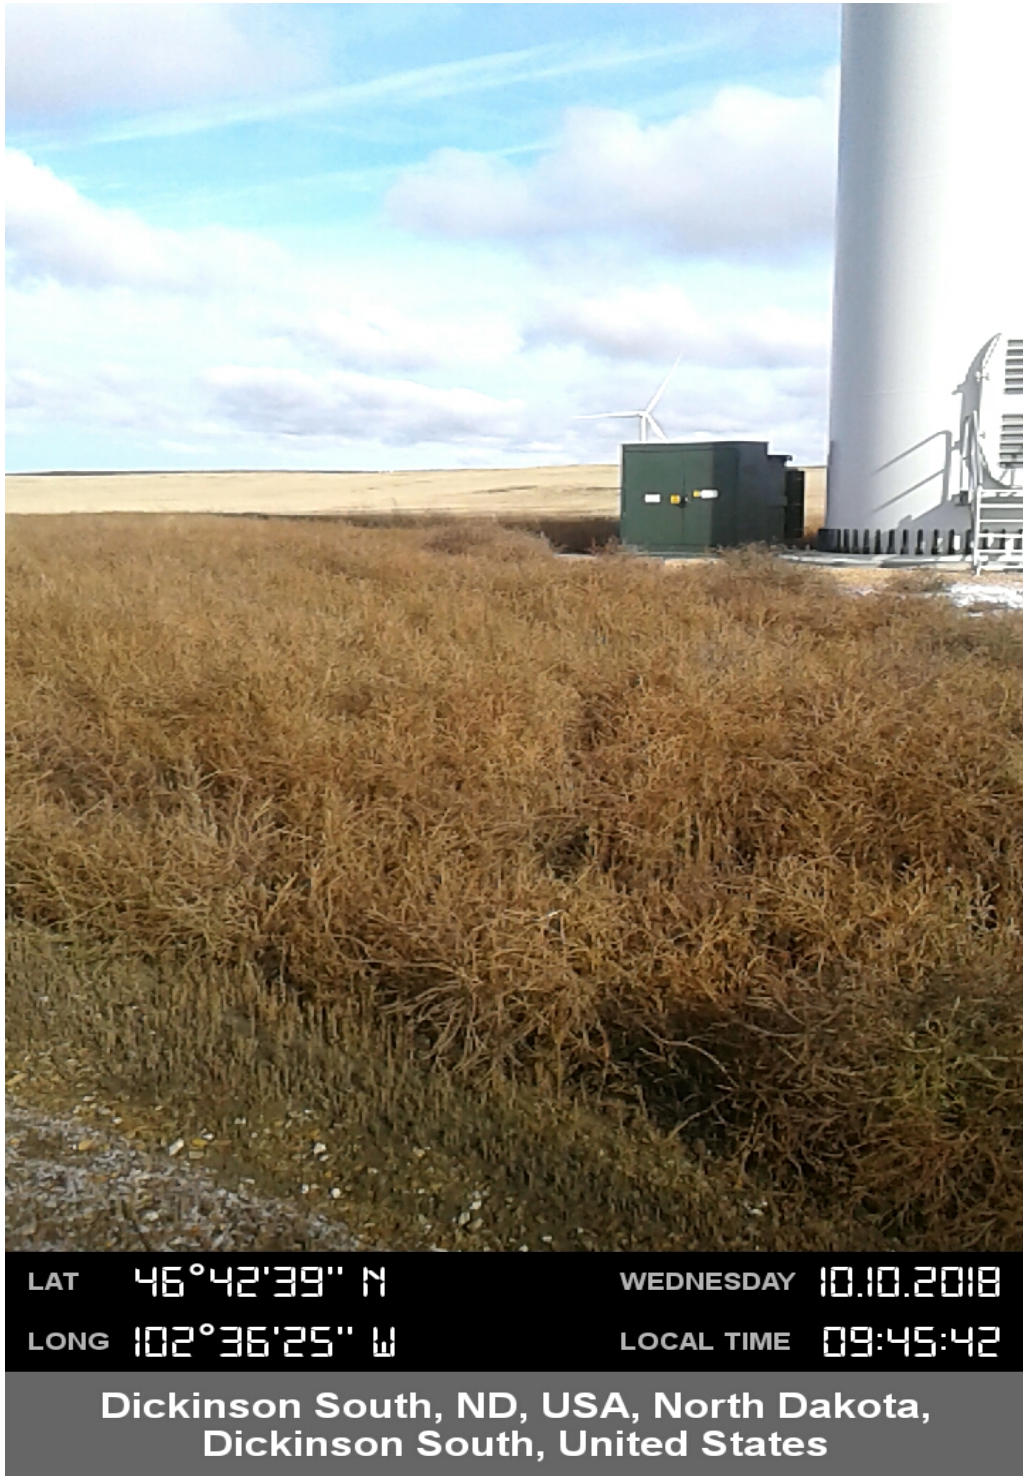
Report Photo #2: Overview of turbine construction block (T78) from South to North.

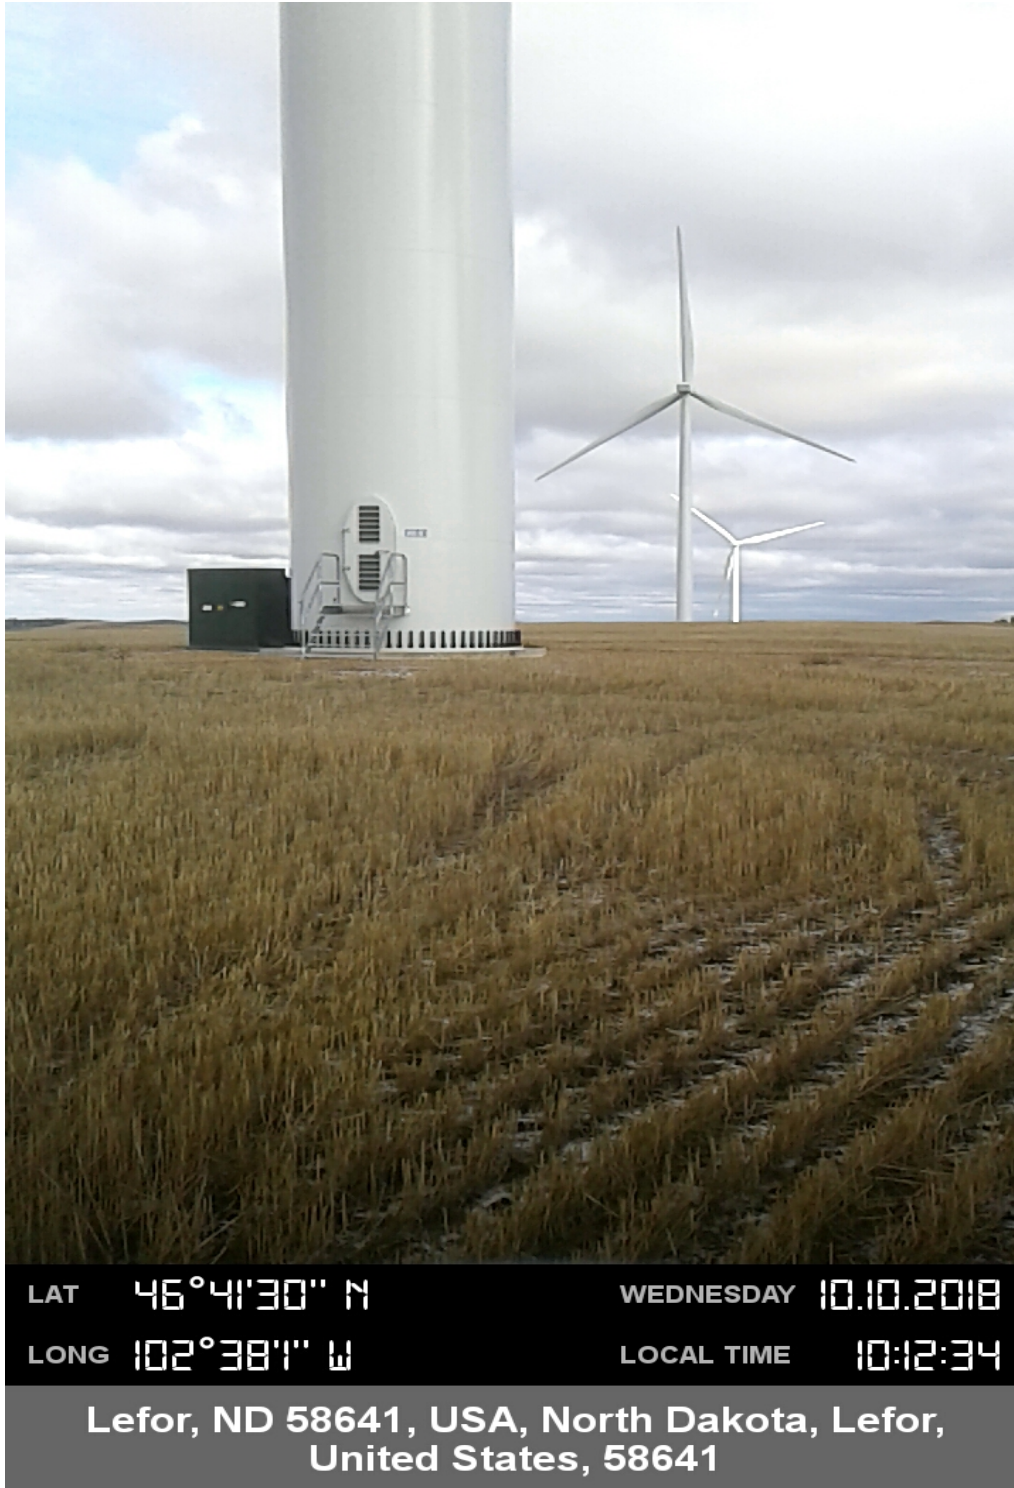
Report Photo #3: Overview of turbine construction block (T71) from South to North.

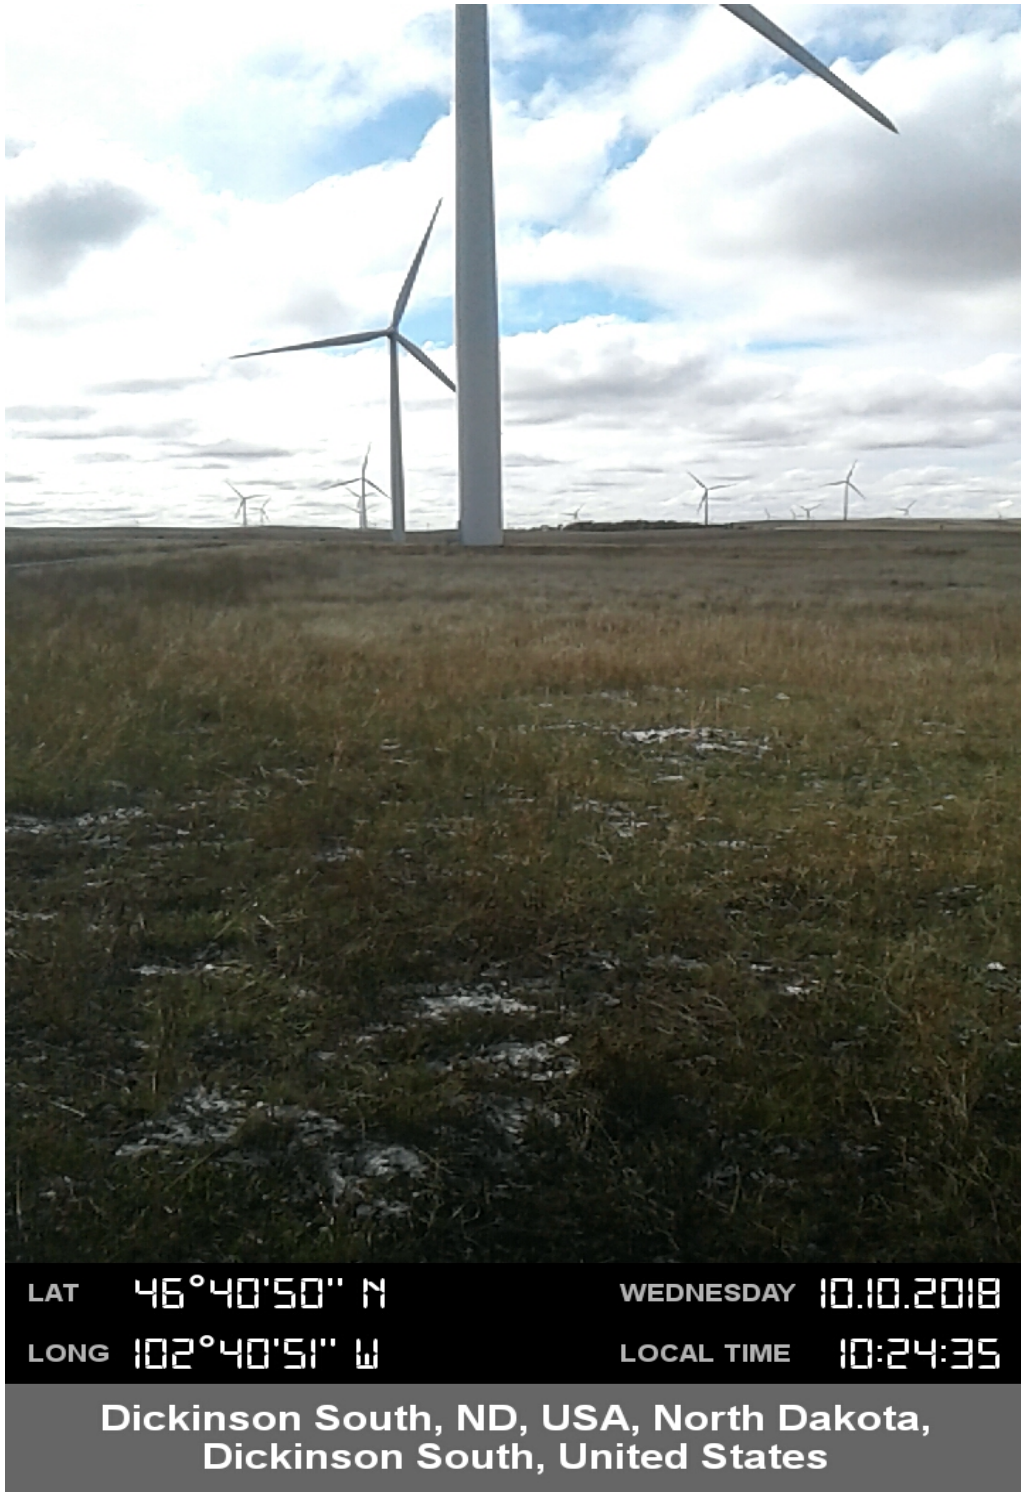
Report Photo #4: Overview of turbine construction block (T63) from North to South.

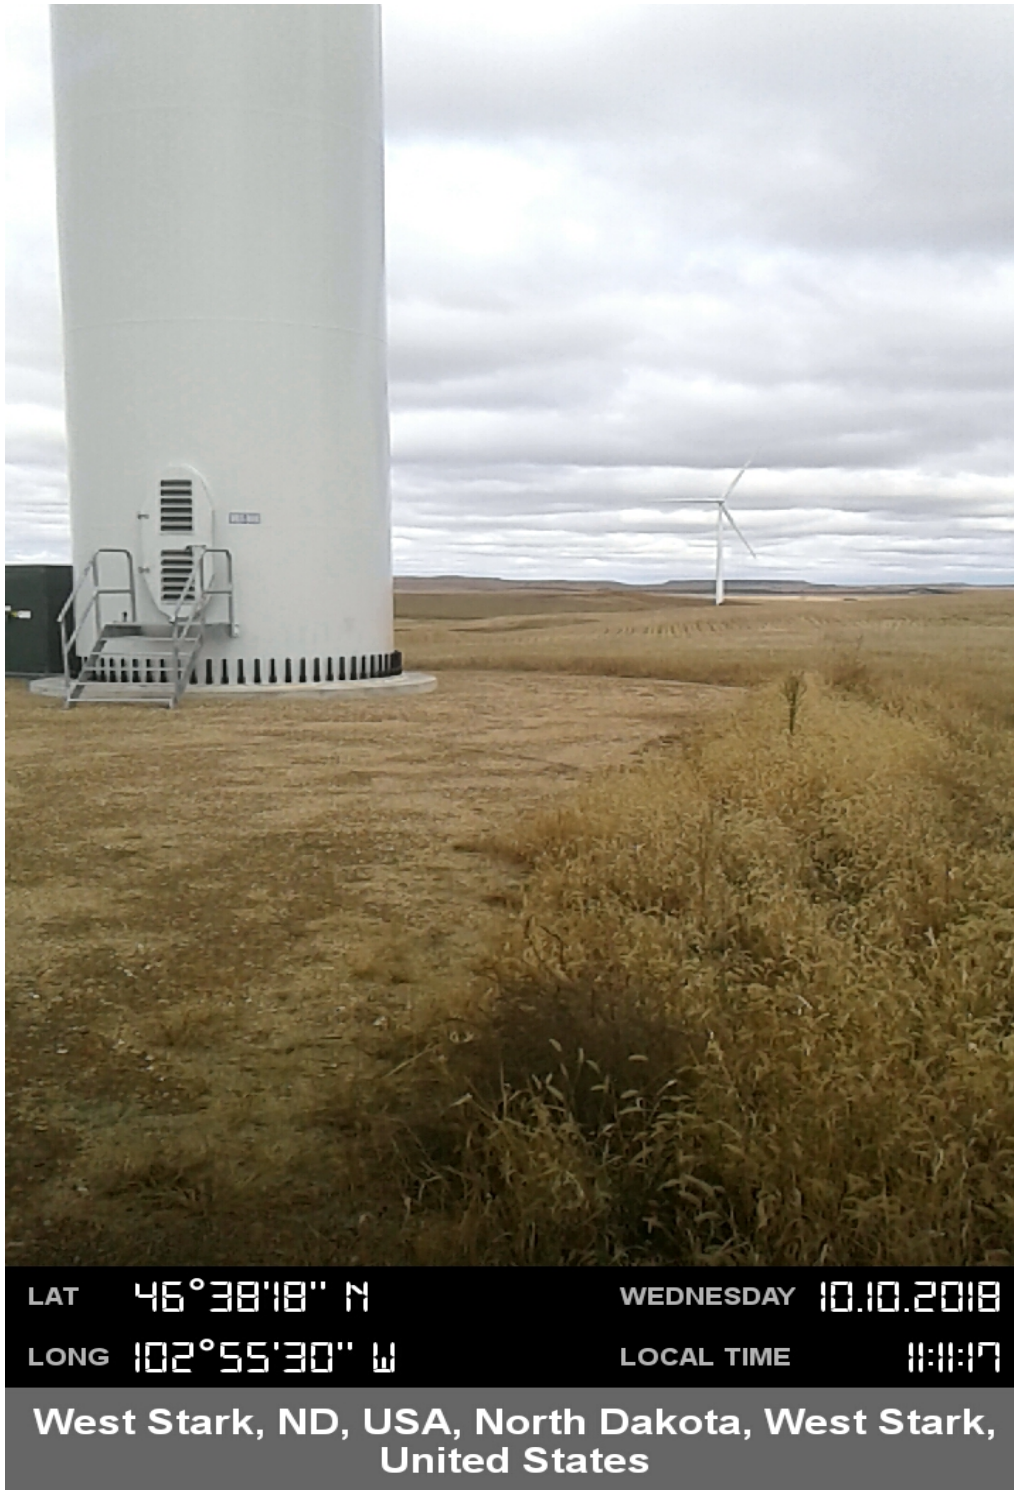
Report Photo #5: Overview of turbine construction block (T6) from South to North.

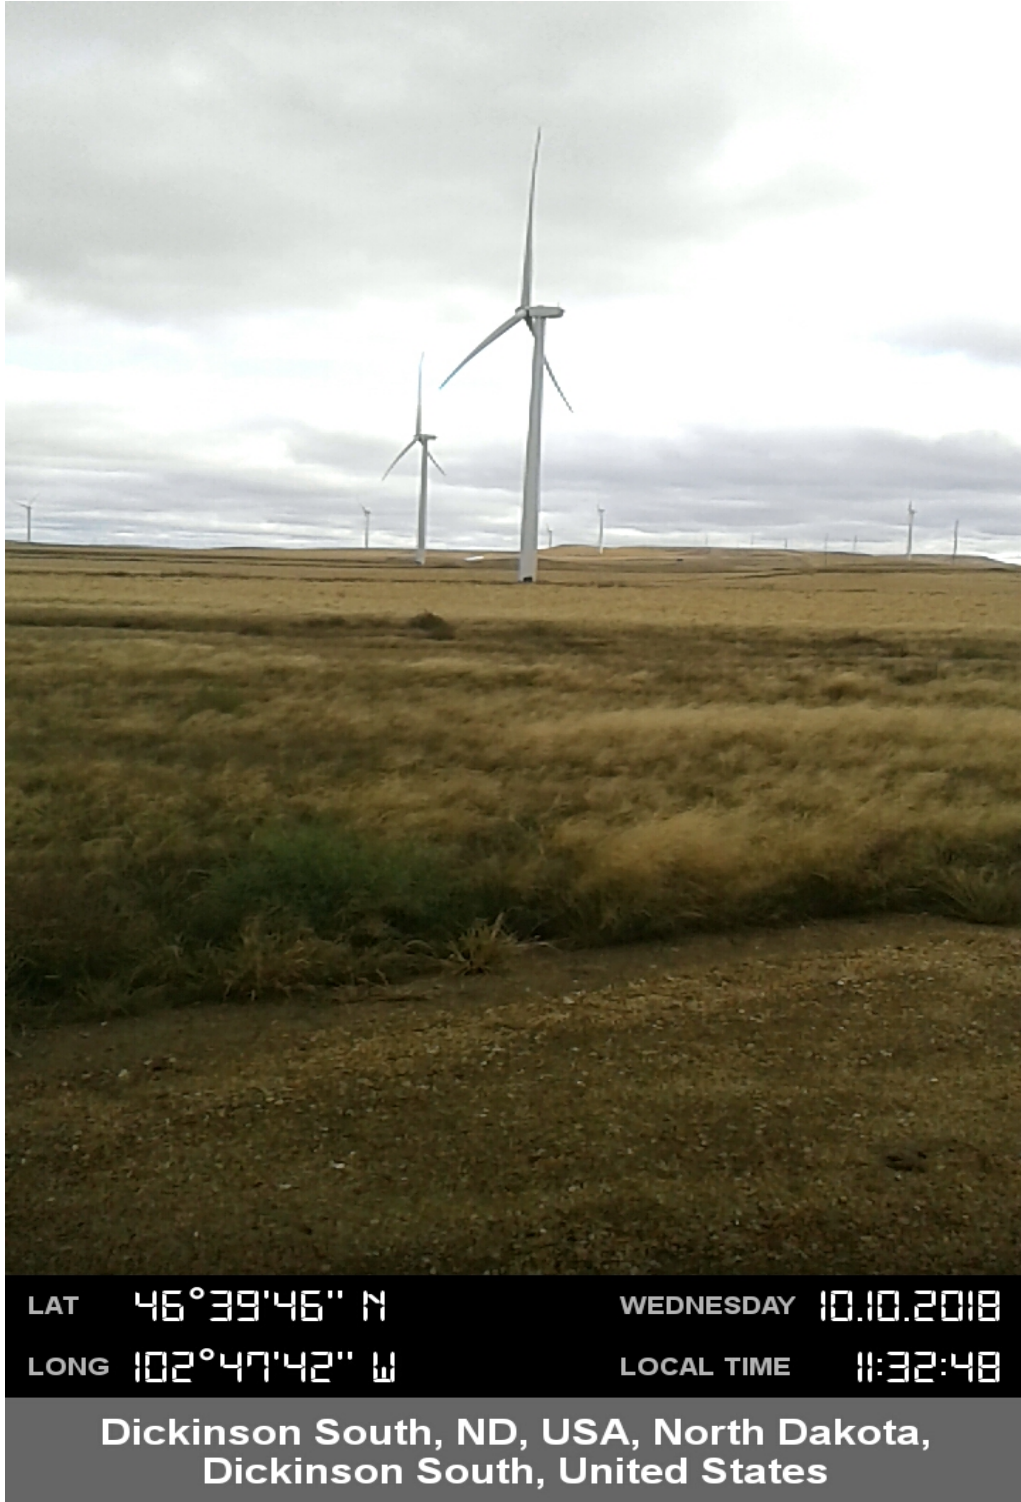
Report Photo #6: Overview of turbine array from T21 to T22. View from West to East.
