**TESORO HIGH PLAINS PIPELINE**

**CONSTRUCTION AS BUILT INSPECTION REPORT**

**Job Site As-Built Inspection  
Crop Review to Verify Proper Top Soil Replacement**

**Report Number:** PU-15-720

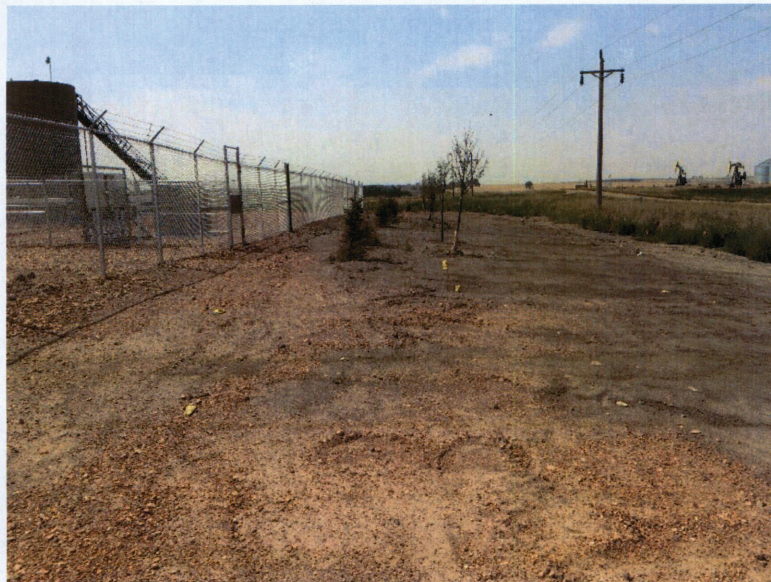
**Photo No. 2 Tesoro Pipeline Station 0+57 to 2+00  
PI #1 of Pipeline Project  
South of 40<sup>th</sup> Street NW  
July 31, 2017**

The above picture taken is looking west. The photograph represents the landscaping between the Tesoro property and the 40<sup>th</sup> Street NW right of way. Trees were planted to buffer the Tesoro fenced area. No action is necessary.

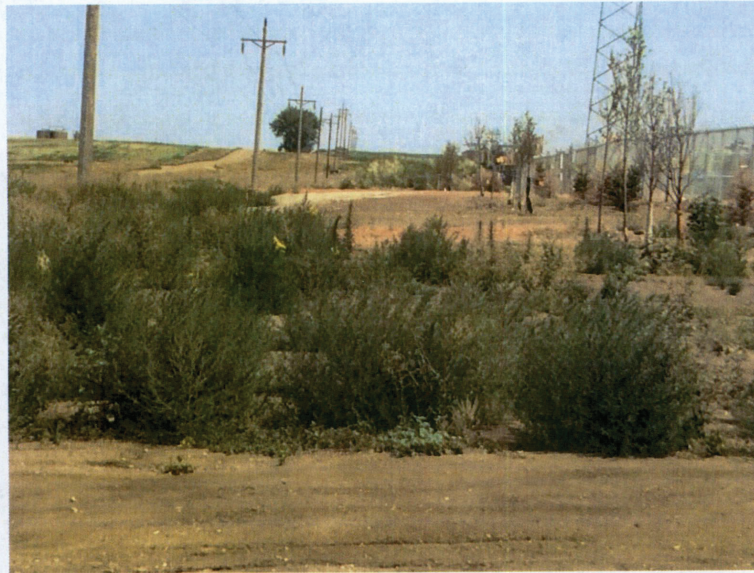
**Photo No. 3 Tesoro Pipeline Station 4+00 to 0+57  
PI #2 of Pipeline Project  
South of 40<sup>th</sup> Street NW  
July 31, 2017**

The above picture taken is looking east. The photograph represents the landscaping between the Tesoro property and the 40<sup>th</sup> Street NW right of way. Trees were planted to buffer the Tesoro fenced area. Ownership of disturbed area is Tesoro. No action is necessary.

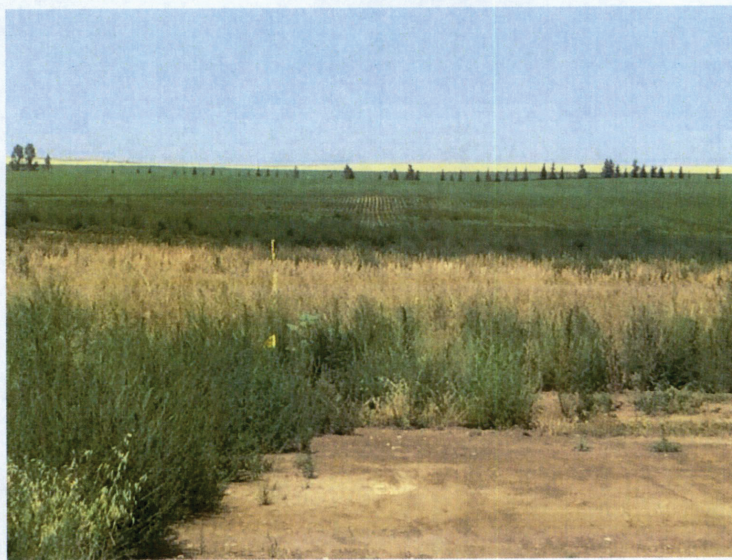
**Photo No. 4 Tesoro Pipeline Station 4+20 to 7+81  
PI #2 of Pipeline Project  
South of 40<sup>th</sup> Street NW  
July 31, 2017**

The above picture taken is looking north beyond 40<sup>th</sup> Street NW. The photograph represents the landscaping south of 40<sup>th</sup> Street NW and crops planted north of 40<sup>th</sup> Street NW. Ownership of disturbed area is Tesoro. No action is necessary.

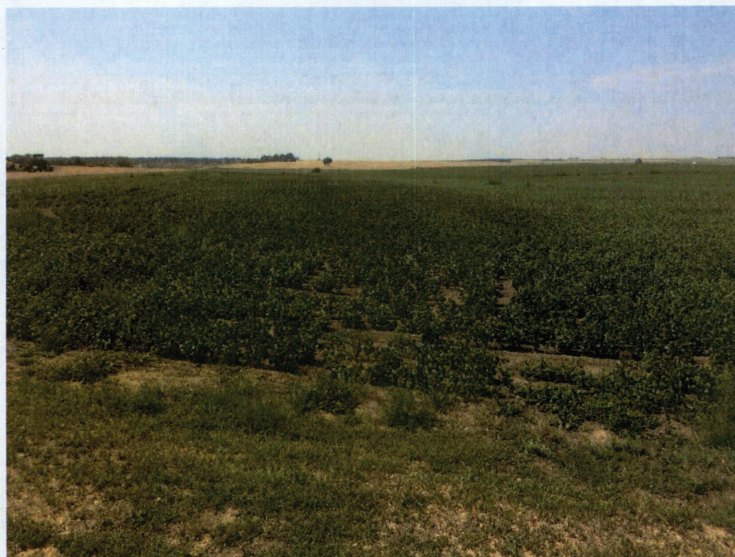
Photo No. 5 Tesoro Pipeline Station 4+20 to 7+81  
PI #3 of Pipeline Project  
South of 40<sup>th</sup> Street NW  
July 31, 2017

The above picture taken is looking north beyond 40<sup>th</sup> Street NW. The photograph represents the crops planted on the North side of 40<sup>th</sup> Street NW to PI #3. There is a good stand of crops, though this area has been under severe drought conditions. The land is owned by Kenneth A. Mogen. No action is necessary.

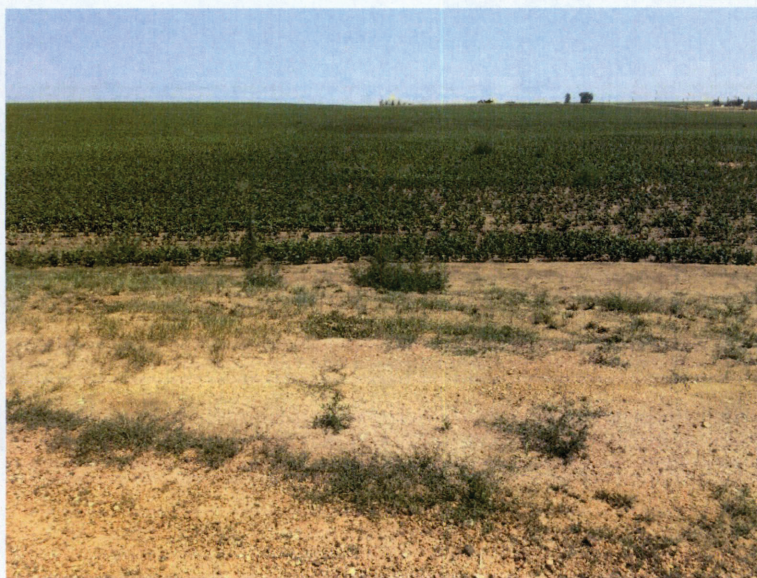
**Photo No. 6 Tesoro Pipeline Station 9+69 to 7+81  
PI #3 of Pipeline Project  
North of 40<sup>th</sup> Street NW  
July 31, 2017**

The above picture taken is looking east towards PI #3 from gravel road. The photograph represents the crops planted on the North side of 40<sup>th</sup> Street NW and west of PI #3. There is a good stand of crops though this area has been under severe drought conditions. The land is owned by Kenneth A. Mogen. No action is necessary.

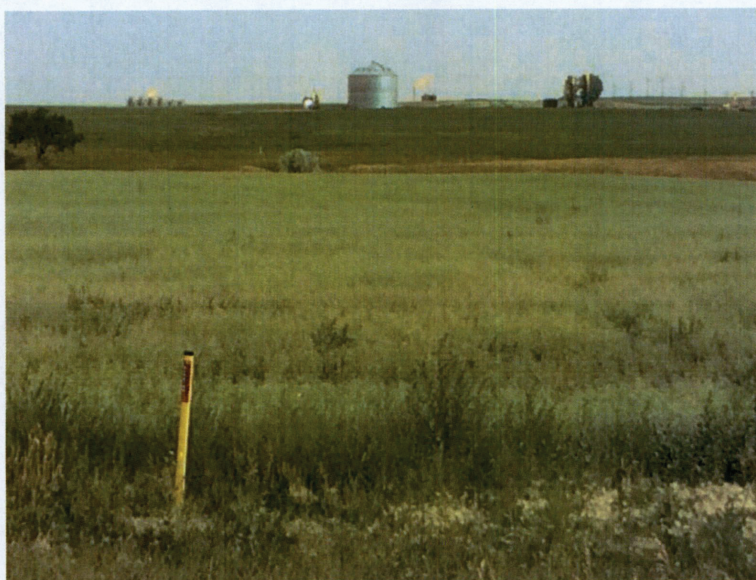
**Photo No. 7 Tesoro Pipeline Station 9+69 to 42+89  
Between PI #3 and PI #6 of Pipeline Project  
North of 40<sup>th</sup> Street NW  
July 31, 2017**

Picture taken is looking west towards PI #4 from gravel road. The photograph represents the crops planted on the North side of 40<sup>th</sup> Street NW and west of PI #3. There is a good stand of crops, though this area has been under severe drought conditions. The drainage draw can be seen and the horizon represents ND Hwy. 1806. The land is owned by Harvey O. and Elizabeth A. Thompson Trust. No action is necessary.

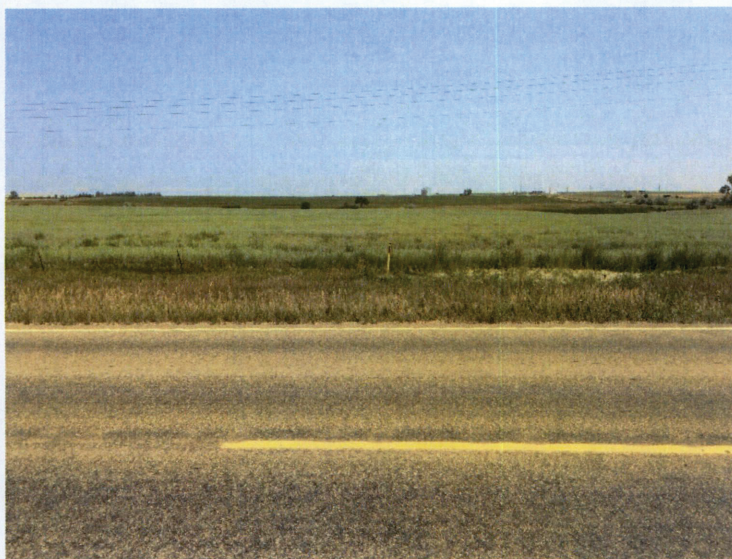
**Photo No. 8 Tesoro Pipeline Station 46+00 to 42+89  
Pipeline Bored under the Highway  
Looking East of ND Hwy 1806  
July 31, 2017**

Picture taken is looking east towards PI #7 from ND Highway 1806. The photograph represents the crops planted on the east side of the highway. There is a good stand of crops though this area has been under severe drought conditions. The land is owned by Harvey O. and Elizabeth A. Thompson Trust. No action is necessary.

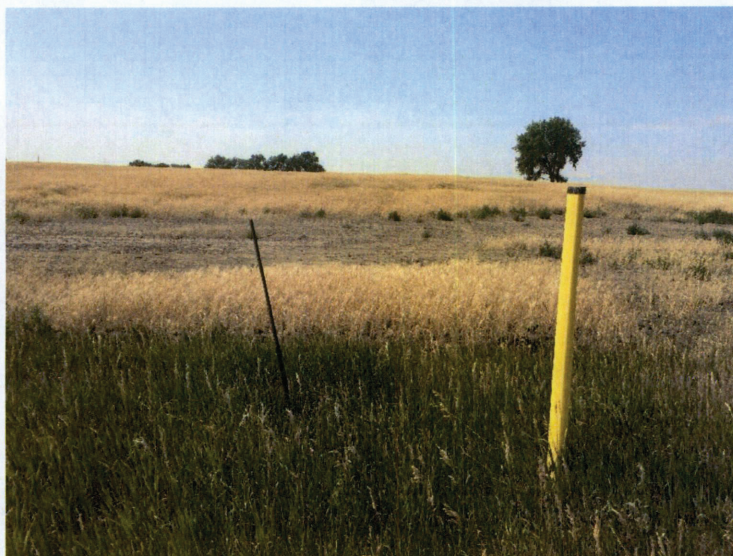
**Photo No. 9 Tesoro Pipeline Station 48+00 to 54+00**

The above picture taken is looking west towards PI #8 from ND 1806. The photograph represents the crops planted on the West side of the Highway. There is a good stand of crops, though this area has been under severe drought conditions. The disturbed area was part of the boring operation, however, crops were not planted in the disturbed area this season. The pipe line goes past the trees on the horizon. The land is owned by Paul and Milo Wisness. No action is necessary.

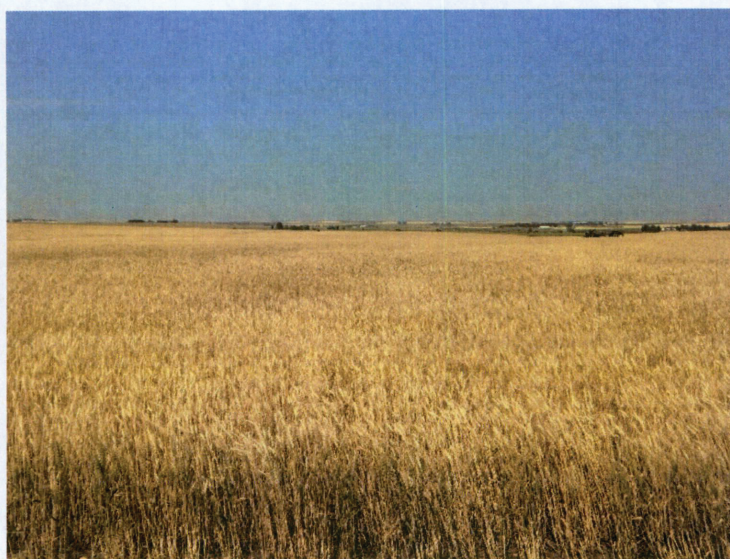
**Photo No. 10 Tesoro Pipeline Station 56+00 to 50+00  
Pipeline west of Highway 1806  
Looking East towards PI #7  
July 31, 2017**

The above picture taken is looking east of PI #8 towards ND 1806. The photograph represents the crops planted on the West side of the Highway. There is a good stand of crops, though this area has been under severe drought conditions. The land is owned by Paul and Milo Wisness. No action is necessary.

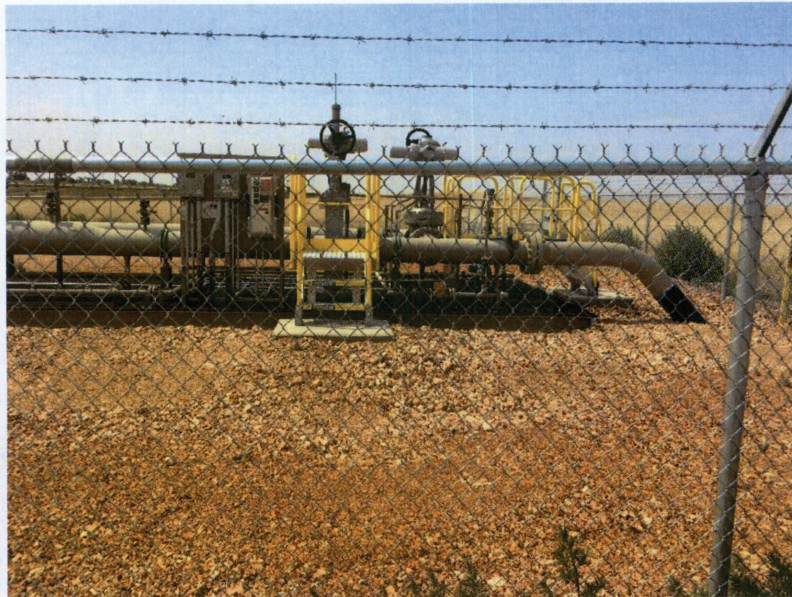
**Photo No. 11 Tesoro Pipeline Station 67+02  
End of Pipeline west of Highway 1806  
Looking West  
July 31, 2017**

**The above picture taken is located immediately south of PI #8. The photograph represents the Tesoro station. The land is owned by Tesoro. No action is necessary.**
