**Site/Project Location:** McKenzie County

**Date of Inspection:** 11, July 2016

Pump Station location property consisting of approximately 5 acres was visited during civil/foundation work construction and the start of equipment placing. Inspection of pump station construction site to focus on (1) confirming surface disturbance/work occurring within ND PSC-approved work corridor and/or route; (2) topsoil segregation occurring; (3) vegetation removal consistent with tree & scrub mitigation plan.

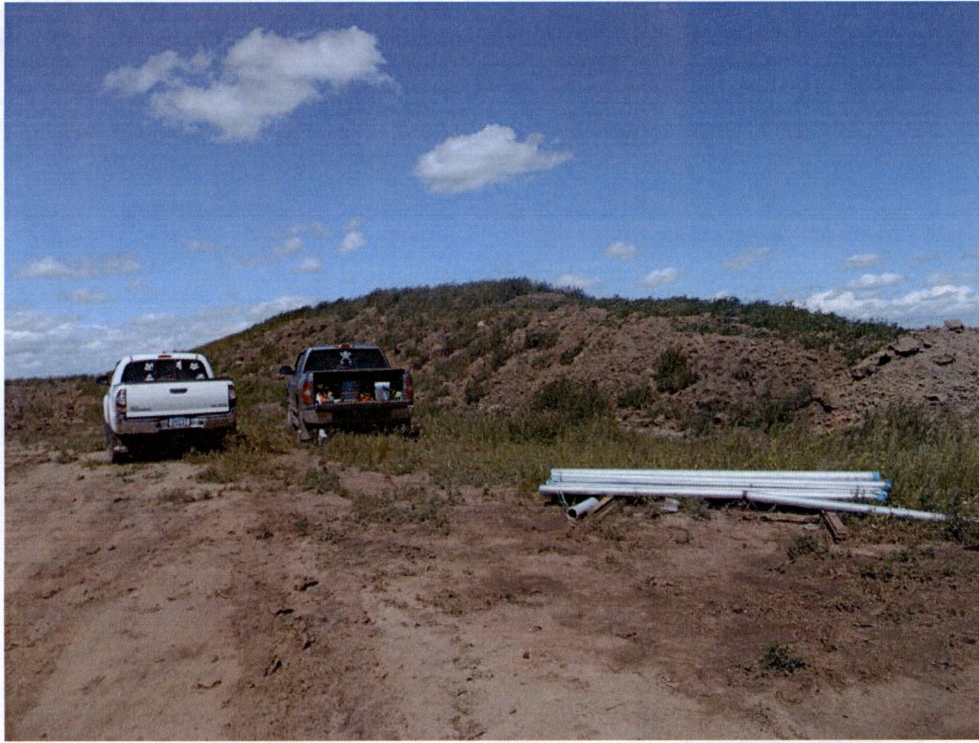
**Report Photo #1 "Topsoil Pile" at GPS Coordinates:**

Site is located in open area. No trees or shrubs were apparently impacted during site construction. Active construction areas and roadway have been cleared of vegetation. Weeds and other vegetative cover noted on topsoil storage piles.
