Reclamation and Revegetation Inspection Report

Spring Creek Pump Station - McKenzie County
ONEOK BAKKEN PIPELINE, LLC

ND PSC Case No. PU-15-725

September 2017

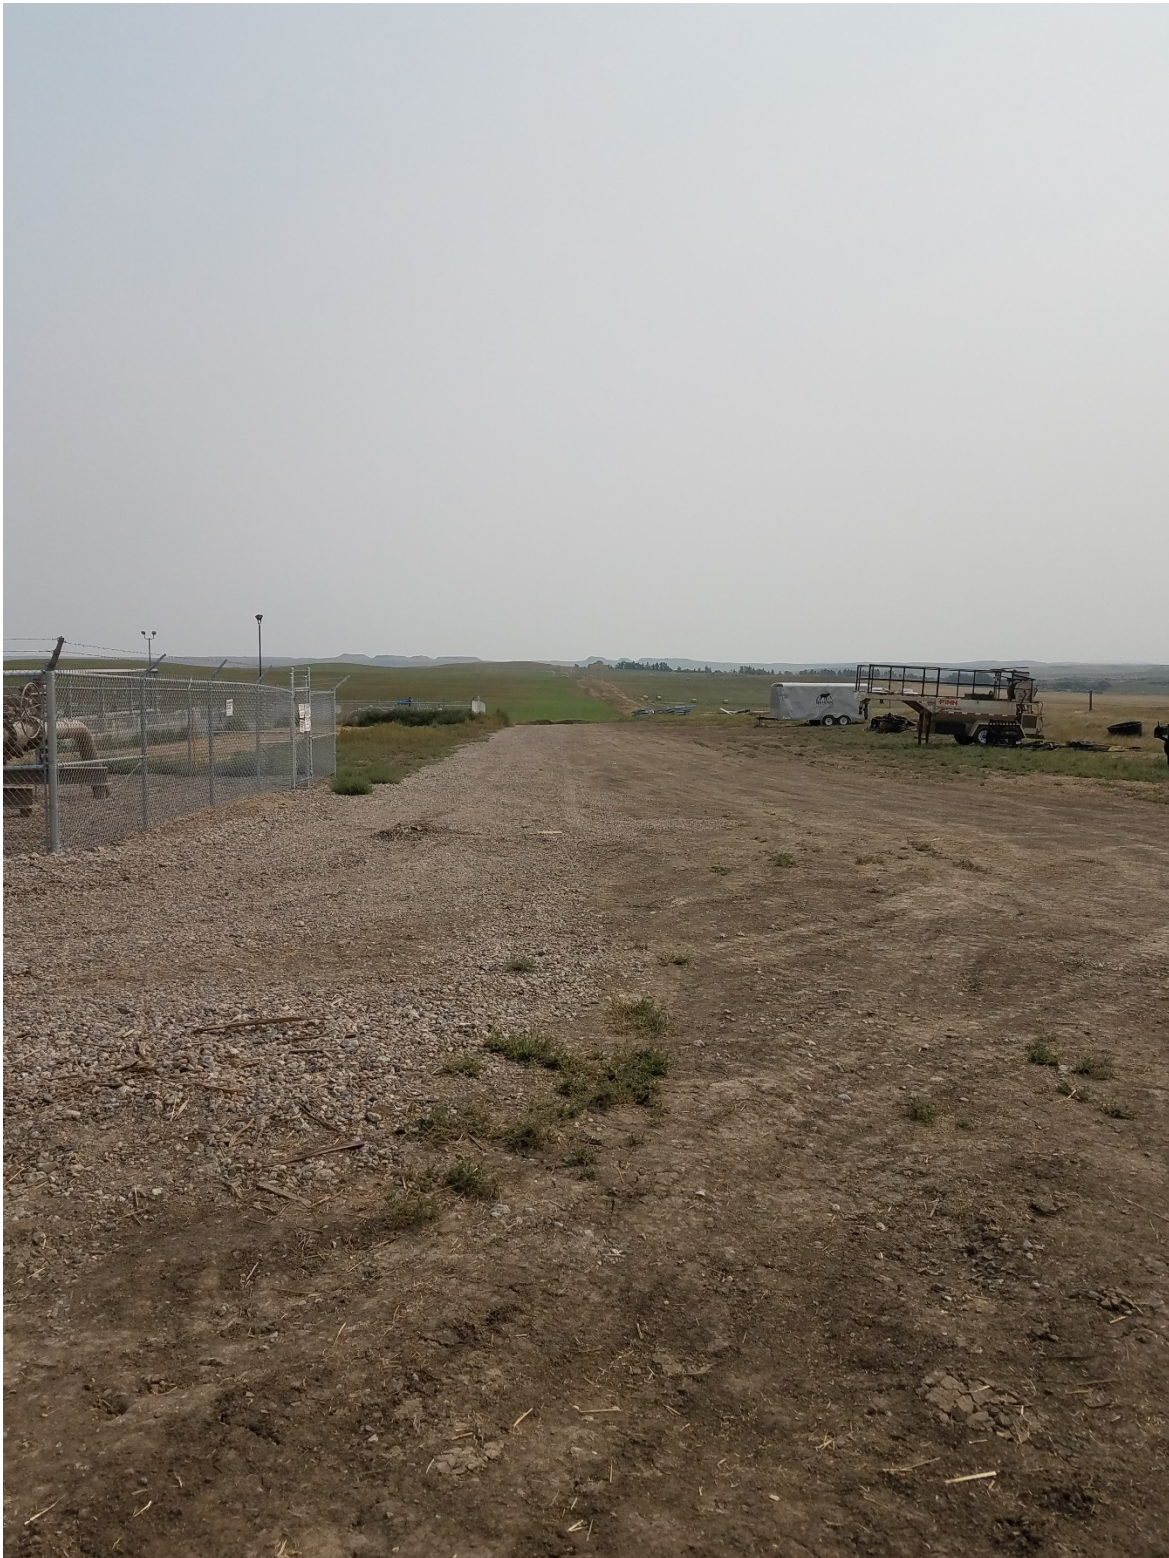
At the time of inspection, the construction was completed. The pump station facilities within fence boundaries were clear of vegetation and completed with gravel for operations. Outside of the fence a majority of the areas were revegetated. On the south side of the Project there is an area free from any vegetation that is being used for vehicle access (Photo #1). In the vegetated areas, coverage ranged from approximately 40%-99%. Vegetation appeared stressed likely due drought conditions.

Report Photo #1: Access road on south side of the Project.

1. The access road have gravel laid on the surface or revegetated to prevent stormwater runoff as it is currently at risk of having sediment runoff during a rainfall event.
2. Management of Canada thistle onsite. North Dakota law requires everyone to do all things necessary and proper to control the spread of noxious weeds in North Dakota²
3. Apply stormwater BMPs to soil pile as it is currently at risk of having sediment runoff during a rainfall event.
4. Improve housekeeping onsite to prevent and remove trash from accumulating at the Project site.
5. Stormwater BMPs (silt fences) need maintenance to be in proper working condition.
6. Continual maintenance to be done to encourage revegetation of desirable species.

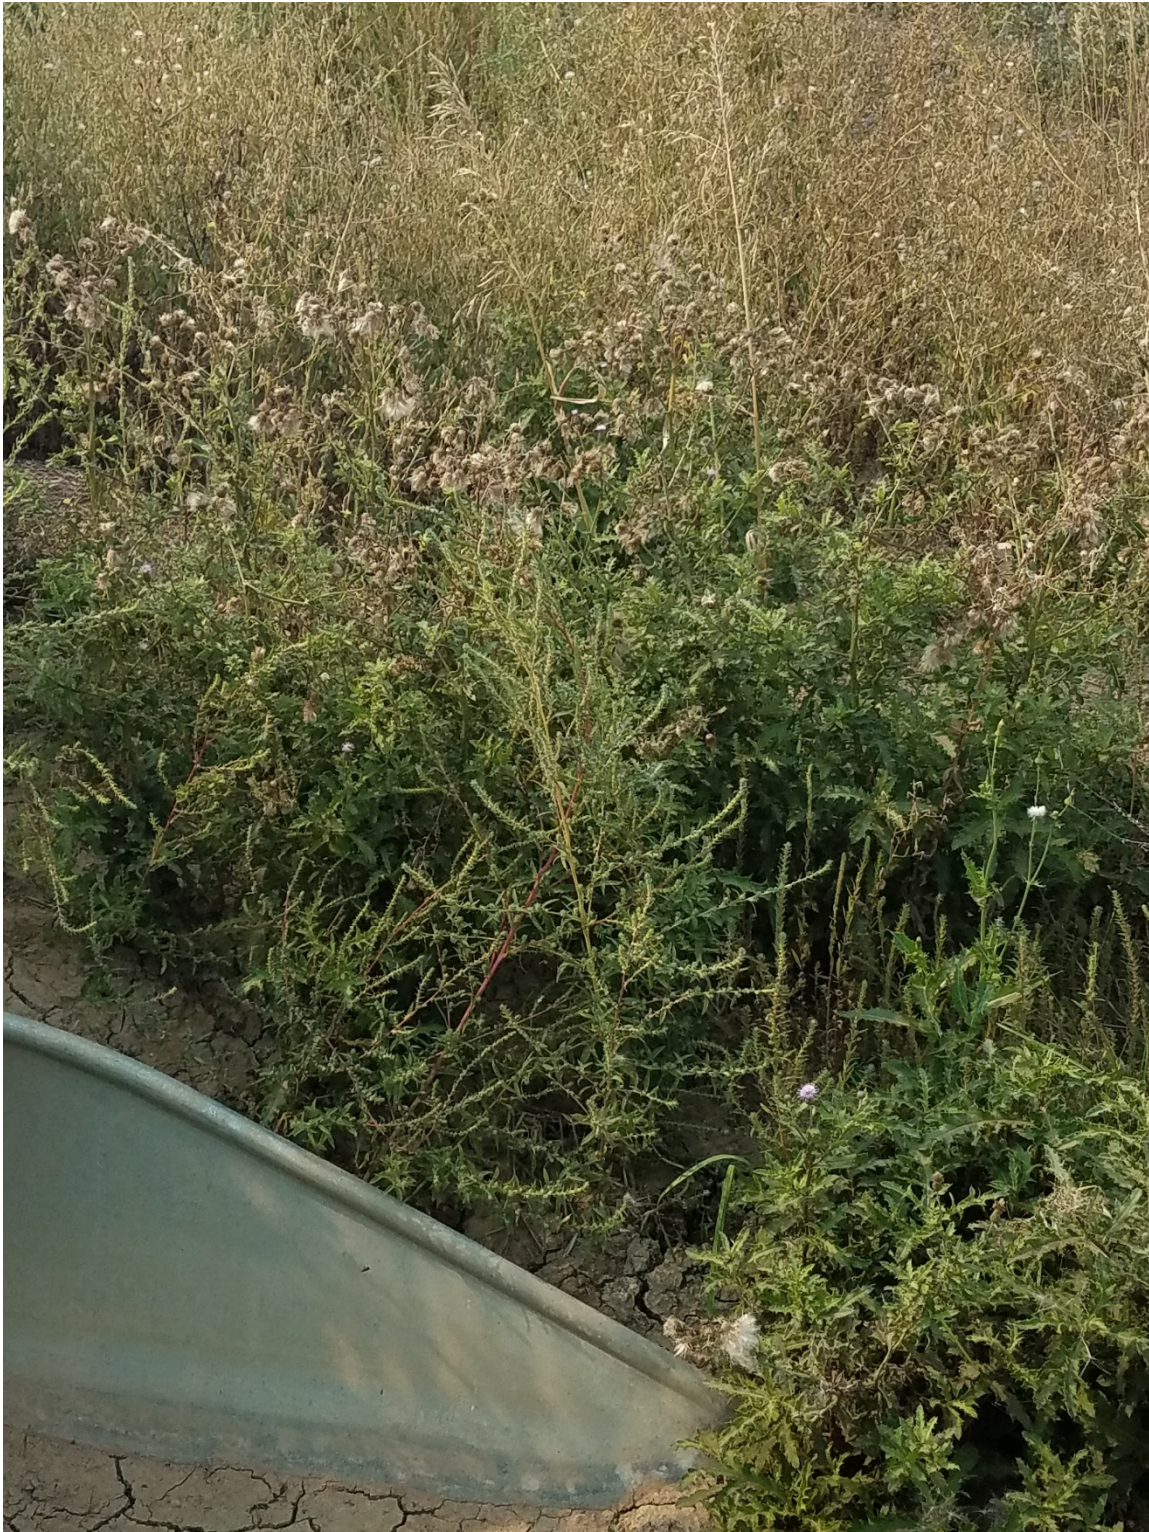
State and County listed species identified during the inspection are: Canada thistle (*Cirsium arvense*) (Photo #2). A population of Canada thistle was observed near the culvert and along the entrance road to the Project.

Report Photo #2: Canada thistle near culvert.

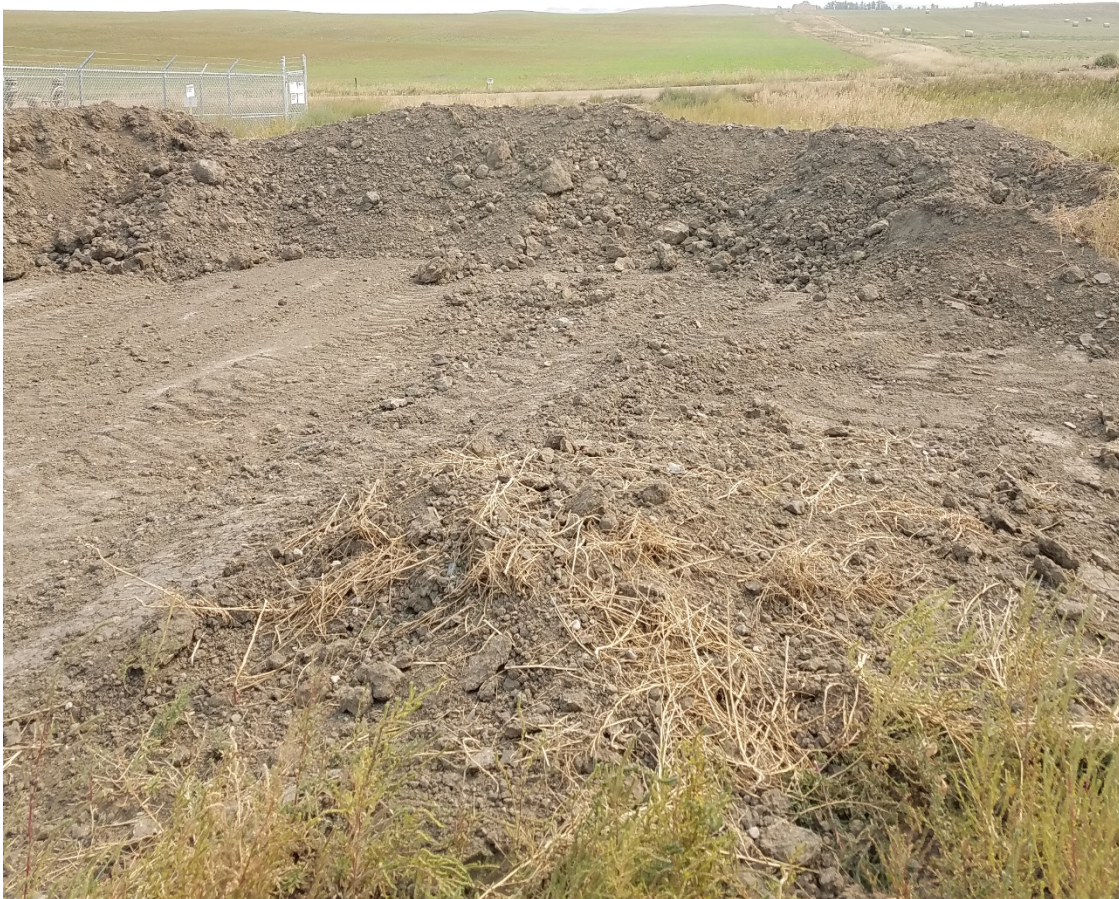
One soil pile that appeared recently disturbed is being stored on site outside of the fenced boundary. (Photo #3). Stormwater BMP's are in place on the east side of the Project and in

Report Photo #3: Soil pile on south side of Project.

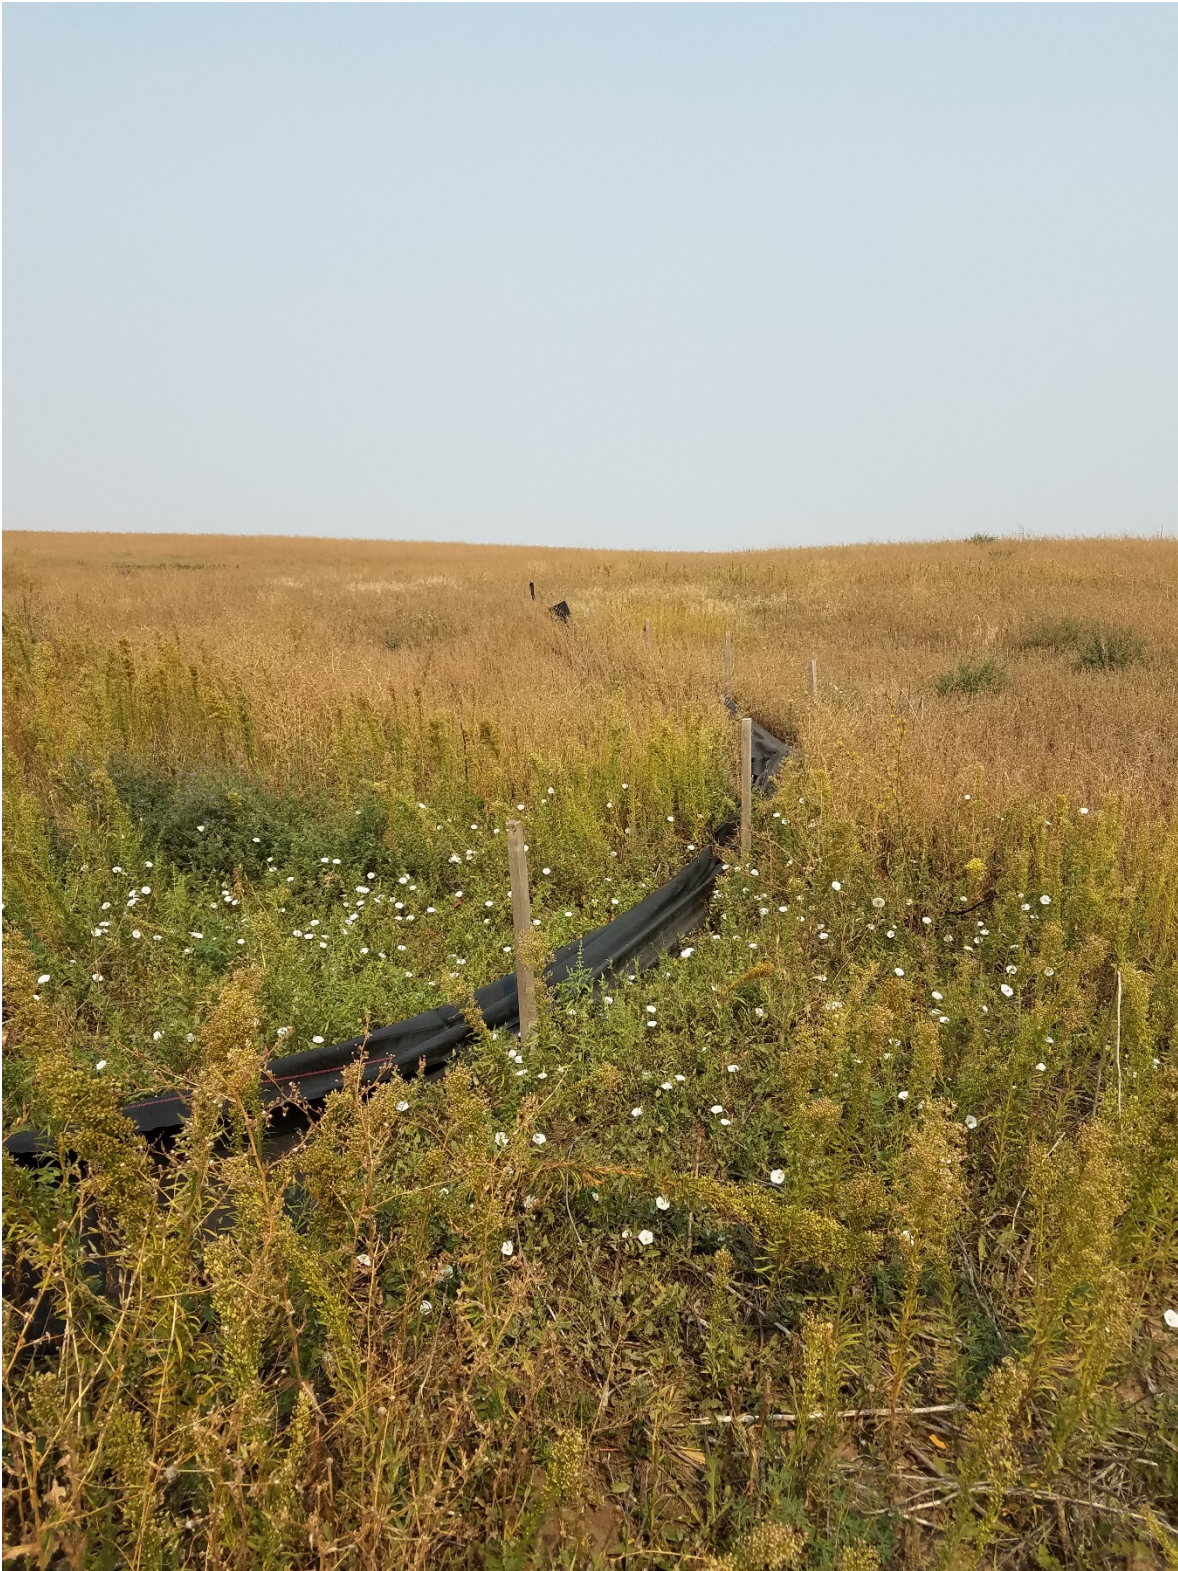
working order except for one silt fence on the north side of the access road (Photo #4). Approximately 20 feet of the fence was not in working condition and torn off of the anchor stakes. During inspection it was noted there was a small amount of miscellaneous trash on the ground throughout site (Photo #5).

Report Photo #4: Silt fence in need of maintenance on east side of Project.

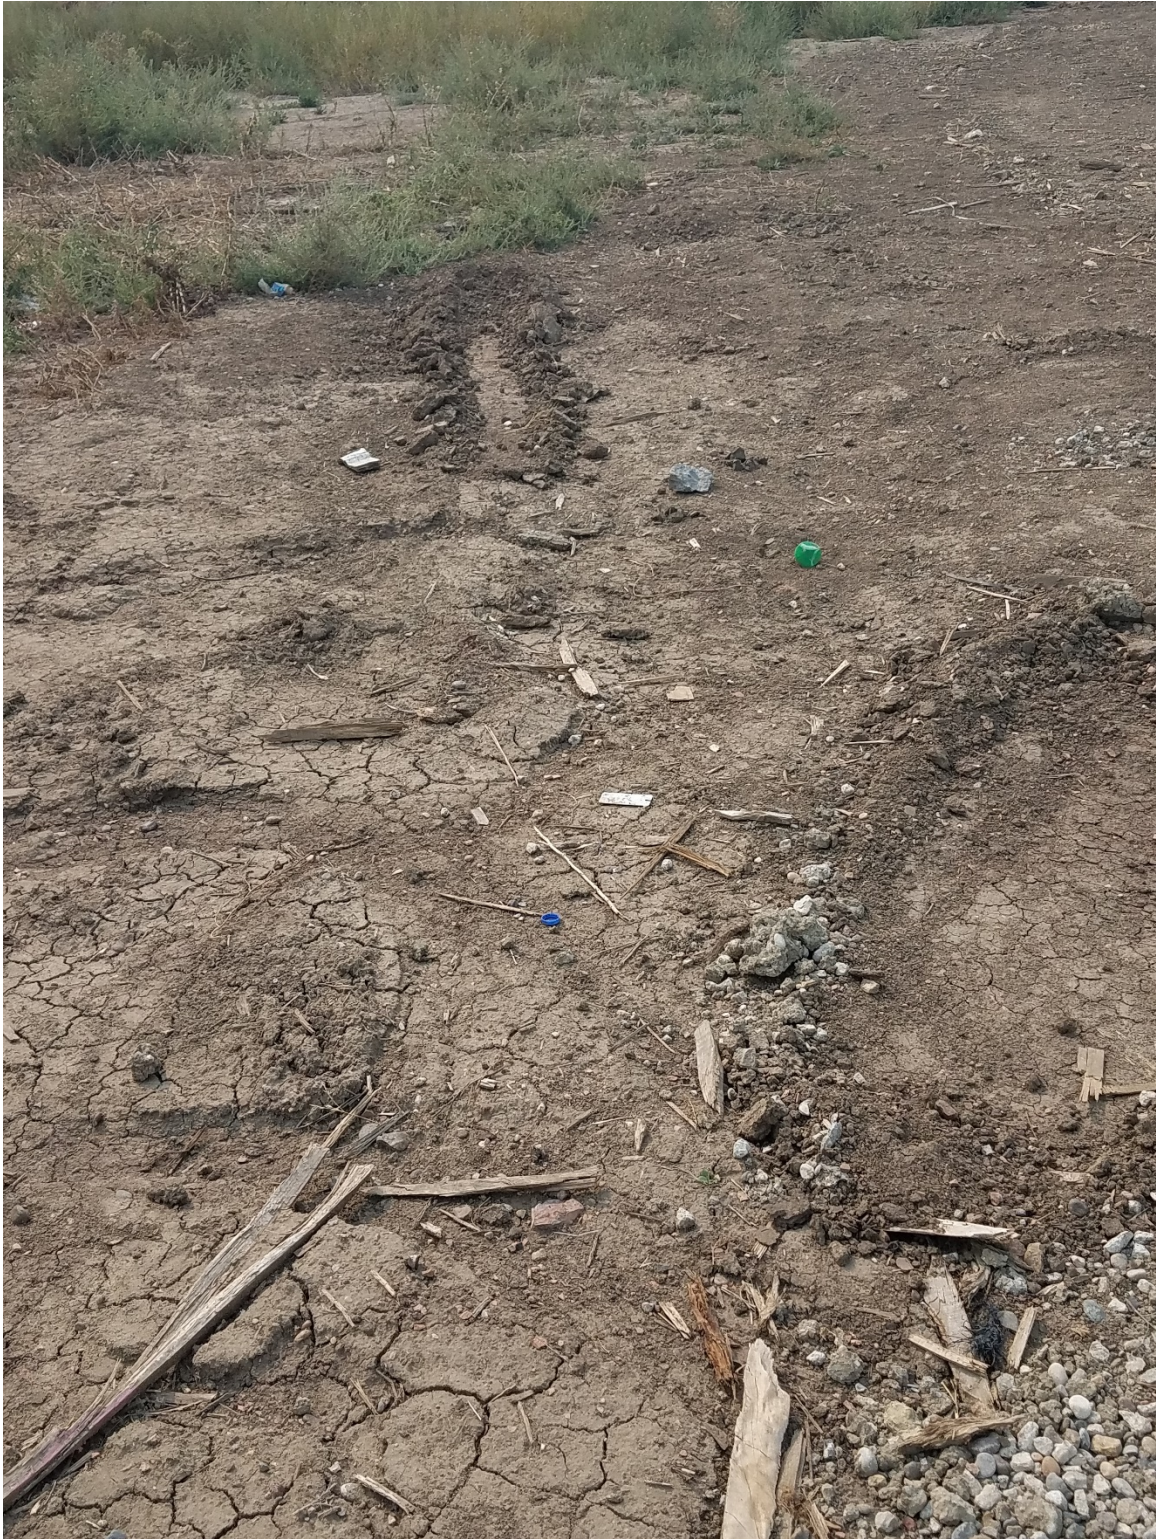
Report Photo #5: Trash scattered onsite.
