In re: ONEOK Bakken Pipeline, L.L.C.
Spring Creek Pump Station Project
McKenzie County
Case No. PU-15-725
Our File No. 072591-000005

Case No. PU-15-725
ONEOK Bakken Pipeline, L.L.C.
Spring Creek Pump station, McKenzie County

ONEOK Bakken Pipeline, L.L.C. ("OBP") respectfully responds to the October 2, 2017 letter regarding the Reclamation and Revegetation Inspection Report for the Spring Creek Pump Station Project ("Project").

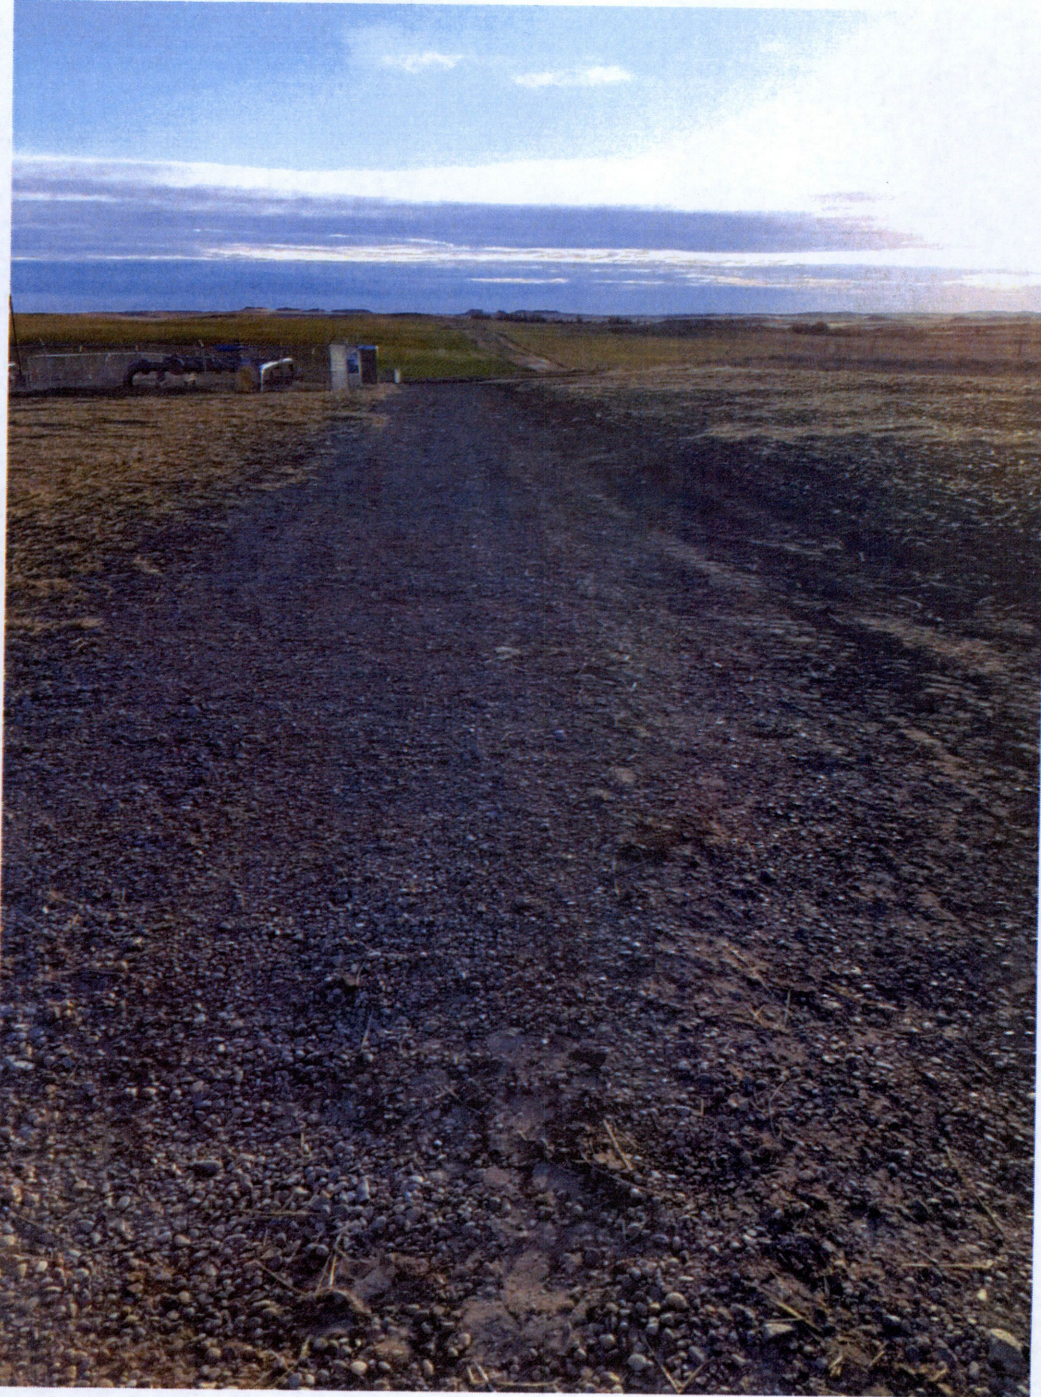
1. The access road conditions due to the Garden Creek Loop and Spring Creek building construction will be addressed upon completion of the Spring Creek building construction. Construction of the building is planned to be completed by the end of November 2017. (Photos 1 and 2)
2. Canadian Thistle near the entrance culvert has been cut. Chemical treatment during this time of year is not recommended by the restoration contractor, but will be applied at the appropriate time in 2018. (Photo 3)
3. Appropriate BMPs have been added around the soil pile. (Photo 4)
4. Site housekeeping issues have been and will continue to be addressed in a timely manner. Please see attached photo. (Photo 5)
5. A new silt fence has been installed at this location. (Photo 6)

Photo 1 – Access road on South side of project looking East

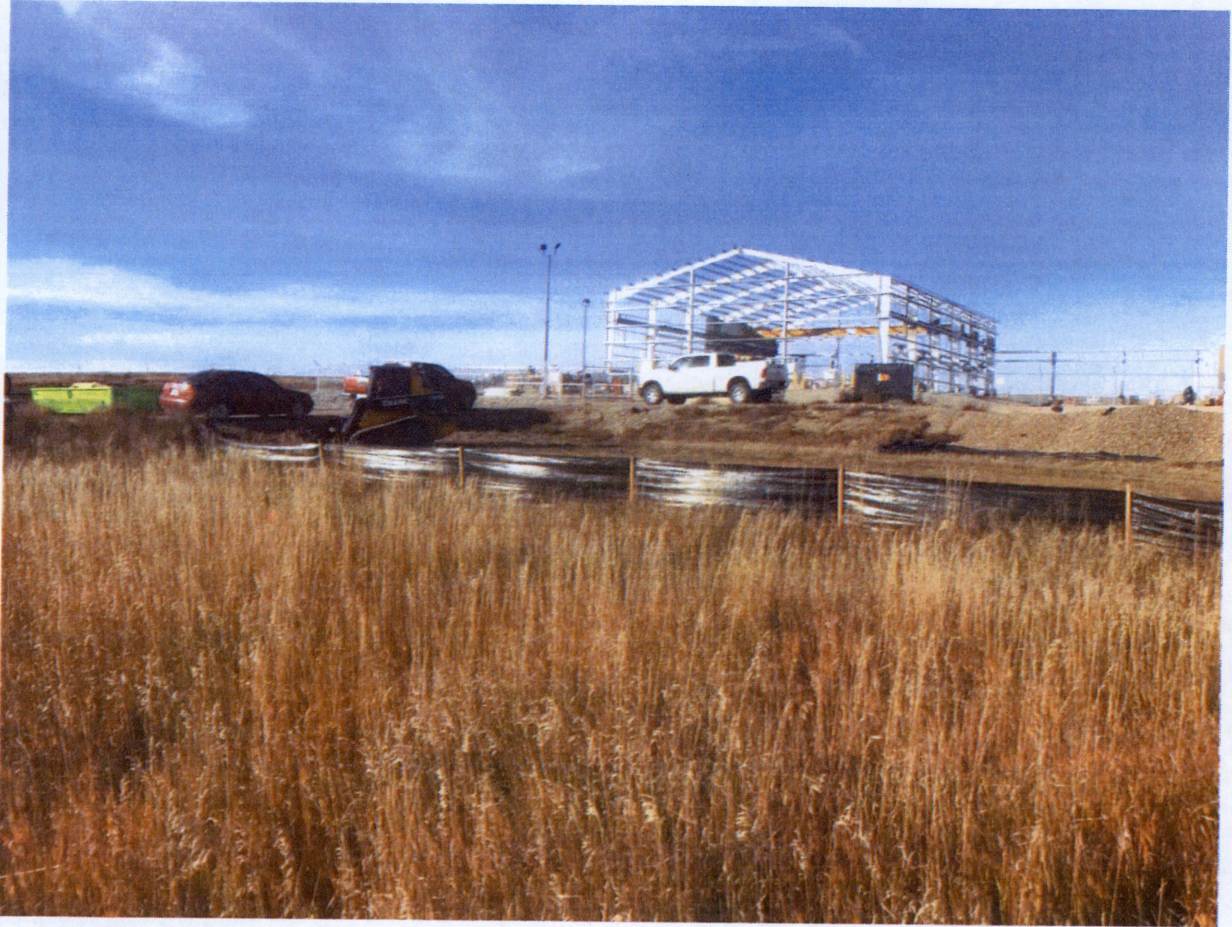
Photo 2 – Spring Creek building construction

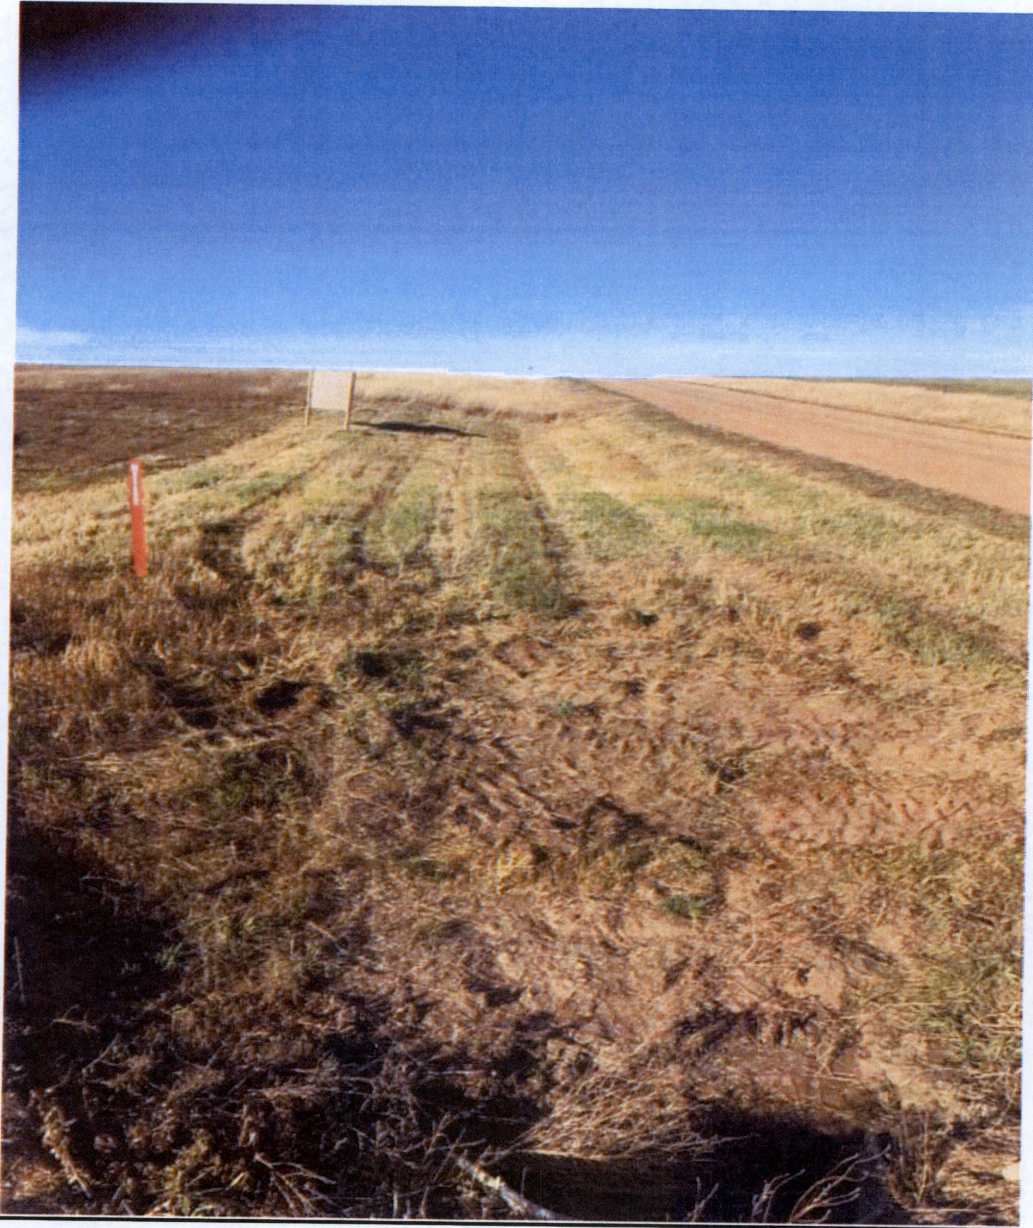
Photo 3 – Canadian Thistle removed near the entrance culvert on the East side of property

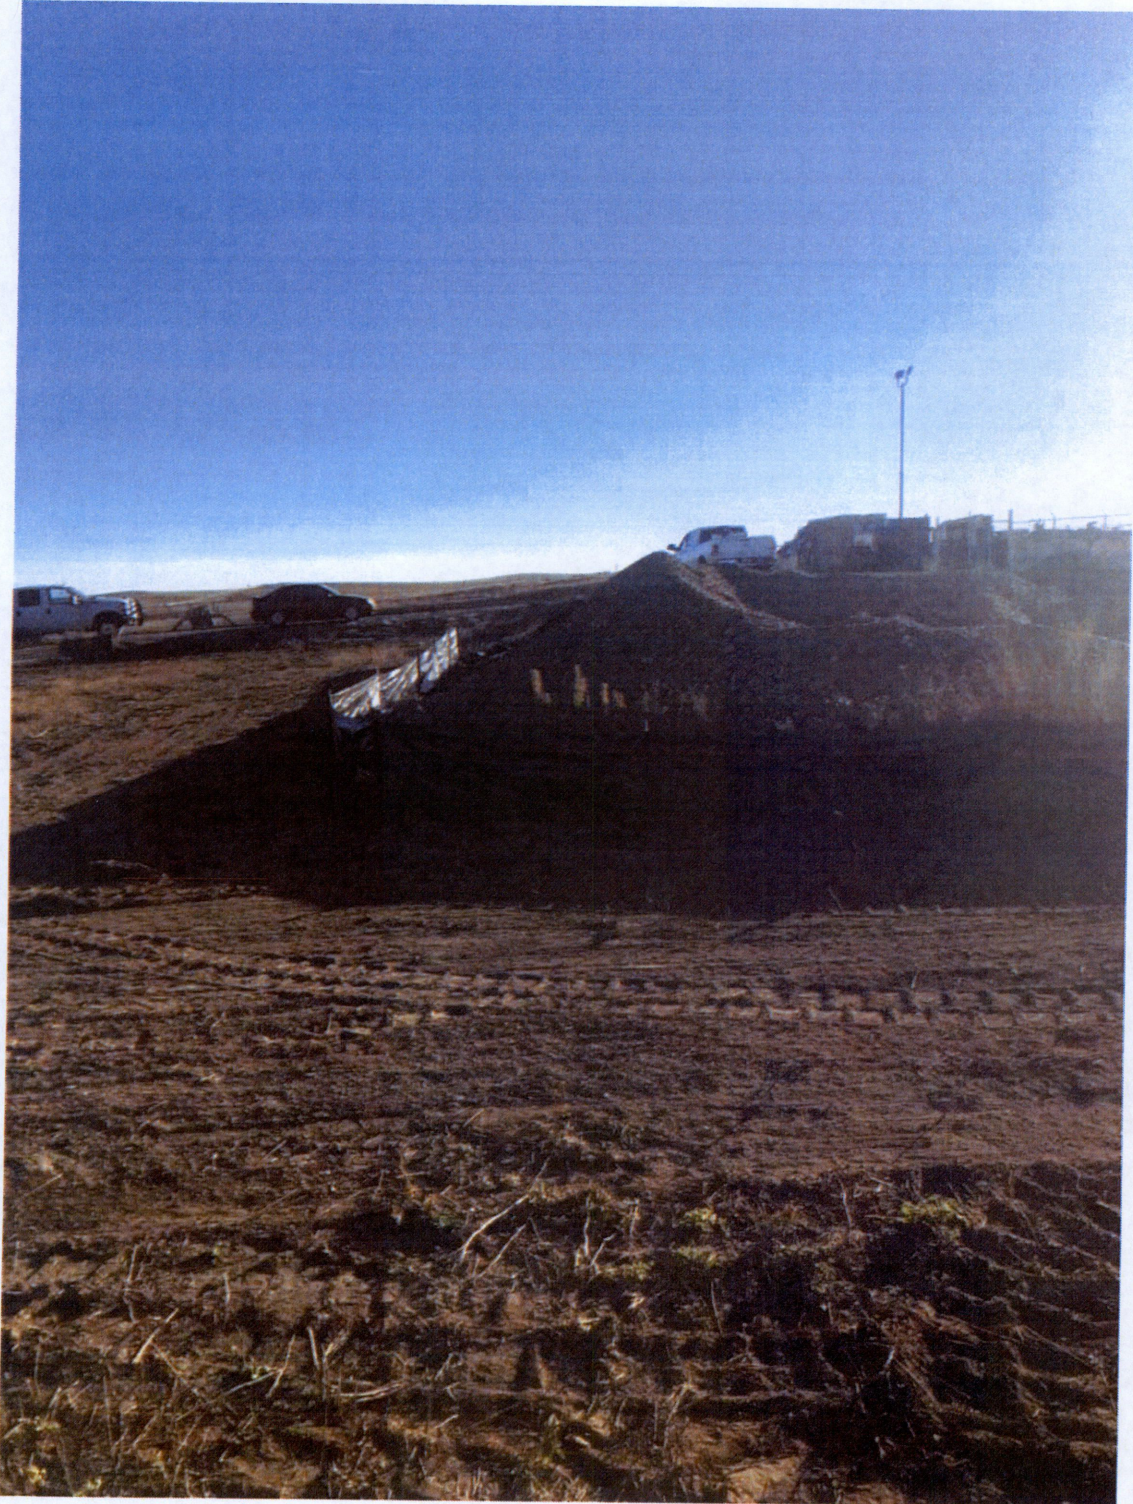
Photo 4 – BMP's added around spoils pile to help control stormwater runoff.

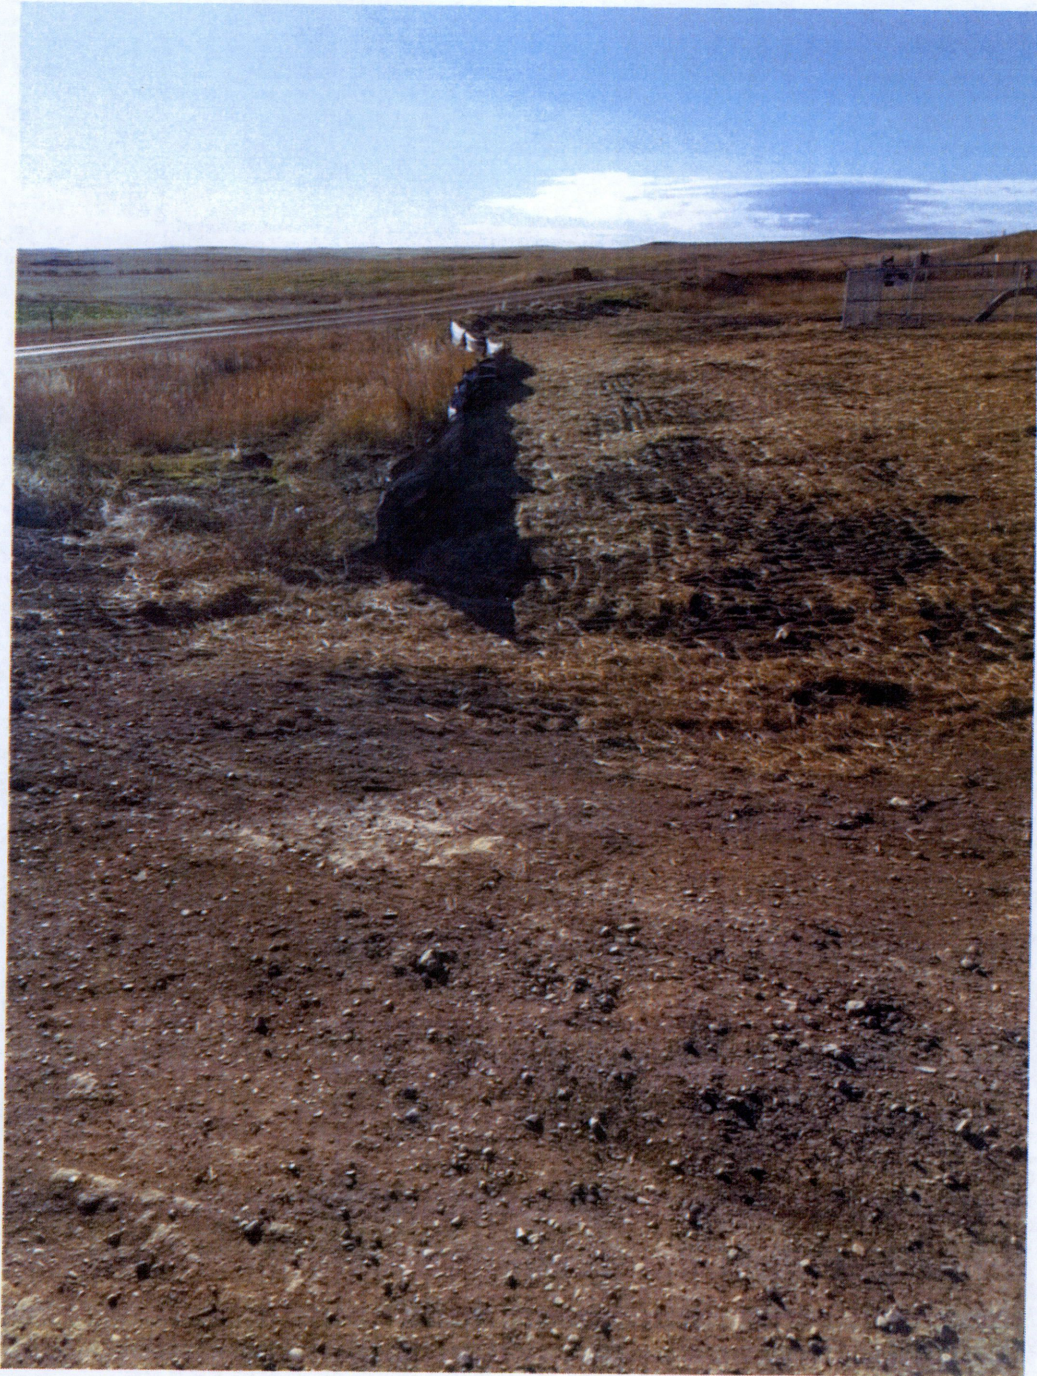
Photo 5 – East side entrance looking South.

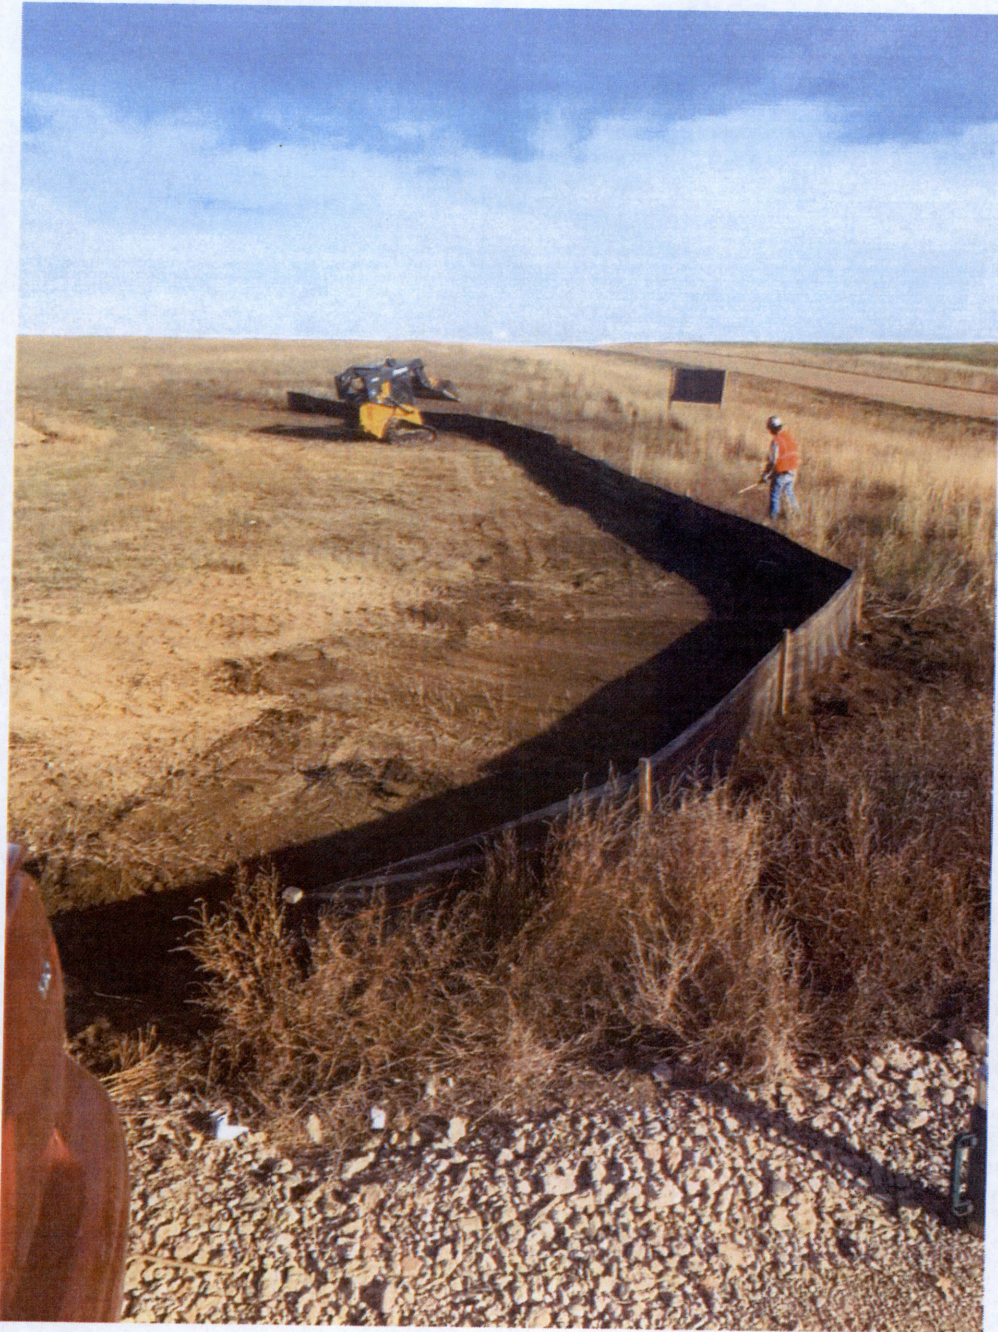
1. The access road should have gravel laid on the surface or be revegetated to prevent stormwater runoff as it is currently at risk of having sediment runoff during a rainfall event.
2. Management of Canada thistle onsite. North Dakota law requires everyone to do all things necessary and proper to control the spread of noxious weeds in North Dakota. Apply stormwater BMPs to soil pile as it is currently at risk of having sediment runoff during a rainfall event.
3. Apply Stormwater BMPs to soil pile as it is currently at risk of having sediment runoff during a rainfall event.
4. Improve housekeeping onsite to prevent and remove trash from accumulating at the Project site.
5. Stormwater BMPs (silt fences) need maintenance to be in proper working condition.

Photo 6 – New silt fence installation on East side facing North.
