Oasis Midstream Services, LLC
Wild Basin to Johnsons Corner Pipeline
Topsoil Removal Inspection Report

April 29, 2016
Case No. PU-15-733

42 **PU-15-733** Filed: 5/2/2016 Pages: 17
Topsoil Removal Inspection Report

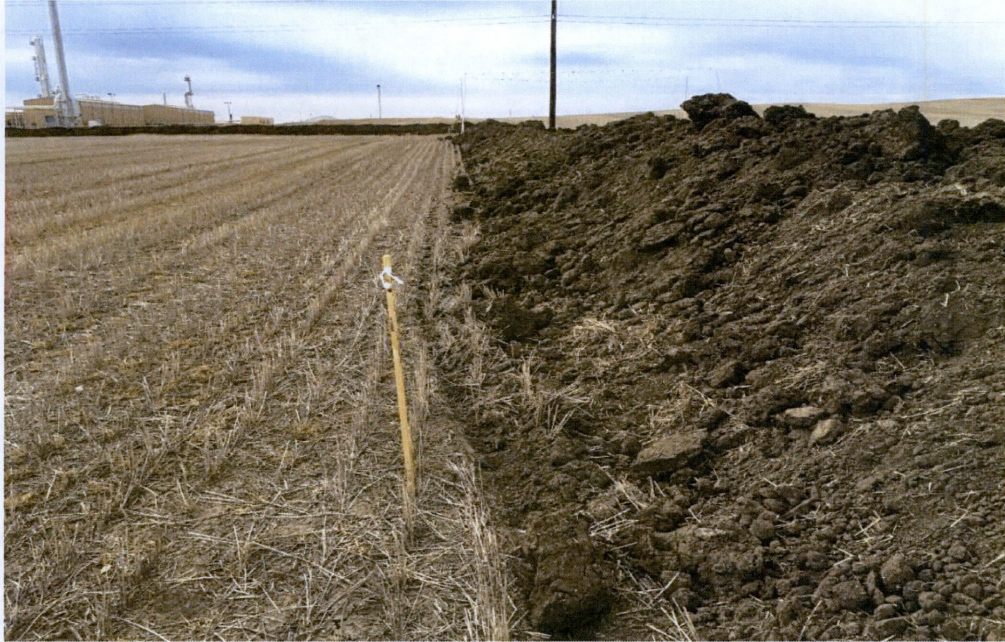
Photo 1 – Approx. Station 7+00. View of topsoil pile inside the boundaries of the approved corridor.

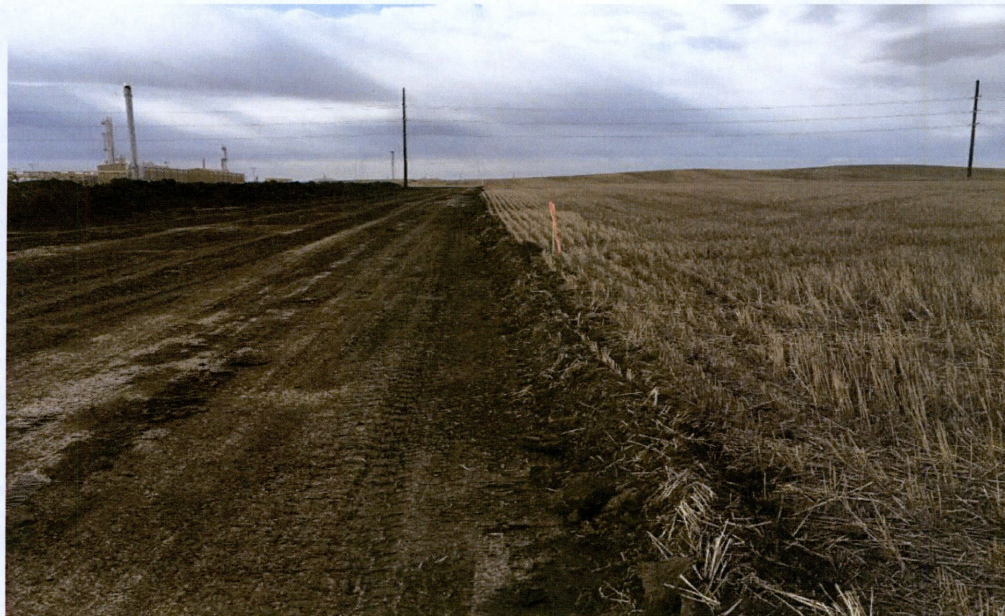
Photo 2 – Approx. Station 7+00. View of impacted area inside the boundaries of the approved work area.

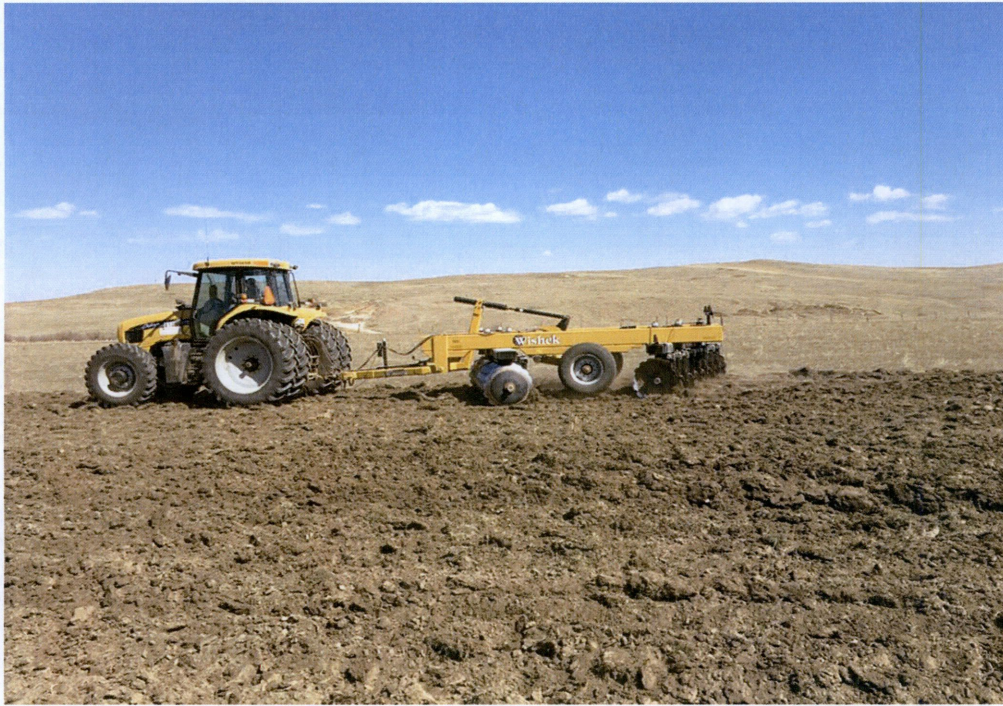
Photo 3 – Approx. Station 128+00. View of discing activities.

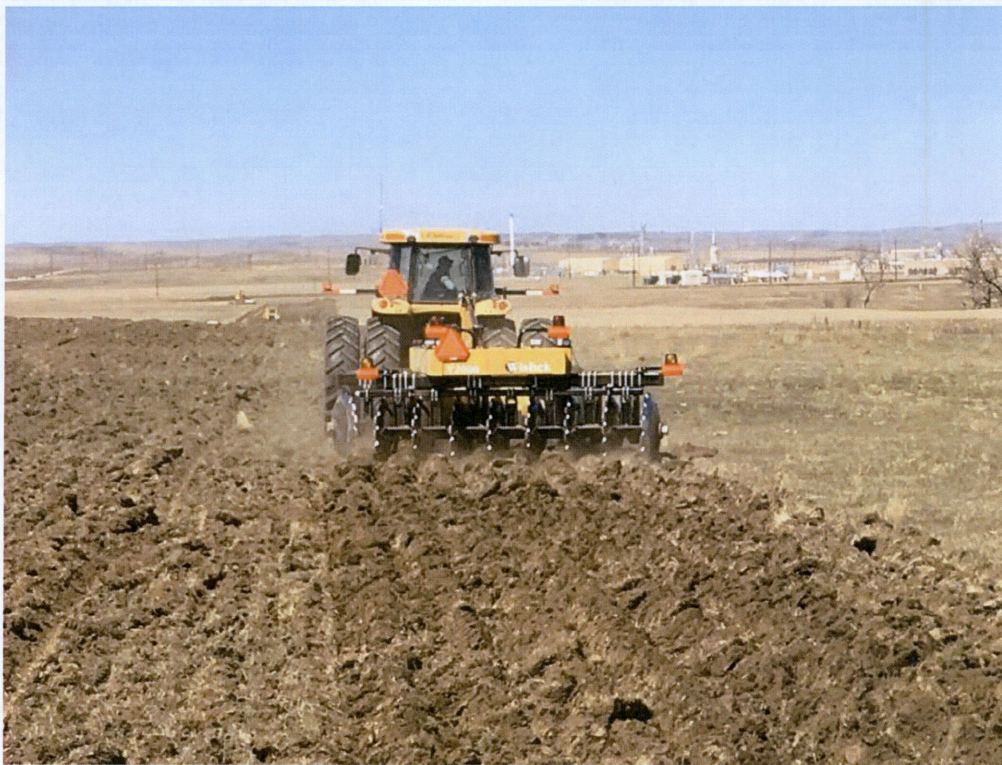
Photo 4 – Approx. Station 128+00. View of discing activities.

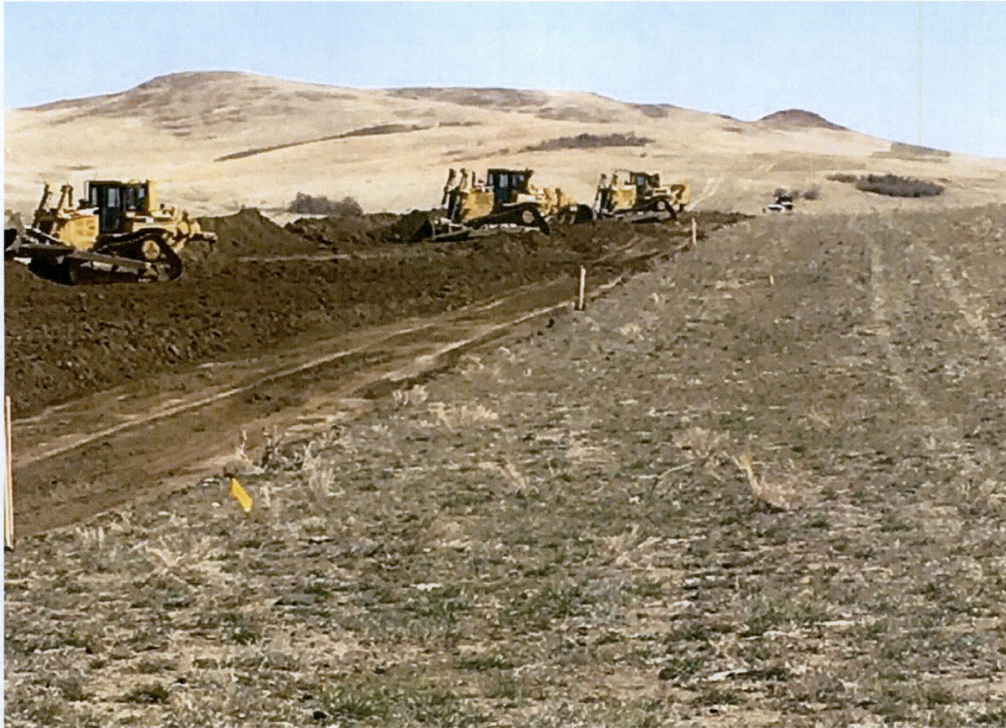
Photo 5 – Approx. Station 114+00. View of topsoil removal.

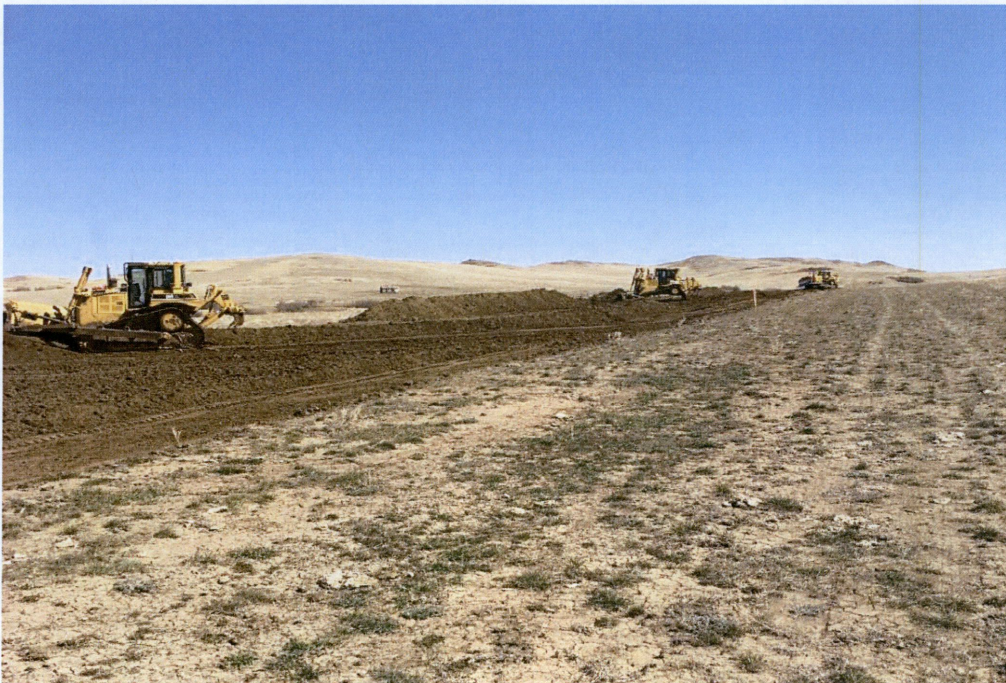
Photo 6 – Approx. Station 114+00. View of topsoil removal.

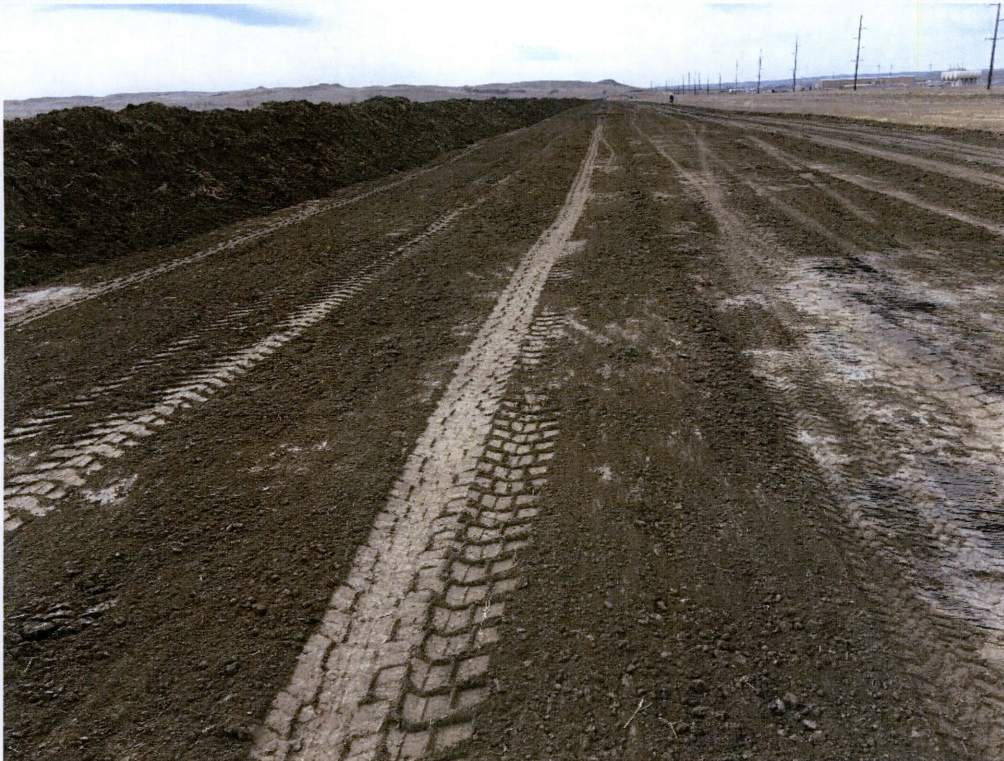
During the inspection, two issues were identified as needing corrective action. At approximate Station 43+00, Mr. Hennen identified an area that appeared to have an insufficient depth of topsoil removed (Photos 7 and 8). Mr. Hyde directed the equipment operators to return to the area of insufficient topsoil depth; within hours, equipment had removed the topsoil to an acceptable depth (Photos 9 and 10). At approximate Station 30+00, Mr. Hennen identified a portion of the spoil from the hydro vac potholing activities that had encroached on the topsoil pile (Photos 11 and 12). This was communicated to Mr. Hyde and by the end of the day, the hydro vac spoil had been separated from the topsoil pile (Photos 13 and 14).

Photo 7 – Approx. Station 43+00. View of area with insufficient depth of removed topsoil.

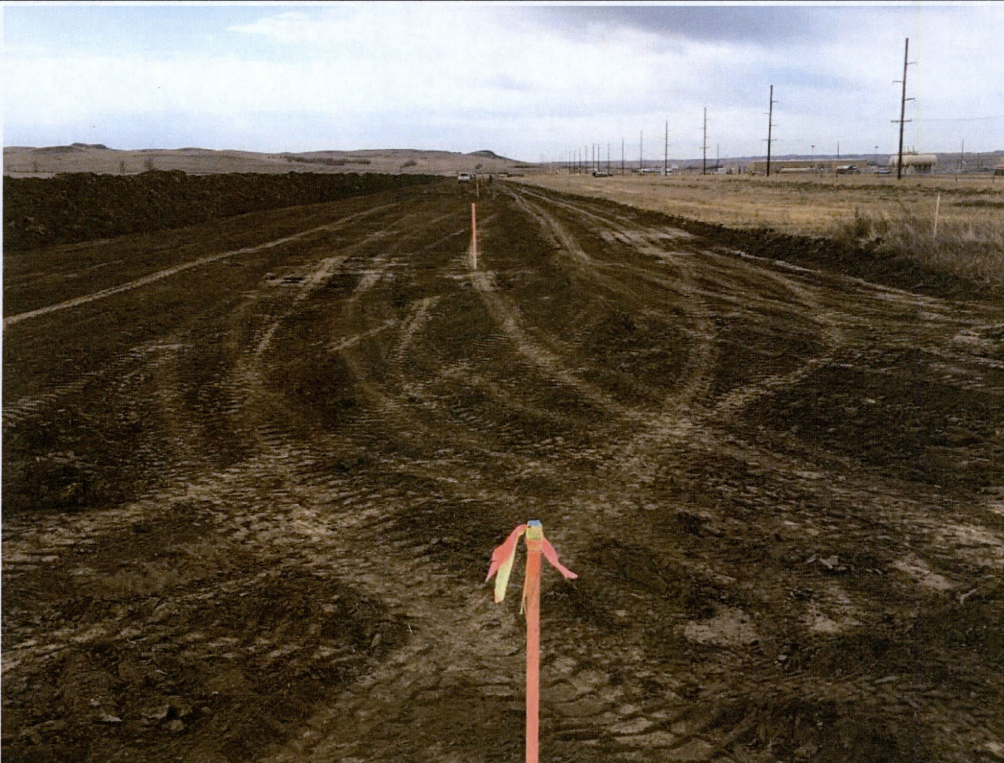
Photo 8 – Approx. Station 43+00. View of area with insufficient depth of removed topsoil.

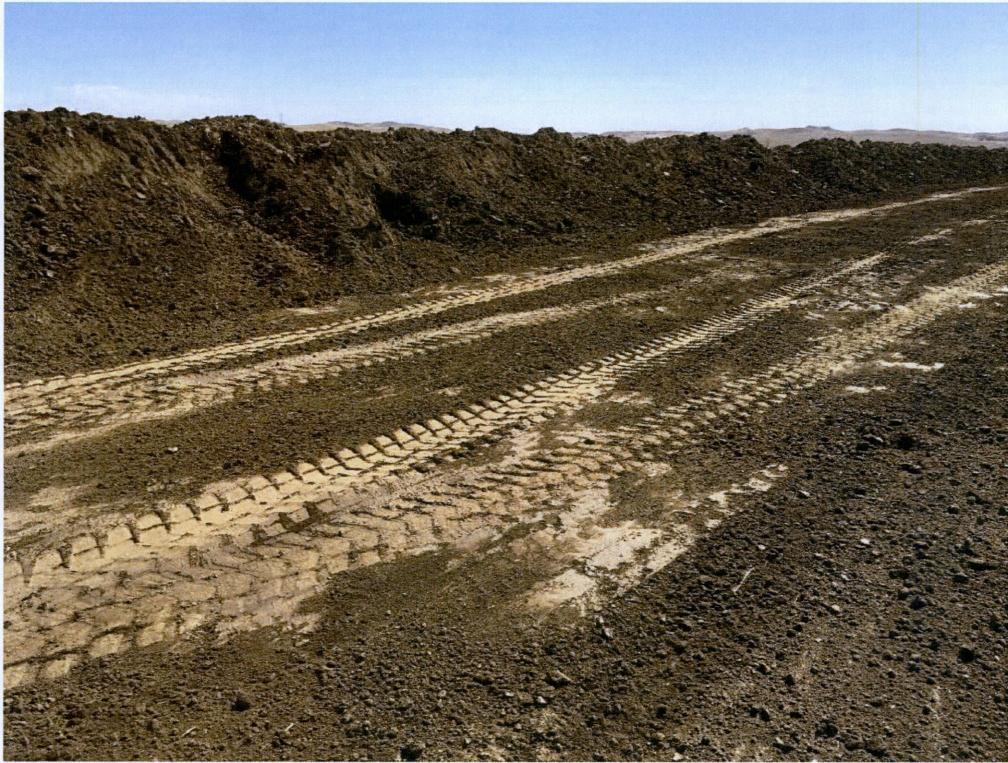
Photo 9 – Approx. Station 46+00. View of area after additional topsoil removal.

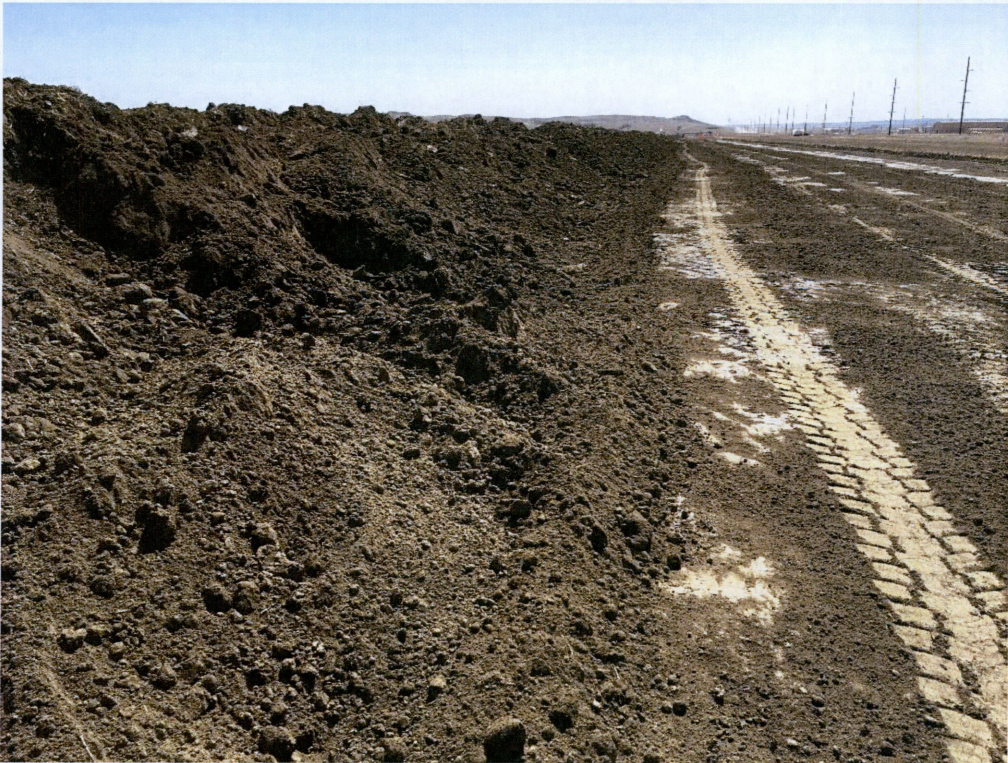
Photo 10 – Approx. Station 46+00. View of area after additional topsoil removal.

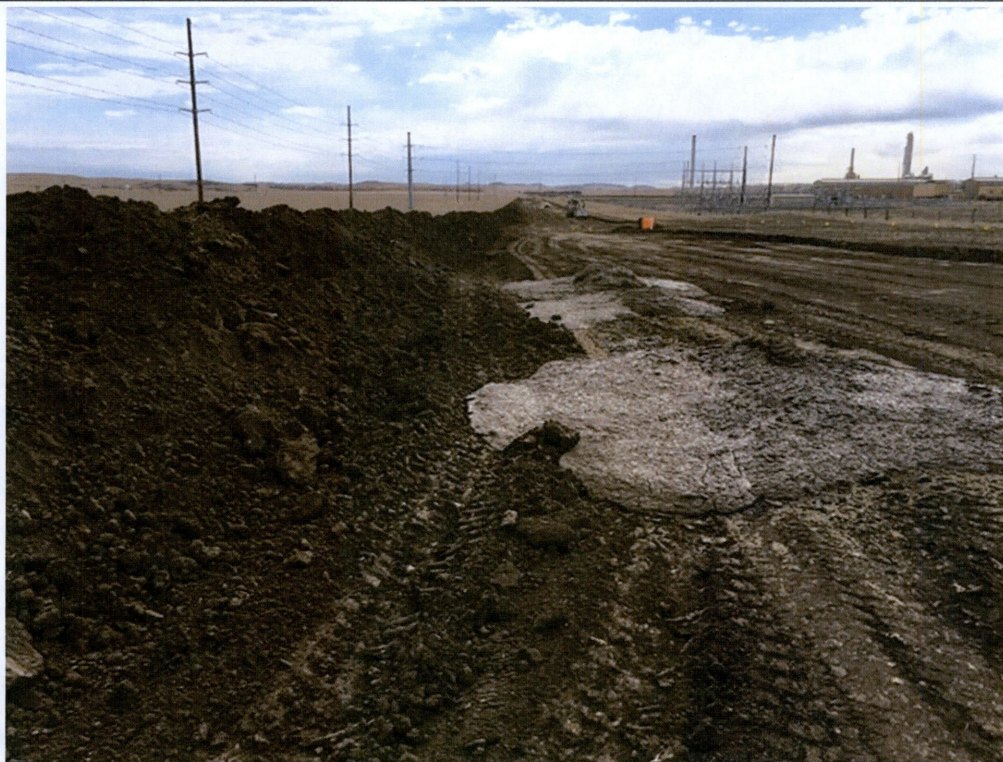
Photo 11 – Approx. Station 30+00. Hydro vac spoil encroaching on topsoil pile.

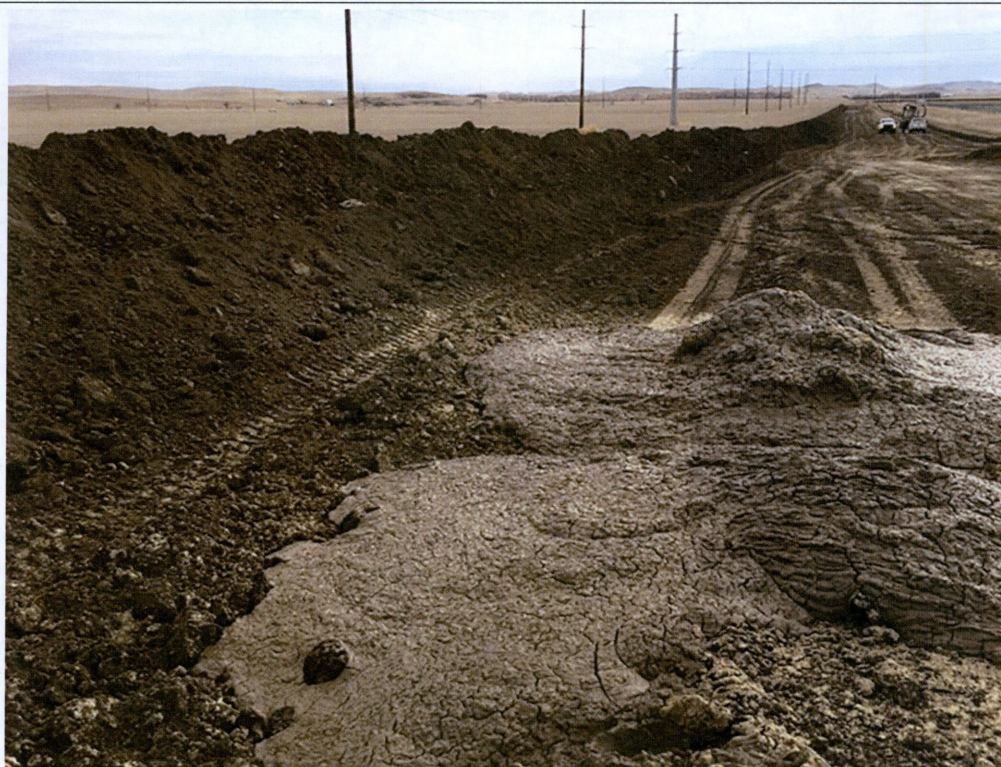
Photo 12 – Approx. Station 30+00. Hydro vac spoil encroaching on topsoil pile.

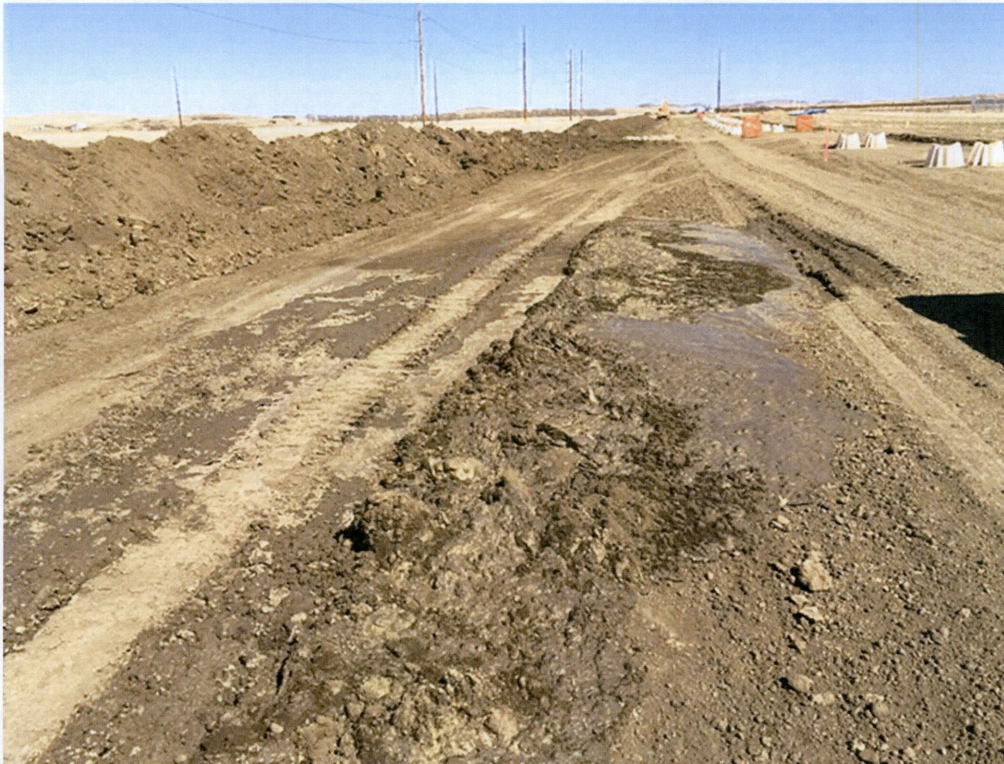
Photo 13 – Approx. Station 30+00. View of the hydro vac spoil separated from the topsoil pile.

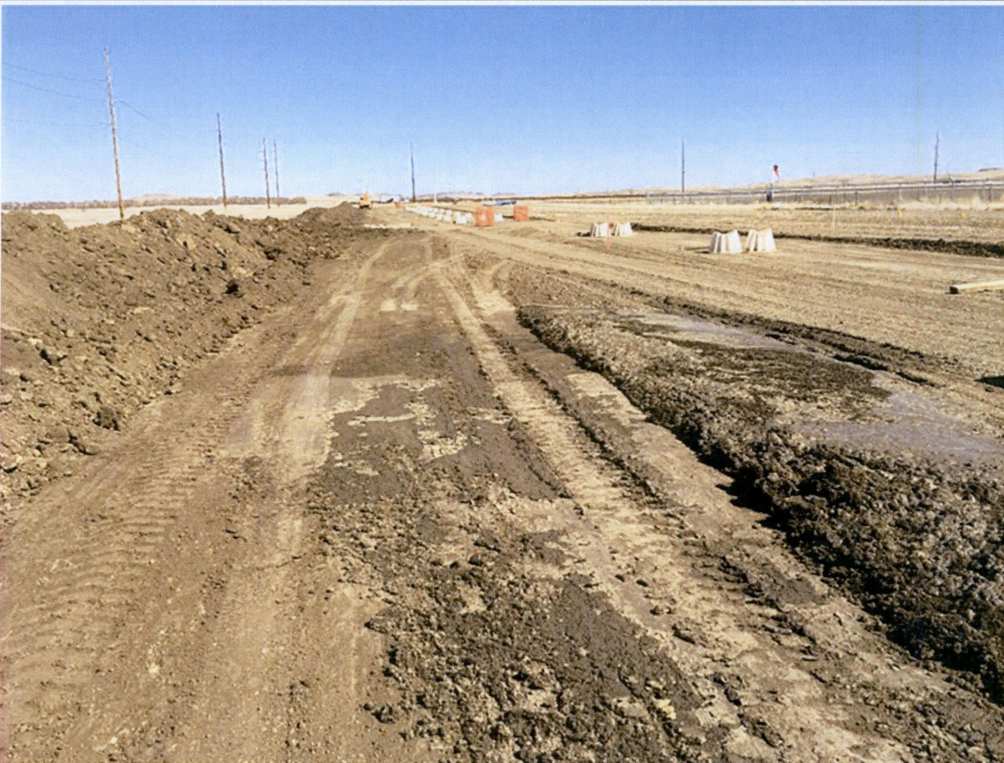
Photo 14 – Approx. Station 30+00. View of the hydro vac spoil separated from the topsoil pile.
