**OASIS MIDSTREAM SERVICES, LLC
WILD BASIN TO JOHNSONS CORNER PIPELINE CONSTRUCTION INSPECTION REPORT**

GENERAL INFORMATION

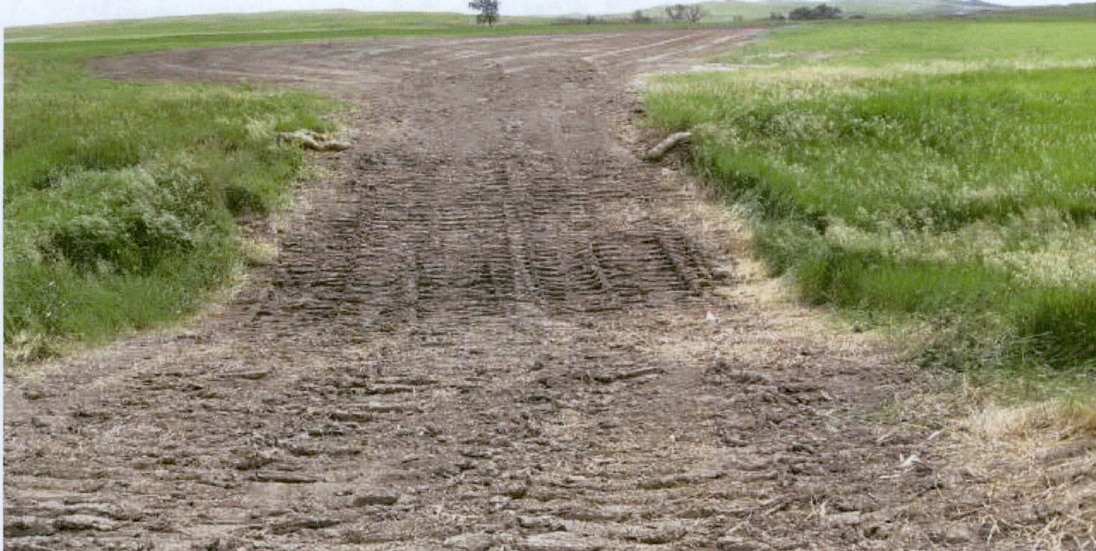
Photo 7 – Approx. Station 93+00. View of slope and wetland; inspector recommended erosion control.

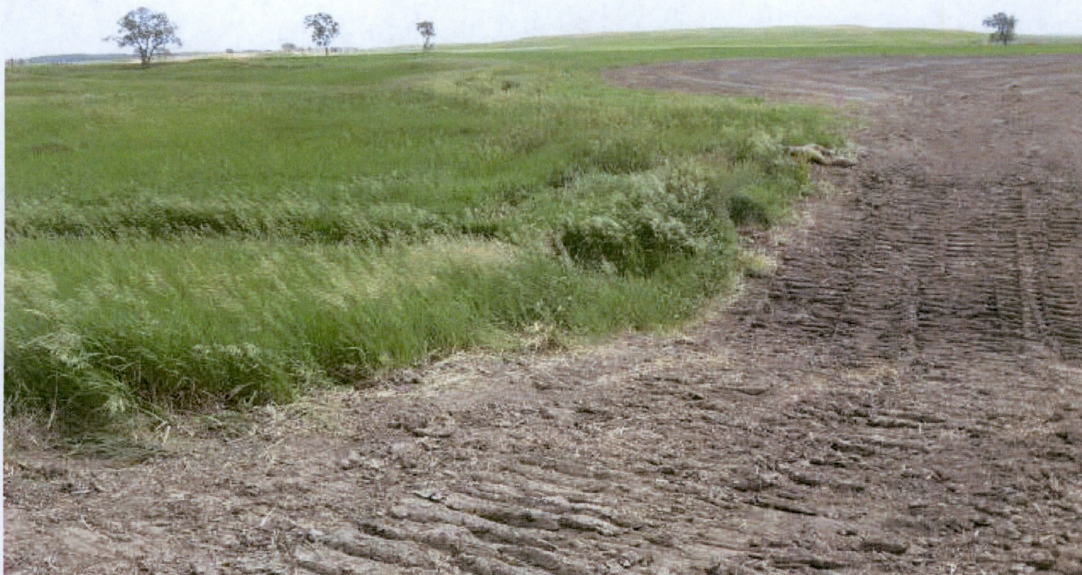
Photo 8 – Approx. Station 93+00. View of slope and wetland; inspector recommended erosion control.

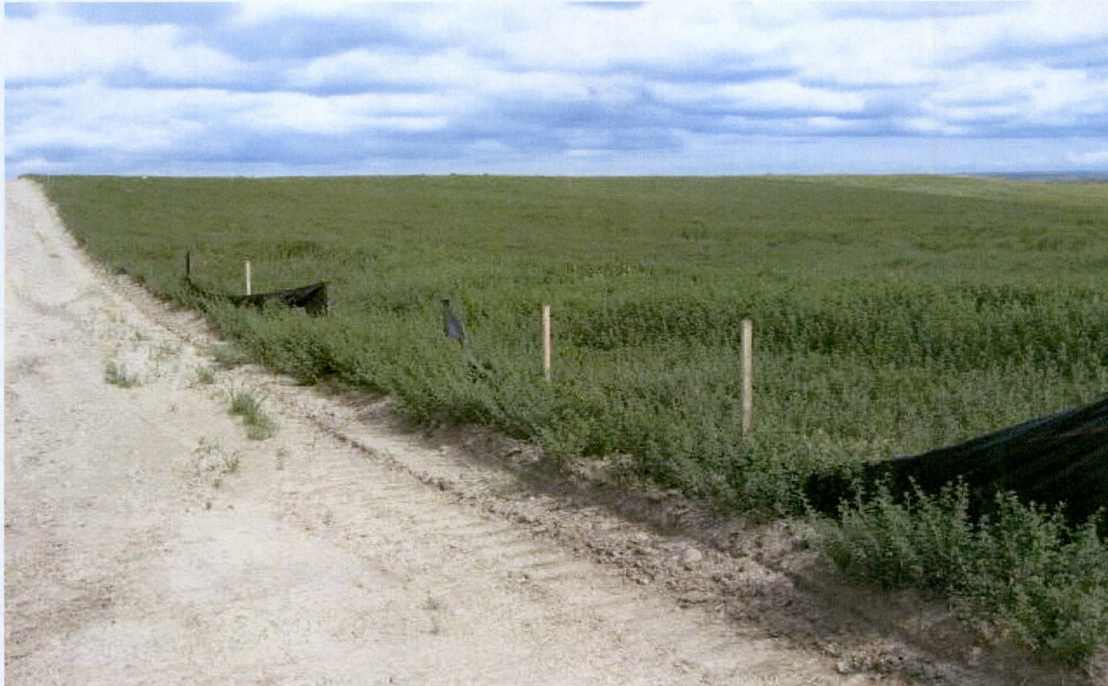
Photo 9 – Approx. Station 300+00. View of erosion control requiring repair.

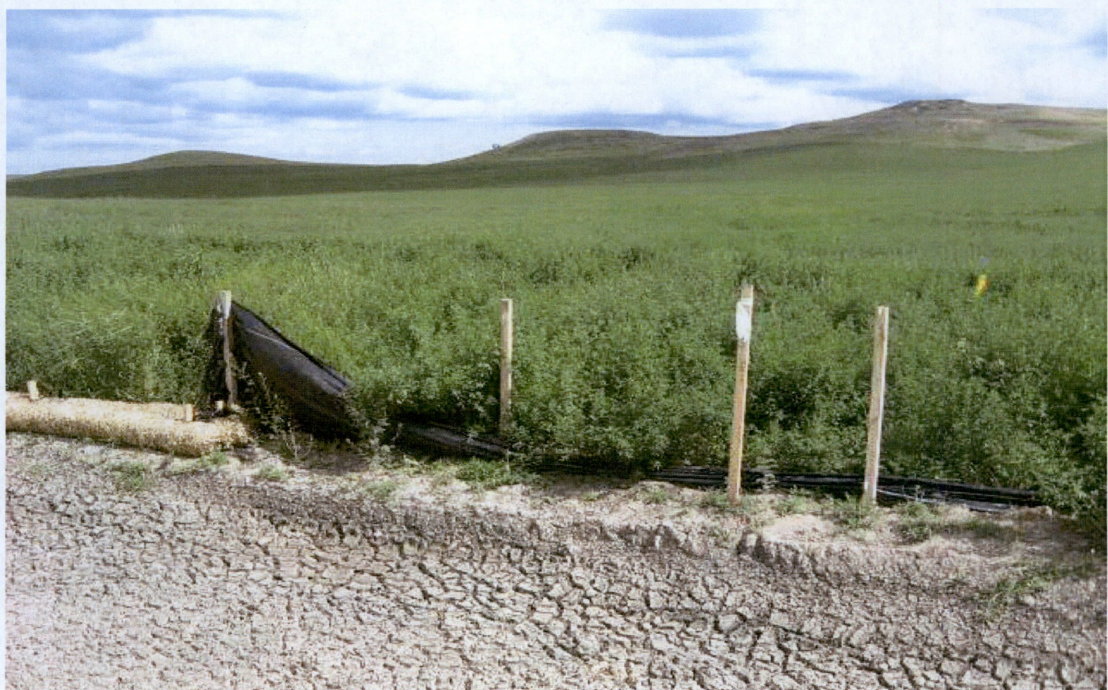
Photo 10 – Approx. Station 328+00. View of erosion control requiring repair.

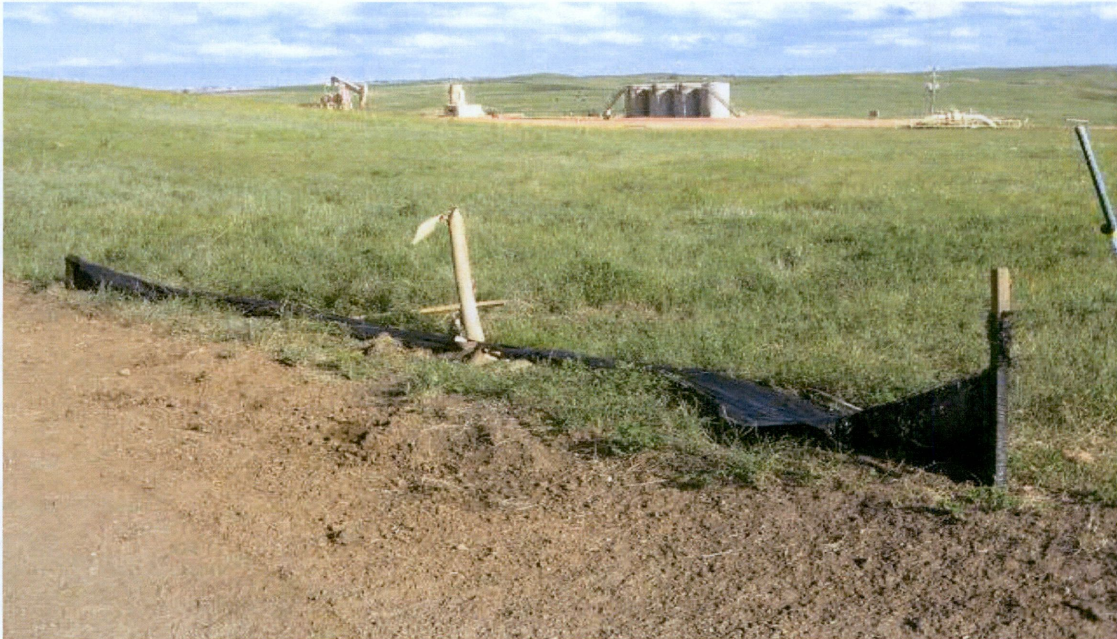
Photo 11 – Approx. Station 604+00. View of erosion control requiring repair.

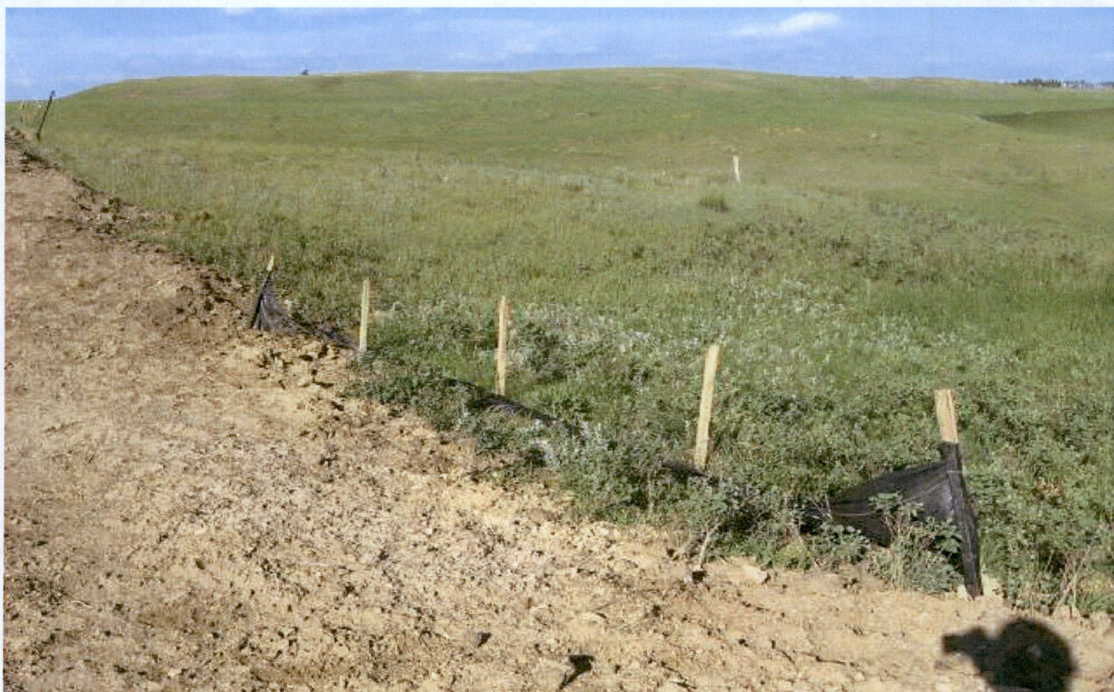
Photo 12 – Approx. Station 612+00. View of erosion control requiring repair.

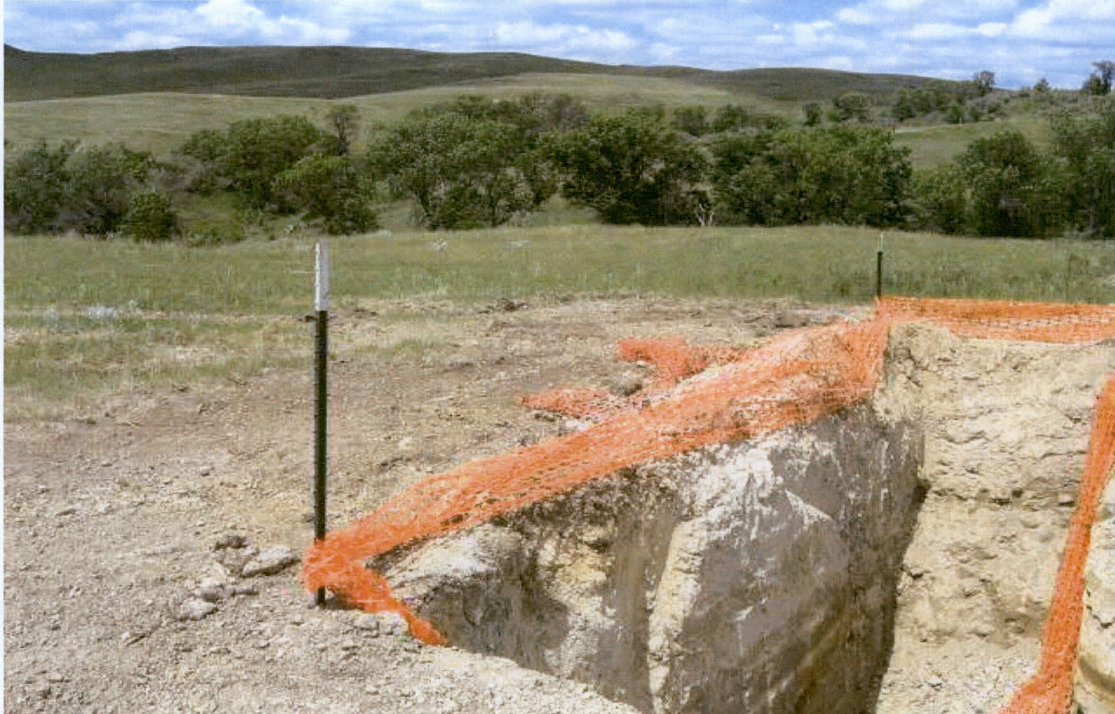
Photo 13 – Approx. Station 212+57. View of exclusion fence requiring repair.

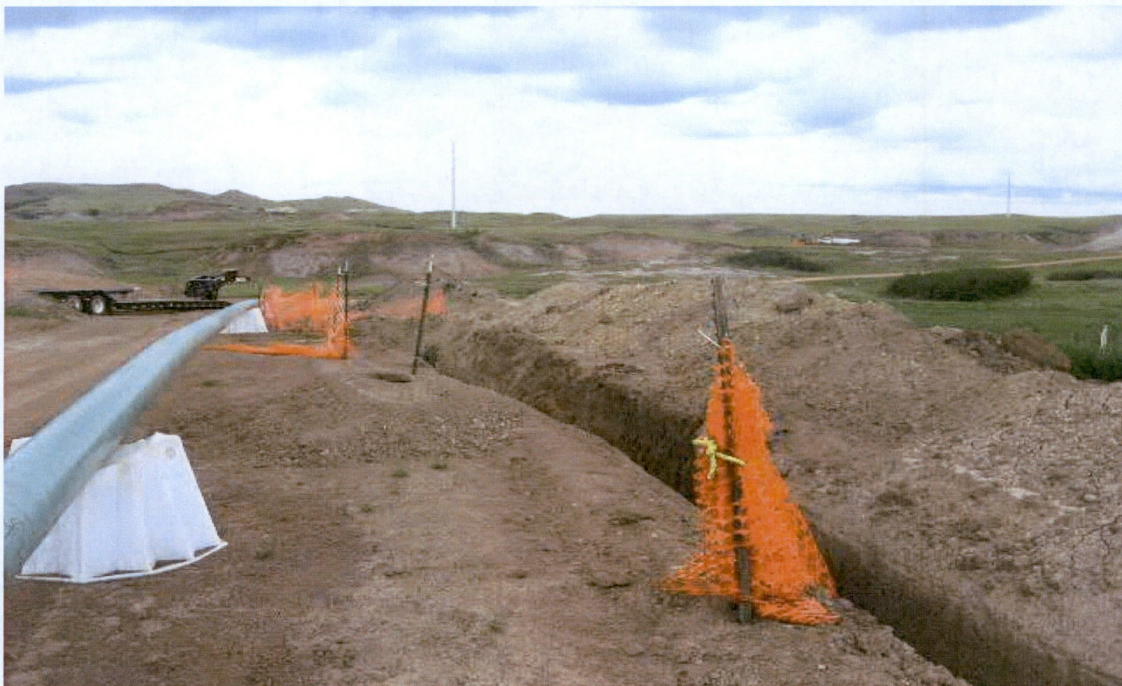
Photo 14 – Approx. Station 342+00. View of exclusion fence requiring repair.

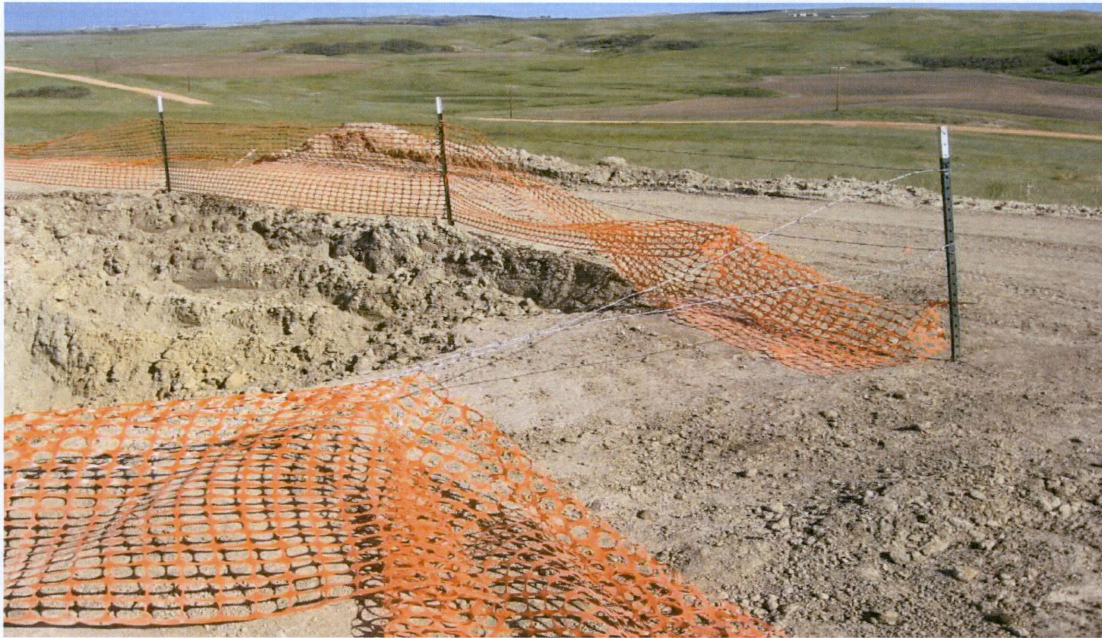
Photo 15 – Approx. Station 571+56. View of exclusion fence requiring repair.

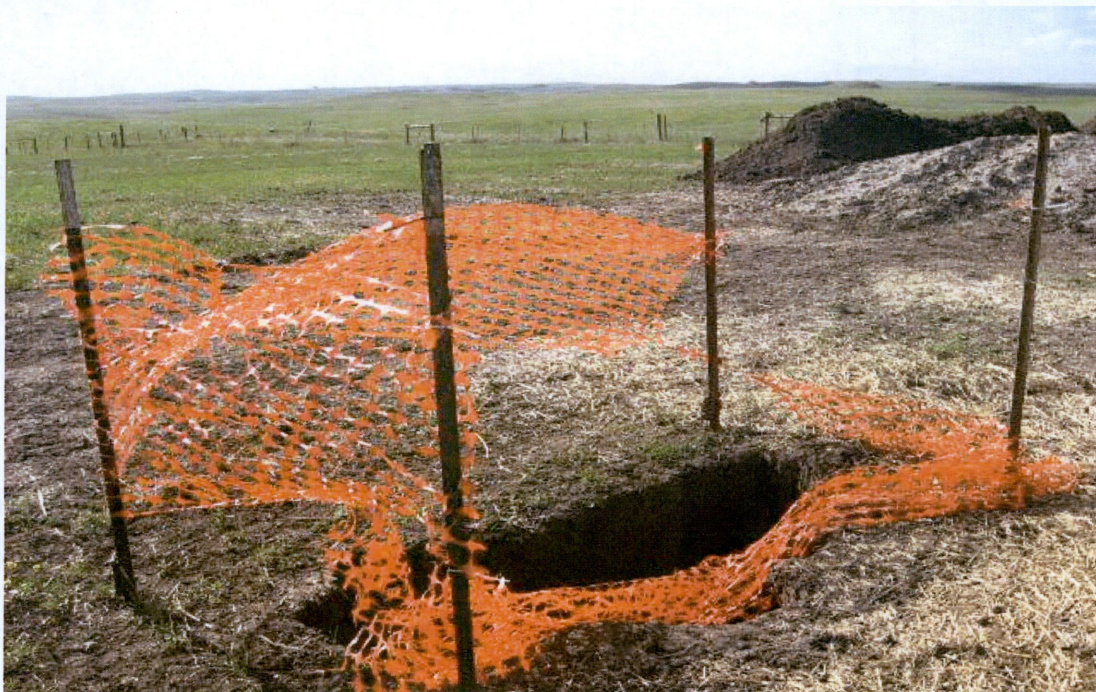
Photo 16 – Approx. Station 630+00. View of exclusion fence requiring repair.

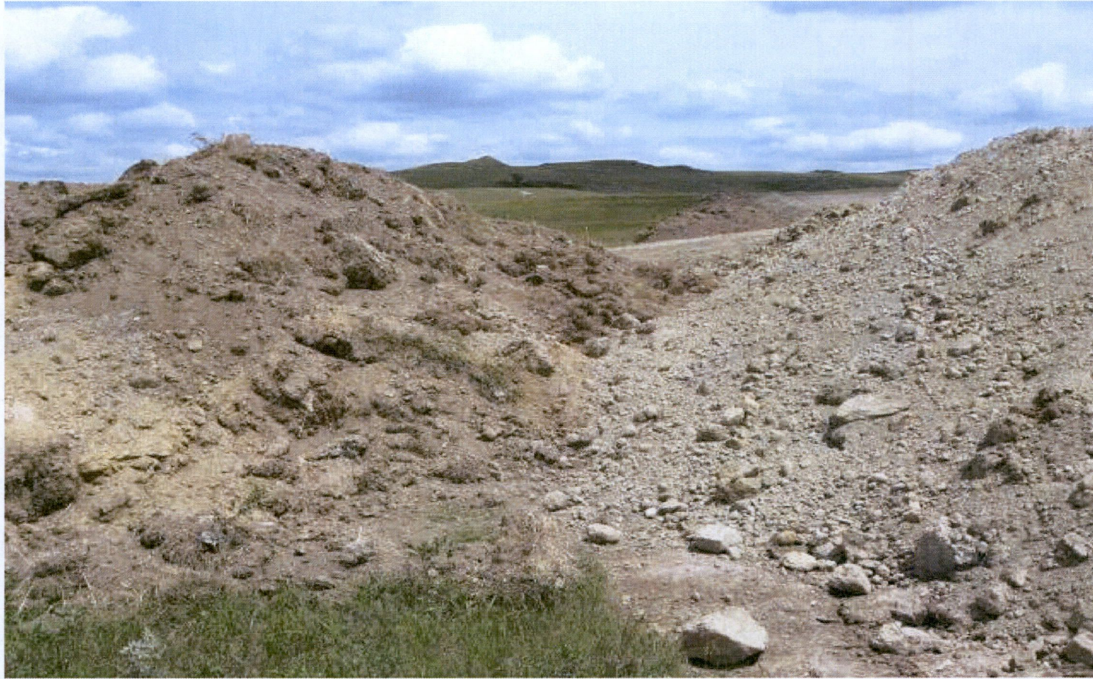
Photo 17 – Approx. Station 223+92. View of mixing topsoil and subsoil piles.

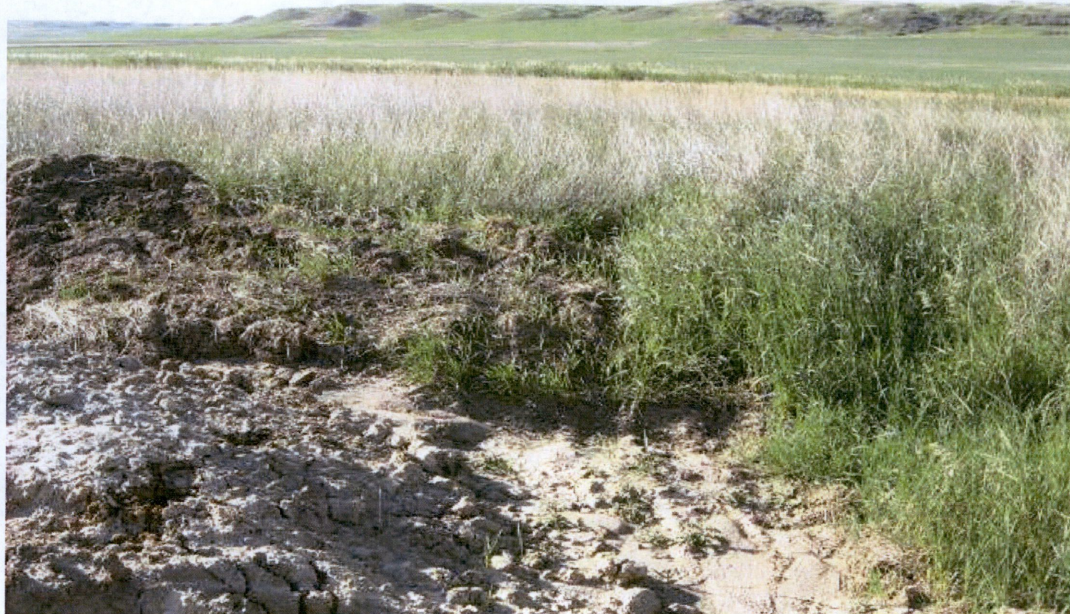
Photo 20 – Approx. Station 708+00. View of recommended erosion control adjacent to wetland.

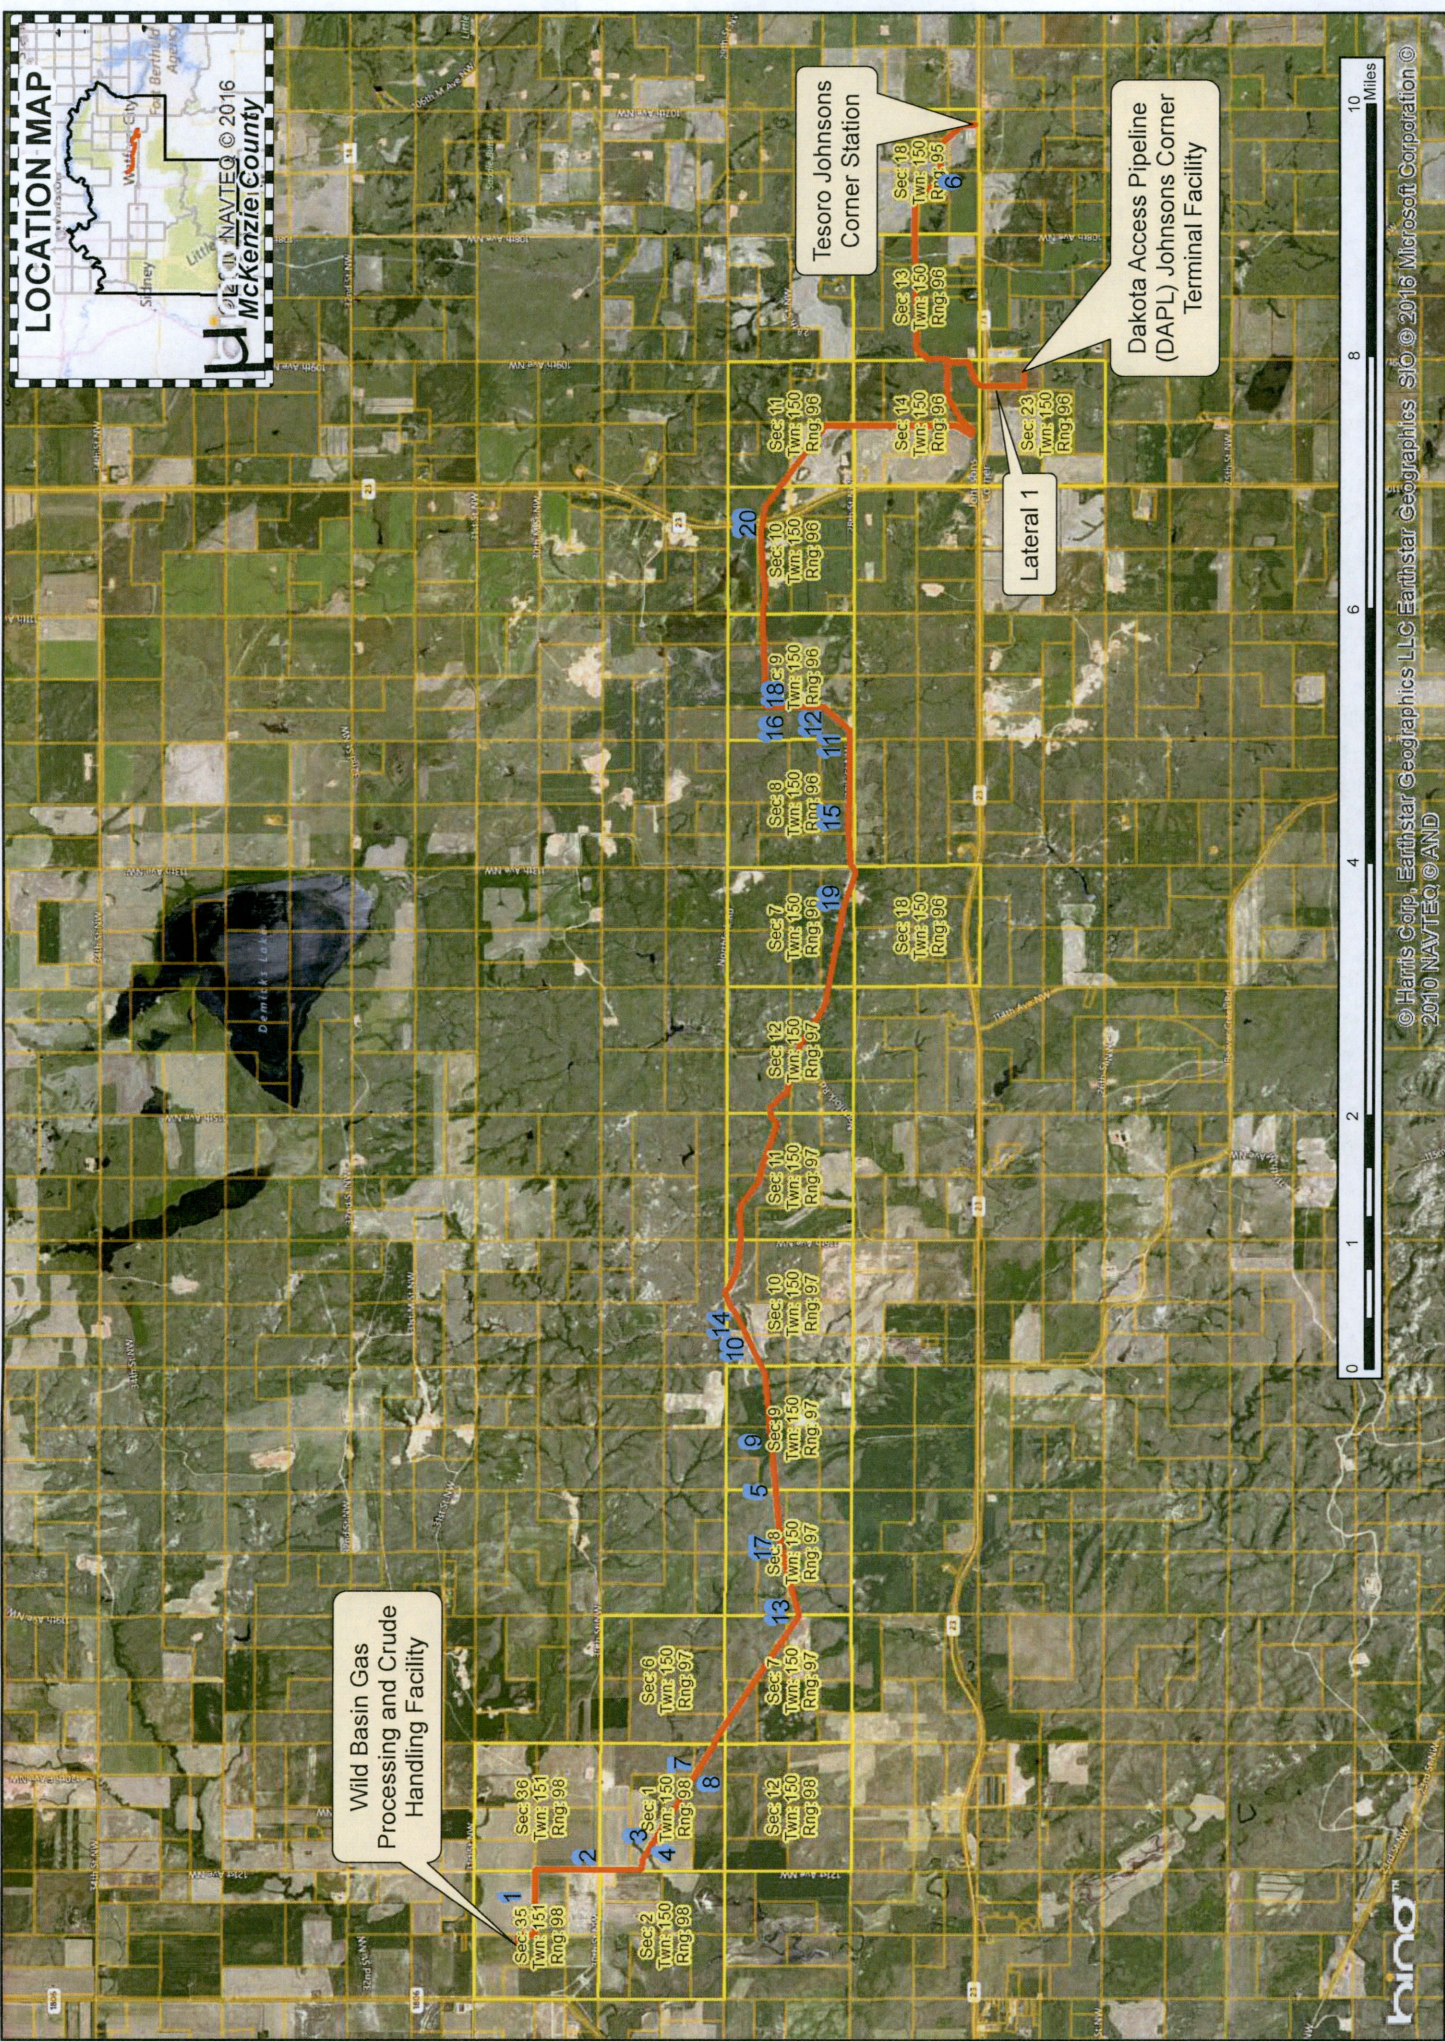
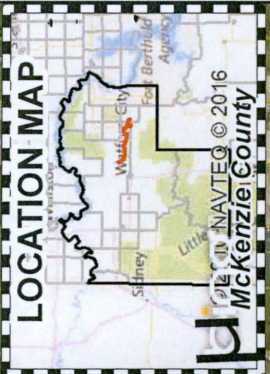
Wild Basin Gas Processing and Crude Handling Facility
