**Oasis Midstream Services, LLC
Wild Basin to Johnson's Corner Pipeline
Reclamation and Revegetation
Inspection Report**

Case No. PU-15-733

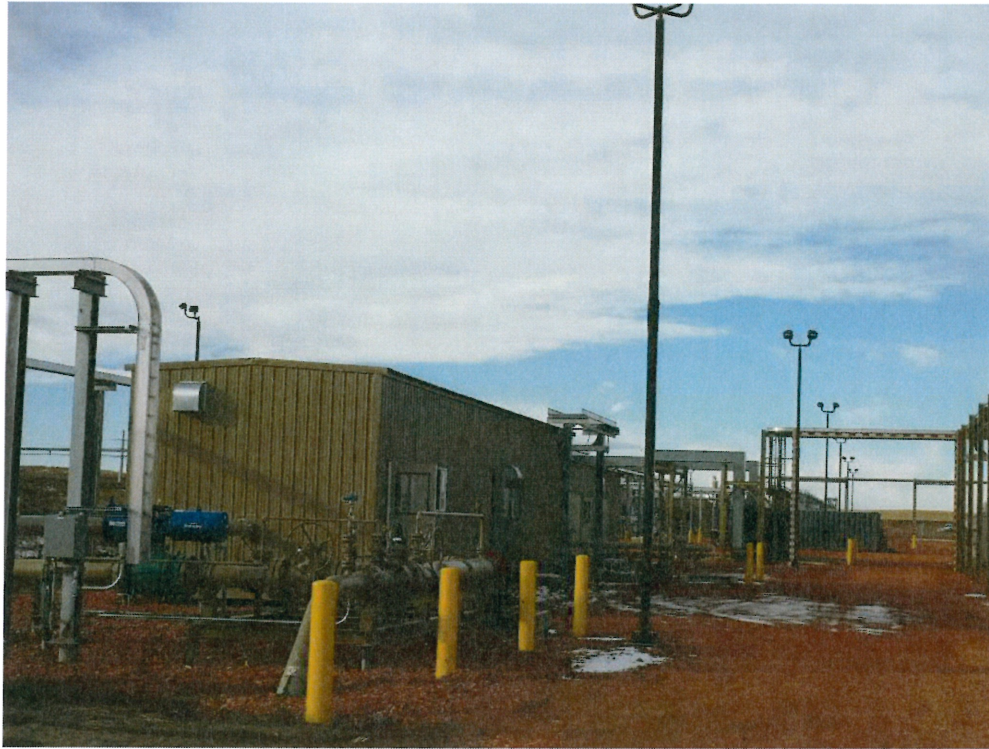
Photo 1 – Approx. Station 0+00. View of interconnect with pump house.

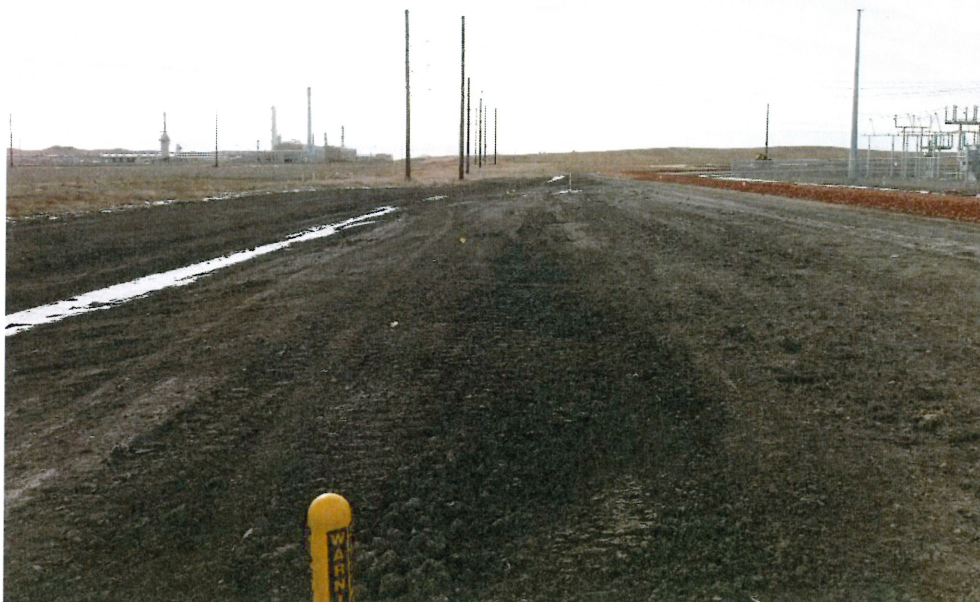
Photo 2 – Approx. Station 6+00. View of portion of right of way requiring additional seeding.

Based on the concerns identified in the Reclamation and Revegetation inspection, ProSource recommends that Oasis inspect the right of way during the Spring of 2018 and reseed the areas that have not established a vegetative cover similar to the condition as it existed prior to construction.

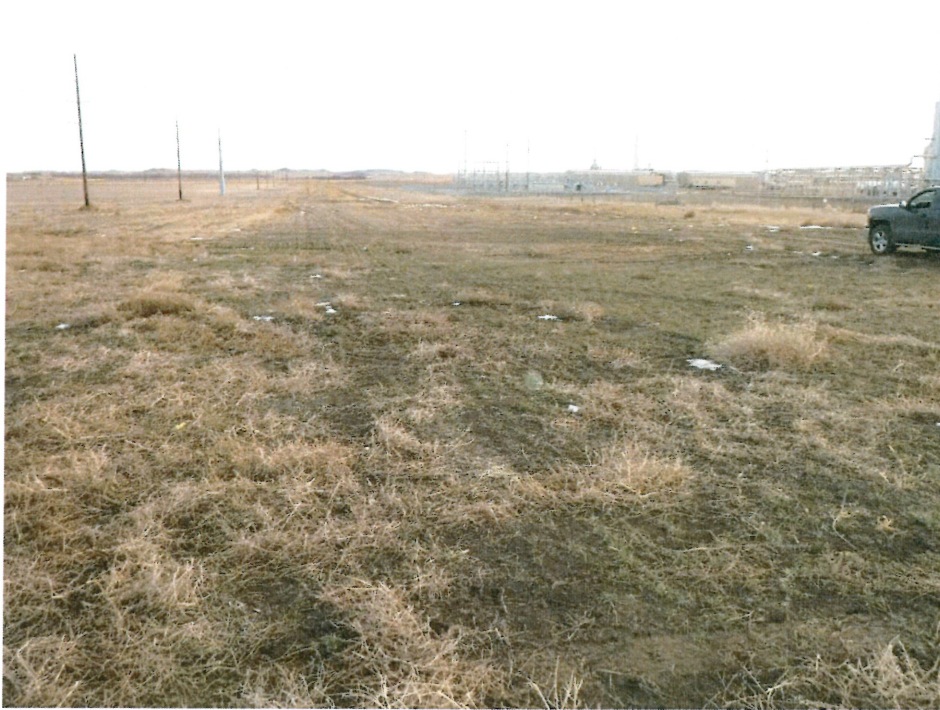
Photo 3 – Approx. Station 15+00. View of right of way requiring additional seeding.

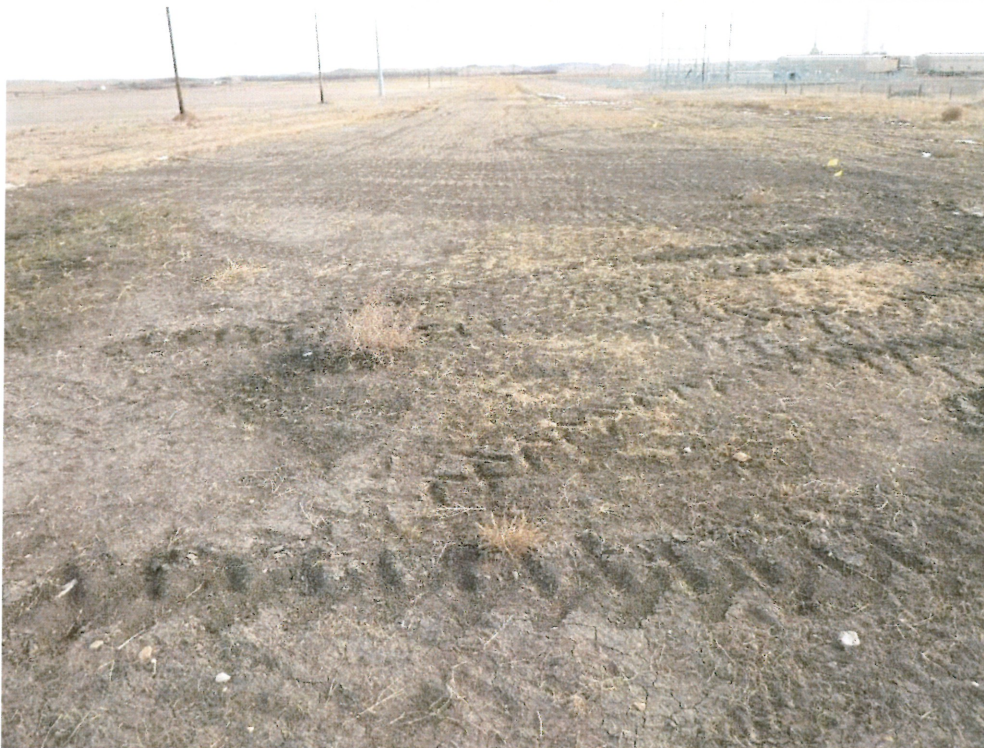
Photo 4 – Approx. Station 21+00. View of right of way requiring additional seeding.

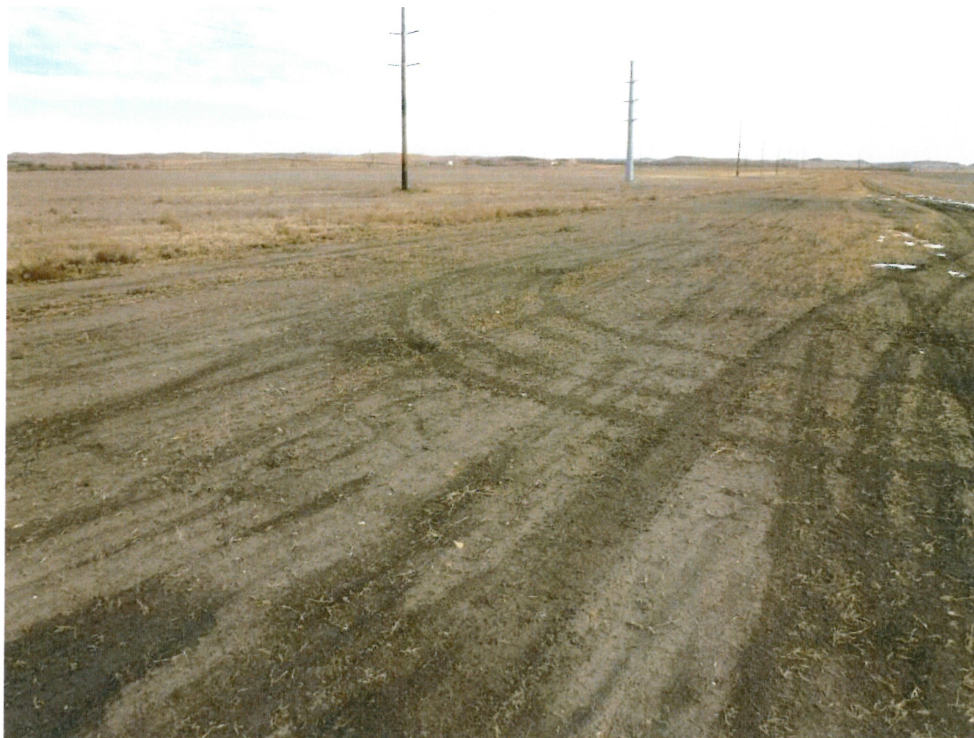
Photo 5 – Approx. Station 30+00. View of right of way requiring additional seeding.

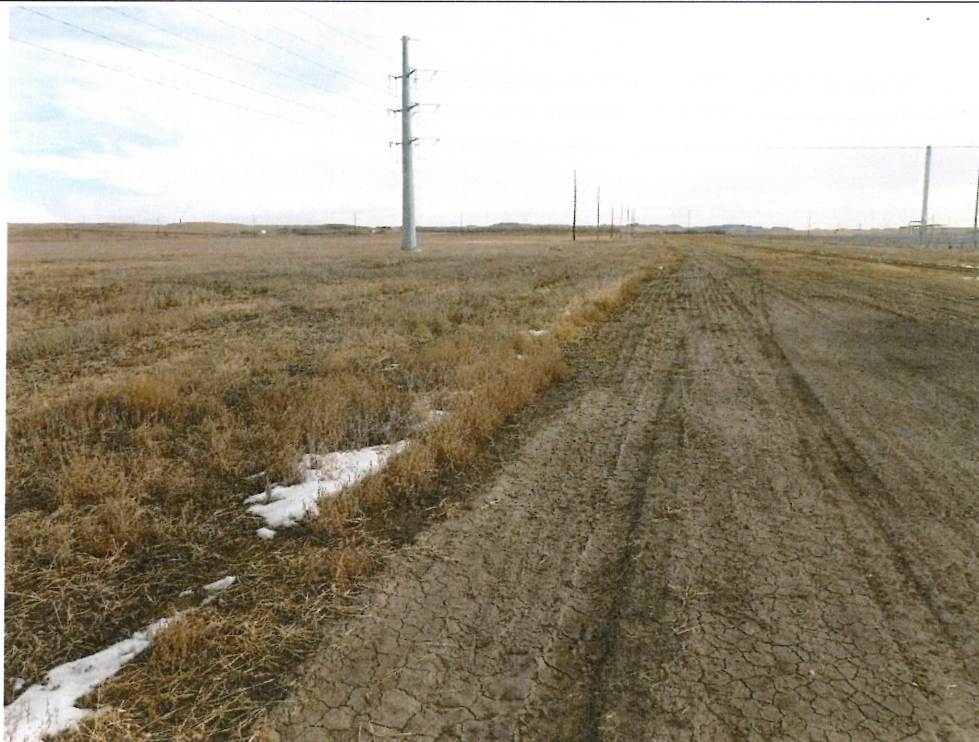
Photo 6 – Approx. Station 38+00. View of right of way requiring additional seeding.

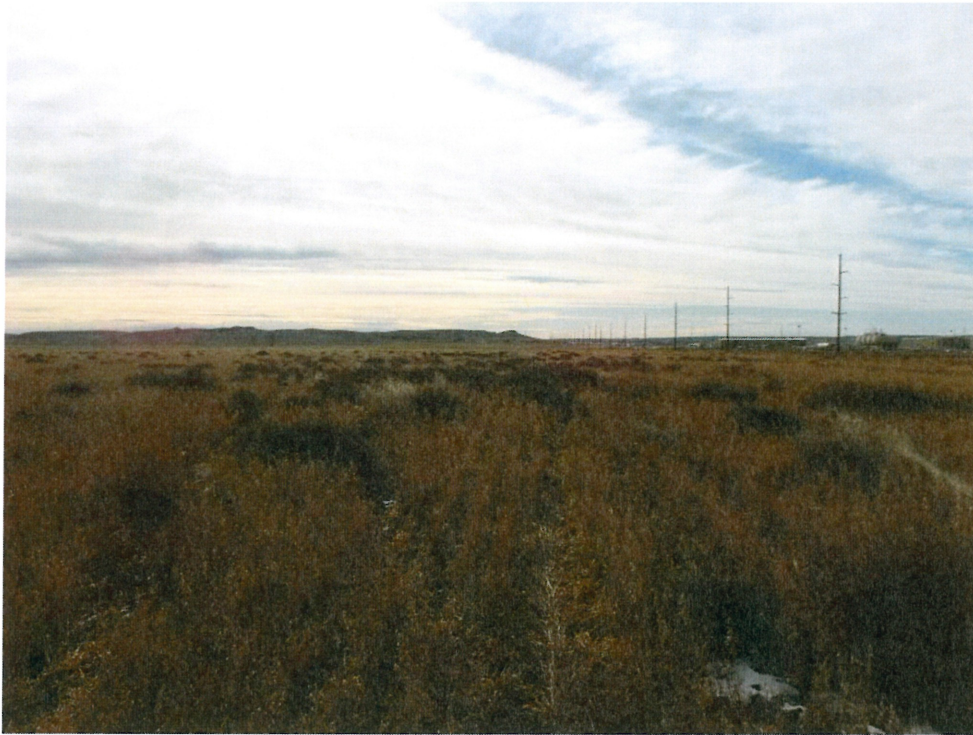
Photo 7 – Approx. Station 51+00. View of successful restoration.

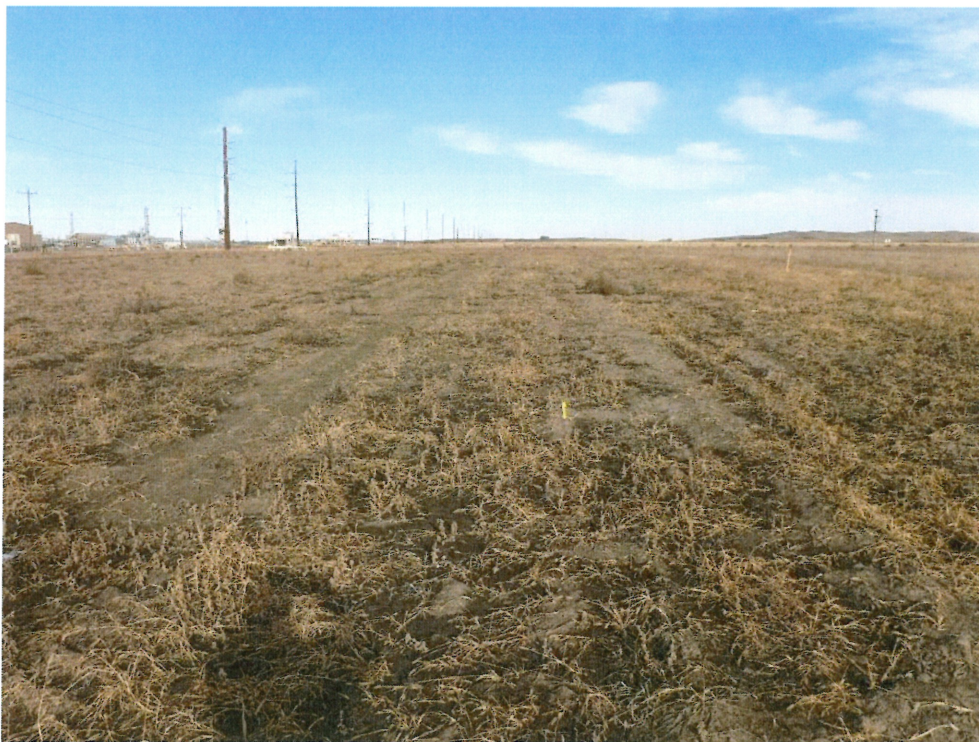
Photo 8 – Approx. Station 75+00. View of right of way requiring additional seeding

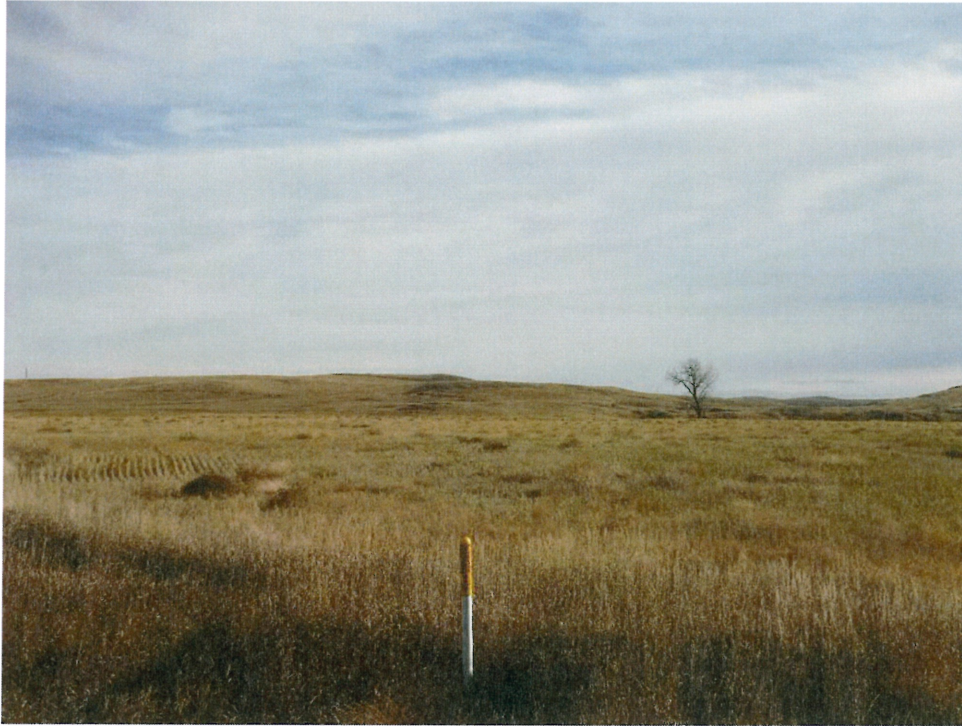
Photo 9 – Approx. Station 93+00. View of successful restoration.

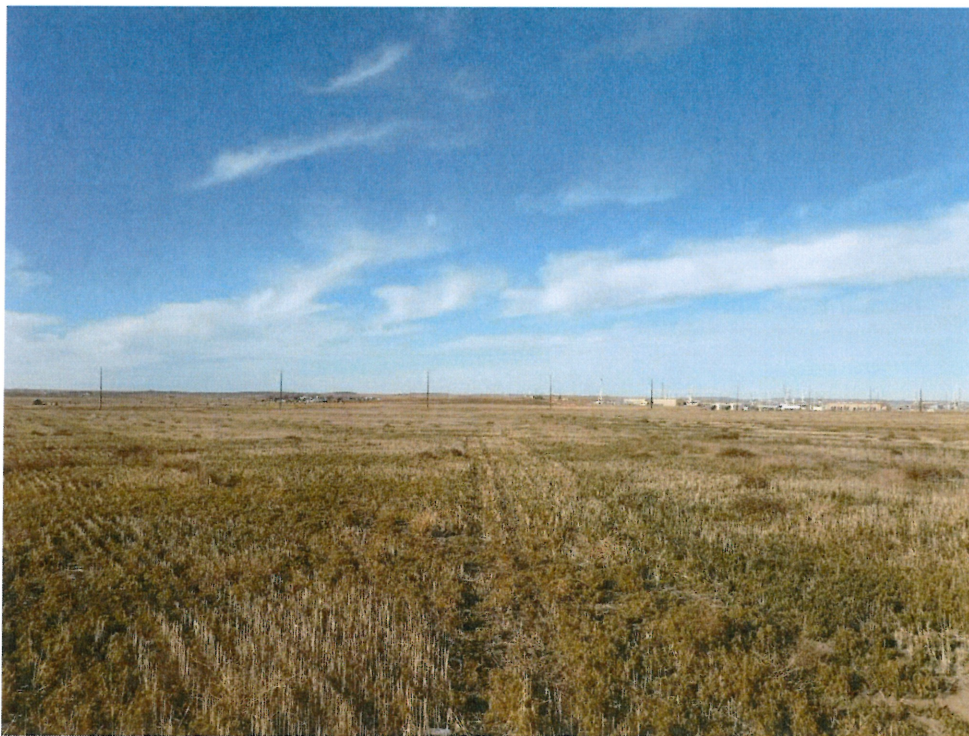
Photo 10 – Approx. Station 104+00. View of successful restoration.

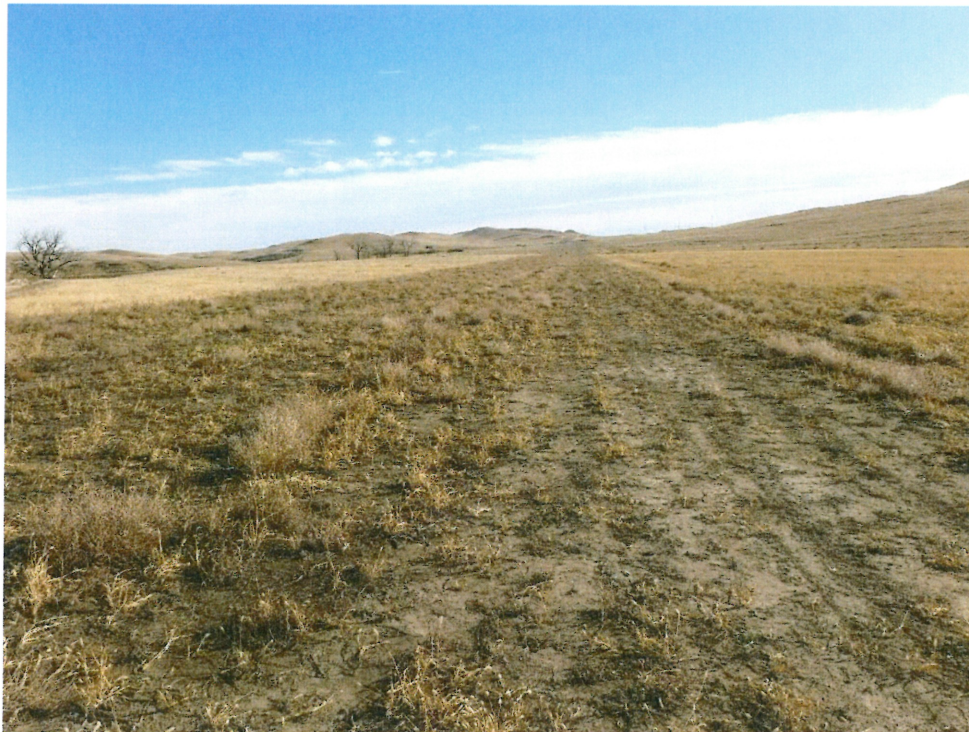
Photo 11 – Approx. Station 107+00. View of right of way requiring additional seeding

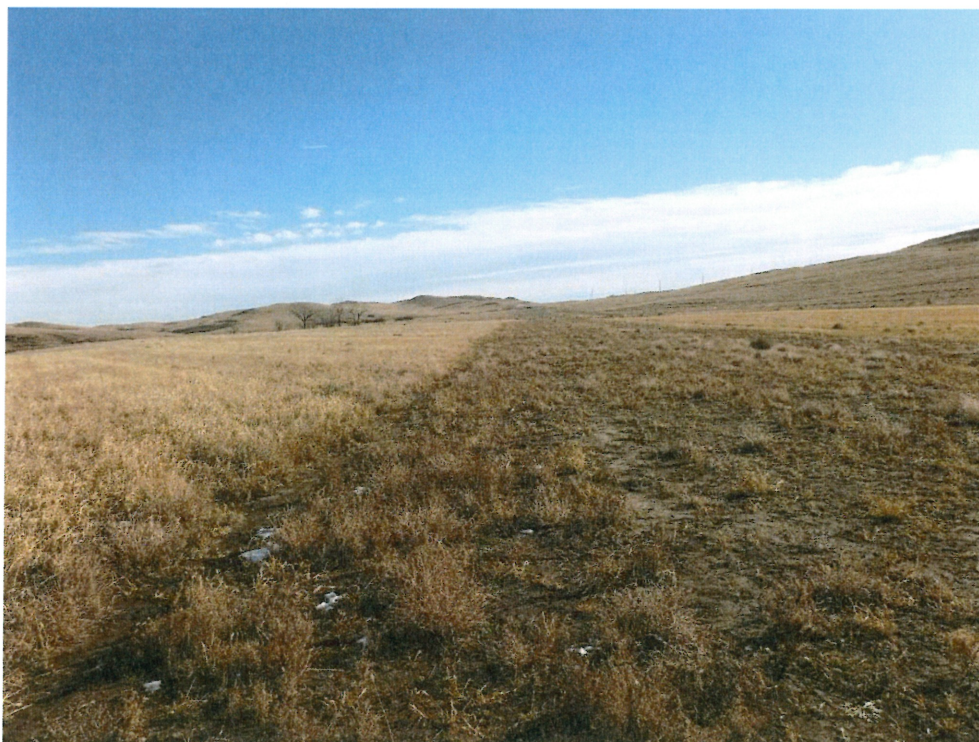
Photo 12 – Approx. Station 108+00. View of vegetation difference from right of way to adjacent area.

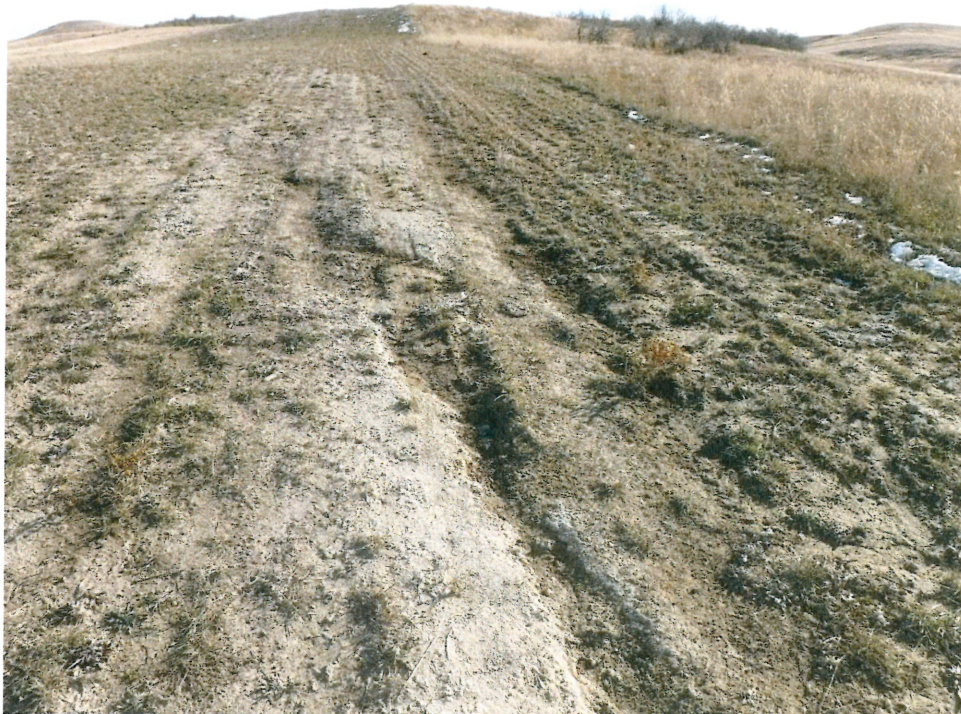
- Many areas require additional restoration and reseeding. The majority of the identified areas were located between approximate Stations 0+00 and 450+00.
- Minor water erosion areas (Photos 13, 19) at approximate Stations 154+00 and 261+00.
- Rock removal (Photo 15) at approximate Station 190+00.
- Two pipeline markers (Photos 23 and 24) requiring repair.

Photo 13 – Approx. Station 154+00. View of minor erosion.

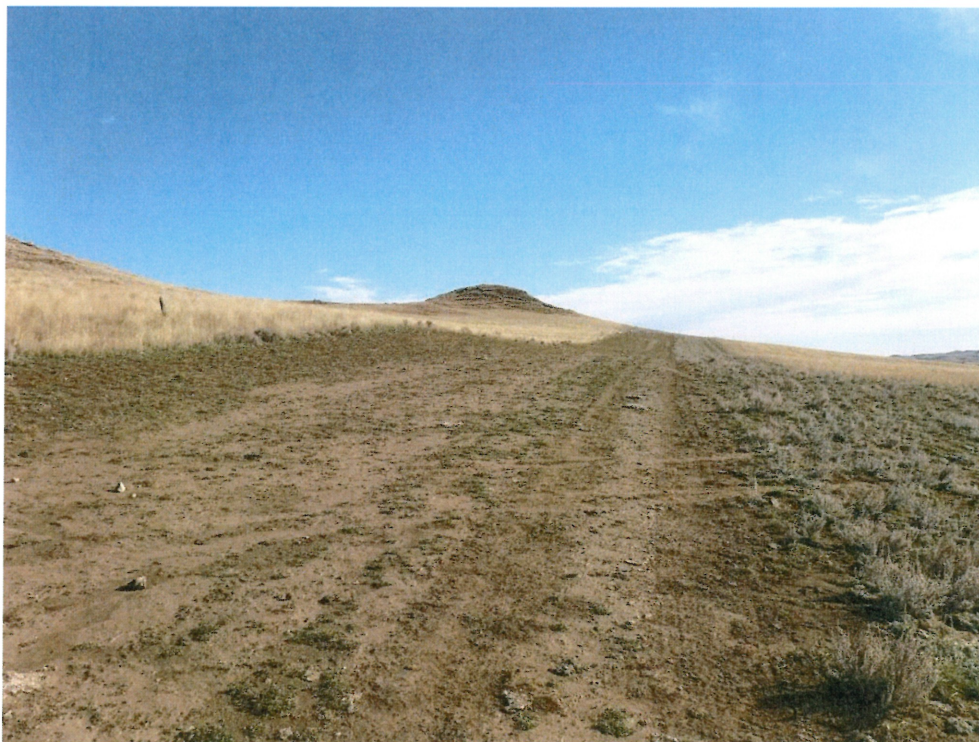
Photo 14 – Approx. Station 187+00. View of the right of way that requires additional seeding.

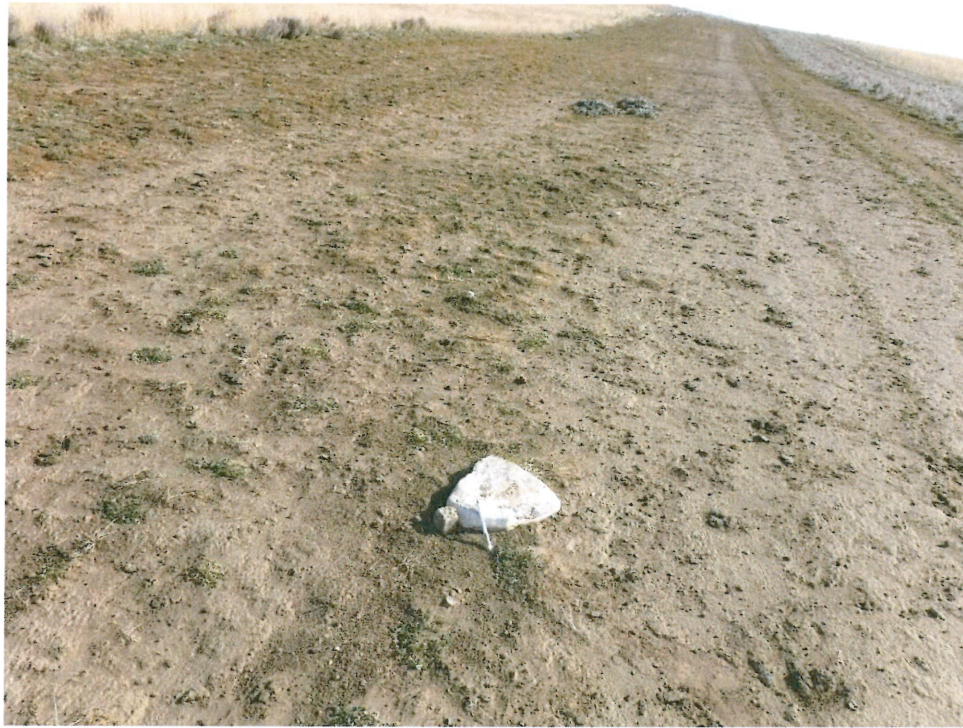
Photo 15— Approx. Station 190+00. View of rock to be removed from the right of way.

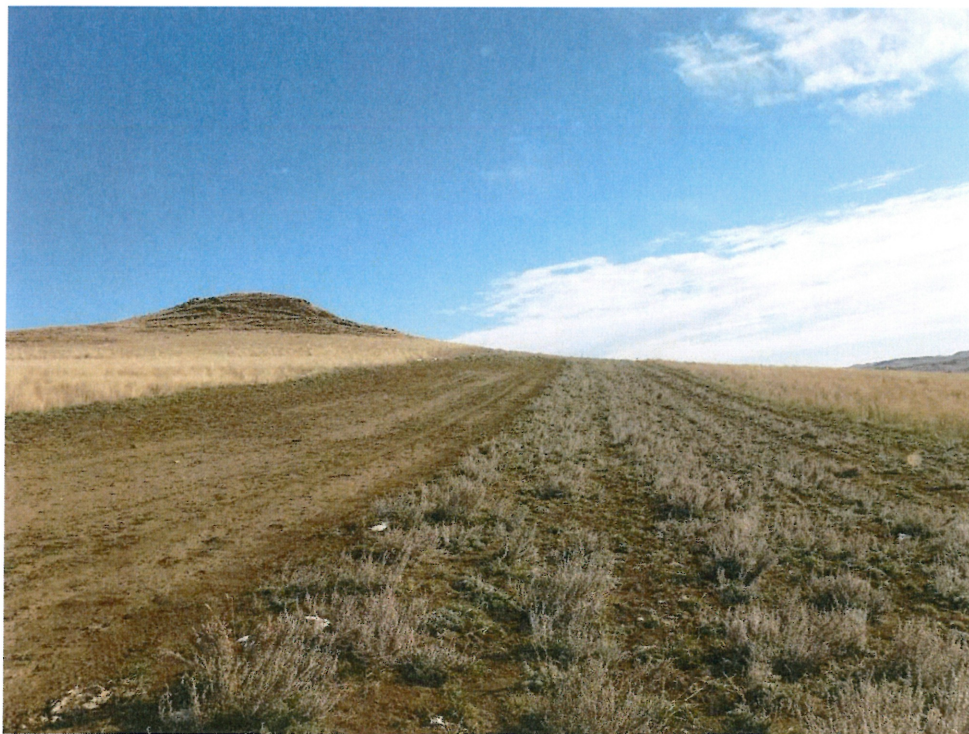
Photo 16— Approx. Station 200+00. View of half right of way revegetation, half requires seed.

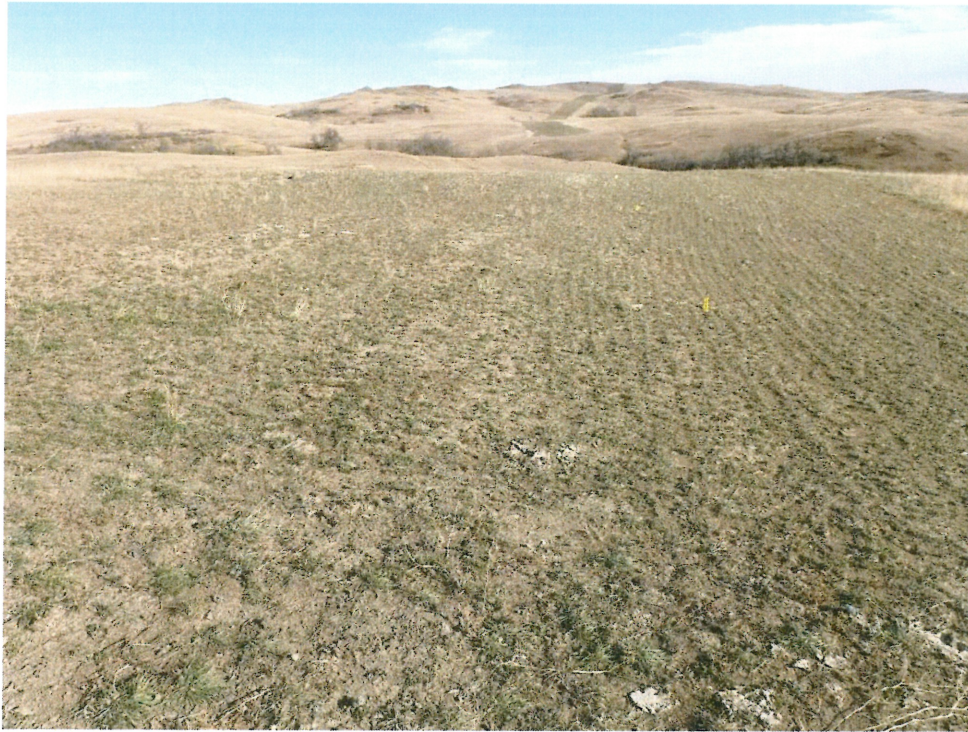
Photo 17 – Approx. Station 207+00. View of the right of way that requires additional seeding.

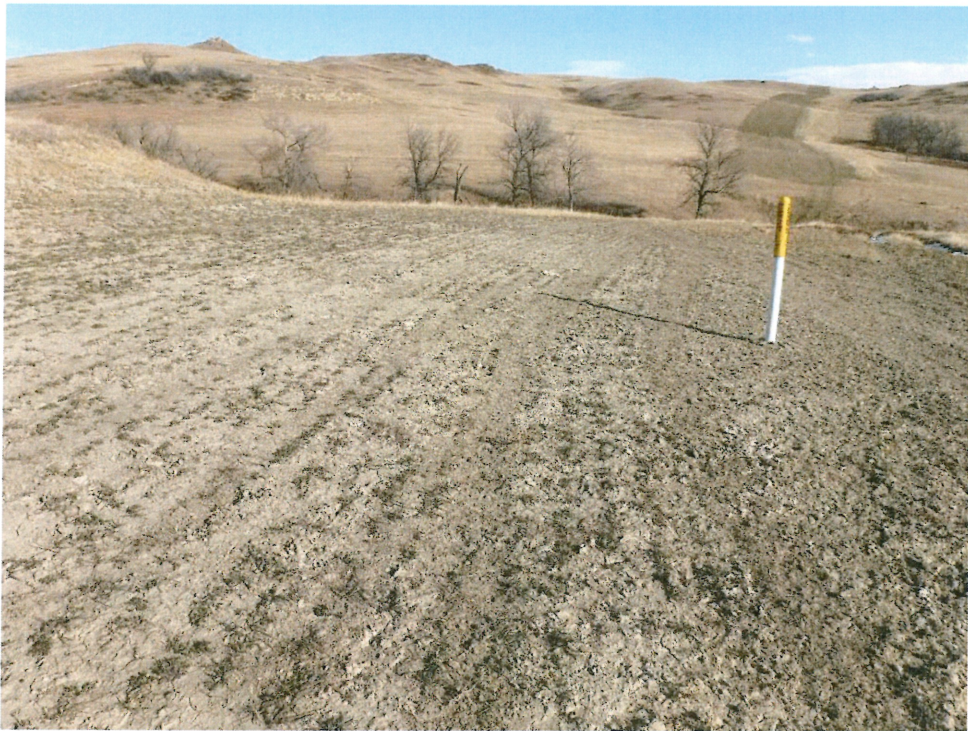
Photo 18 – Approx. Station 234+00. View of the right of way that requires additional seeding at HDD workspace.

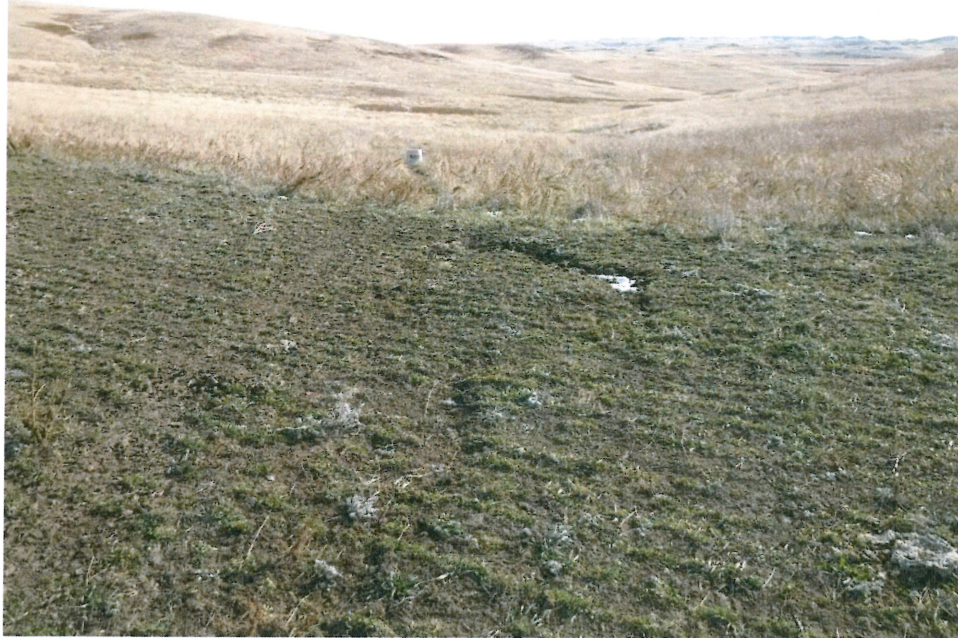
Photo 19 – Approx. Station 261+00. View of minor erosion.

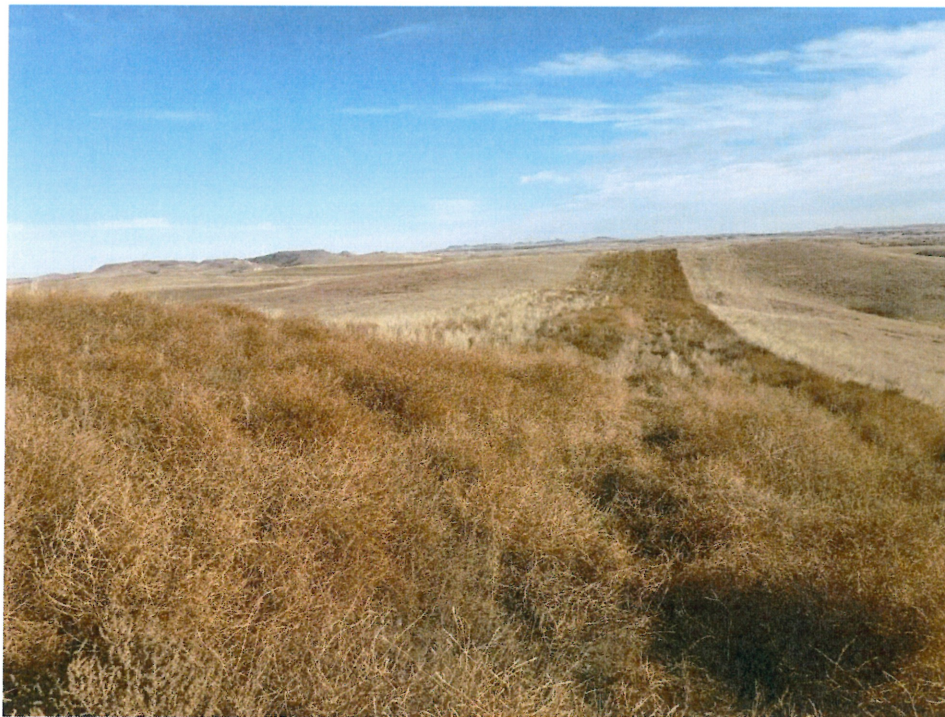
Photo 20 – Approx. Station 267+00. View of the right of way showing successful revegetation.

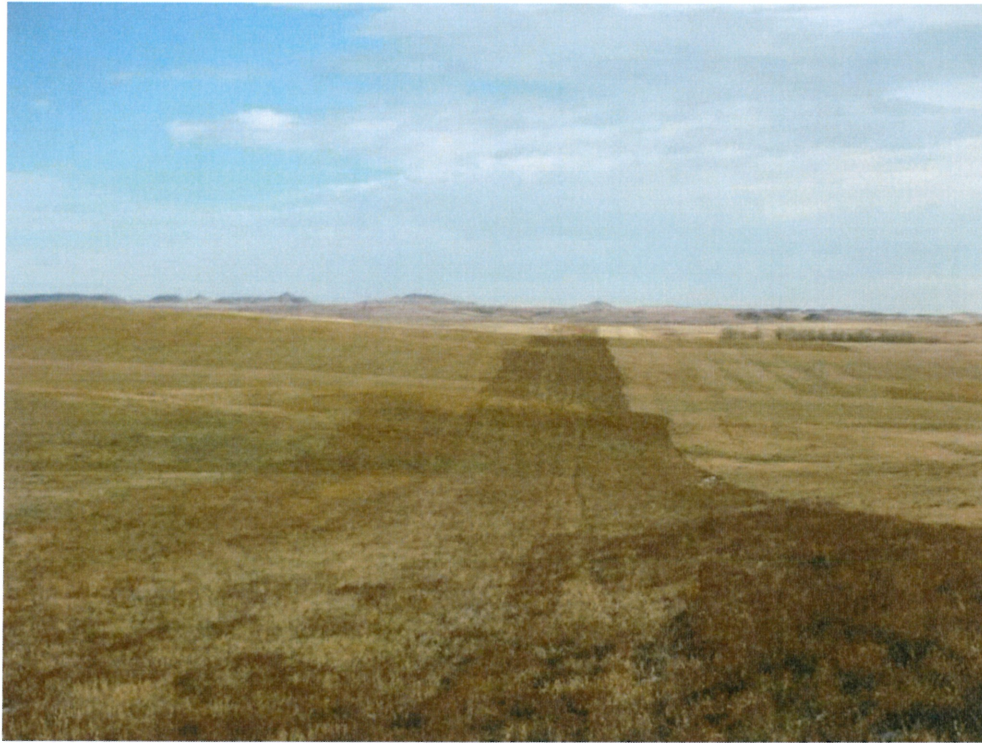
Photo 21 – Approx. Station 348+00. View of the right of way showing successful revegetation.

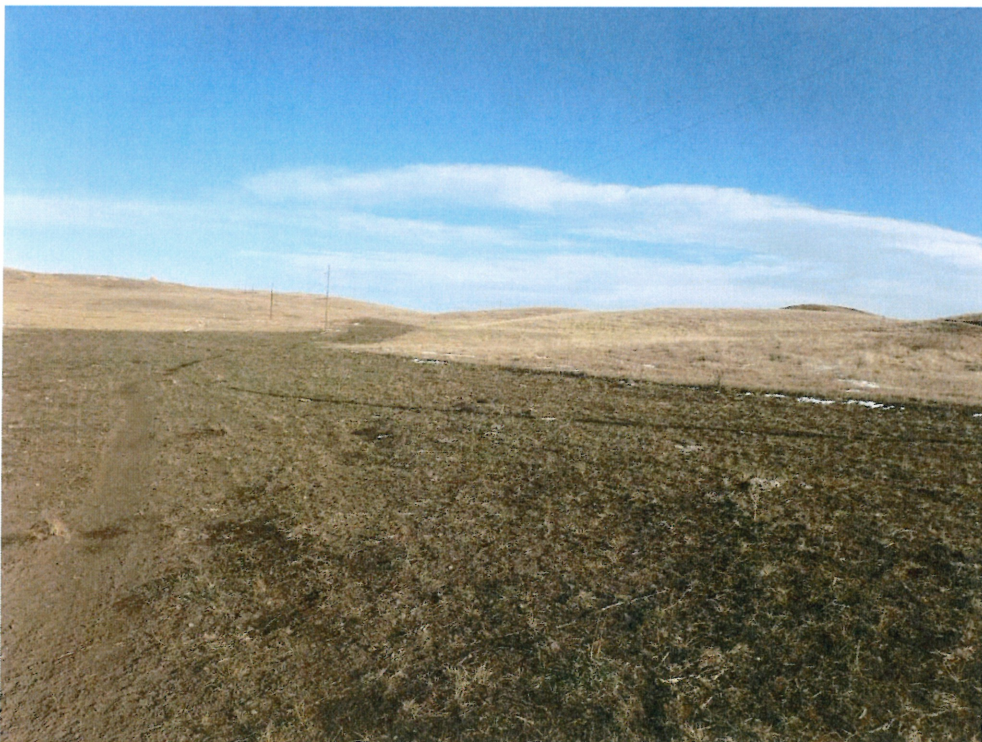
Photo 22 – Approx. Station 417+00. View of the right of way that requires additional seeding.

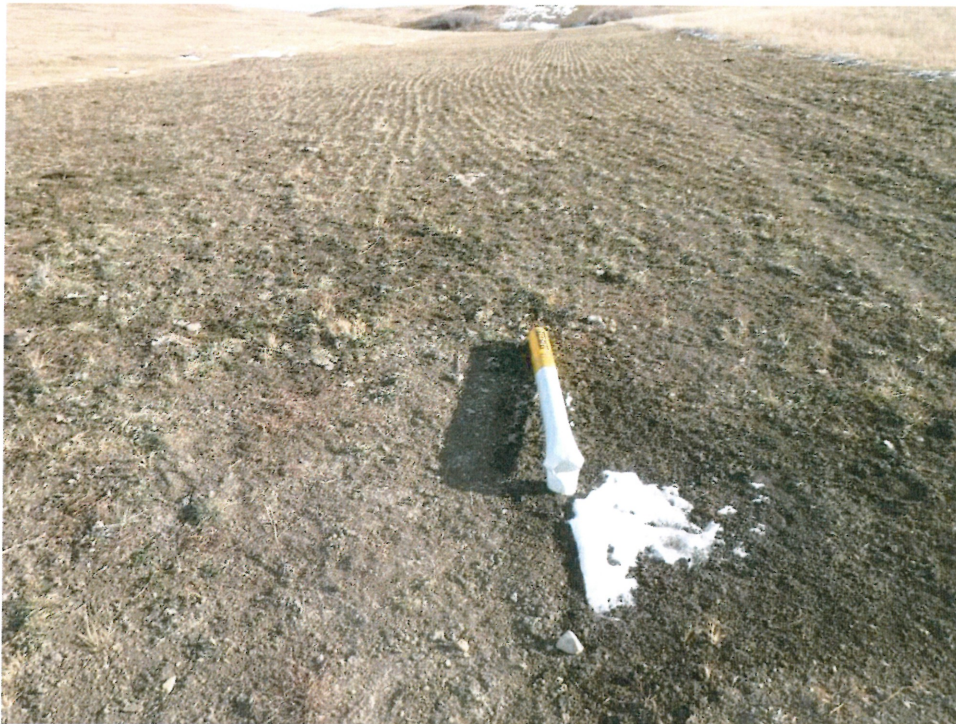
Photo 23 – Approx. Station 434+00. View of pipeline marker needing repair.

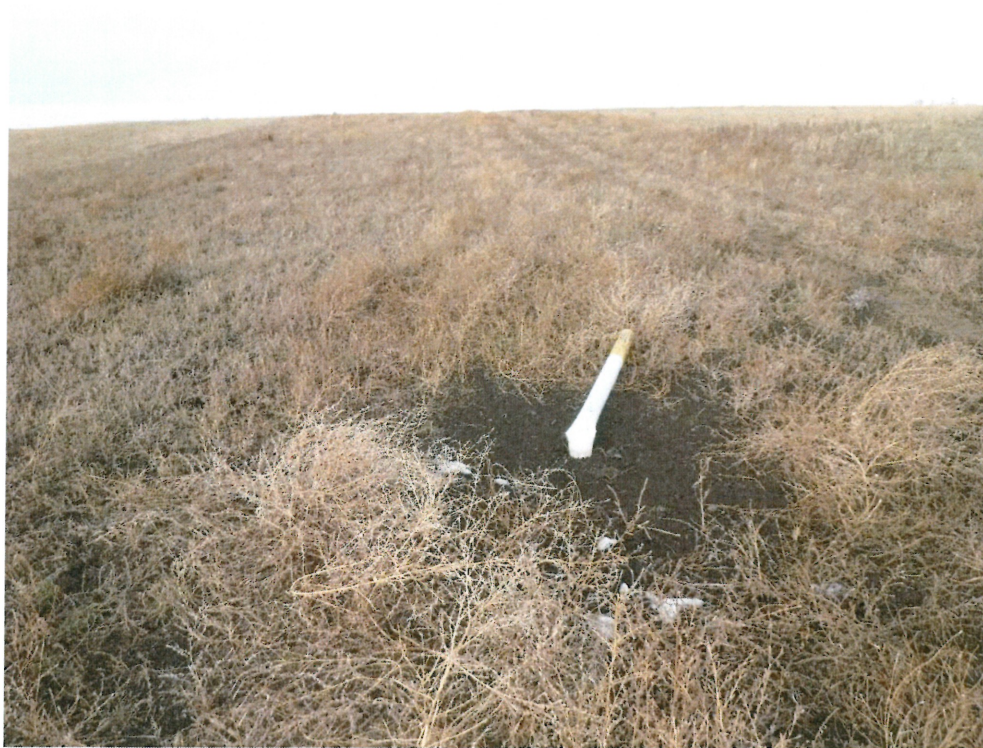
Photo 24 – Approx. Station 611+00. View of pipeline marker needing repair.

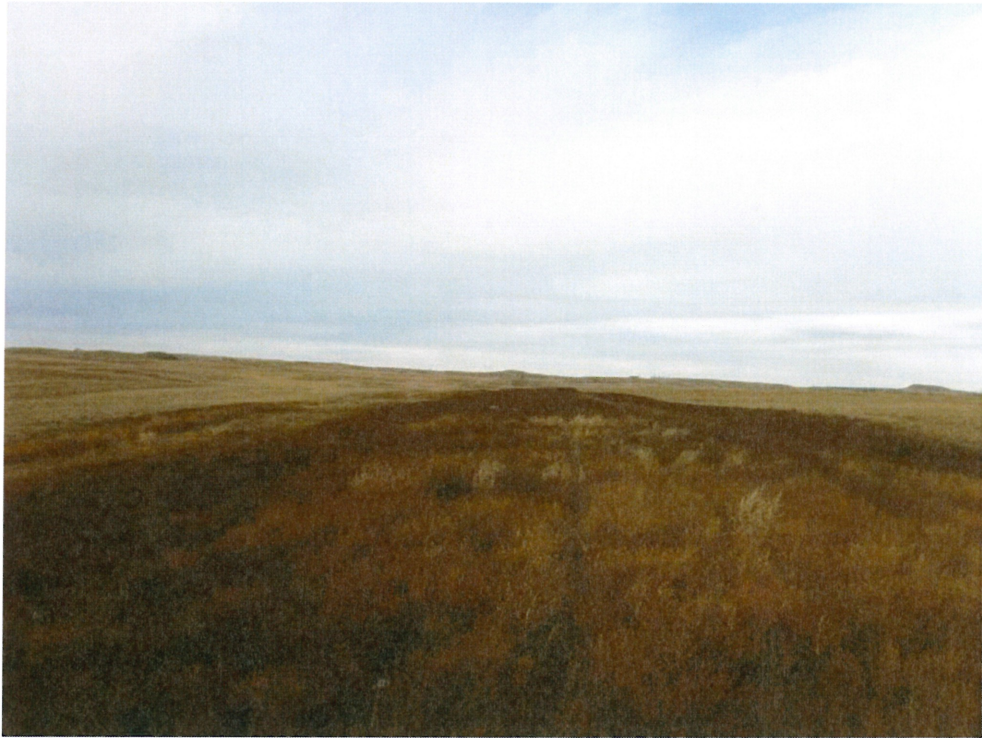
Photo 25 – Approx. Station 654+00. View of the right of way showing successful revegetation.

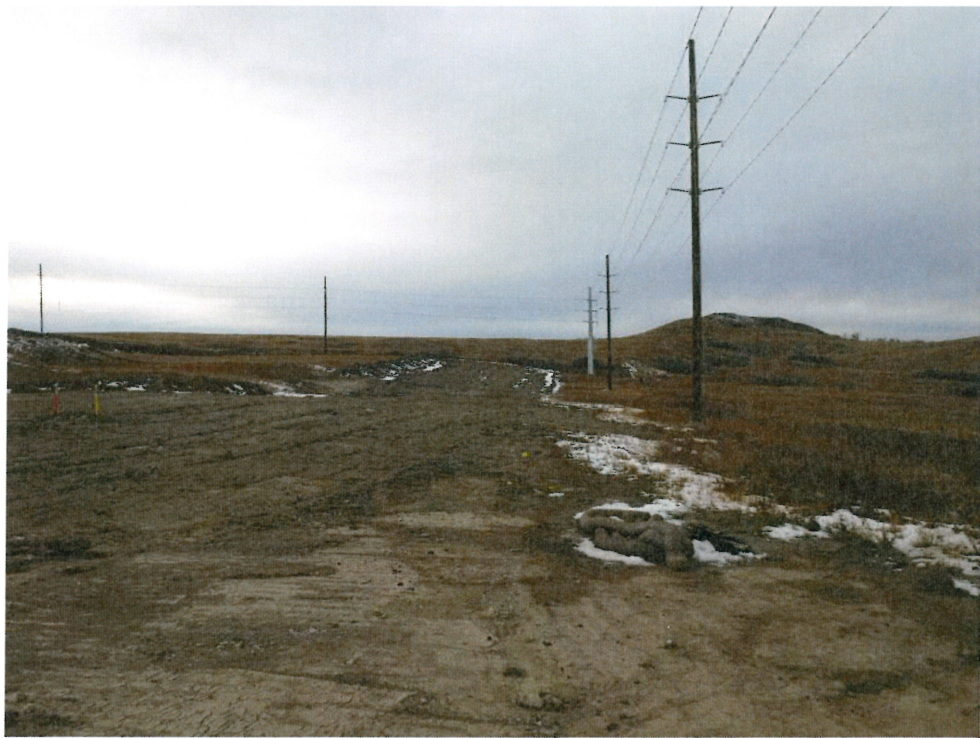
Photo 26 – Approx. Station 876+50. View of the other projects inside Oasis right of way.

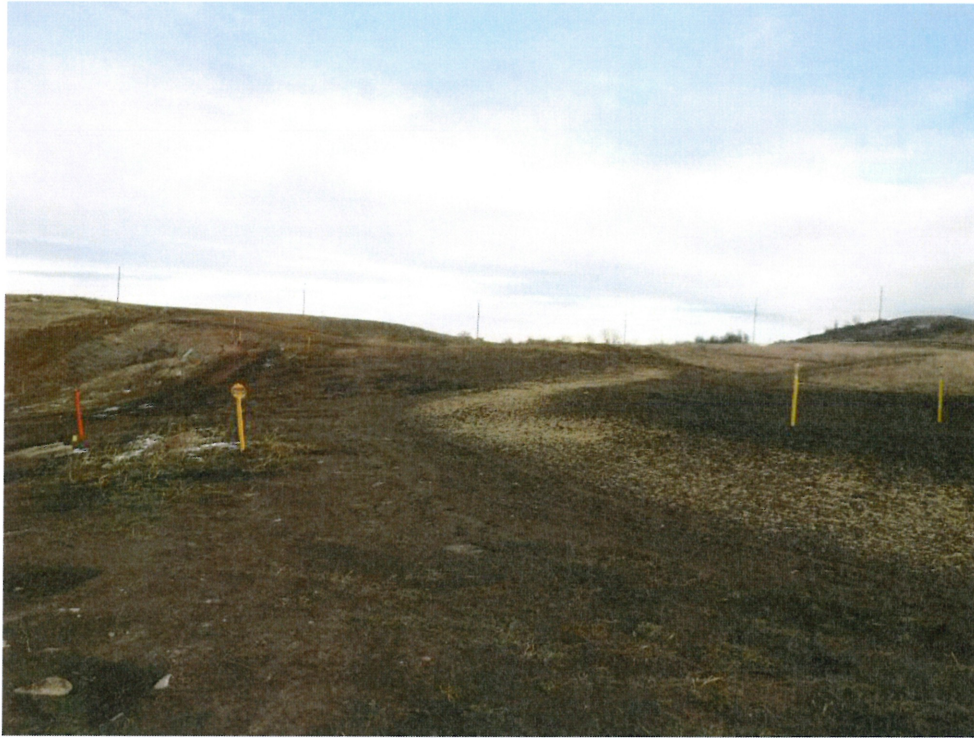
Photo 27 – Approx. Station 890+00+00. View of the other projects inside Oasis right of way.

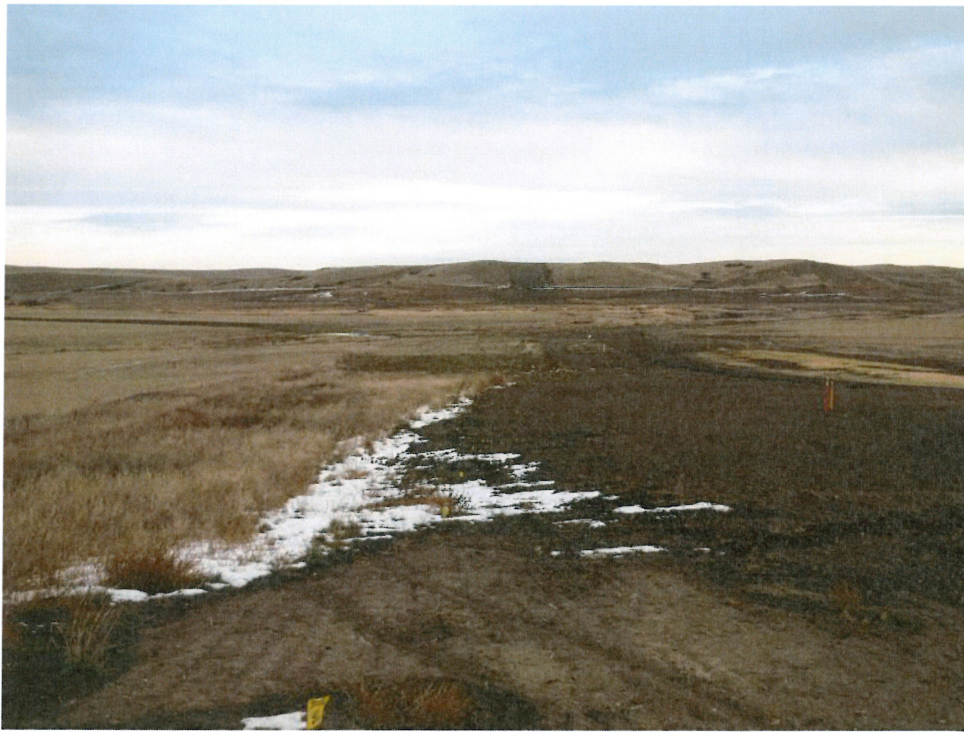
Photo 28 – Approx. Station 891+00. View showing half of the Oasis right of way impacted by another project.

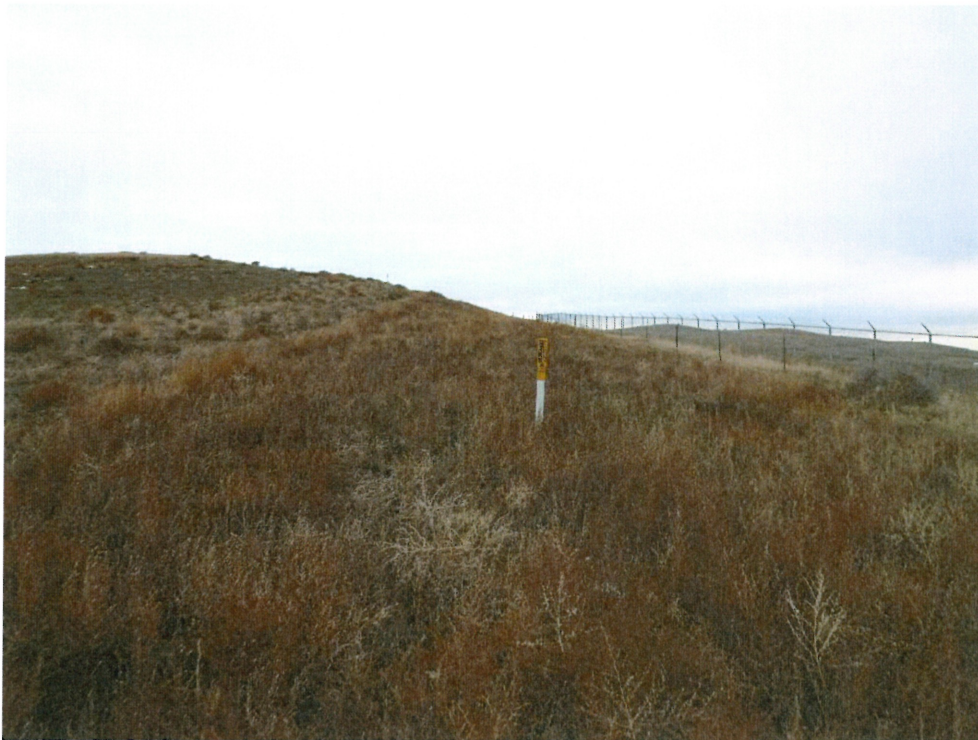
Photo 29 – Approx. Station 960+00. View of the right of way showing successful revegetation.

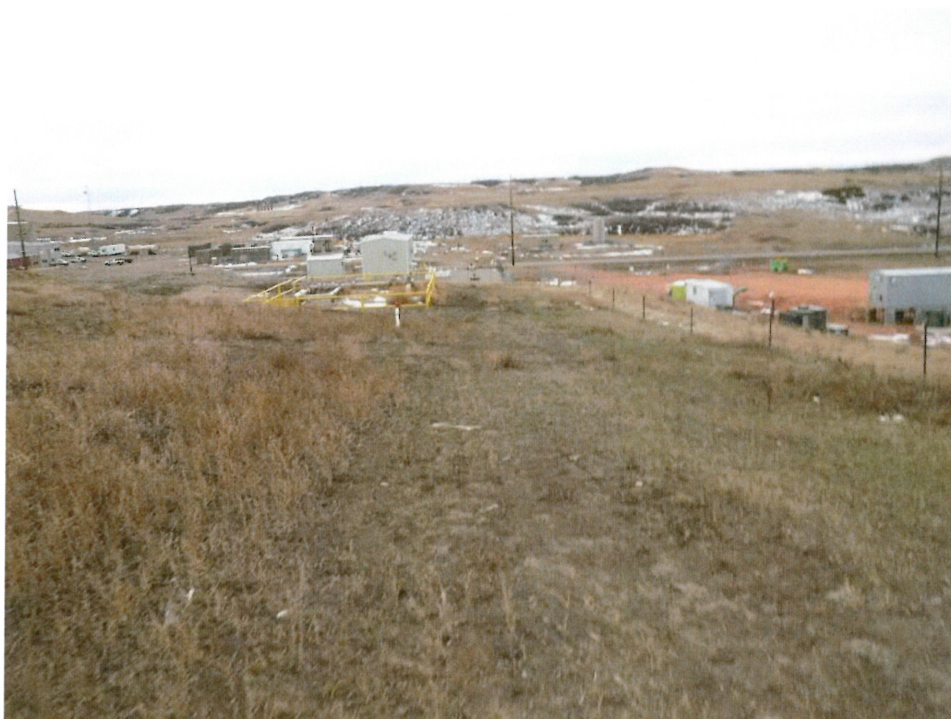
Photo 30 – Approx. Station 891+00. View of the right of way that requires additional seeding.
