Re: Topsoil Inspection Report for Sacagawea Pipeline Project  
Johnson's Corner Connector Crude Oil Pipeline  
PU-15-744

# Sacagawea Pipeline Co.

Johnson's Corner Connector  
Crude Oil Pipeline Project  
PU-15-744  
KLJ#1215109

*October 27, 2016*

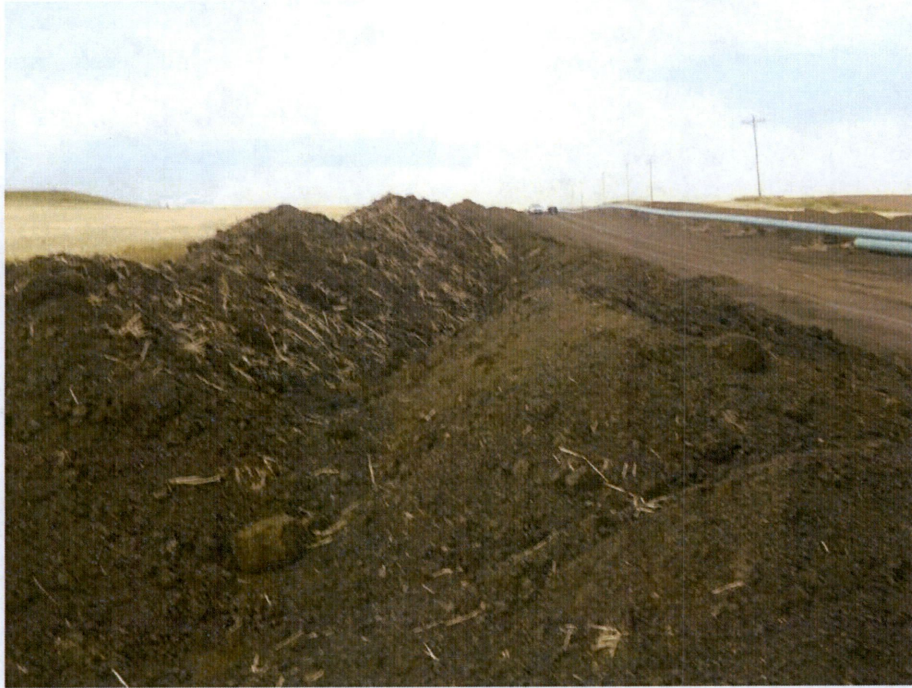
*Photo 1: Located at station 6+00, showing Right of Way direction looking east with graded top soil placed on edge of Right of Way. Subsoil is pushed to left edge of topsoil, but is segregated and separated from each. Pipe is welded and sitting on skids ready for trenching.*

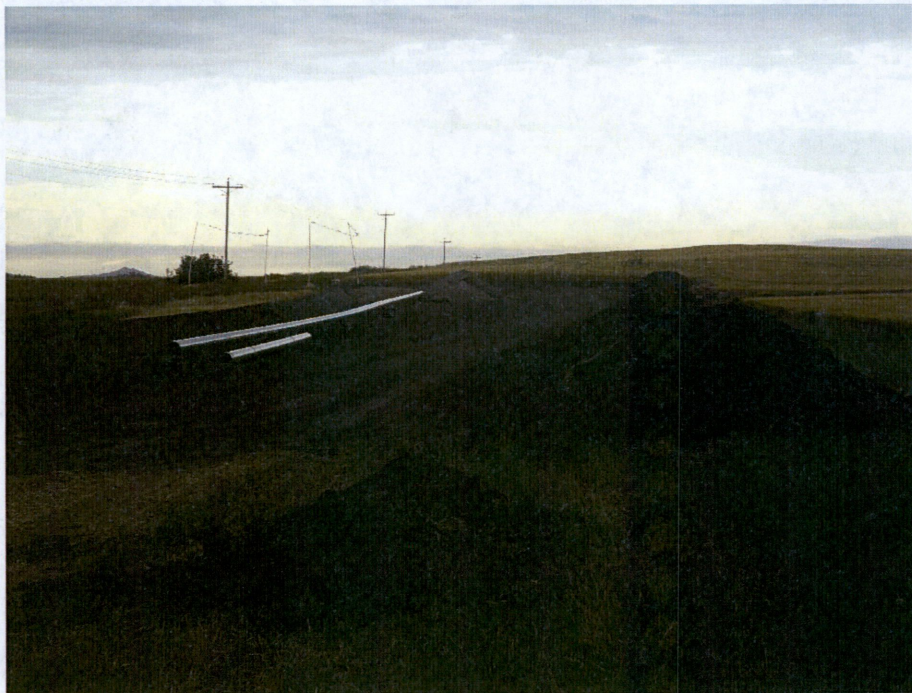
*Photo 2: Located at station 15+00, showing Right of Way direction looking east with graded topsoil placed on right edge of Right of Way. Subsoil is pushed on Right of Way edge on left side. Bore pipe located on Right of Way.*

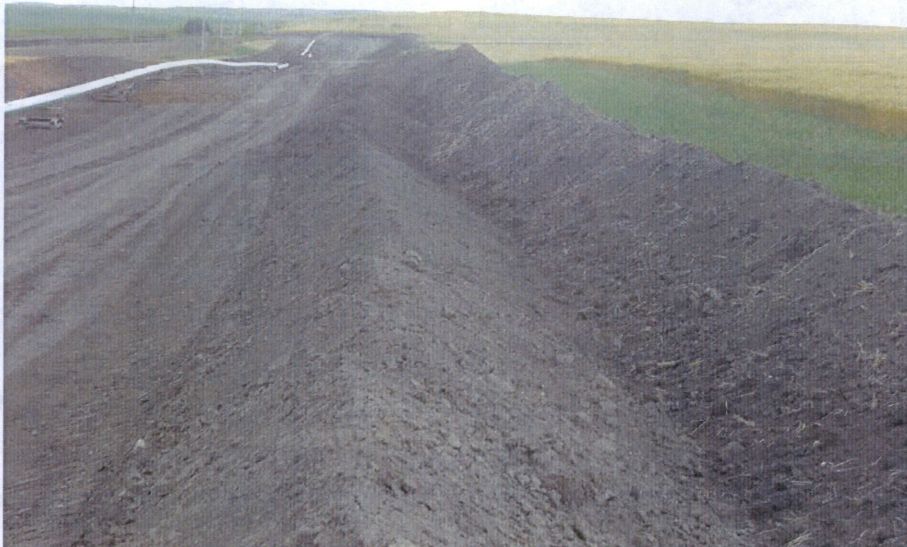
*Photo 3: Located at station 21+00, showing Right of Way direction looking west graded with topsoil placed on the edge of Right of Way. Subsoil is pushed to the edge of topsoil, but is segregated and separated from each. Pipe is welded and setting on skids ready for trenching.*

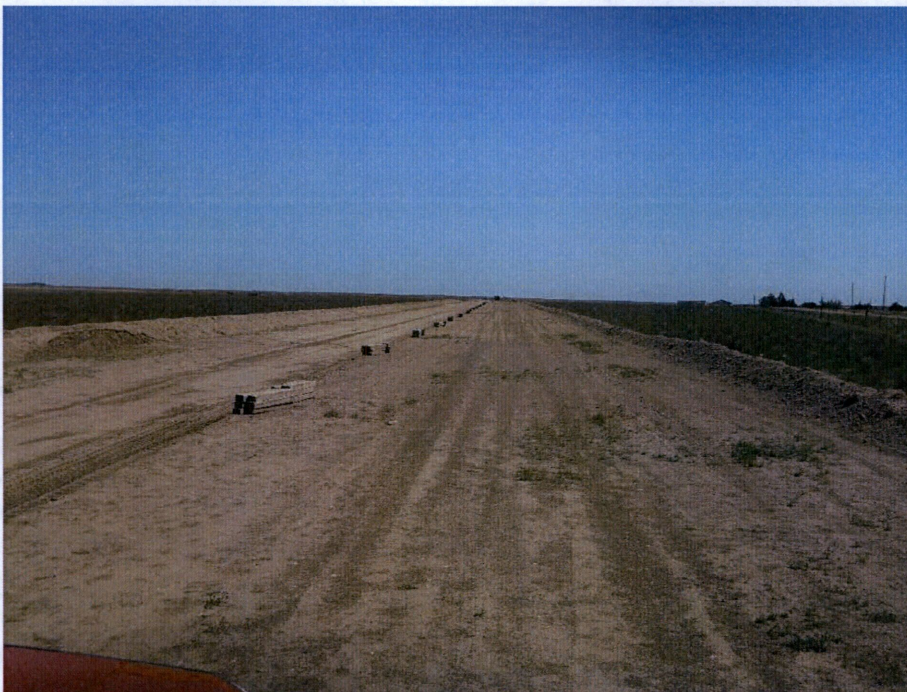
*Photo 4: Located at station 27+00, showing Right of Way direction looking west graded with top soil pushed off Right of Way. Pipeline skids placed on Right of Way ready for piping.*

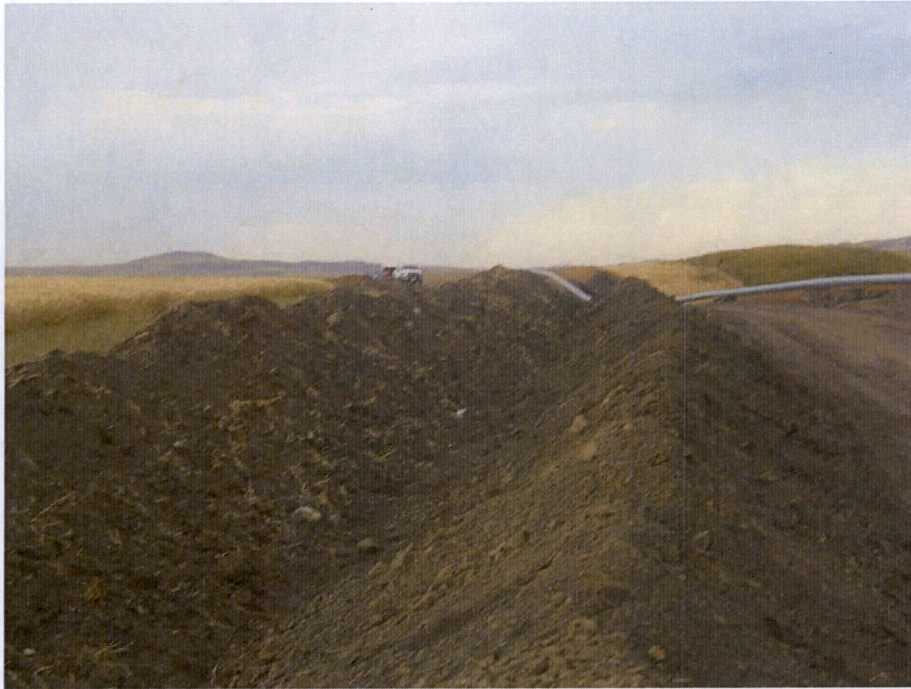
*Photo 5: Located at station 48+00, showing graded Right of Way with subsoil located on left side on Right of Way and topsoil stockpiled on extreme left side of Right of Way. Both topsoil and subsoil have been kept segregated. Pipe has been welded and ready to install in trench.*

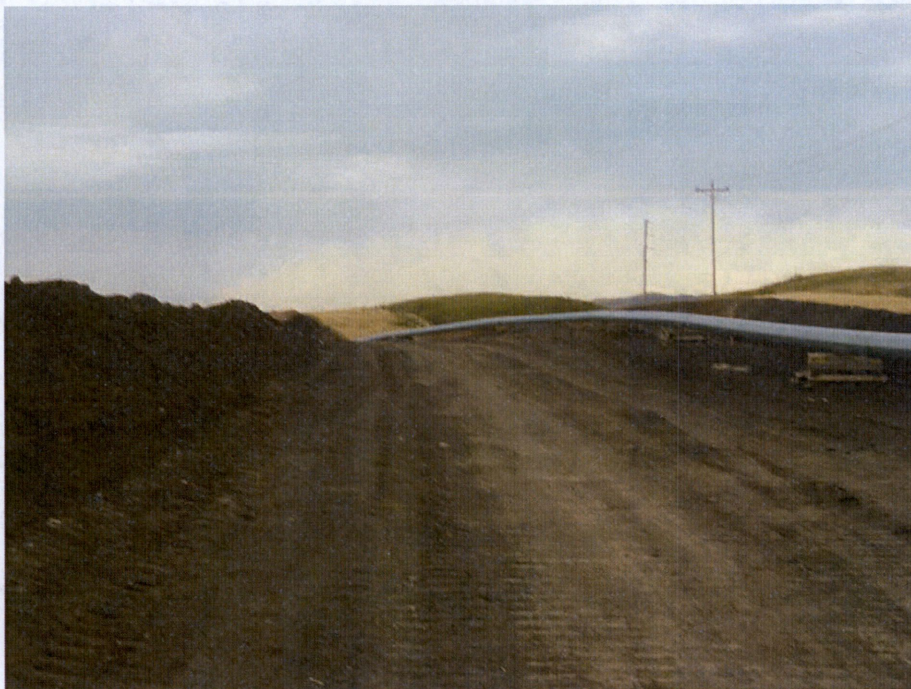
*Photo 6: Located at station 66+00, showing graded Right of Way with welded pipe on skids ready for trenching. Topsoil is shown on edge of left side of Right of Way.*

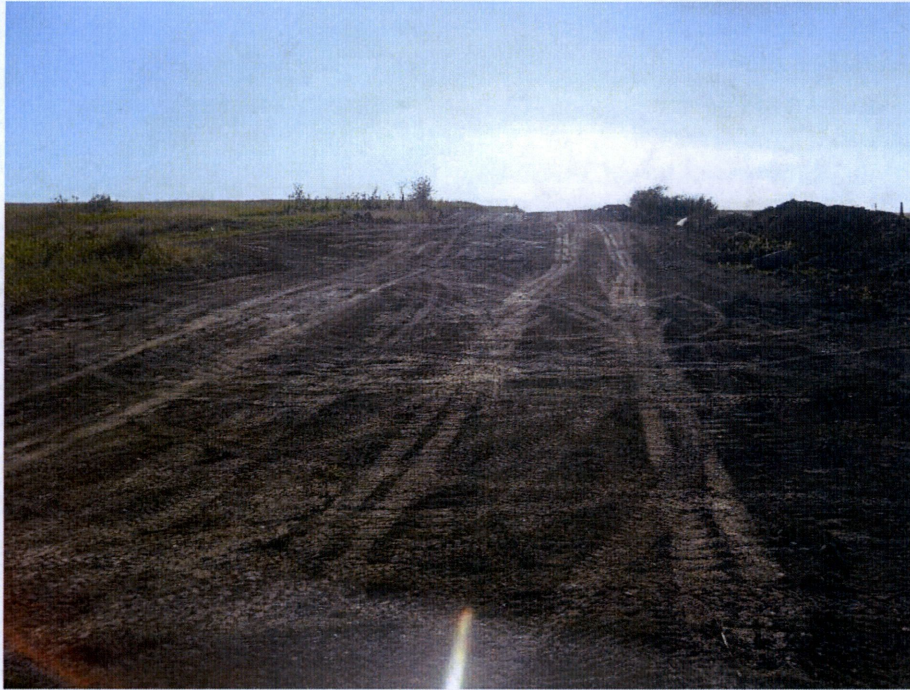
*Photo 7: Located at station 78+00, showing Right of Way direction looking west with graded topsoil pushed to edge of Right of Way.*

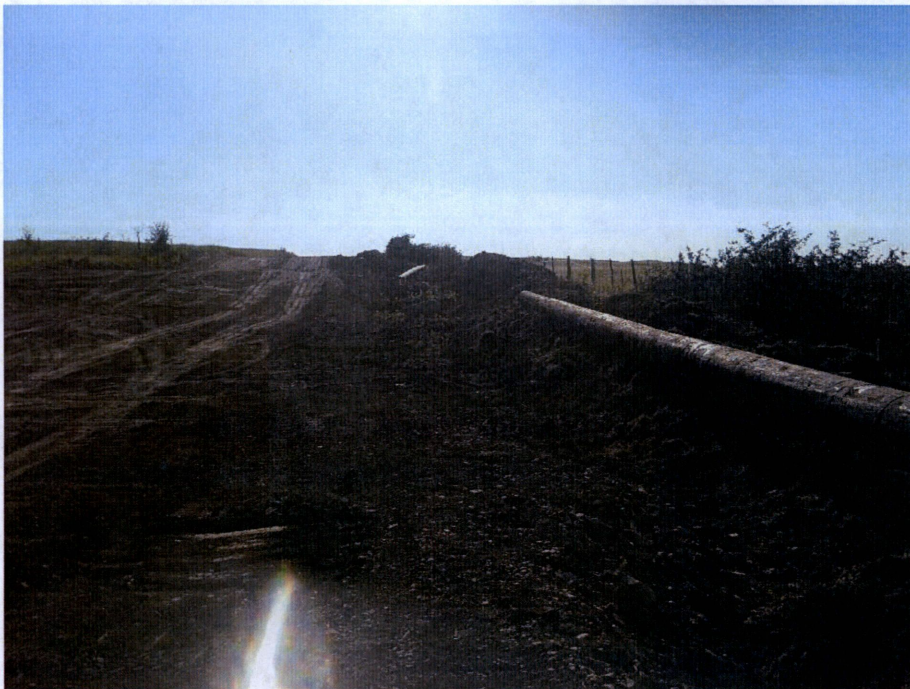
*Photo 8: Located at station 93+00, showing Right of Way direction looking east with graded topsoil pushed to edge of Right of Way. Power pole is shown laying on topsoil located on right side of photo.*

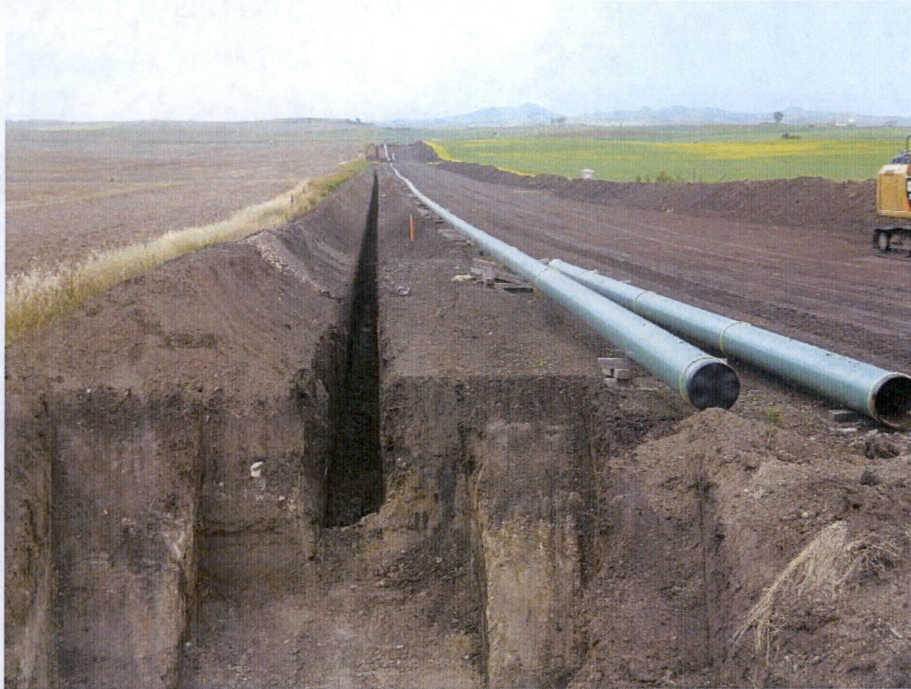
*Photo 9: Located at station 126+00, showing grade Right of Way direction looking east with trench excavated. Pipe is welded and ready to place in trench. Photo shows subsoil placed on left side of Right of Way. Top soil placed along right side edge on Right of Way.*

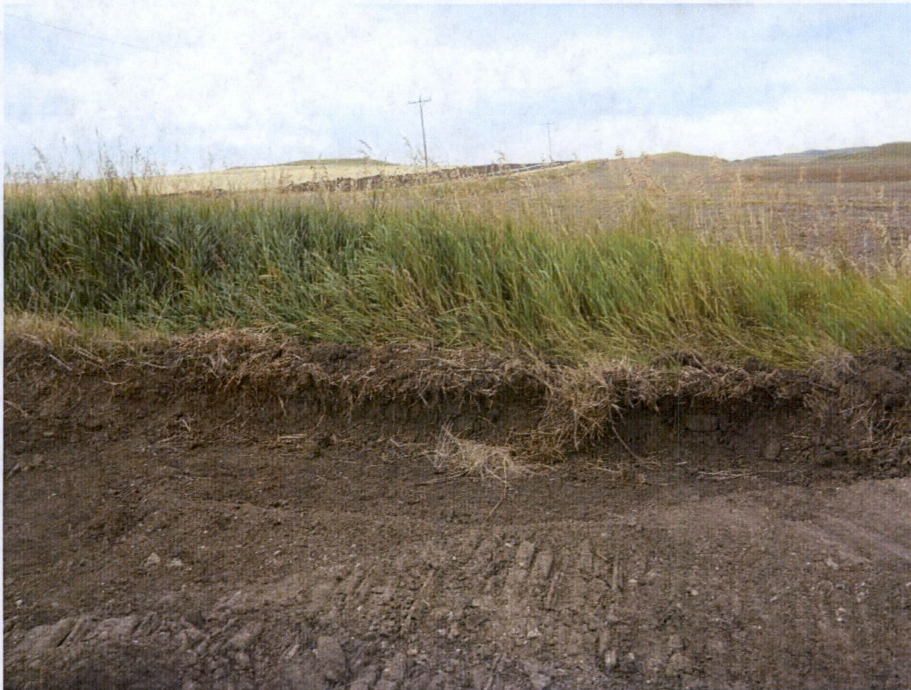
*Photo 10: Located at station 132+00, photo showing stripped Right of Way at approximate topsoil depth of 12 inches. Photo is showing west side of Right of Way.*

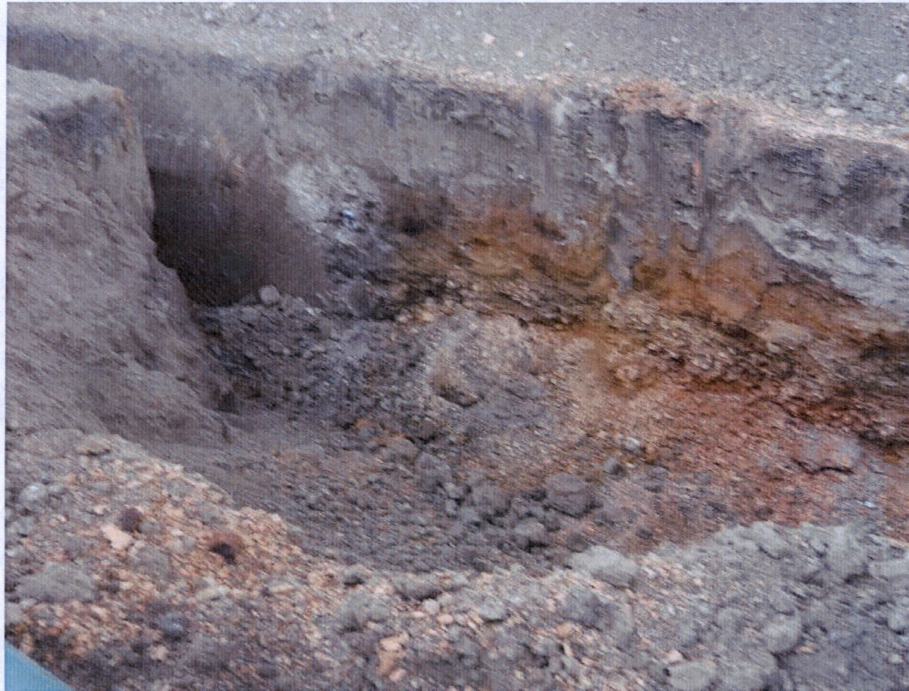
A struck abandon line, found to be located at station 141+00 and 142+00, was hit during pipe trenching. It turned out to be a Hess line, no longer used. Hess was on site, during inspection, repairing line. Contractor needs to coordinate better with One-Call's locators and other operators, to verify other existing lines in areas even if not marked. Safety regulations including improved pipe safety as it is an important part of project operations and regulations.

*Photo 11: Located at station 141+00, photo showing open trench where existing line was hit while excavating trench. Hess line was not damaged and existing line location was not found or exposed.*

Issue 3) - Hess was called out to repair and mark abandoned pipe location, after hitting line during trench excavation.

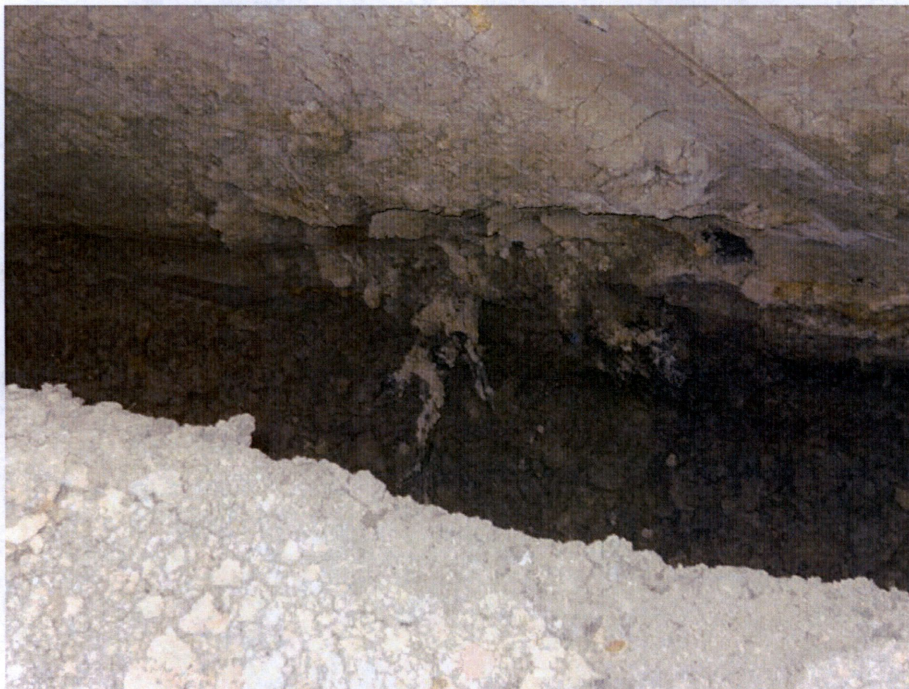
*Photo 12: Located at station 141+00, looking inside trench where existing Hess pipeline was partially hit and disturbed during excavation of trench. Pipe was repaired by Hess and no liquid from pipe flowed into trench. Location of Hess pipe was mismarked during locating existing piping for trench work.*

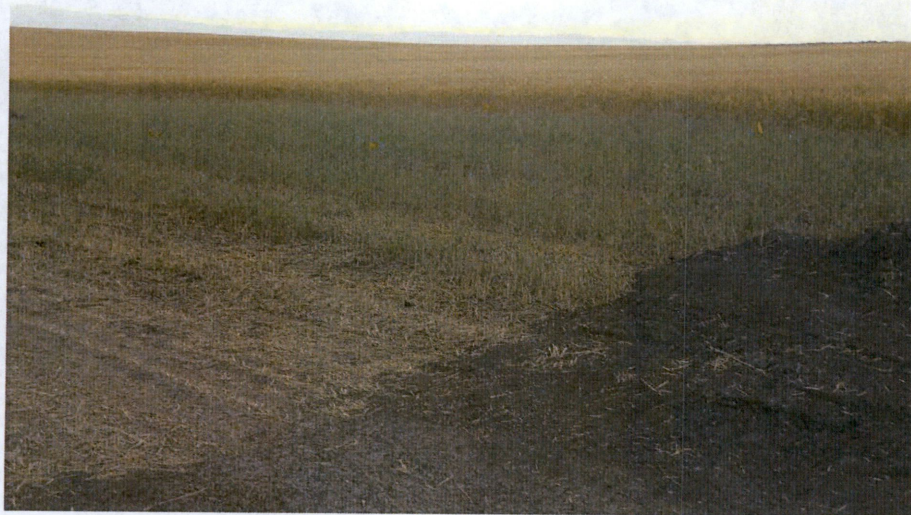
*Photo 13: Located at station 146+00. Photo showing flagged location of existing Hess lines which is approximately 700 ft. east of actual Hess line location hit during trench excavation.*

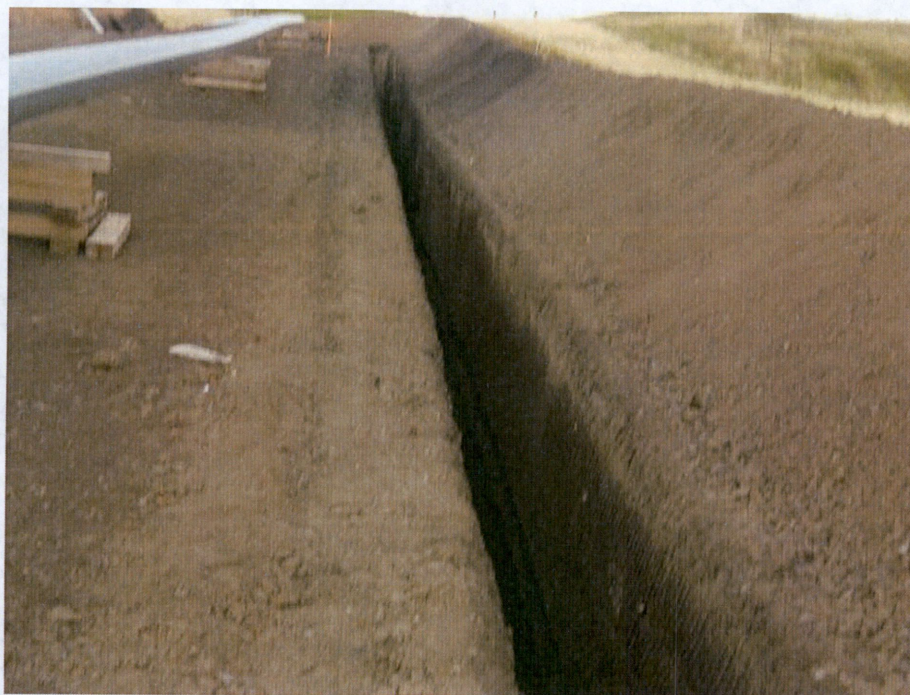
*Photo 14: Located at station 146+00, showing Right of Way direction looking west with Right of Way graded. Right of Way has been trenched with subsoil located on right side of trench. Topsoil is pushed off Right of Way located on left side of photo not shown. Pipe is welded, sitting on skids ready to place in trench.*

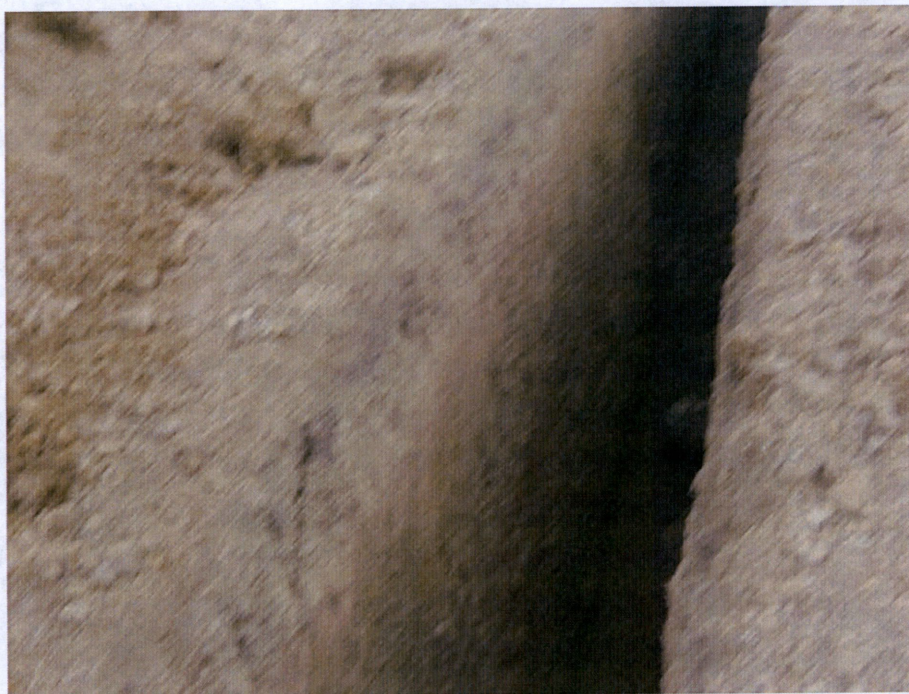
*Photo 15: Located at station 148+00, showing trench work completed on Right of Way ready to place piping in trench.*

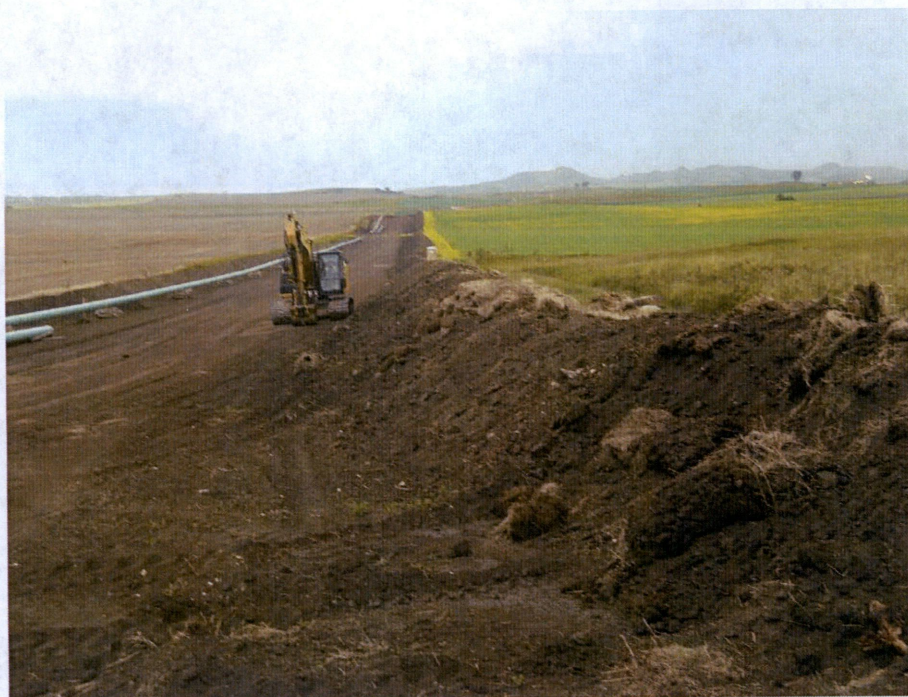
*Photo 16: Located at station 162+00, Photo looking north showing stripped Right of Way. Photo showing topsoil placed on east edge of Right of Way. Subsoil is placed on west edge (left side) along Right of Way.*

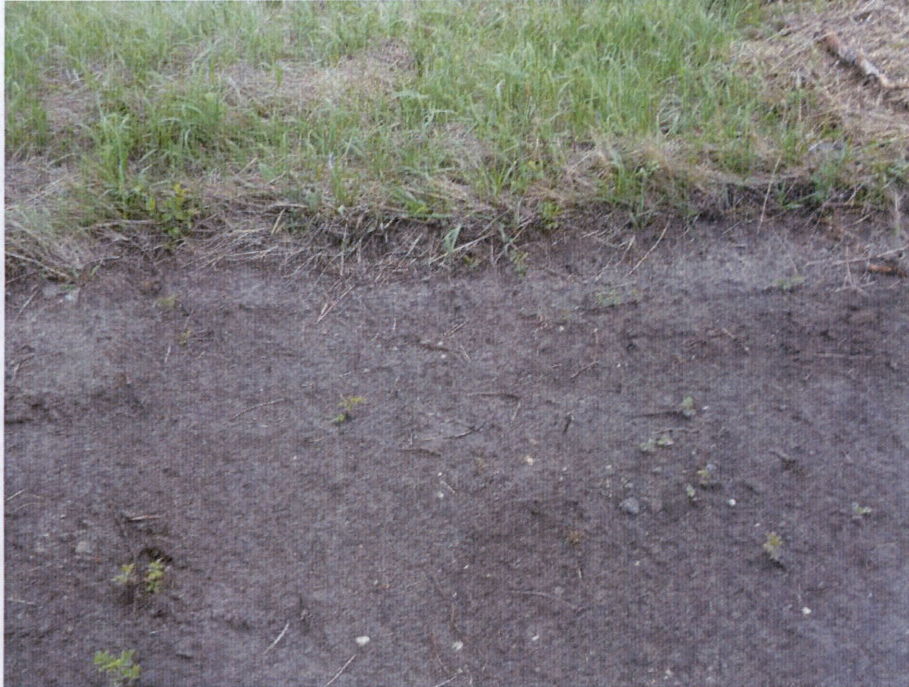
*Photo 17: Located at station 165+00, photo showing stripped Right of Way with approximate topsoil depth exposed at 12 inches. Photo showing east side at edge of Right of Way.*

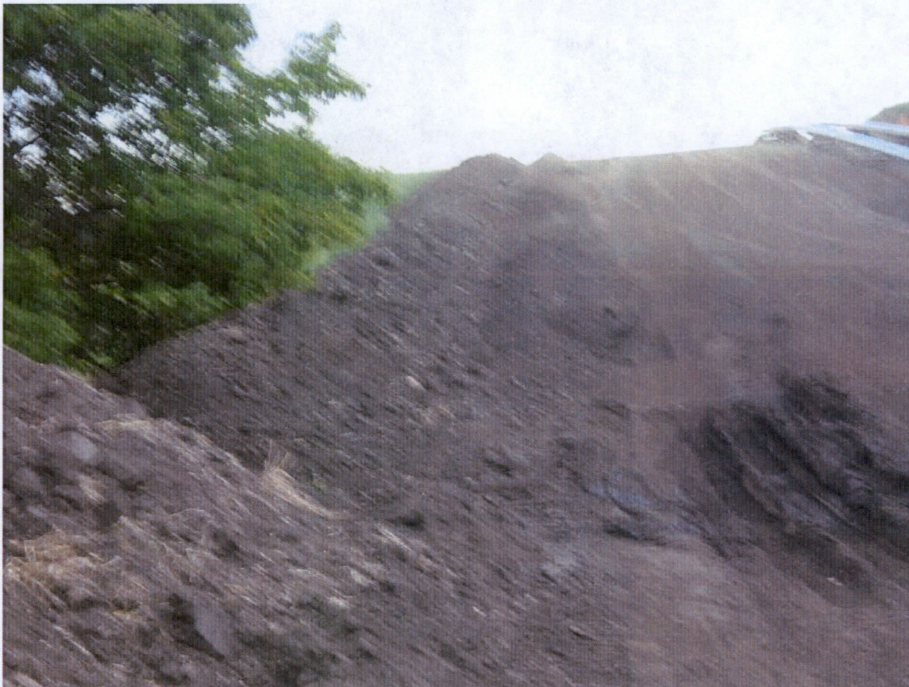
*Photo 18: Located at station 198+00, showing Right of Way heading west. Station is at bore pit located at County Road 14 that heads east. Right of Way has been stripped with topsoil located at left side (south edge) on Right of Way. Topsoil depth stripped has been approximately 12 inches. Photo showing bore piping located on left side of photo.*

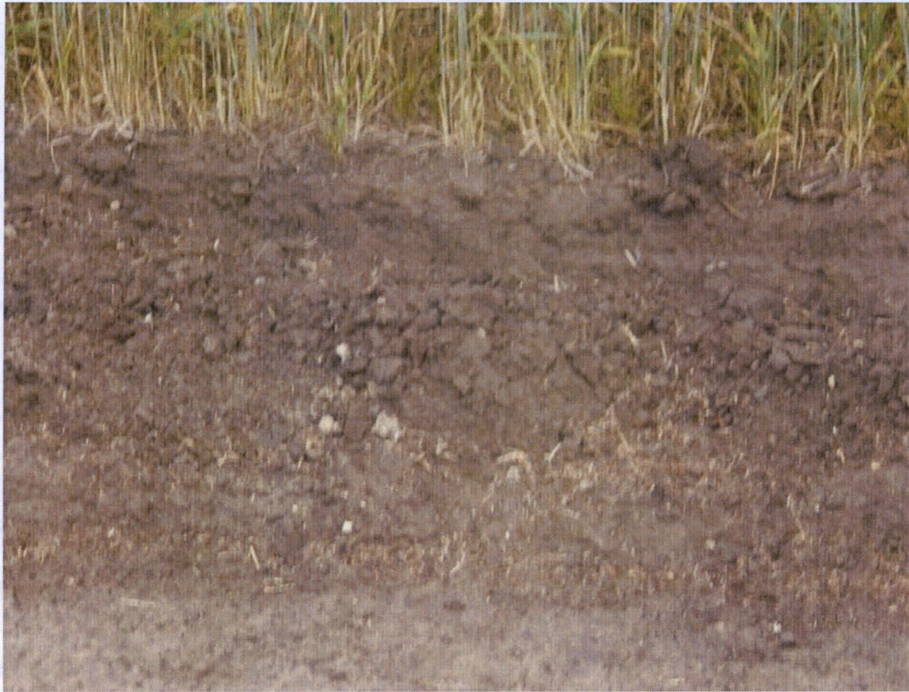
*Photo 19: Located at station 203+00, showing stripped Right of Way with approximate topsoil depth of 12 inches. Photo is showing north side of Right of Way.*

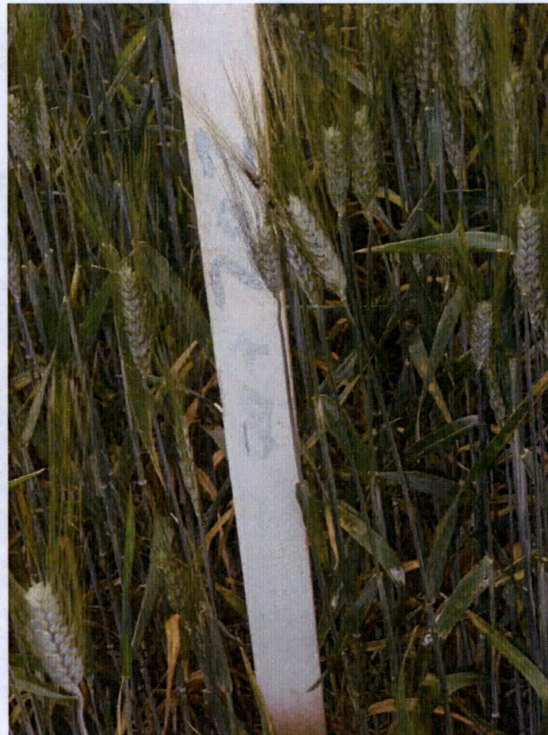
*Photo 20: Located at station 202+00, showing station 202+00 located at bore site at County Road 14. Wheat field is shown off Right of Way looking north.*

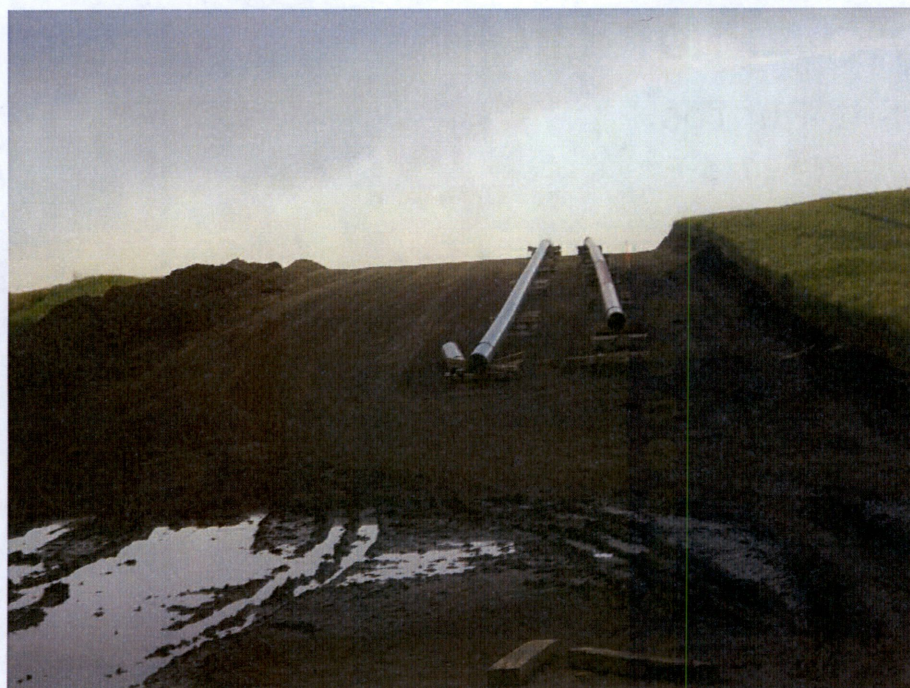
*Photo 21: Located at station 204+00, showing Right of Way heading west. Station is at bore pit, location by County Road 14 that heads west. Right of Way has been stripped of topsoil which is located along left side (south edge) of Right of Way. Photo showing pipe welded and ready to be bored under County Road 14.*

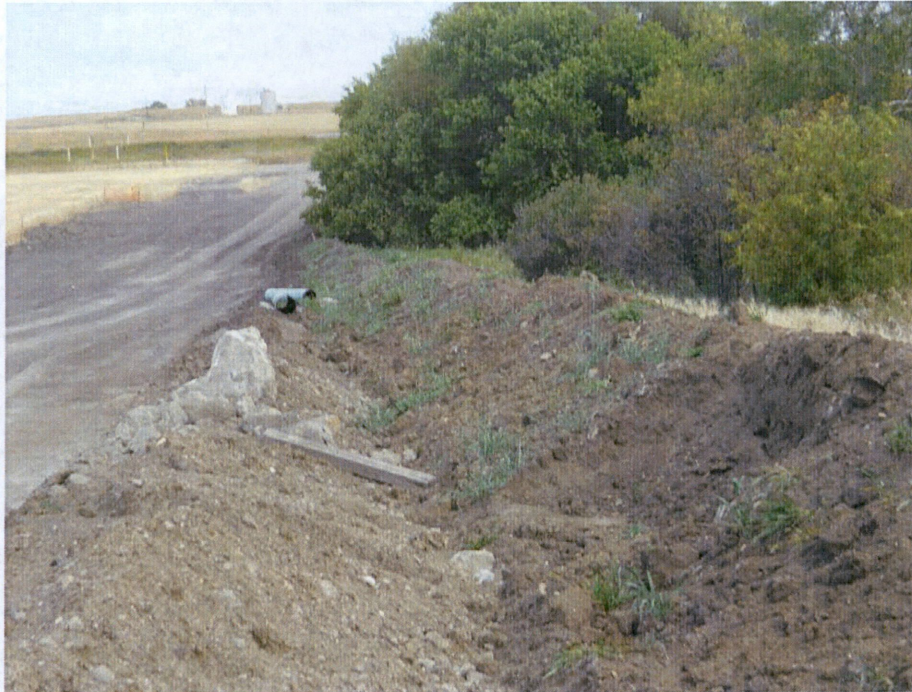
*Photo 1: Showing Right of Way at station 198+00, Bore site located at County Road 14. Right of Way needs cleaning. Photo looking east, showing subsoil at lower left of photo with topsoil pushed off Right of Way on right side of photo. Both soil types are kept separated and segregated.*

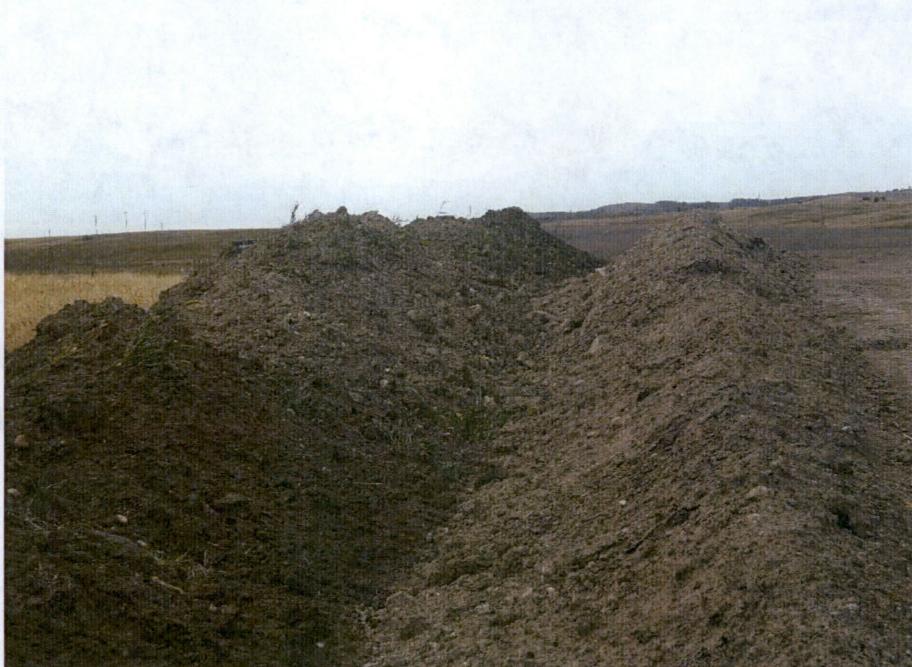
*Photo 2: Located at station 207+00, showing Right of Way direction looking east. Right of Way has been stripped with subsoil on right side of photo and topsoil is located on the left side of photo and Right of Way. Both soil types are kept separated and segregated.*

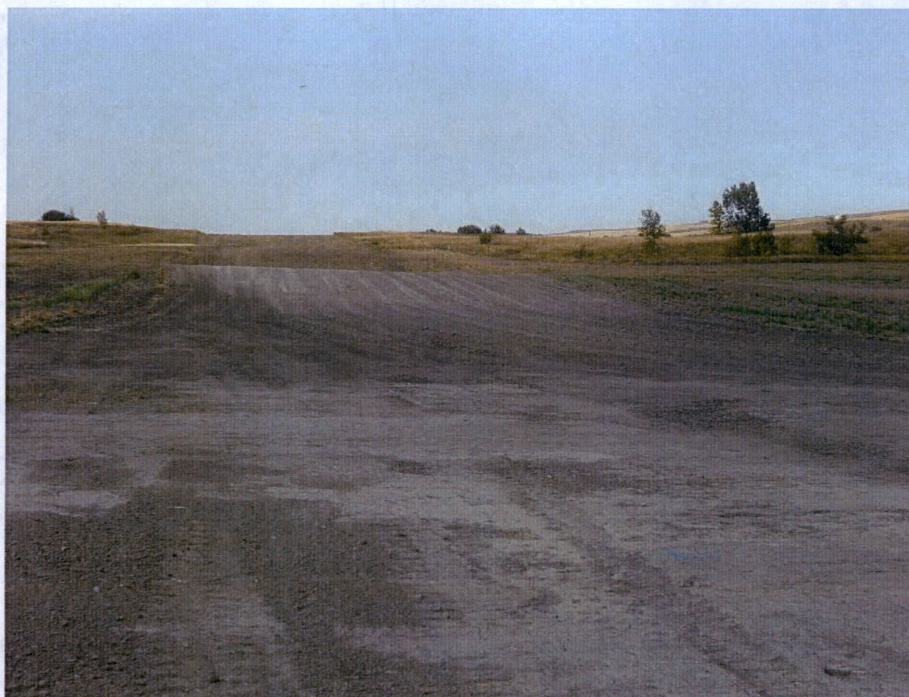
*Photo 3: Located at station 213+00, showing graded Right of Way headed north.*

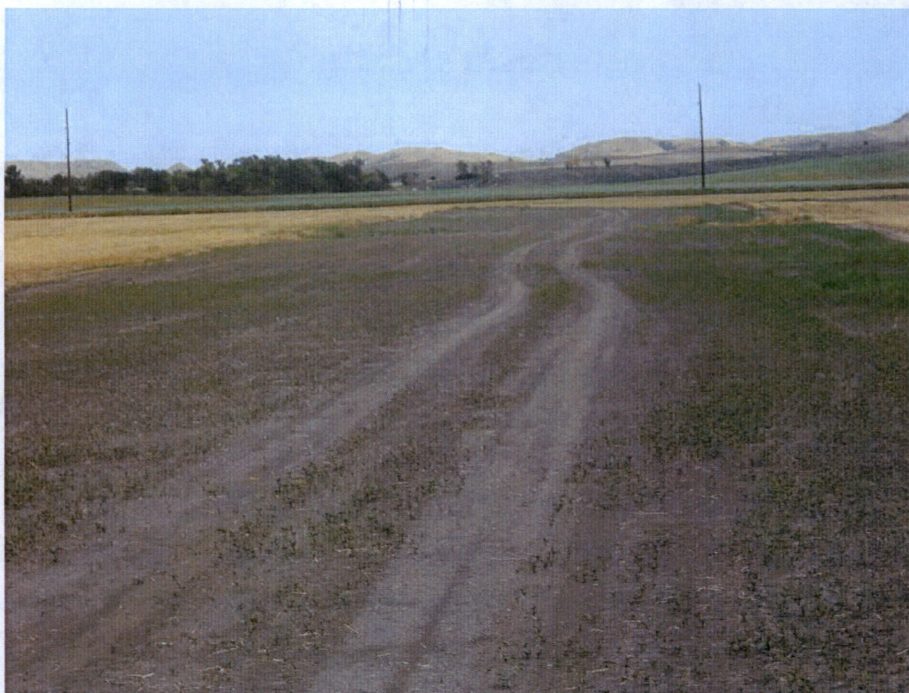
*Photo 4: Located at station 222+00, Looking north of Right of Way with pipe in trench and Right of Way leveled and regraded to original condition. Right of Way has been cleaned and ready for seeding.*

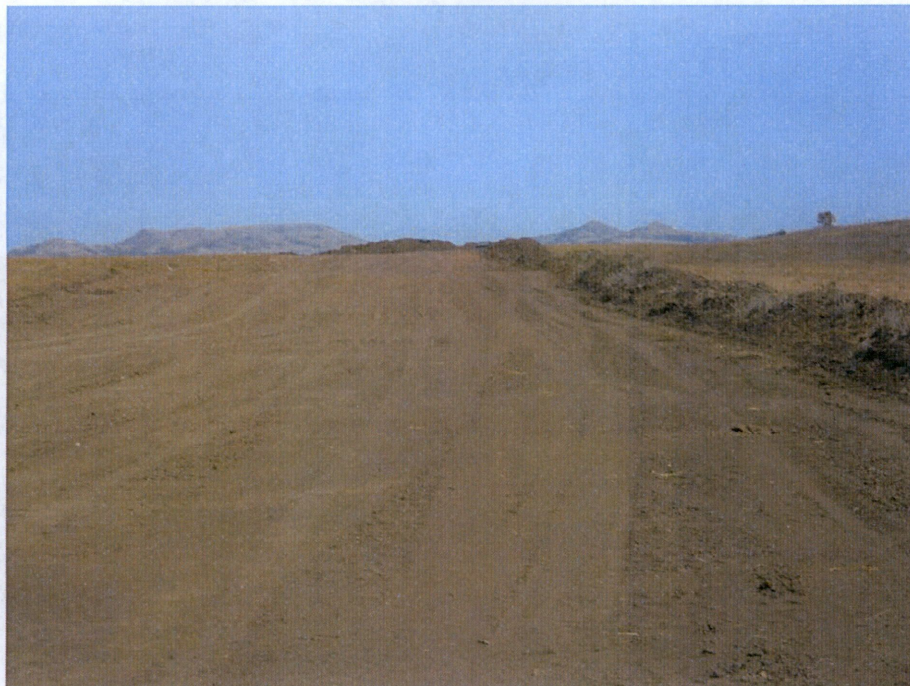
*Photo 5: Located at station 225+00, taken from east end of Right of Way facing west, heading uphill. Right of way graded, with topsoil pushed to north edge of Right of Way easement. No BMP's have been installed along entire length of Right of Way for erosion control.*

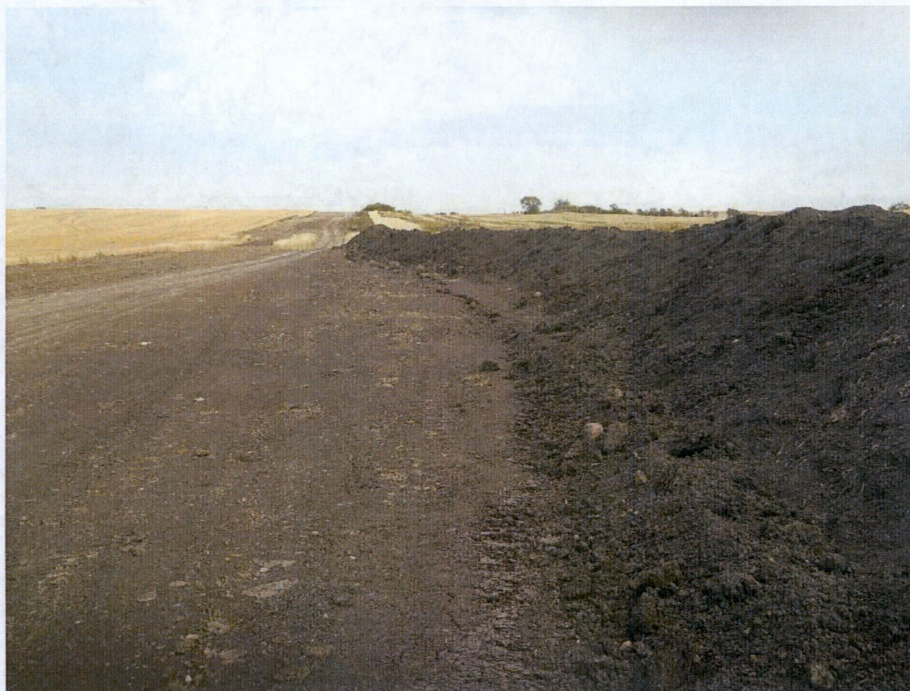
*Photo 6: Located at station 240+00, showing graded Right of Way direction looking north. Topsoil is pushed off and placed in edge of Right of Way on the west side.*

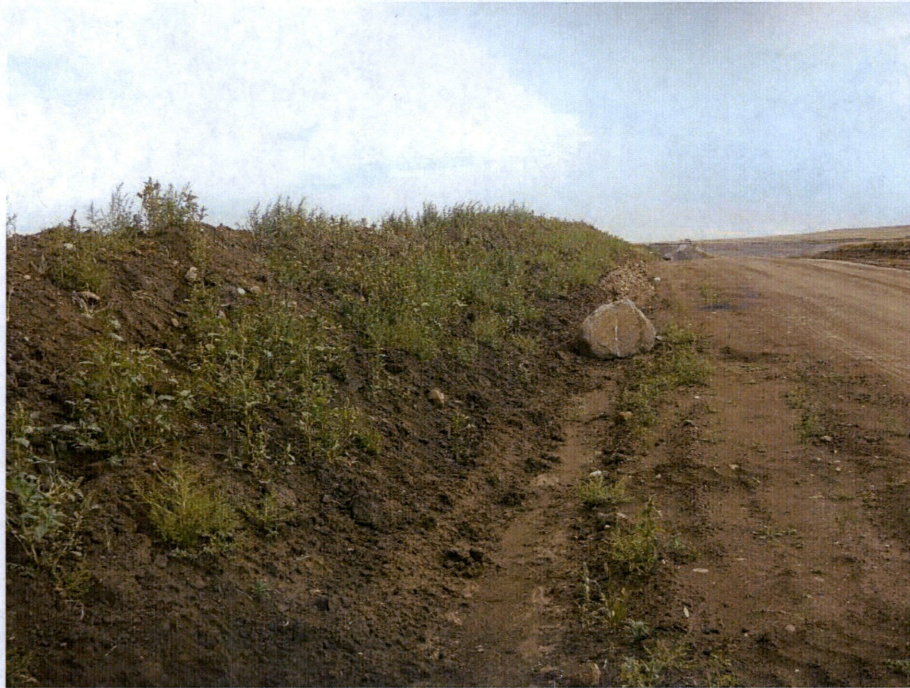
*Photo 7: Located at station 248+00, Facing west, showing graded Right of Way with topsoil pushed off Right of Way edge on west side. Subsoil is pushed on Right of Way edge on left side. Rocks need to be removed from Right of Way when replacing topsoil.*

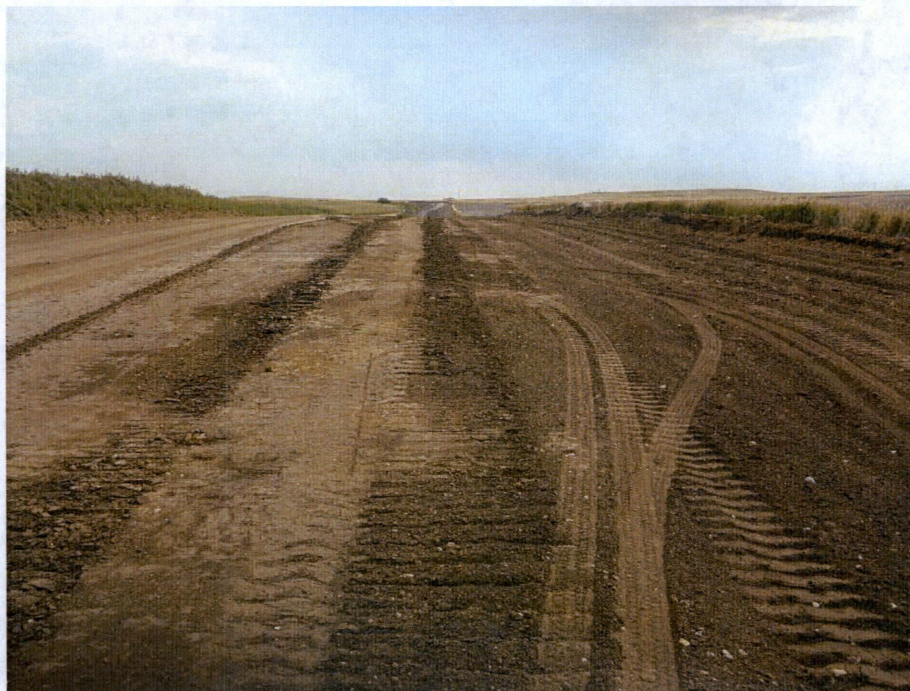
*Photo 8: Located at station 264+00, looking west at graded Right of Way showing topsoil located on left side of Right of Way. Topsoil removal is approximately 12 inches deep.*

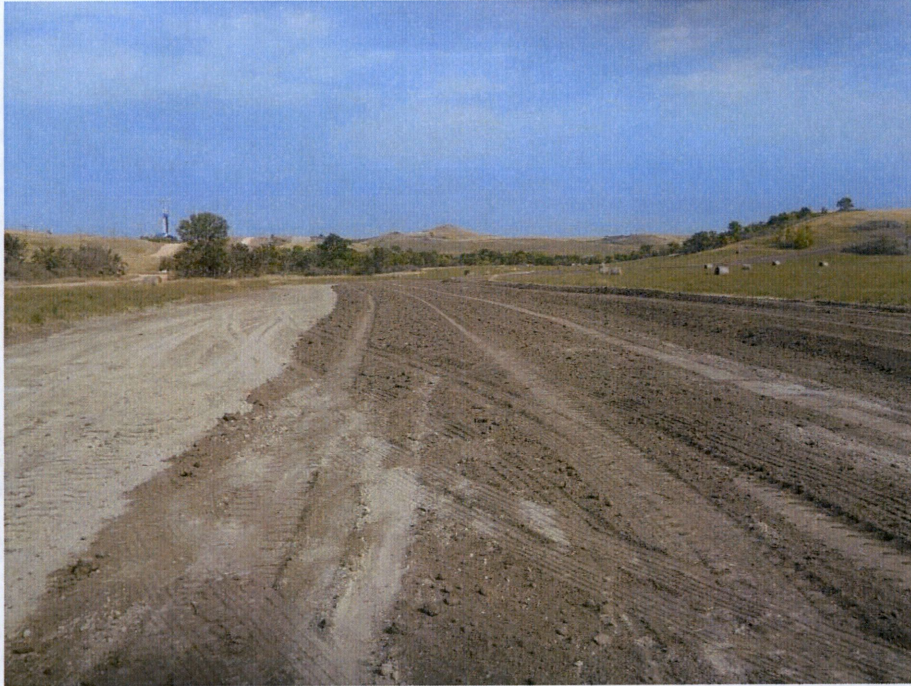
*Photo 9: Located at station 297+00, looking east at graded Right of Way. Pipe installed in trench with subsoil replaced over Right of Way. Existing topsoil being regraded and leveled over Right of Way. Clean up in progress.*

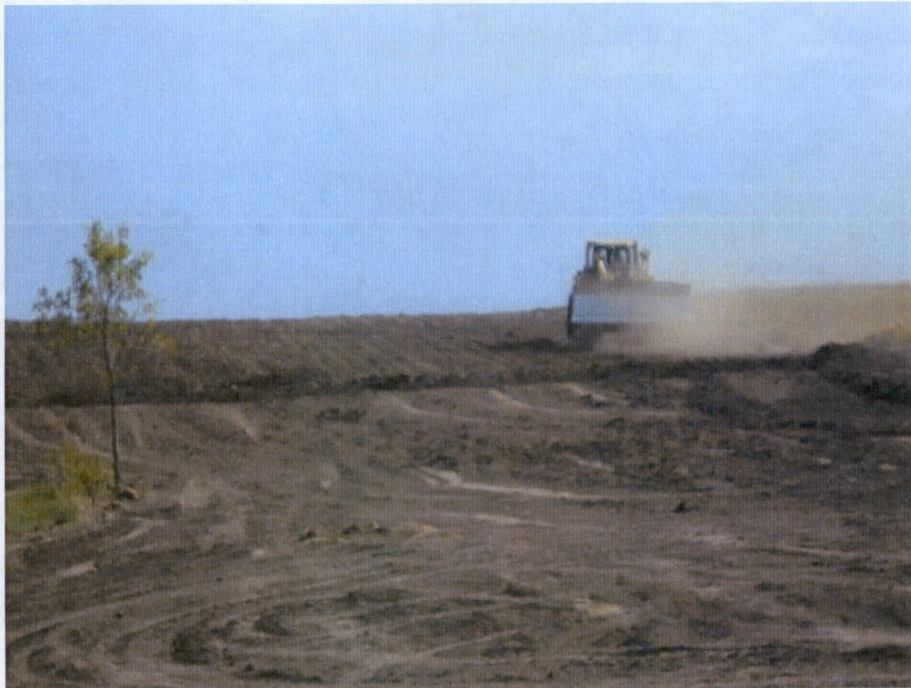
*Photo 10: Located at station 288+00, looking south at Right of Way. Pipe installed in trench and backfilled. Contractor in process of installing and leveling Right of Way to original condition. Clean up in process.*

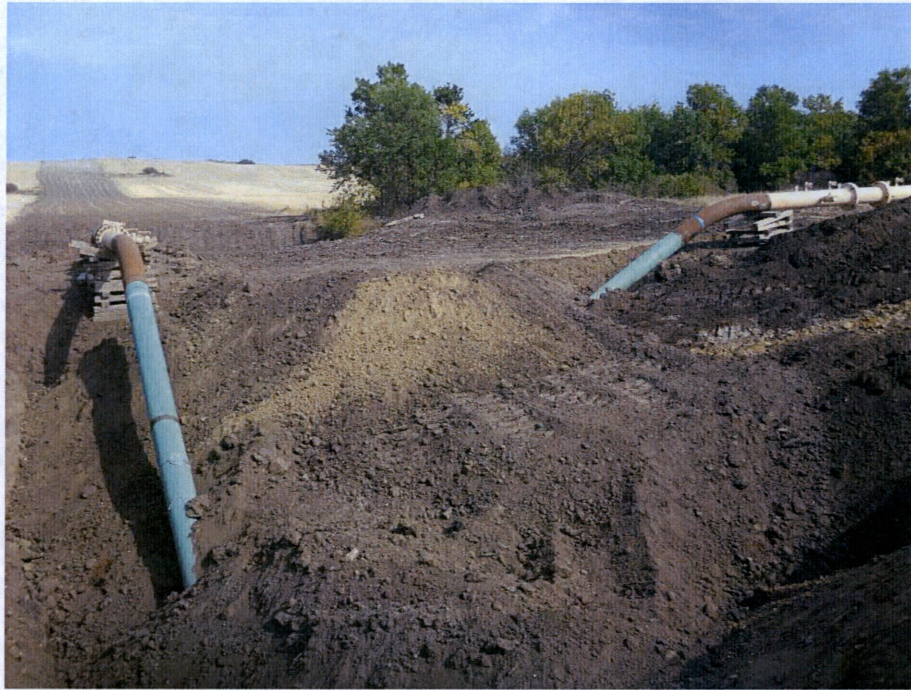
*Photo 11: Located at station 319+52.27, looking at bore pit on east side of County Road 14. Photo showing piping and valve settings.*

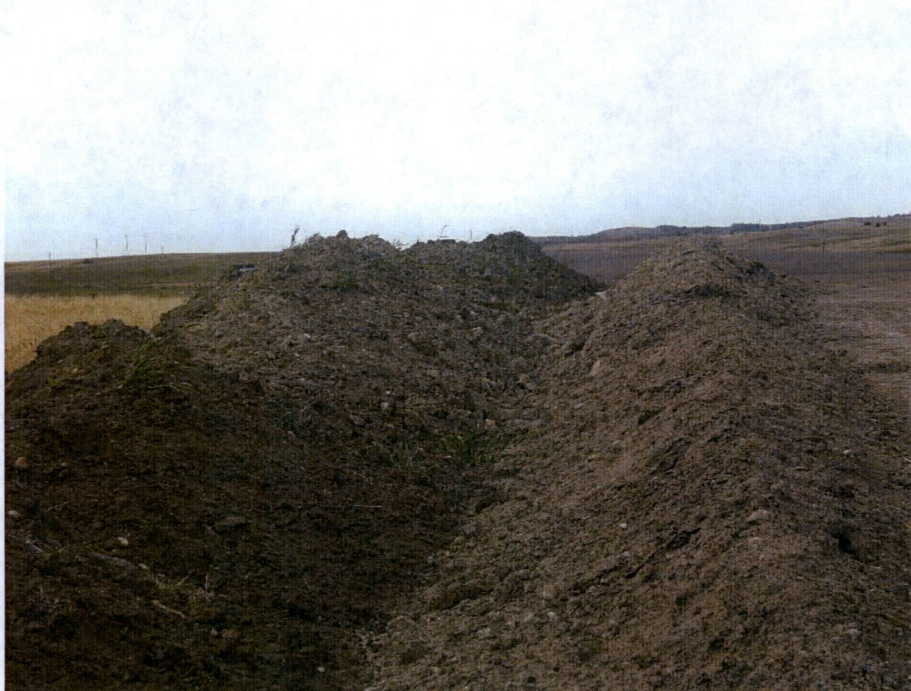
*Photo 12: Located at station 324+00, looking at graded Right of Way showing subsoil and topsoil pushed off of Right of Way. Both soil types are segregated and separated as required.*

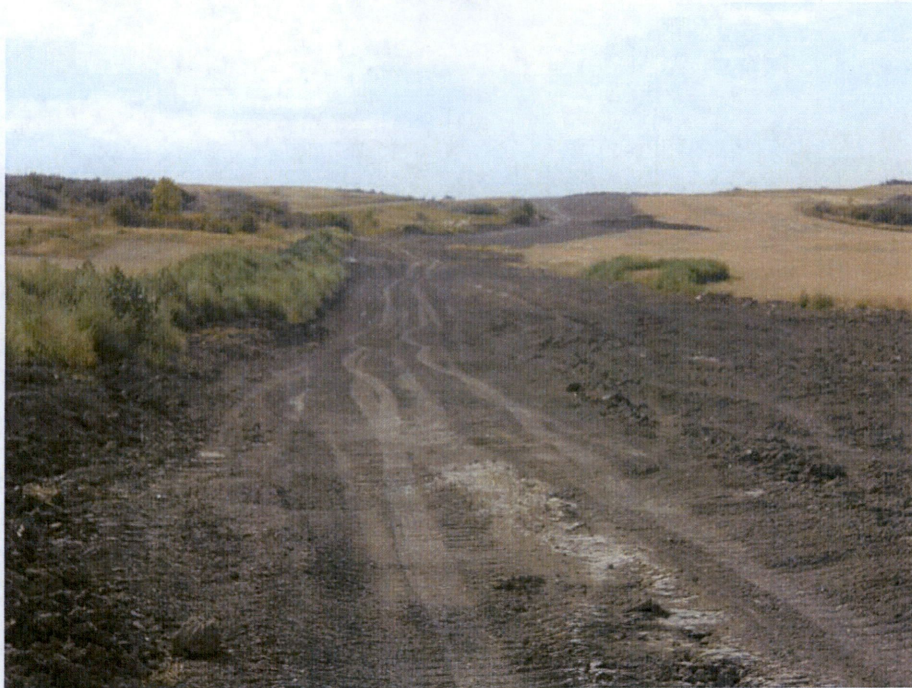
*Photo 13: Located at station 342+00, looking north at graded Right of Way. Pipe installed in trench and regraded. Right of Way topsoil needs to have leveling finished and cleaned up to original condition.*
