Re: Topsoil Inspection Report for Sacagawea Pipeline Project  
Johnson's Corner Connector Crude Oil Pipeline  
PU-15-744

# Sacagawea Pipeline Co.

Johnson's Corner Connector  
Crude Oil Pipeline Project  
PU-15-744  
KLJ#1215109

*October 27, 2016*

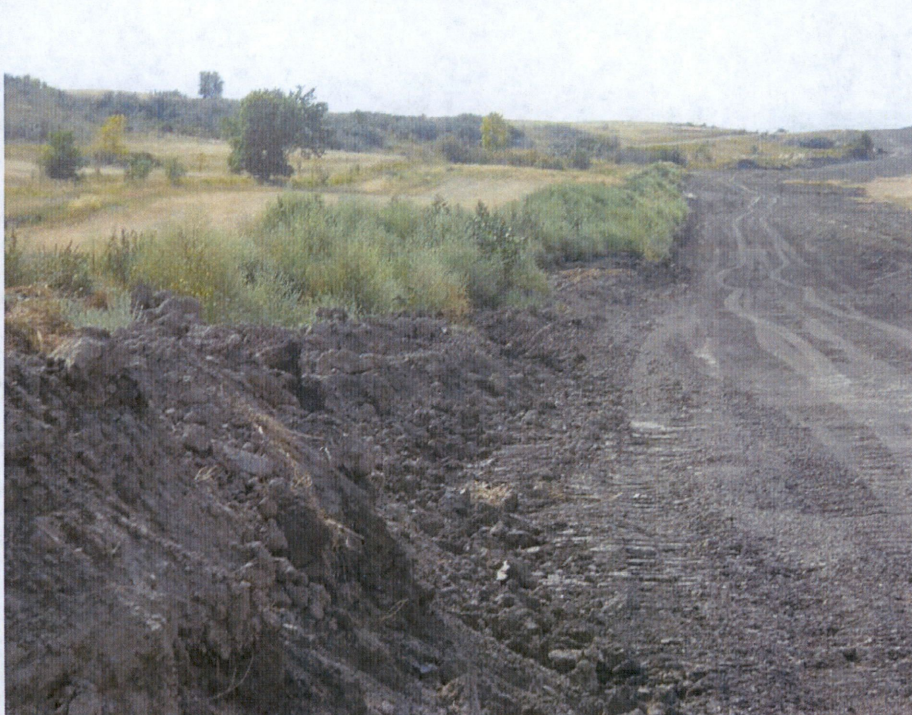
*Photo 14: Located at station 345+00, looking north at graded Right of Way showing pipe installed in trench and backfilled. Topsoil still needs to be regraded and leveled out across Right of Way.*

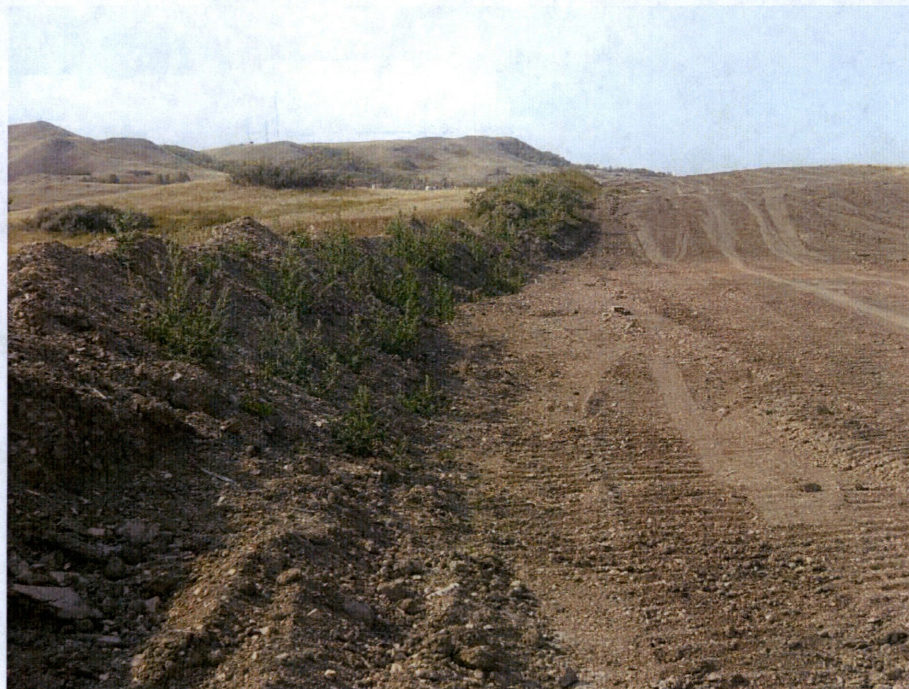
*Photo 15: Located at station 354+00, looking north at graded Right of Way showing pipe installed in trench with subsoil backfilled and graded across Right of Way. Photo shows topsoil placed on edge of Right of Way ready to grade and level over Right of Way to original condition.*

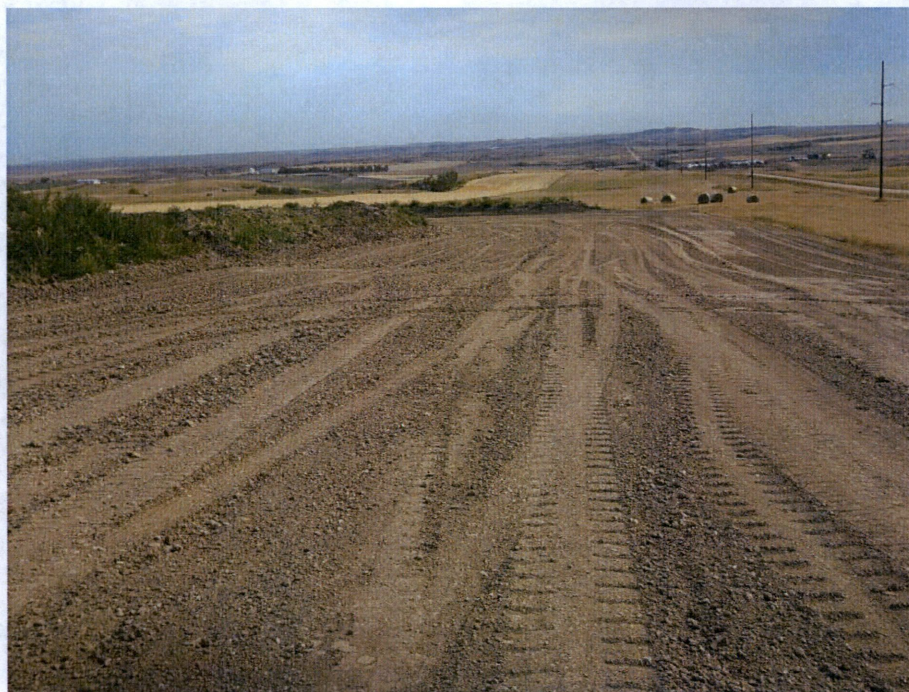
*Photo 16: Located at station 435+00, looking south at graded Right of Way, showing pipe installed in trench with subsoil graded and leveled. Topsoil still shown placed on edge of Right of Way, needs to be regraded and returned to original condition.*

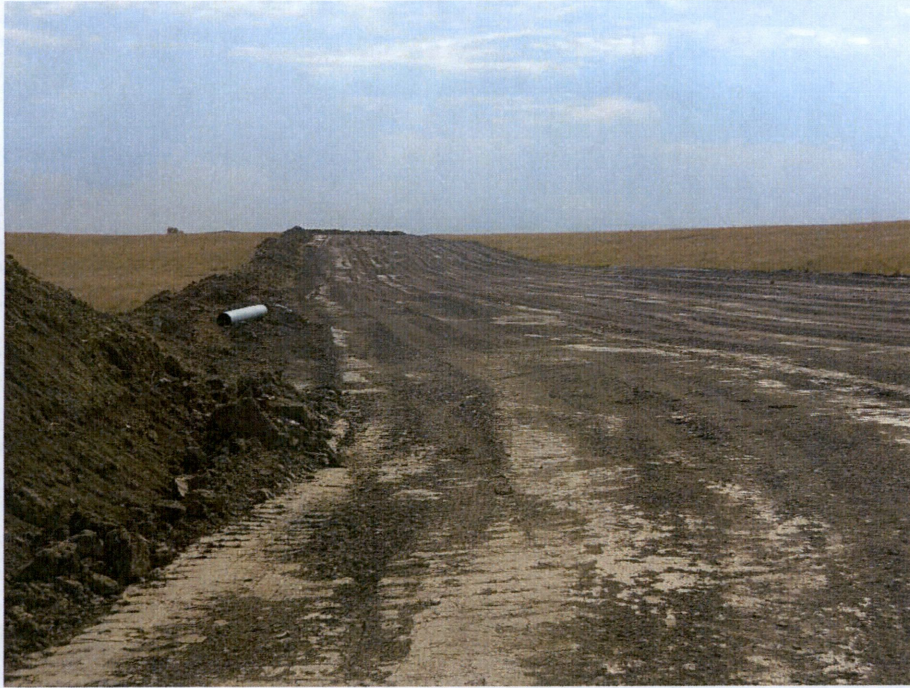
*Photo 17: Located at station 420+00, looking west at graded Right of Way, showing pipe installed in trench with subsoil graded and leveled. Topsoil replacement and Right of Way cleanup still needs to be completed.*

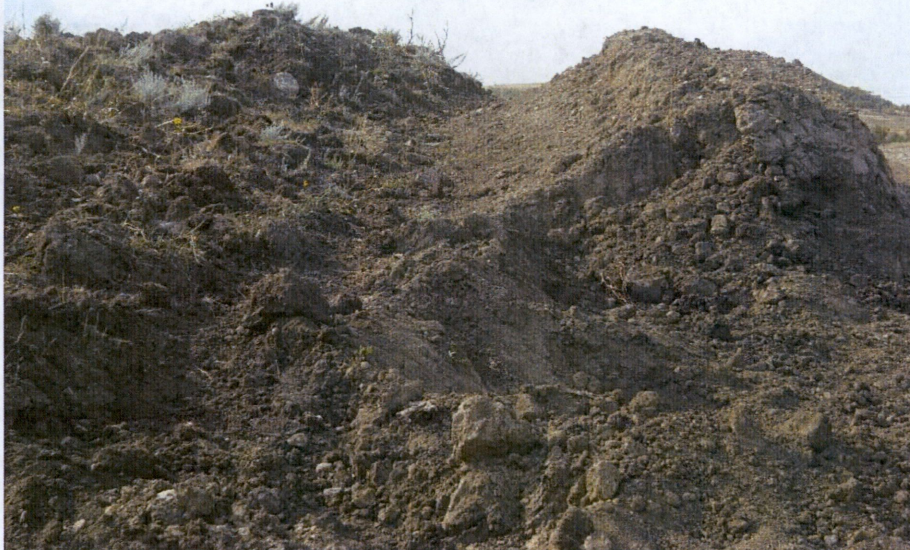
*Photo 18: Located at station 450+00, looking north at Right of Way, showing subsoil and topsoil along the edge of Right of Way. Subsoil shown on right side of photo and topsoil on left side of photo. Both soil types are separated and segregated.*

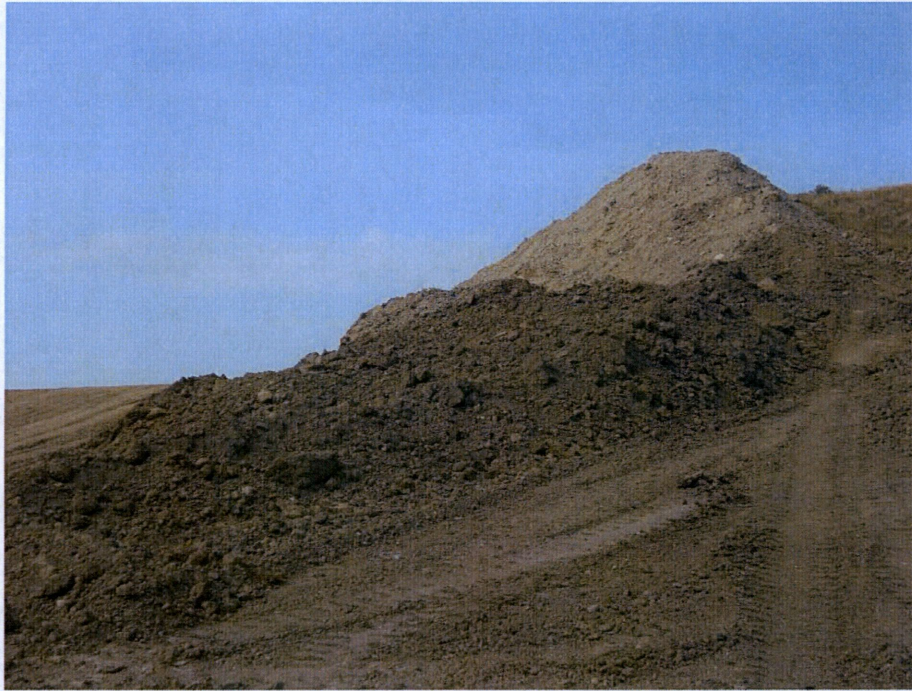
*Photo 19: Located at station 459+00, showing topsoil placed along edge of Right of Way. Topsoil needs to be regraded and levelled over Right of Way to original condition.*

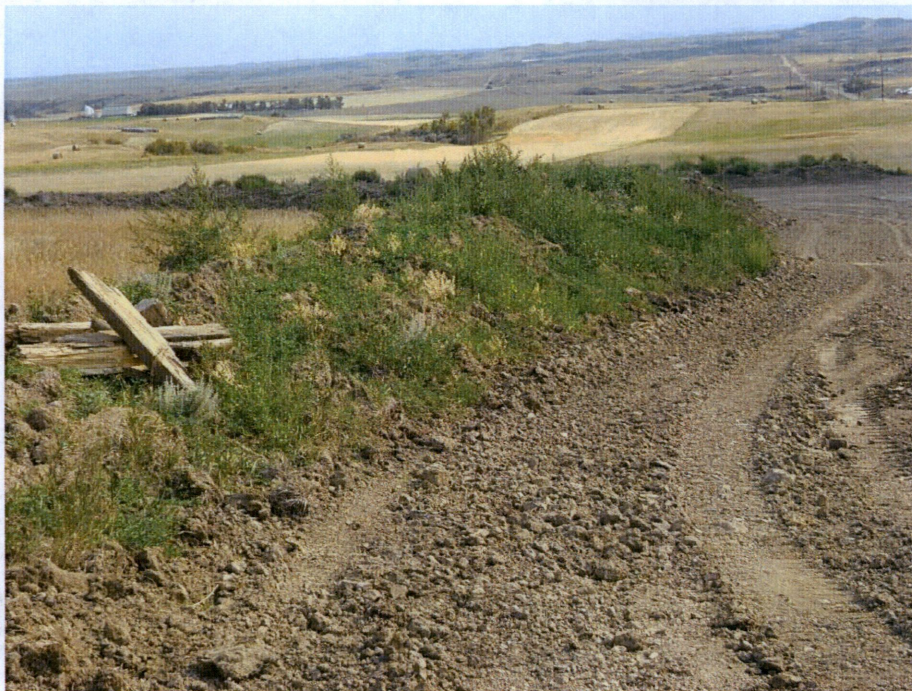
*Photo 20: Located at station 438+00, looking south at Right of Way, then turning east, showing graded subsoil. Topsoil still placed on edge of Right of Way, needing to be regraded and levelled across Right of Way to original condition. Clean up work across Right of Way not completed.*

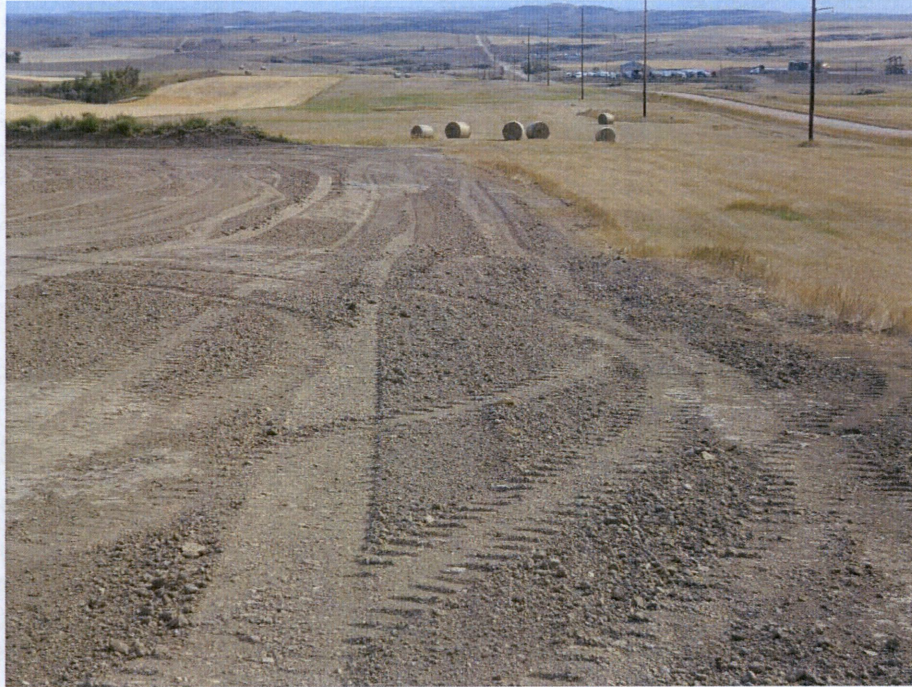
*Photo 21: Located at station 444+00, looking south at Right of Way showing piping installed in trench and backfilled. Subsoil has been regraded and leveled across Right of Way. Topsoil has not been regraded and levelled out across Right of Way.*

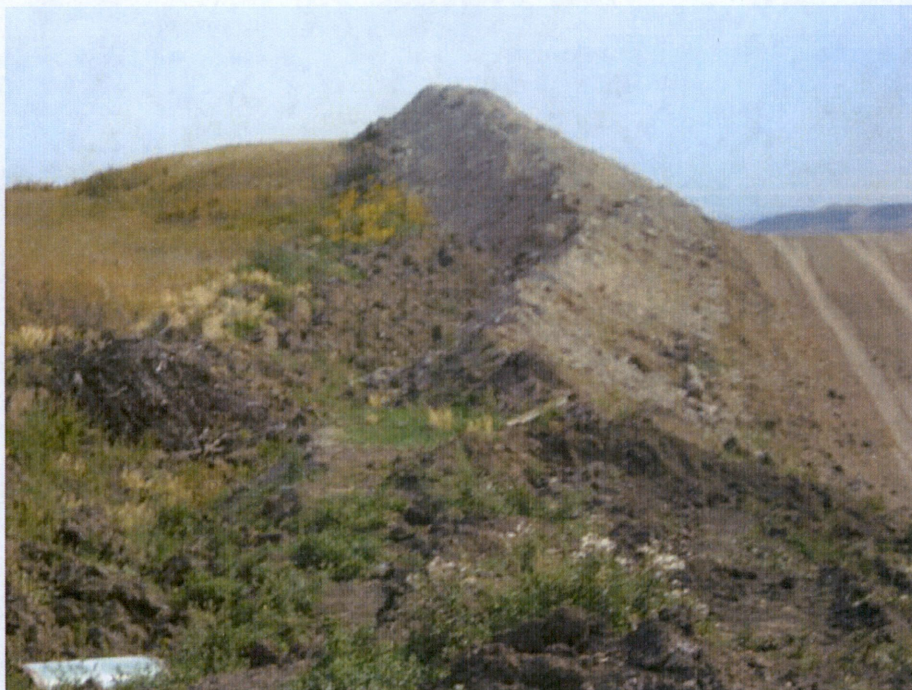
*Photo 22: Located at station 459+00, looking south at topsoil placement along edge of Right of Way. Right of Way has been graded and ready to install topsoil over Right of Way to original condition.*

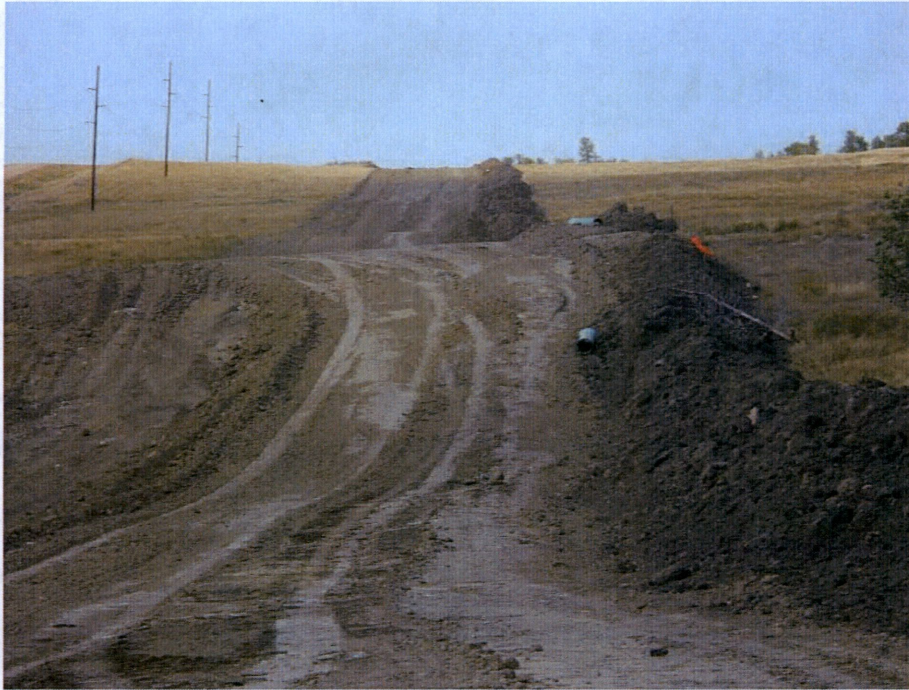
*Photo 23: Located at station 474+00, looking north at Right of Way, showing piping installed in trench and backfilled. Subsoil has been regraded across Right of Way. Topsoil work has not started yet, shown on right side of photo. Clean up work across Right of Way is not completed.*

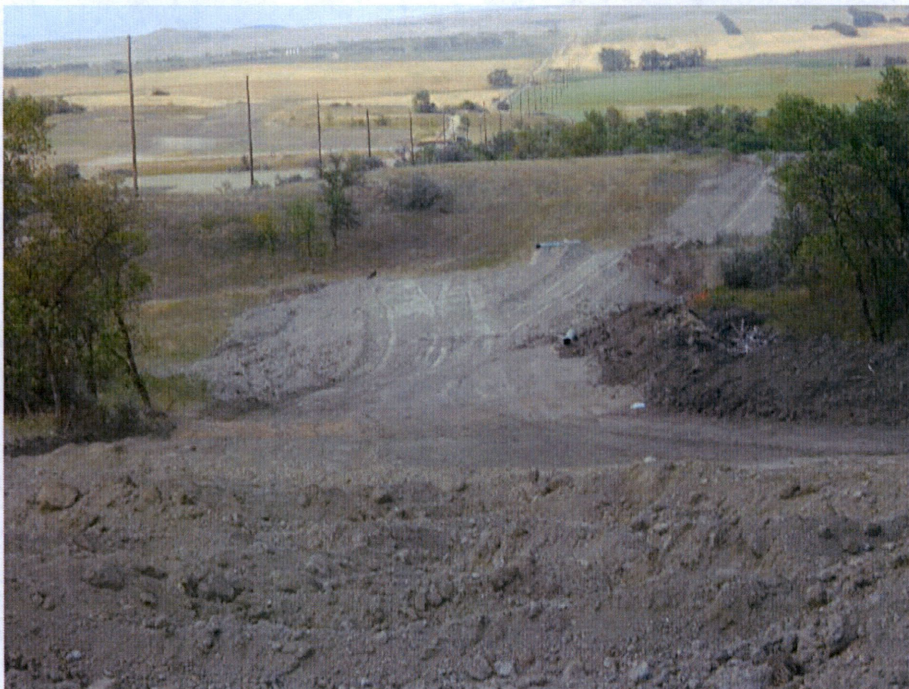
*Photo 24: Located at station 483+00, looking north, showing subsoil grading started but not completed. Topsoil placed on edge of Right of Way, showing no work started. Clean up work across Right of Way not started.*

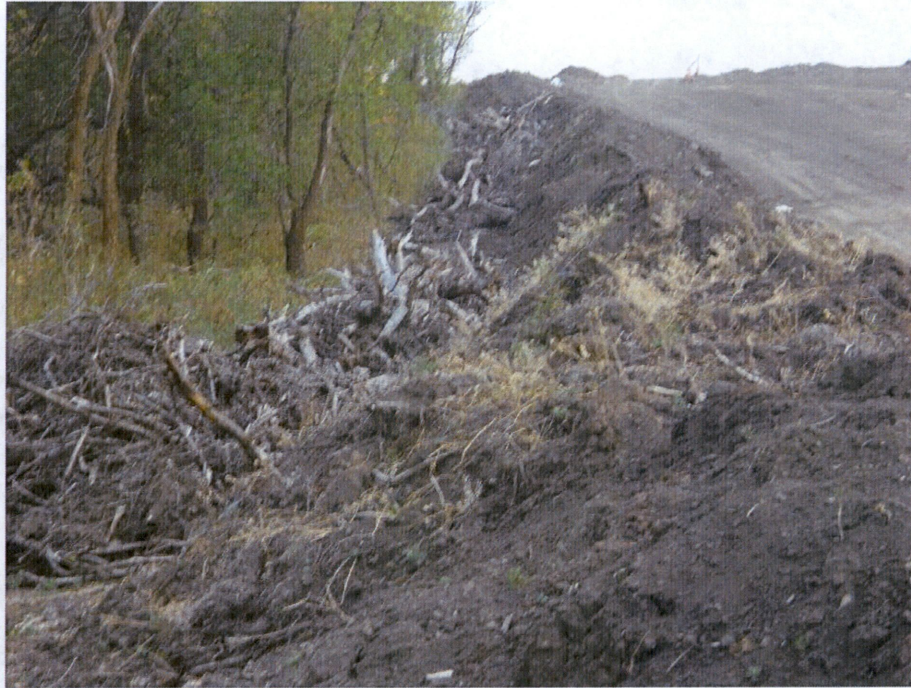
*Photo 25: Located at station 492+00, photo showing Right of Way graded with piping in trench and backfilled. Topsoil shown on outside of Right of Way with a lot of dead timber located with topsoil, that needs to be cleaned up and removed.*

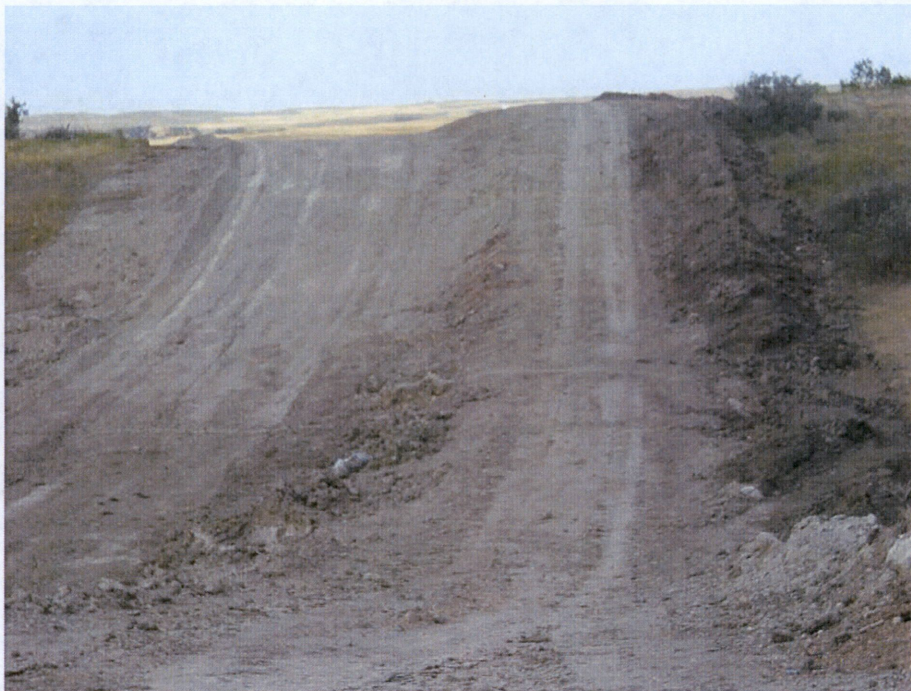
*Photo 26: Located at station 510+00, looking north of Right of Way, showing piping installed in trench and backfilled. Topsoil shown on right side along Right of Way. Grading work has not been started yet.*

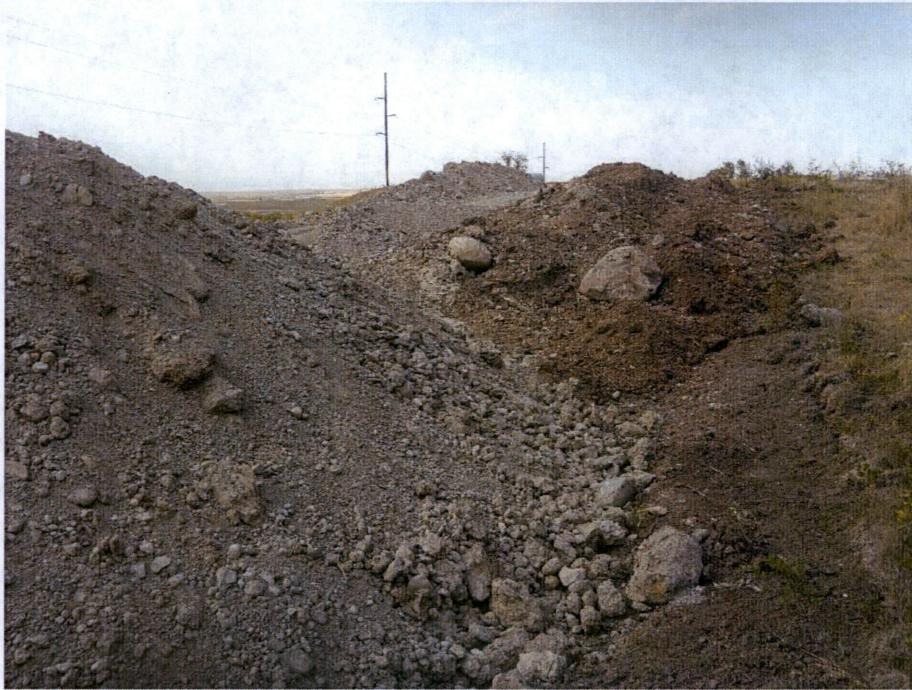
*Photo 27: Located at station 519+00, showing Right of Way with segregated subsoil and topsoil along edge of Right of Way.*

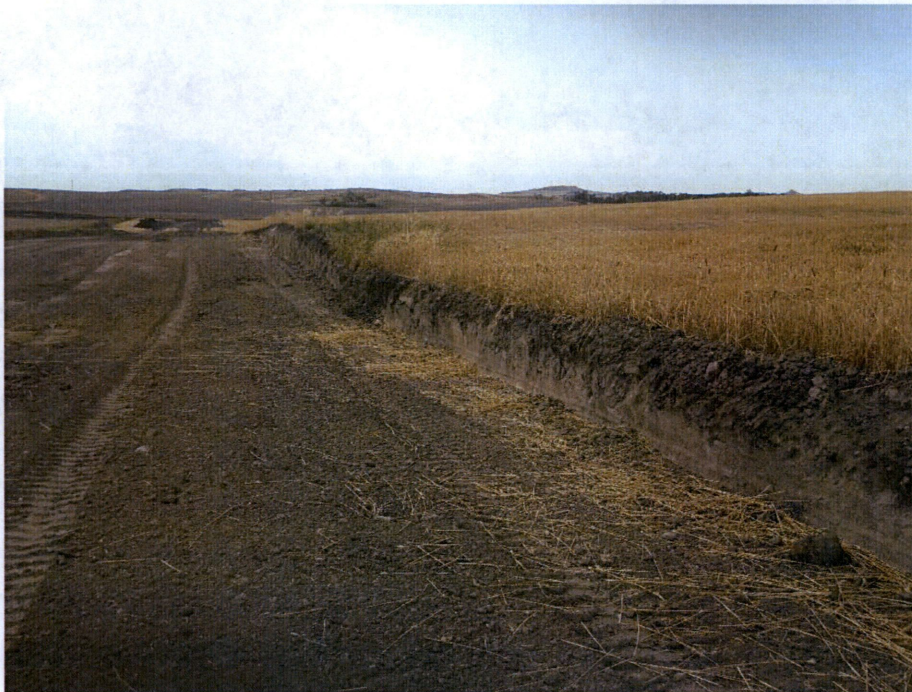
*Photo 28: Located at station 570+00, showing graded Right of Way with 12 inches of topsoil removed. Grading showing subsoil below topsoil after grading completed.*

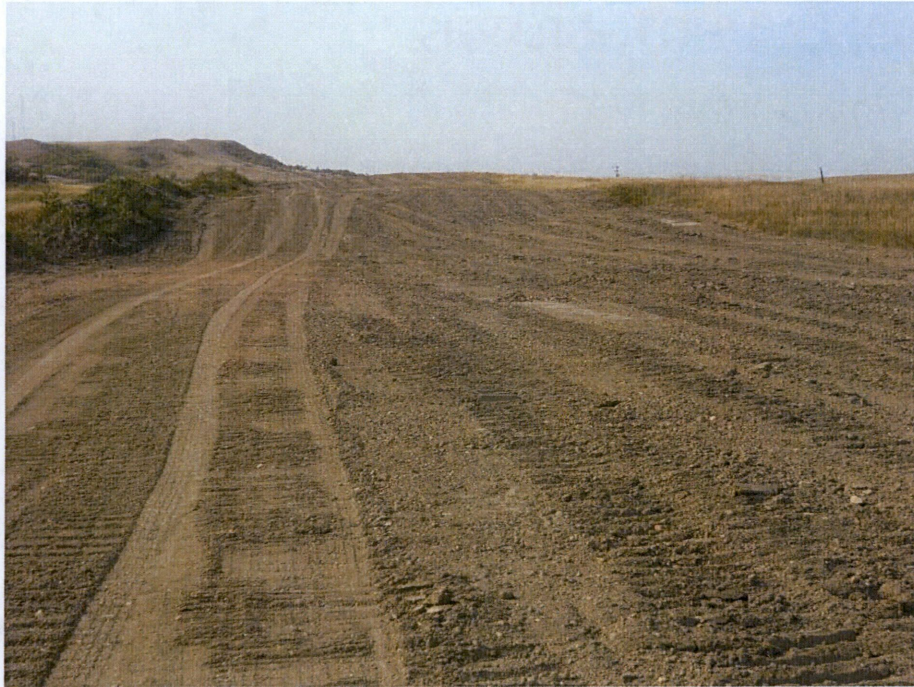
*Photo 29: Located at station 600+00, looking north, showing graded subsoil across Right of Way levelled. Topsoil shown on left side of photo. Topsoil work not started yet.*
