Johnson's Corner Connector
Crude Oil Pipeline Project
Reclamation and Revegetation Inspection Report
PU-15-744

February 14, 2019

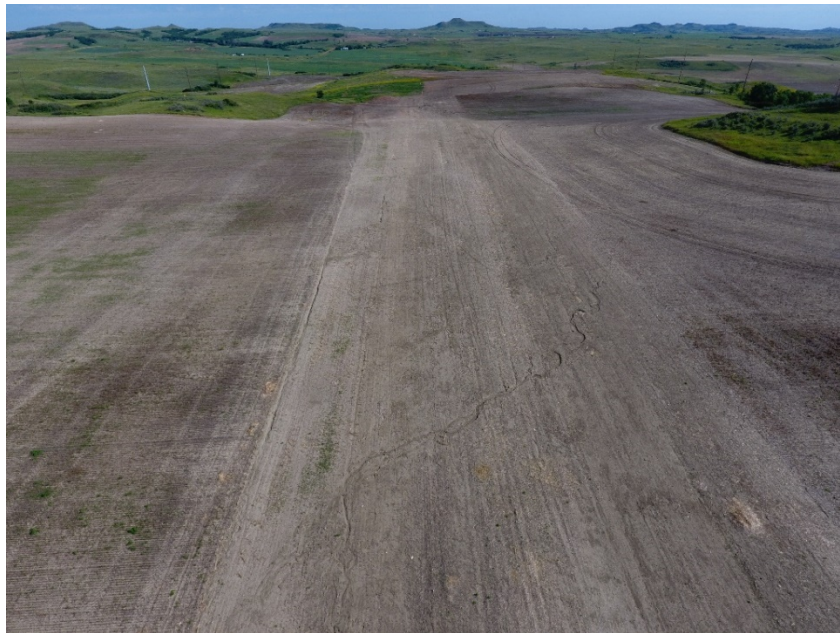
Location 1, Looking North (47.807301, -102.901184)

Minimal disturbance. Erosion observed to be typical in farmland before plants are established.

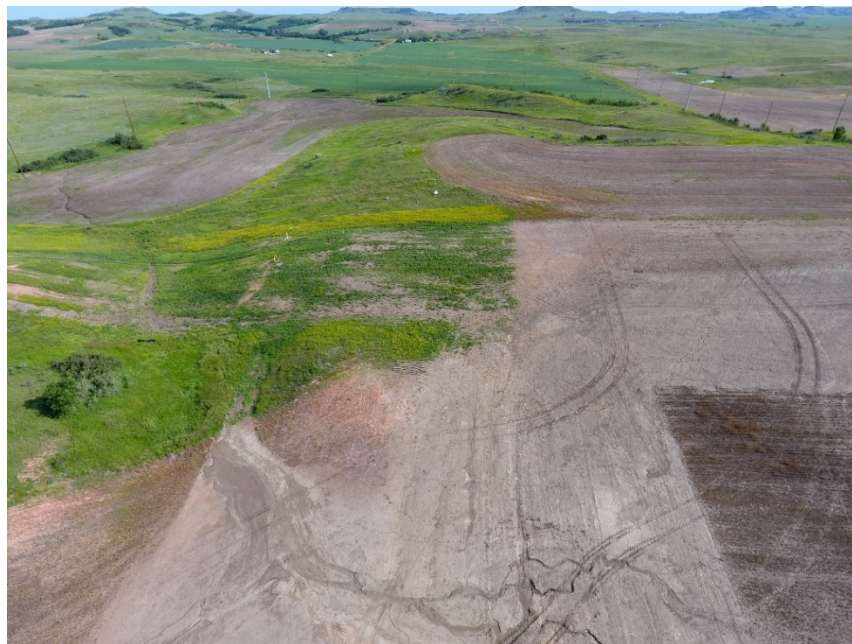
Location 2, Looking North (47.810032, -102.901039)

Erosion observed to be typical in farmland before plants are established.

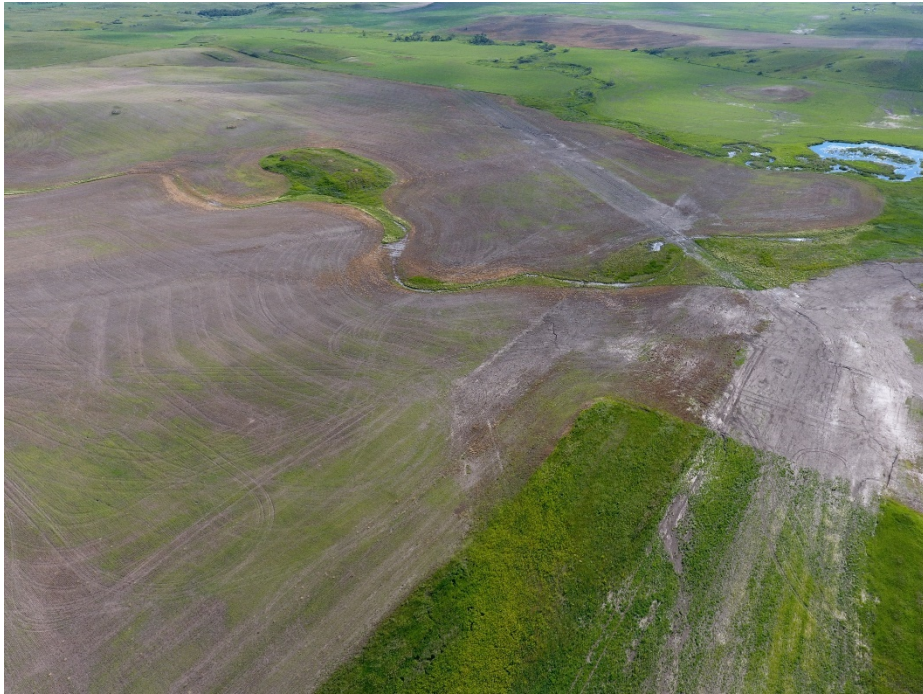
Location 3, Looking Northeast (47.810955, -102.894943)
Well vegetated, blending in with adjacent surroundings

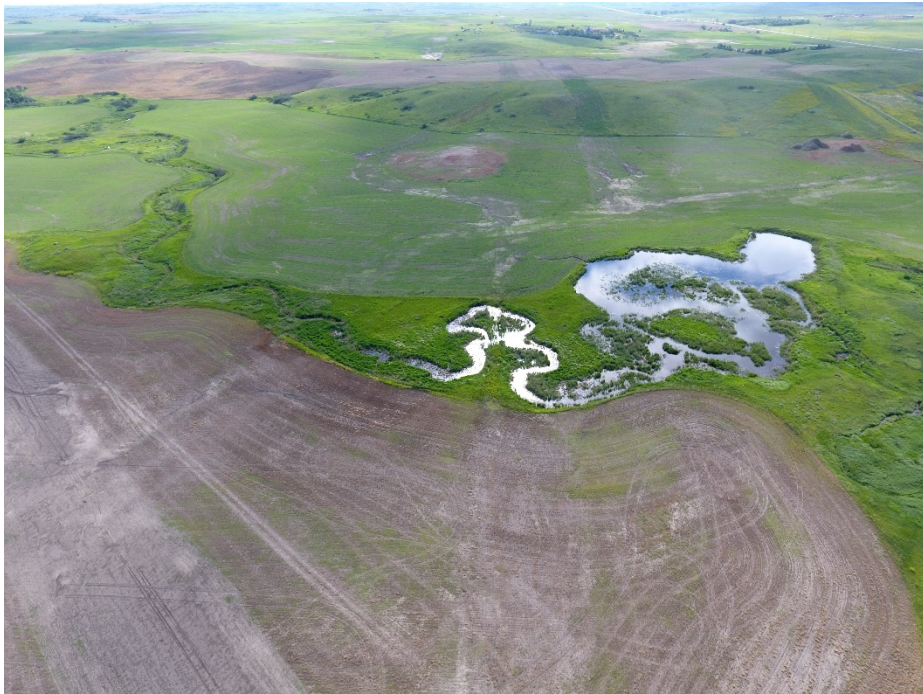
Page 11, Location 5: Pipeline scar somewhat visible in cropland, but vegetation closely matches conditions of adjacent land.

Location 5, Looking West (47.811615, -102.891319)
Well vegetated, beginning to blend into existing conditions

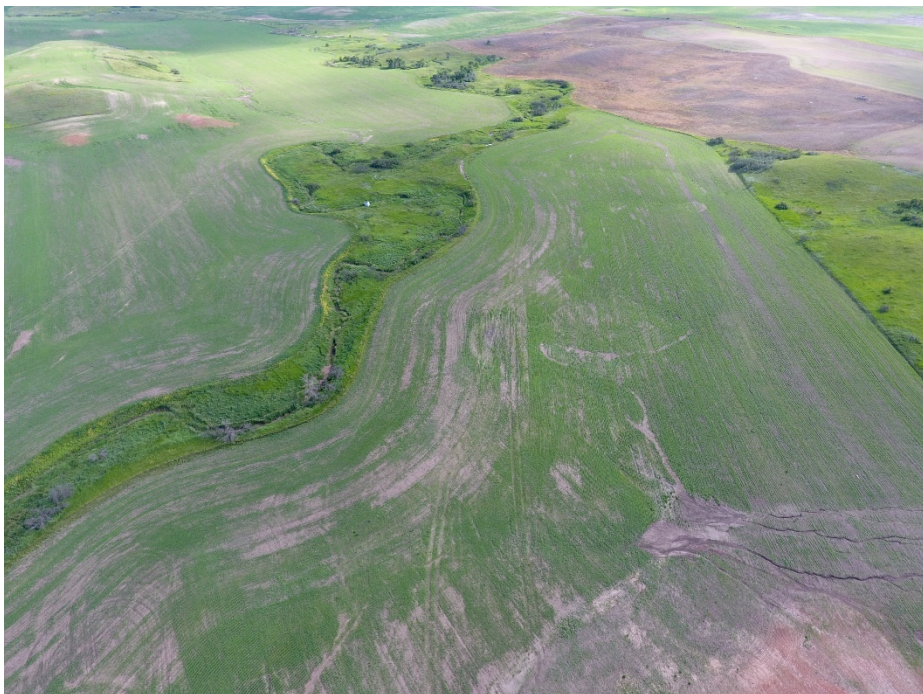
Location 6, Looking Northeast (47.812176, -102.886841)
Minimal disturbance visible in cropland

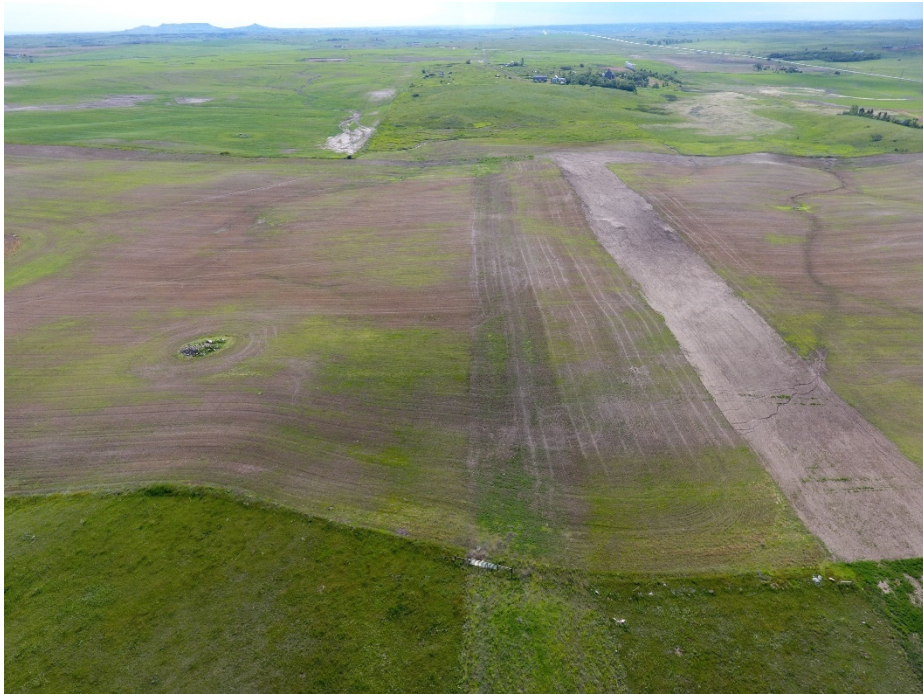
Page 12, Location 7: Reclamation of PU-15-744 on left, more recent pipeline work on the right. Photo shows the status of vegetation completed in previous growing season.

Location 7, Looking East (47.811546, -102.883499)
Multiple pipeline scars in this location. Beginning to blend well into surrounding conditions

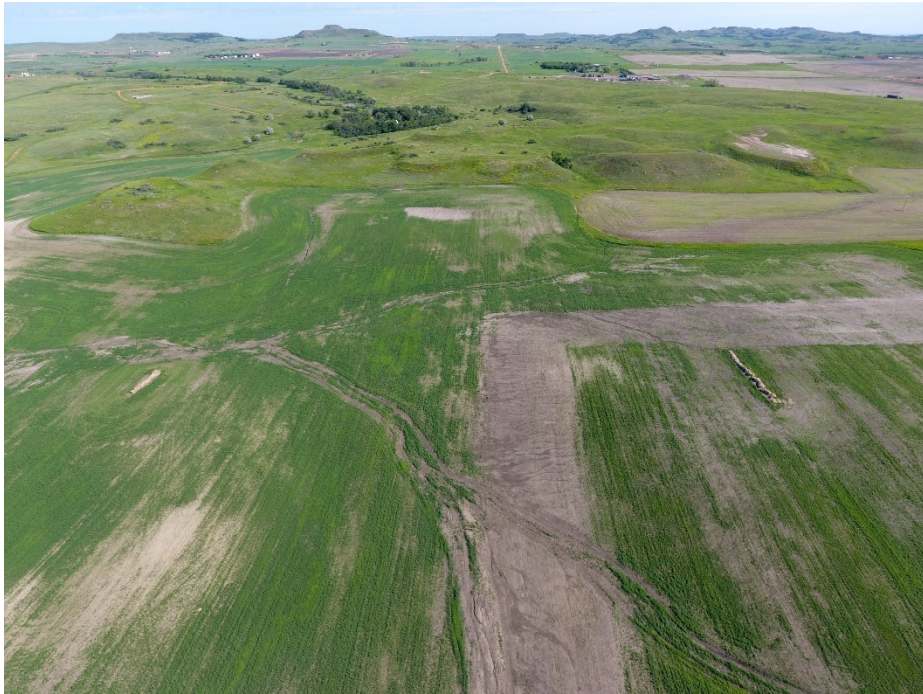
Page 13, Location 9 and 10: Areas of natural drainage causing erosion both on and off the pipeline corridor.

Location 9, Looking North (47.819866, -102.877708)
Scar visible from recent/adjacent work on a different pipeline

Based on our observations, we found that the vegetation has been well established throughout the project. The erosion shown in locations 9 and 10 is likely due to concentrated drainage from adjacent areas. Monitoring of these areas in the spring could be beneficial to compare to adjacent farmland, but feel no further action is required at this time.

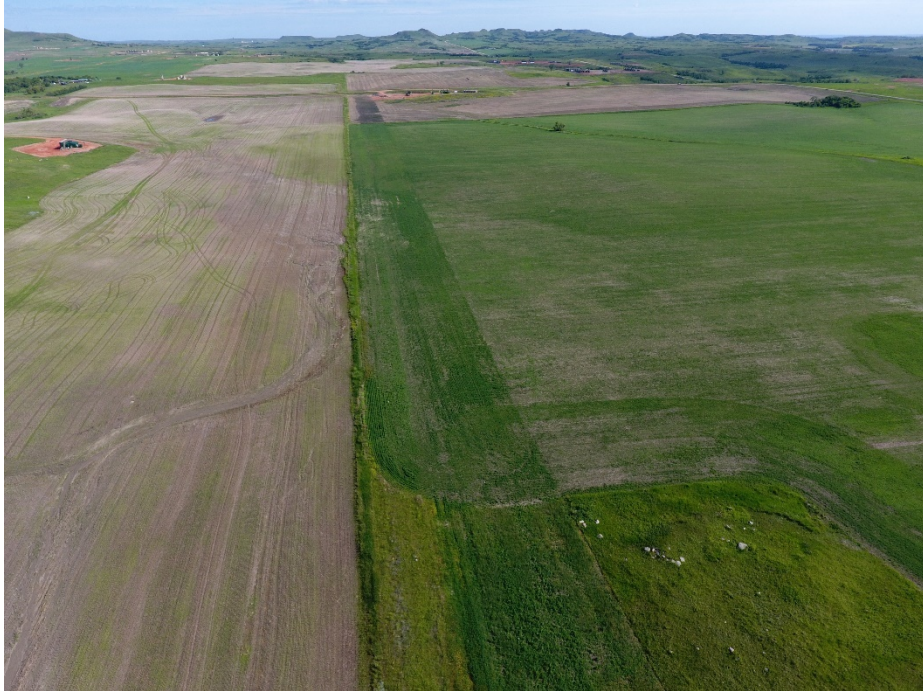
Location 11, Looking North (47.822784, -102.866325)
Scar becoming well blended into existing conditions

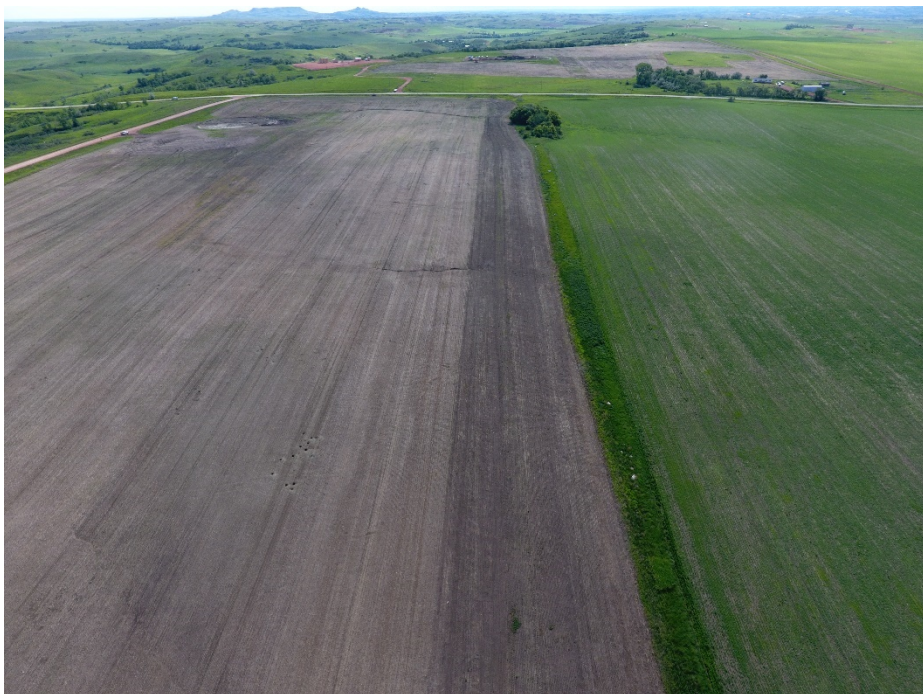
Location 12, Looking East (47.829647, -102.863251)
Minimal disturbance visible in cropland

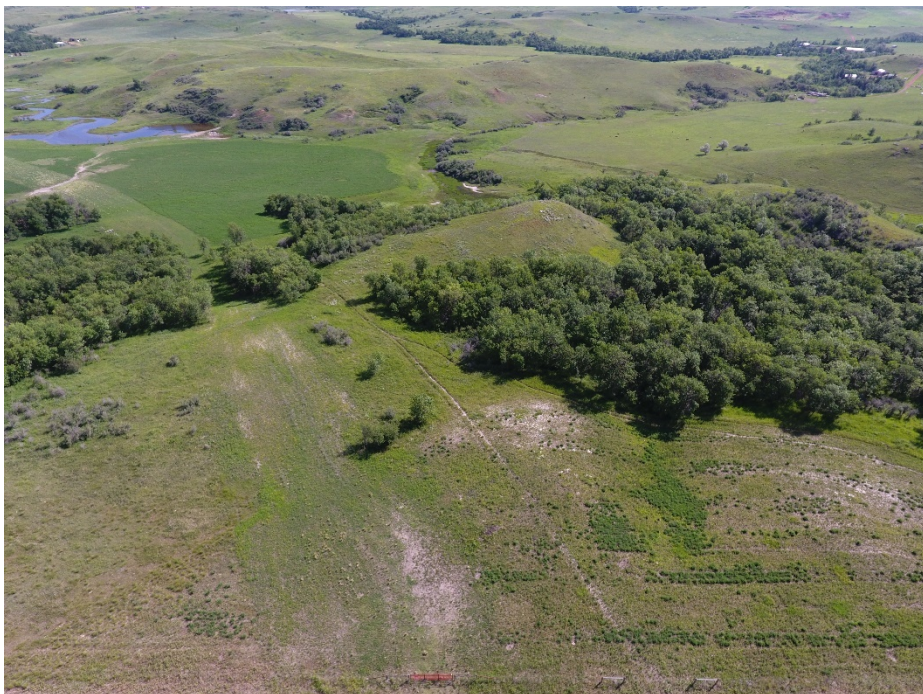
Page 15, Location 14: Example of scar which has become well blended to adjacent conditions

Location 14, Looking Northeast (47.828869, -102.848923)
Well blended to surrounding conditions

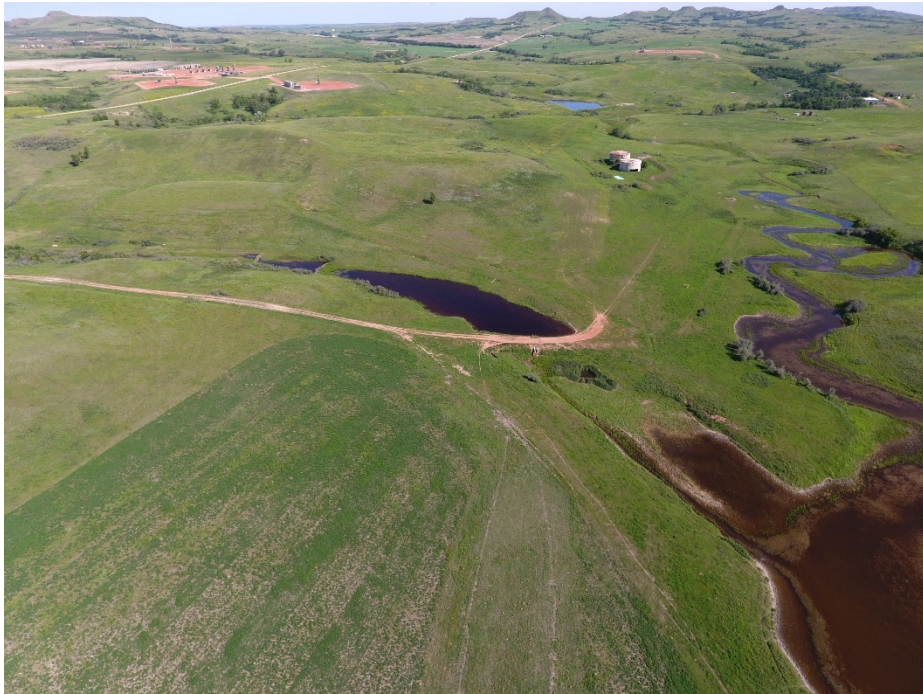
Location 15, Looking North (47.833252, -102.848045)
Scar well blended into existing conditions

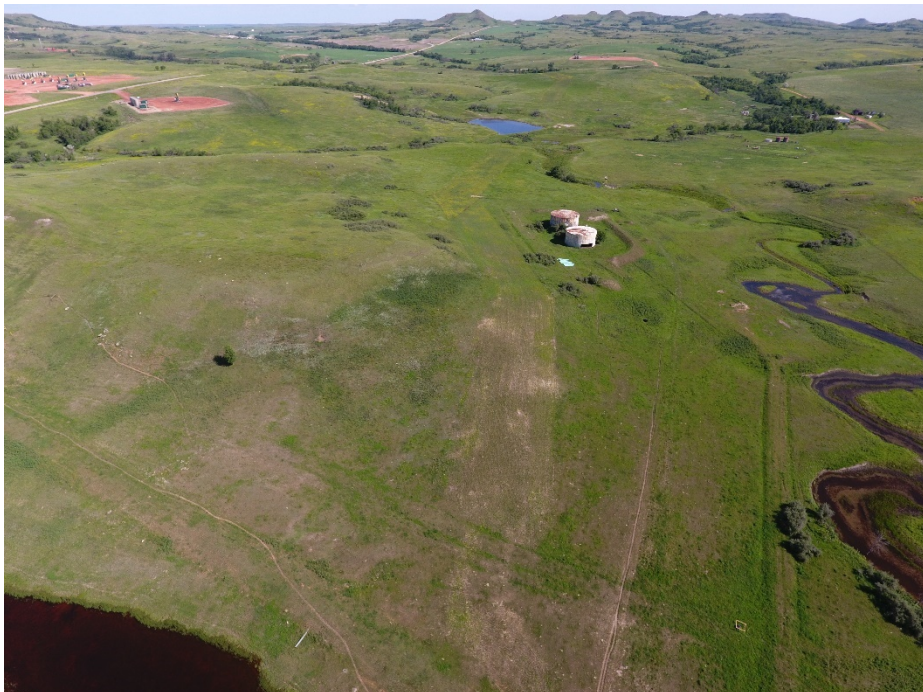
Location 16, Looking North (47.834862, -102.848213)
Well blended into adjacent grasslands

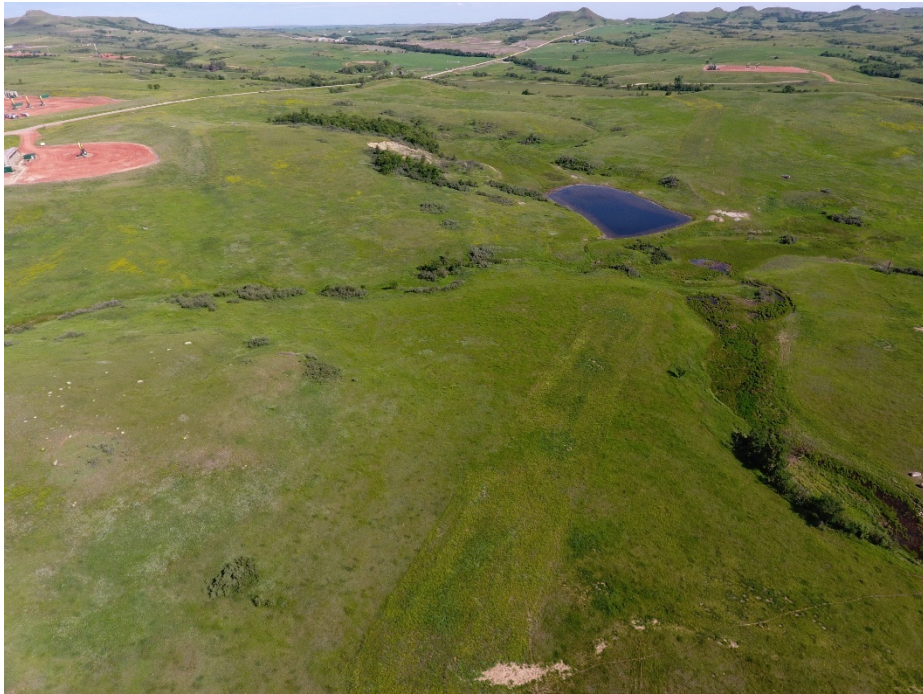
Page 17, Location 17 and 18: Example of scar which has become well blended to adjacent conditions

Location 17, Looking North (47.8377, -102.848877)
Well blended into native grassland

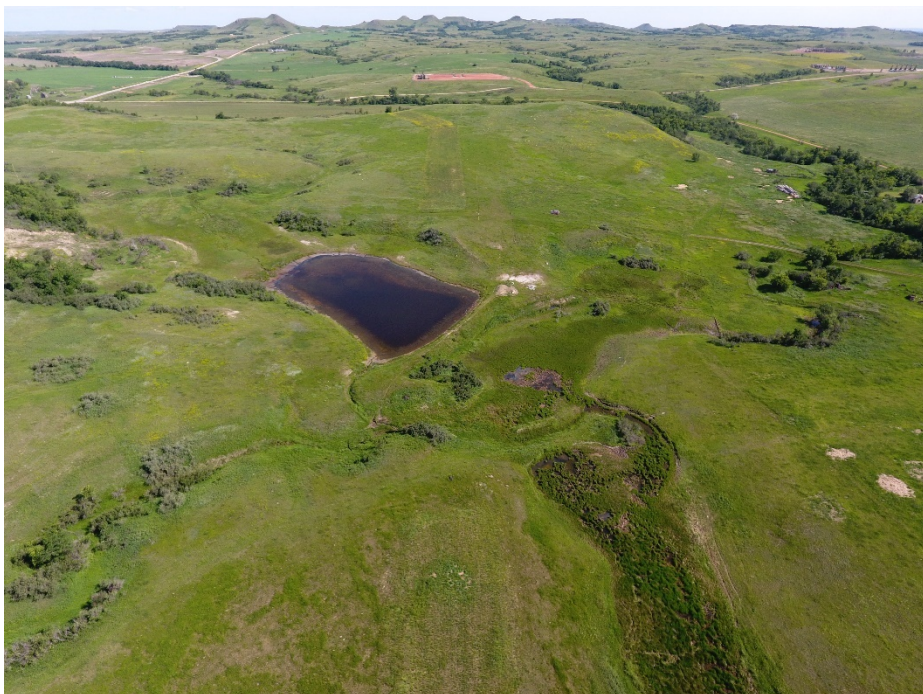
Location 18, Looking North (47.838921, -102.849091)
Well blended into existing grassland

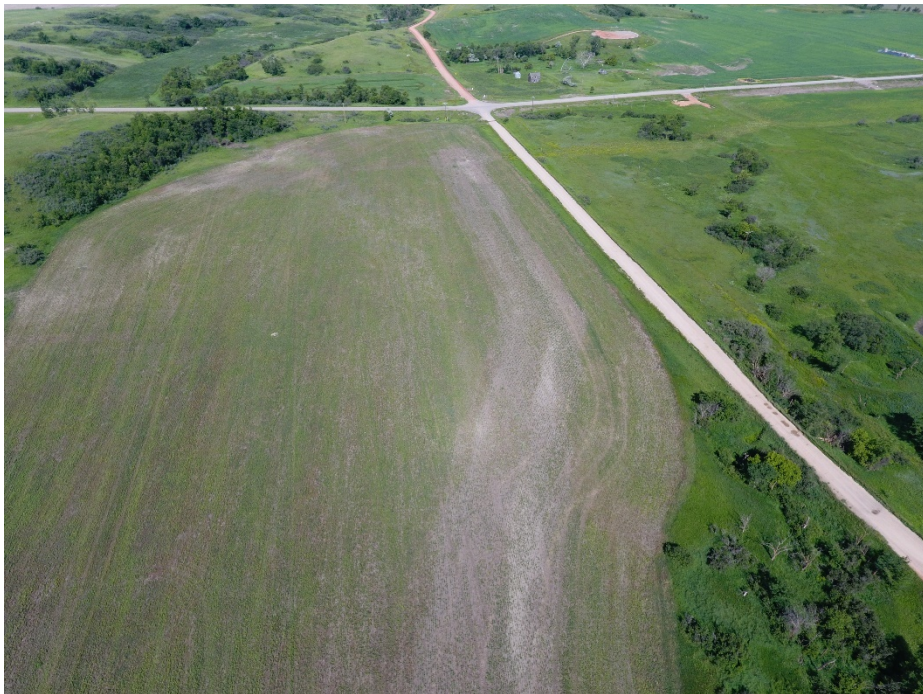
Location 20, Looking West (47.846405, -102.84977)
Minimal disturbance in cropland

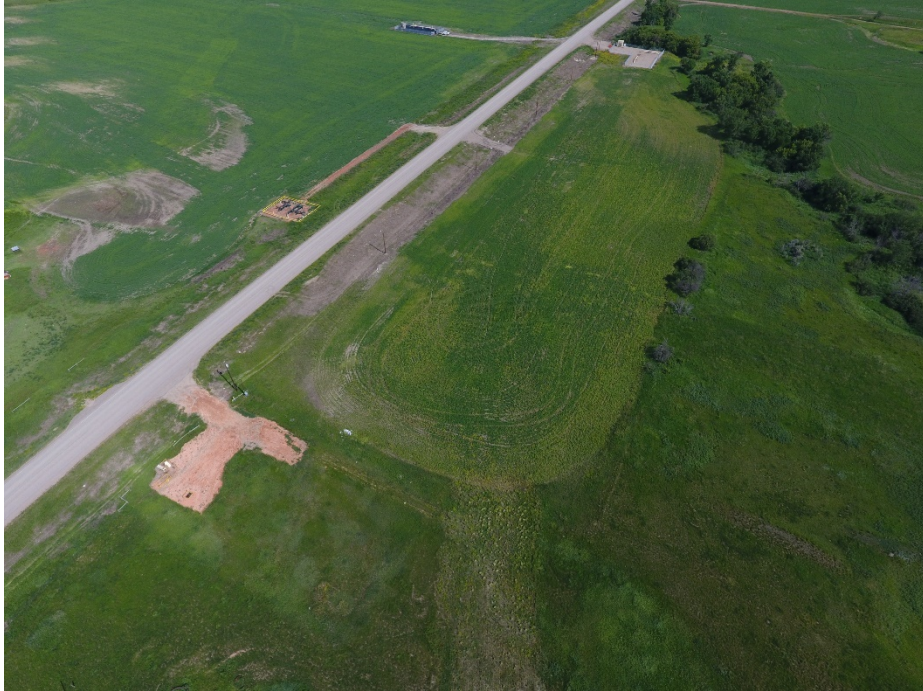
Page 19, Location 21: Minimal disturbance in grassland. At the bottom of the picture, vegetation is well established, but not as closely matching the surrounding conditions.

Location 21, Looking North (47.848446, -102.853958)
Minimal disturbance in cropland

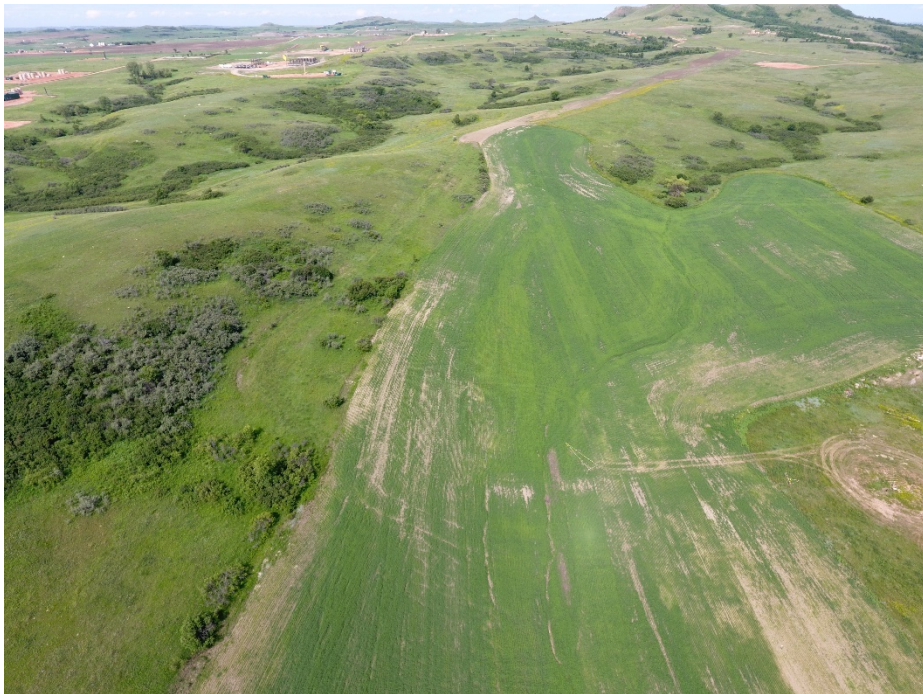
Location 24, Looking West (47.851913, -102.862465)
Minimal disturbance in cropland

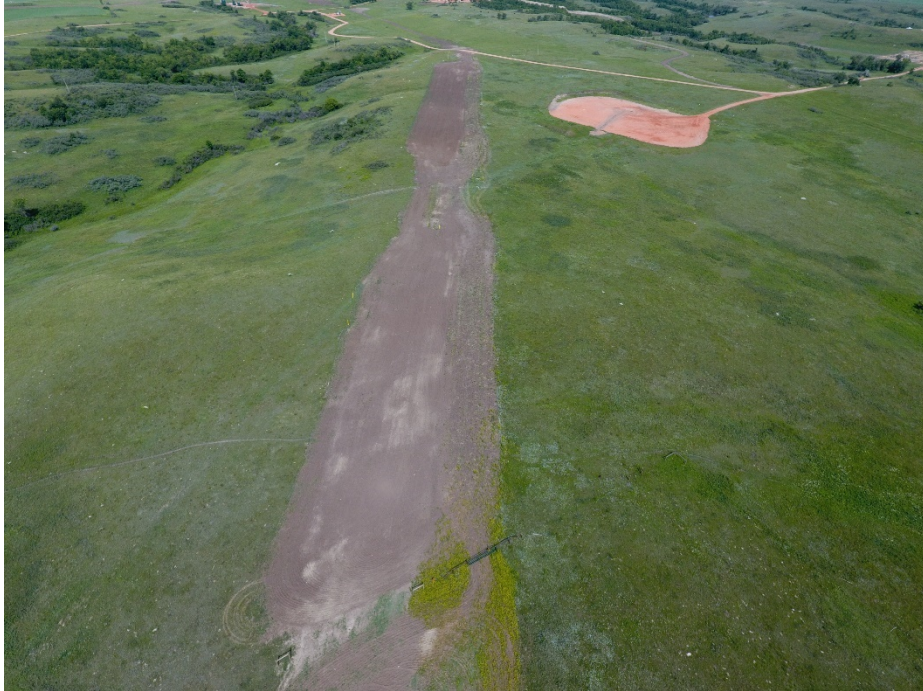
Location 25, Looking Northwest (47.854008, -102.871193)
Scar visible from adjacent work

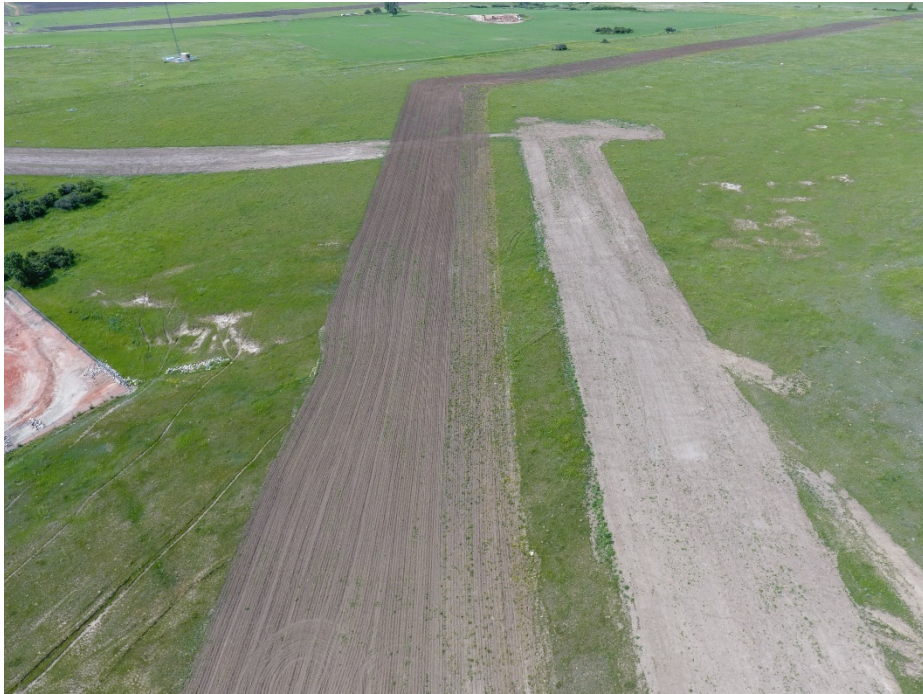
Location 27, Looking Southwest (47.857288, -102.88588)
Multiple pipelines in this area.

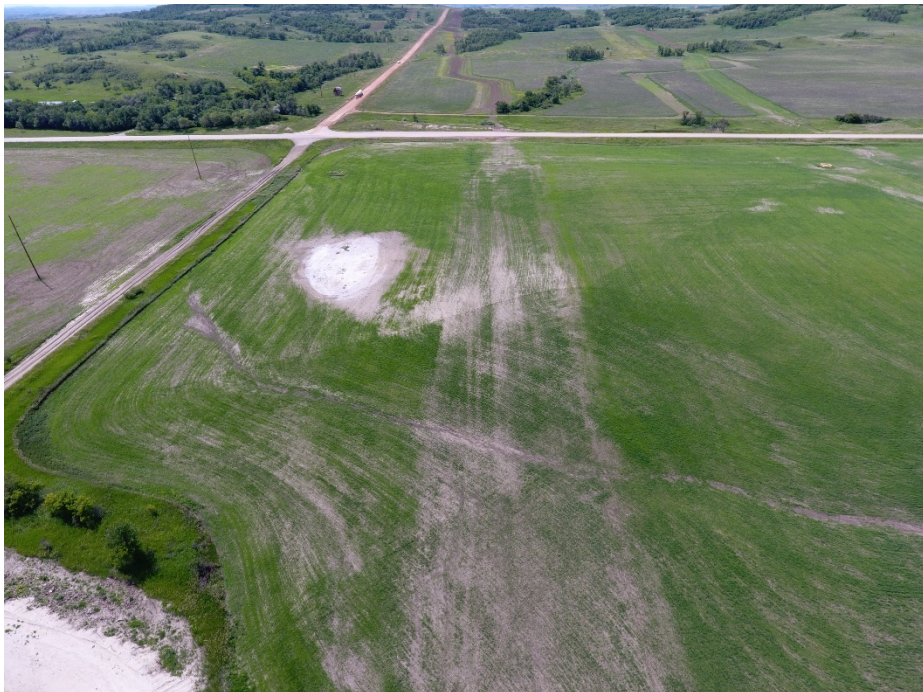
Location 30, Looking South (47.87928, -102.899864)
Scar becoming well blended in cropland

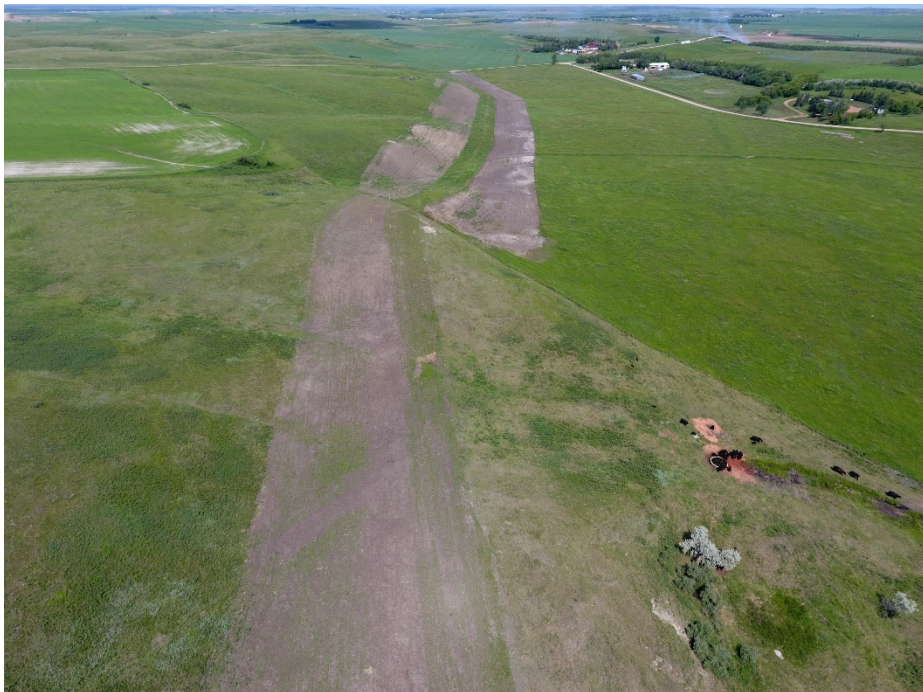
Page 24, Location 32. Photo shows multiple areas of pipeline work adjacent to PU-15-744. Multiple markers visible in center of photo.

Location 32, Looking Northwest (47.886139, -102.911003)
Multiple pipelines in this area. Recent work assumed to be from a different pipeline

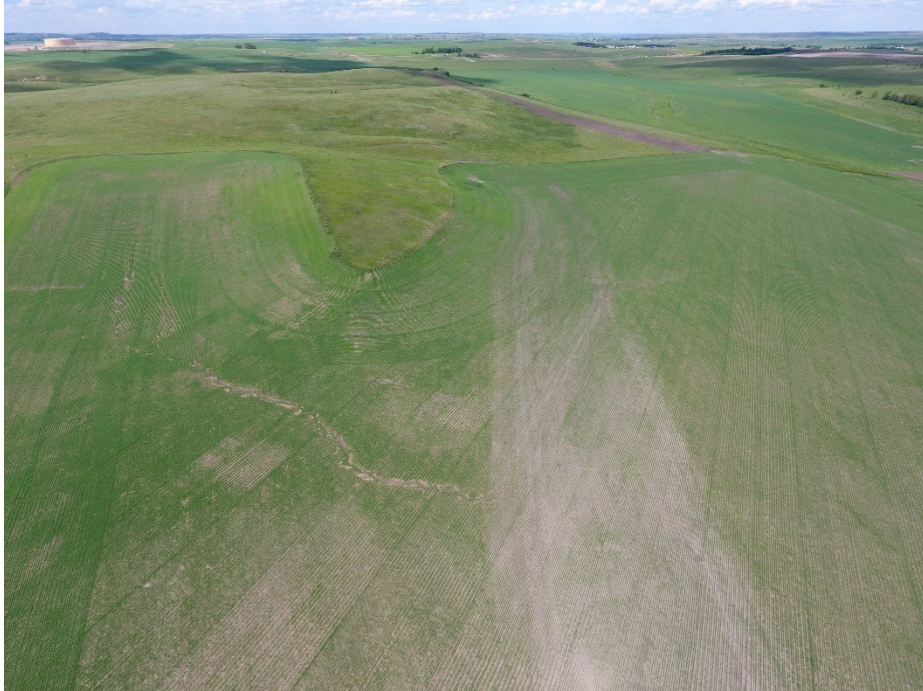
Page 25, Location 33 and 34: Vegetation well blended into surrounding conditions.

Location 33, Looking Northwest (47.891479, -102.921448)
Minimal disturbance in cropland

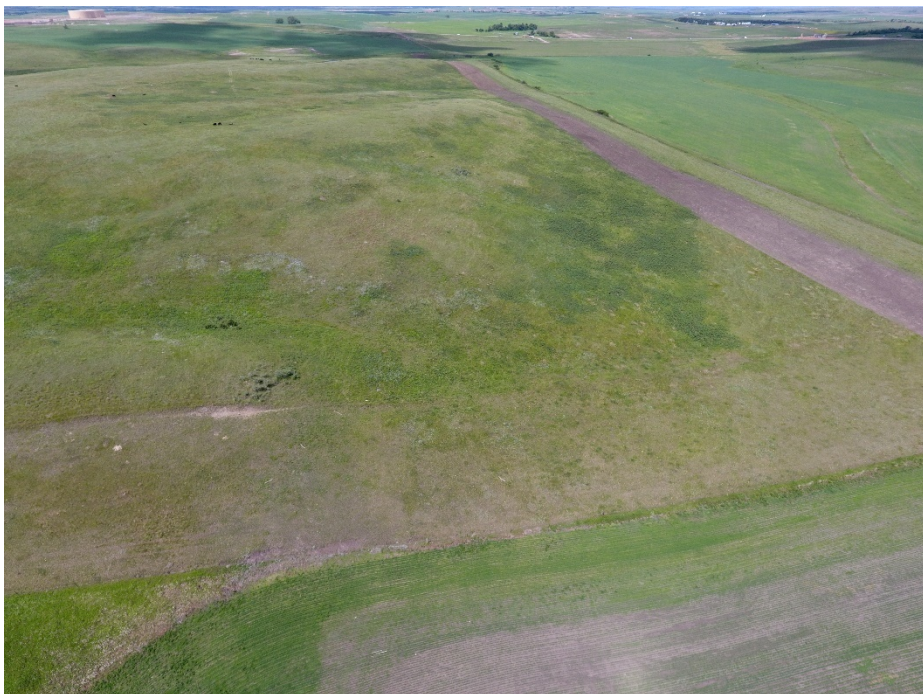
Location 34 (47.892708, -102.92469)
Minimal disturbance in cropland

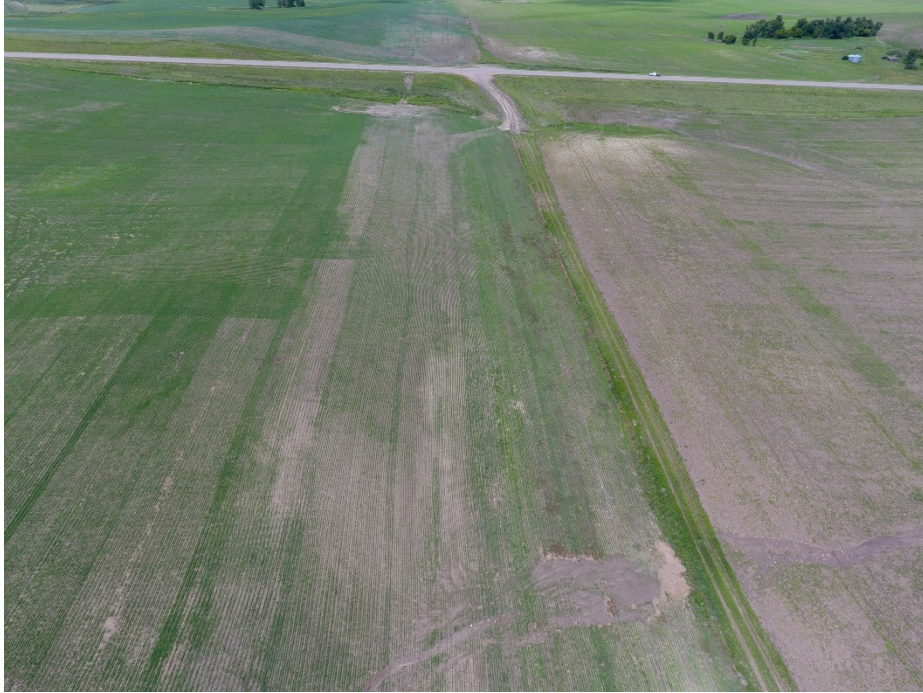
Location 35, Looking West (47.894169, -102.936989)
Minimal disturbance in cropland
