Site/Project Location: Brady Wind Laydown Area

Date of Inspection: 22 June 2016

118 PU-15-797 Filed 07/22/2016 Pages: 12
Site inspection trip report - Topsoil Inspection Report
Keitu Engineers & Consultants, Inc.

Site/Project Location: Brady Wind Collection Substation

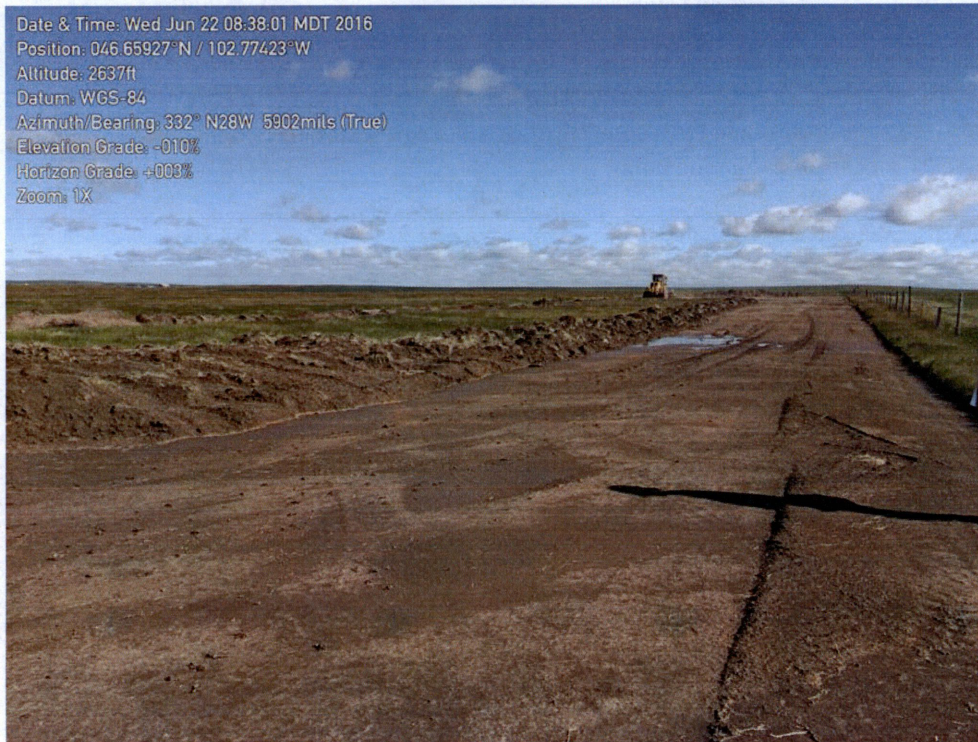
Report Photo #1 "Topsoil removal at 4-6 inches"

Topsoil had been removed to a depth of 4-6 inches, more topsoil was visible. Site foreman was told to go deeper to remove all topsoil up to a depth of 12 inches. Site staff agreed to continue removing topsoil.

Topsoil segregation was noted to be acceptable at this time, site staff agreed to remove all topsoil up to 12 inches. Equipment operator has demonstrated proficiency in topsoil removal and segregation in compliance with the Commission's Order.

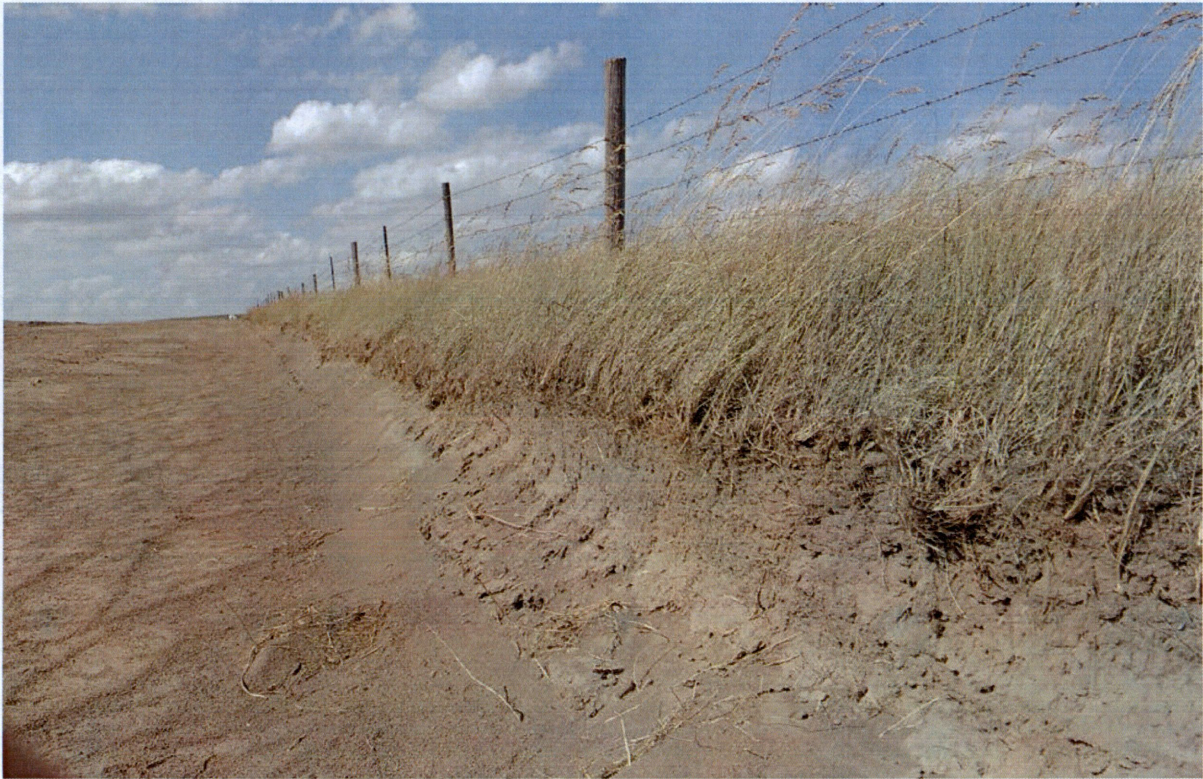
Report Photo #1 "Topsoil removal at 8-12 inches"

Topsoil had been removed to a depth of 8-12 inches.
