Reclamation and Revegetation Inspection Report

230 kV Transmission Line – Stark County

Brady Wind, LLC

ND PSC Case No. PU-15-797

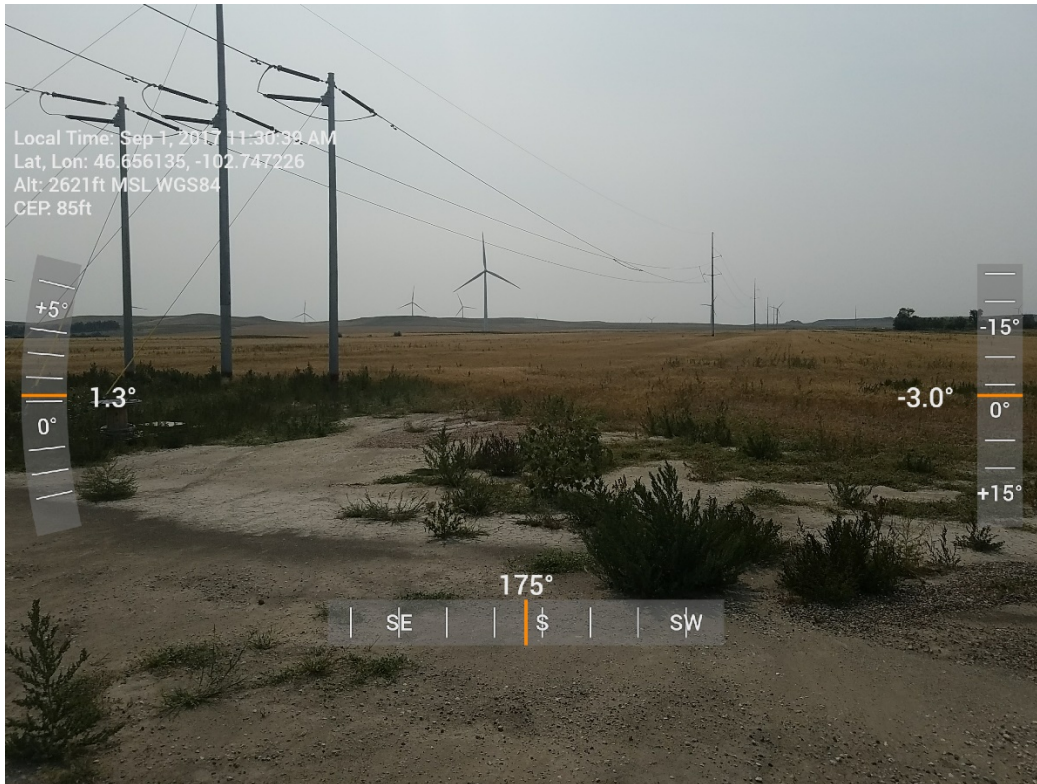
Construction was complete and the Project was operational during the time of visit. Cropland was the majority of the vegetation along the Project area. The plants in the cropland appeared to be similar in size and density to crops in areas adjacent to the Project area. Outside of the fences around the substations there were areas of bare soil and areas that had nearly 100% coverage which were dominated by weeds and nonnative species.

Report Photo #1: Bare soil outside of substation.

1. Continual maintenance should be done to encourage the revegetation of desirable species in areas near the substations.

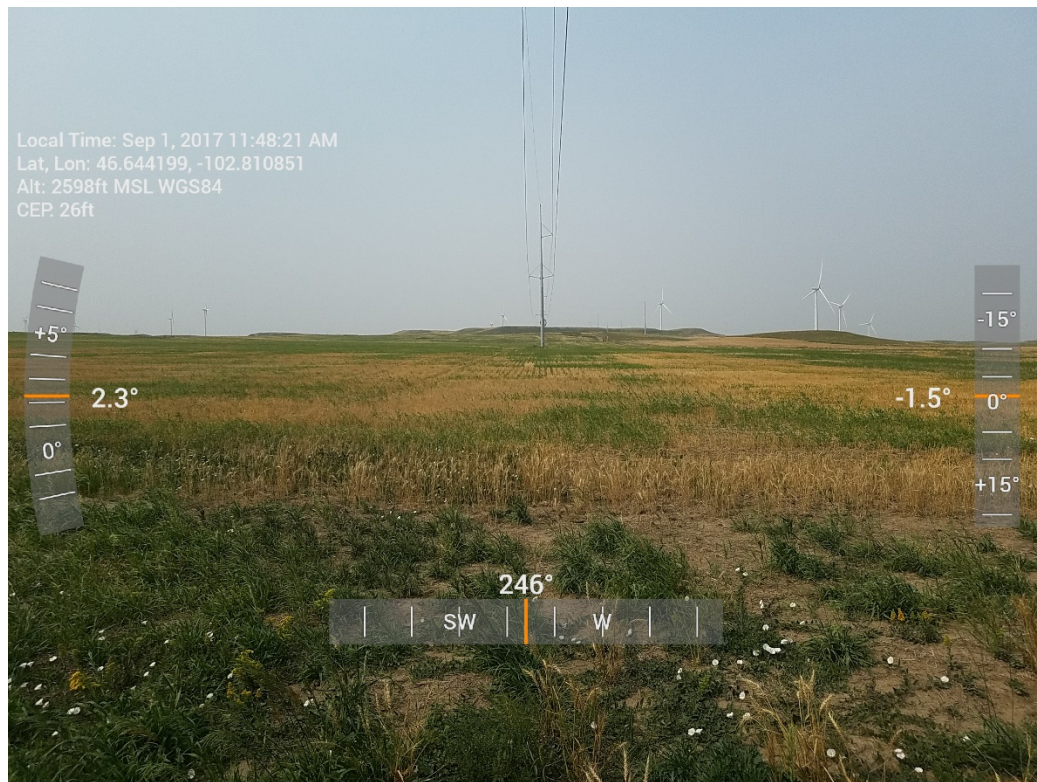
Report Photo #2: Crop field under transmission line.

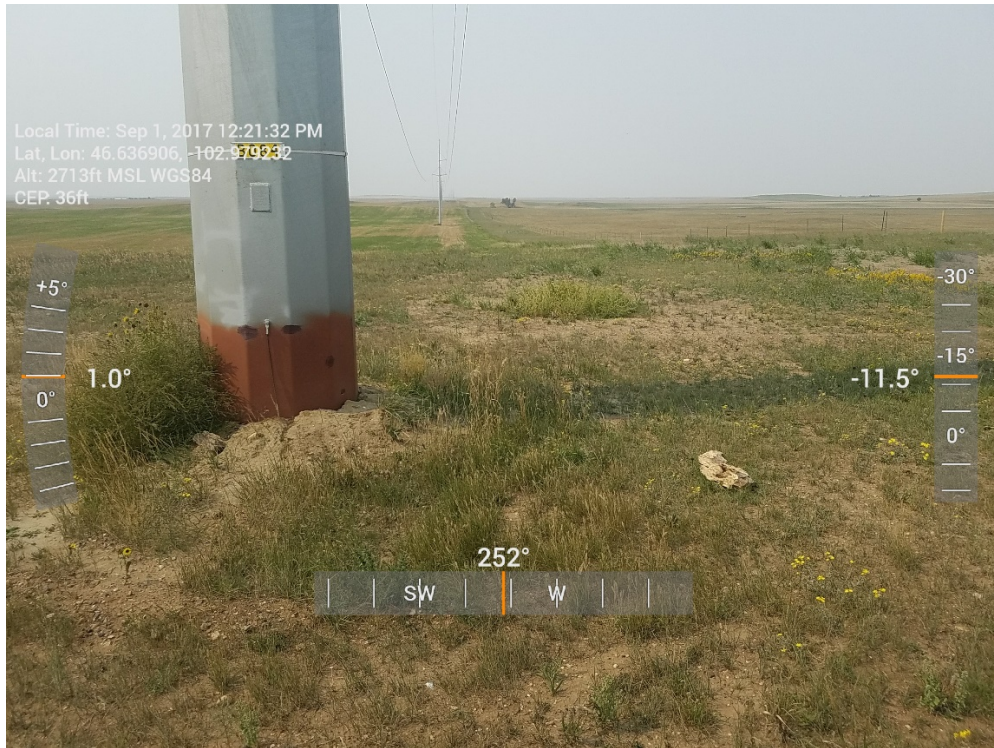
Report Photo #3: Desirable vegetation regrowth under transmission line.

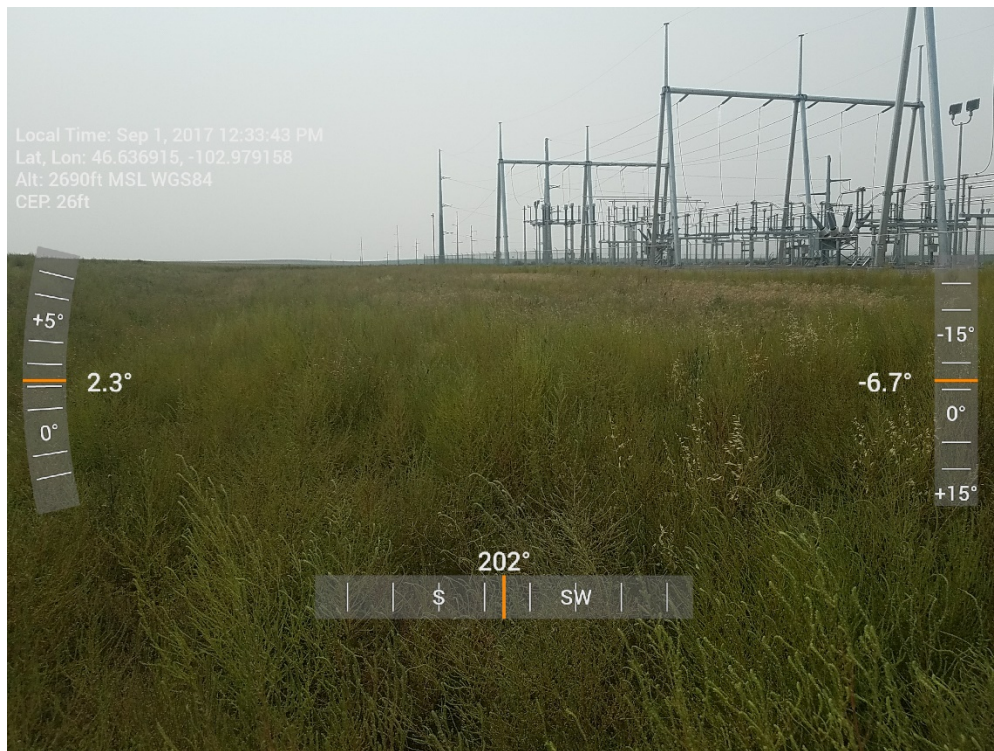
Report Photo #4: Vegetation near west switchyard.
