ONEOK Bakken Pipeline Project Topsoil Inspection Report PU-15-801

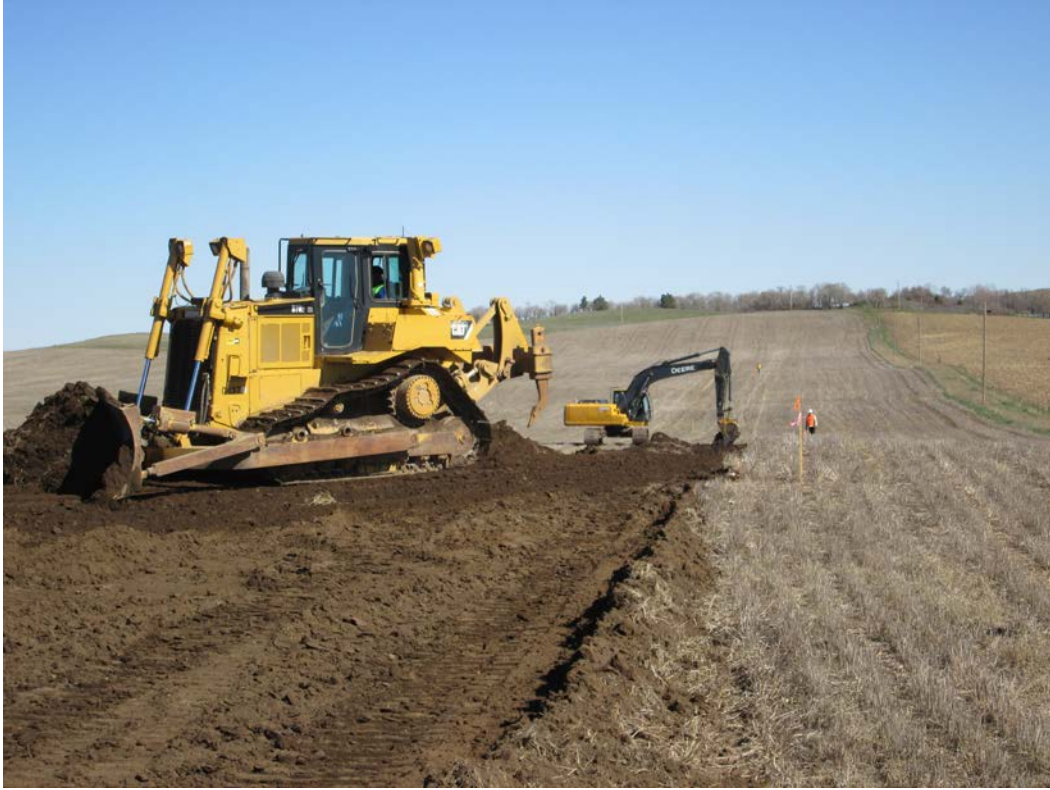
Equipment operators started by scraping a small area or a line in the topsoil with the edge of the dozer near the edge of the right of way (ROW) to identify where the topsoil pile should be placed (**Appendix B, Photos 1, 2**); or there would be a spotter for the dozer operator to make sure the topsoil pile was staying within the ROW. In one area, it was observed that, due to the potential wet conditions from the previous days rain, the contractors used an excavator to scrape the ROW so the dozer could get in the area and twist and turn to scrape the topsoil without taking too much topsoil or rutting up the area. Next, dozers were used to strip the topsoil to the appropriate depth, averaging a range of approximately 4-10 inch depths (**Appendix B, Photos 2, 4, 9, 10, and 22**). After the dozer had taken the appropriate amount of topsoil, they came through with a grader to finish or smooth out the area in the ROW for the trenching machine and other equipment (**Appendix B, Photo 9**). Contractors often employ a combination of graders and dozers depending on the equipment available, depth of topsoil, land use and procedure used to remove the topsoil.

Above: Photo 1 (Point 267) – Direction looking north. Start of topsoil stripping. Dozer and excavator/hoe were used in this area, because this was a potential wet area, the excavator was used to start the topsoil stripping so the dozer could get in there, and would not twist and turn and mess up the area or take an incorrect amount of topsoil.

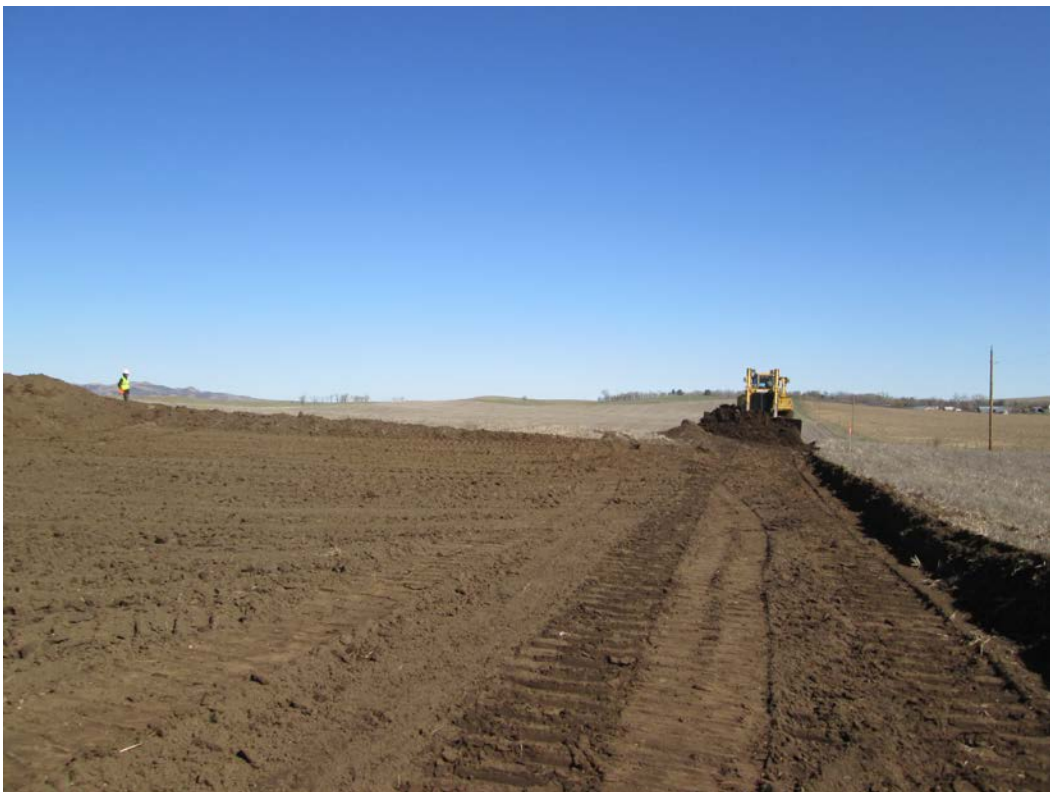
Below: Photo 2 (Point 267) – Direction looking north. Start of topsoil stripping.

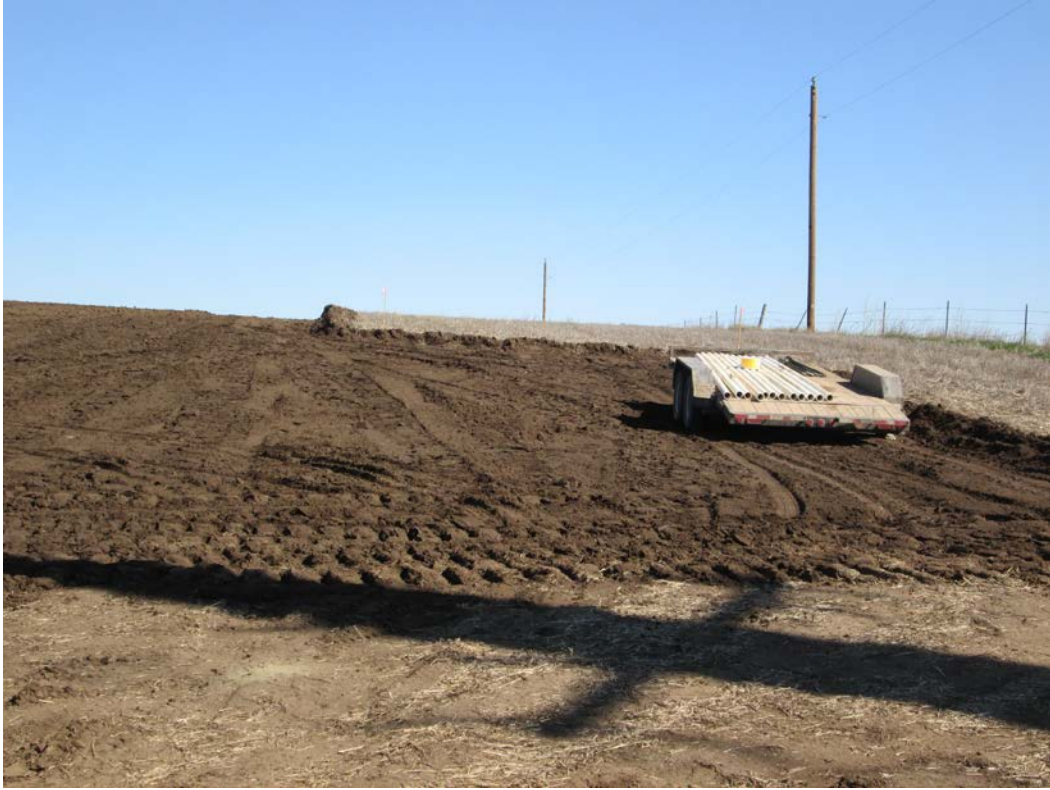
The pipeline utilized a 100-ft construction ROW; additional temporary workspace was often used for bore locations. ROWs were often extended to 125-ft at bore locations or if there was a bore pull back area, it would have an additional 50-ft ROW (**Appendix B, Photos 3, 17**). The company appeared to manage newly acquired access roads like their ROW; they would strip the topsoil on the new access roads and place the topsoil pile alongside the road (**Appendix B, Photo 7**). If they acquired farmers two-track roads (previously used road area) they would manage as needed.

Above: Photo 3 (pt. 267) - Direction looking north. Extended ROW to 125-ft for additional work space for road bore.

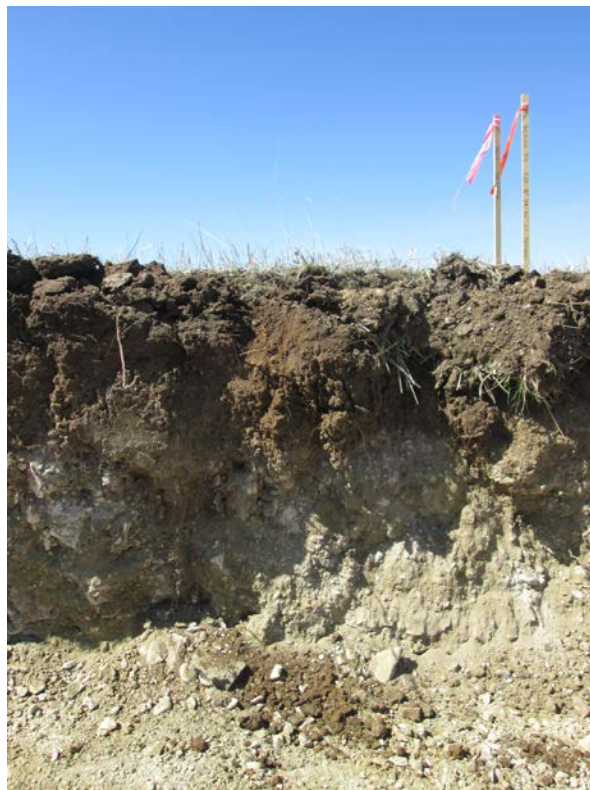
Below: Photo 4 (pt. 269) – Cut along the ROW where two-toning is located; shows soil profile.

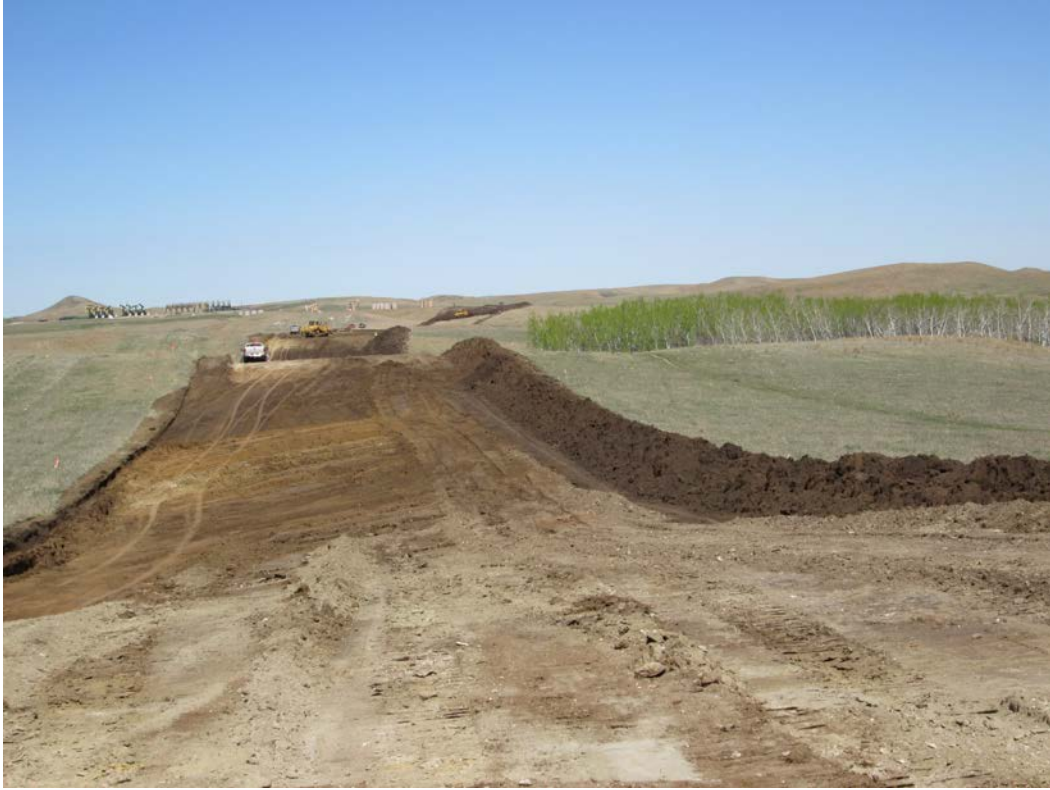
Above: Photo 5 (pt. 269) – Direction looking south. Topsoil stripped (far right) in two-toning area. There is space between topsoil and subsoil piles.

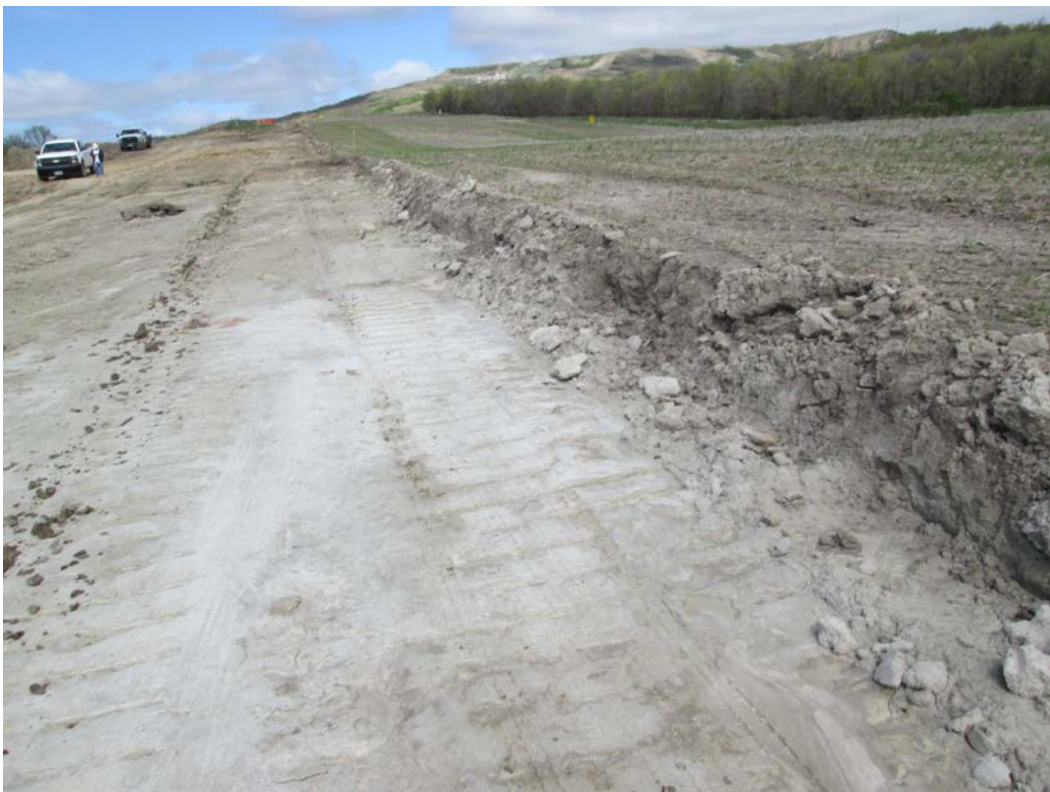
White areas or zones were observed on a few small areas of cropland on the pipeline ROW, likely indicating a calcareous area; the area did not appear saline (**Appendix B, Photo 6**). The white color was observed on the stripped ROW area, and small amounts in the topsoil pile. This is likely natural or could be enhanced from fertilizer and would have a higher pH.

Below: Photo 6 (pt. 273) – Direction looking north. Topsoil stripped; small zone of light, white coloring on soil, appeared calcareous.

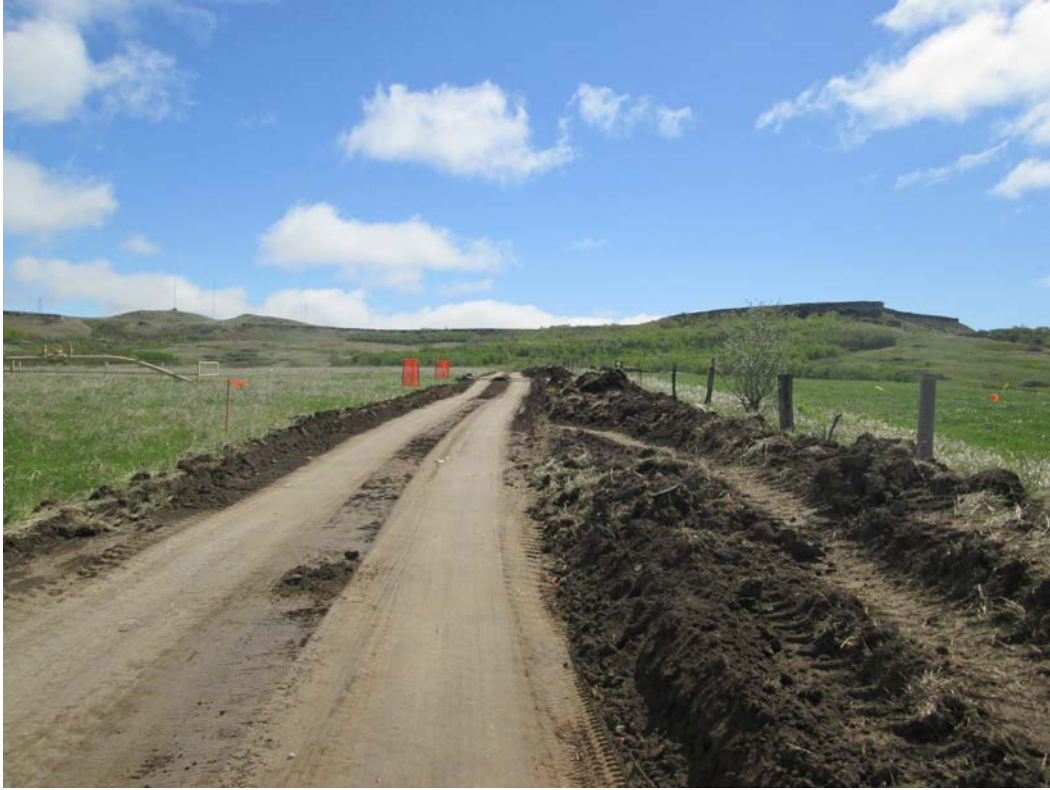
Above: Photo 7 (pt. 274) – Direction looking east. Topsoil stripped for access road.

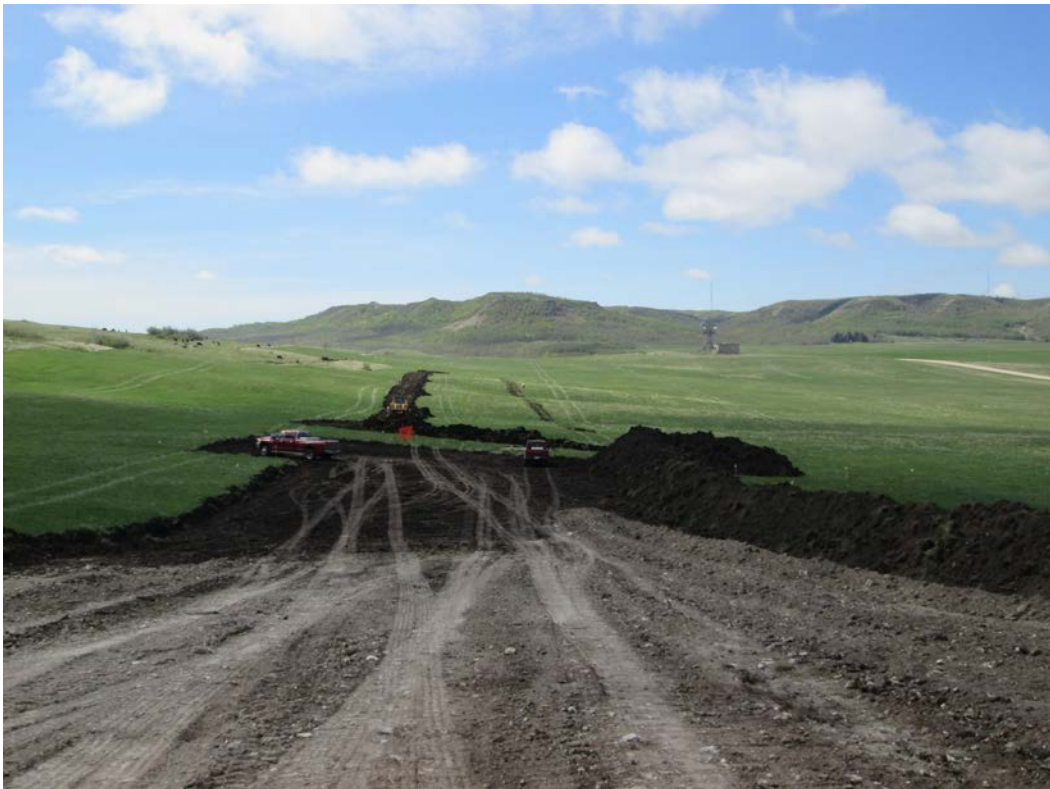
Below: Photo 8 (pt. 275) – Direction looking south. View on top of two-tone area, pushed some subsoil downhill, angled down to level out area after 12-in topsoil was taken. Extended ROW for bore location, boring under other line. Dozer stripping topsoil.

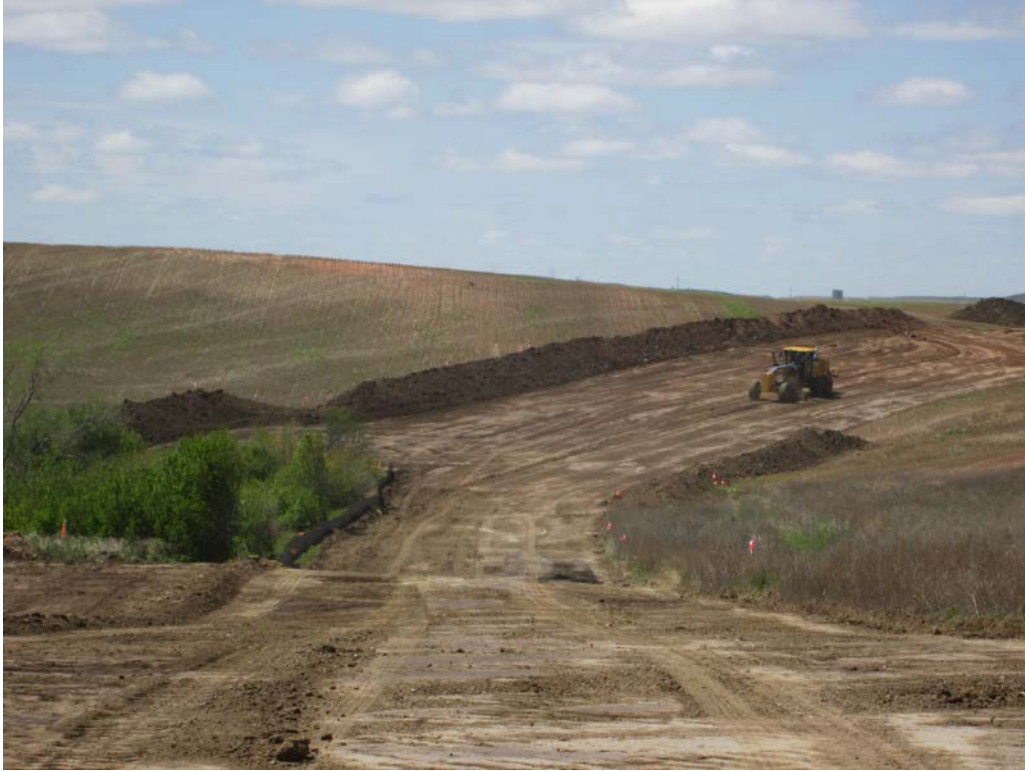
Above: Photo 9 (pt. 276) – Direction looking west. Neck down location; observe silt fences in front of trees and ravine area.

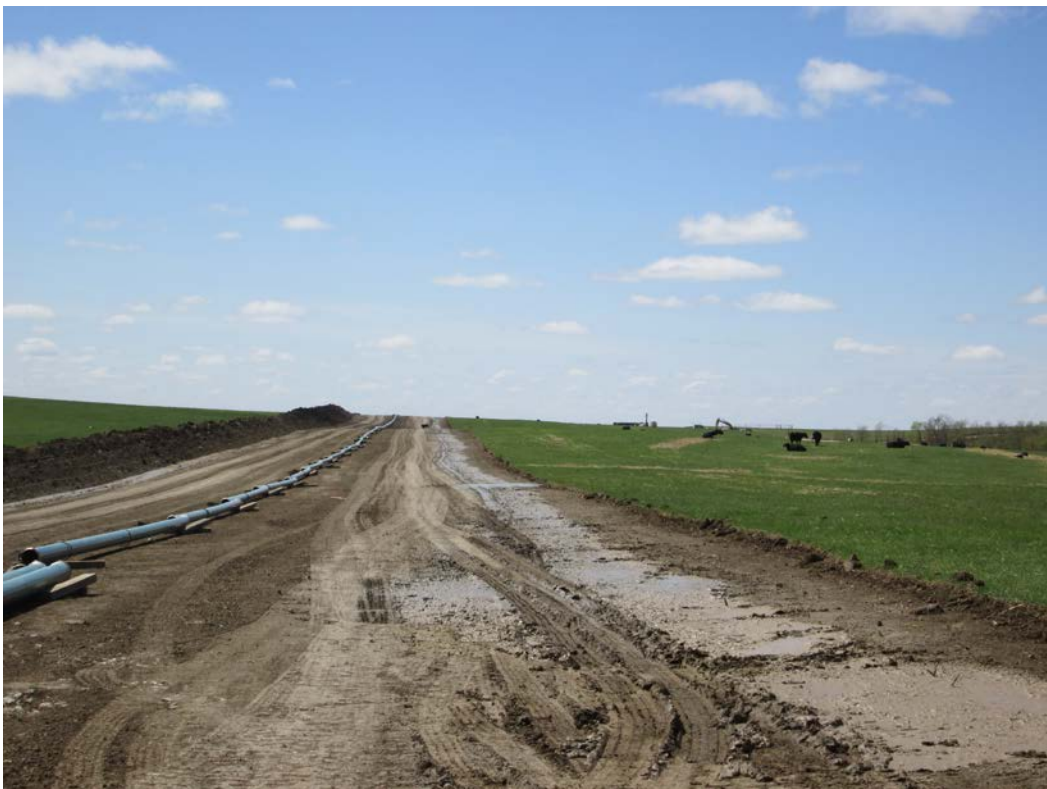
Below: Photo 10 (pt. 277) – Direction looking west. Topsoil stripped and area smoothed. The slurry from hydrovac truck was dumped and ran across edges of ROW. Clean water and mud/bentonite was used. Slurry was only dropped on ROW after topsoil stripped and if landowner approved.

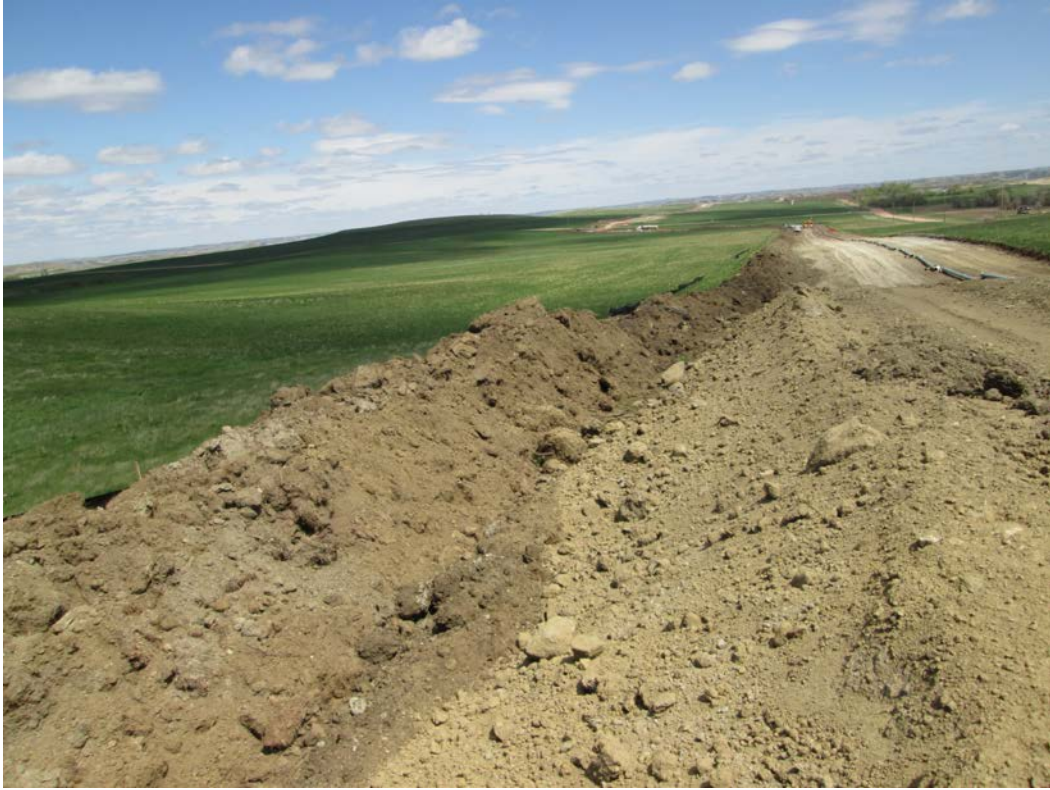
Above: Photo 11 (pt. 278) – Direction looking east. Side-sloping/two-toning area, used to level hill slope. Topsoil pile on far left of photo.

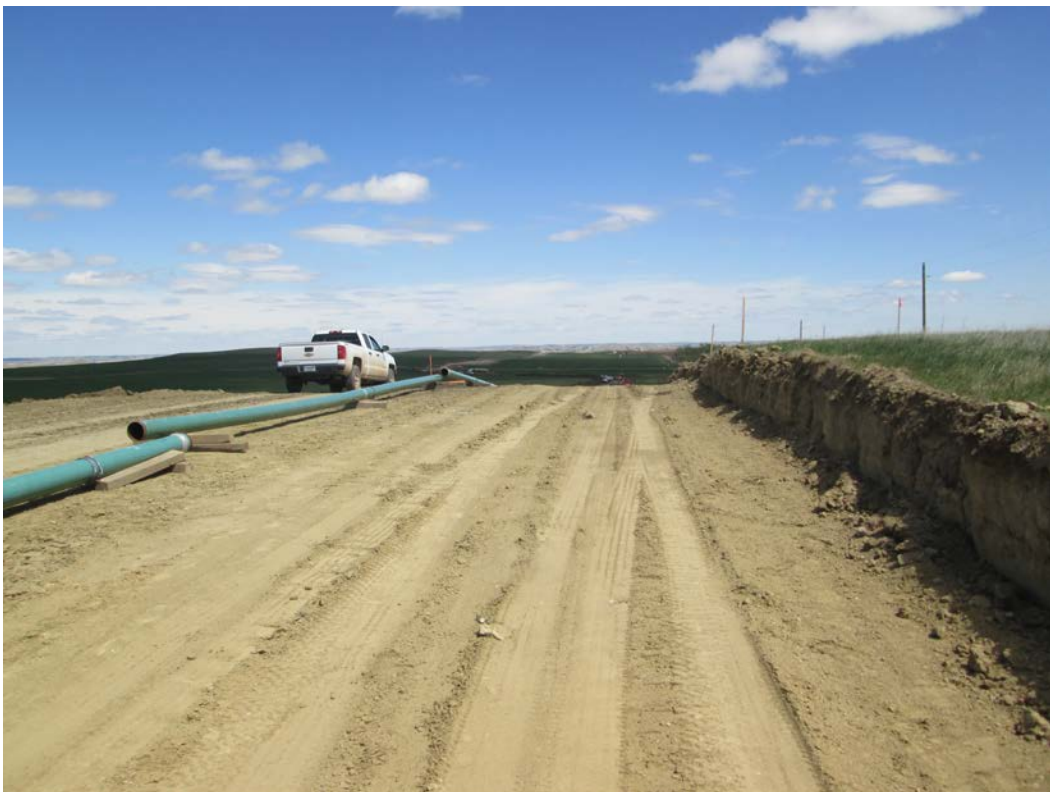
Below: Photo 12 (near pt. 278) – Direction looking east. Side-sloping/two-toning area, used to level hill slope. Can see cut into hill on far right of photo.

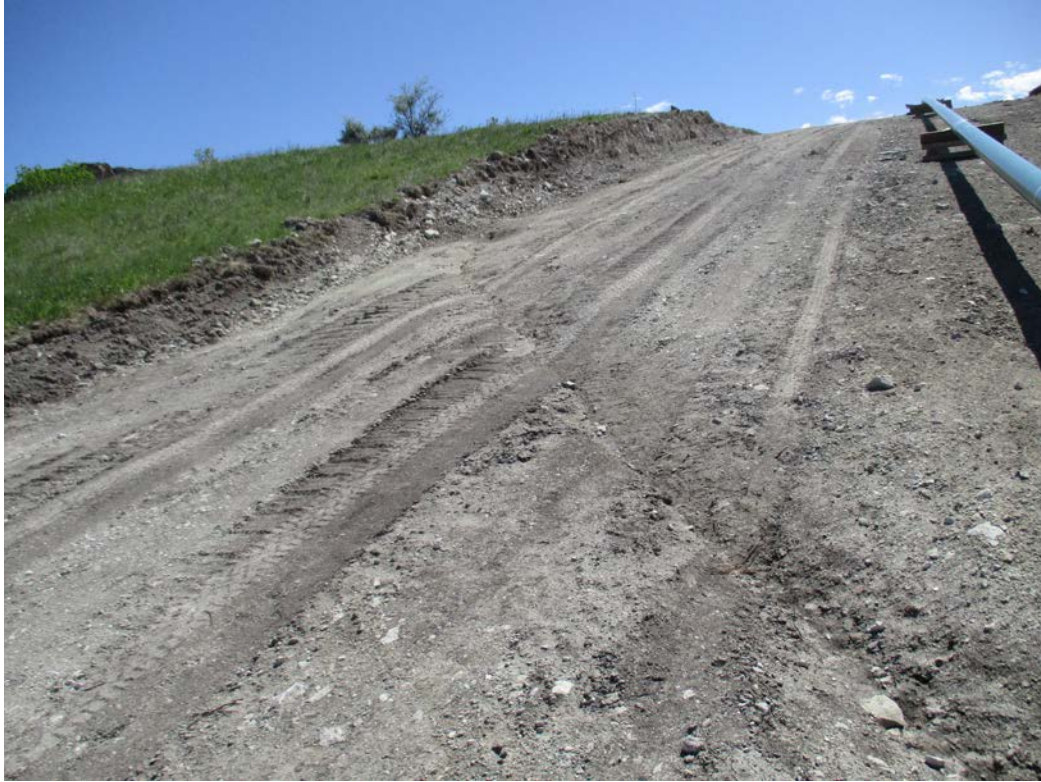
Above: Photo 13 (pt. 435) – Slope breaker on ROW.

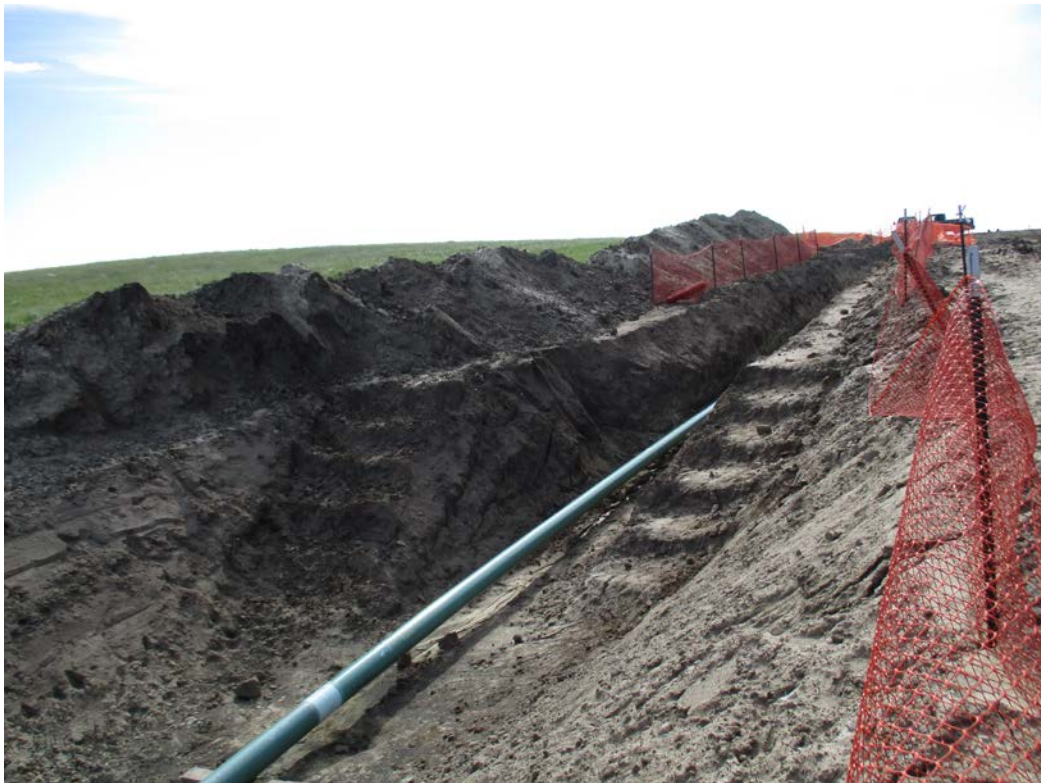
Below: Photo 14 (pt. 432) – Fence around trenched area, with stairs cut out along the sides.
Subsoil pile to the left of photo.

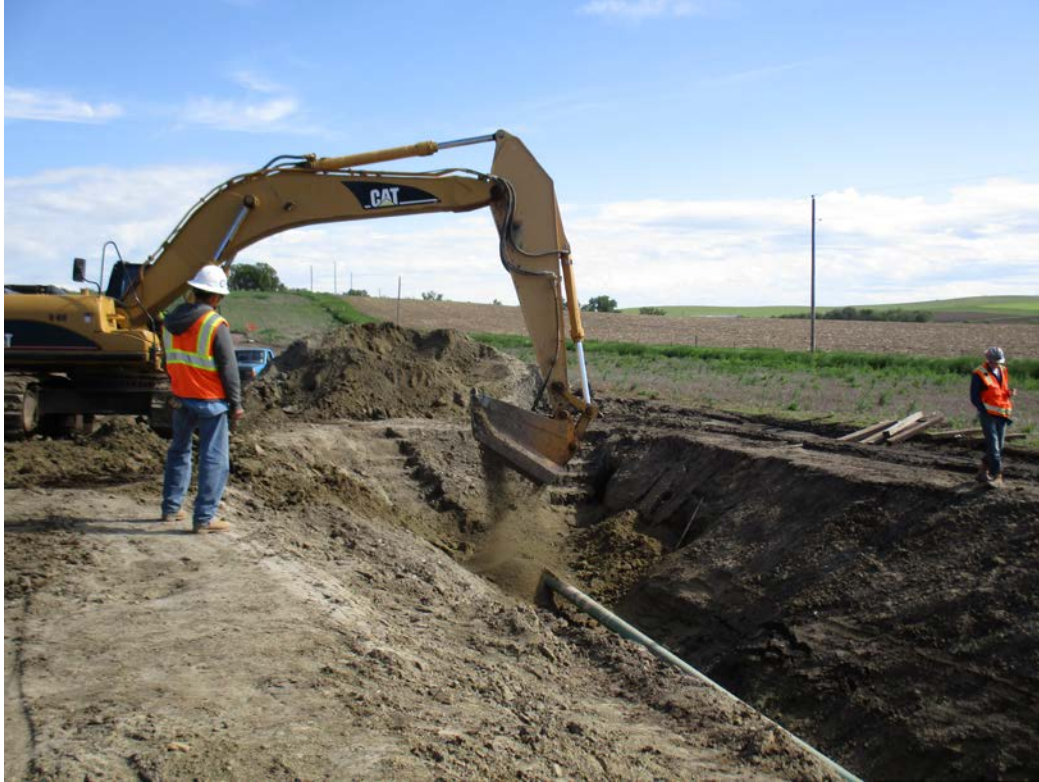
Above: Photo 15 (near pt. 433) – Direction looking north. The excavator uses a shaker with $\frac{3}{4}$ -inch screen, used for rocky areas. The area around the pipe is padded with this finer material/soil from the shaker, 4-12 inches around the pipe, to protect the pipeline.

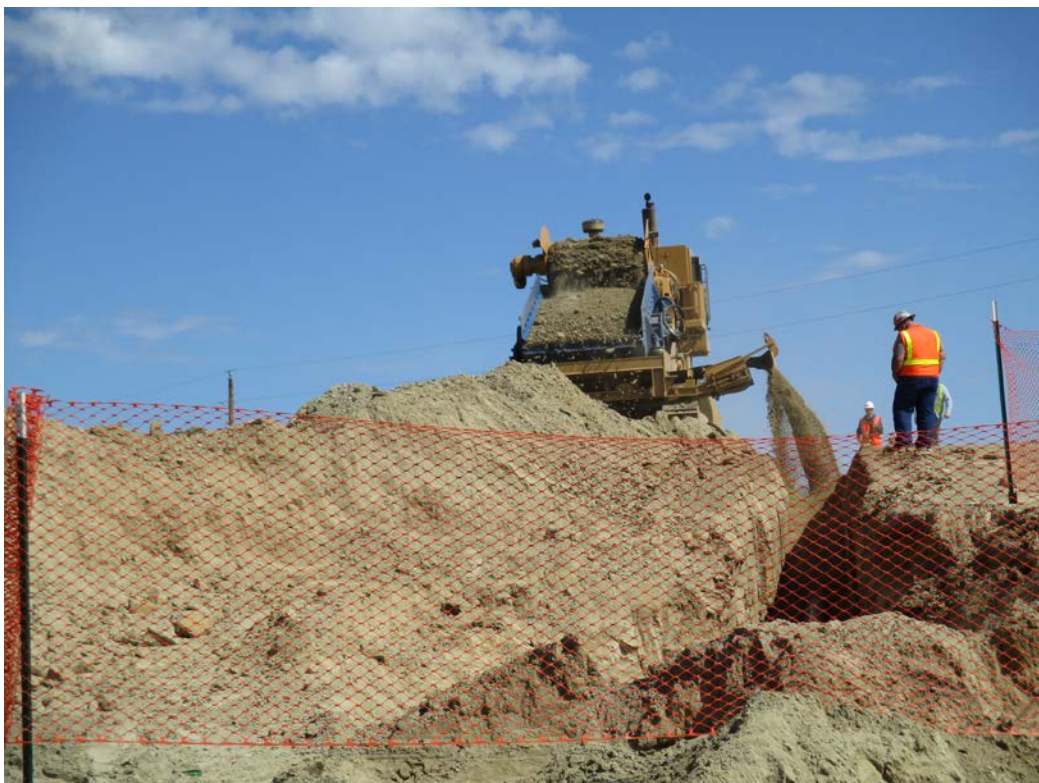
Below: Photo 16 (pt. 434) – Direction looking north. Padding machine, used to get rocks out of subsoil stratum. The loose fill will compact down around the pipe.

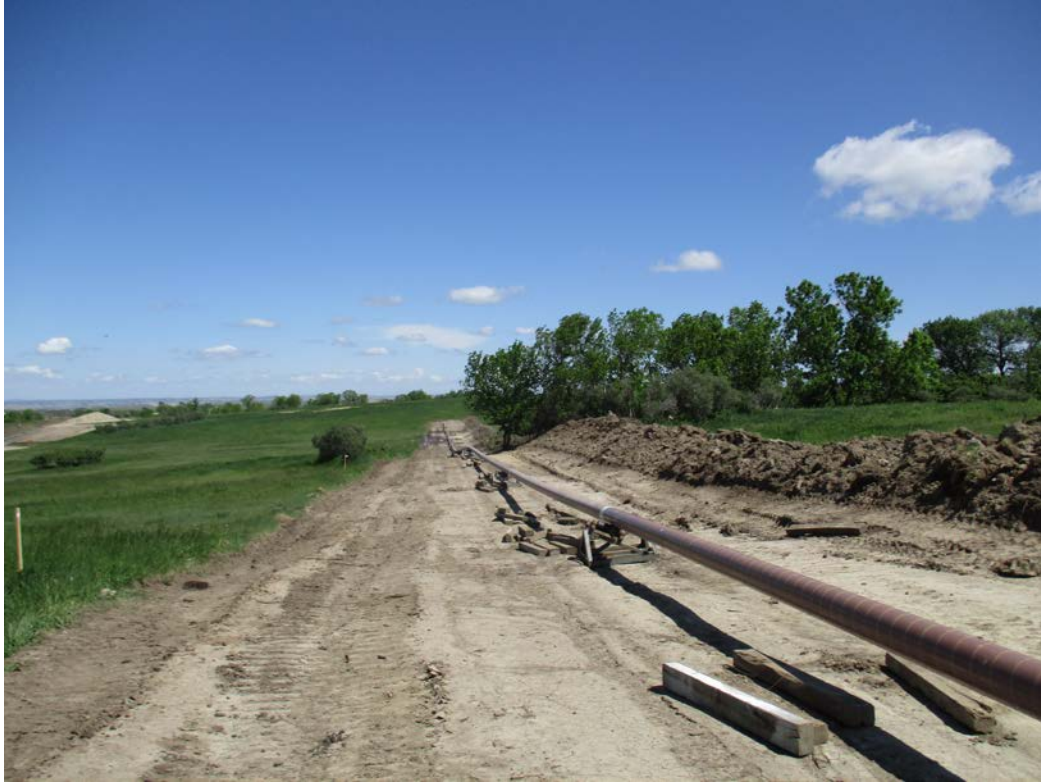
Above: Photo 17 (pt. 437) – Direction looking north. Bore area. Topsoil has been removed on additional bore pull back area, 50-ft ROW. To the far left of the photo is the pipeline ROW.

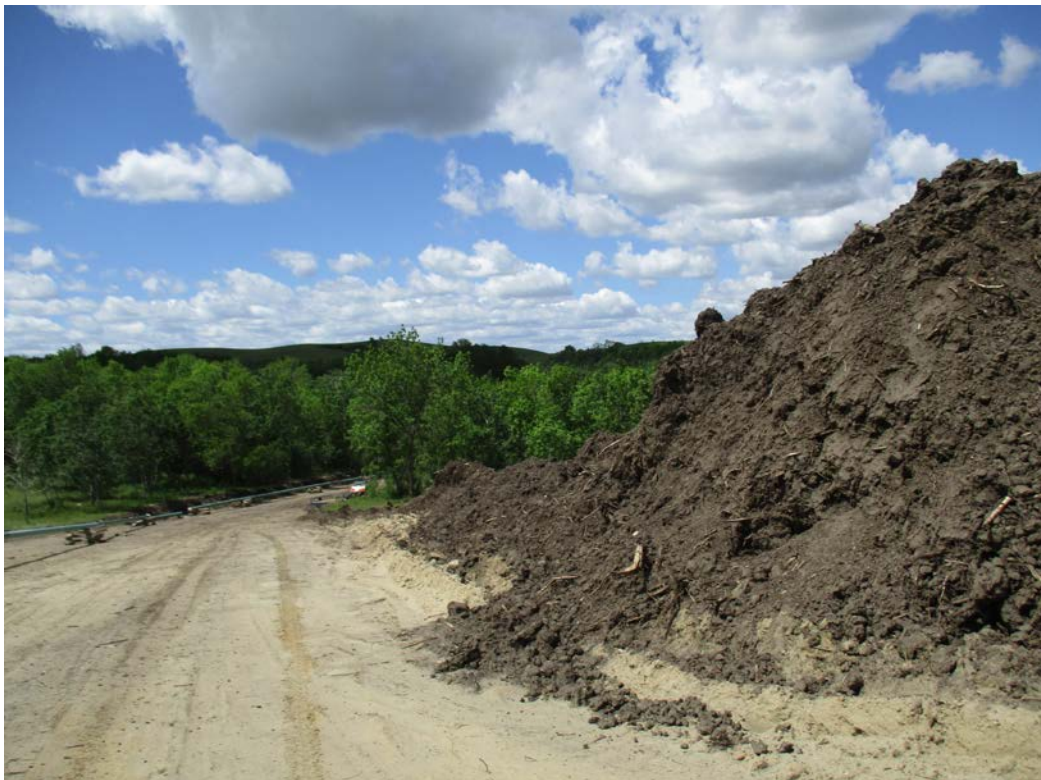
Below: Photo 18 (pt. 438) – Direction Looking west. Wooded ravine has a smaller ROW, topsoil from woody ravine brought up and piled. Woody debris in topsoil pile.

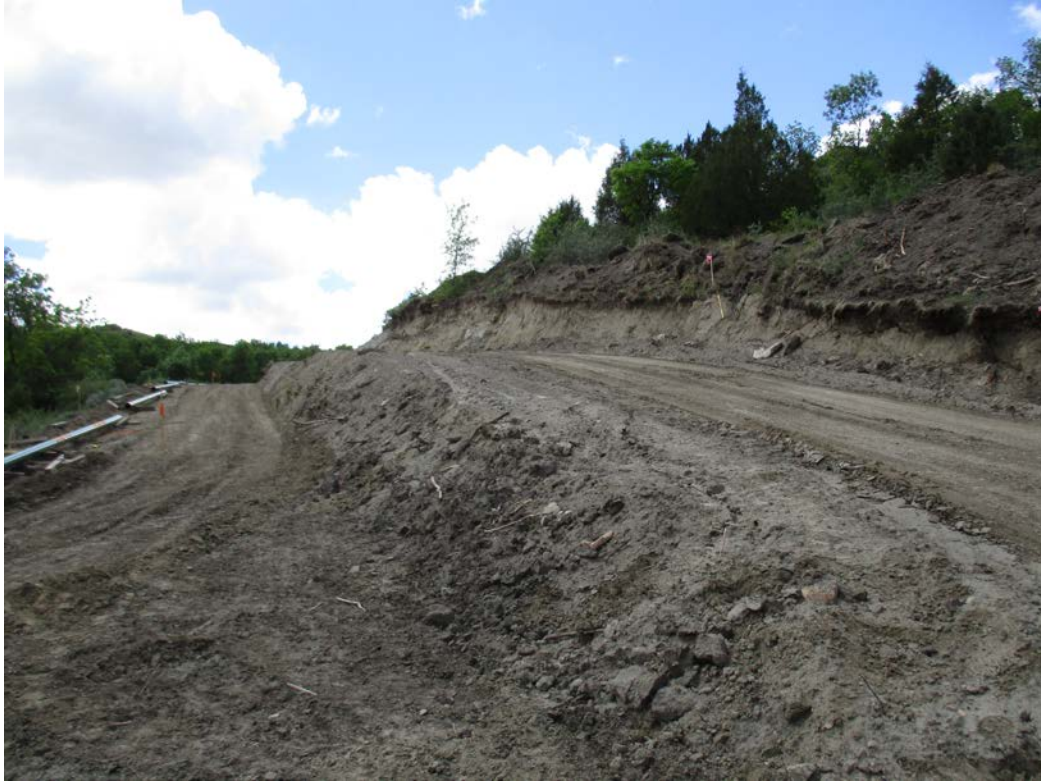
Portions of the project cross steep terrain (Observation Point 441, **Appendix B, Photo 19**). Areas of steep terrain often have shallow topsoil depths. These areas often require additional grading to a gentler slope to obtain a safe, flat, work terrace to accommodate pipeline work. In steep terrain, best management practices (BMPs) are needed to prevent movement of disturbed soil off the ROW, temporary sediment barriers could include silt fences and slope breakers. Silt fences, straw wattles and slope breakers were observed on site. Following construction, BMPs are also needed, such as, seed, mulch with certified weed-free hay/straw, or cover with erosion-control fabric. These are a few options to maintain the ROW until permanent vegetation is established.

Above: Photo 19 (pt. 441) – Steep slope, with little topsoil. Two-tone area. Topsoil to the far right of photo.

When the topsoil inspection of the project was conducted, there were portions of the project that went through steep slopes (Observation Point 441 and 439, **Appendix A, Figure 1 and Appendix C**). Areas of steep terrain often have shallow topsoil depths. These steep areas require additional grading down to a gentler slope to accommodate pipeline work. In steep terrain, best management practices (BMPs) are needed such as silt fences, slope breakers, certified weed-free mulch, seed, and erosion-control fabric; these are a few options to maintain the ROW until permanent vegetation is established. Silt fences, straw wattles and slope breakers were observed on site. Contractors/equipment operators need to take special care in this area to prevent movement of disturbed soil off the ROW. Wenck recommends monitoring and documentation of this area to ensure vegetation becomes established after reclamation.

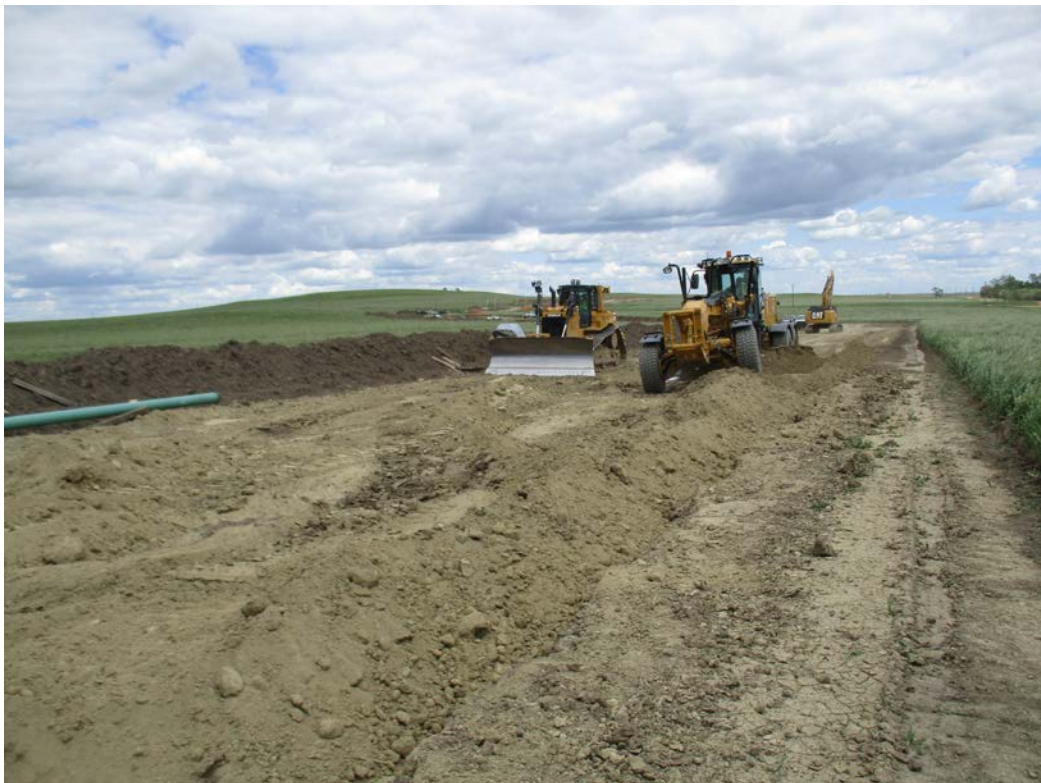
Below: Photo 20 (pt. 442) – Direction looking east. Trench just backfilled, equipment smoothing out area.

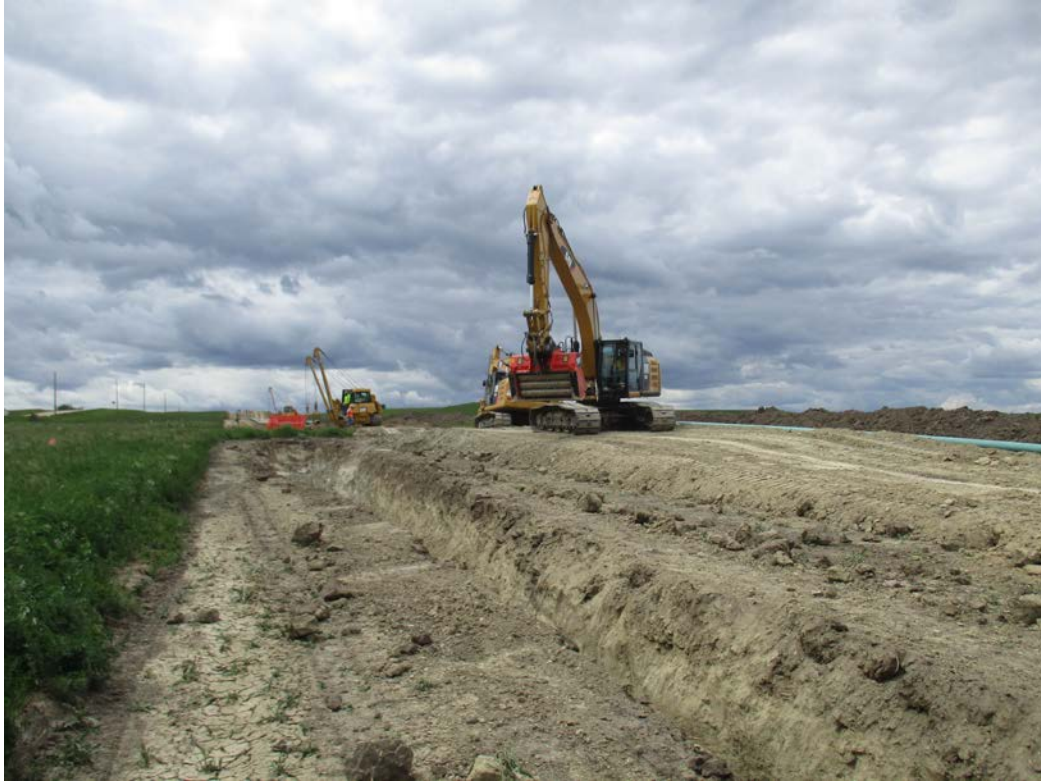
Above: Photo 21 (pt. 442) – Direction looking west. Subsoil pile from trench is flattened for work area.

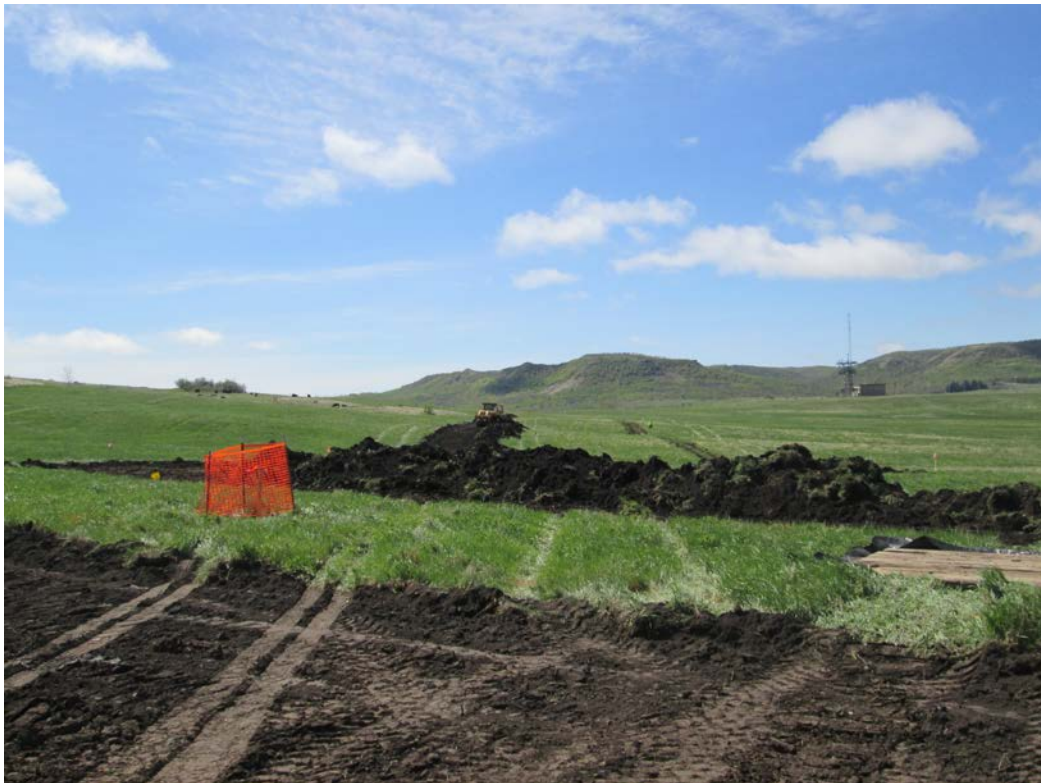
Below: Photo 22 (pt. 275) – Direction looking south. Another line runs through here, this area will be bored under. Dozer stripping topsoil.
