# Technical Memo

**Subject:** PU-15-801 ONEOK Bakken Pipeline Project (Bear Creek Pipeline) - Construction Inspection Report

## **Construction Inspection Report**

### **ONEOK Bakken Pipeline LLC. – 8-inch Natural Gas Liquids Pipeline Project (Bear Creek Pipeline) – PSC Case No. PU-15-801**

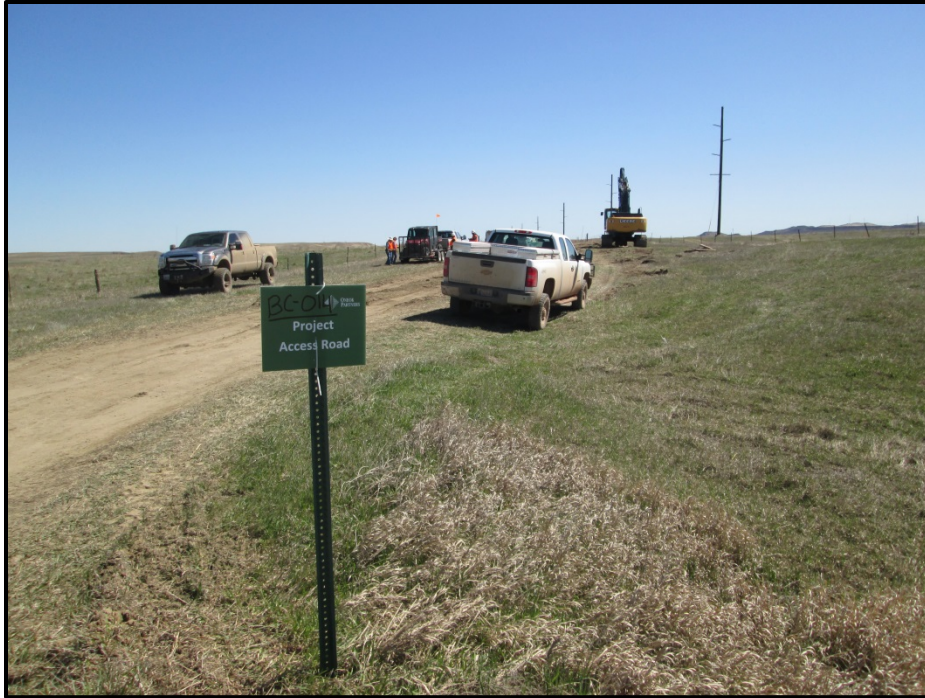
- Temporary sign put up to show approved project access road. Other signs were put up throughout the project area which included, but were not limited to, environmentally sensitive area, speed limits, and a “slow, children at play” sign near a residence (Photo #1);

**Photo 1.** – Temporary sign put up to show approved project access road. Other signs were put up throughout the project area which included, but were not limited to, environmentally sensitive area, speed limits, and a “slow, children at play” sign near a residence.

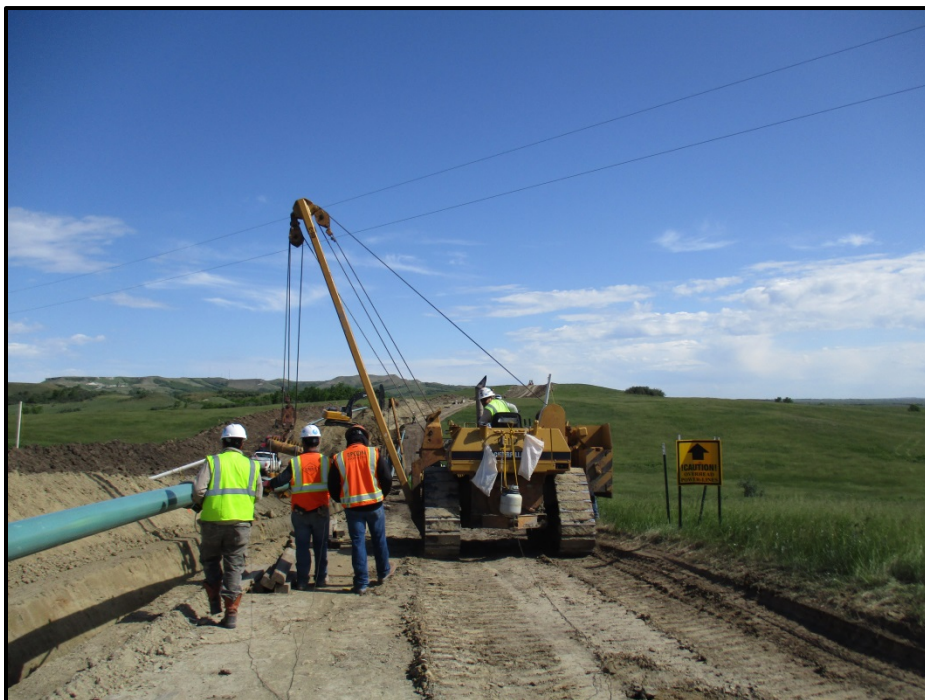
- Contractor lowering pipe into trench. There is a "Caution Overhead Power-Lines" sign on the far right of the ROW (Photo #2, Point #434);
- Survey crew (shown at top of hill) came in after pipe was laid to survey for the as-built (pipe welds and depths) (Photo #3, Point #434);

**Photo 2.** (GPS Point #434) – Contractor lowering pipe into trench. There is a “Caution Overhead Power-Lines” sign on the far right of the ROW. Direction: North.

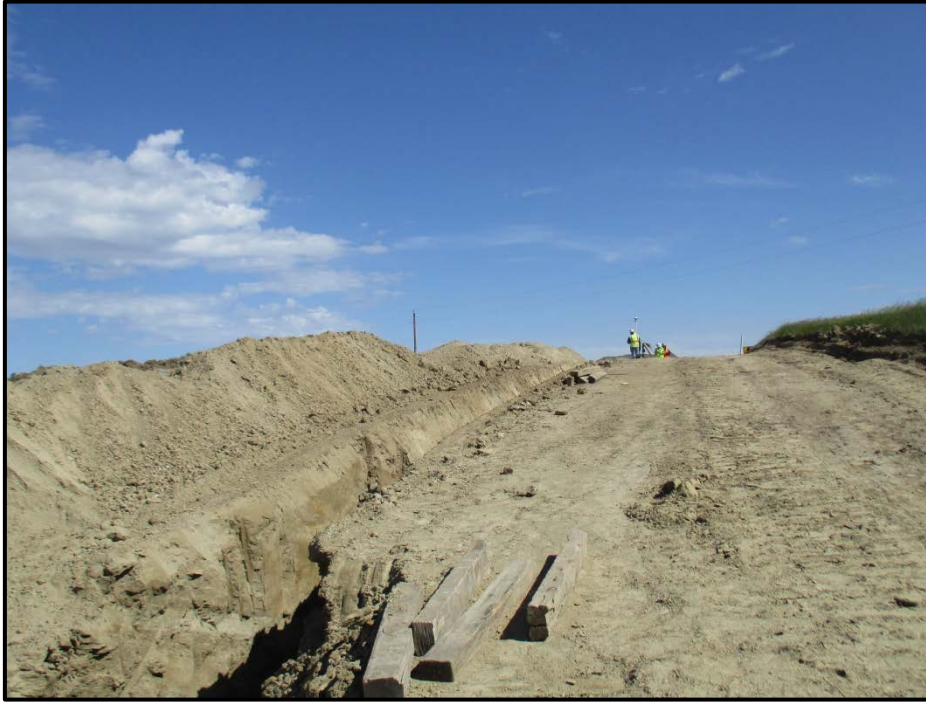
**Photo 3.** (GPS Point #434) – Survey crew (shown at top of hill) came in after pipe was laid to survey for the as-built (pipe welds and depths). Direction: North.

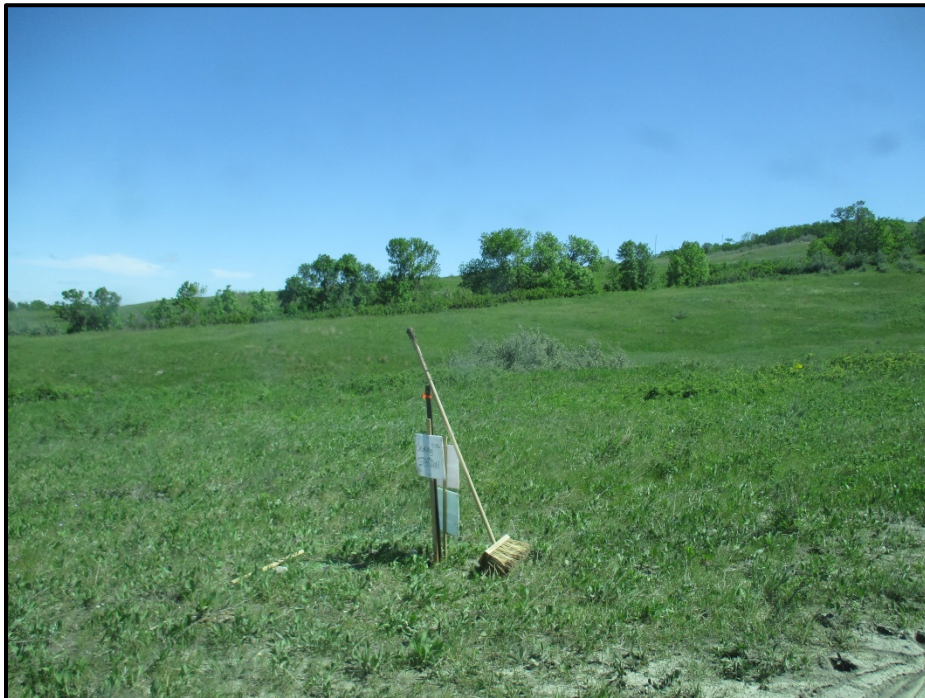
- Cleaning station set up near edge of ROW. This could be used when going into environmentally sensitive areas, etc., to prevent spread of weeds (Photo #4);

**Photo 4.** – Cleaning station set up near edge of ROW. This could be used when going into environmentally sensitive areas, etc., to prevent spread of weeds.

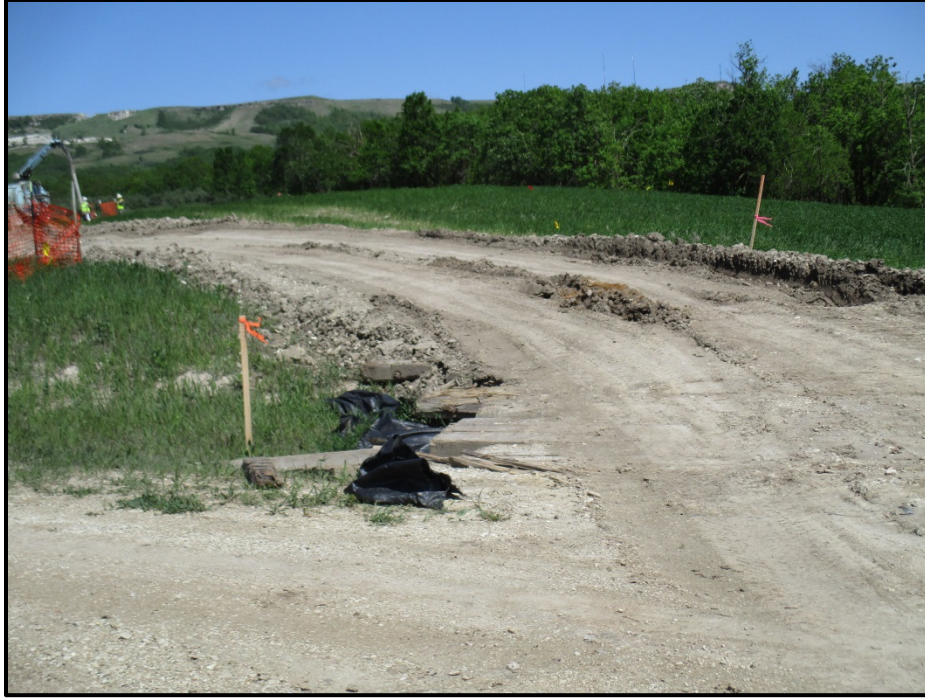
**Photo 5.** (Near GPS Point #435) – Many of the swamp mats on site were laid over a tarp, which prevents the mat from being buried when driven over.

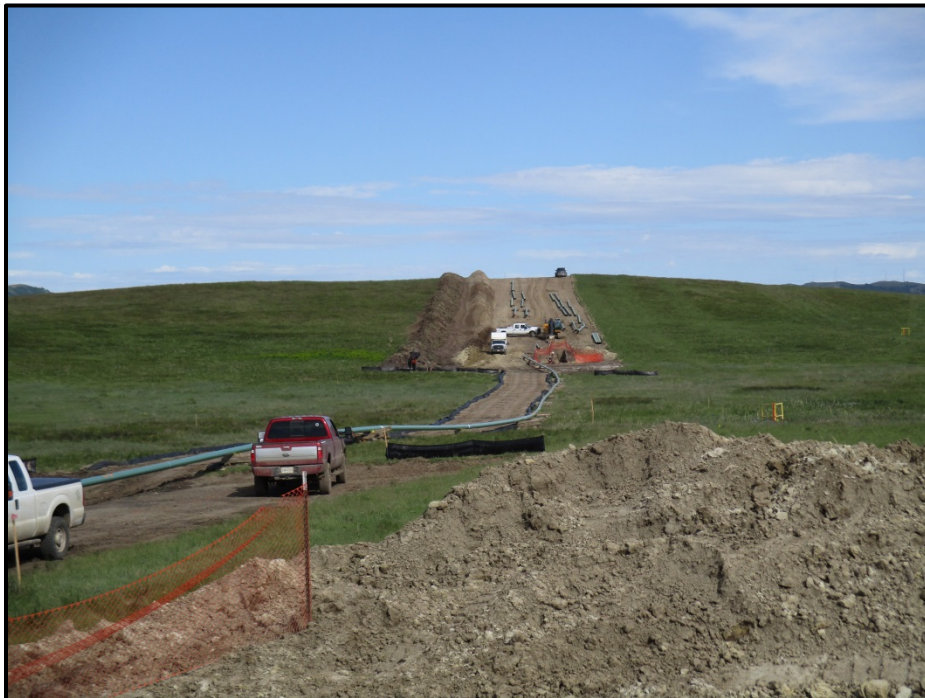
**Photo 6.** (GPS Point #432) – Near bore tie-in area showing fence along bell-holes. Swamp mats are visible in center of photo, used to cross low area/drainage. Silt fences were in place along edges of ROW in low areas. Contractors stated that the open trench was not open for more than 3 days.

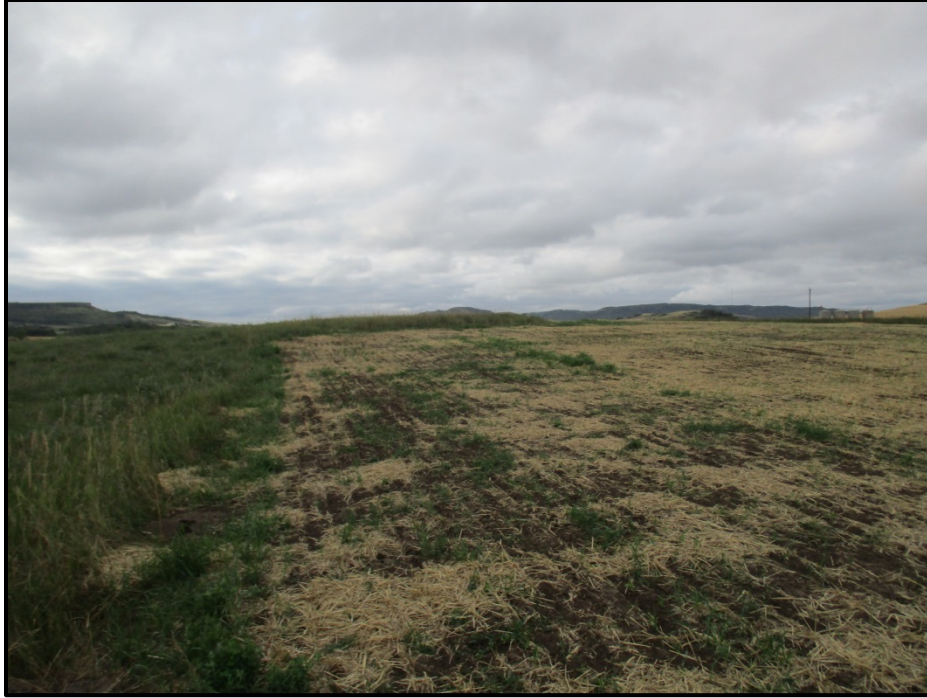
- Topsoil had been replaced back on the ROW. Straw mulch was laid down with seeding. Some vegetation had already started to grow (Photo #7, Point #451);

**Photo 7.** (GPS Point #451) - Topsoil had been replaced back on the ROW. Straw mulch was laid down with seeding. Some vegetation had already started to grow.

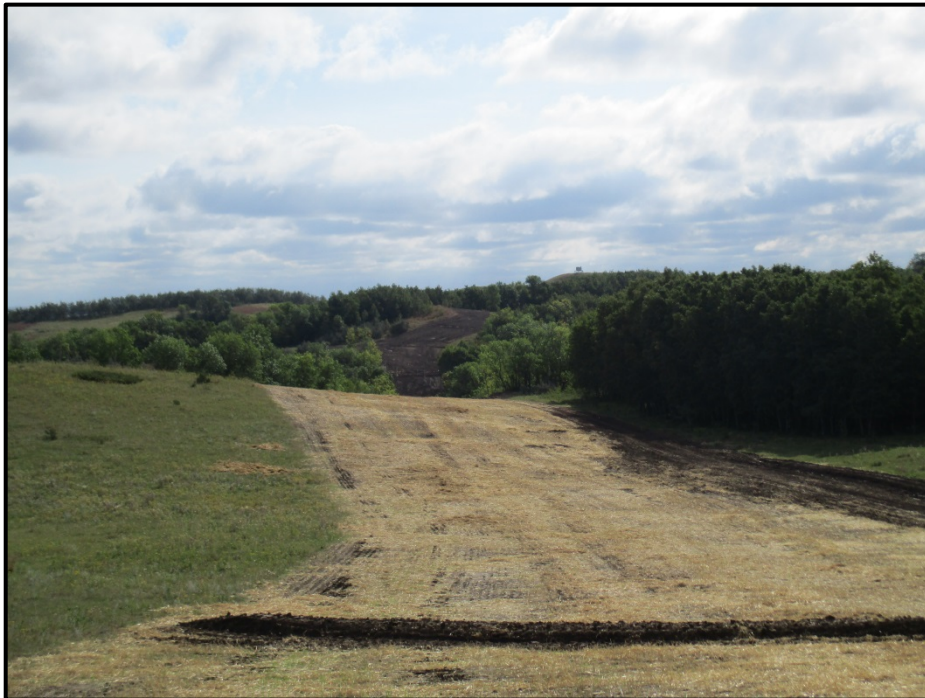
- Water bar shown at the bottom of the photo. Travel lane still being used on the right side of the ROW to get to the hill in the background. The hill in the background was rocky and has not yet been seeded (Photo #8, Point #453);

**Photo 8.** (GPS Point #453) – Water bar shown at the bottom of the photo. Travel lane still being used on the right side of the ROW to get to the hill in the background. The hill in the background was rocky and has not yet been seeded. Direction: East.

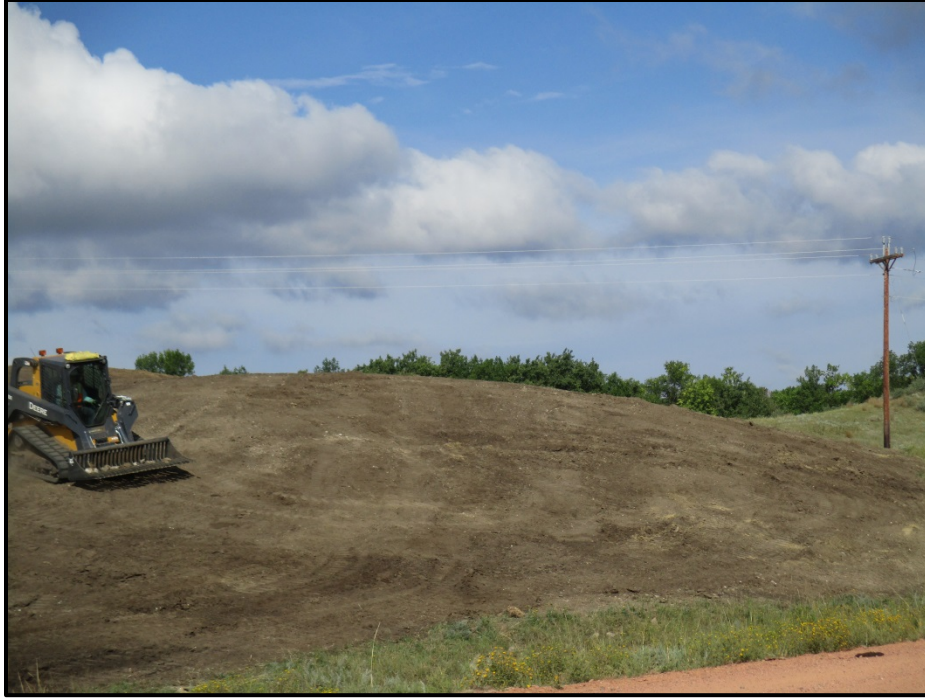
**Photo 9.** (GPS Point #453) – ROW still needs to be fine graded, seeded and crimped.  
Direction: West.

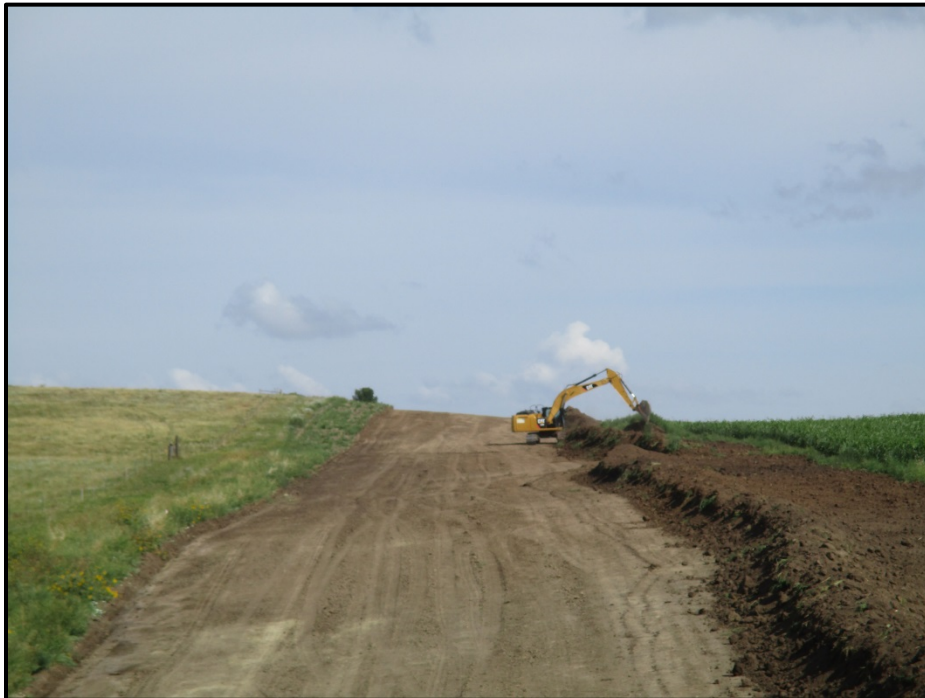
**Photo 10.** (GPS Point #454) – Excavator/hoe moving topsoil pile out from the edge so dozer can come through and spread topsoil on ROW. Direction: North.

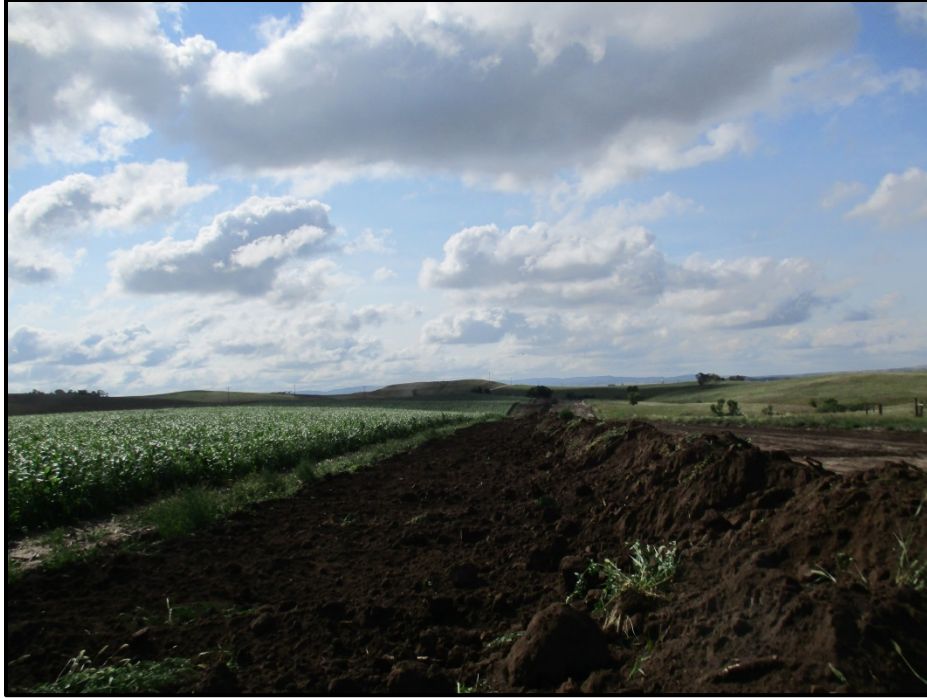
**Photo 11.** (GPS Point #454) – Topsoil pile moved from edge of ROW closer to the center of ROW. Direction: South.

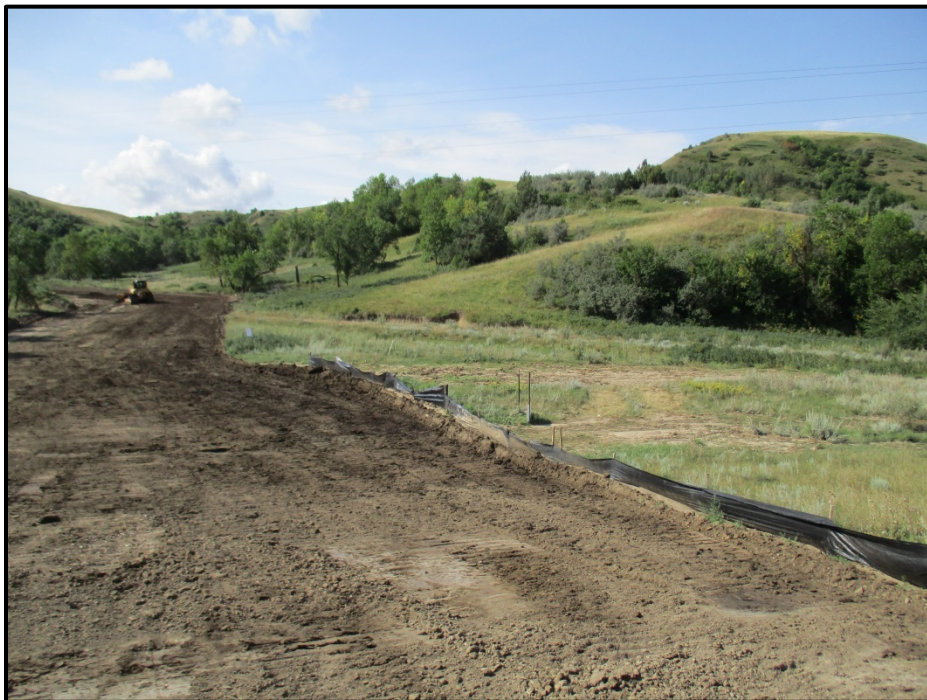
**Photo 12.** (GPS Point #455) – Rain event washed some sediment down the hill and was caught in silt fence. Dozer pushing some of the sediment back up the hill. Direction: South.

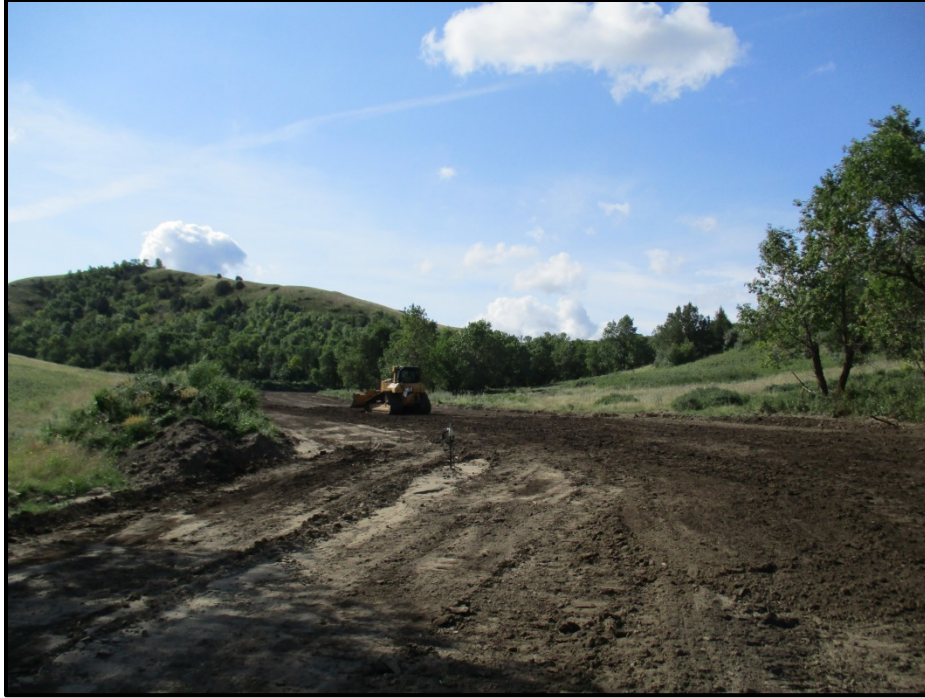
**Photo 13.** (GPS Point #455) – Dozer pushing sediment up the hill and smoothing out the area from a rain event. Pipe test lead with metal stake shown in the middle left of ROW.  
Direction: South.

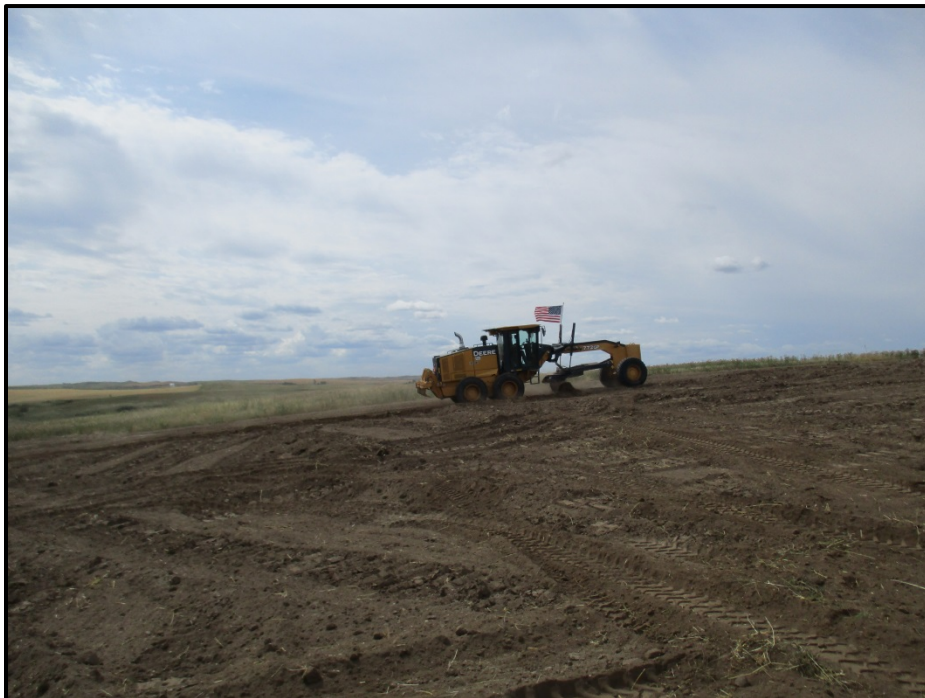
**Photo 14.** (GPS Point #457) – Motor grader shown smoothing out ROW.

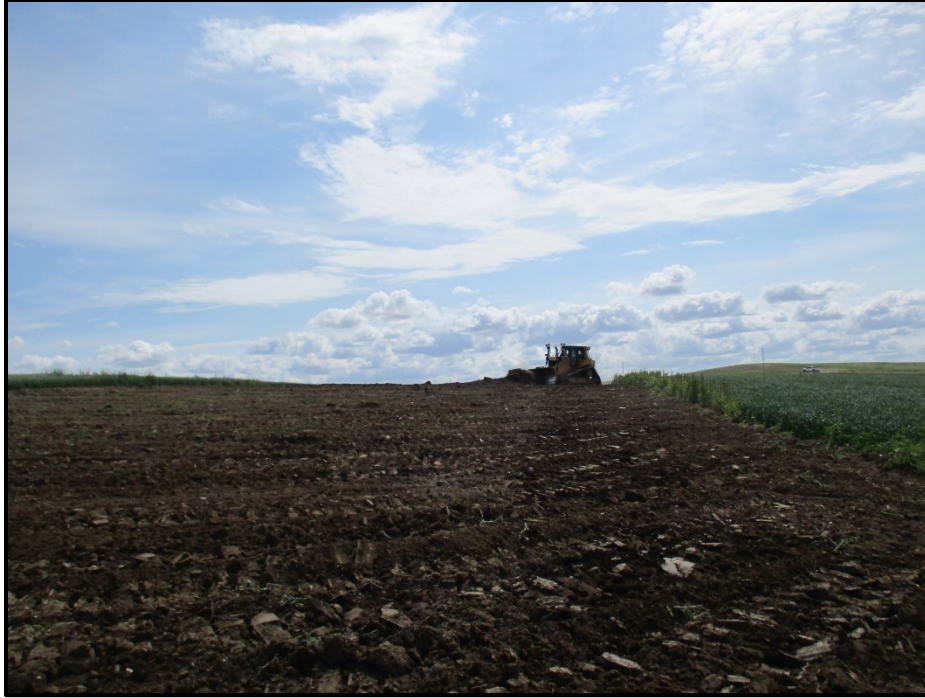
**Photo 15.** (GPS Point #456) – Dozer spreading topsoil out on the ROW.

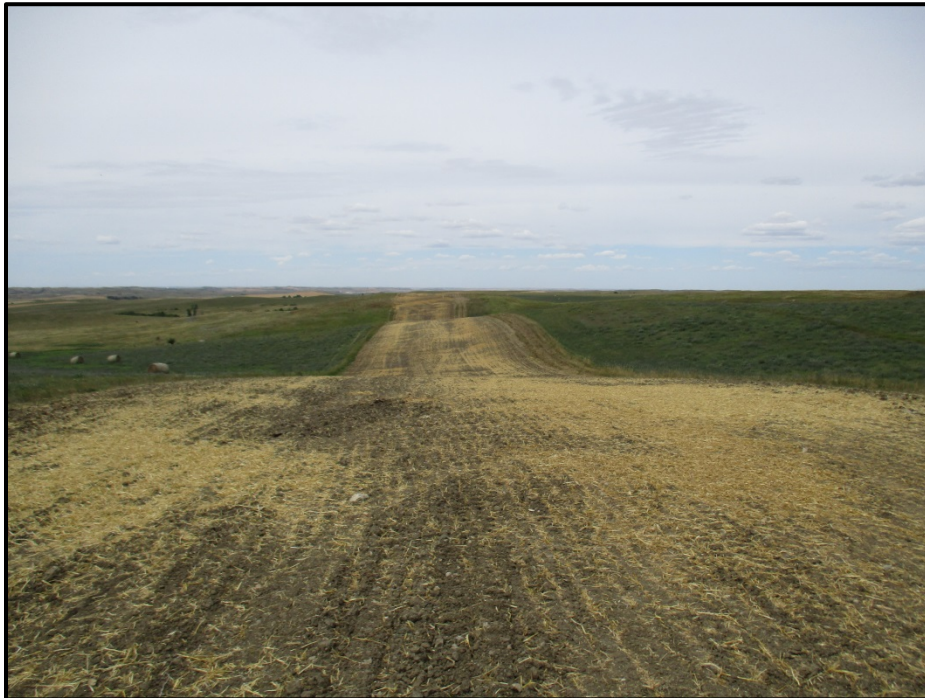
**Photo 16.** (GPS Point #458) – Pipeline ROW, reclamation done by local contractor (not H2 Enterprises). ONEOK/H2 Enterprises stated that they thought it had been re-seeded (a second seeding) the week before. Direction: Northwest.

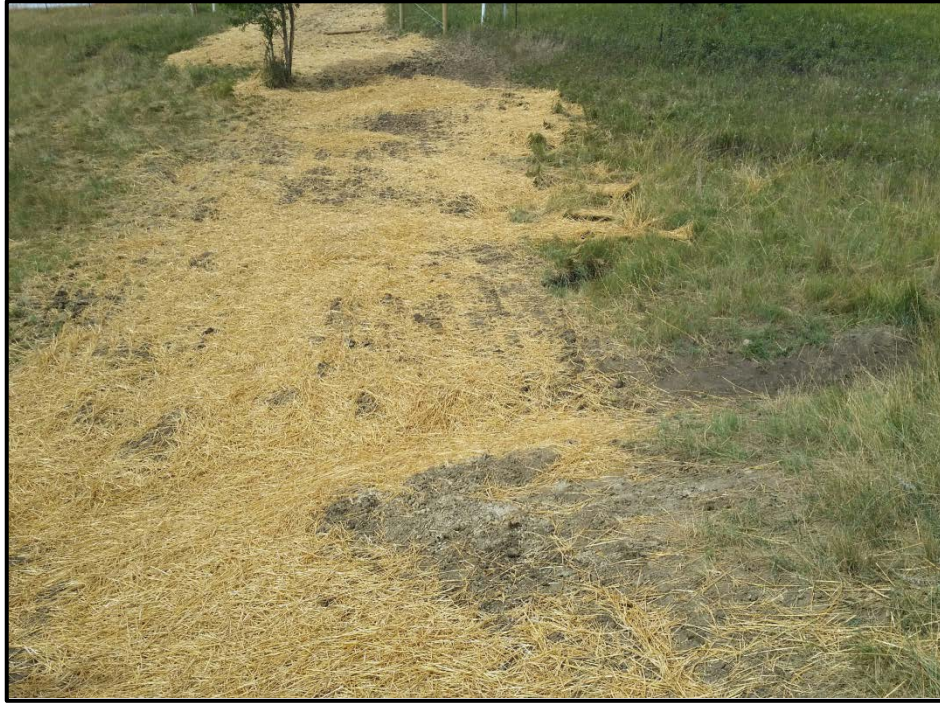
- Gully forming in drainage area. No erosion control device was in place but it was stated by H2 Enterprises that an erosion control device will be placed here (Photo #17, Point #458);

**Photo 17.** (GPS Point #459) – Gully forming in drainage area. No erosion control device was in place but it was stated by H2 Enterprises that an erosion control device will be placed here.

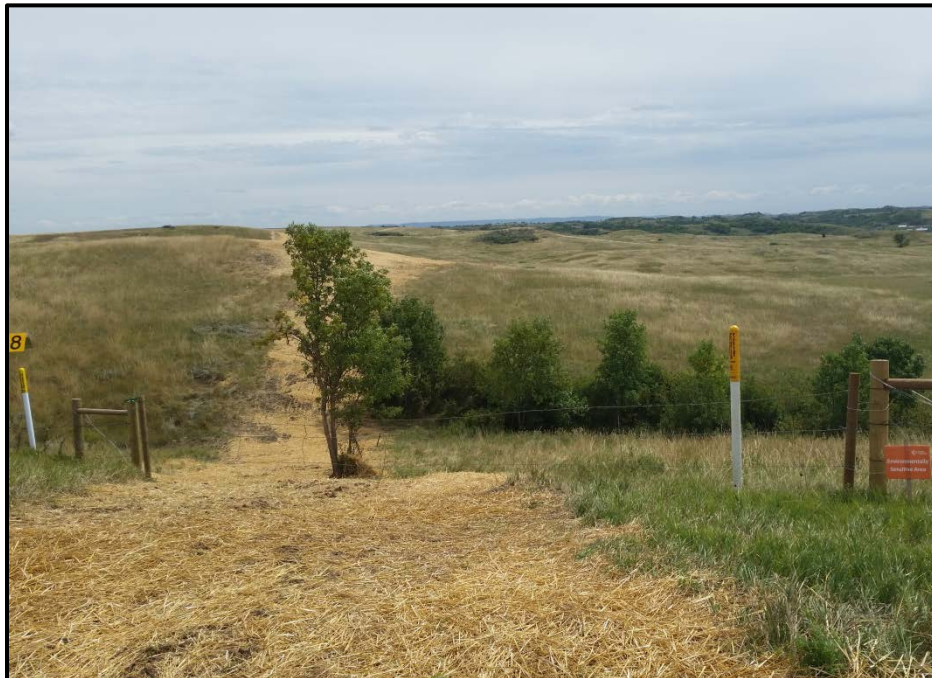
- Pipeline ROW, drainage area and road bored. Bore pit was at the top of the hill, area in between was driven on to access bore area. Note signs and pipeline markers along fence line with fence gate (Photo 18, Point #458).

**Photo 18.** (GPS Point #459) – Pipeline ROW, drainage area and road bored. Bore pit was at the top of the hill, area in between was driven on to access bore area. Note signs and pipeline markers along fence line with fence gate. Direction: Southeast.
