Technical Memo

To: Patrick Fahn, North Dakota Public Service Commission
From: Sara Simmers, Wenck Associates, Inc.
Date: September 5, 2017
Subject: PU-15-801 ONEOK 8-in Bakken Pipeline - Revegetation Inspection Report

**ONEOK Bakken Pipeline, LLC – 8-inch Natural Gas Liquids Pipeline
also known as the “Bear Creek Pipeline” – PSC Case No. PU-15-801 –
Revegetation Inspection Report**
Site Visit: August 17, 2017

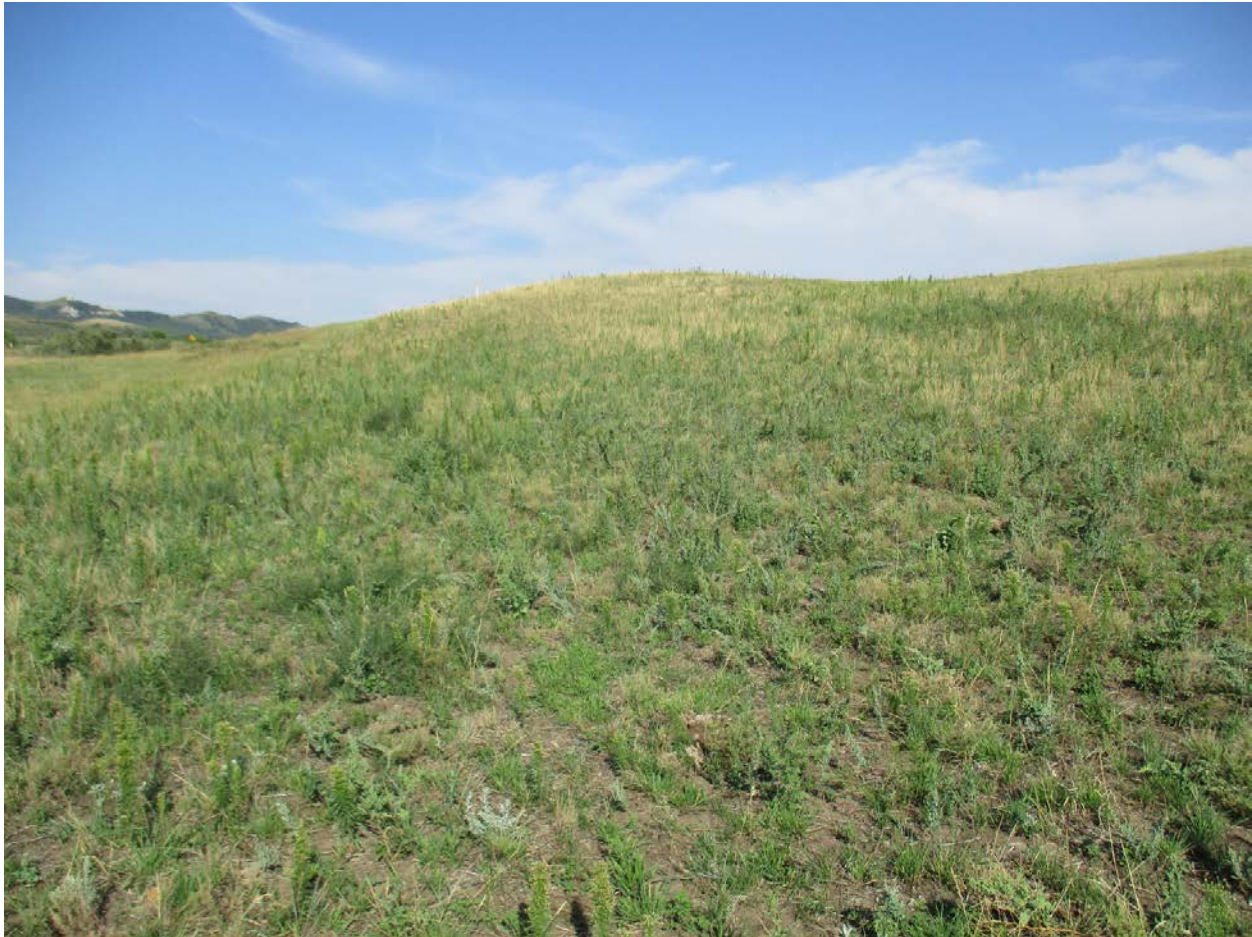
Photo 1. (Point 534). Facing: West. View of a reclaimed grassland area over rolling hills. The soil reclamation and recontouring over uneven terrain was done very well. Annual weed cover is most visible at about 25-50% cover; species noted include horseweed, lambsquarters, and Russian thistle. Several seedlings of the noxious weed absinth wormwood were present. Seeded grasses had germinated and were at about 50-75% cover, including western wheatgrass and slender wheatgrass. The native forbs yellow coneflower, white sagewort, and daisy fleabane had presumably recolonized the area from seed or vegetative parts remaining in the replaced topsoil. While bare ground and annual weeds were notable, the presence and cover of planted grasses indicates that given time and moisture grasses will continue to establish in this area.

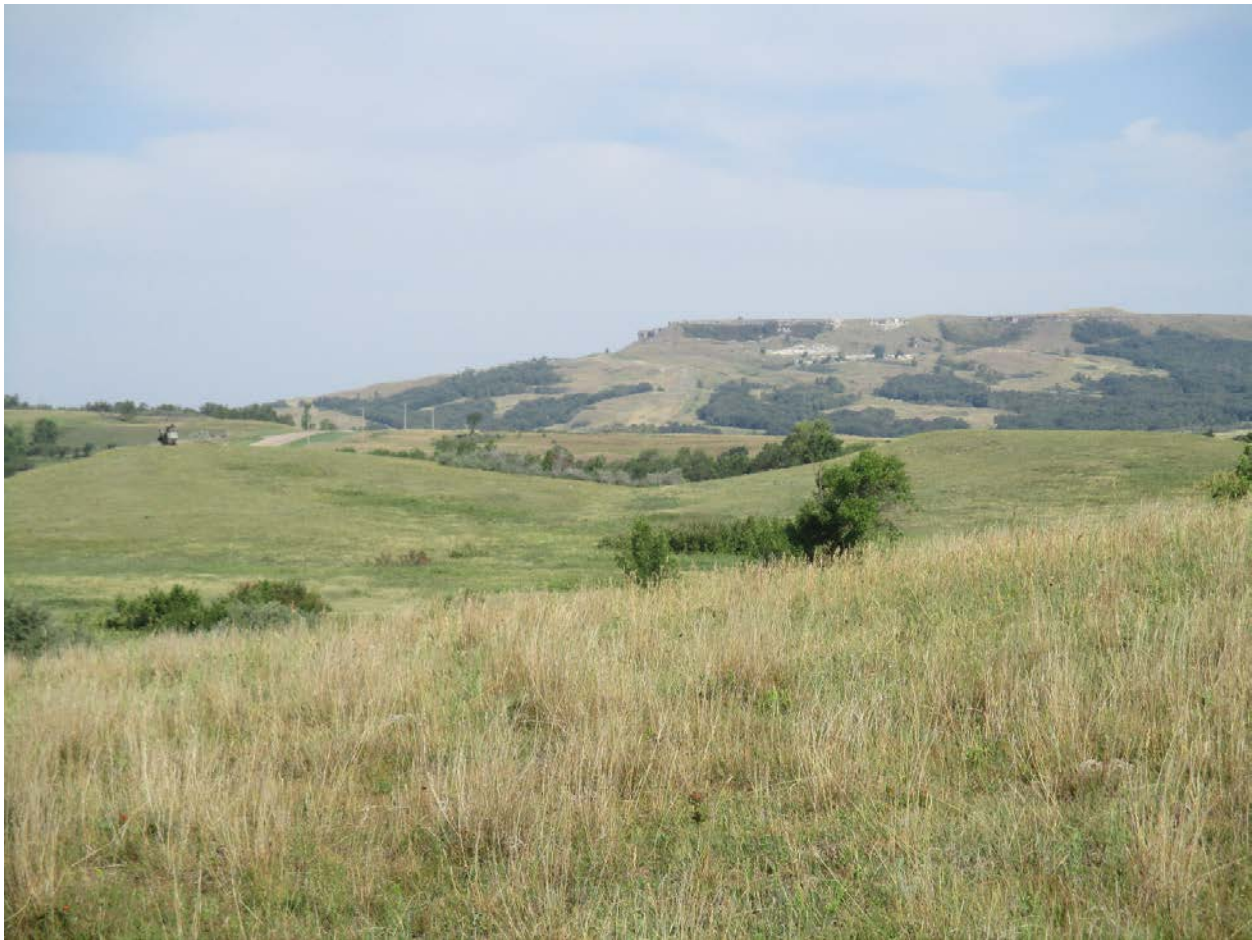
Photo 2. (Point 535). Facing: Northwest. The foreground area is not part of the route. The ROW is visible going up the high hill/butte in the distance. Some larger areas of bare ground were noticeable on the top of the butte. These areas were not a major concern because that area is naturally low on topsoil; exposed subsoils and barren breaks were part of the natural landscape.

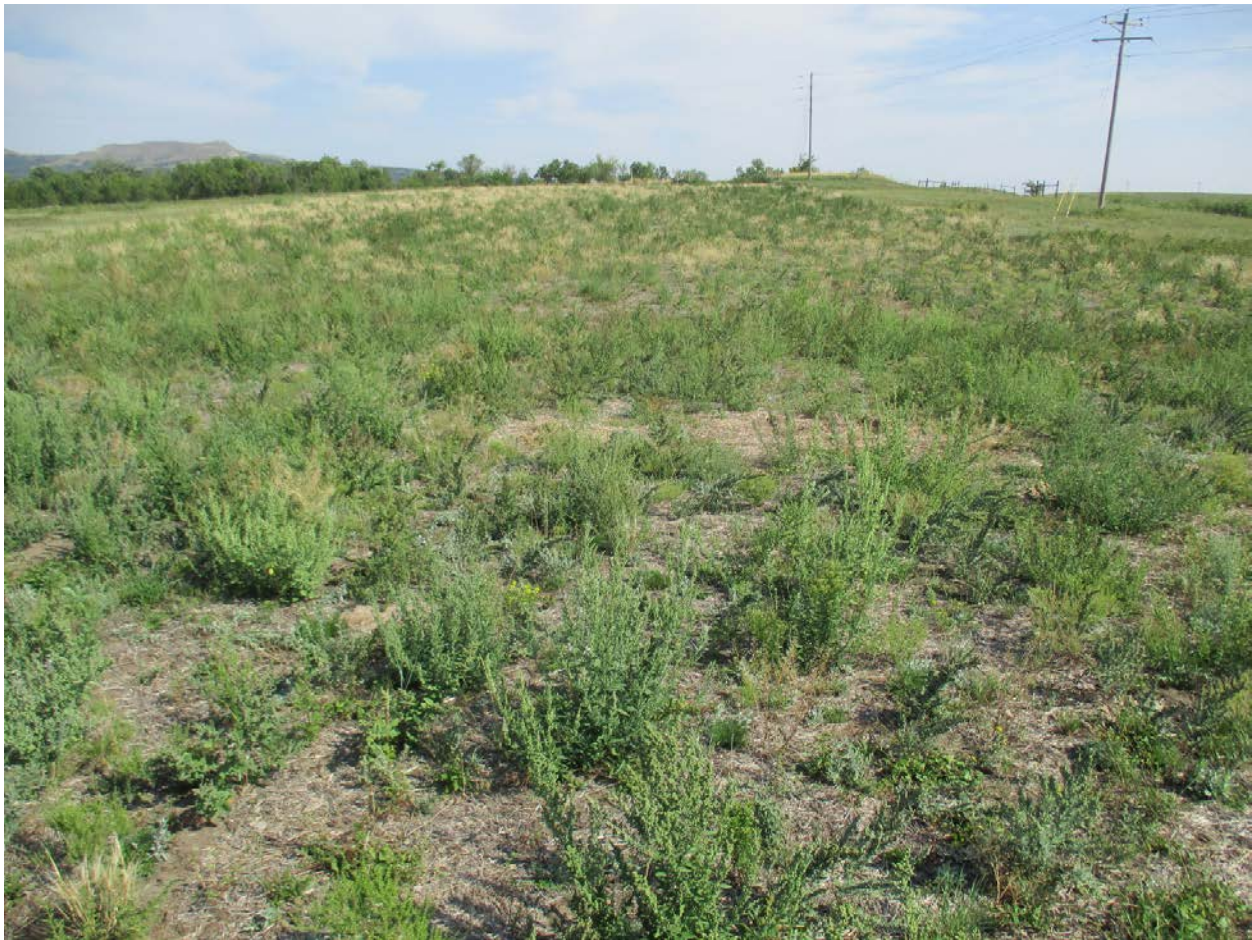
There were a few problem areas, but because of the early stage of reclamation, it is unclear if intervention at this stage would be worthwhile. A horse pasture was dominated by annual weeds, had lower cover of planted grasses, and absinthe wormwood, a noxious weed, was present (**Photo 3**). In another long stretch of the ROW, where there had been no grazing,

Photo 3. (Point 536). Facing: North. View of a reclaimed grassland area within a horse pasture. Cover of annual weeds was over 75% and included pepperweed, lambsquarters, and horseweed. The noxious weed absinth wormwood was present throughout the reclaimed area at less than 1% cover. Planted grasses were present throughout at about 5-10% cover. Several horses were actively grazing the area. The center of the photo is a low area where drainage runs which had been noted during the as-built inspection as having erosion forming. The erosion appeared to have been corrected and stopped; while there were water flow patterns visible in the soil, there was not any downcutting or channel formation.

the cover of annual weeds, particularly tumble mustard, and absinth wormwood was also very high (**Photo 6**). Management that may help increase the cover of the planted grasses includes mowing the annual weeds and spraying the wormwood. However, the reclamation has had only one full season of growth. Planted grasses may be able to increase in abundance in following years with better precipitation. Treating the wormwood may be ineffective unless the landowner also treats the patches in the adjacent grassland.

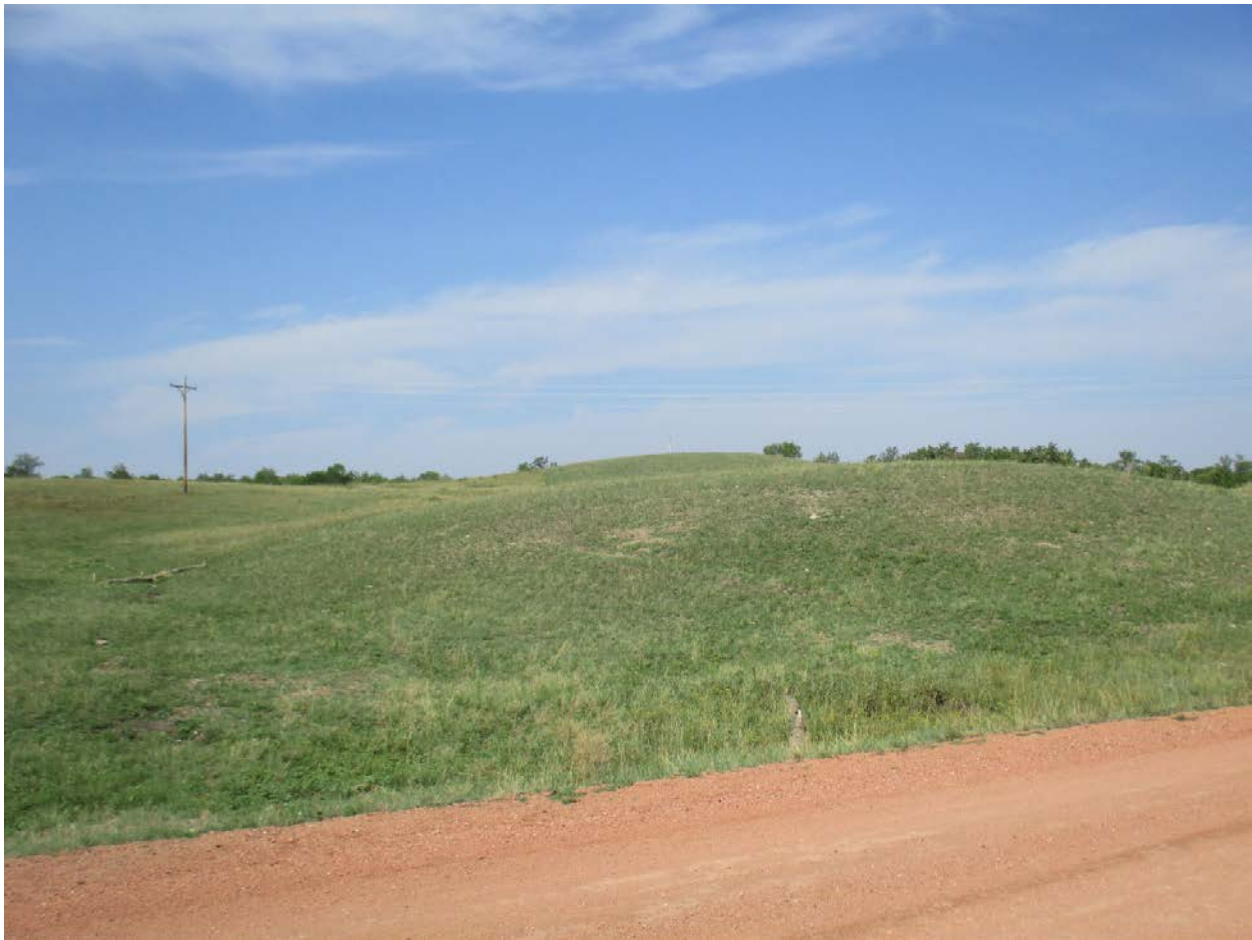
Photo 4. (Point 537). Facing: Northwest. View of reclaimed grassland/rangeland over rolling hills. Recontouring and soil replacement appeared excellent. The area was being actively grazed, which appeared to reduce the cover of annual weeds to less than 10%. Planted grasses were evenly distributed with a cover between 50-75%. Staked erosion rolls were in place in the swale on the left of the photos. Other erosion and drainage controls were observed along the ROW (not shown in photo), including waterbars, vertical waterbars, and culverts.

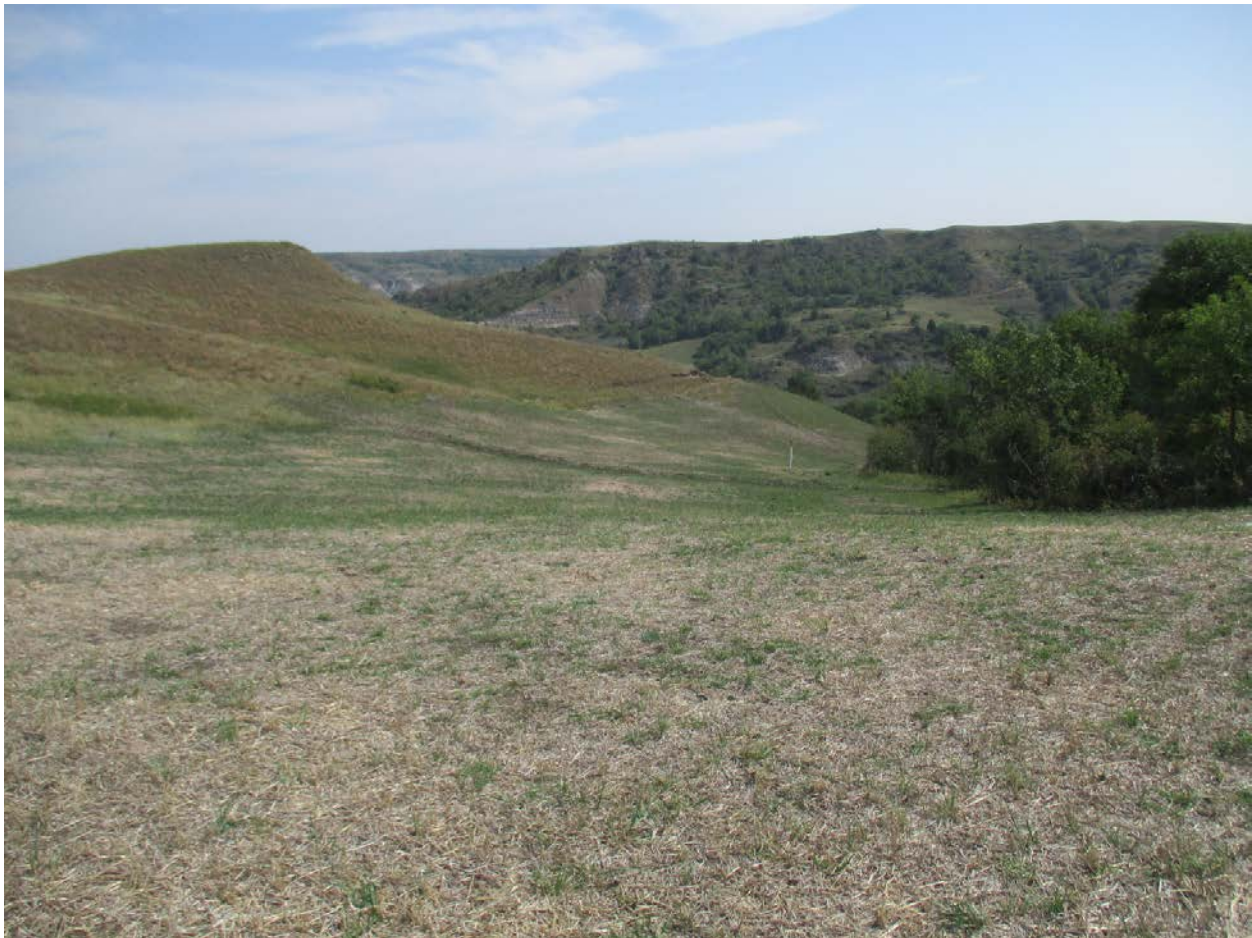
Photo 5. (Point 538). Facing: Northeast. View of reclaimed grassland/rangeland along steep slope. Recontouring, soil replacement, and erosion controls were complete and in good condition. Active grazing in this area kept annual weed cover down, but it was also affecting the cover and establishment of planted grass cover, in combination with the dry conditions. The distribution of planted grasses varied somewhat in this area from between 25-75% cover. Bare ground was up to 50% in some areas. The introduced grass smooth brome was present, and green needlegrass had apparently been planted along with the typical western wheatgrass and slender wheatgrass.

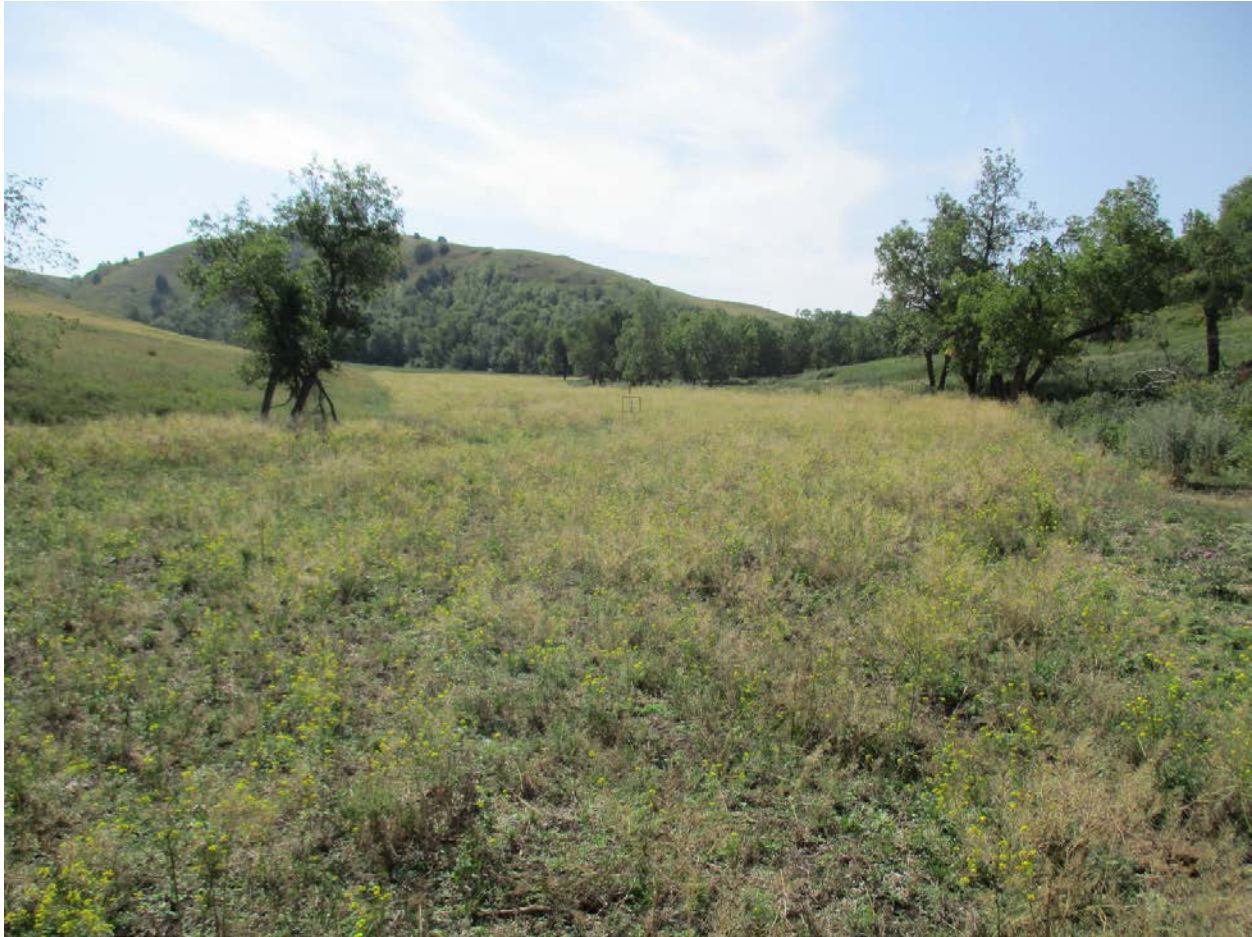
Photo 6. (Point 540). Facing: South. View of ROW in a valley between two hills; to the south the route continues through the valley and over lower slopes of adjacent ridges. Along this area and continuing to the south, it appeared there was no active grazing. Cover of planted grasses was between 10-20% and bare ground was similar. Introduced weeds had a cover of about 50%, with mustard and black bindweed being common annuals and noxious absinthe wormwood seedlings being common as well. Wormwood was common in patches in surrounding grassland. ONEOK could attempt to chemically treat the wormwood in the ROW, but unless there was similar effort by the landowner in adjacent areas, the wormwood would likely continue to spread into the ROW.

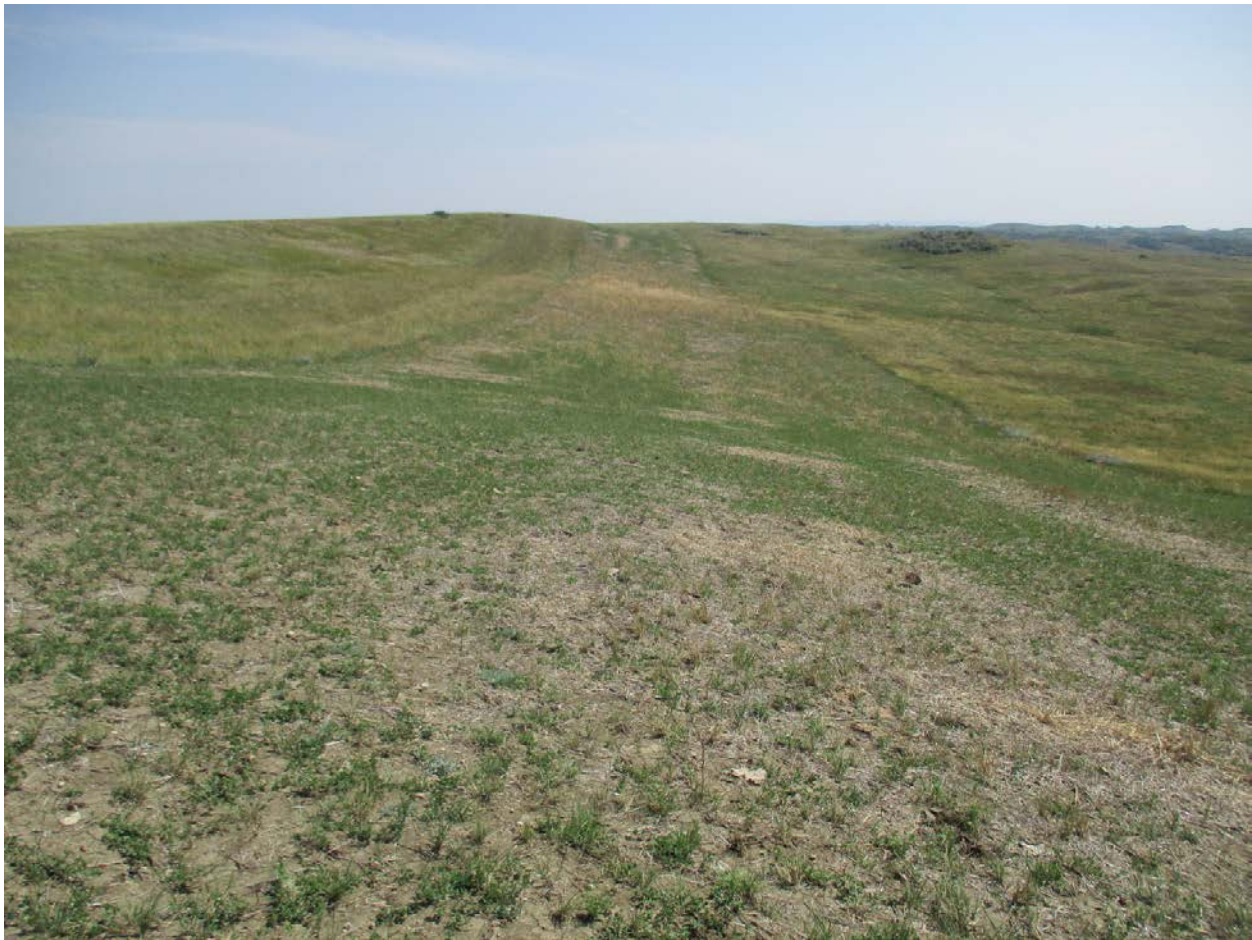
Photo 7. (Point 545). Facing: Southeast. View of ROW across state-owned rangeland. The area had active grazing. Annual weed cover was less than 5% and no noxious weeds were noted. Cover of planted grasses was between 25-50% and there were areas of significant bare ground between plants. Dominant species were slender wheatgrass and western wheatgrass (planted); yellow sweetclover (possible planted or colonized); and the native forbs yellow coneflower, white sagewort, and fringed sagewort (colonized).

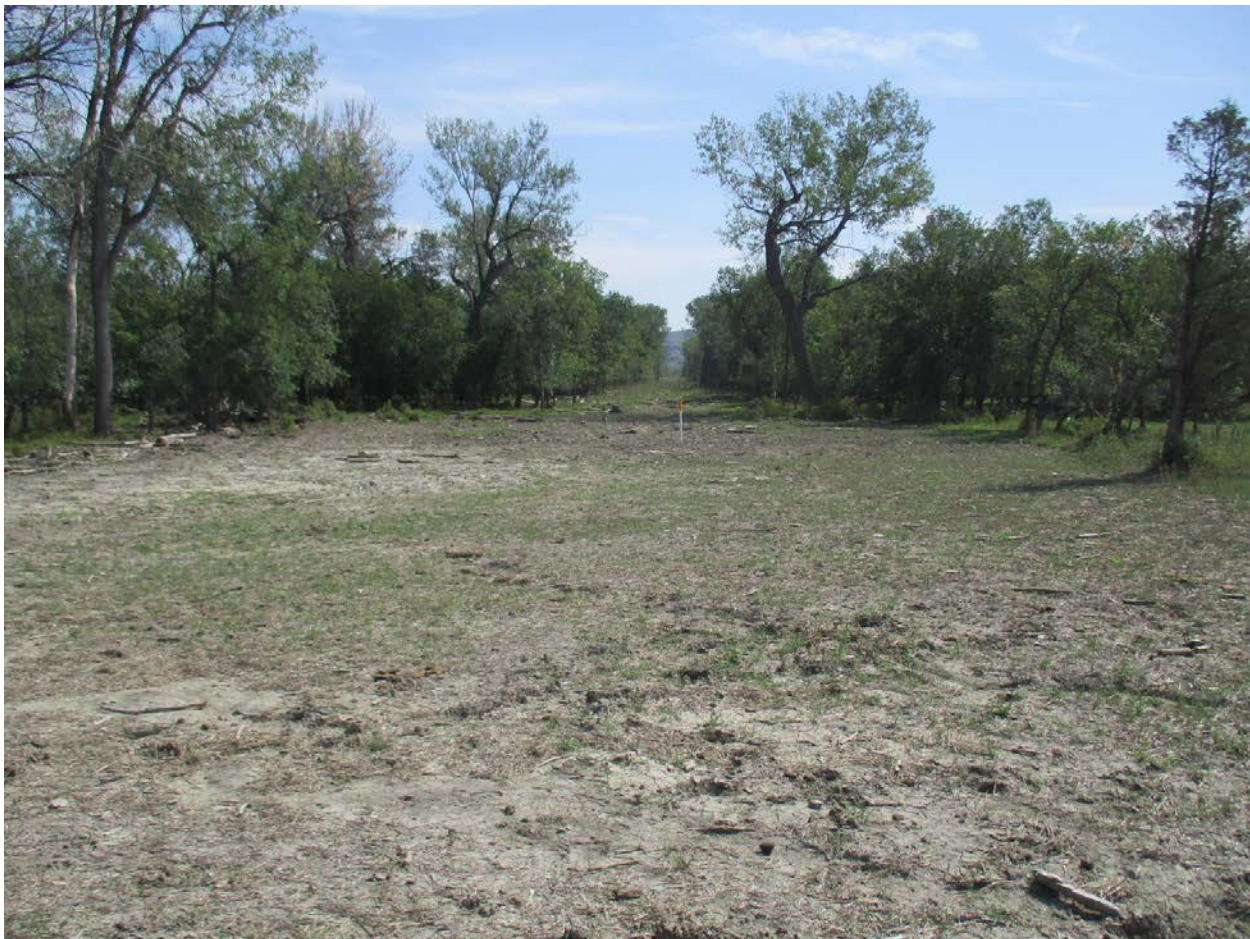
Photo 8. (Point 541) Facing: East. View across the cut of the ROW through the wooded floodplain toward the Little Missouri River (the route was bored but woody vegetation was cut to ground level within permanent ROW). The foreground shows the reclaimed workspace for the bores to the west and east from this point. The planted species were coming in across the area but cover was fairly low at 10-25%; species observed were western wheatgrass, slender wheatgrass, and green needlegrass. Yellow sweetclover and prostrate vervain (*Verbena bracteata*) were common. Bare ground was over 75%. In the cut area between woodland, native shrubs were growing back from cut stems and native woodland sedges (likely *Carex sprengei*) and wood violet were growing back. The noxious weed Canada thistle (*Cirsium arvense*) was scattered in this area; it was common in the adjacent woodland.

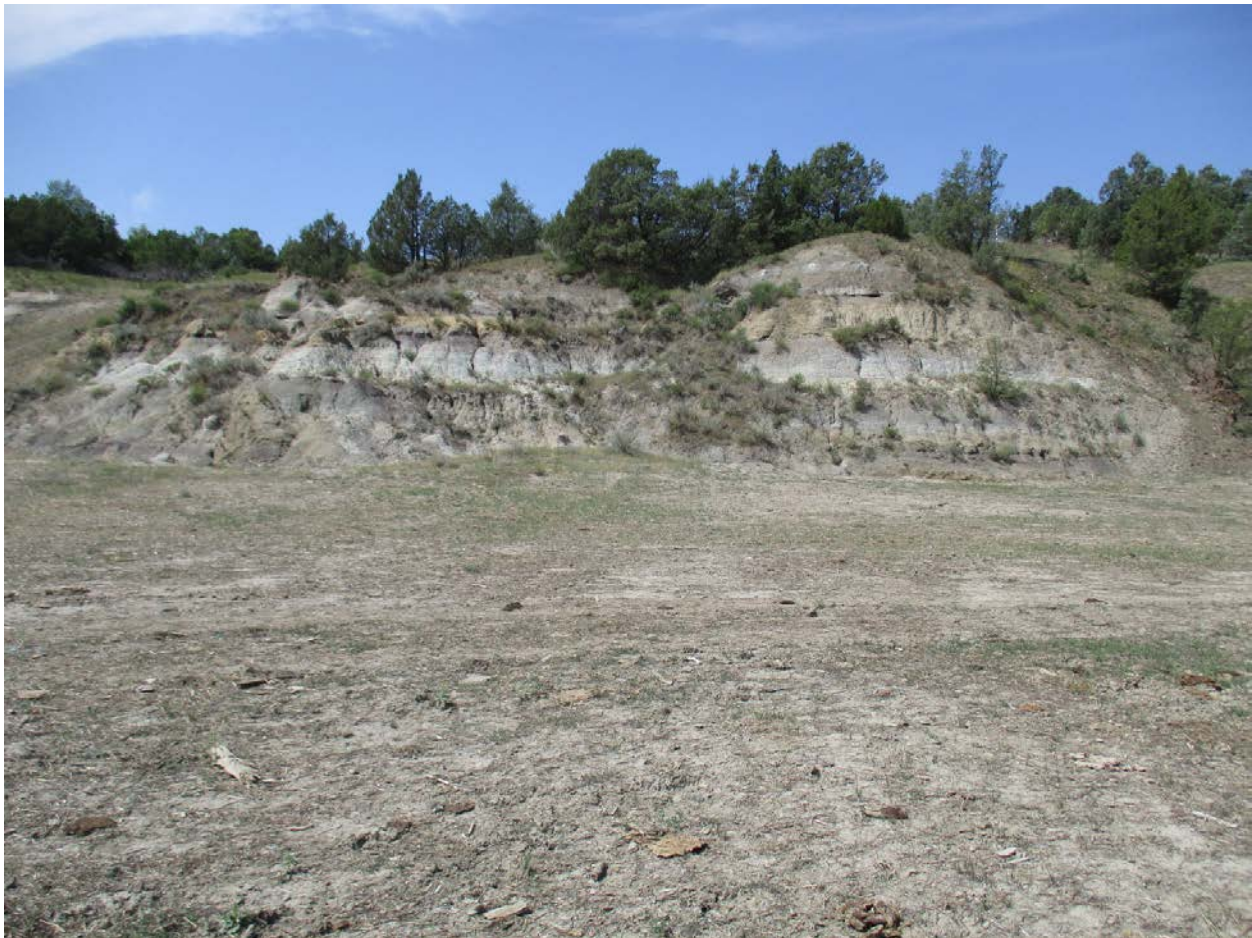
Photo 9. (Point 541) Facing: West. Opposite view from Photo 8 at the base of the steep and woody badlands bluff on the west bank of river floodplain. The area in the foreground is part of the reclaimed area of the workspace, as described above for Photo 8. Grasses are heavily grazed, but present, and annual weed cover is negligible.

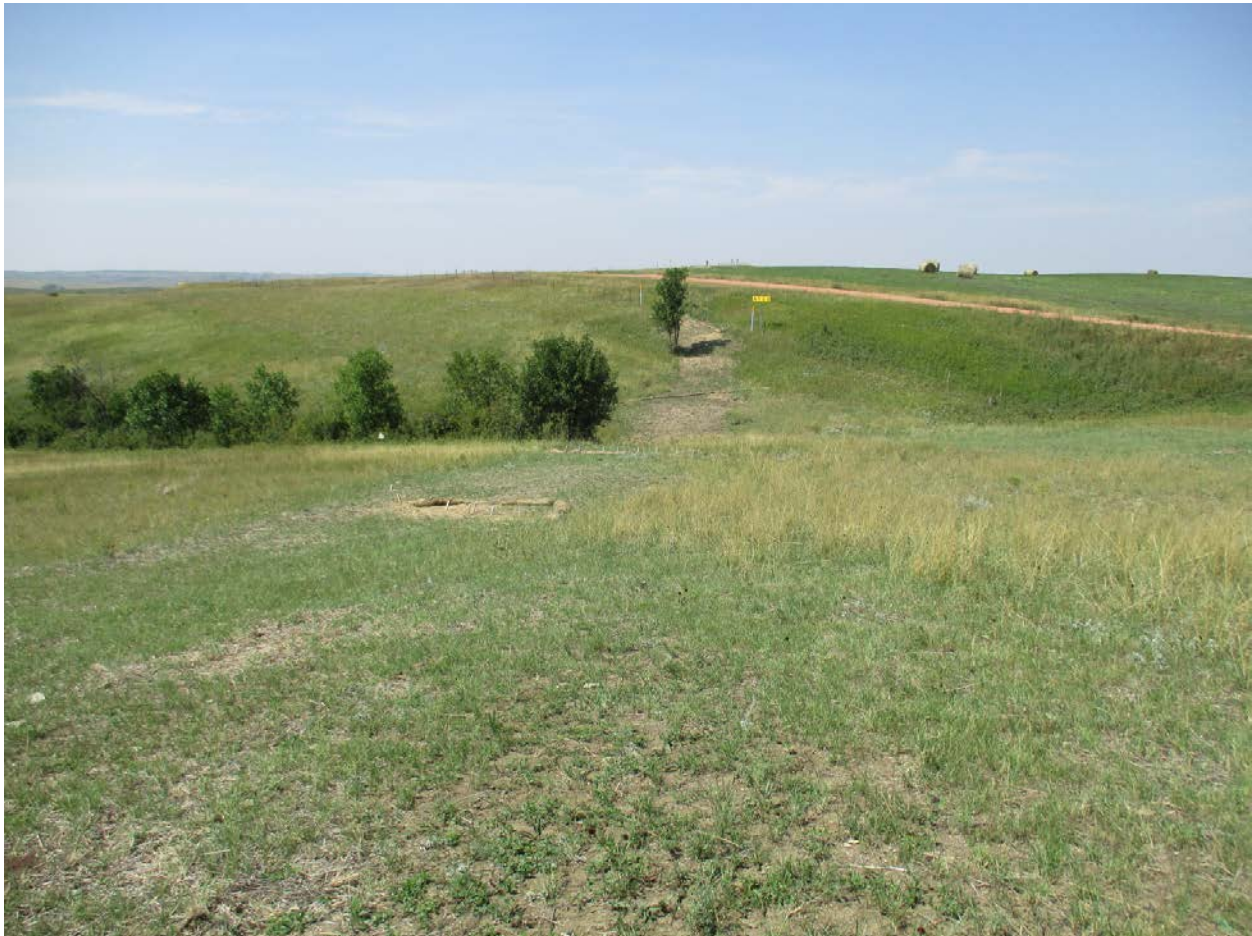
Photo 10. (Point 545) Facing: Northwest. View of an upland drainage crossing. This particular drainage had several spots of bare ground, but overall the planted grasses were coming in, erosion control was in place, and drainage flows had been reestablished.

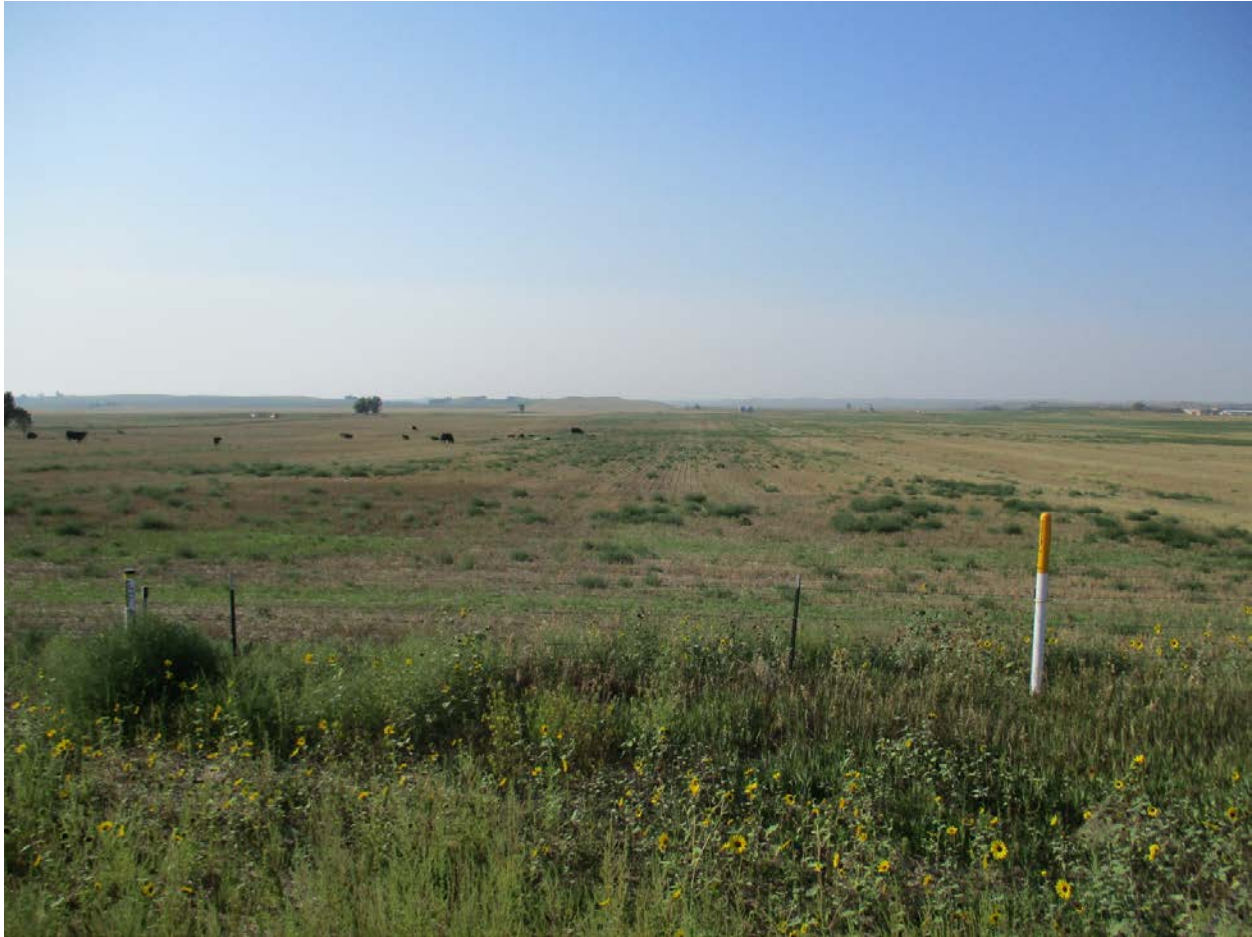
Photo 11. (Point 532) Facing: South. Project ROW through a harvested wheat field, somewhat discernable by the scattered small patches of annual weeds. Pipeline markers were present at road crossing.

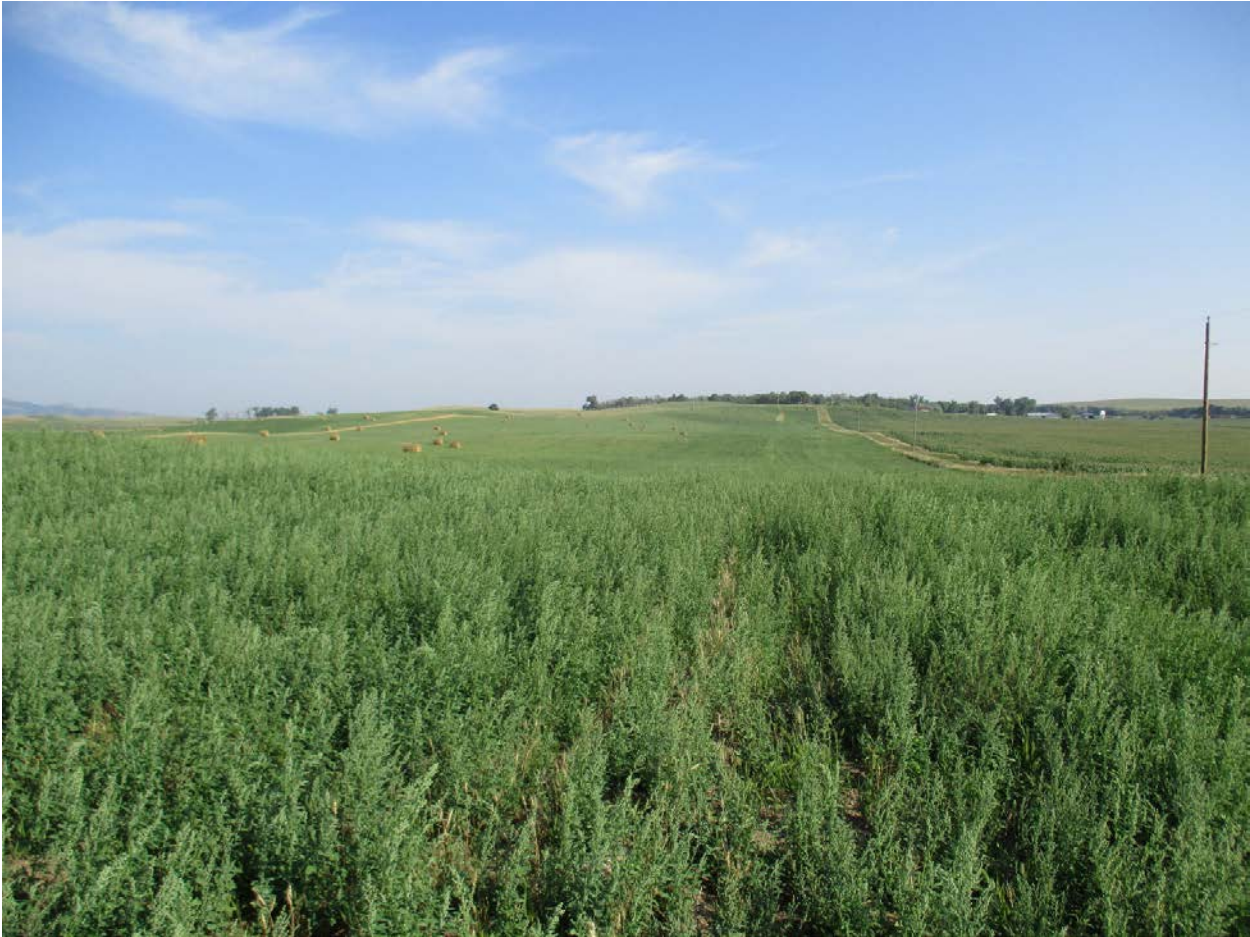
Photo 12. (Point 533). Facing: North. View of the Project ROW on the edge of a wheat field that had been baled for hay because of the drought conditions. Bales are visible on the left of the photo; the wheat had not been baled within the ROW, presumably because of the high annual weed cover.

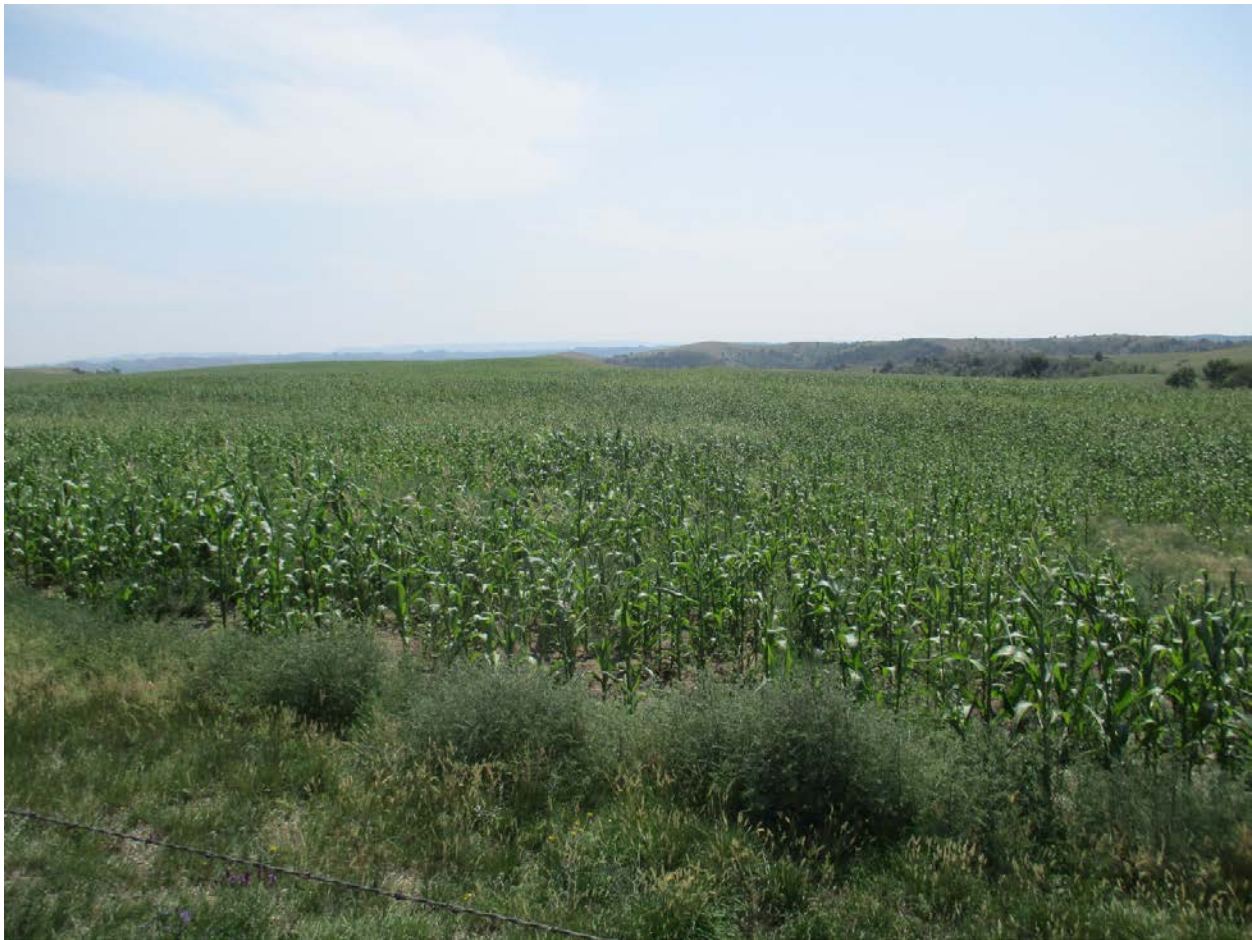
Photo 13. (Point 542) Facing: South. View of the Project ROW through a corn field toward the southeast. No difference was observed between the Project ROW and other cropped areas. Pipeline markers were present (not shown).

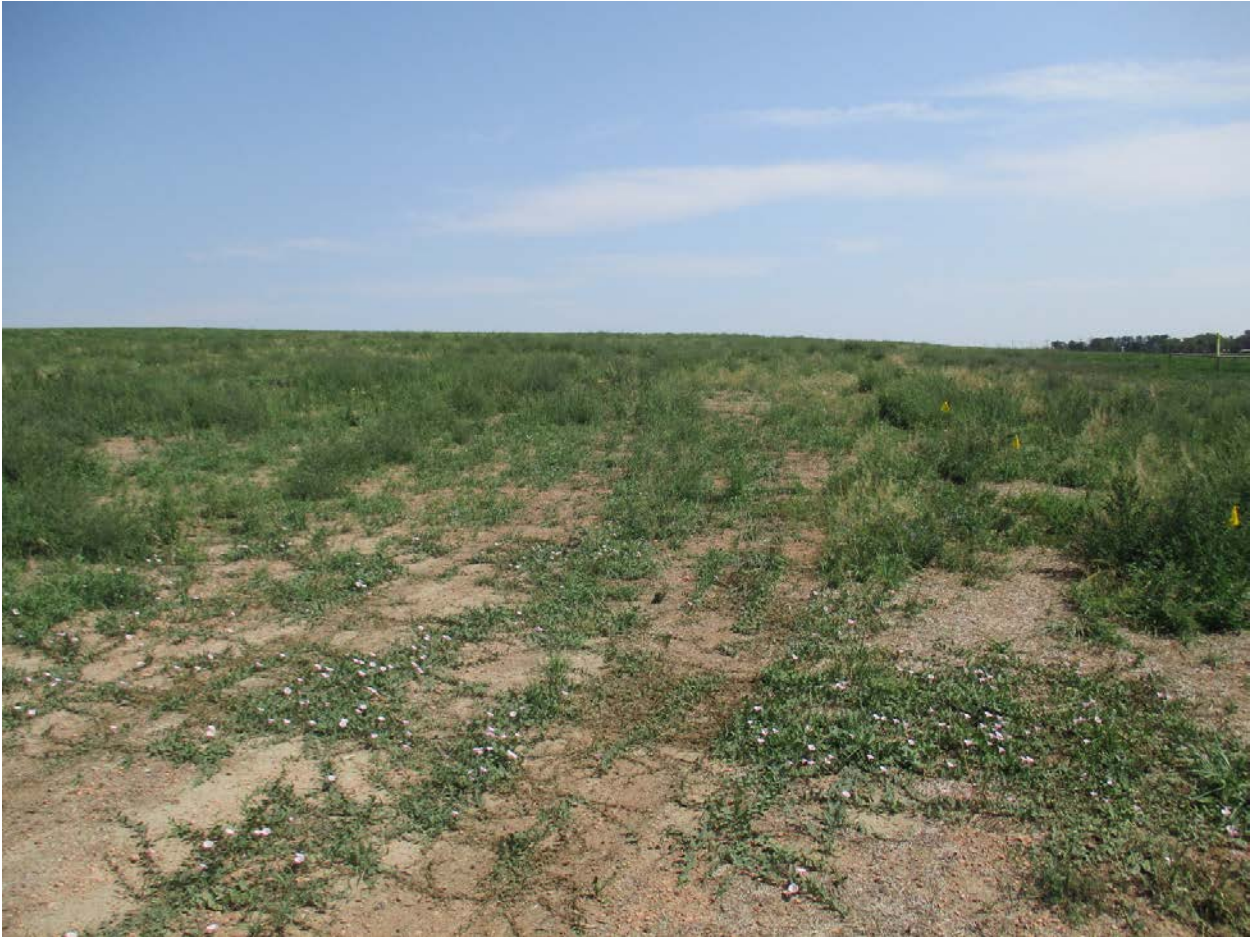
Photo 14. (Point 543) Facing: East. View of the Project ROW through hayland. The dominant species were alfalfa, brome, slender wheatgrass, and the annual weeds lambsquarters, kochia, and field bindweed. Bare ground is present but the planted species should continue to establish.

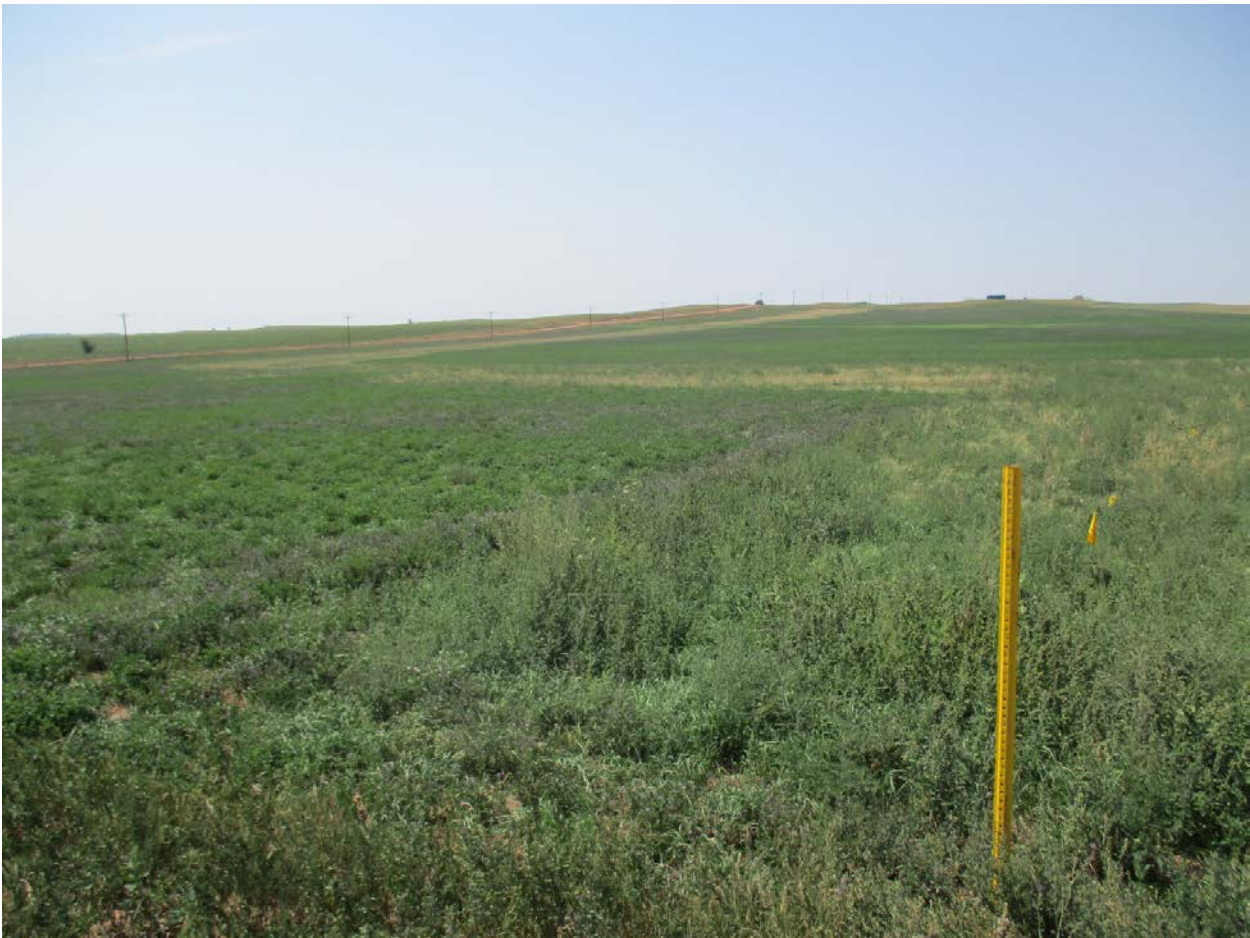
Photo 15. (Point 543) Facing: Southwest. Project ROW through hayland, visible as a lighter-colored zigzag from the right of the photo, through the middle (south), then parallel to the scoria-surfaced road on the left of the photo. The ROW had planted species, as well as higher cover of annual weeds compared to the adjacent hayland, which was primarily alfalfa. Pipeline markers were present.

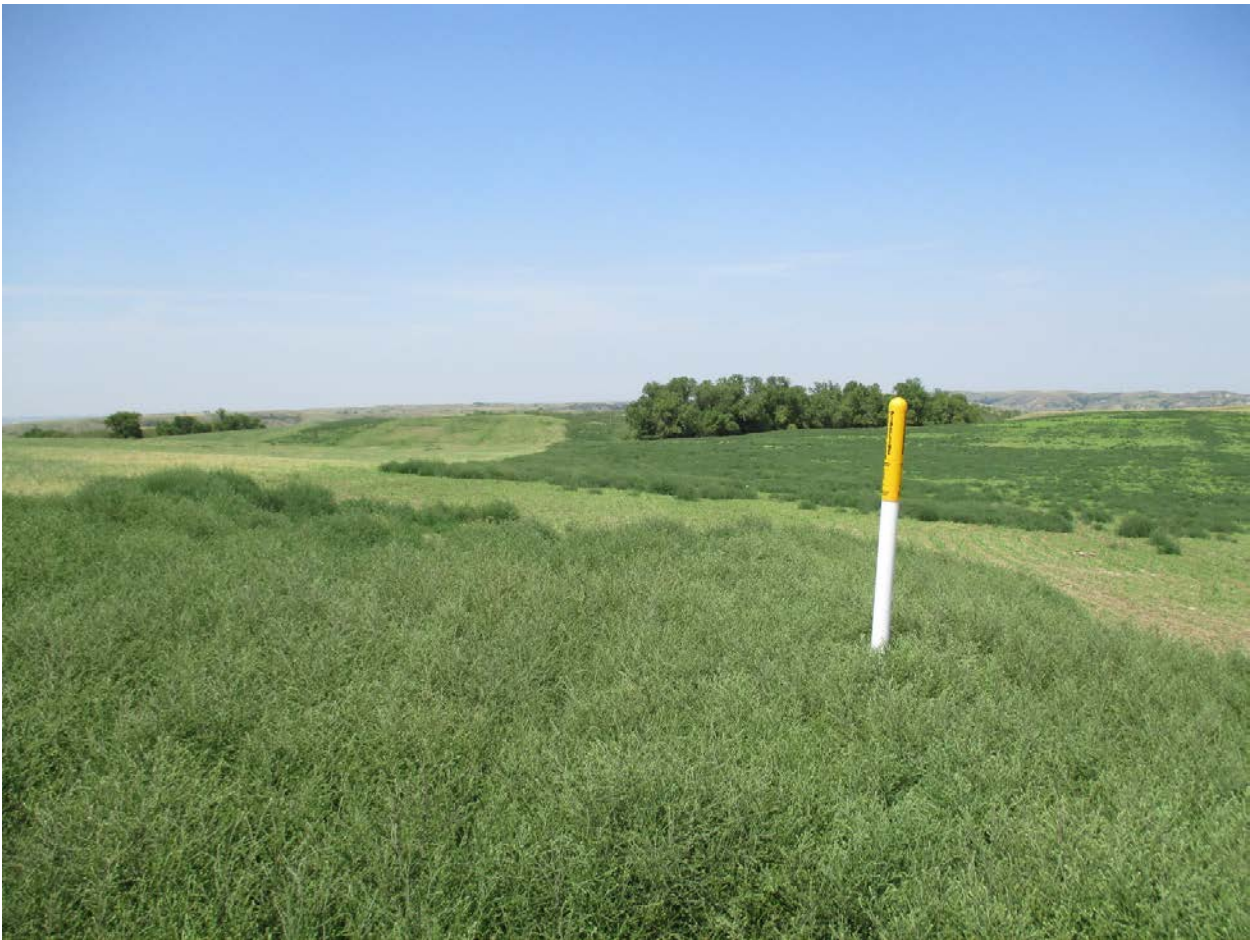
Photo 16. (Point 544) Facing: North. A field of some crop had been planted recently over the ROW; the seedlings were young, possibly winter wheat. Germination of the crop appeared to be consistent in and out of the ROW. Annual weeds were present in dense patches both in the ROW and the adjacent field. Pipeline markers were present.

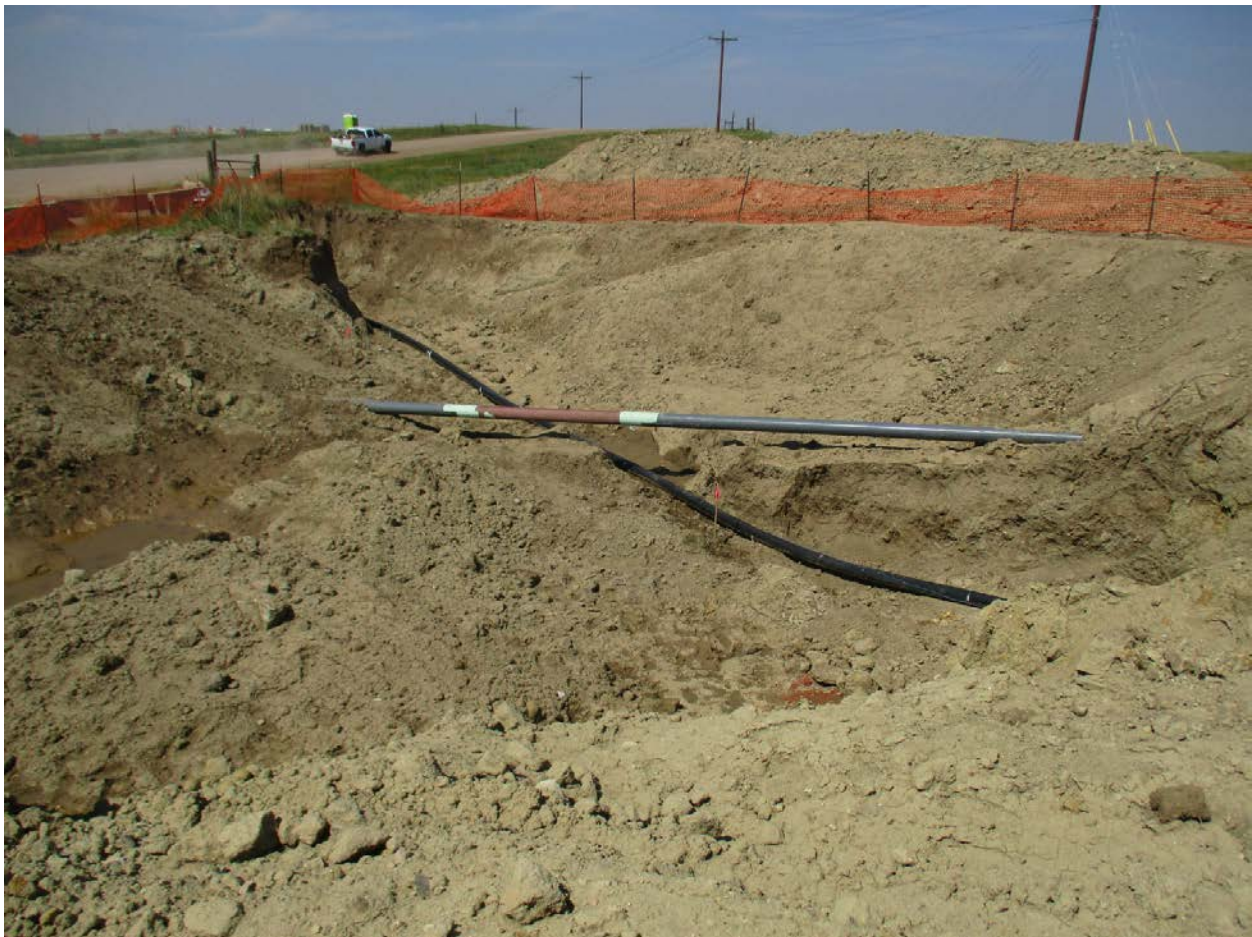
On the east side of County Road 34, east of U.S. Highway 85, a line strike occurred in the northwest portion of the Bear Creek NGL Pipeline in early August 2017. A contractor installing a rural water polyline was attempting to bore underneath the NGL line, when they struck the line. A large area was tested and contaminated soils were removed from around the strike (**Photo 17**). The dirtwork contractor hired by rural water to remove soils and complete installation of the water line after the strike did not appropriately segregate surface scoria, topsoil, and subsoil (**Photos 18, 19**). ONEOK is in the process of getting the cleanup and repair completed. Reclamation of this area will likely be impaired due to the mixed soils.

Photo 17. (Point 546) Facing: North. The area excavated to repair the recent line strike and remove contaminated soils. The Bear Creek NGL Line is the gray-colored steel line; the strike repair is the reddish brown portion bounded by white bands. The rural water line is the black polyline below the NGL line and at an angle in the photo.
