Technical Memo

To: Patrick Fahn, North Dakota Public Service Commission
From: Sara Simmers, Wenck Associates, Inc.
Date: September 5, 2017
Subject: PU-15-801 ONEOK 8-in Bakken Pipeline - Revegetation Inspection Report

**ONEOK Bakken Pipeline, LLC – 8-inch Natural Gas Liquids Pipeline
also known as the “Bear Creek Pipeline” – PSC Case No. PU-15-801 –
Revegetation Inspection Report**
Site Visit: August 17, 2017

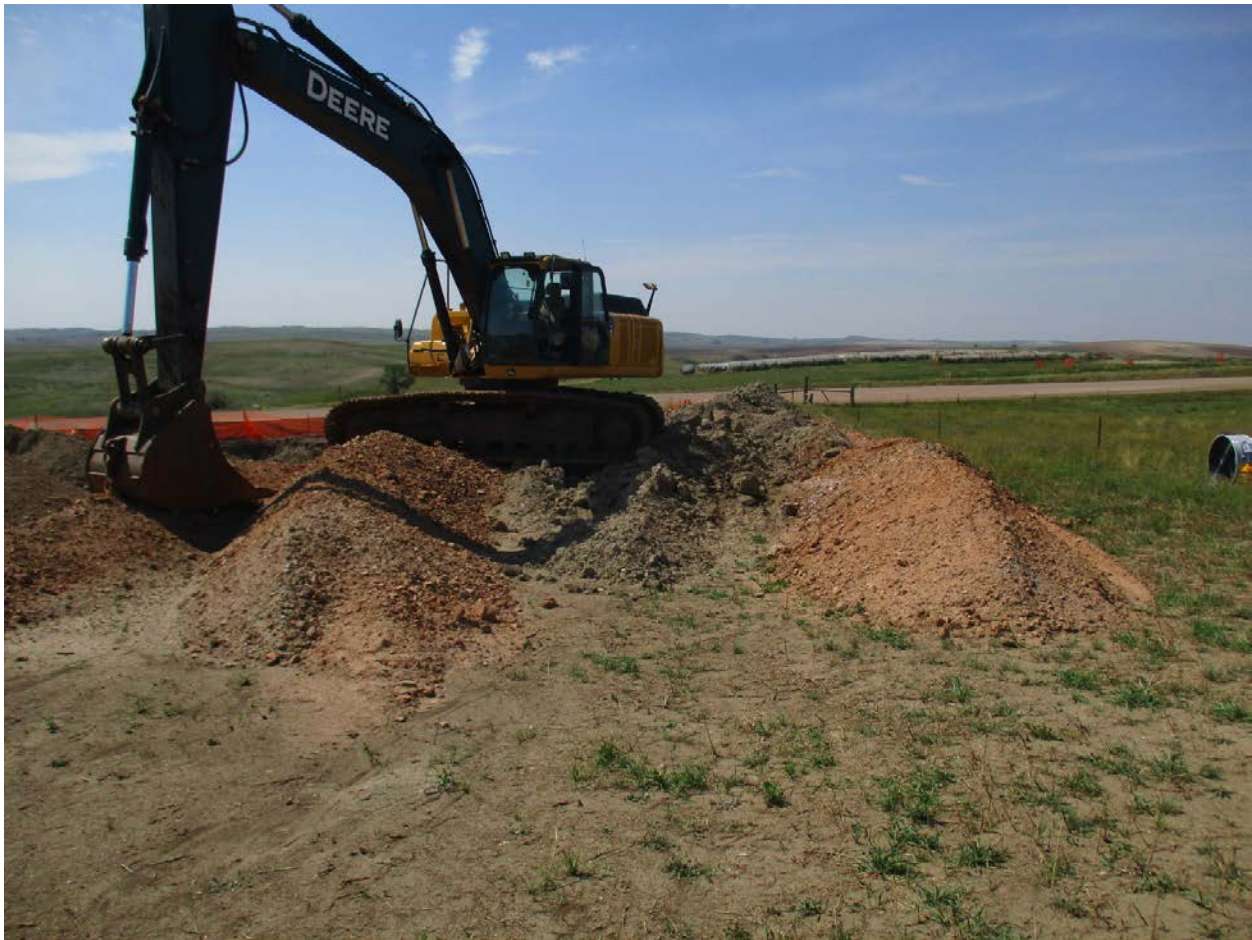
Photo 18. (Point 546) Facing: West. View of the equipment and spoil piles at the line strike site. The photo shows mixing of scoria piles with subsoils. This work was completed by a contractor for rural water, not ONEOK. No topsoil piles were visible in the area.

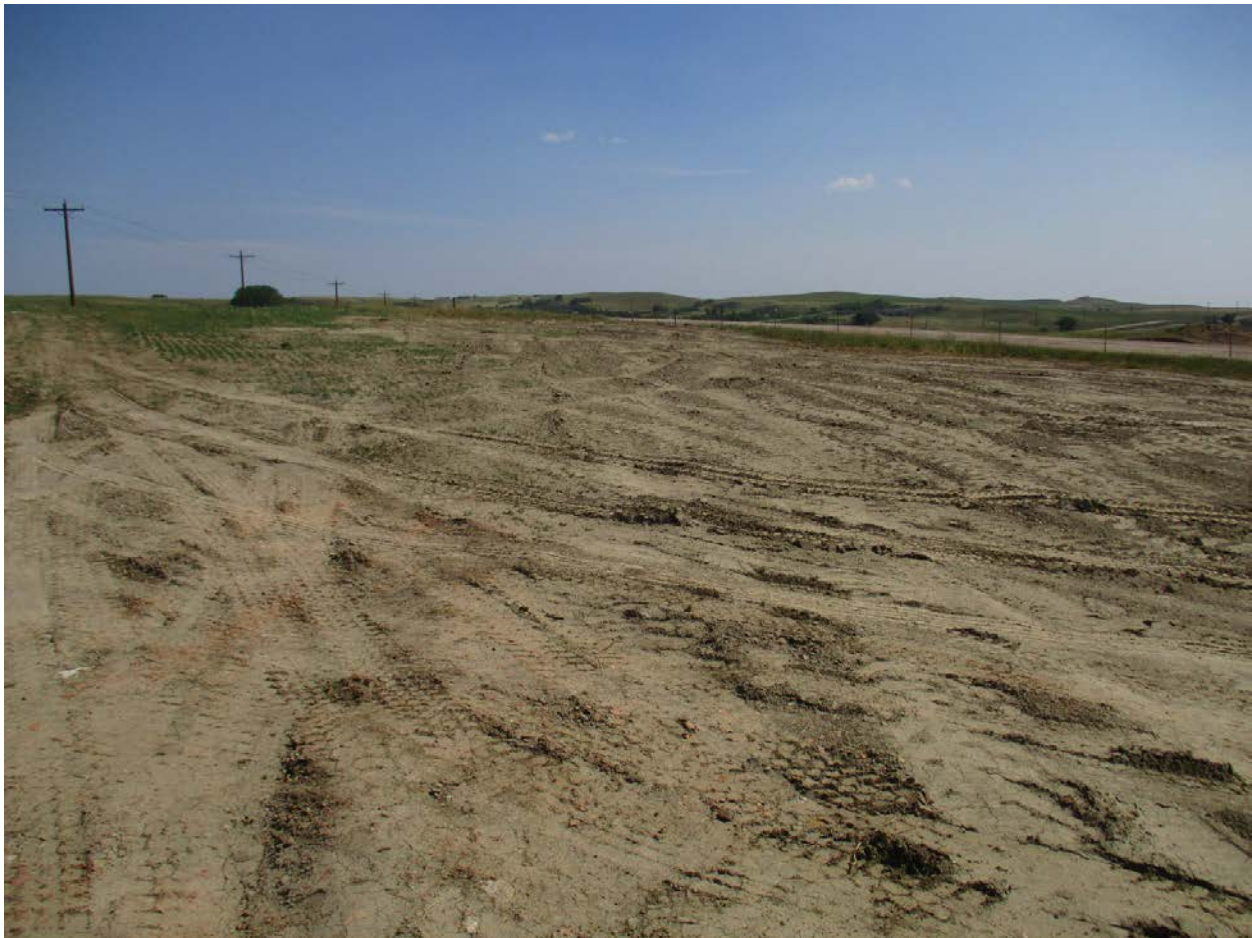
Photo 19. (Point 546) Facing: East. The area east of the line strike that had recent dirt work by the rural water contractor. The soil spread around appeared to be subsoil based on the color; scoria appeared to be mixed in. Repair and reclamation of the area was not complete at the time of the inspection, but the ability of vegetation to reestablish in the area will likely be hindered by how the soils were handled.
