**Site/Project Location:** Brady Wind II

**Date of Inspection:** 16 August 2016

92 PU-16-42 Filed 09/02/2016 Pages: 3  
Site inspection trip report - Topsoil Inspection Report August 16, 2016  
Keitu Engineers & Consultants, Inc.

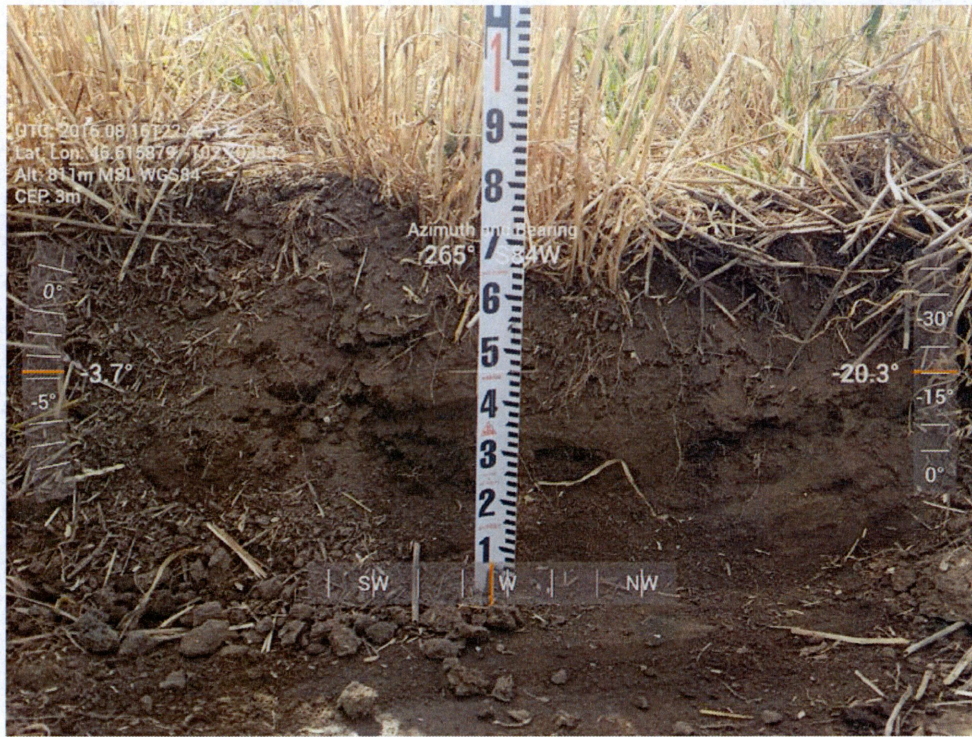
Grader cleared a road going north from the gravel road 55<sup>th</sup> St SW. Grader operator was informed topsoil depth was 7 inches deep on the low areas and less than 5 inches deep on the tops of hills. Grader operator said he would watch the topsoil depths and he had noticed at other areas the topsoil depth seemed to be the same depth as where the root growth stopped. Grader was informed to continue to remove topsoil to the depth of topsoil or to 12 inches. The area being cleared was a harvested wheat field. Two windmills are to be constructed on this access road. Operator informed inspector that they will be constructing a 16 foot wide permanent road and putting the scraped topsoil up to the edge for reclamation. Grader understood the rules and regulations and was operating and clearing topsoil correctly.

**Report Photo #1 "Subsoil Reached at 7 Inches"**

Topsoil segregation was noted to be acceptable at this time in the areas observed. Equipment operator was reminded to strip soil, where it existed, down to a maximum of 12 inches.

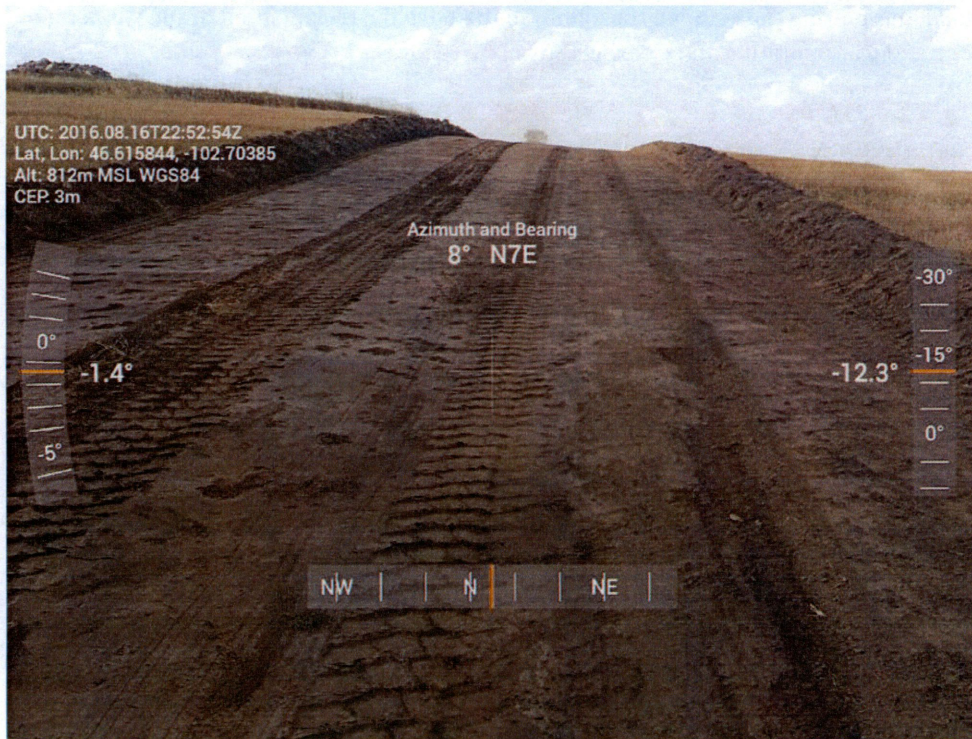
**Report Photo #2 "Topsoil Being Piled To Edges Of Future Access Road"**

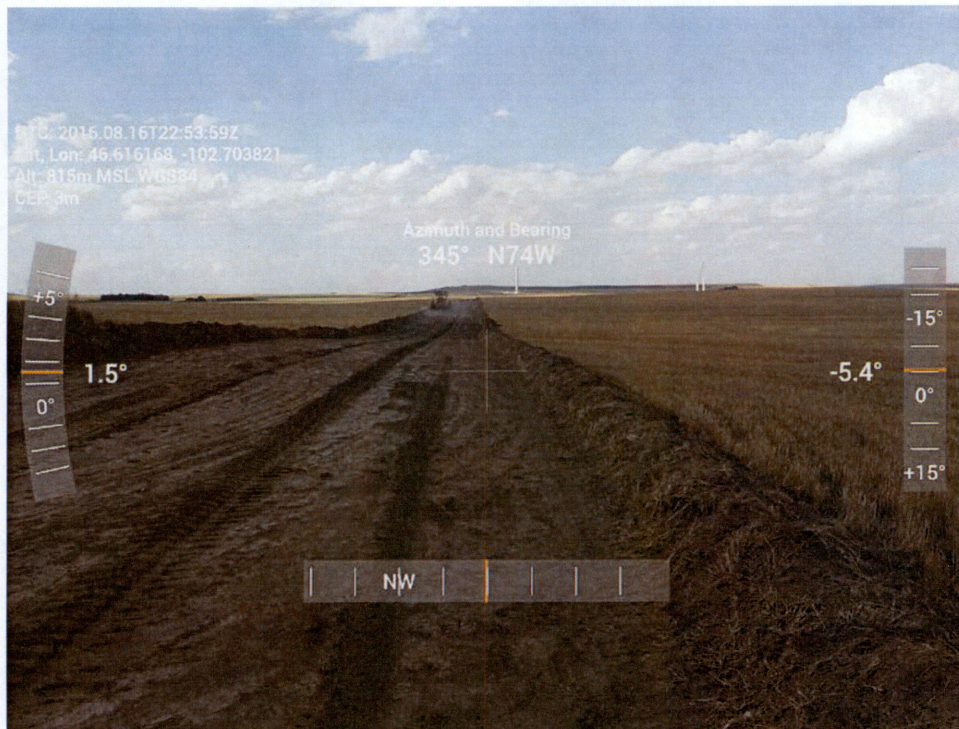
The Brady Wind II project kicked off its construction at the time of the visit. Grader operator started construction access road to windmills 52 and 53. Crew is planning on working on the access roads and windmills along 55<sup>th</sup> St SW first and then moving to 57<sup>th</sup> St SW.

**Report Photo #3 "Access Road To Windmill 52 and 53"**
