Site/Project Location: Brady Wind II Wind Energy– Stark County **Date of Inspection:** 26 September 2016

Keitu staff visited the Brady Wind II Energy project for a construction inspection. Inspection of construction sites to focused on (1) confirming surface disturbance/work occurring within ND PSC-approved work corridor and/or route; (2) topsoil segregation occurring; and (3) vegetation removal consistent with tree & scrub mitigation plan.

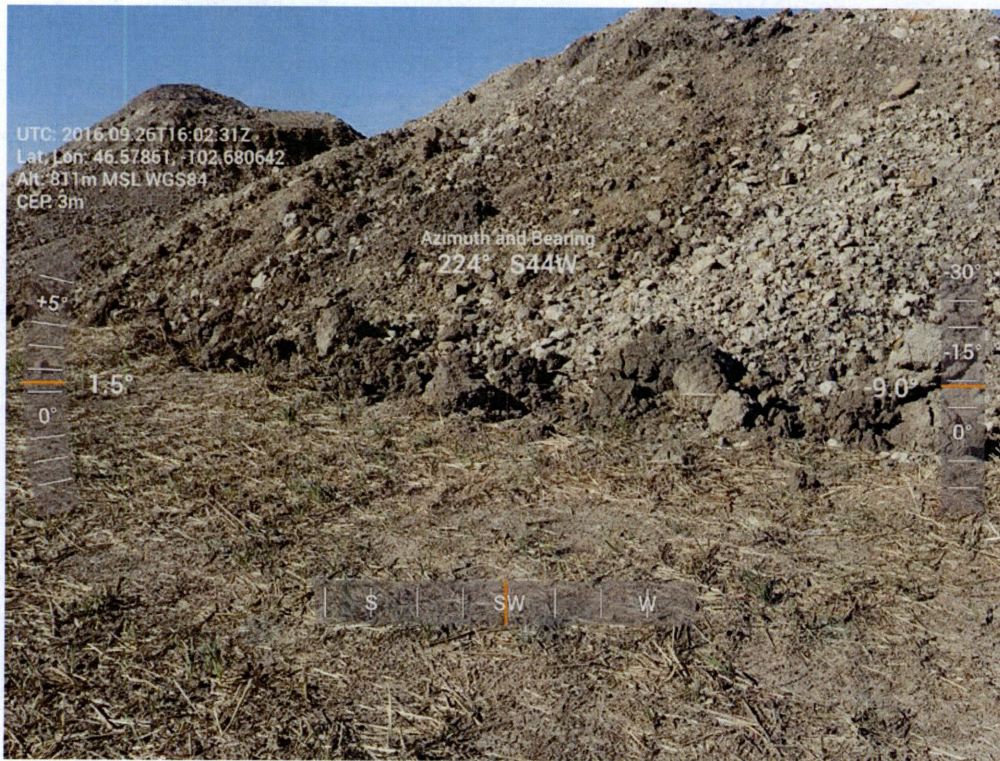
Silt fence damages on site 57, Kyle McNab stated this issue will be fixed by the end of the day (9/26/16). Subsoil piled on topsoil at site 68, no evidence of topsoil removal before footing was dug.

Report Photo #1 "Site 68 Subsoil Pile On Topsoil"

At site 68, topsoil must be cleared to the appropriate depth where subsoil is met. Topsoil should then be piled where it will not come in contact with subsoil. Subsoil pile should then be transferred to be stored on top of subsoil. Crew should be careful not to remove topsoil under subsoil pile, only to take the subsoil when the transfer is made. After transfer is made crew should remove topsoil where pile was and continue construction of turbine.

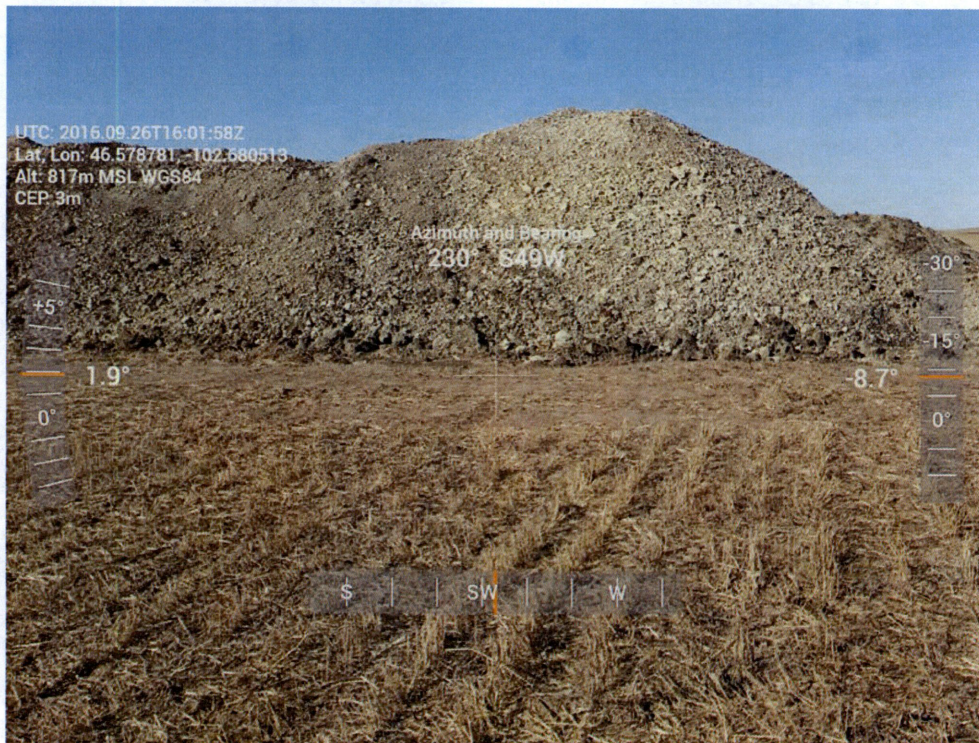
Report Photo #2 "Site 68 Subsoil Pile On Topsoil"

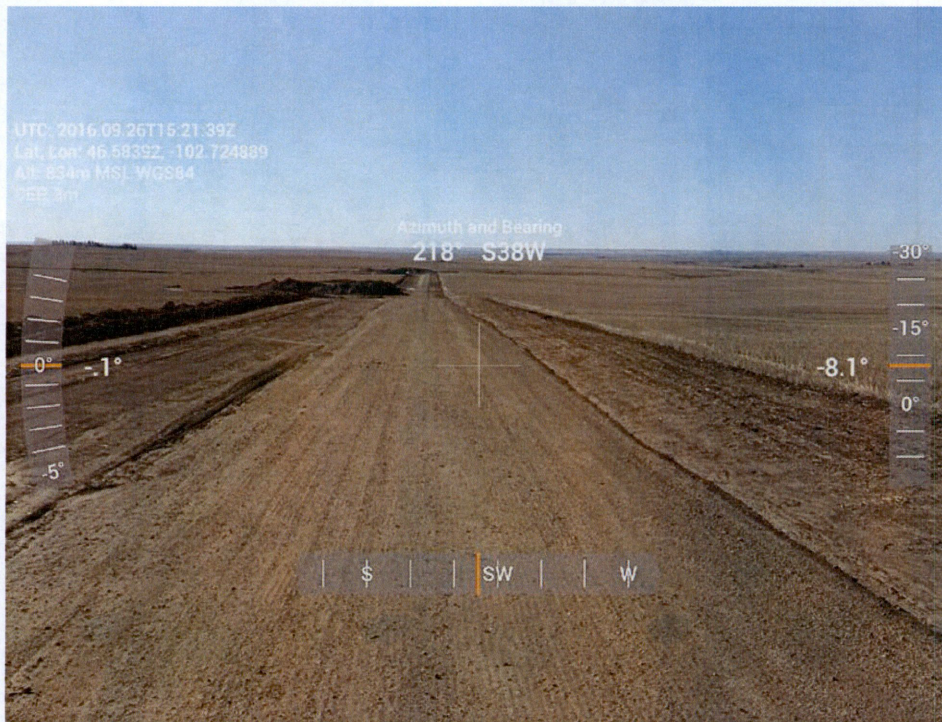
Report Photo #3 "Cement Treated String Road To Sites 57-63"
