Executive Summary:

Keitu staff visited the Brady Wind II Energy project for a construction inspection. Inspection of construction sites to focused on (1) confirming surface disturbance/work occurring within ND PSC approved work corridor and/or route; (2) topsoil segregation occurring; and (3) vegetation removal consistent with Tree and Shrub Mitigation Specifications.

Site/Project Location: Brady Wind II Wind Energy - Stark County **Date of Inspection:** 22 November 2016

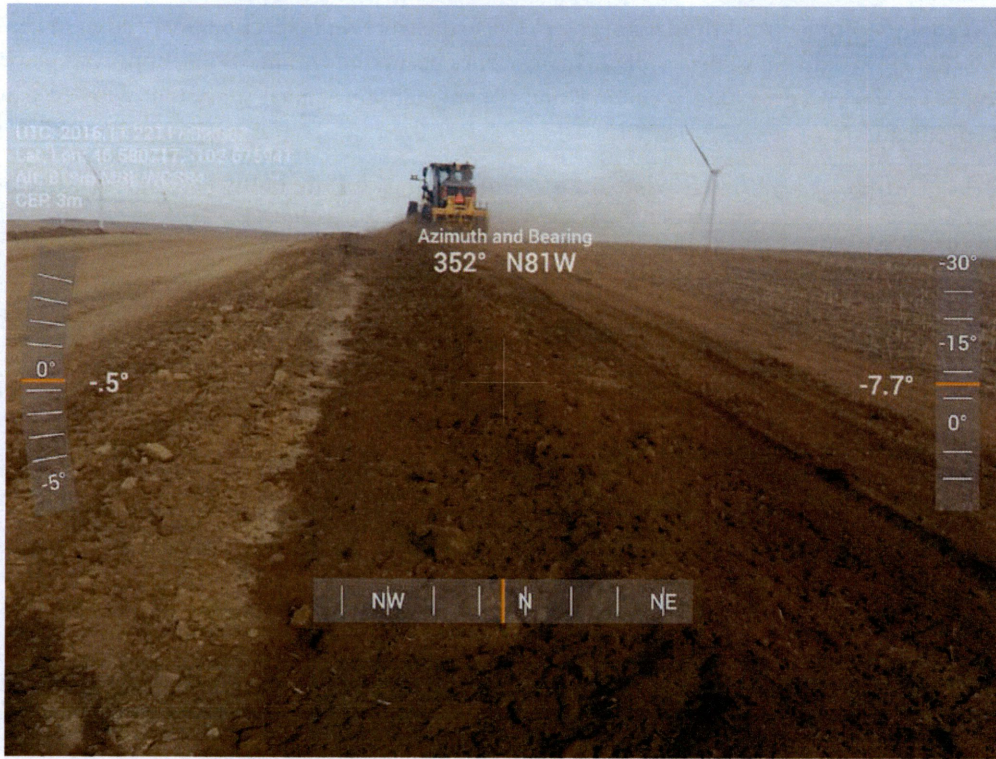
All pads have been cleared and have, at a minimum, the towers constructed on the site. Crews finished topsoil removal for string roads and pads, although minimal topsoil will be cleared for wire splicing work. Blade operators have been working to pull topsoil back to cement treated string roads and completed turbine pads. No deficiencies were noted in these activities. (See report photo #1) On the string road south of turbine 69, operators reshaped the hillside to create a flat string road for safe travel of equipment. Crews constructed low water crossings in areas where the string road crosses a natural drainage pathway. Crews used crushed rock under the string road to allow water to travel freely under the road. (See report photo #3)

Report Photo #1 "Pulling Topsoil Back To String Road"

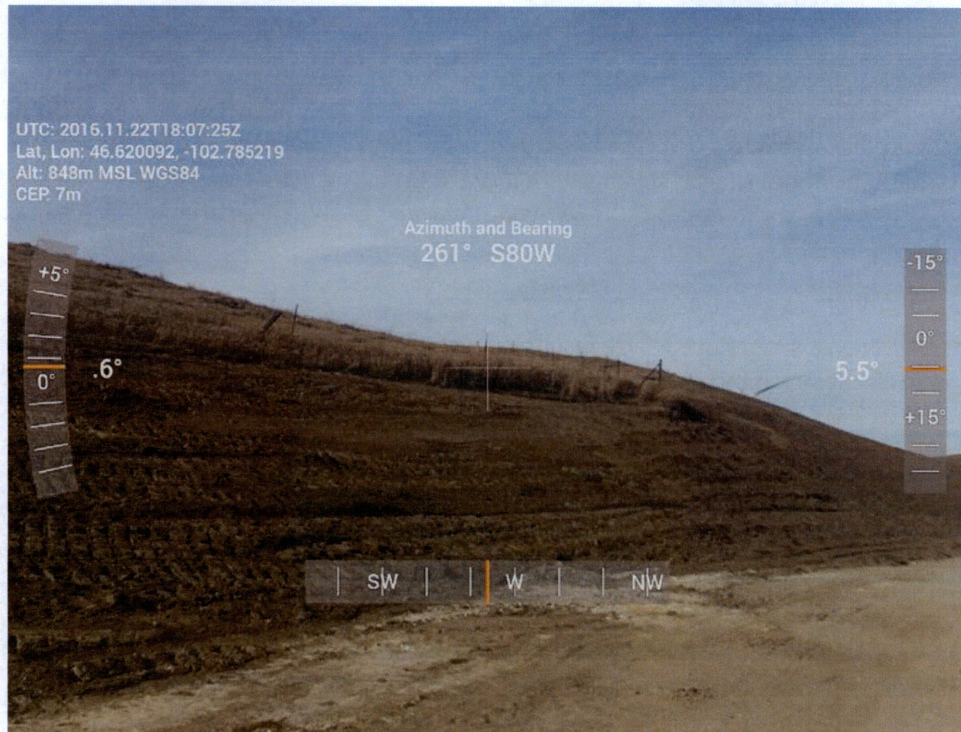
Turbine 24 was built on a steep slope where reshaping was needed. BMPs were not implemented on the open hillsides. Crews were informed to add erosion control BMPs (see report photo #2). Subsoil piled on topsoil from bore location. (See report photo #4) Subsoil piled on topsoil at splices. Missing or damaged orange fencing at open trenches from splicing. (See report photo #5).

Report Photo #2 "Turbine 24 Future BMP"

At splicing locations crew will be careful to pull only subsoil back into open trench and to ensure topsoil and subsoil mixing does not occur. Erosion control to be implemented on the hillside at turbine 24.

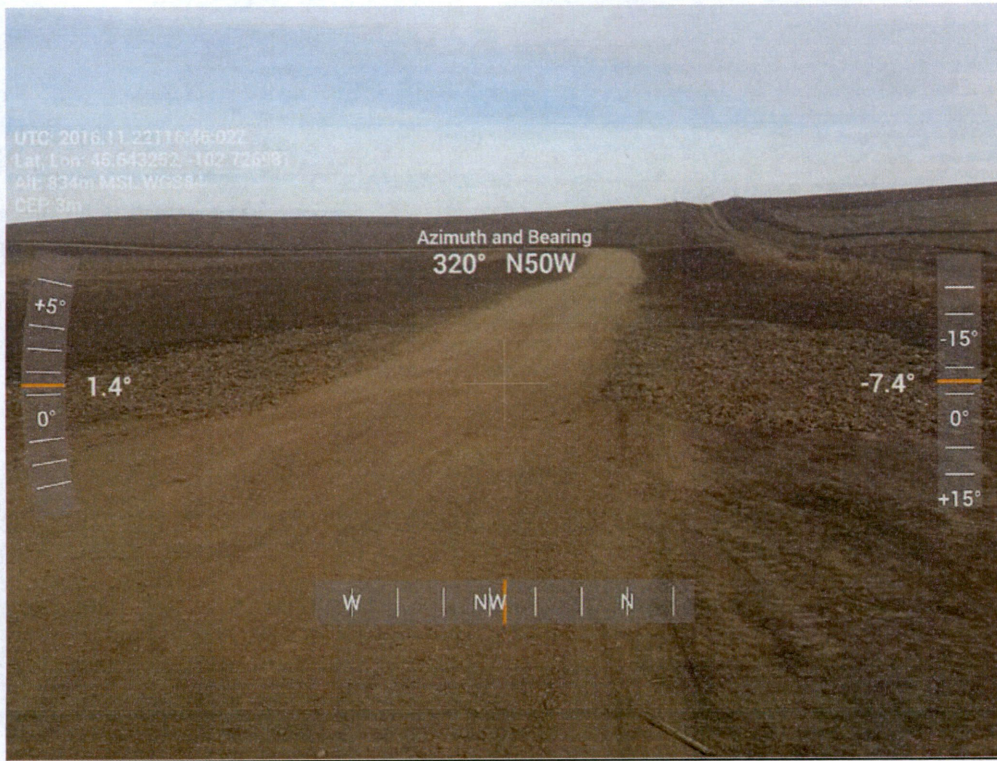
Report Photo #3 "Low Water Crossing"

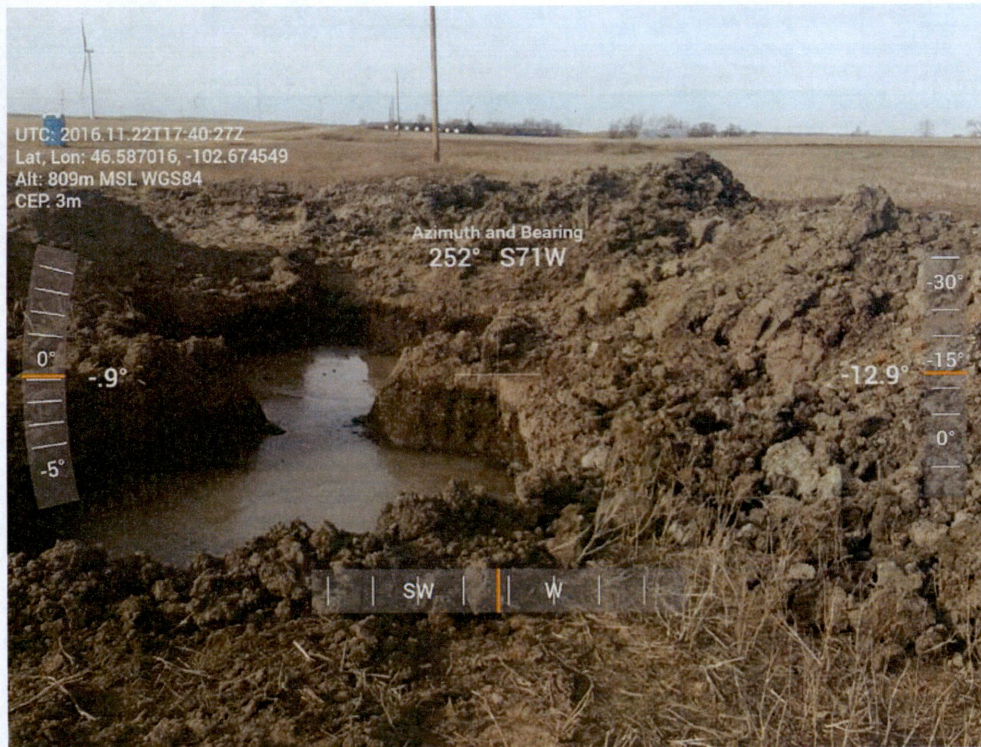
Report Photo #4 "Subsoil on Topsoil at Bore"

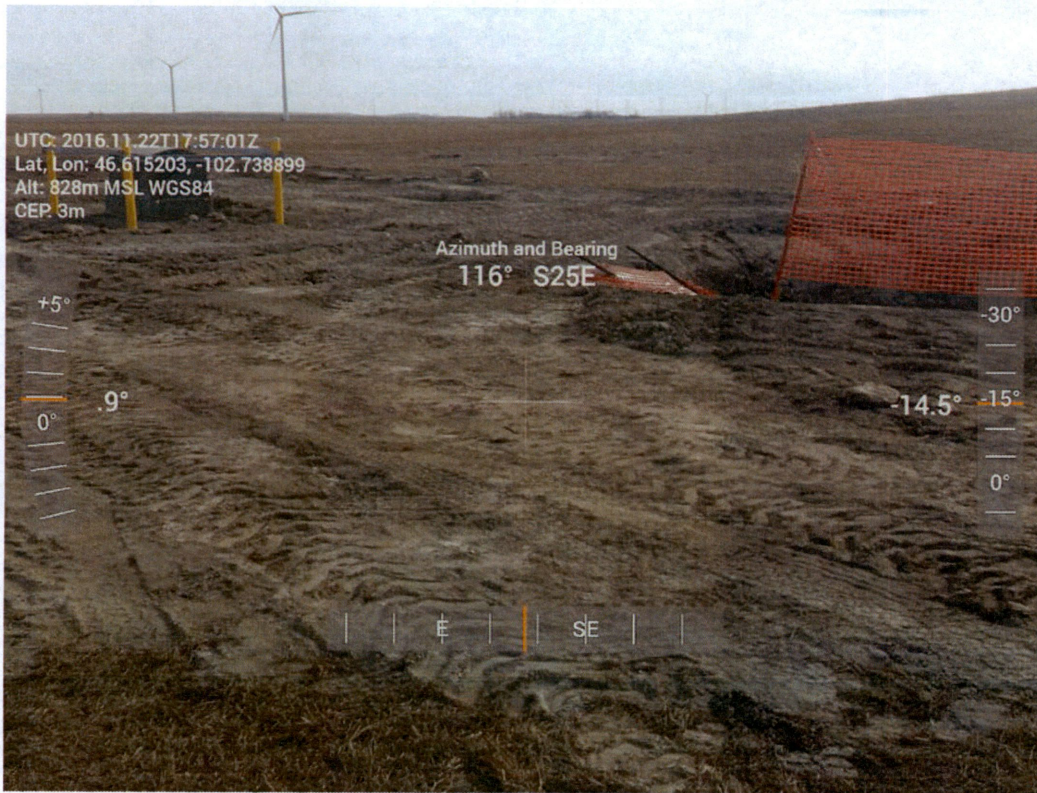
Electrical crews had been working on splicing wire into the gathering lines. Many of these open trenches had damaged fences or were not fenced off. Crews were informed to fix fences around open trenches and to construct fences where there were none.

Report Photo #5 "Subsoil on Topsoil, Fence Down at Splicing Trench"
