Reclamation and Revegetation

Inspection Report

Brady II Wind Energy Center
Stark and Hettinger Counties

ND PSC Case No. PU-16-42

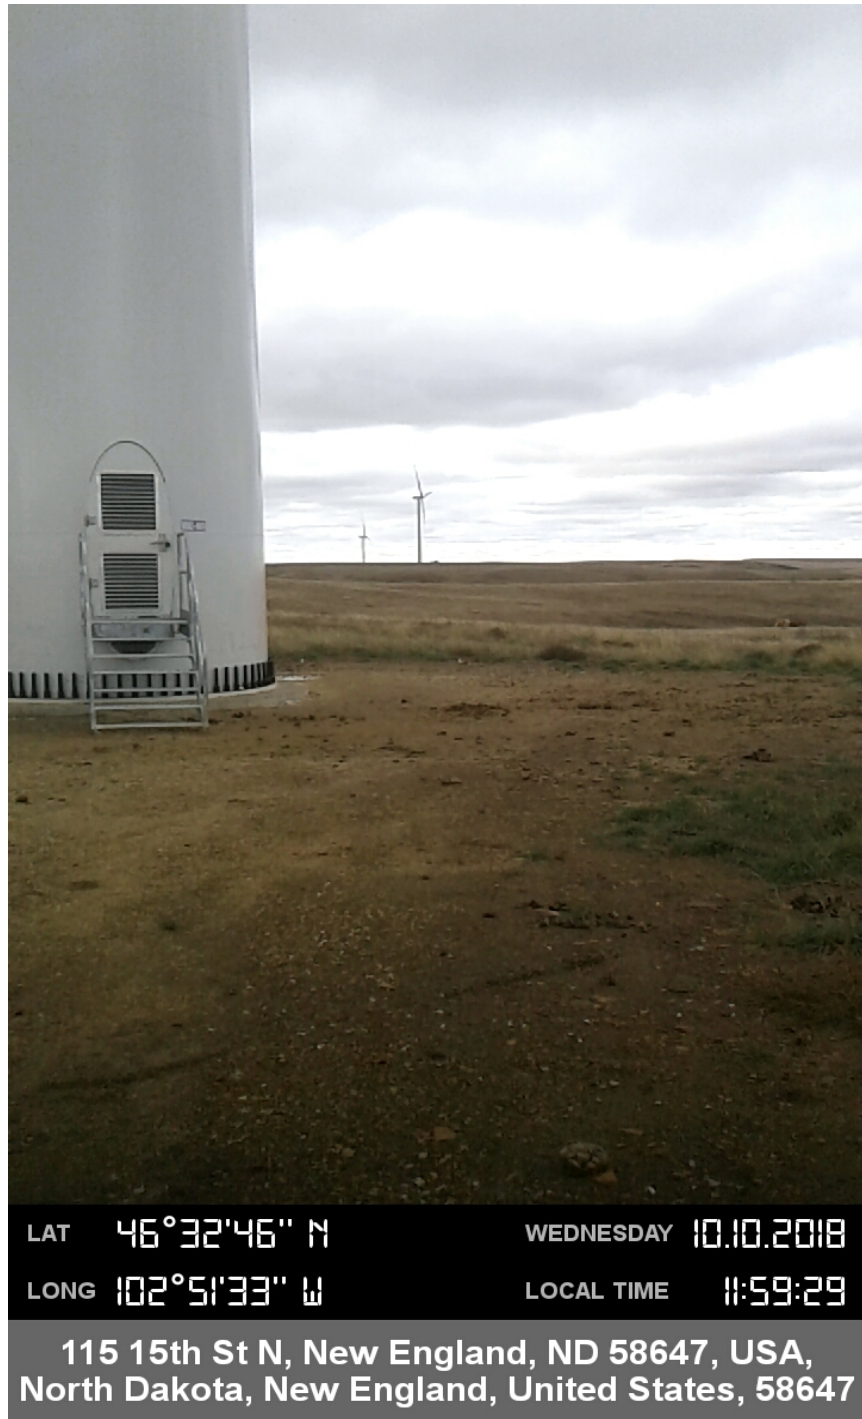
Report Photo #1: Overview of turbine construction block (T9) from East to West.

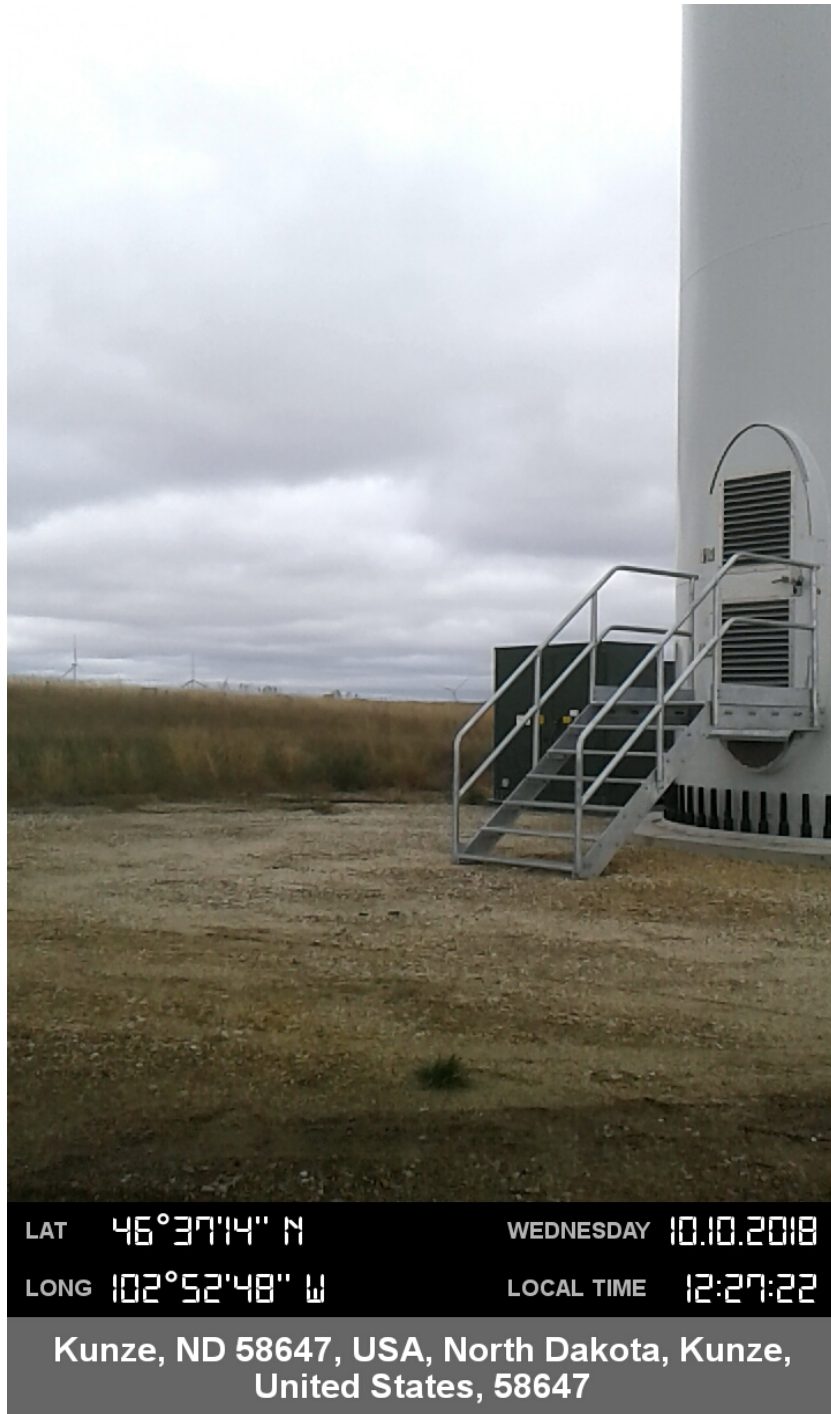
Report Photo #2: Overview of turbine construction block (T23) from South to North.

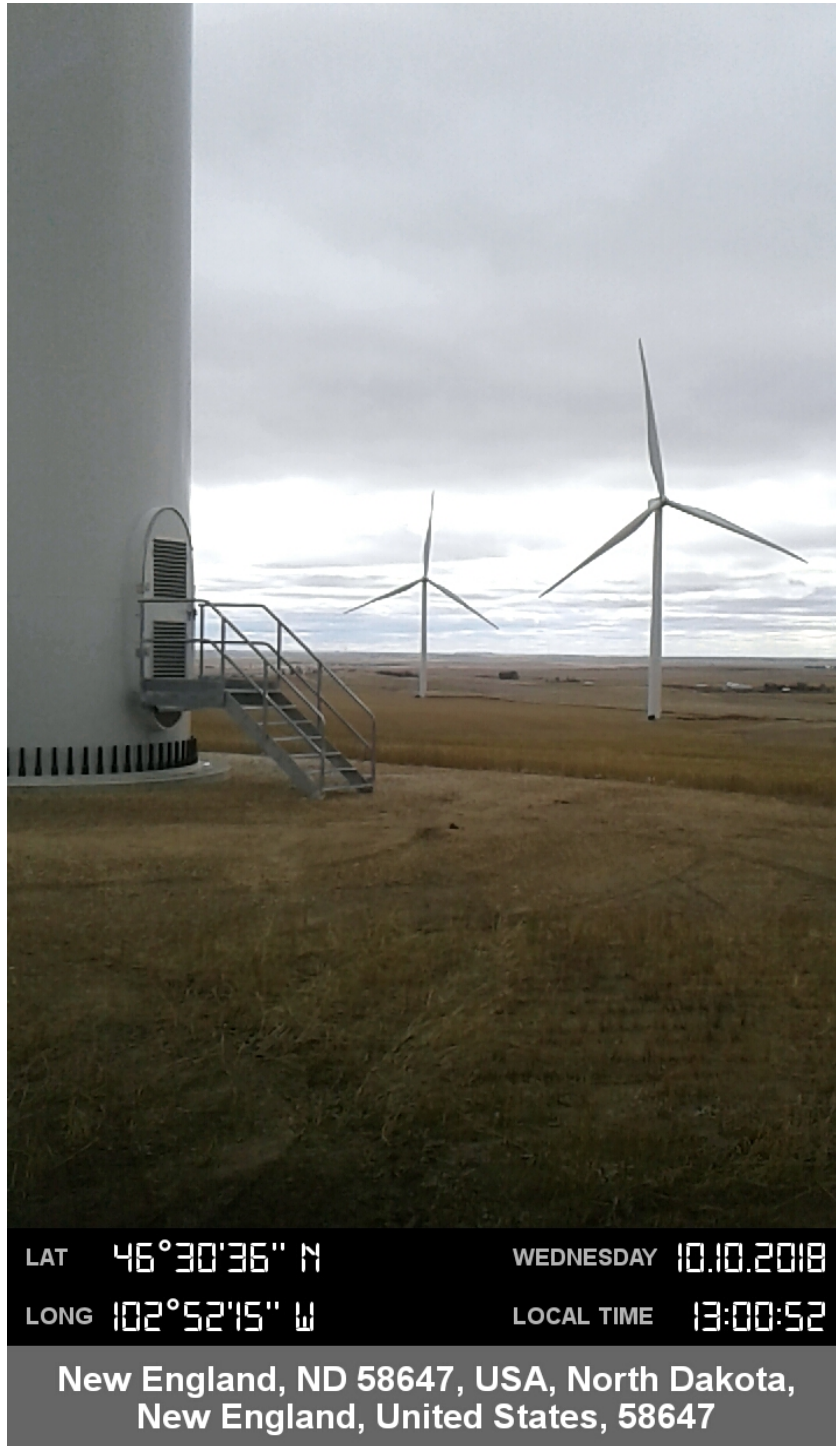
Report Photo #3: Overview of turbine construction block (T38) view to South Southwest.

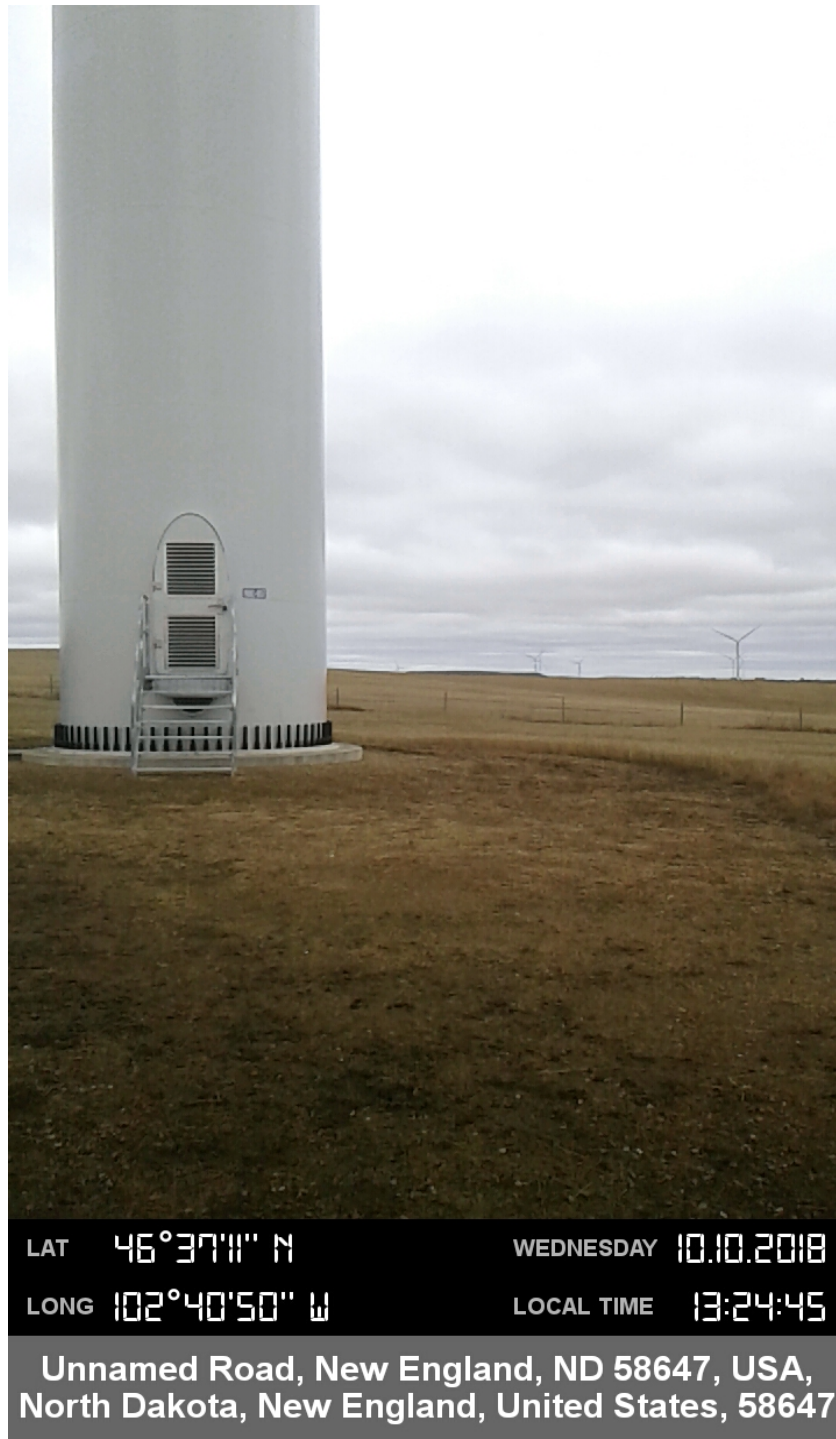
Report Photo #4: Overview of turbine construction block (T57) from South to North.

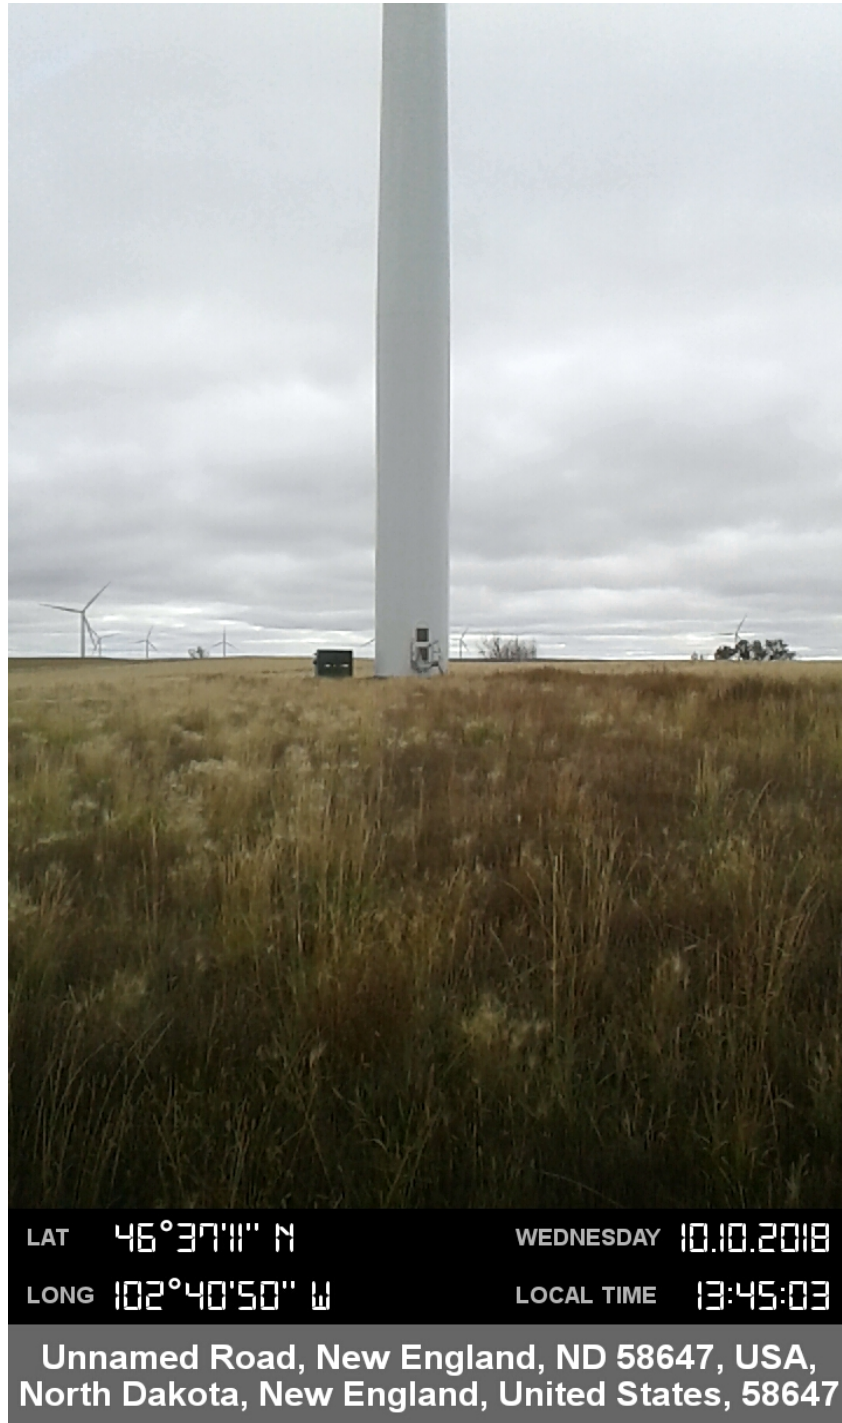
Report Photo #5: Overview of turbine construction block (T56) from North to South.

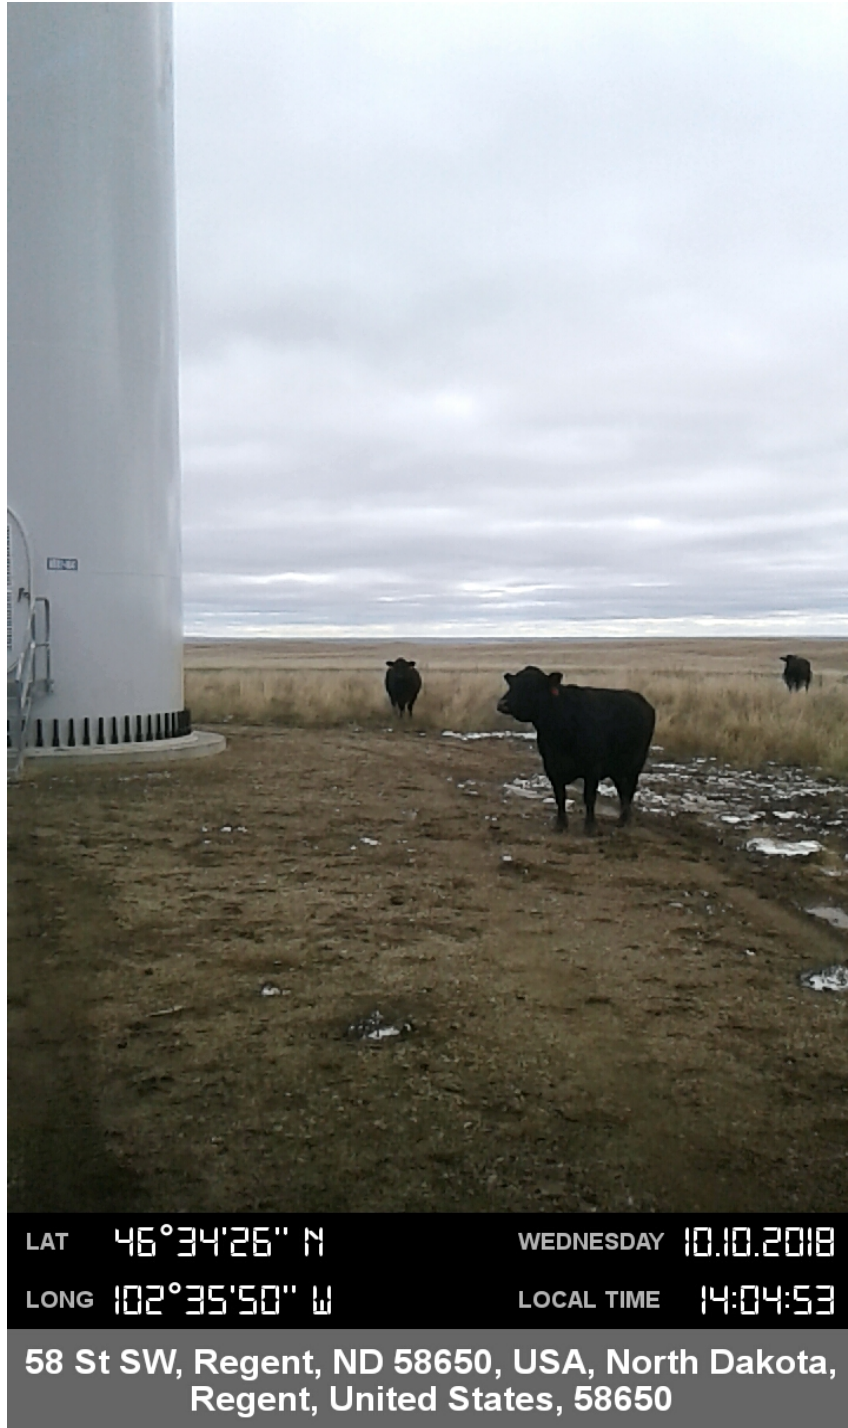
Report Photo #6: Overview of turbine construction block (T41) from North to South.
