Site/Project Location: Oliver Wind Laydown Yard **Date of Inspection:** 14 July 2016

Site/Project Location: Oliver Wind Substation Area **Date of Inspection:** 7 July 2016

Site/Project Location: Oliver III Wind Switchyard **Date of Inspection:** 14 July 2016

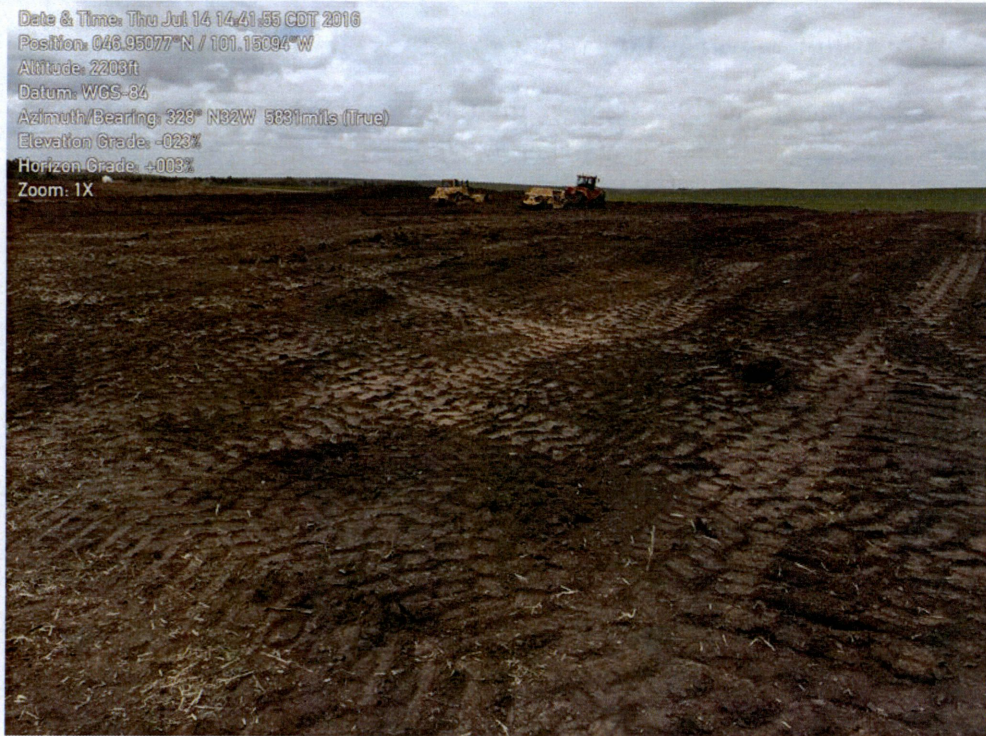
Topsoil from subsoil segregation appears adequate. 6-8 inches of topsoil had been removed in areas with some subsoil visible. Other areas topsoil is being removed to 12 inches where it is present. Site foreman was instructed to continue to remove topsoil to depth of subsoil or to 12-inches, whichever is greater, and these instructions have been followed. Stormwater / sediment control were not yet in place although no signs of runoff were noted.

Report Photo #1 "Topsoil removal at 6-8 inches, visible subsoil"

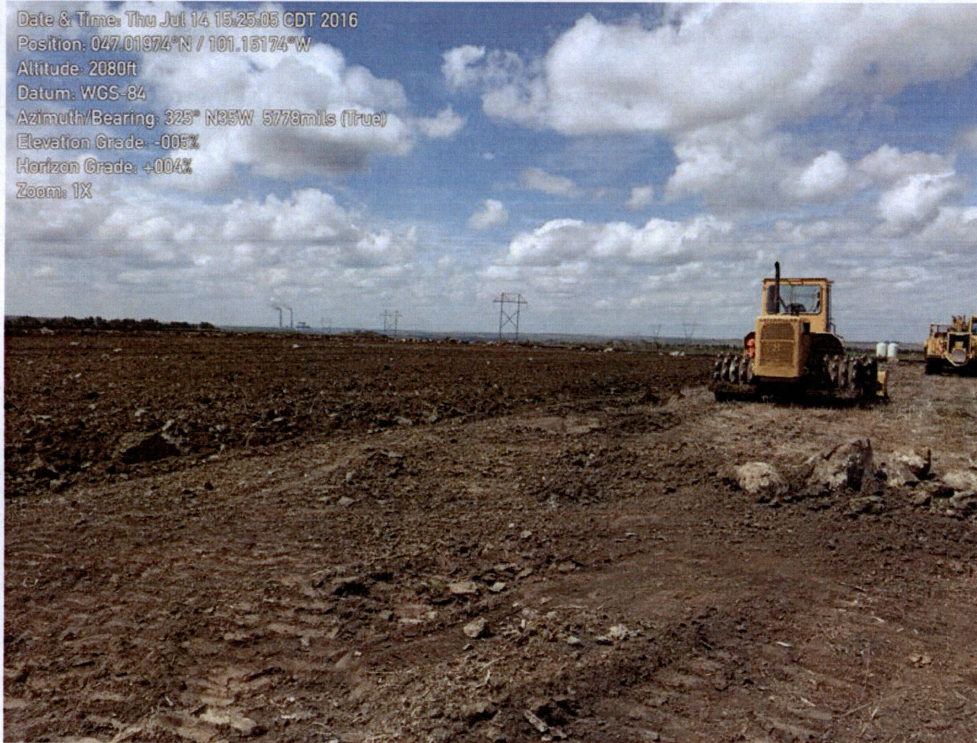
Topsoil from subsoil segregation appears adequate. 8-12 inches of topsoil had been removed. Stormwater / sediment control were not yet in place although no signs of runoff were noted.

Report Photo #1 "Topsoil removal at 8-12 inches, visible subsoil"

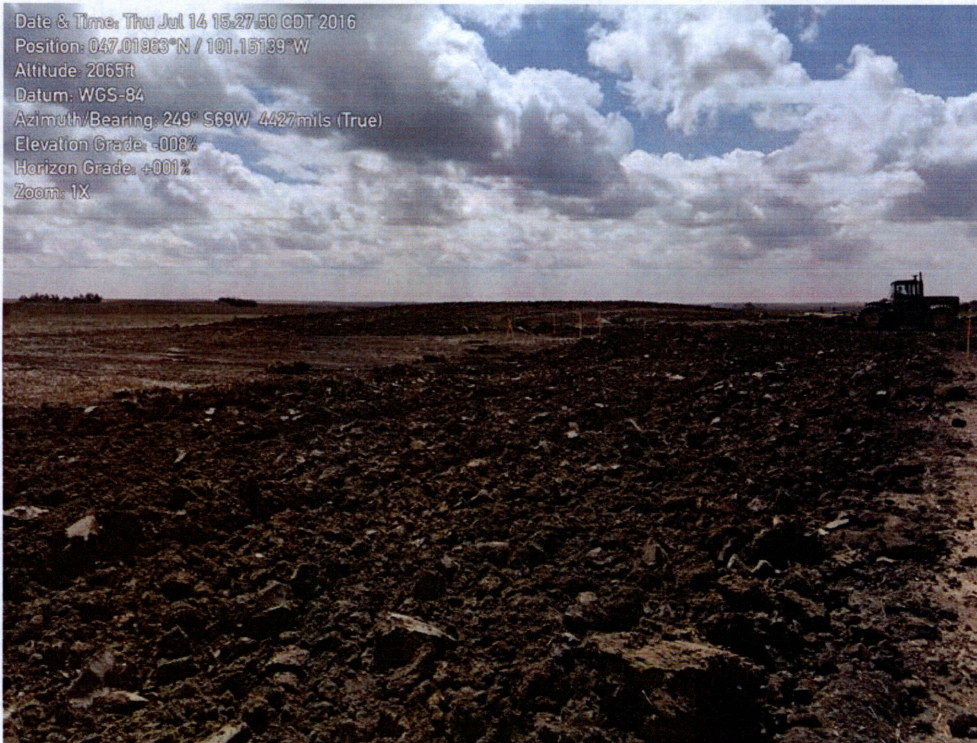
Report Photo #2 "Topsoil removal and stockpile"
