Site/Project Location: Oliver III Wind Transmission Line

Date of Inspection: 4 October 2016

120 PU-16-122 Filed 10/13/2016 Pages: 3
Site inspection trip report - Construction Inspection Report 4 October 2016
Keitu Engineers & Consultants, Inc.

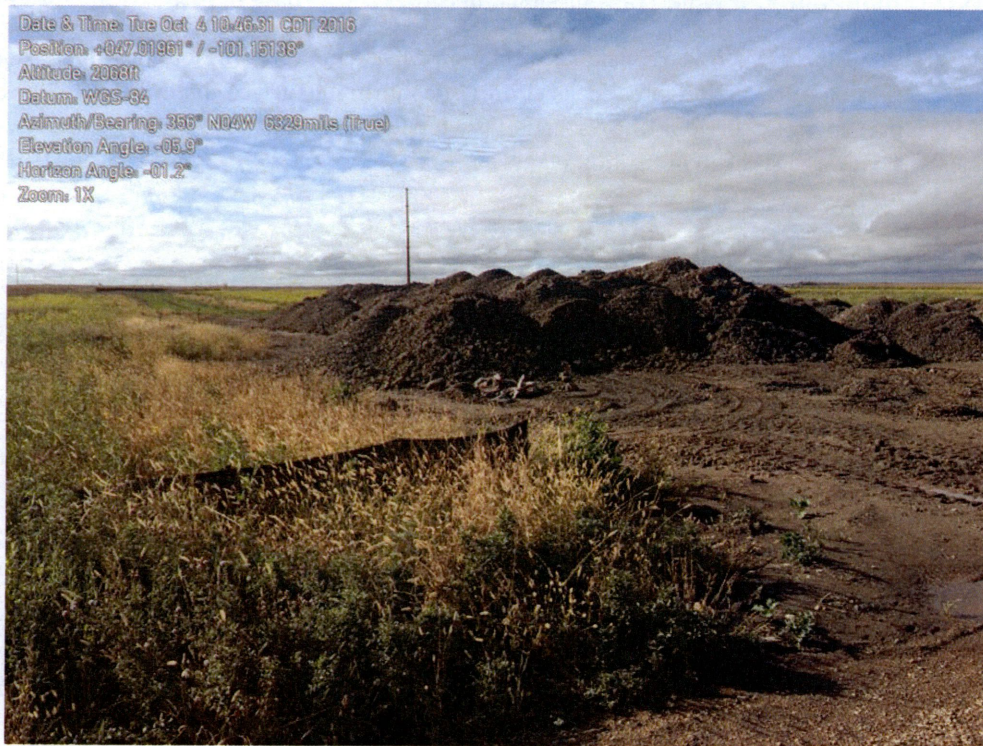
Report Photo #1 "Topsoil Pile At Switchyard"

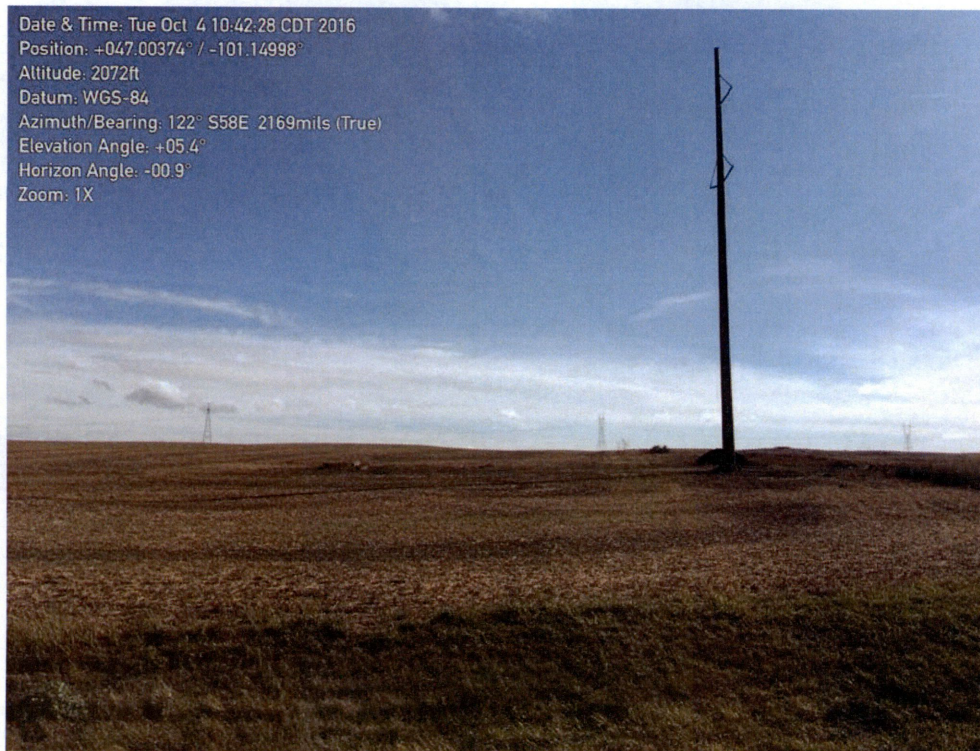
Report Photo #2 "Topsoil Pile At Power Pole"

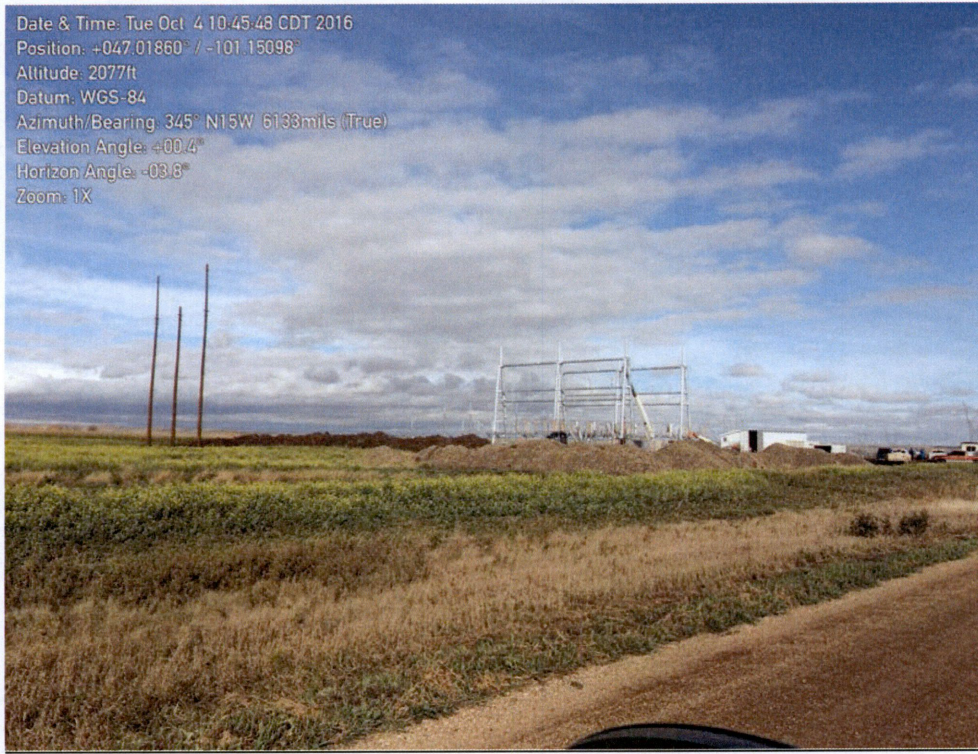
Report Photo #3 "Topsoil and Subsoil Piles At Switchyard"
