Executive Summary:

Site/Project Location: Oliver III Wind Transmission Line – Oliver and Morton County

Date of Inspection: 22 November 2016

131 PU-16-122 Filed: 12/9/2016 Pages: 4
Construction Inspection Report 22 Nov. 2016

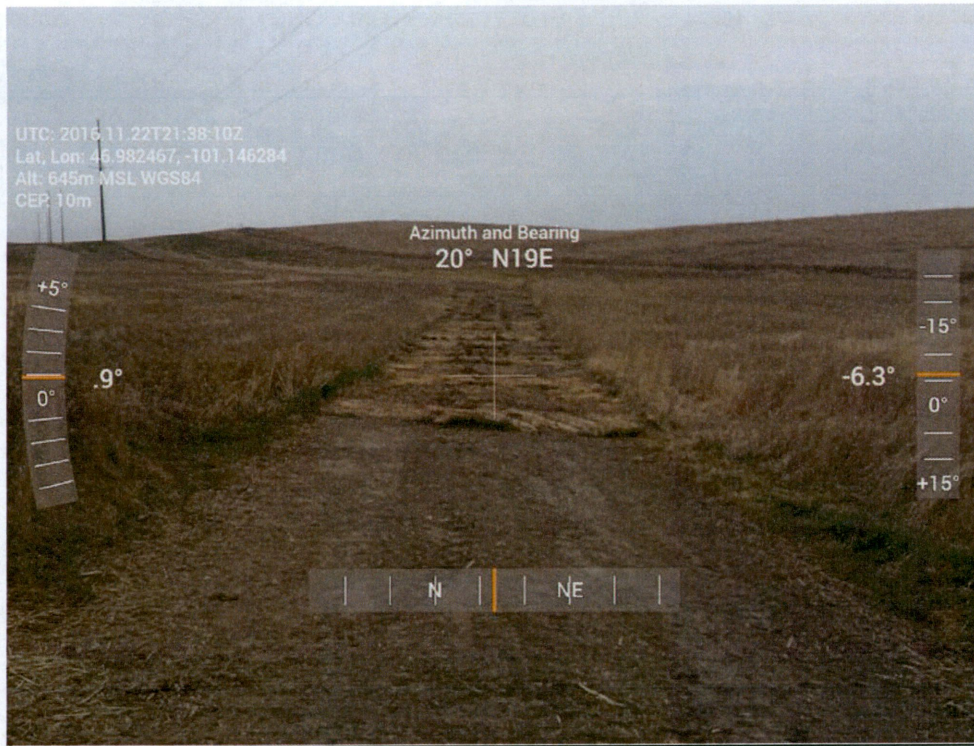
Mats were being removed from waterbody crossings. (See report photo #3)

Report Photo #3 "Mat Was Removed at River Crossing"

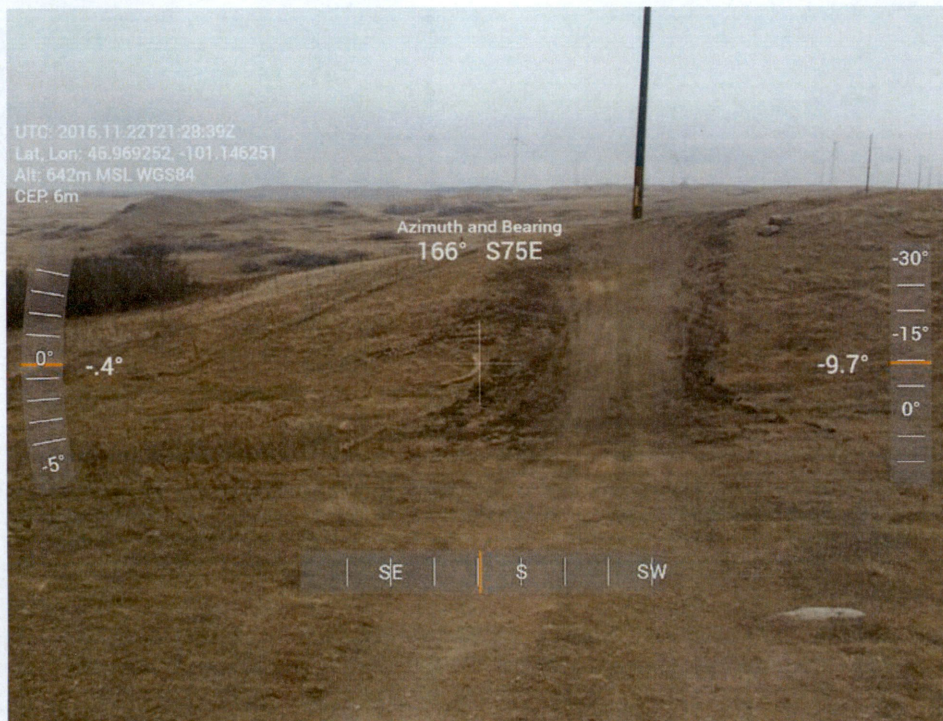
Due to steep slopes at pole 21, crew has placed straw wattles along the low area and up the southern hill. Additional straw wattles are needed on the north slope of the hill. No erosion noted at this time, additional straw wattles are precautionary. (See report photo #4)

Report Photo #4 "Additional Straw Wattles Needed"

Additional straw wattles should be placed on the north slope of the hill leading to pole 21.
