Reclamation and Revegetation Inspection Report

Oliver Wind III 230 kV Transmission Line

NextEra Energy Resources, LLC

ND PSC Case No. PU-16-122

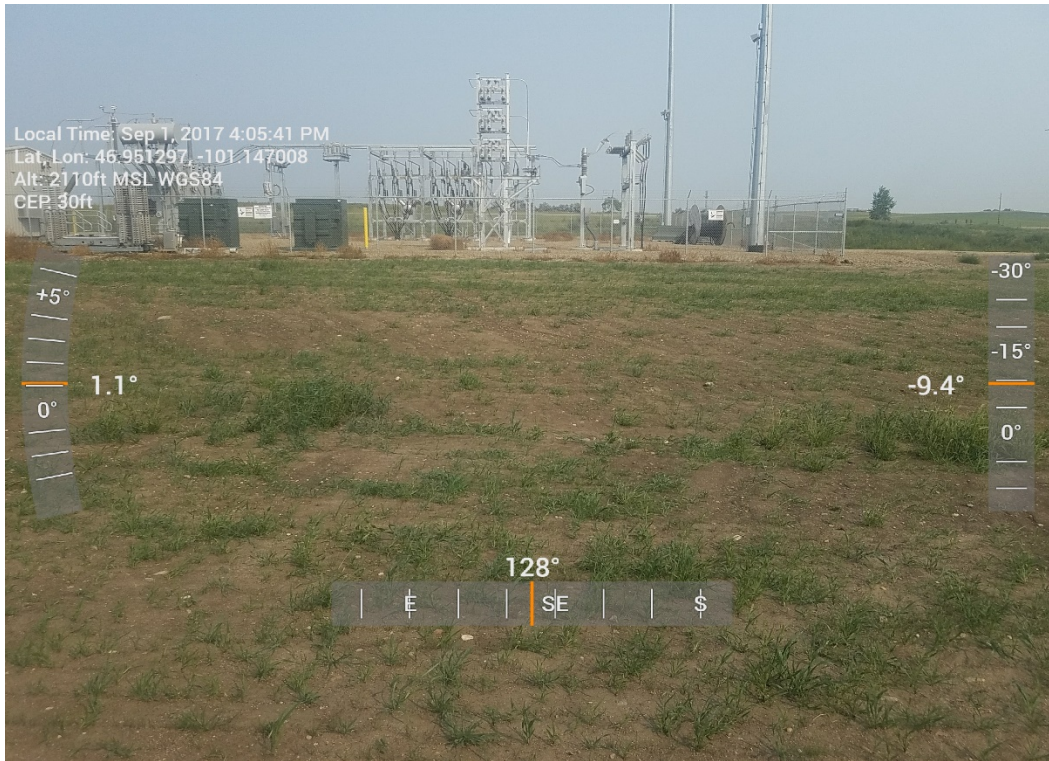
Report Photo #1: West Side of Substation

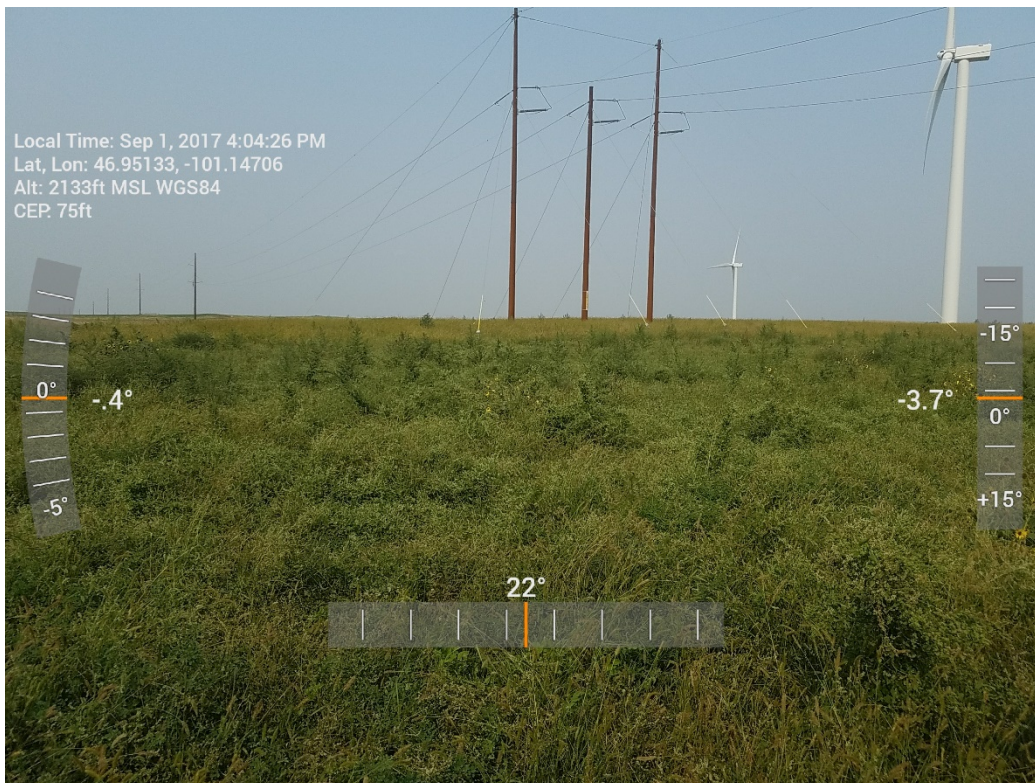
Report Photo #2: North Side of Substation.

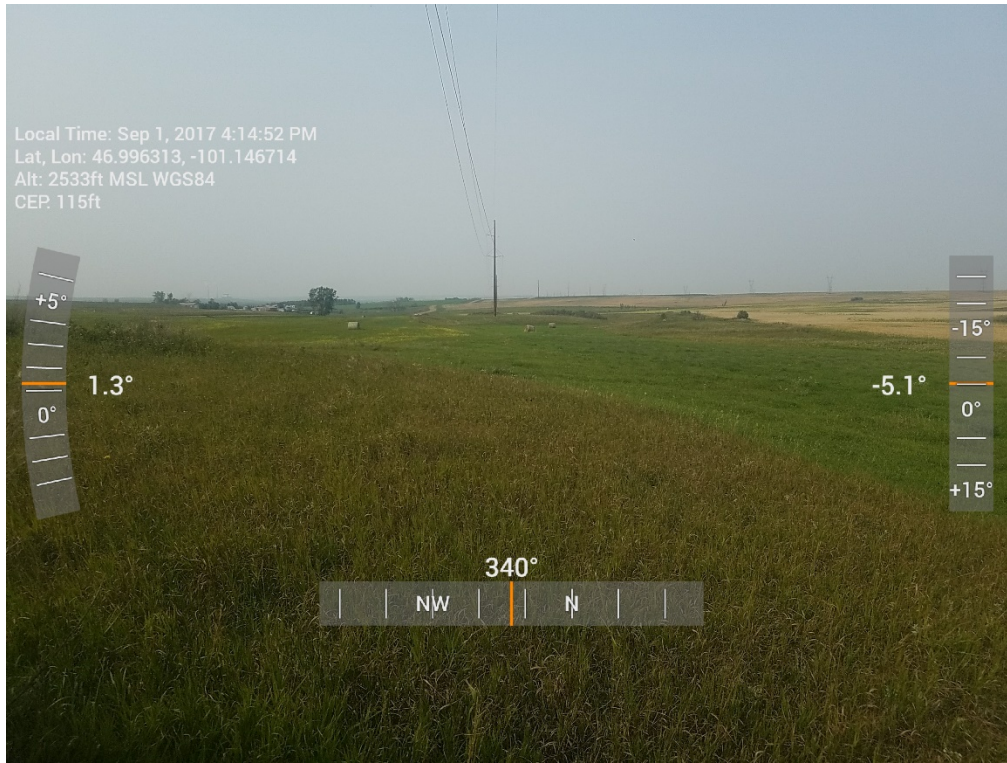
Report Photo #3: Hay Field under Transmission Line.

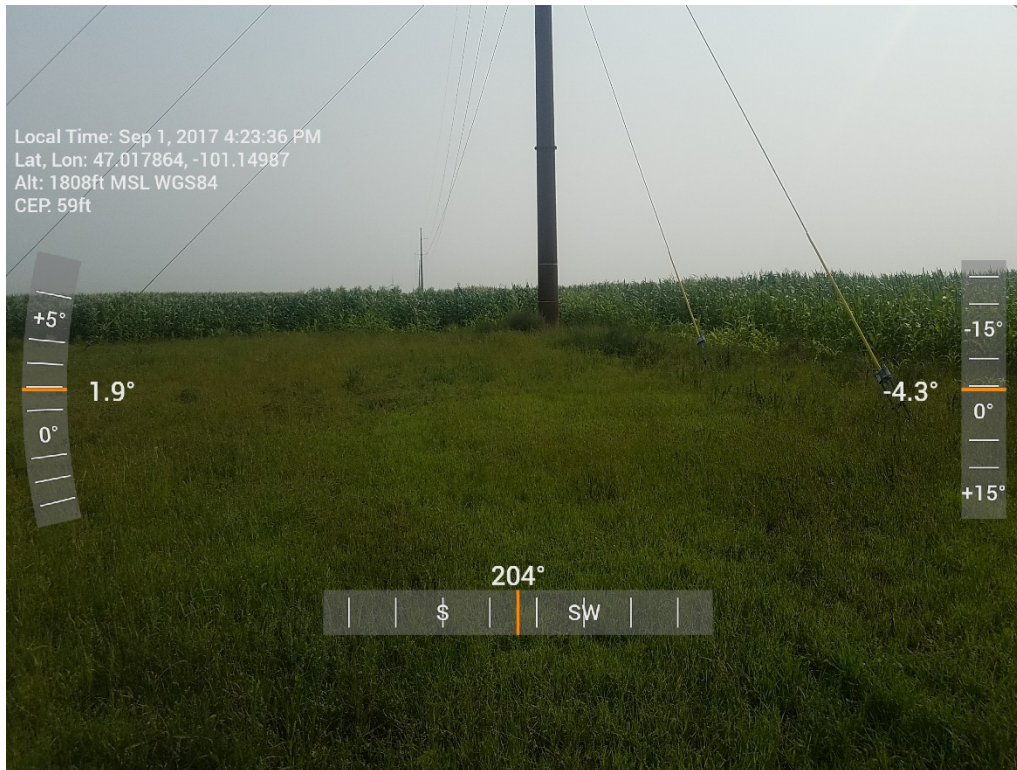
Report Photo #4: Corn field under Transmission Line.
