**Site/Project Location:** Oliver Wind Laydown Yard      **Date of Inspection:** 14 July 2016

**Site/Project Location:** Oliver Wind Substation Area      **Date of Inspection:** 7 July 2016

**Site/Project Location:** Oliver III Wind Switchyard      **Date of Inspection:** 14 July 2016

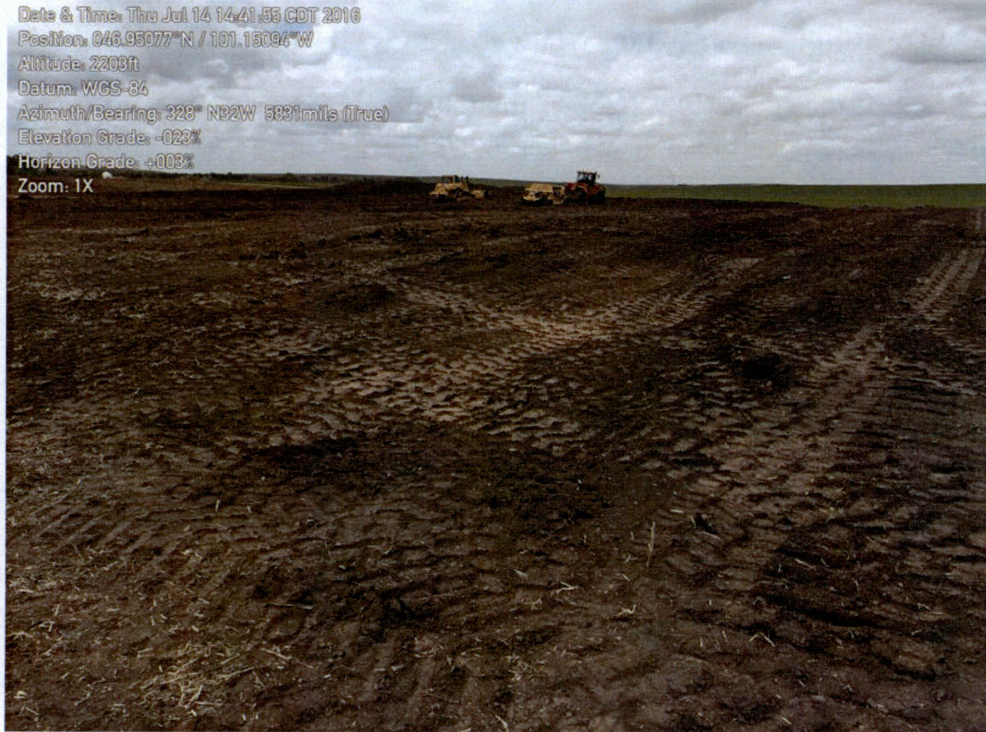
Topsoil from subsoil segregation appears adequate. 6-8 inches of topsoil had been removed in areas with some subsoil visible. Other areas topsoil is being removed to 12 inches where it is present. Site foreman was instructed to continue to remove topsoil to depth of subsoil or to 12-inches, whichever is greater, and these instructions have been followed. Stormwater / sediment control were not yet in place although no signs of runoff were noted.

**Report Photo #1 "Topsoil removal at 6-8 inches, visible subsoil"**

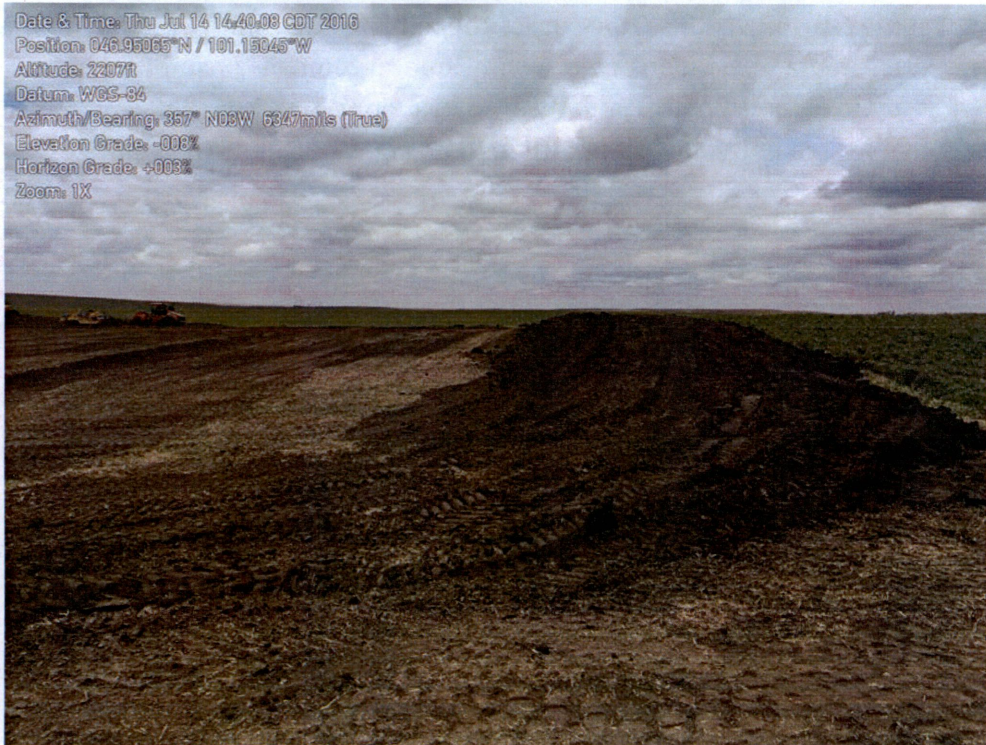
**Report Photo #2 "Topsoil removal and east stockpile"**

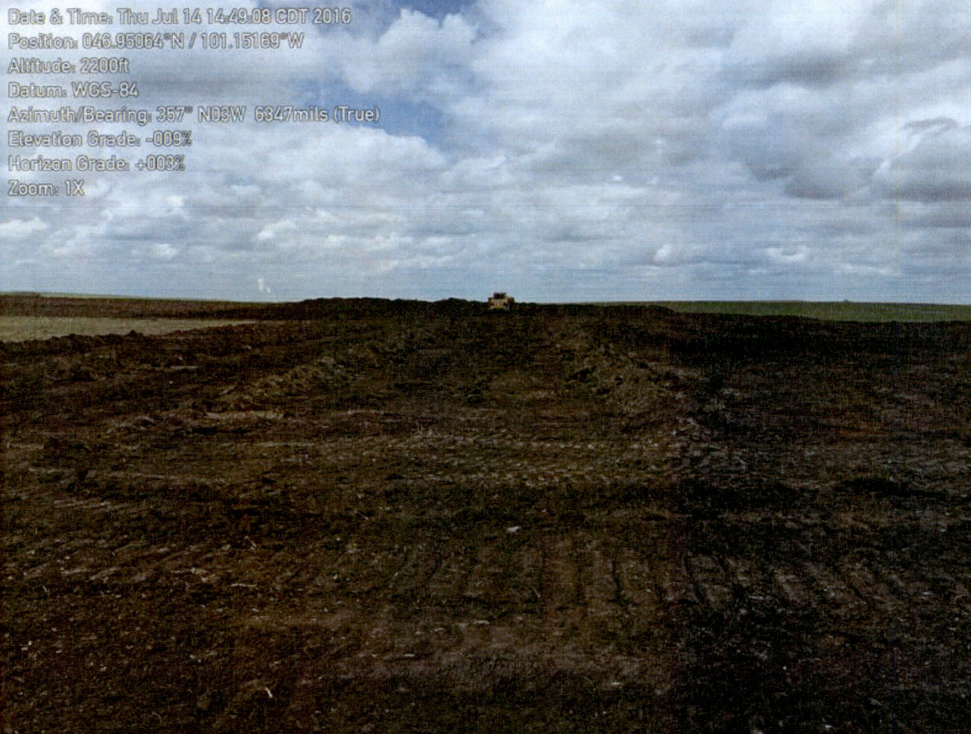
**Report Photo #3 "Topsoil removal and north stockpile"**

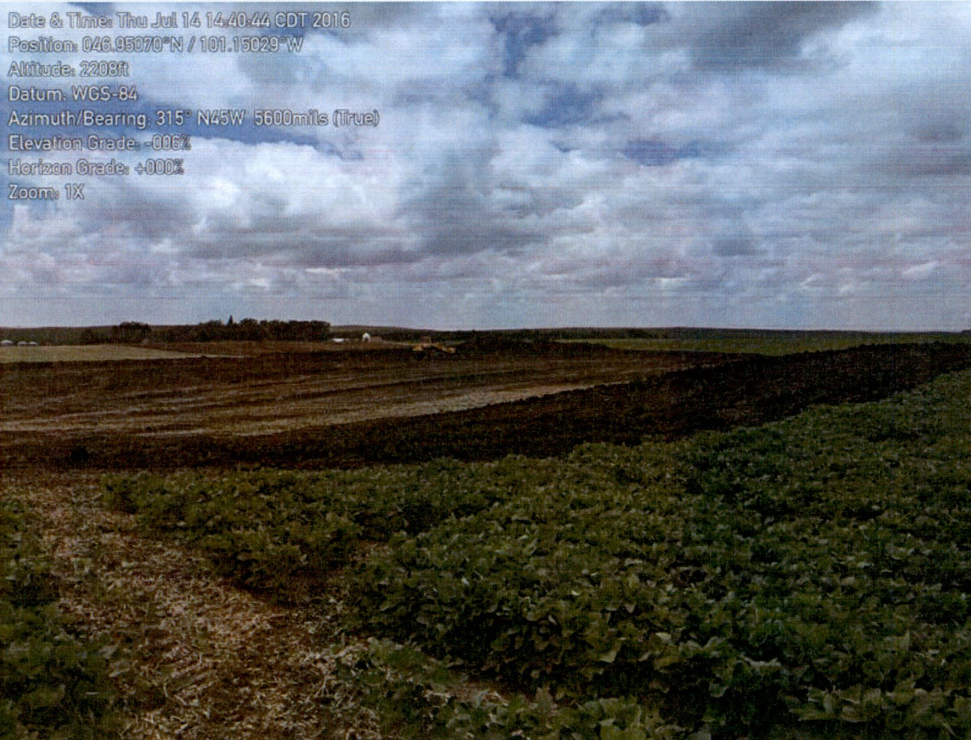
**Report Photo #4 "Topsoil Removal"**

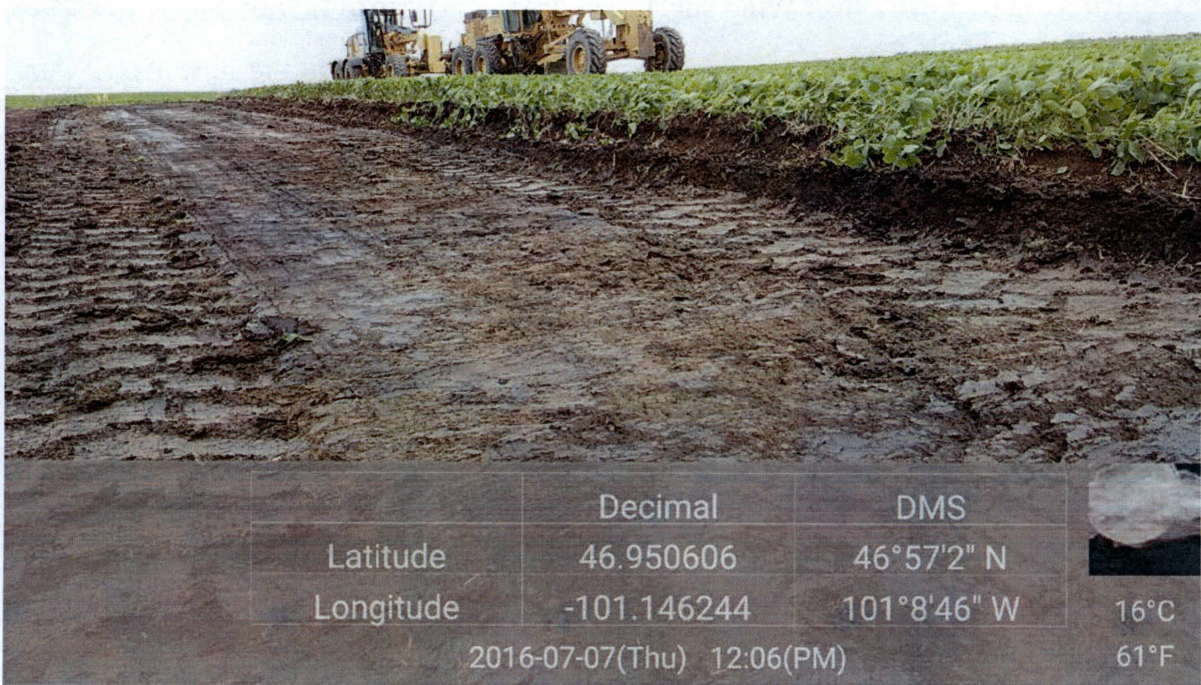
Topsoil from subsoil segregation appears adequate. 8-12 inches of topsoil had been removed in areas with some subsoil visible. Site foreman was instructed to continue to remove topsoil to depth of subsoil or to 12-inches, whichever is greater, and these instructions have been followed. Stormwater / sediment control were not yet in place although no signs of runoff were noted.

**Report Photo #1 "Topsoil removal at 8-12 inches, visible subsoil"**

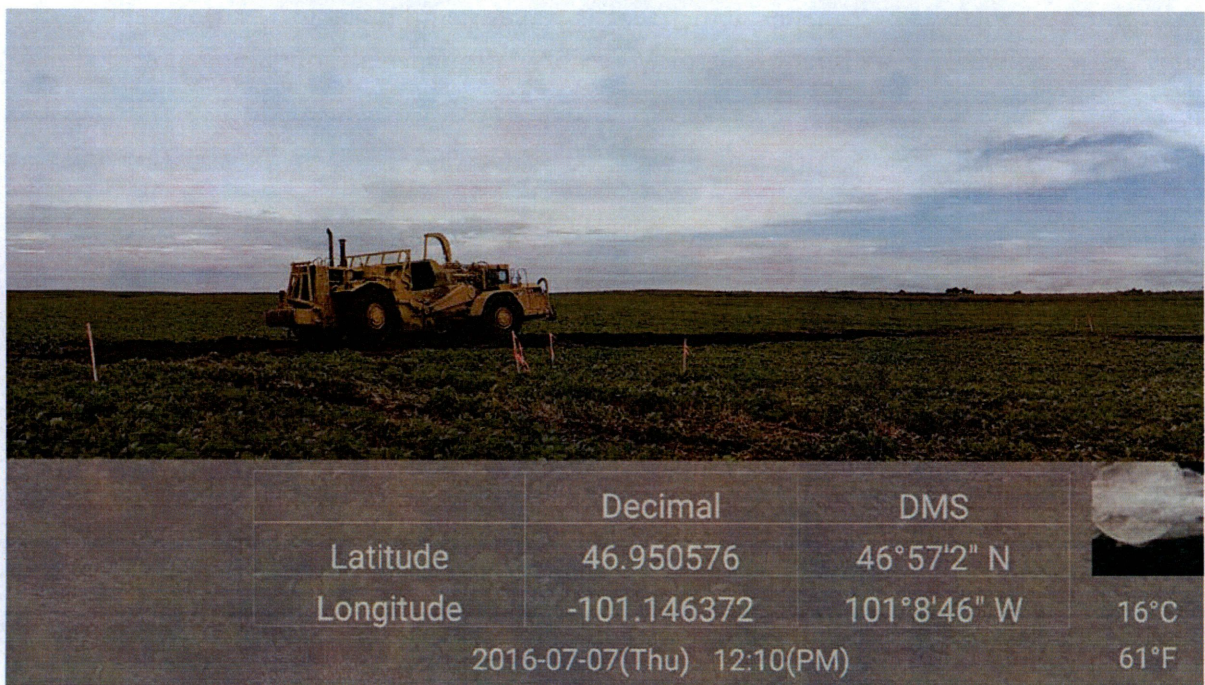
**Report Photo #2 "Topsoil removal and north stockpile"**

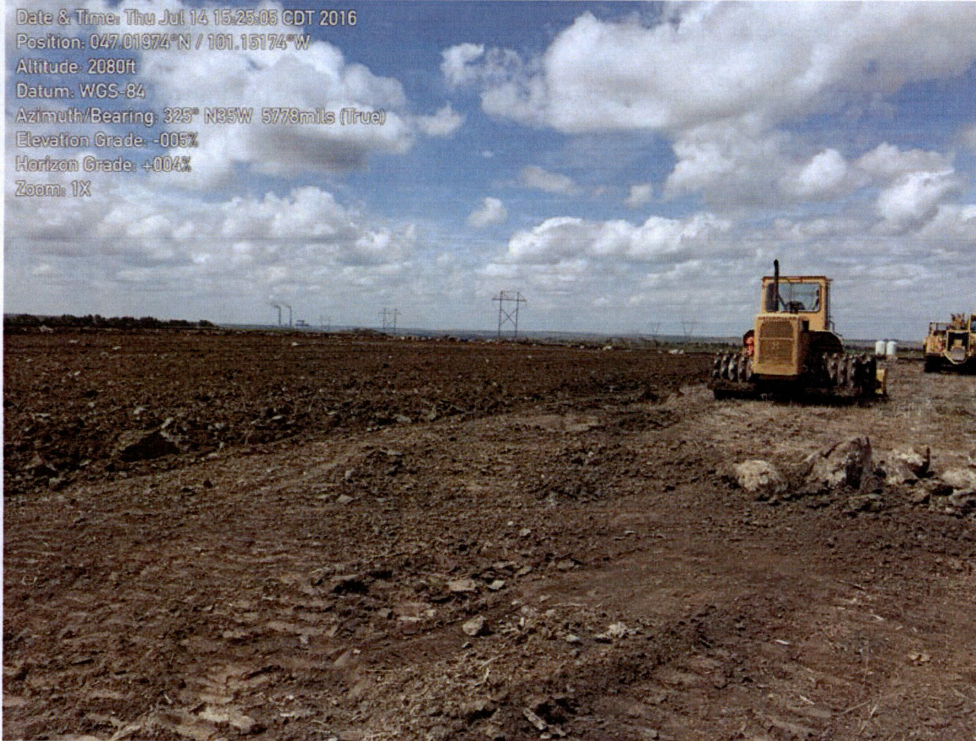
Topsoil from subsoil segregation appears adequate. 8-12 inches of topsoil had been removed. Stormwater / sediment control were not yet in place although no signs of runoff were noted.

**Report Photo #1 "Topsoil removal at 8-12 inches, visible subsoil"**

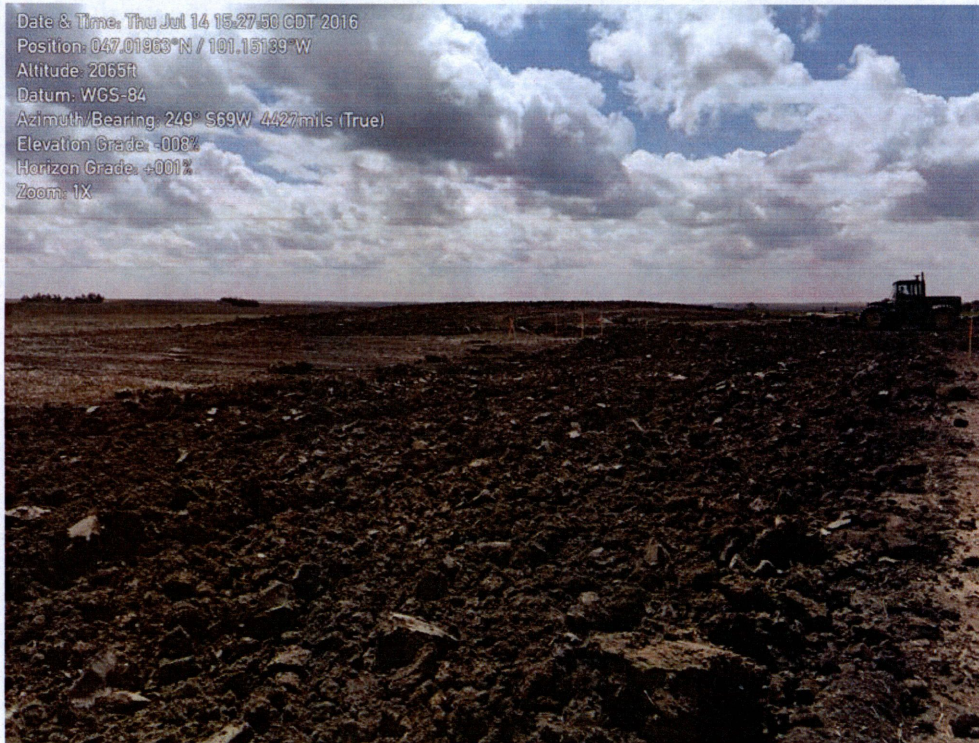
**Report Photo #2 "Topsoil removal and stockpile"**
