Site/Project Location: Oliver Wind III Farm/Morton Oliver Counties **Date of Inspection:** 18 August 2016

116 PU-16-123 Filed 08/29/2016 Pages: 3
Site inspection trip report - Construction Inspection Report August 16, 2016
Keitu Engineers & Consultants, Inc.

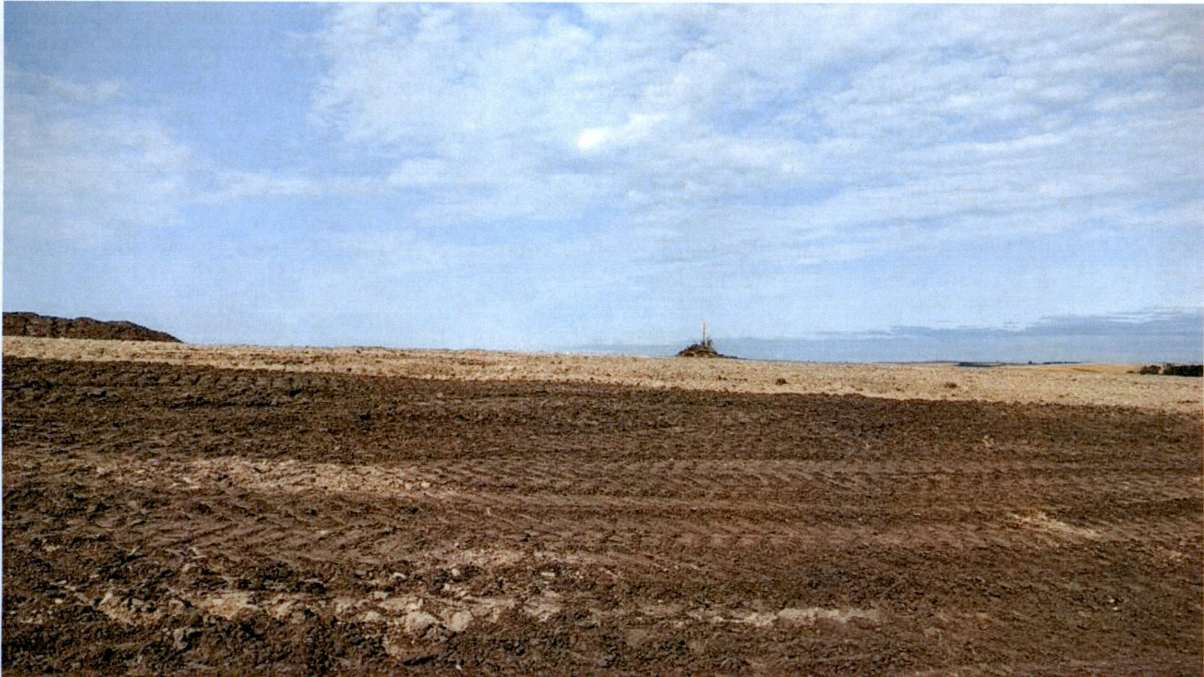
Report Photo #1 "Lighter Subsoil Visible After Scraper Pass"
(Coordinates: 46.945262, -101.18663)

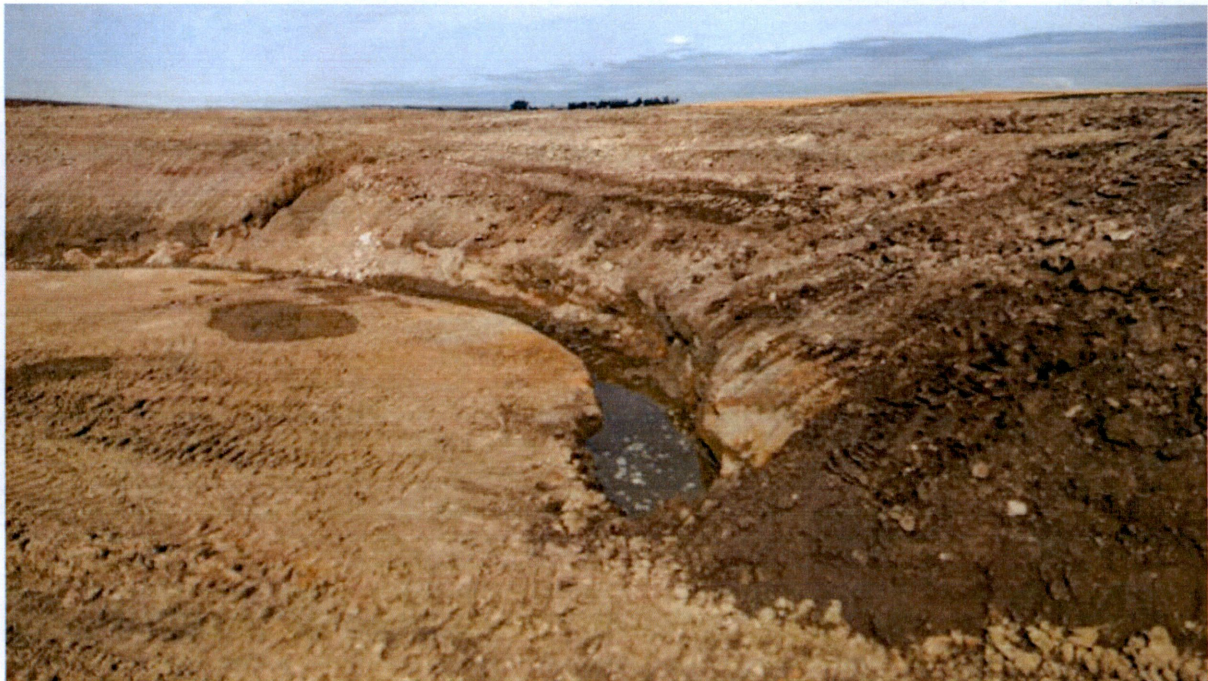
Report Photo #2 "Ground Water Encountered While Excavating on Turbine Pad"
(Coordinates: 46.961692, -101.232544)

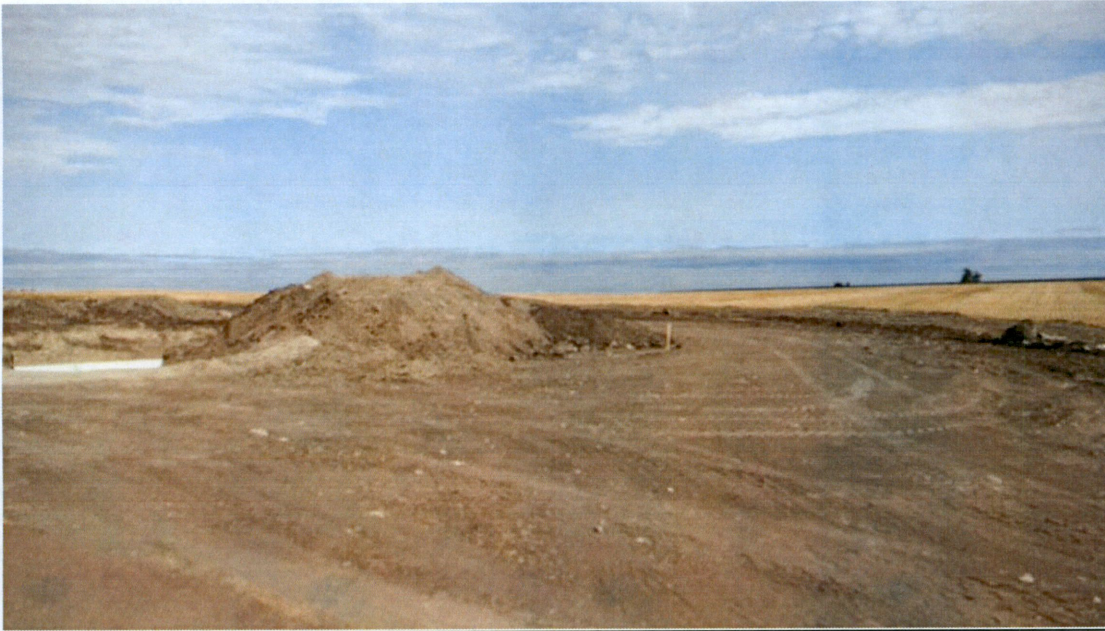
Topsoil from subsoil segregation appears adequate. Site operators stated they have been instructed to strip soil from sites until they see a change in the soil color. They state they have been removing around 6 inches of topsoil before seeing subsoil in most locations but have reached subsoil as shallow as 2 inches or as deep as 36 inches. Ground water has been encountered at some of these sites at depths greater than 2 feet. The effects of this water on excavation and construction are being mitigated appropriately. The construction crew is doing an adequate job of separating topsoil and keeping soil layers separate during construction. Erosion control has been implemented in disturbance areas and heavy slopes. Silt fences are installed correctly and being inspected and maintained.

Report Photo #3 “Subsoil is Piled Separate (left center) from Top Soil (stored around perimeter of site)”
(Coordinates: 46.967605, -101.242654)
