**Site/Project Location:** Oliver III Wind Energy Center

**Date of Inspection:** 26 September 2016

123 PU-16-123 Filed 10/04/2016 Pages: 3  
Site inspection trip report - Construction Inspection Report September 26, 2016  
Keitu Engineers & Consultants, Inc.

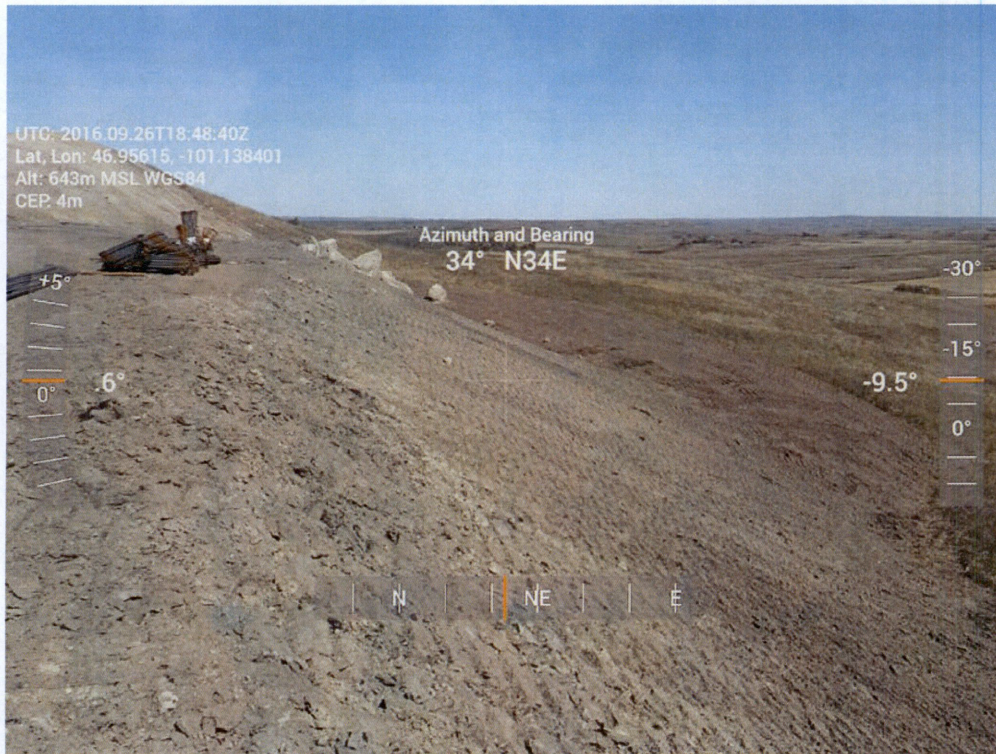
**Report Photo #1 "Shaping Hillside to Create Flat Pad For Turbine"**

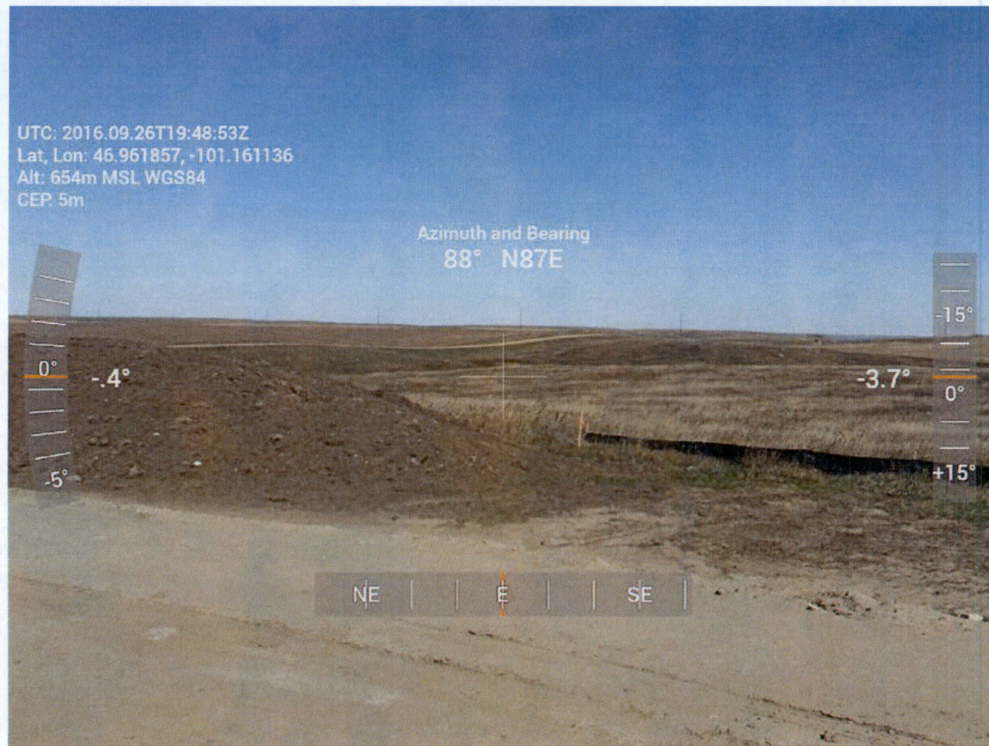
**Report Photo #2 "Topsoil Pile and Silt Fence BMP"**

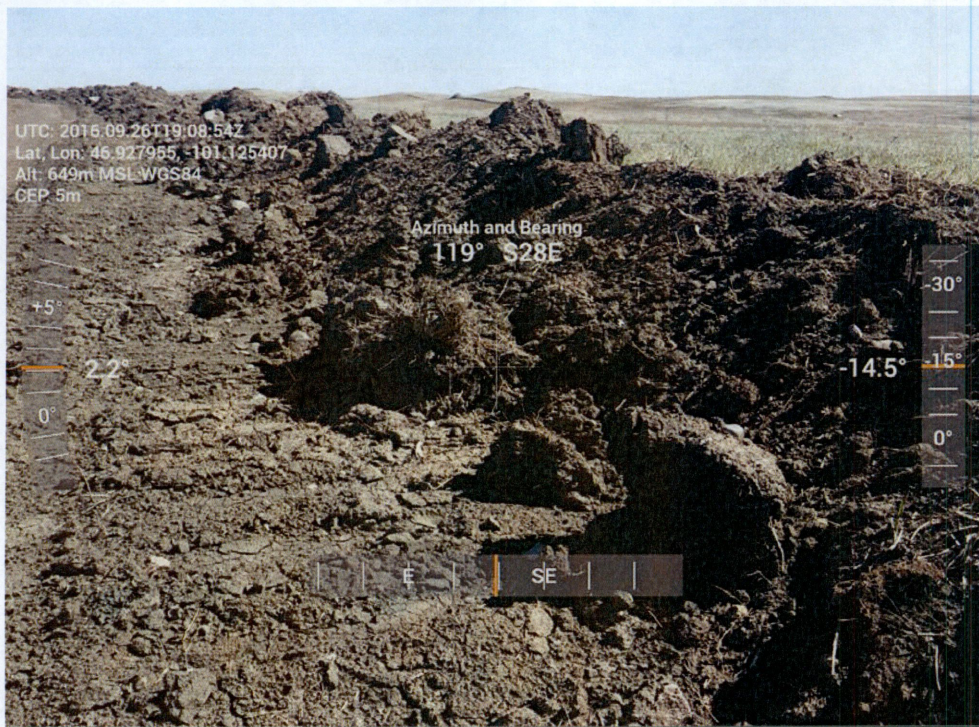
**Report Photo #3 "Topsoil Separation On String Road"**
