# Reclamation and Revegetation Inspection Report

Oliver III Wind Energy Center – Morton & Oliver Counties  
Oliver Wind III, LLC

ND PSC Case No. PU-16-123

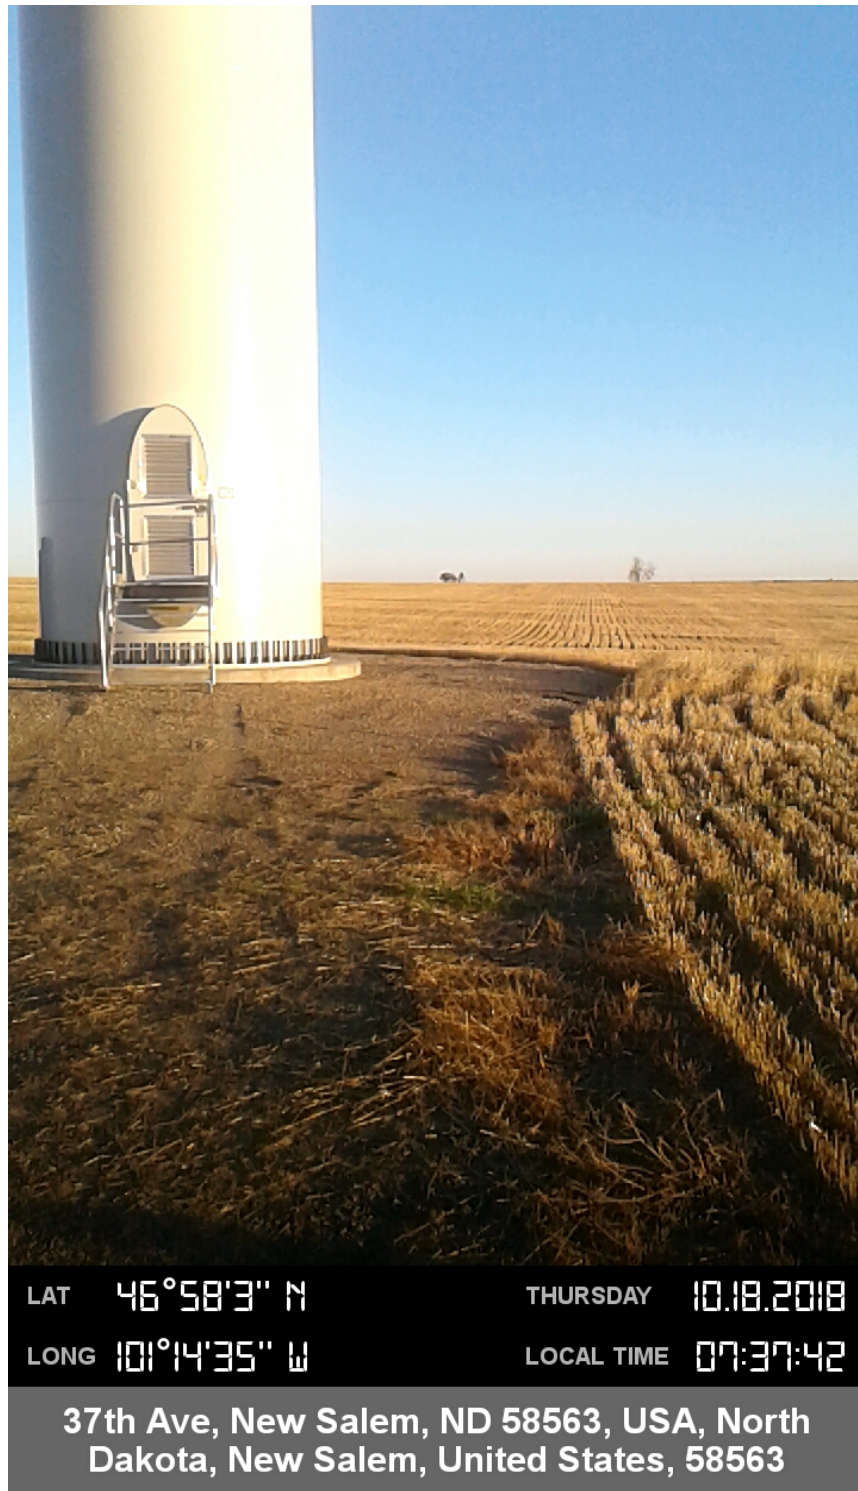
**Report Photo #1:** Overview of turbine construction block (T48) from South to North.

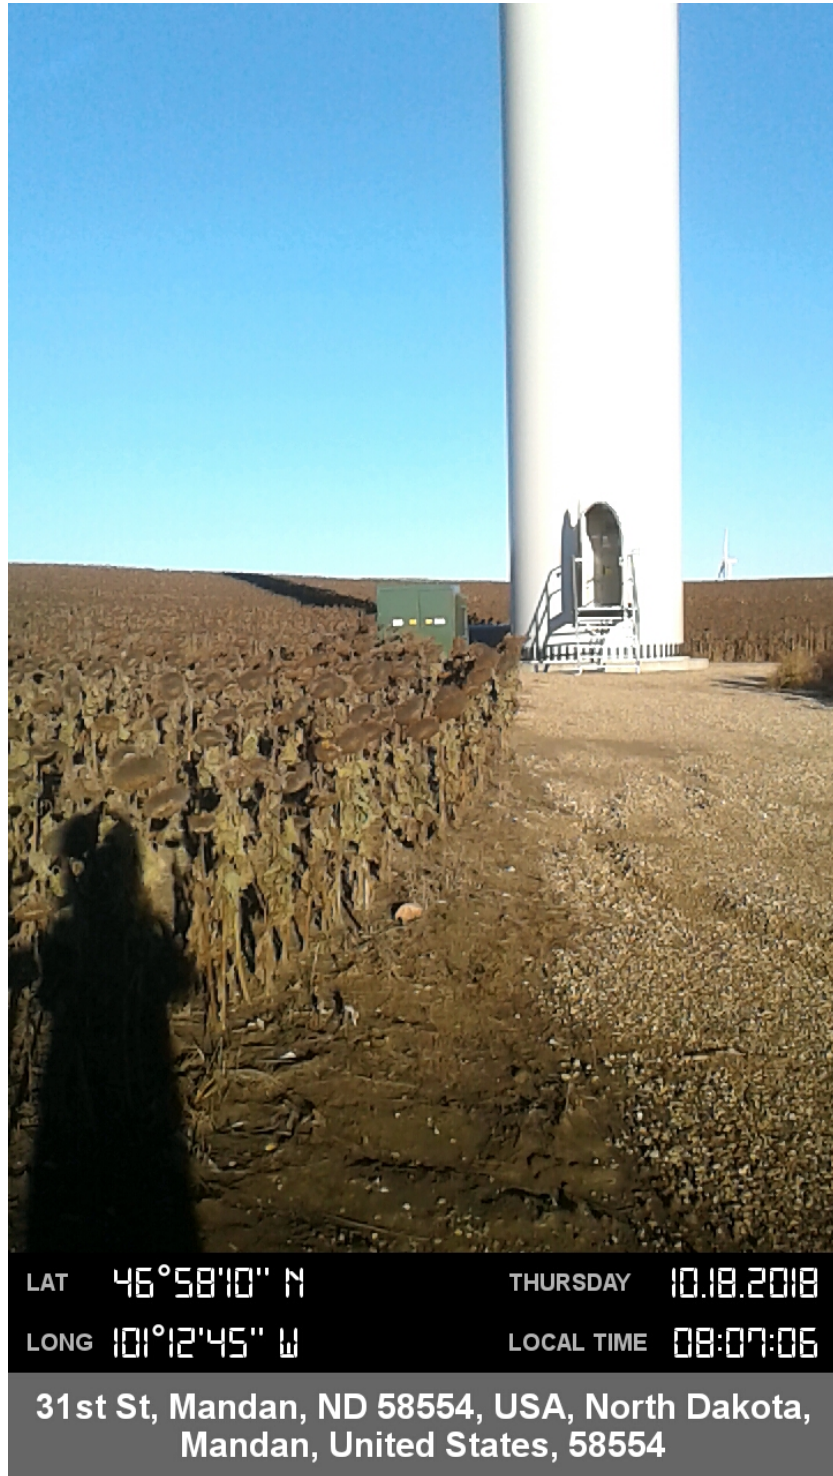
**Report Photo #2:** Overview of turbine construction block (T40) from South to North.

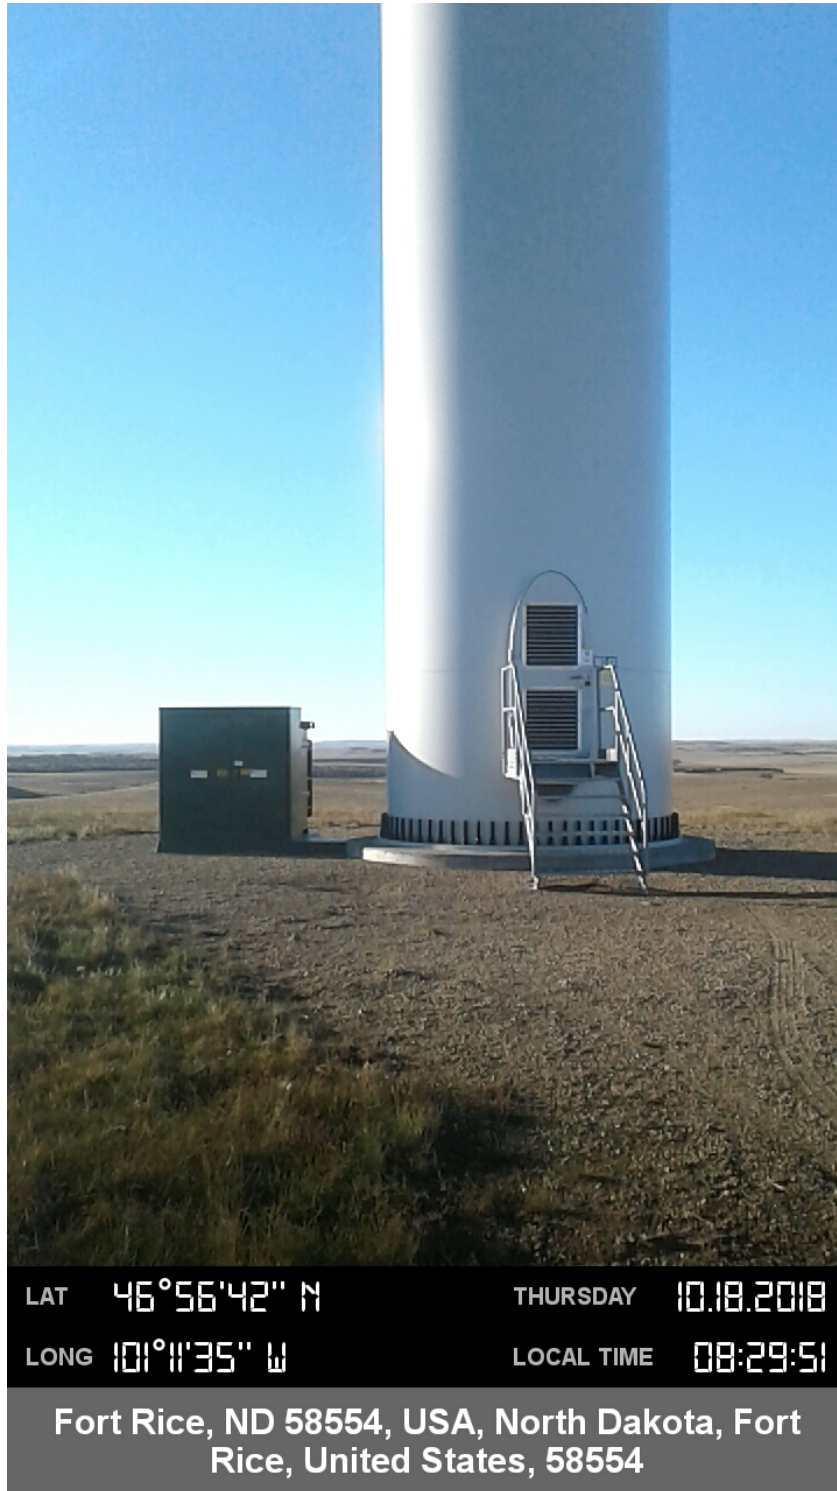
**Report Photo #3:** Overview of turbine construction block (T18) from North to South.

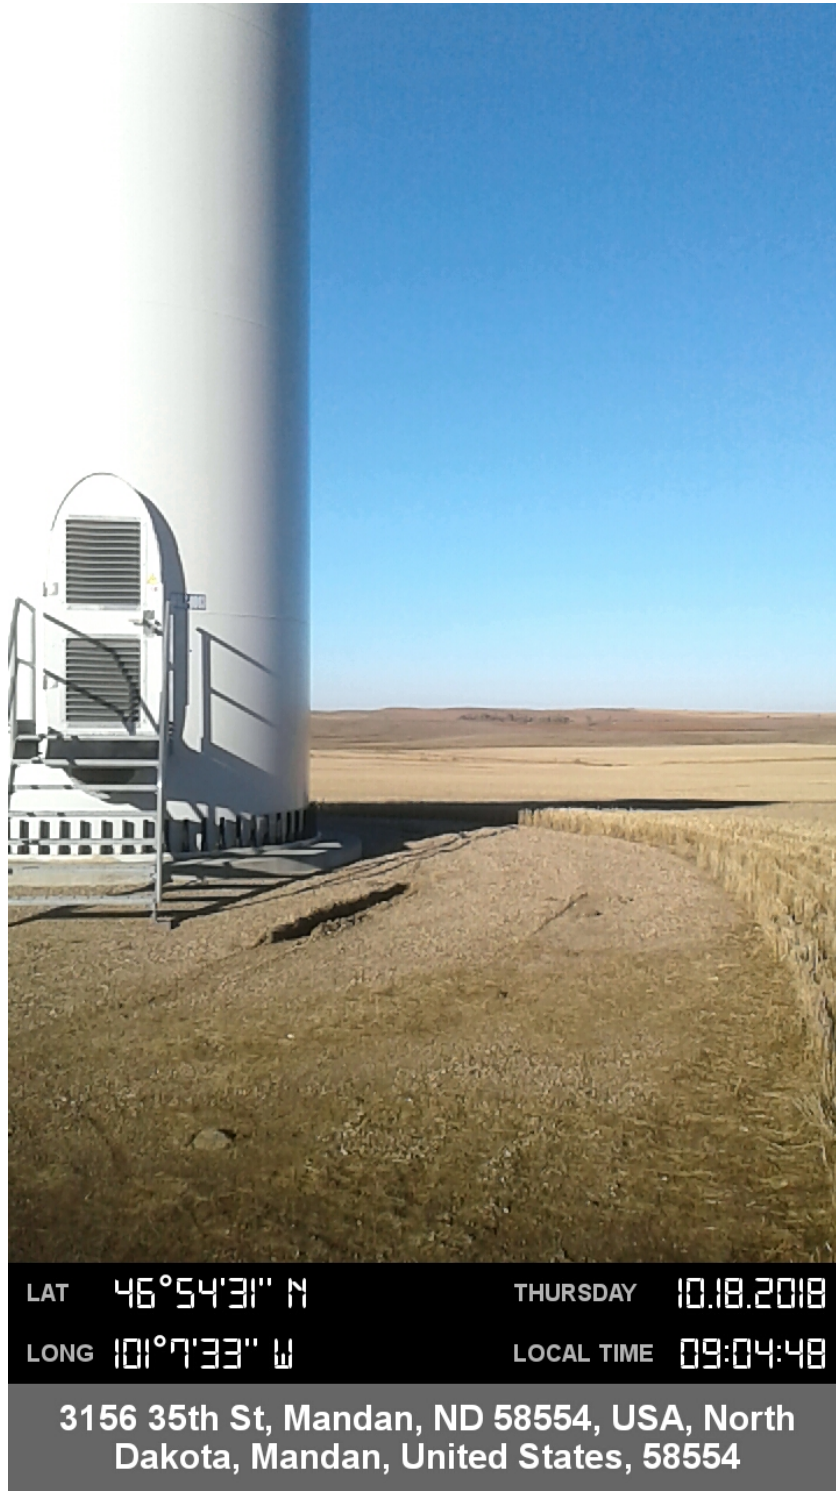
**Report Photo #4:** Overview of turbine construction block (T3) from South to North.

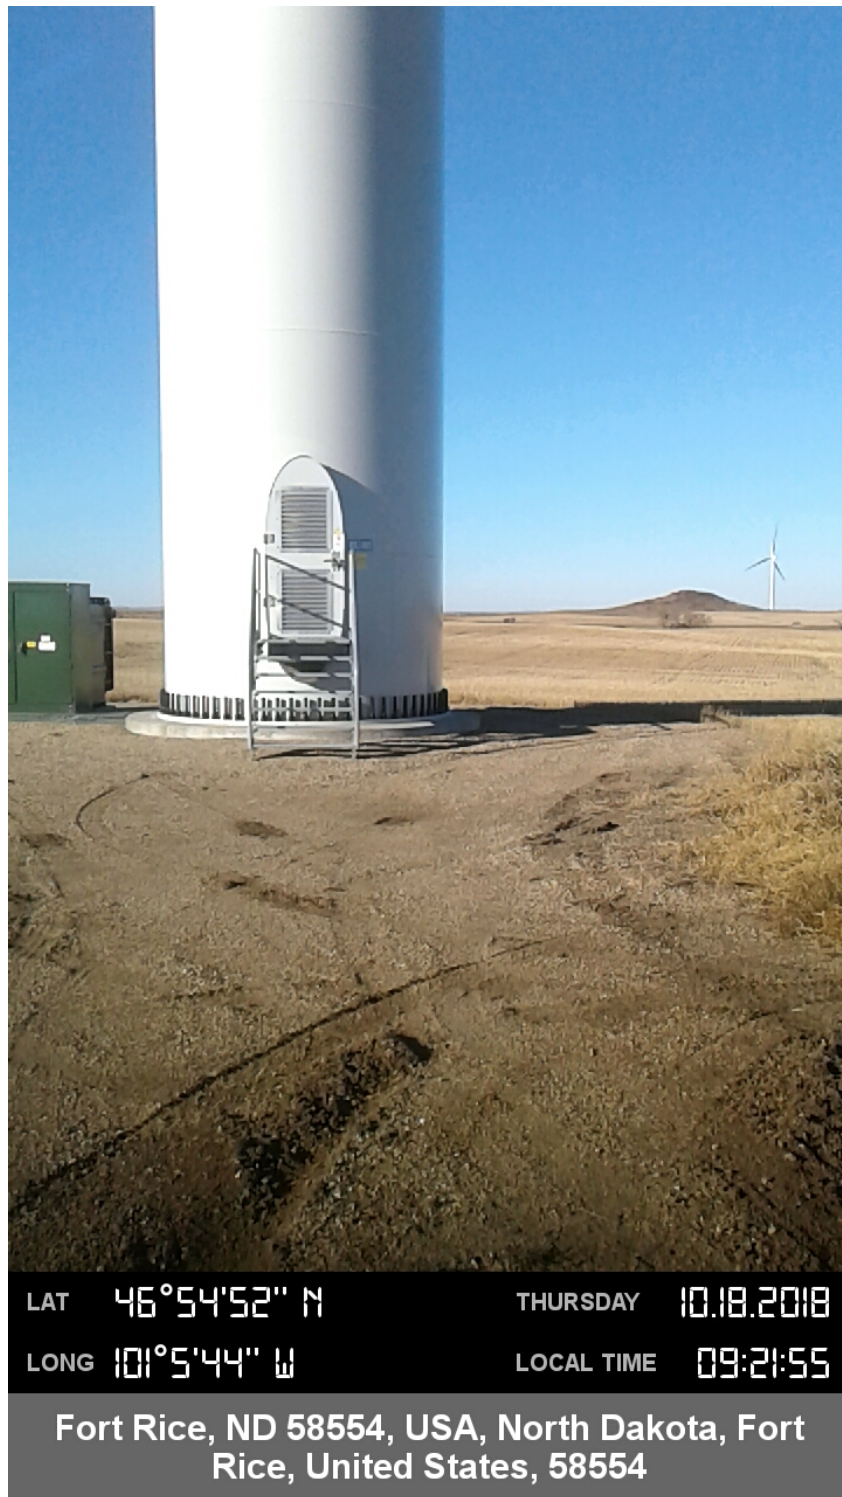
**Report Photo #5:** Overview of turbine construction block (T1) from South to North.

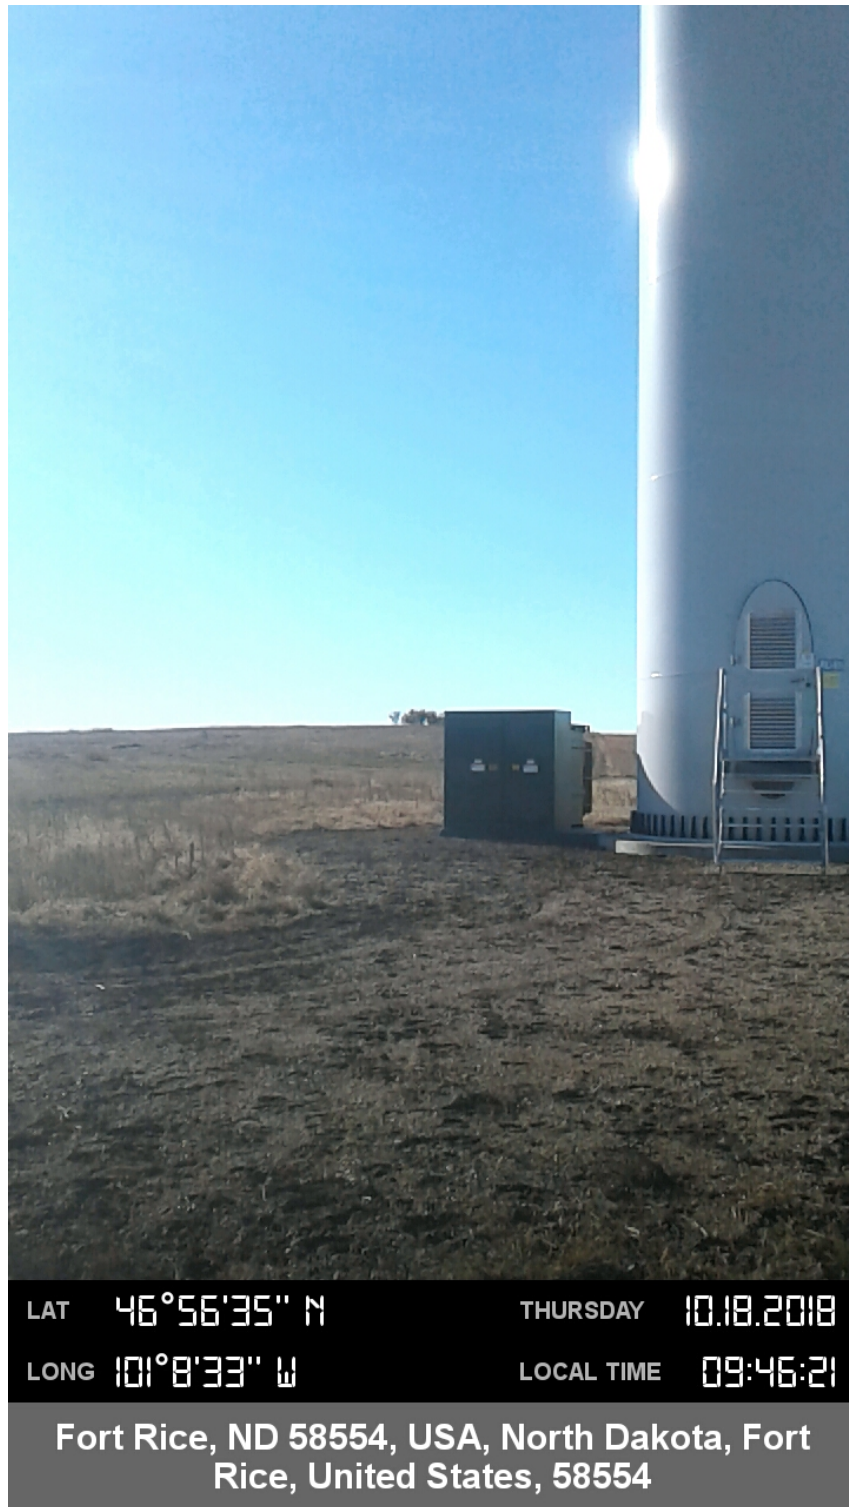
**Report Photo #6:** Overview of turbine construction block (T14) from South to North.

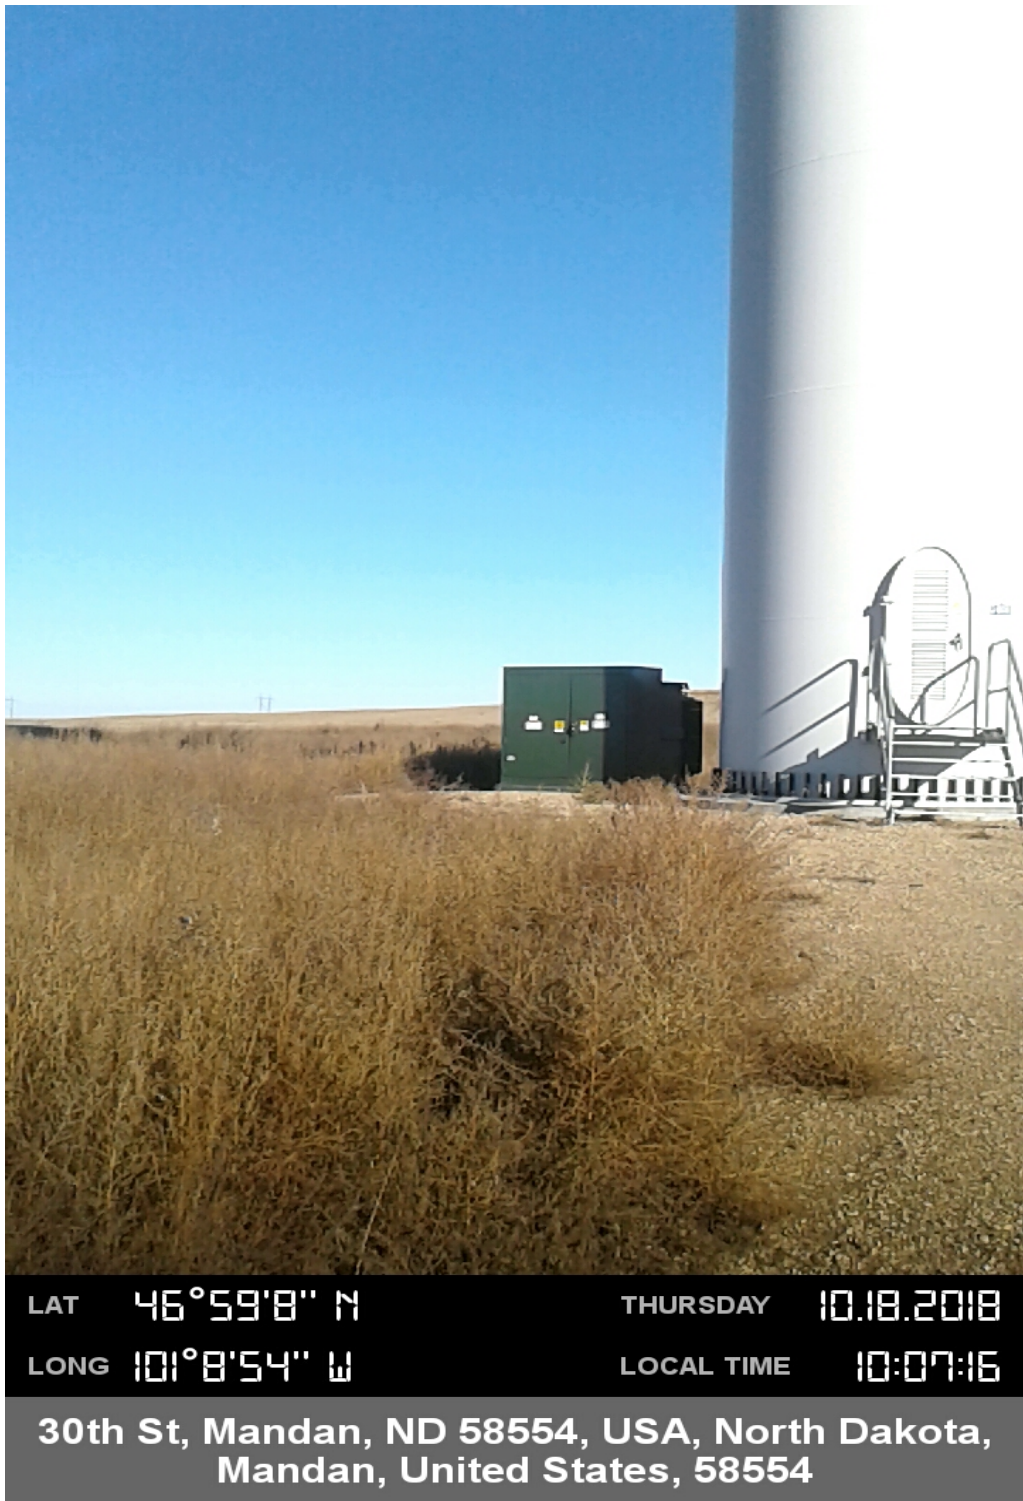
**Report Photo #7:** Overview of turbine construction block (T30) from South to North.
