Sacagawea Pipeline Co.

Keene to Johnsons Corner to
(DAPL) Dakota Access Pipeline
16" Crude Oil Pipeline Project
PU-16-140
KLJ#1216124

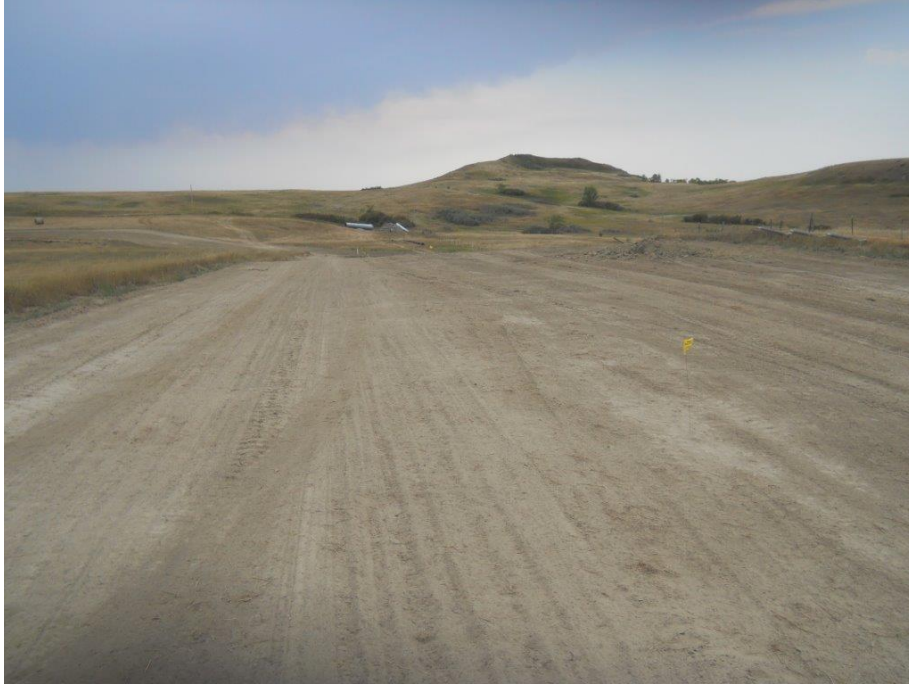
Photo 23: Located at station 84+00, looking west at graded Right of Way. Pipe installed in trench and backfilled. Right of Way topsoil needs to be finished level and cleaned up to original condition.

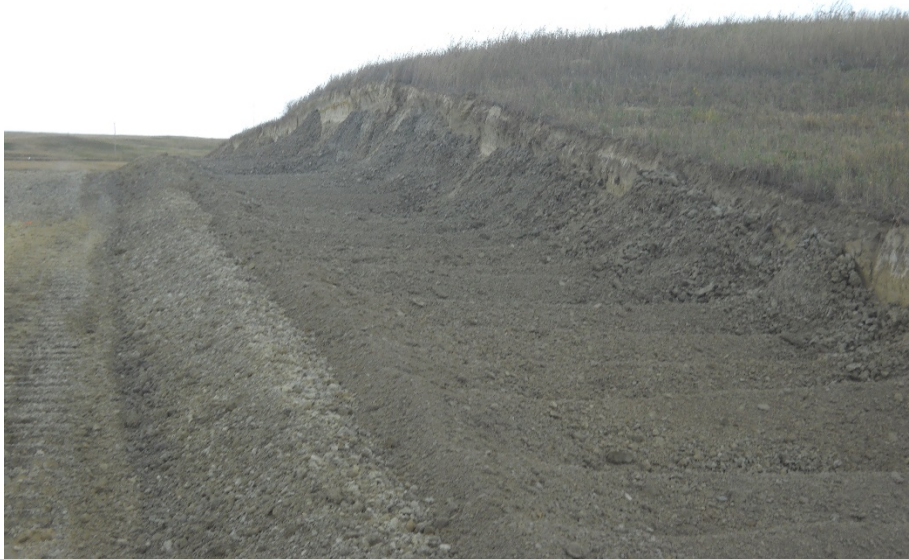
Photo 24: Located at station 87+00, looking north. Photo showing Right of Way with two toning slope with topsoil pile shown on left side of photo.
