# PU-16-140 CONSTRUCTION INSPECTION

Plains Terminal 16-Inch Crude Oil Pipeline – McKenzie Co.  
Johnson's Corner to Dakota Access Pipeline

*October 24, 2017*

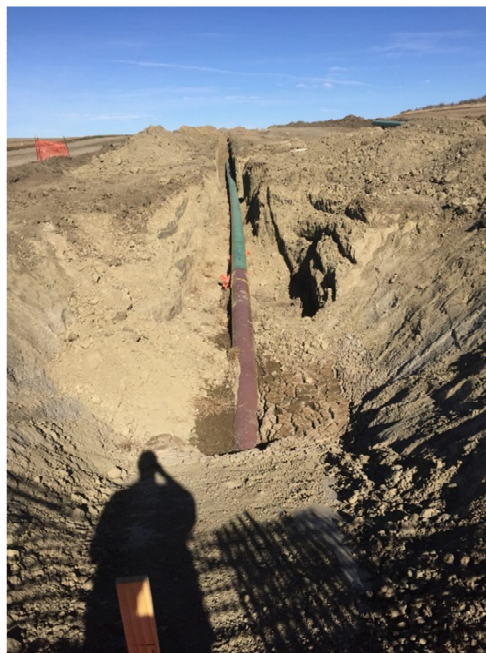
Picture 2: Pipe bore/trench. Depths checked at 4 feet or greater cover in trench.

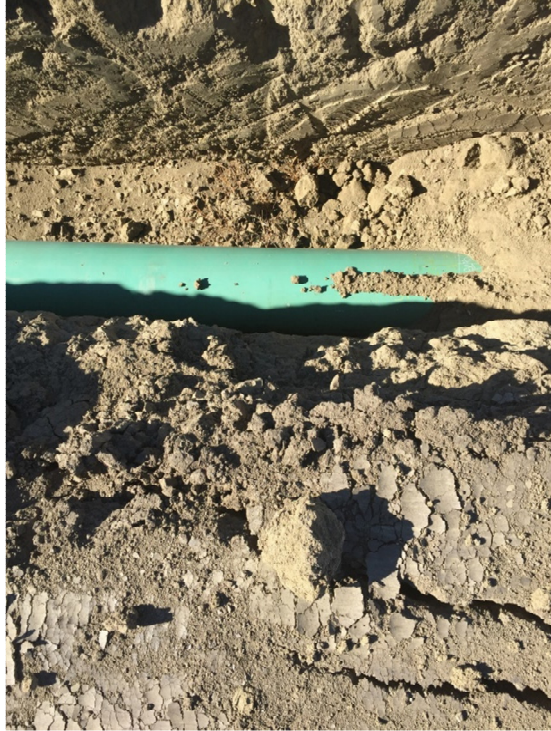
Picture 3: Pipe backfill

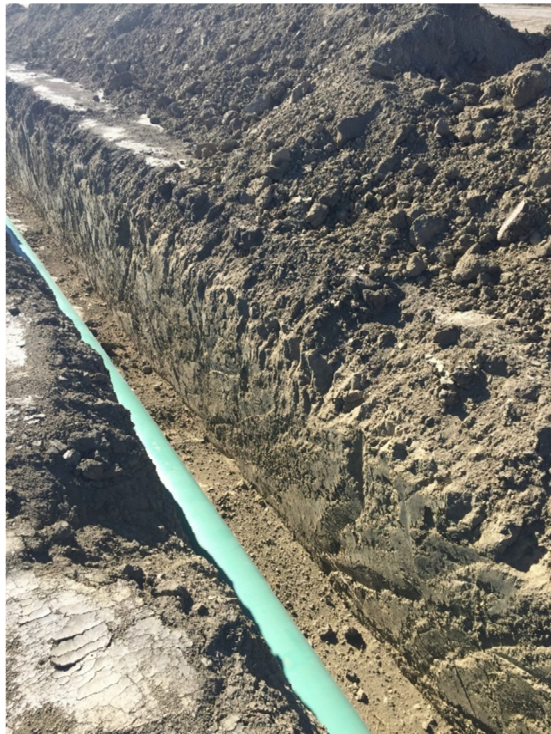
Picture 4: Laying pipe, cover verified greater than 4 feet.

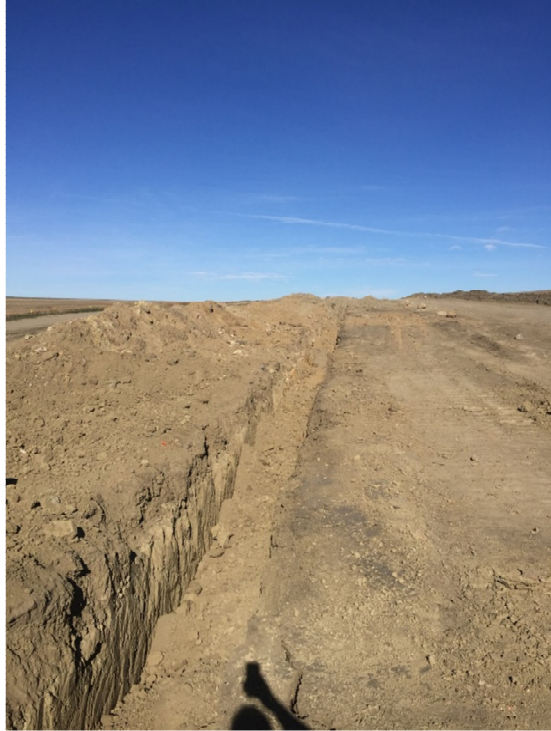
Picture 5: Backfilling pipe

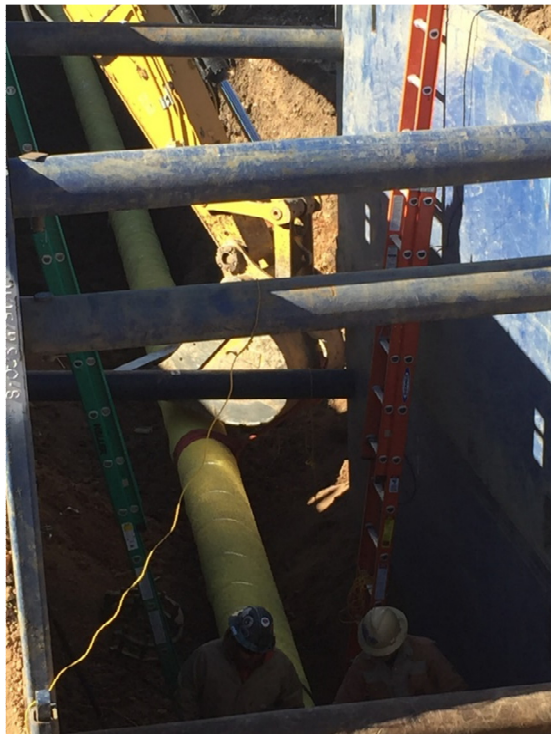
Picture 6: Trench box and installation of pipe at utility crossing

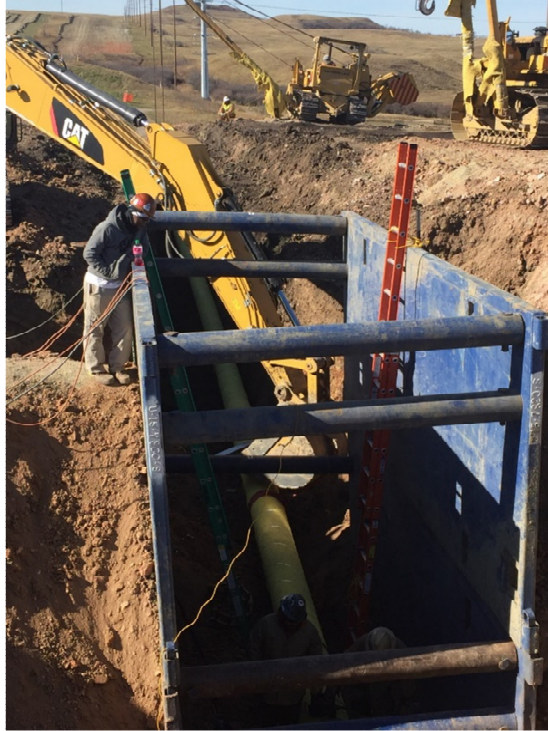
Picture 7: Utility crossing

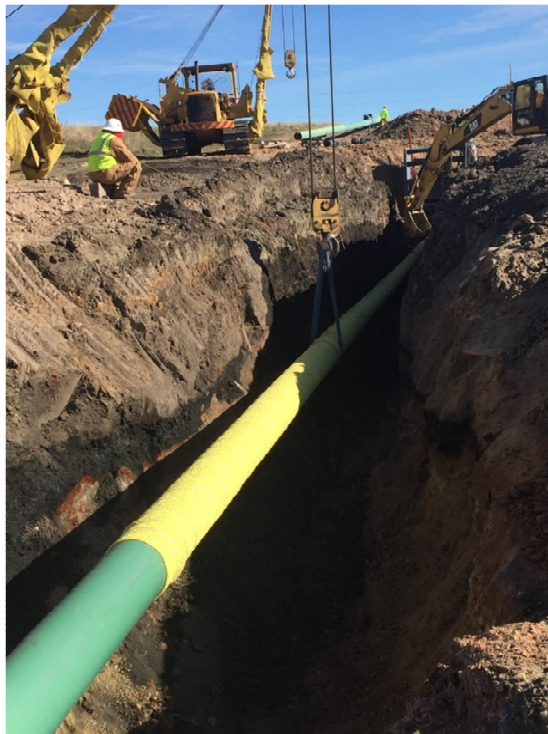
Picture 8: Placing pipe near utility crossing

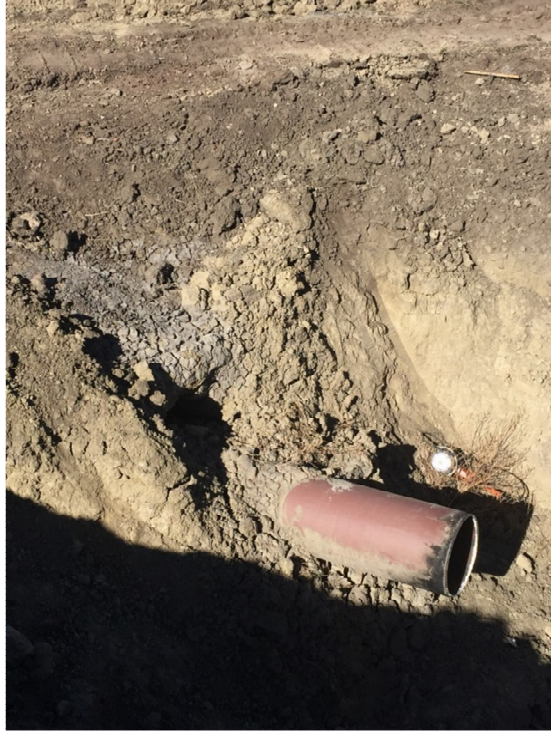
Picture 9: Location of bore tie-in

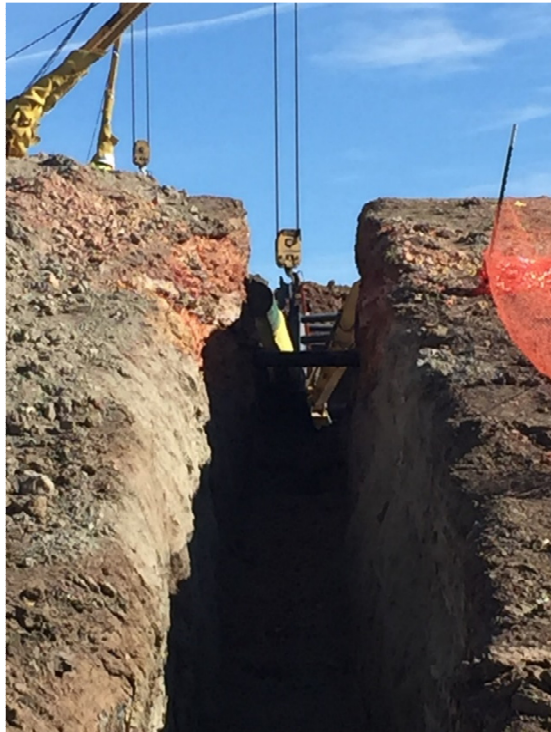
Picture 10: Installing pipe at utility crossing

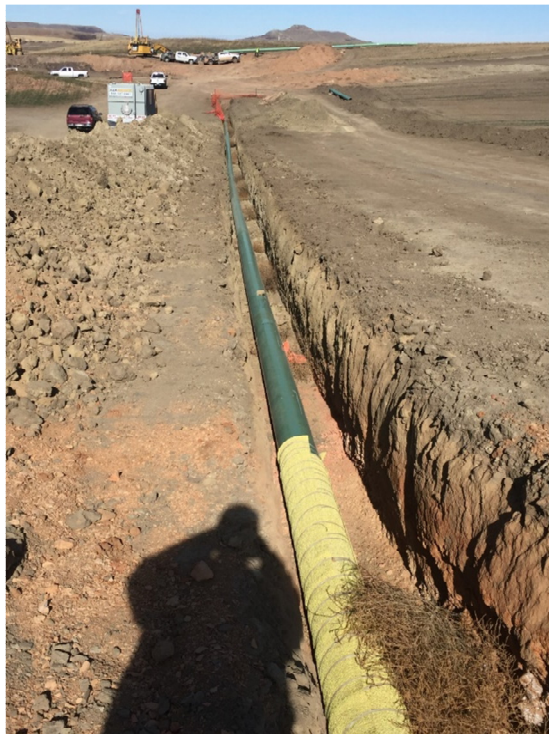
Picture 12: Pipe laid in trench, preparing for backfill

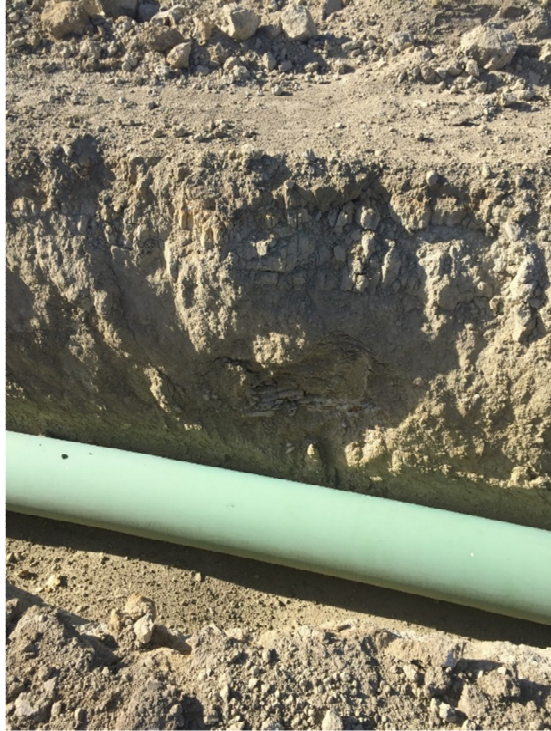
Picture 13: Pipe recently placed in trench

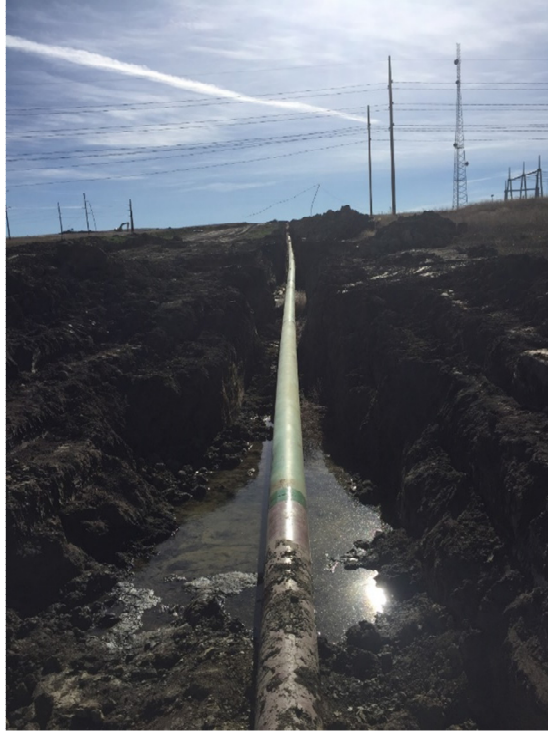
Picture 15: Pipe placed in trench, some water collecting in low area

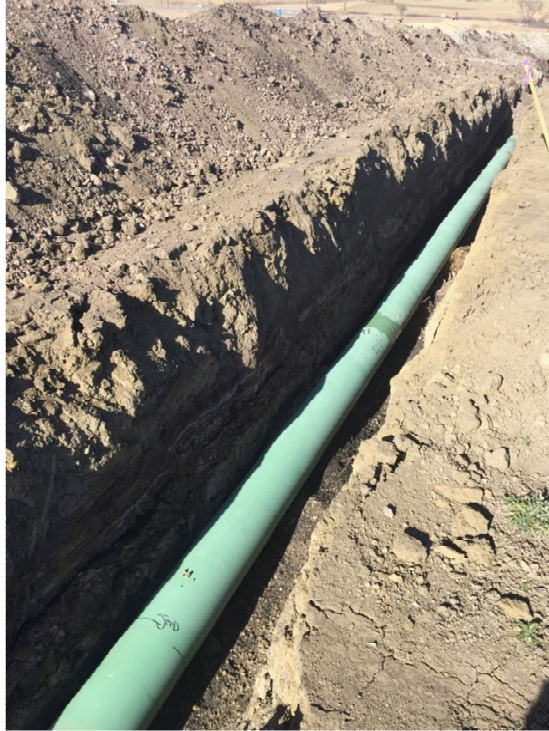
Picture 17: Pipe ready for backfill, minimum depth requirements verified

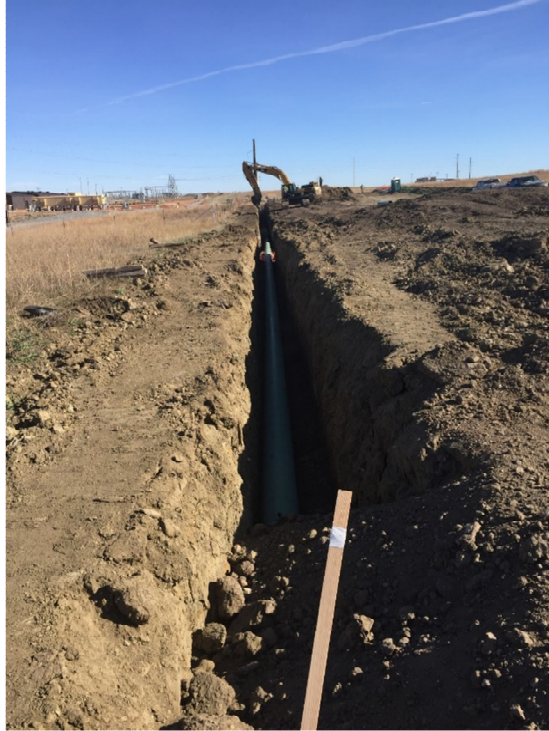
Picture 19: Backfill in progress

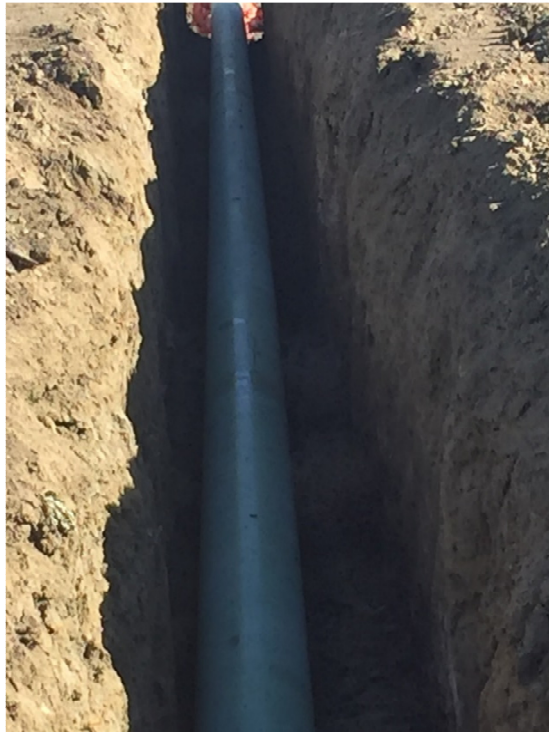
Picture 20: Backfill in progress

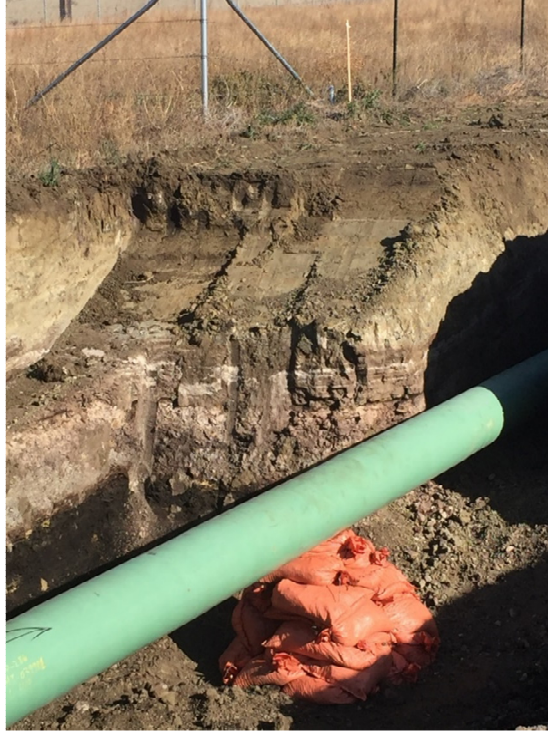
Picture 21: Pipe leveled on sandbags to make connection at PI

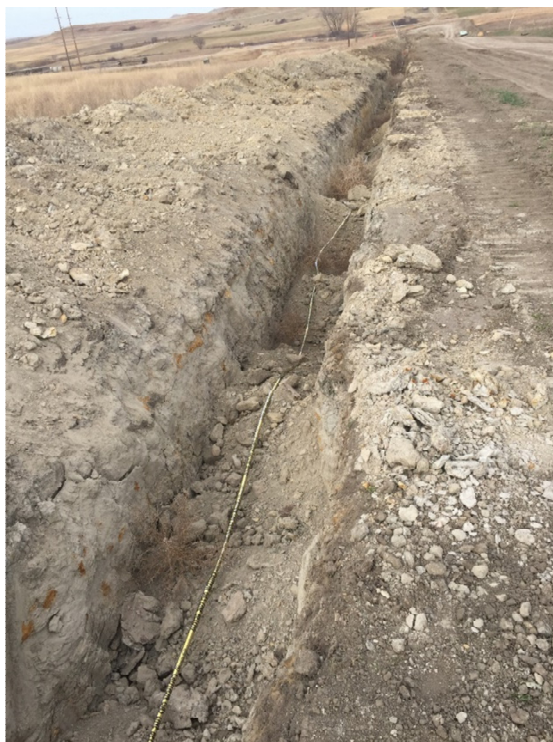
Picture 22: Backfill pipe trench, warning tape placed in trench

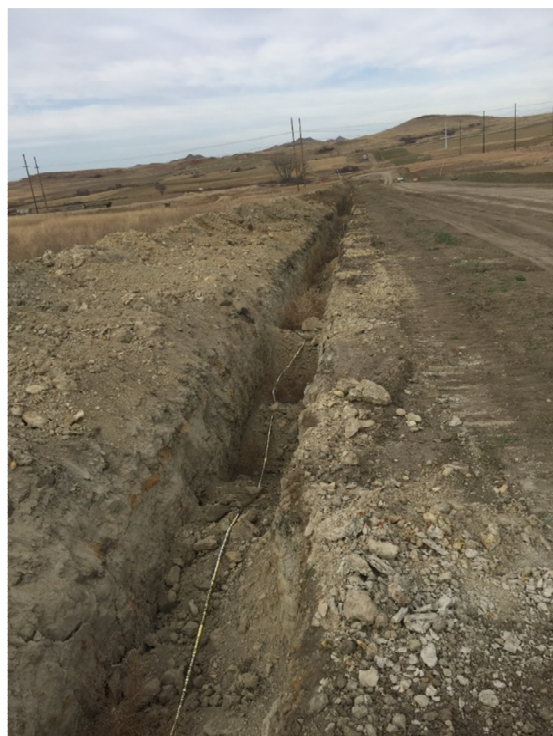
Picture 23: Backfilling, warning tape placed in trench

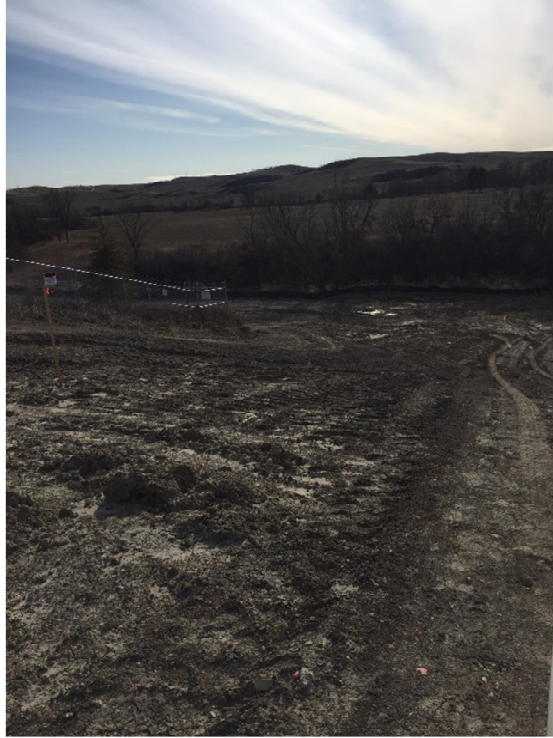
Picture 24: PI near Johnsons Corner Terminal backfilled

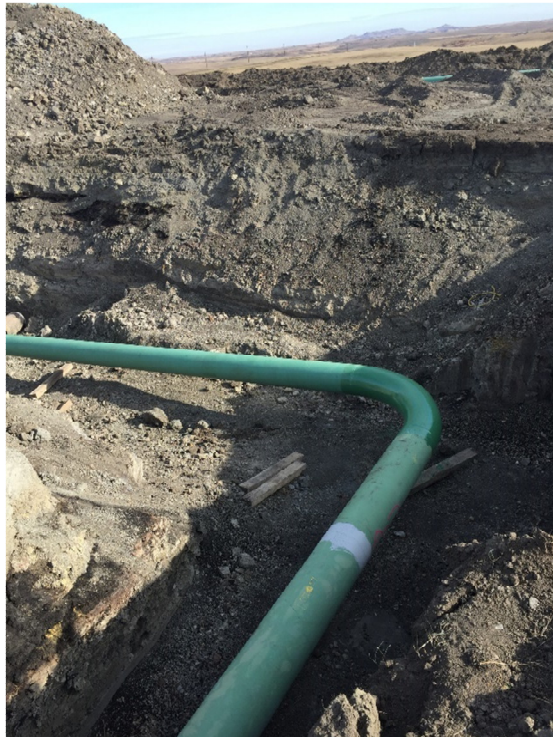
Picture 25: Point of intersect west of Johnsons Corner Terminal

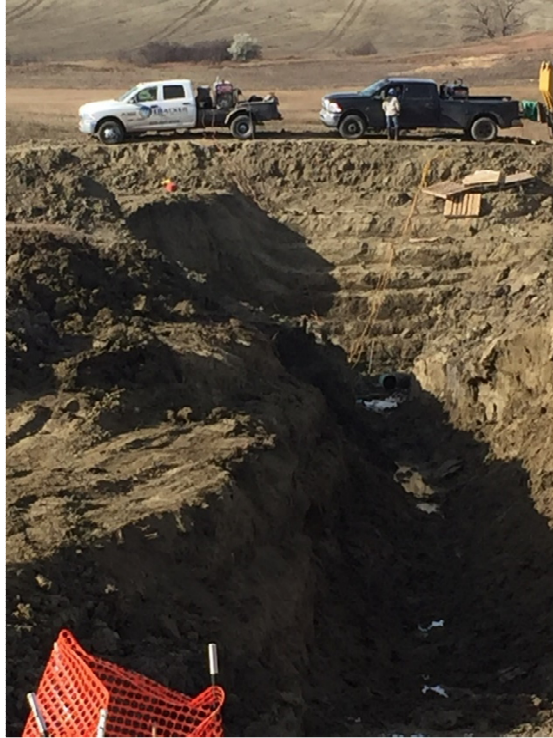
Picture 26: Excavating for trench near Highway 73 bore

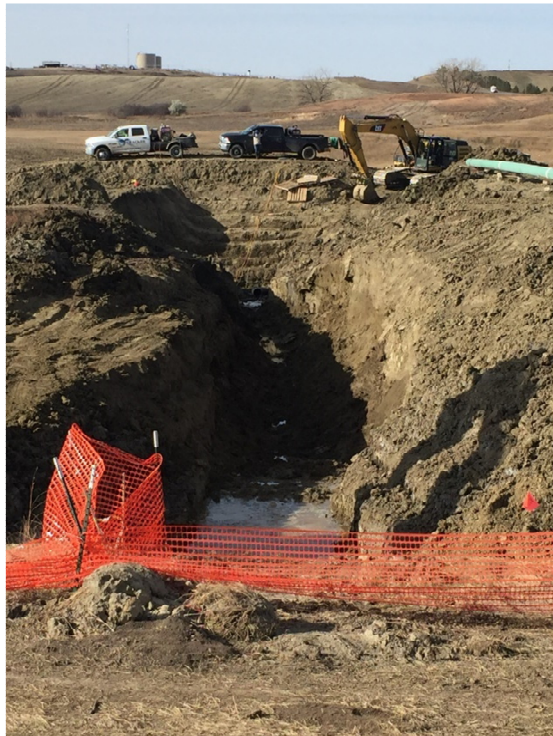
Picture 27: Excavating for trench near Highway 73 bore

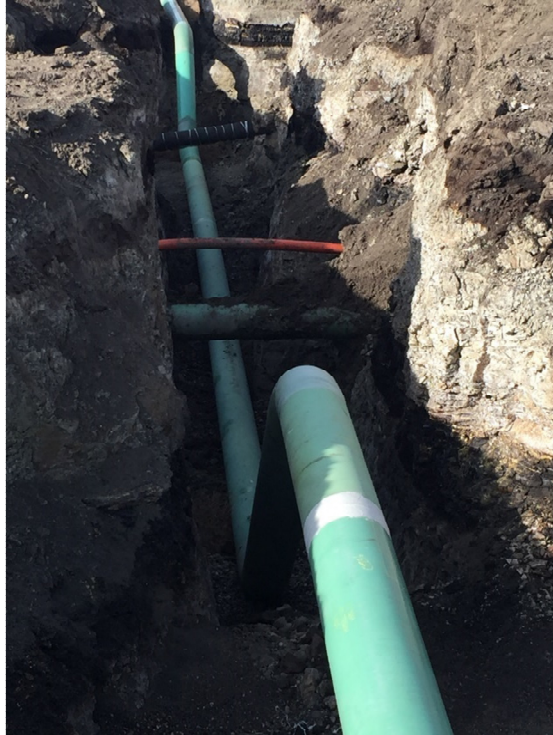
Picture 28: Utility crossing completed west of PI near station 60+00

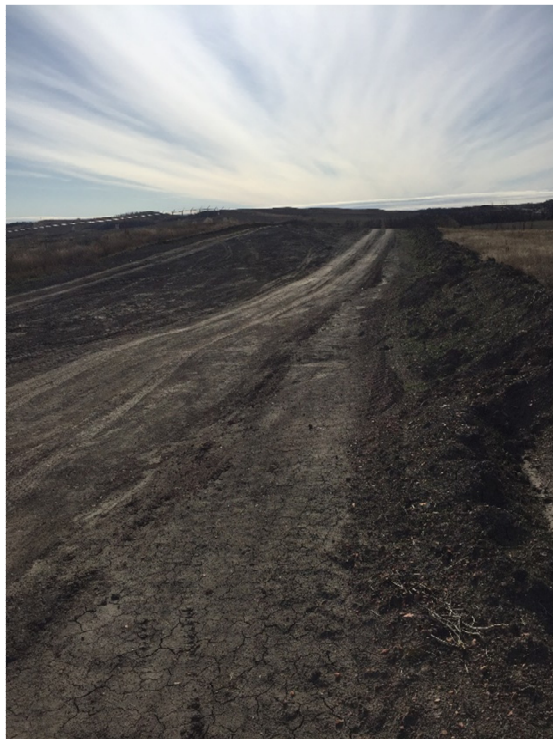
Picture 29: Backfill completed, prior to topsoil placement

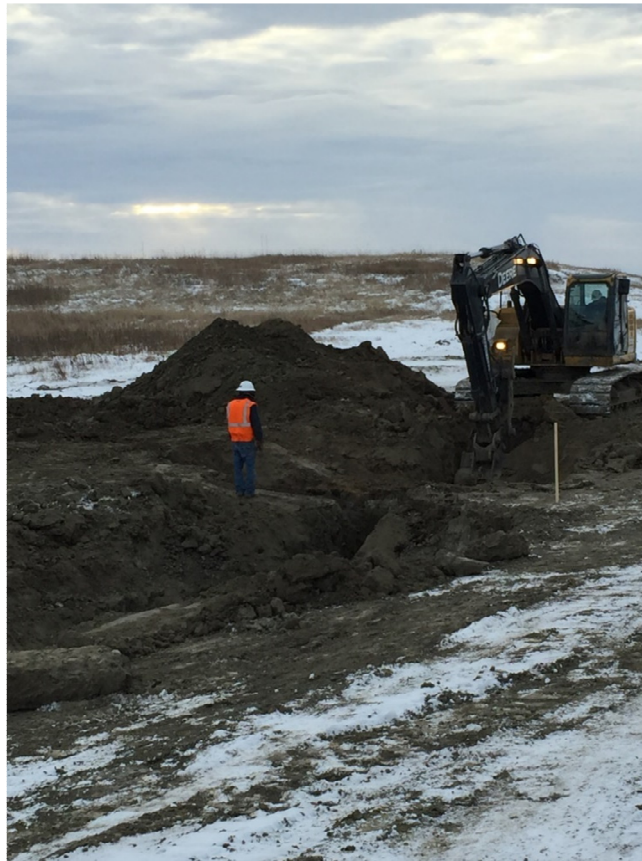
Picture 31: Excavation
