PU-16-140 TOPSOIL INSPECTION

Plains Terminal 16-Inch Crude Oil Pipeline – McKenzie Co.
Johnson's Corner to Dakota Access Pipeline

August 22, 2017

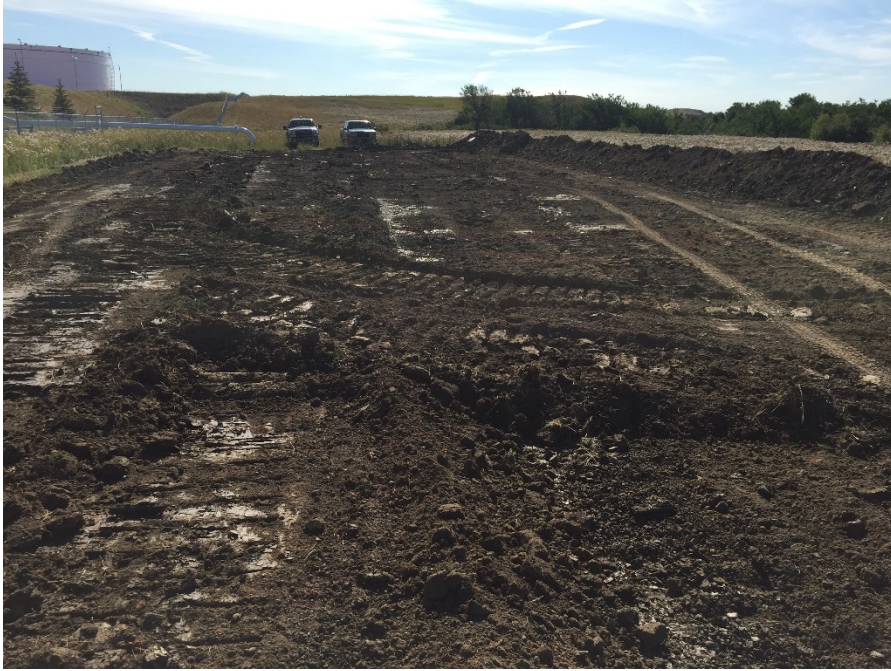
Photo 1: Sta. 3+00 looking east to start of project at 0+00

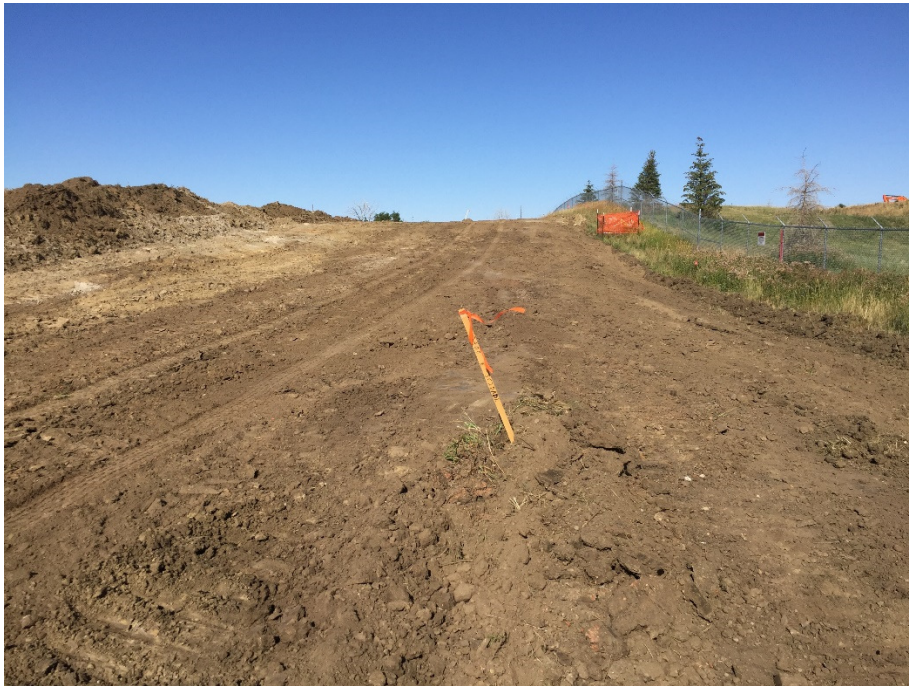
Photo 2: Sta. 3+00 looking west

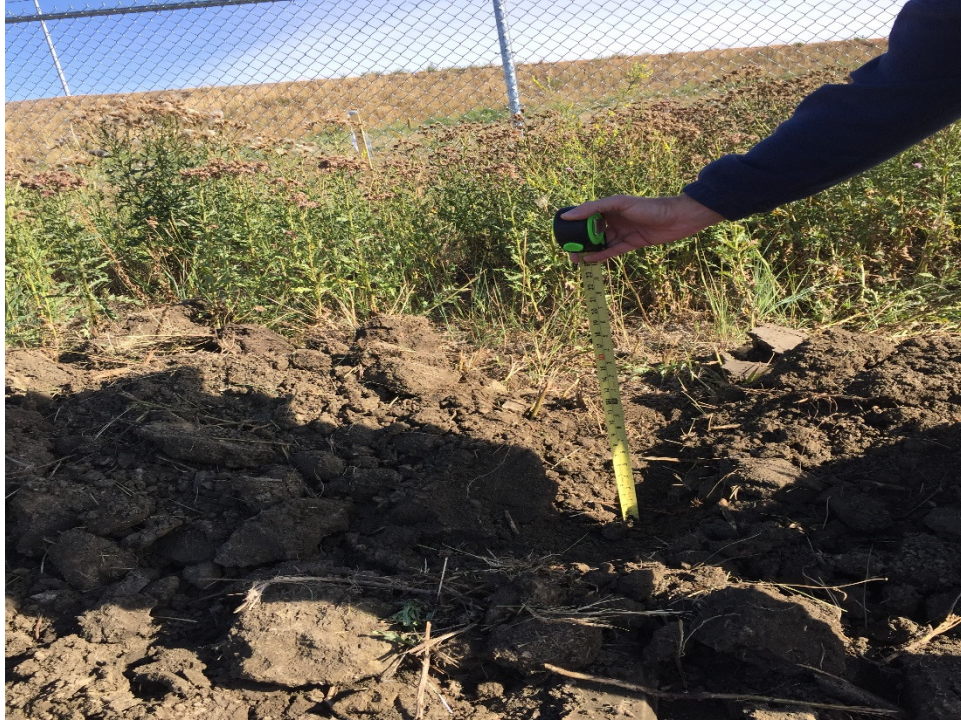
Photo 3: Sta. 3+00 showing 8 inches topsoil removal

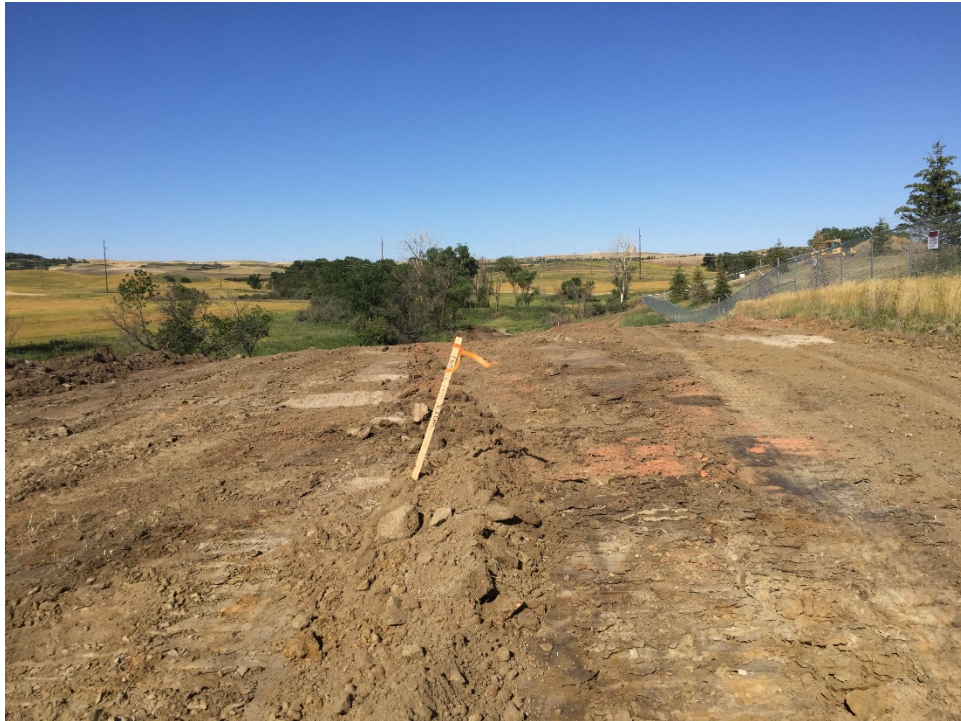
Photo 4: Sta. 4+00 looking west

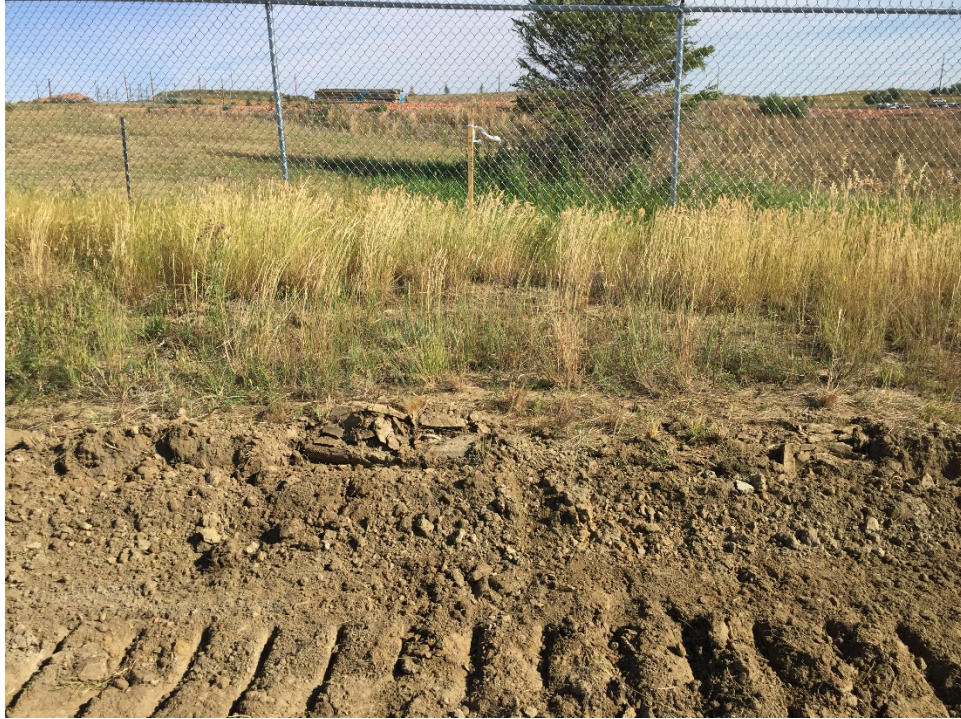
Photo 5: Sta. 4+00 showing top soil removal depth

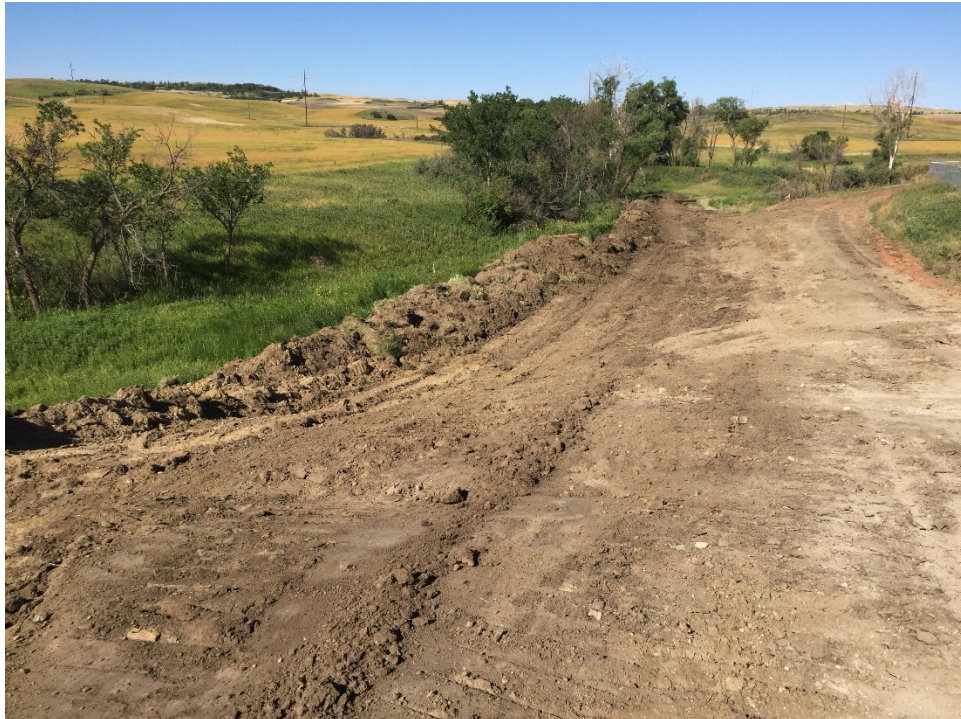
On August 4th, 2017 Paul Lee visited the worksite for approximately 5 hours. During inspection, the work activities include mowing within the ROW and topsoil stripping. Depth of topsoil varied but was observed to typically be in the range of 4" to 5" with low areas containing up to 12". Procedures of topsoil removal and stockpile were discussed while on site in order to determine the best places to stockpile. Efforts were made to reduce the risk of erosion or pooling of water due to the pile locations.

*Photo 6: Sta. 5+50 looking west showing top soil pile along drainage area.
See photo 10 on August 8 showing replacement of topsoil stockpile with silt fence.*

Construction was monitored to insure the Certificate of Corridor Compatibility and Route Permit was followed. This included verification of work locations, width of right-of-way, topsoil stripping depth, segregation of topsoil, and erosion and sediment control. Two on-site inspections were performed and documented during the topsoil removal phase. Prior to beginning earthwork, the ROW was cleared/mowed in order to assist in stripping. In the areas observed, all distinguishable amounts of topsoil (4-12 inches typical) was being cleared and placed at the edge of the ROW or in alternative locations on the project if necessary. Per discussion with contractor, some topsoil stockpiles were kept clear of low areas, where heavy drainage would be likely to cause issues with erosion along the stockpiles. Silt fence was installed in these locations to prevent erosion outside of the work area. This resolution is documented in pictures 6 and 10.

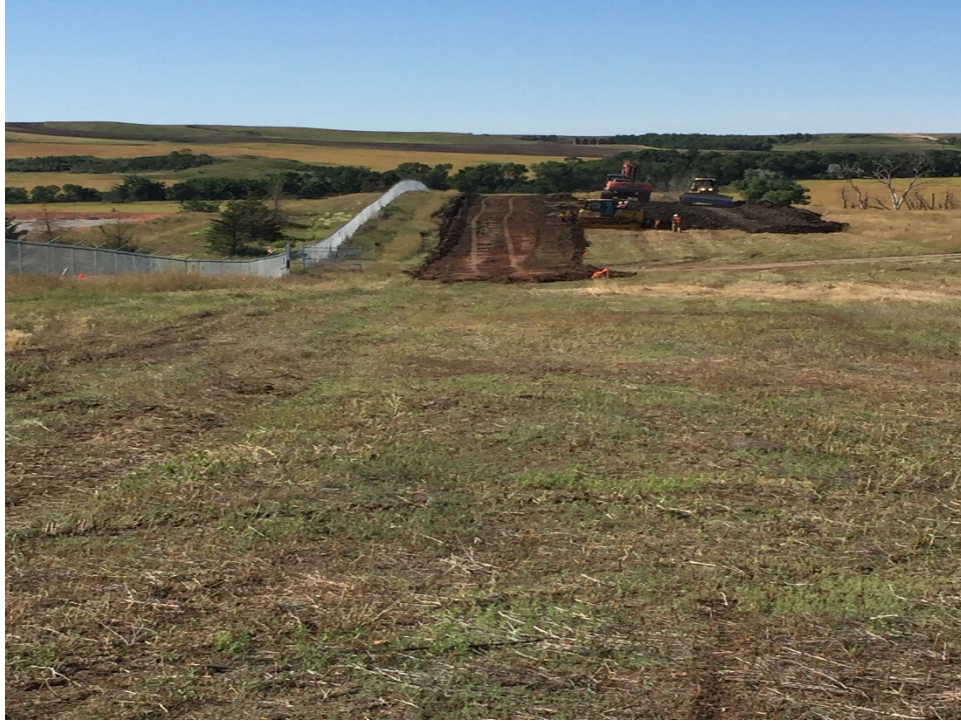
Photo 7: Sta. 13+00 looking south showing stripping operation and equipment

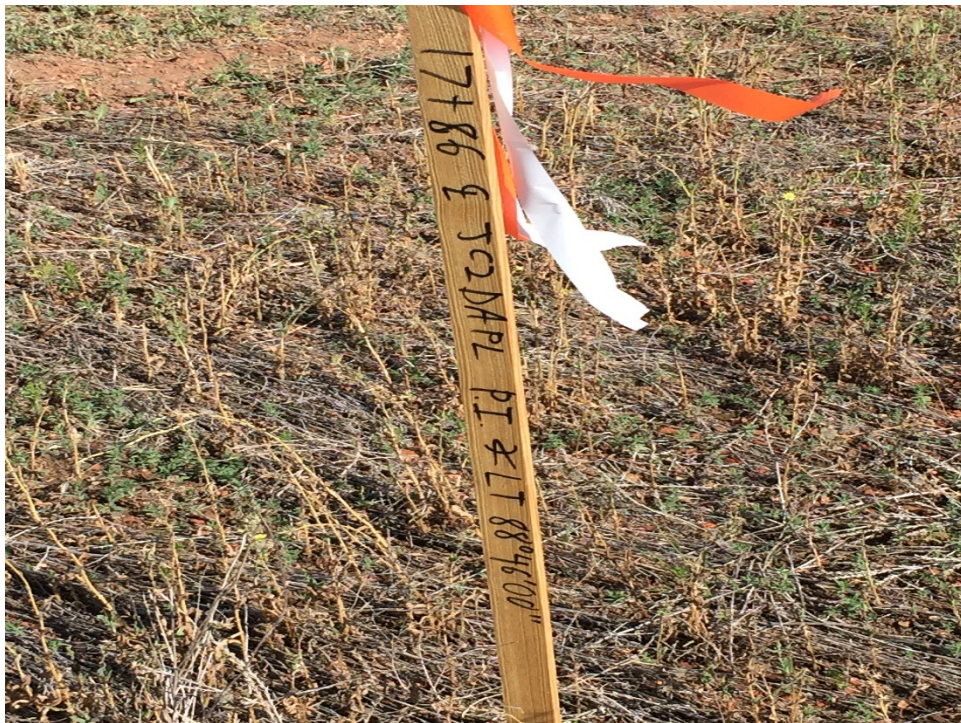
Photo 8: Sta. 17+86 point of intersection angle Lt. 88°46'00"

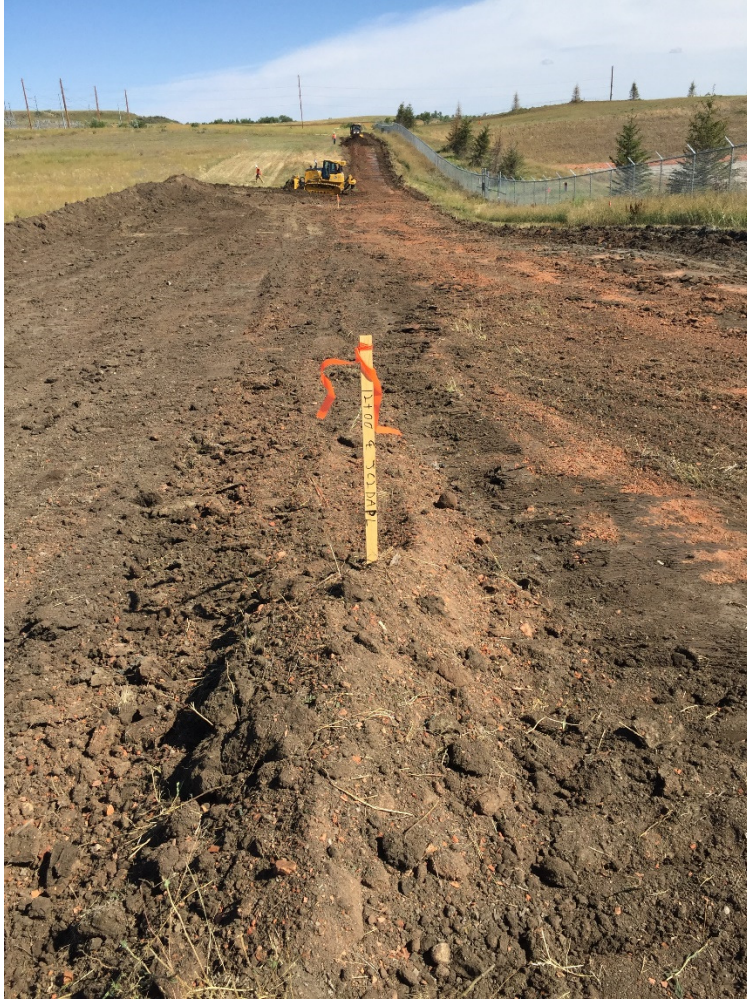
Photo 9: Sta. 12+00 looking north showing an old road under the stripping of limited top soil

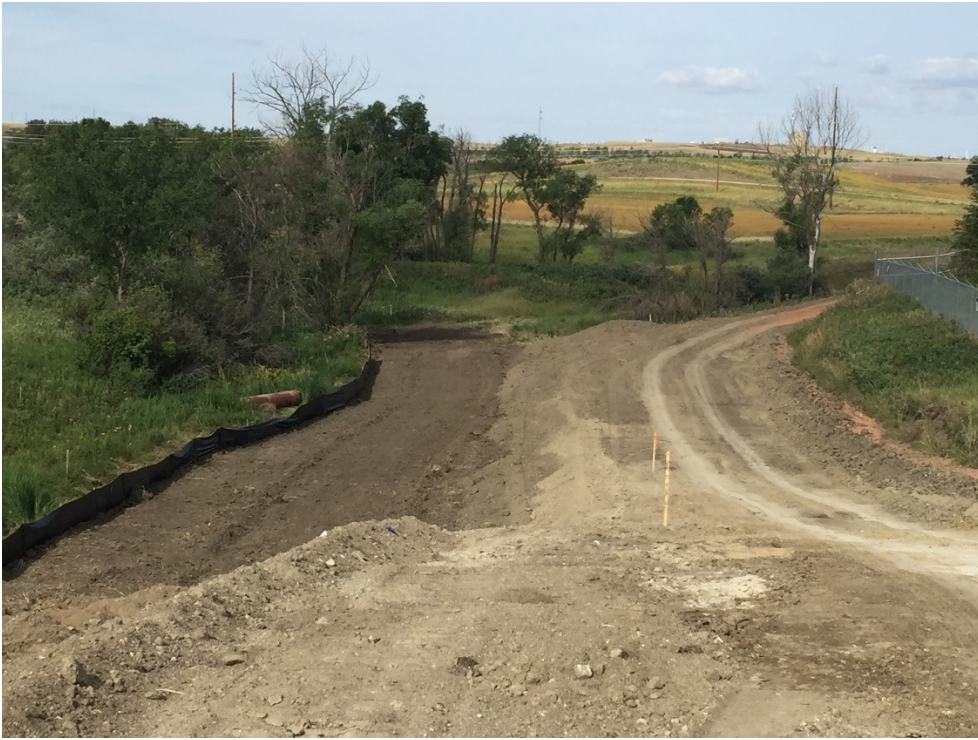
Photo 10: Sta. 7+00 looking west at the channel with topsoil removed to safe location and silt fence installed as previously committed to on site.

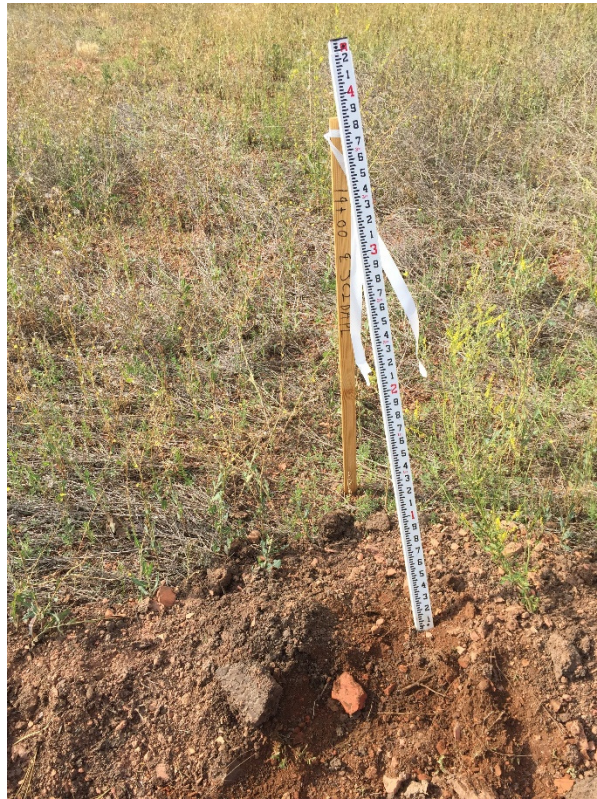
Photo 11: Sta. 14+00, 7 inches topsoil removed.

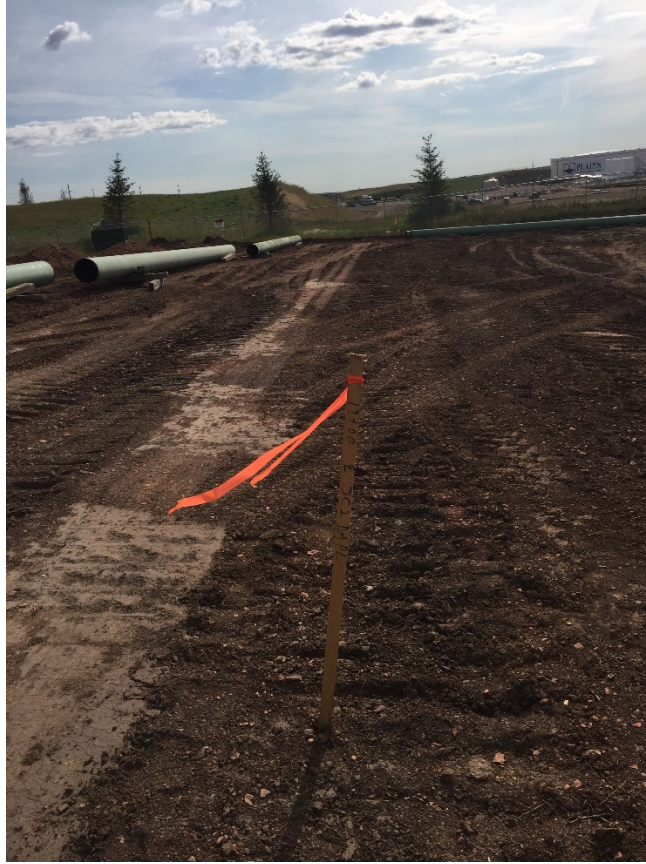
Photo 12: Sta. 19+00 looking east, pipe being delivered.

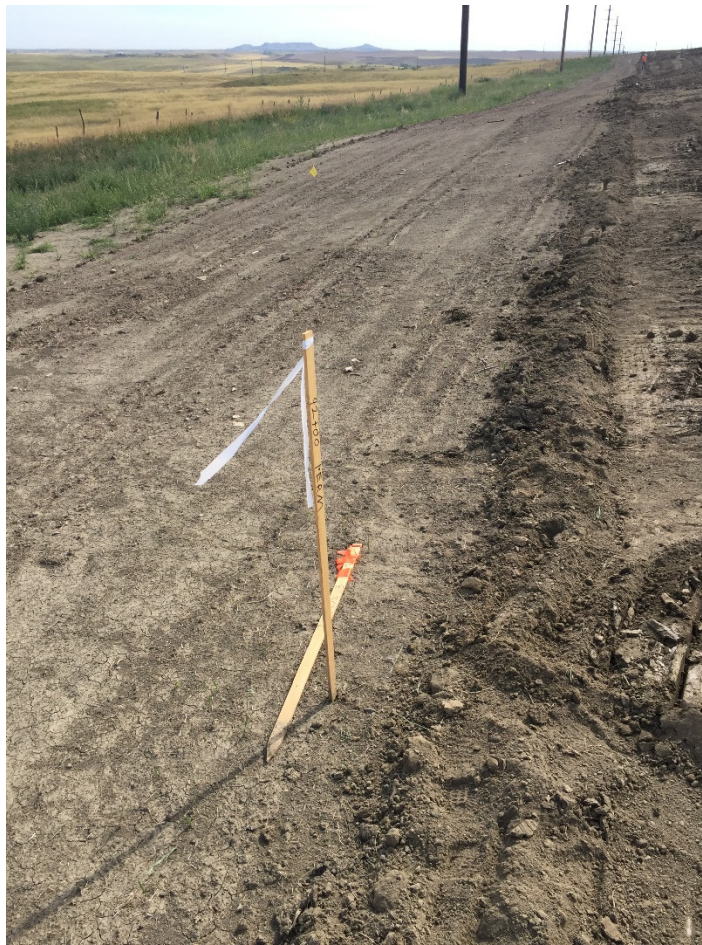
A second visit to the site took place on August 8th. Paul Lee spoke with Joe Pease to discuss some areas of thin or mixed topsoil where other pipeline installations had previously taken place. The contractor agreed to salvage whatever topsoil they could distinguish in these locations.

*Photo 14: Sta. 92+00 showing back side of topsoil pile along R/W.
The previous pipe installation is visible to the north or left with no vegetation.*

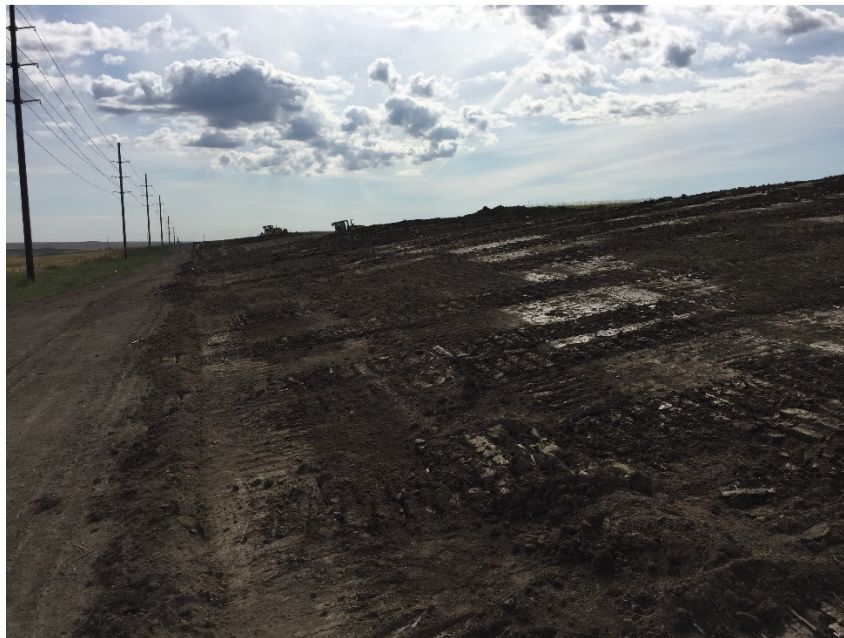
Photo 15: Sta. 92+00 looking east.

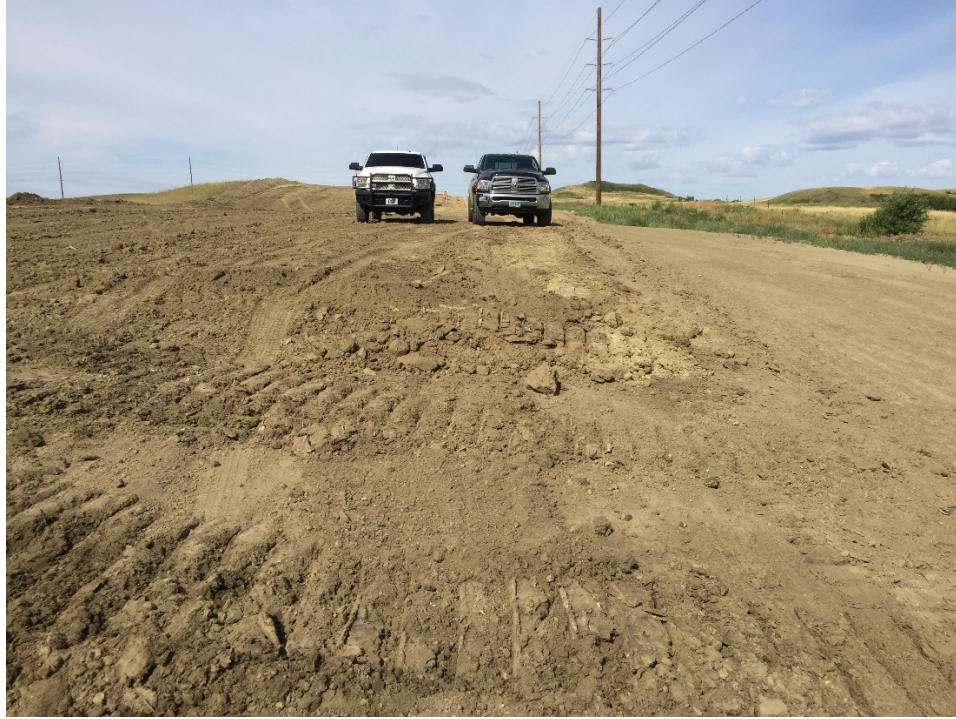
Photo 16: Sta. 92+00 looking west

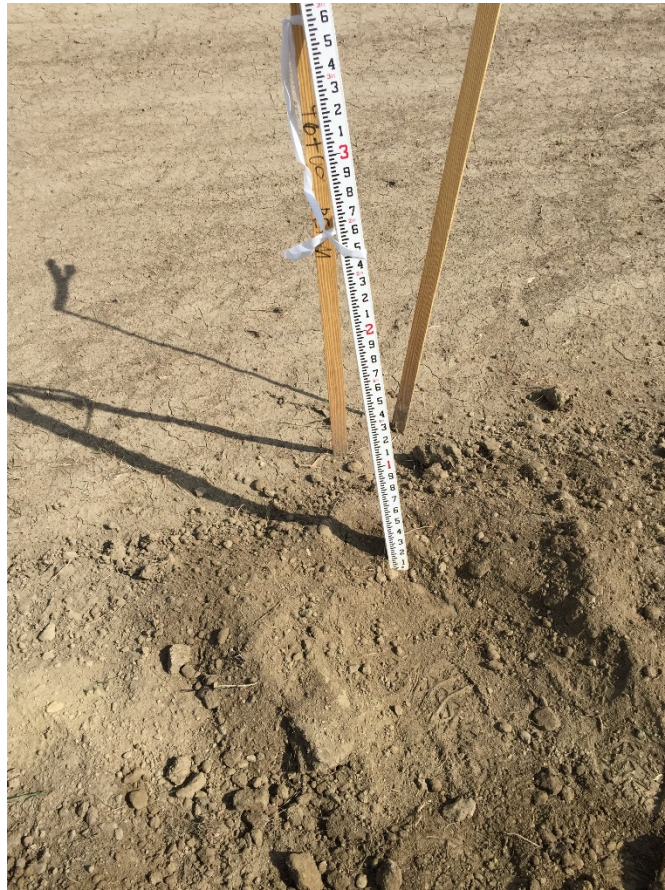
*Photo 17: Sta. 92+00 showing 4-5 inches top soil removal.
Notice soil is same from previous pipe installation on the left, outside of R/W.*

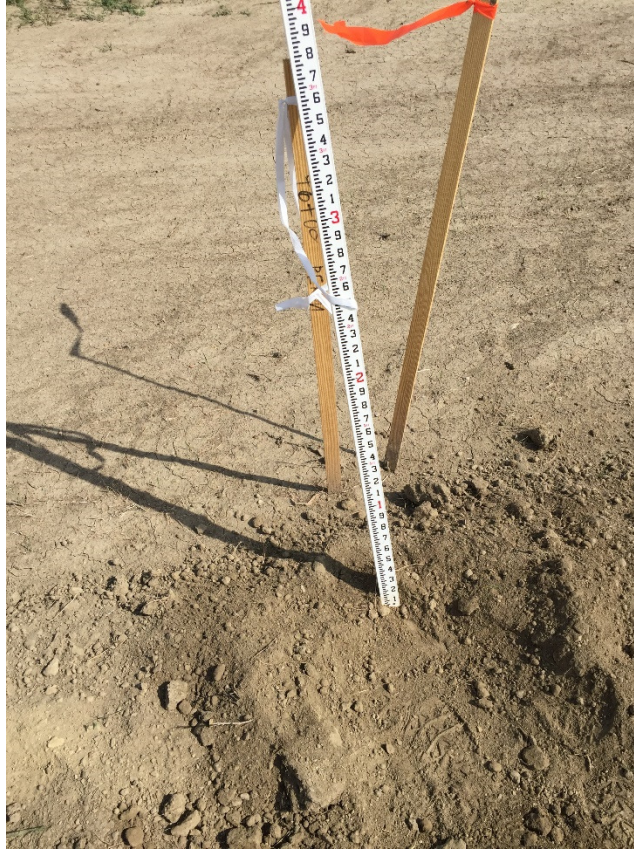
*Photo 18: Sta. 92+00 showing 4-5 inches topsoil removal.
Notice soil is same from previous pipe installation on the left outside of R/W.*

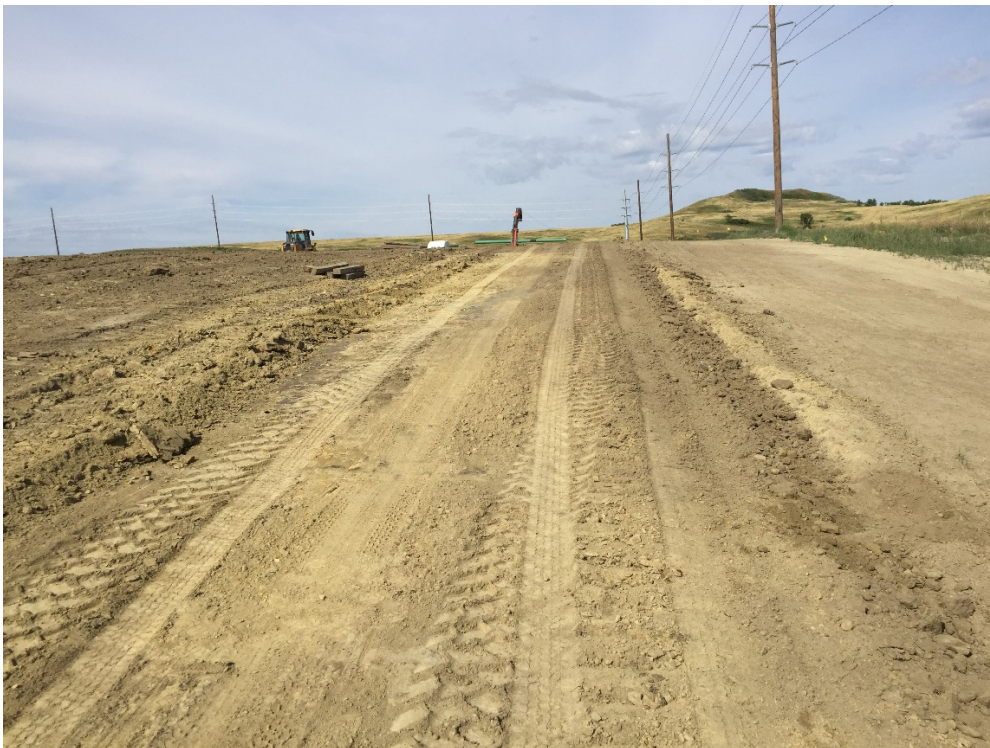
Photo 19: Facing west, Sta. 100+00. Area to right is previously installed pipeline. Area on the left side is the current project.

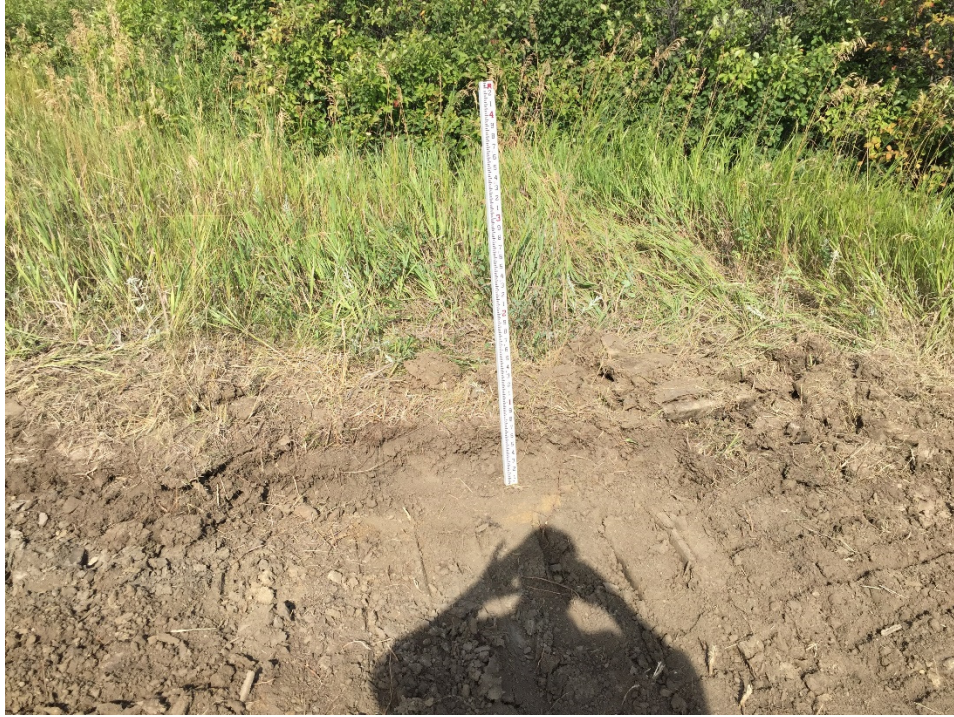
Photo 20: Sta. 108+00, 8-10 inches of topsoil.

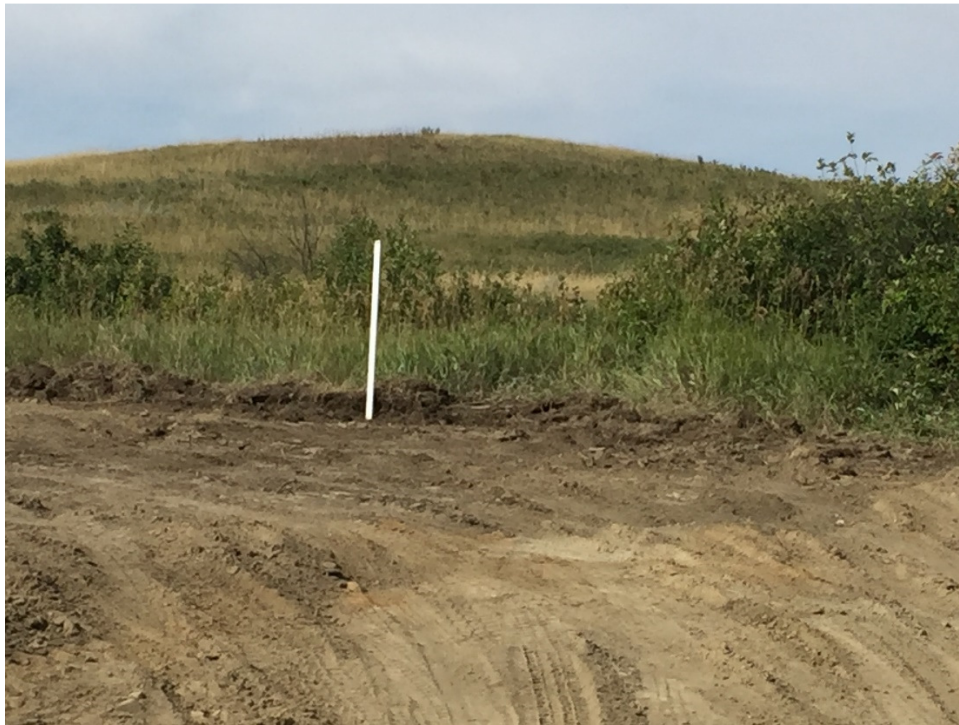
Photo 21: Sta. 108+00, 8-10 inches of topsoil.

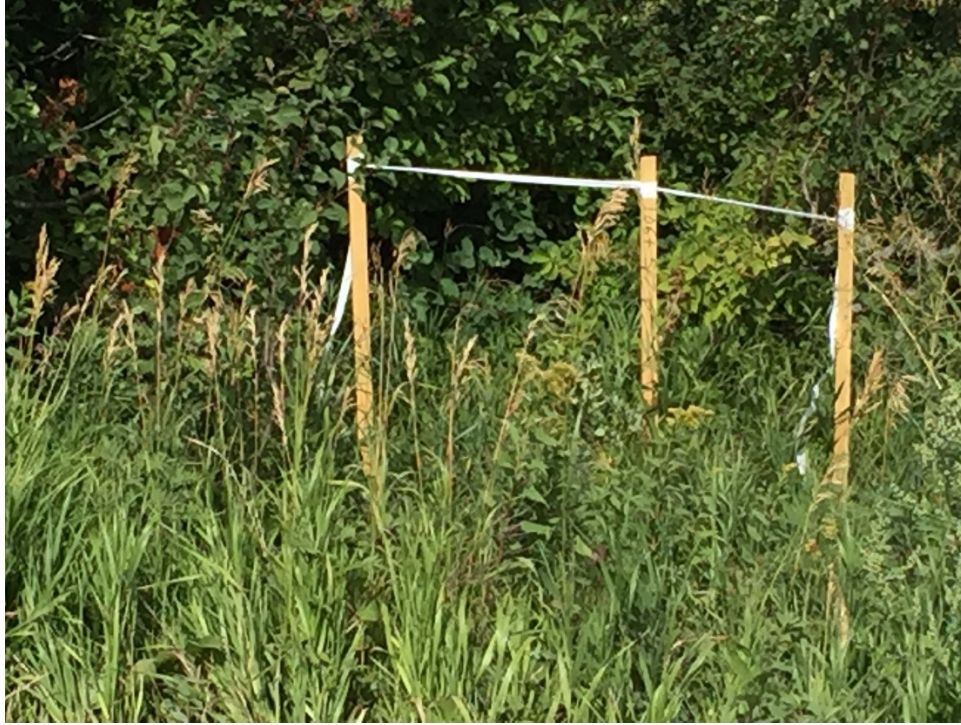
Photo 22: Angle pt. Sta. 106+00.

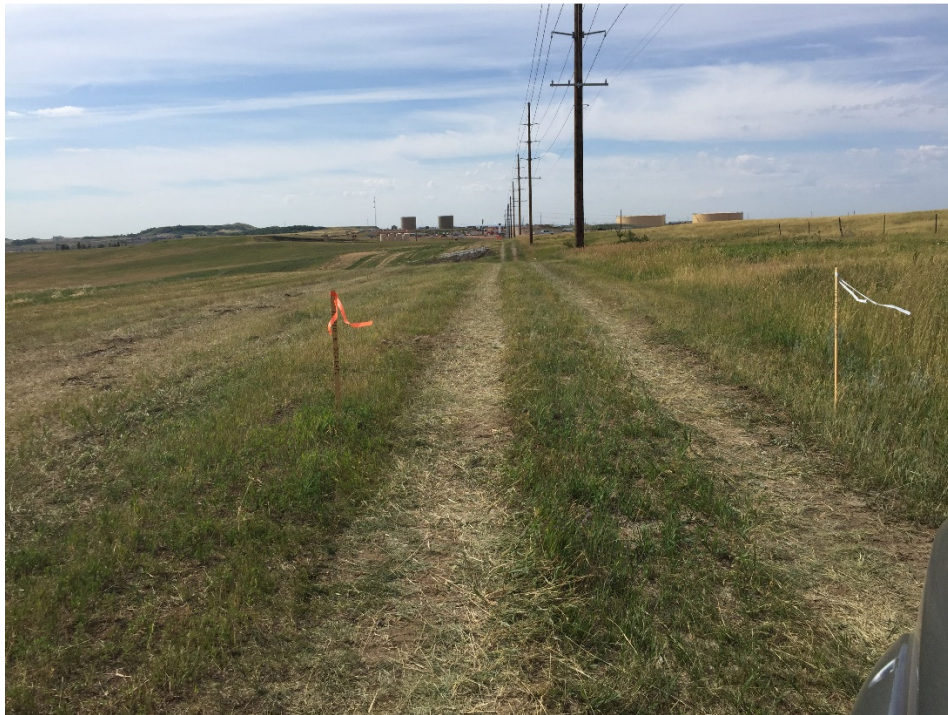
Photo 23: Sta. 113+00 area to be bored.

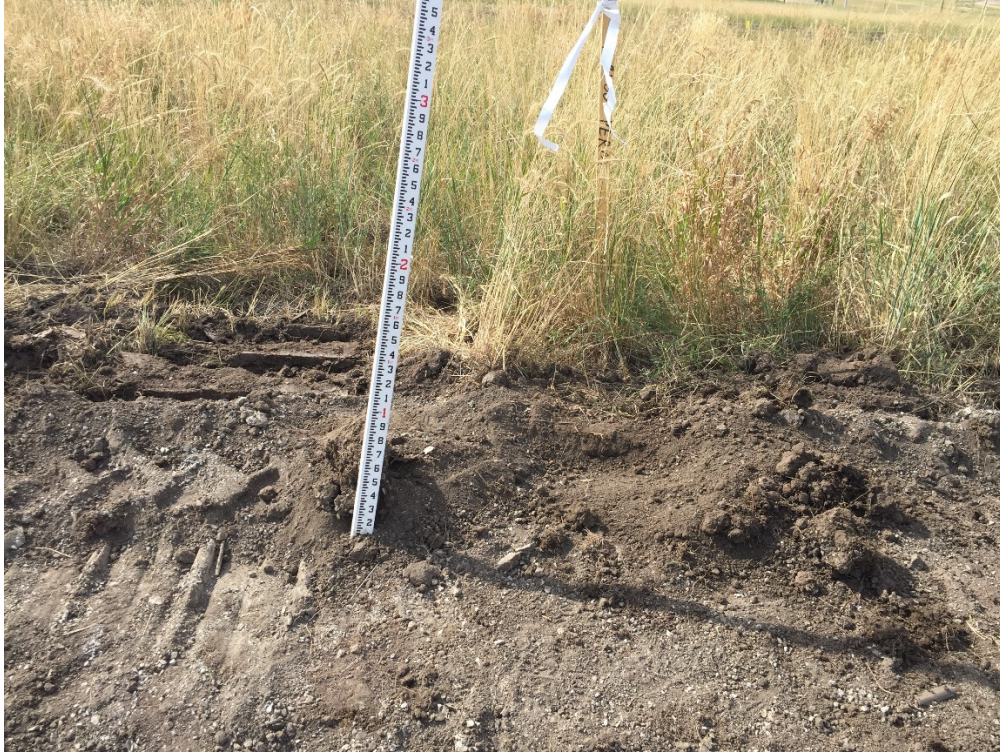
Photo 24: Sta. 126+00 8-9 inches topsoil.

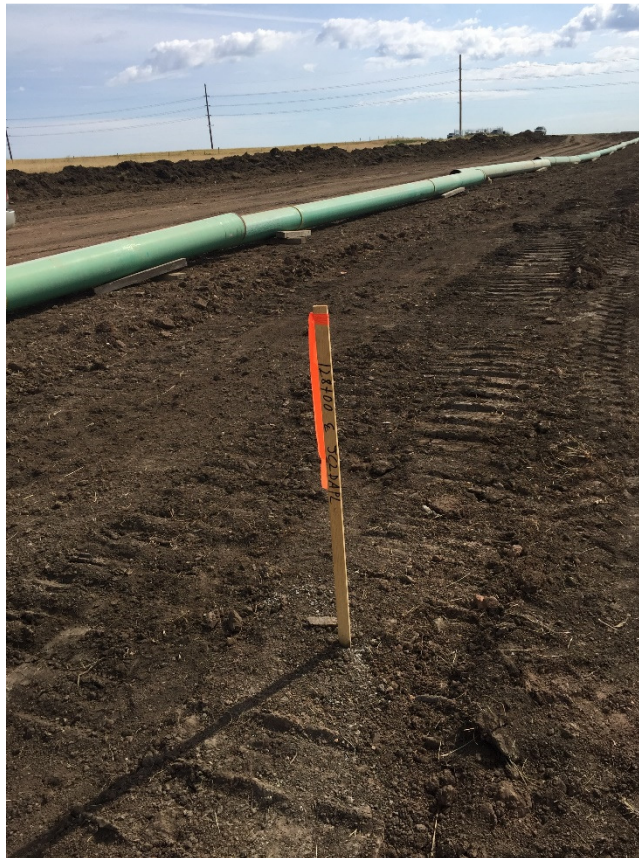
Photo 25: Sta. 128+00 pipe staged, preparing to weld.

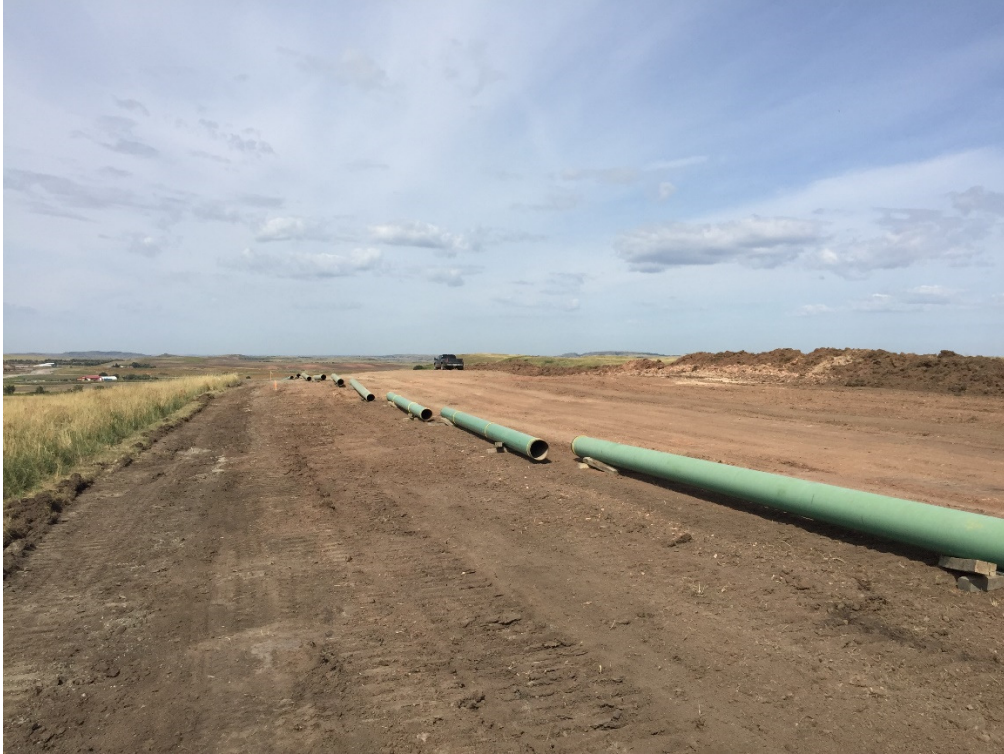
Photo 26: Sta. 130+00 looking west.

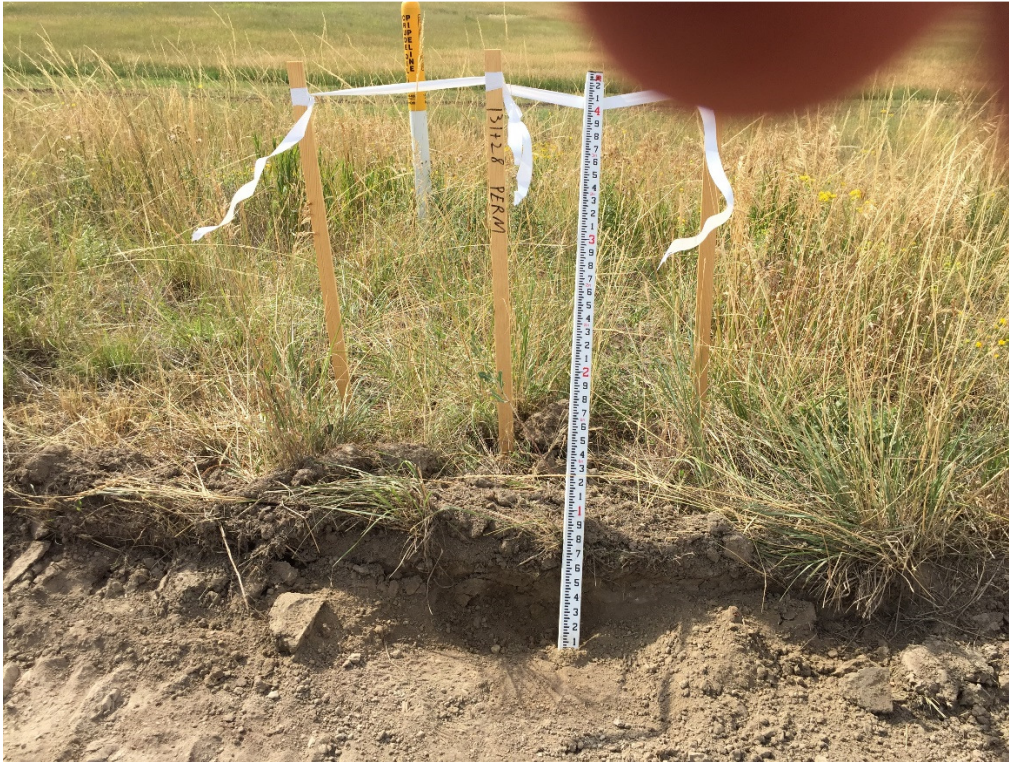
Photo 27: Sta.131+28 8-9 inches of topsoil.

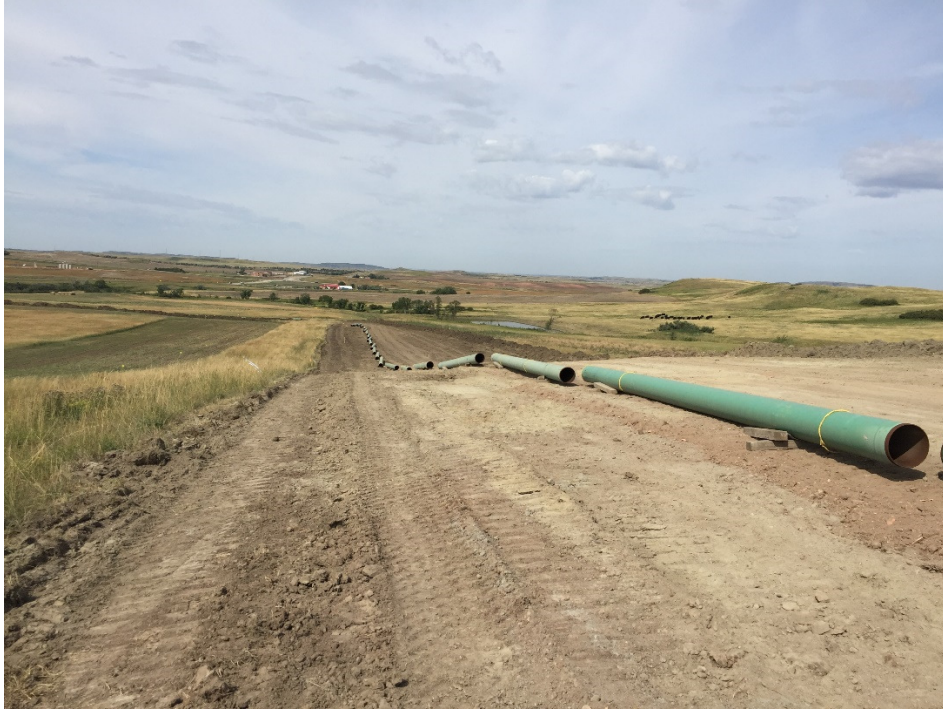
Photo 28: Sta. 142+00 Looking west.

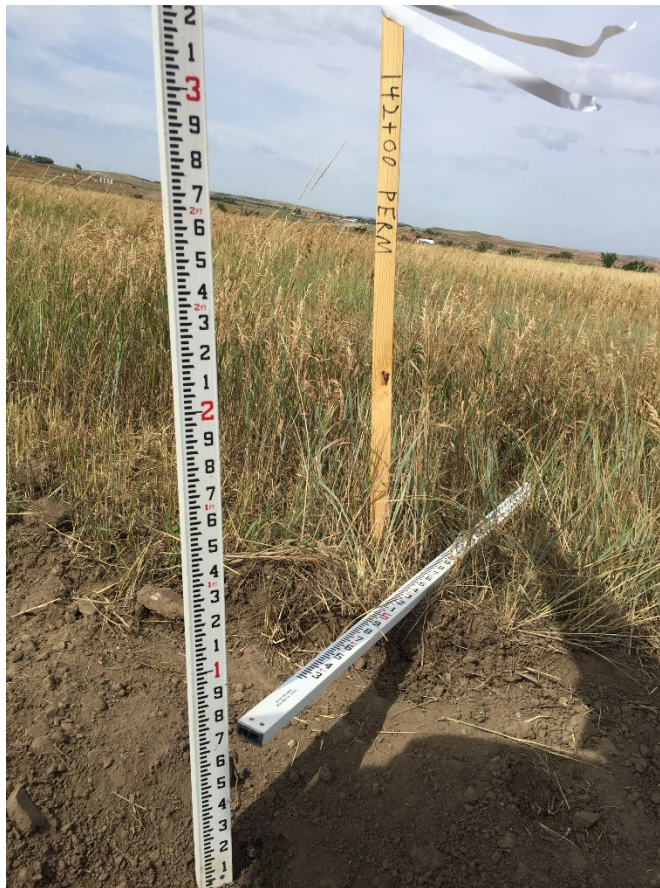
Photo 29: Sta. 142+00 7-8 inches of topsoil.

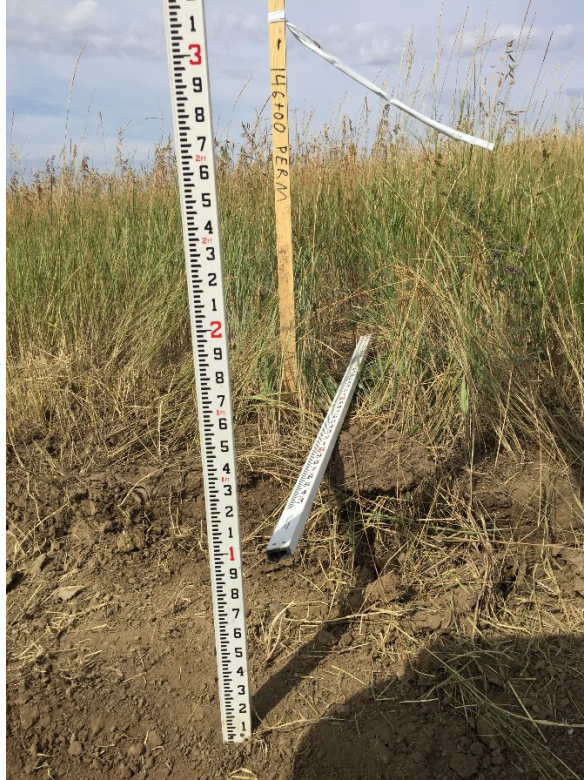
Photo 30: Sta. 146+00 9-10 inches of topsoil.

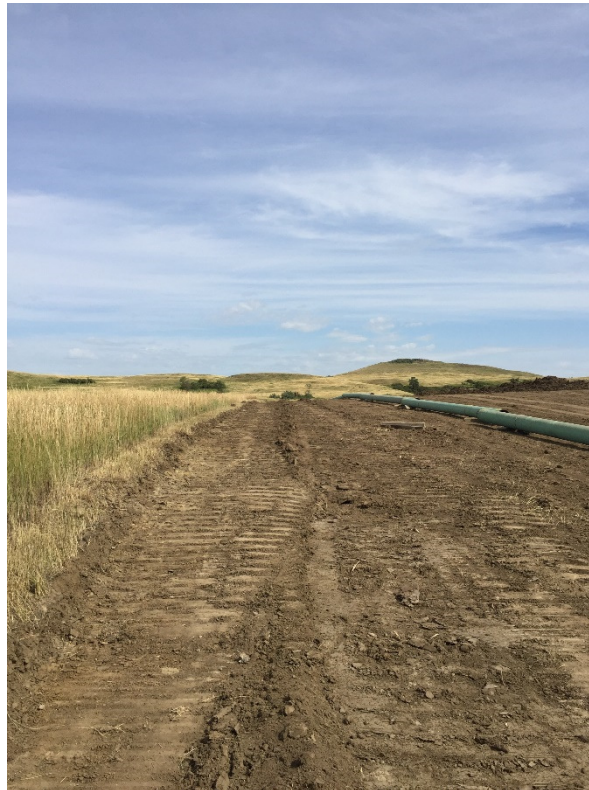
Photo 31: Sta. 146+00 looking north.

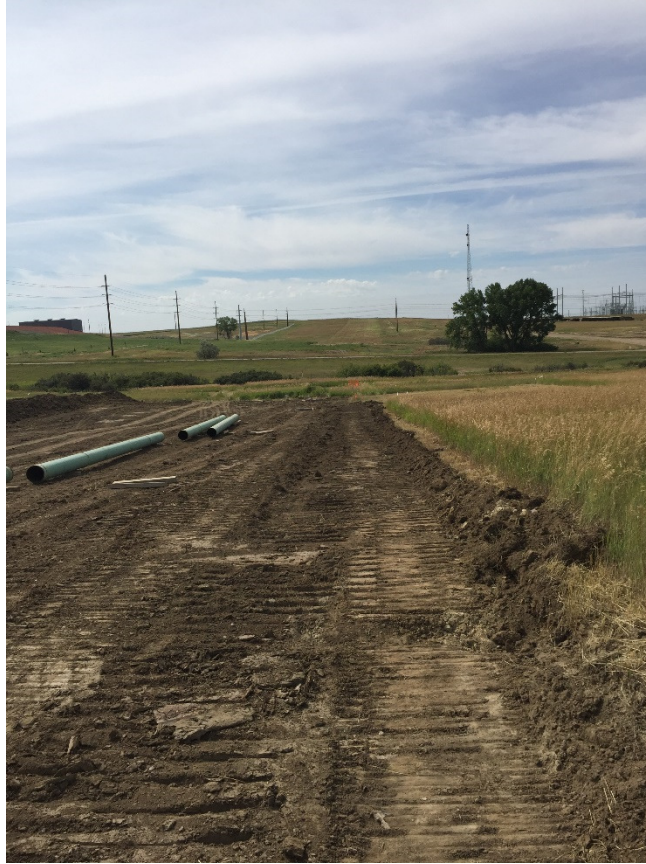
Photo 32: Sta. 147+00 looking south.
