PU-16-140 AS-BUILT INSPECTION

Plains Terminal 16-Inch Crude Oil Pipeline – McKenzie Co.
Johnson's Corner to Dakota Access Pipeline

November 28, 2017

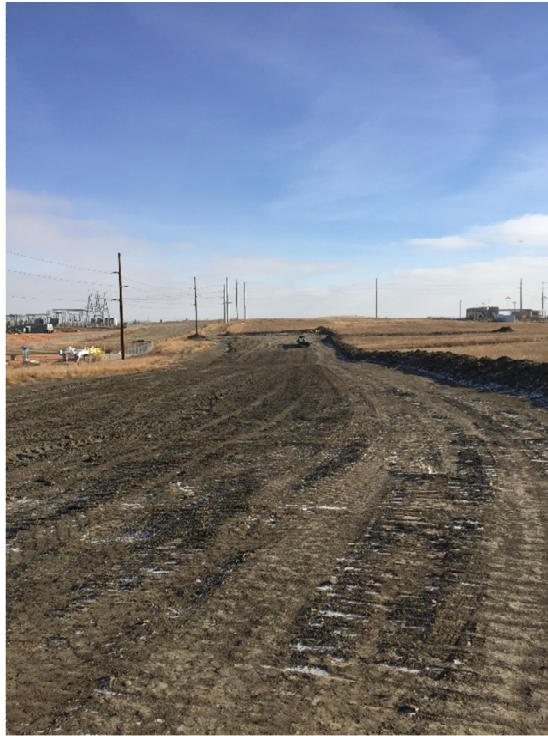
Picture 1: Finish grading, some topsoil remaining to be spread

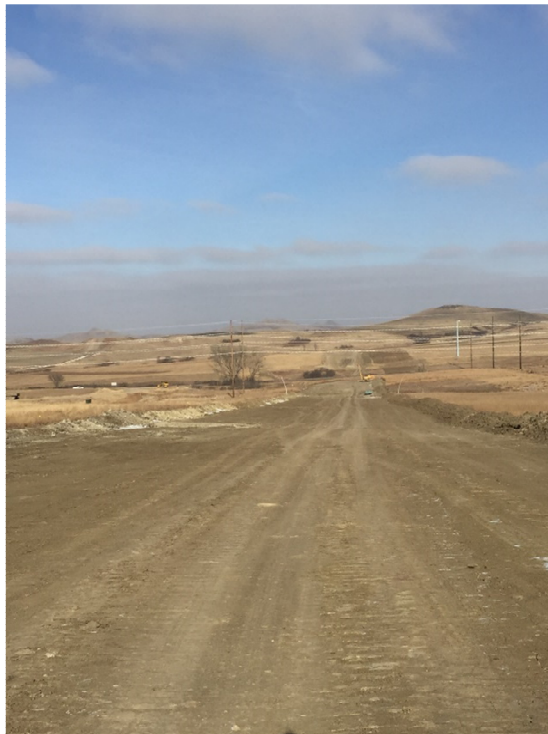
Picture 2: Finish grading subgrade, looking north

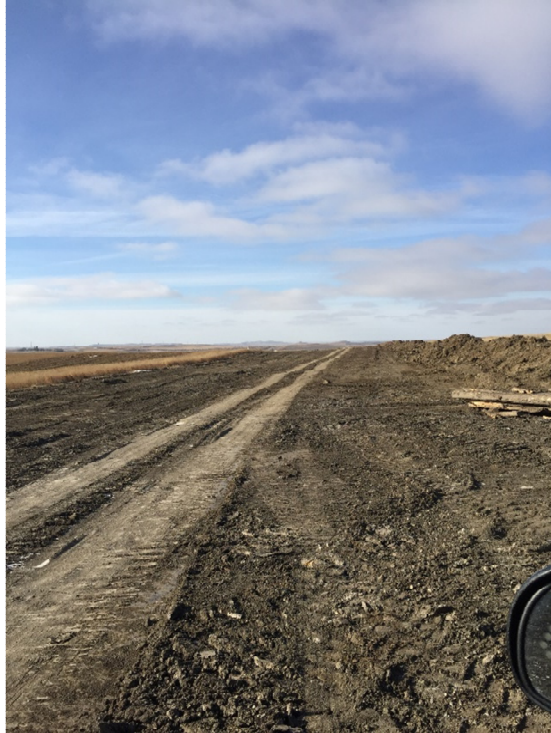
Picture 3: Grading completed prior to topsoil spreading

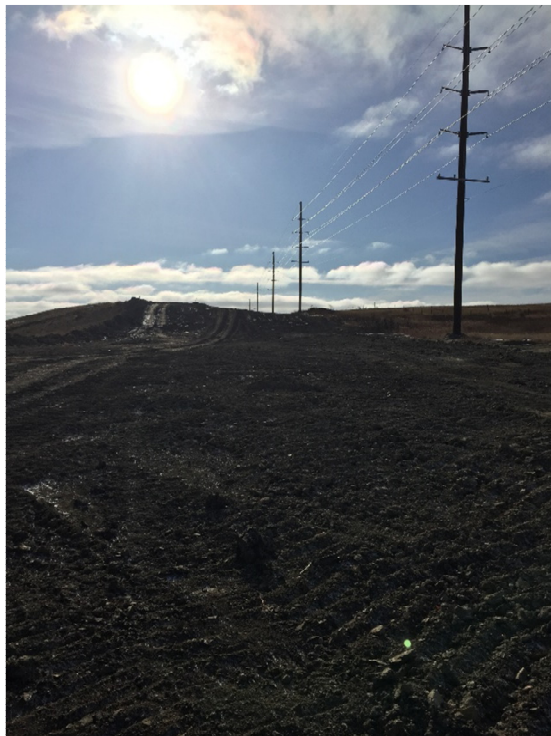
Picture 4: Grade returned to previous contours

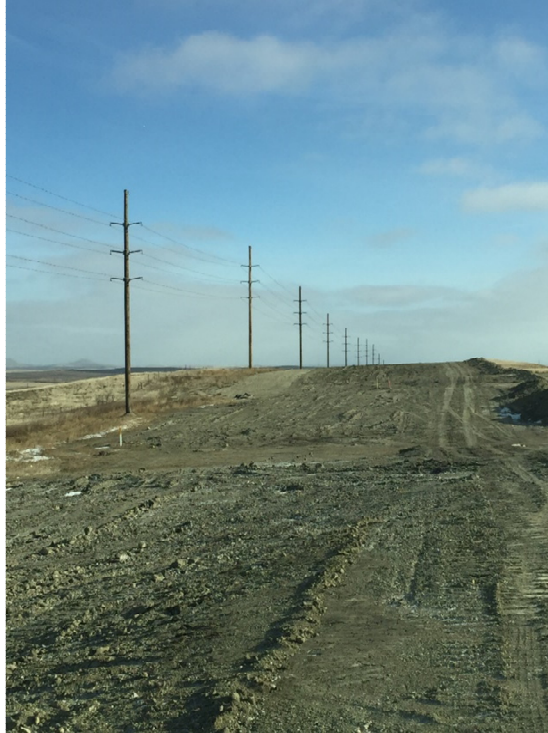
Picture 5: Low area to be graded before topsoil is spread, looking east

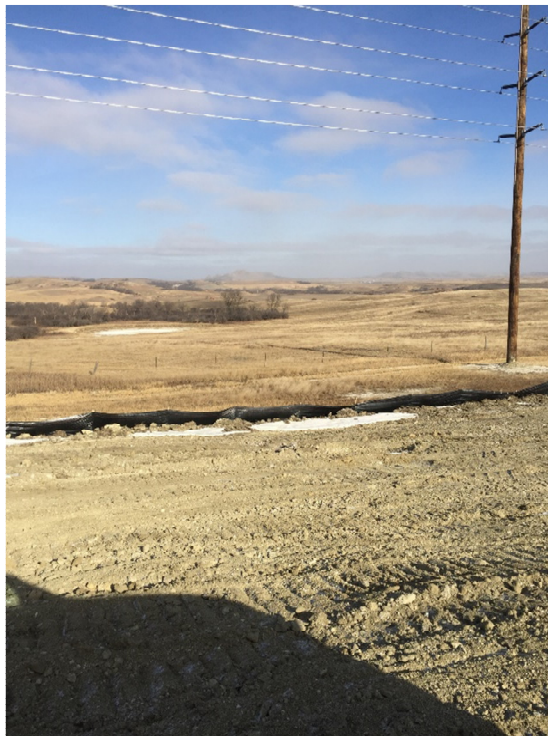
Picture 6: Silt fence at drainage area, finish grading completed

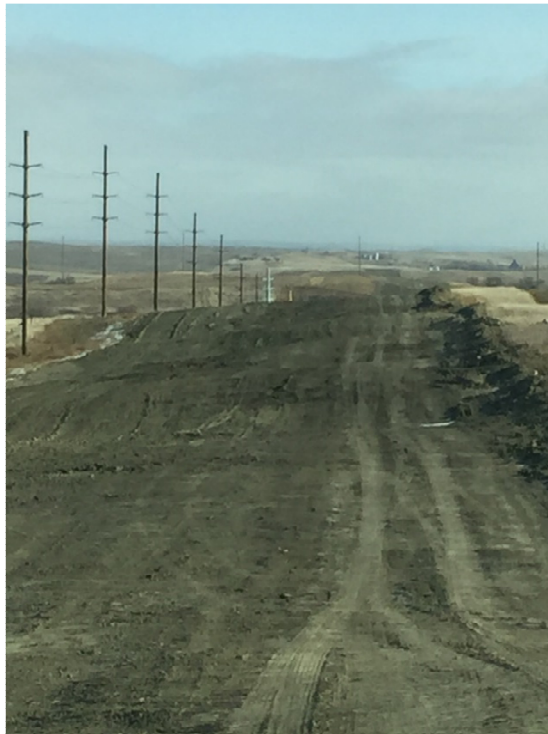
Picture 8: Grade restored to original contours prior to placing topsoil

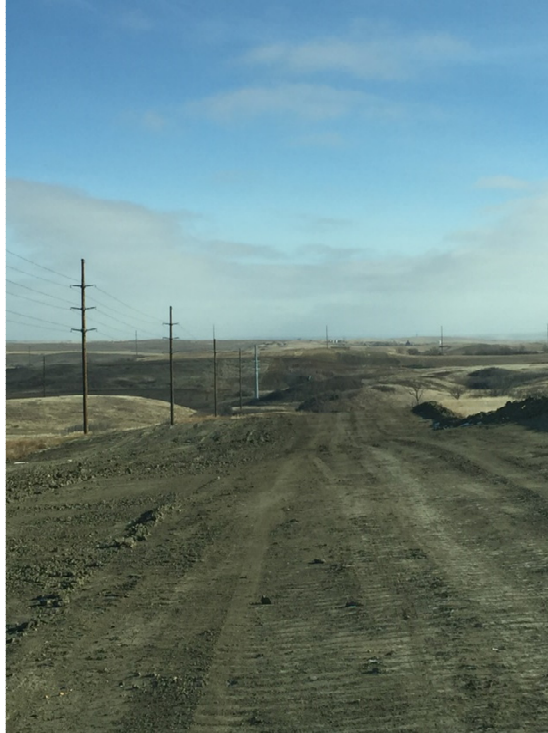
Picture 11: Ready for topsoil to be spread, showing grade returned to existing contours

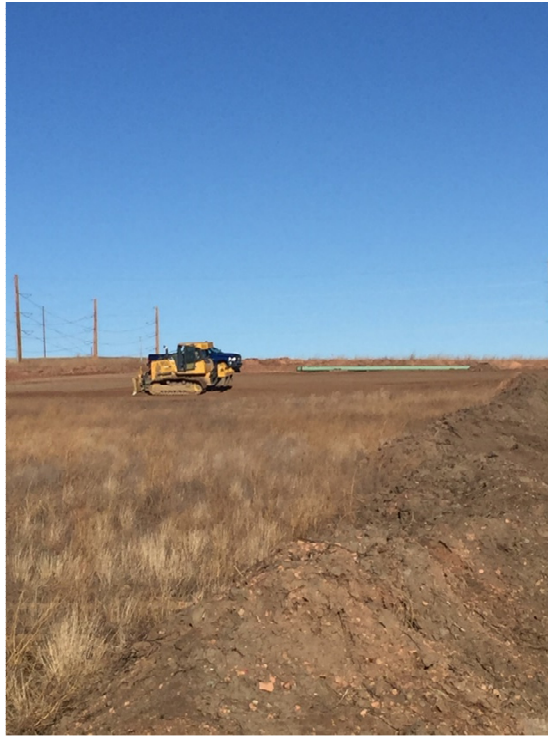
Picture 14: Equipment working on restoring grade

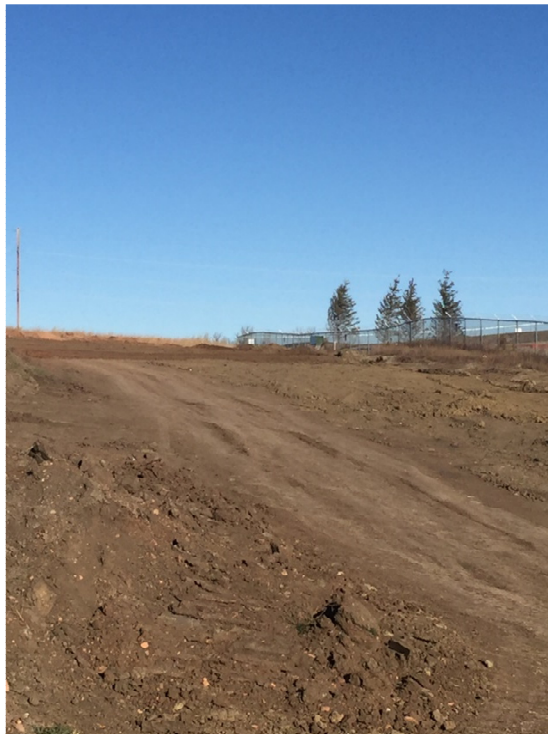
Picture 15: Topsoil spreading beginning near Johnsons Corner Terminal

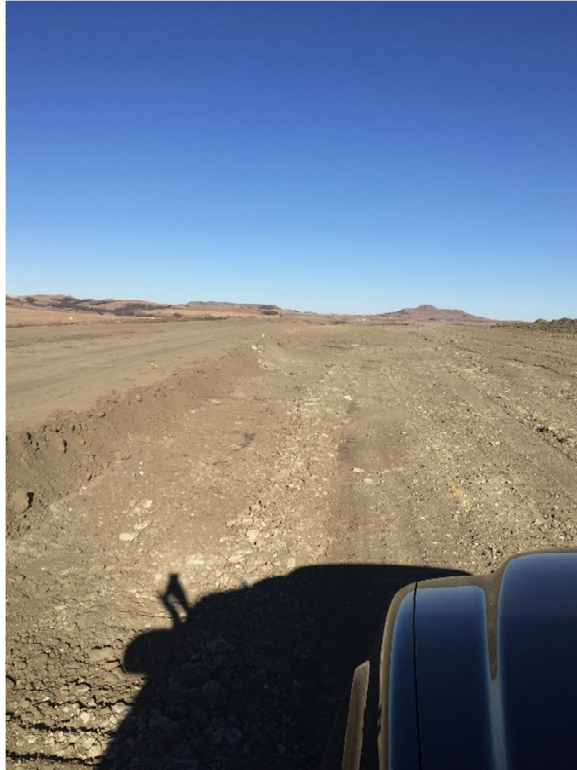
Picture 18: Grading in progress, looking north. Beginning to spread topsoil from berm

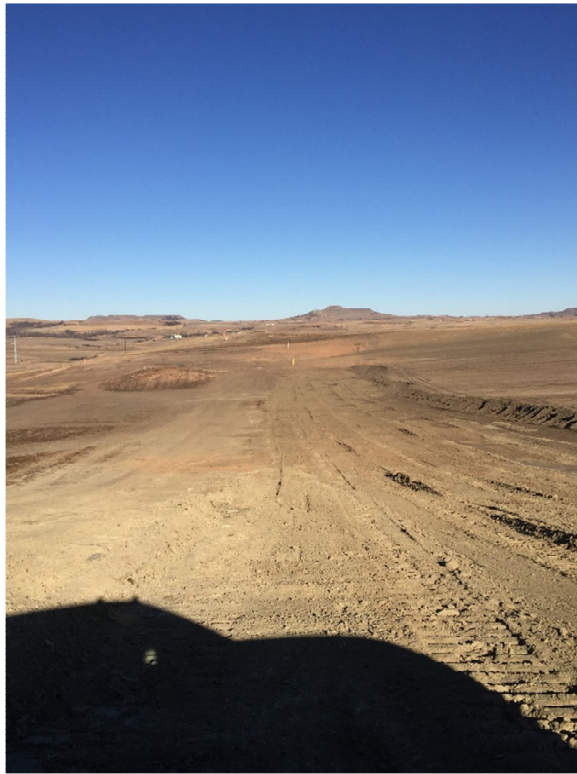
Picture 19: Grading in progress, looking north

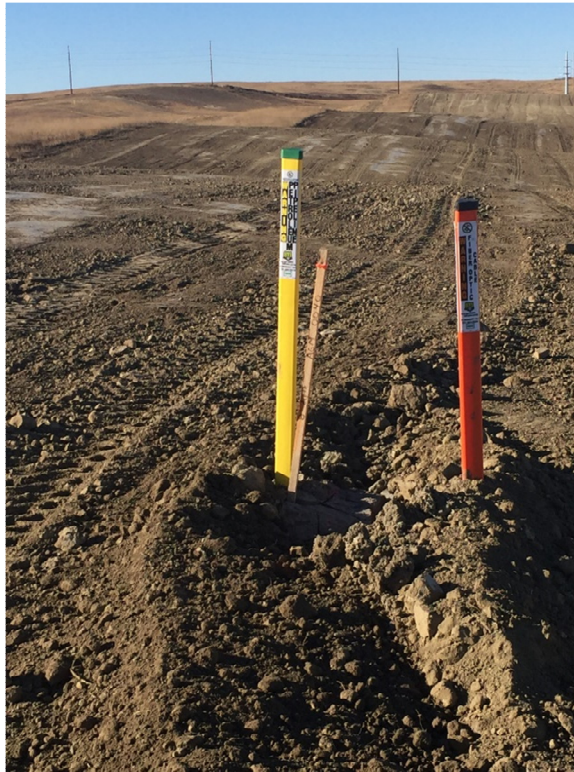
Picture 20: Topsoil completed, looking west

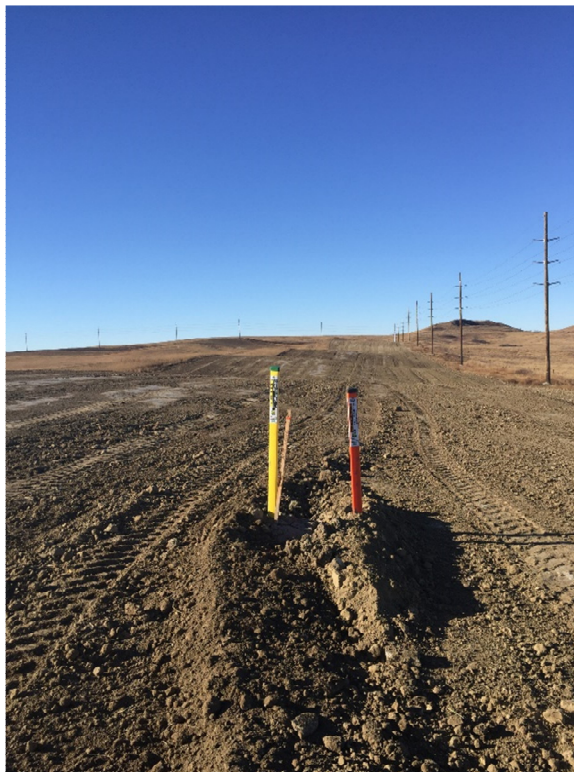
Picture 21: Topsoil spreading completed, looking west

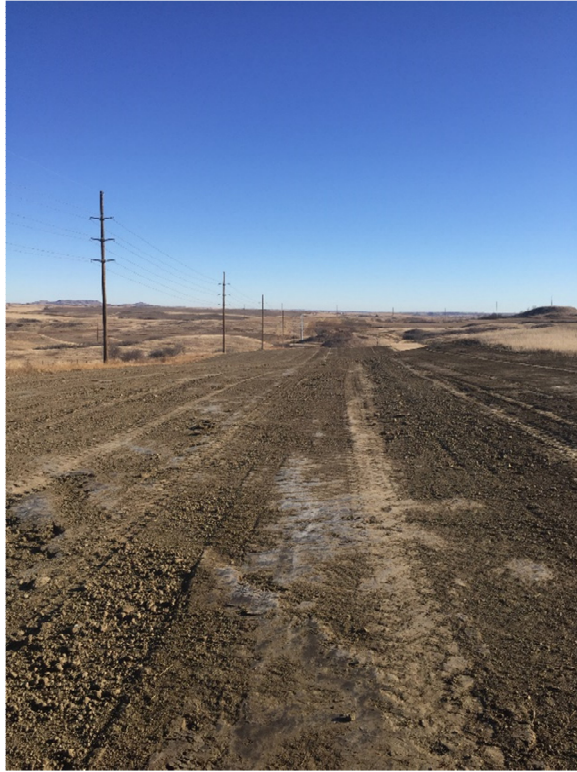
Picture 22: Topsoil spreading completed, looking east

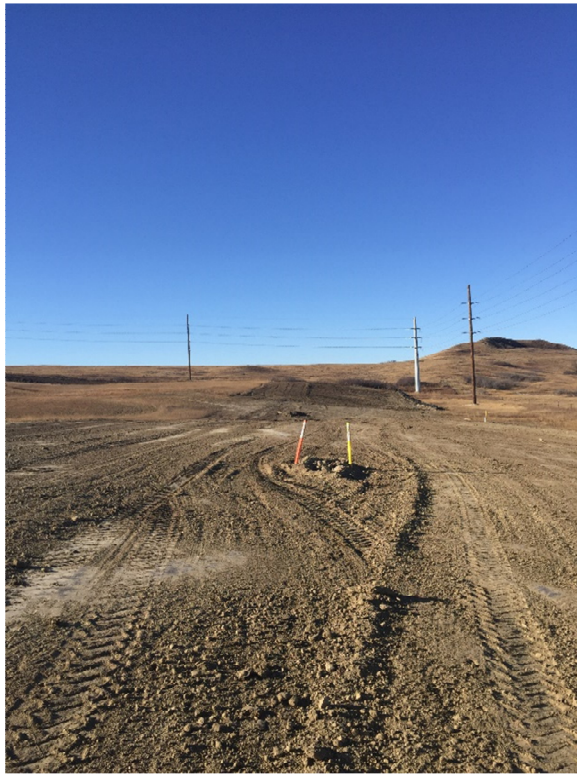
Picture 23: Topsoil spreading recently completed in background, looking west

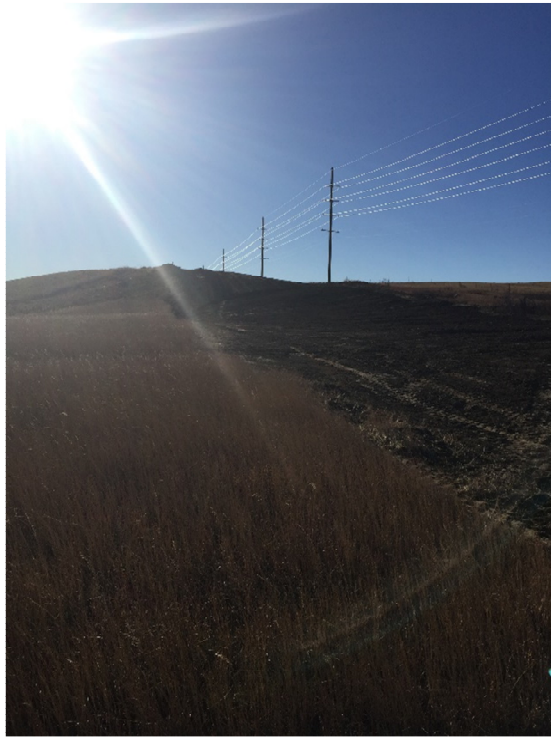
Picture 25: Topsoil spreading completed

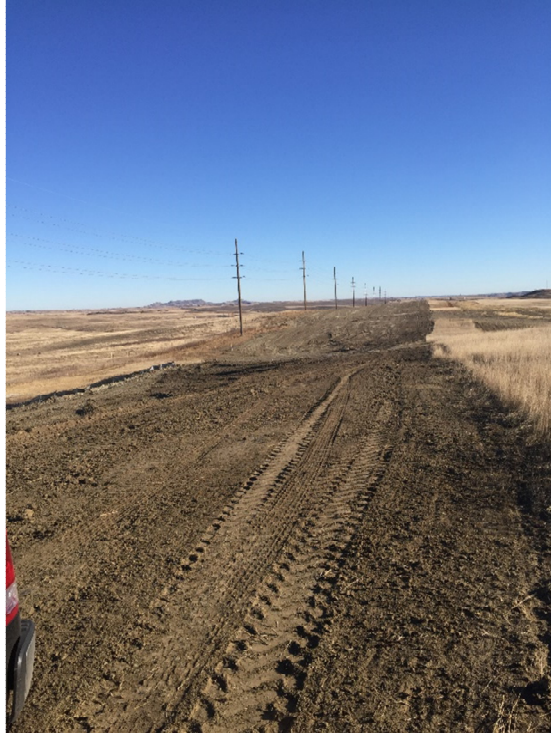
Picture 26: Topsoil spreading completed, looking east

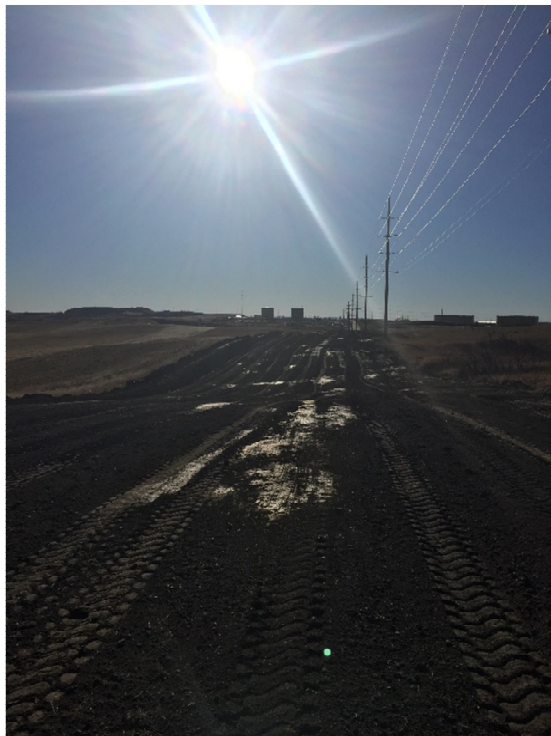
Picture 27: Topsoil spreading completed

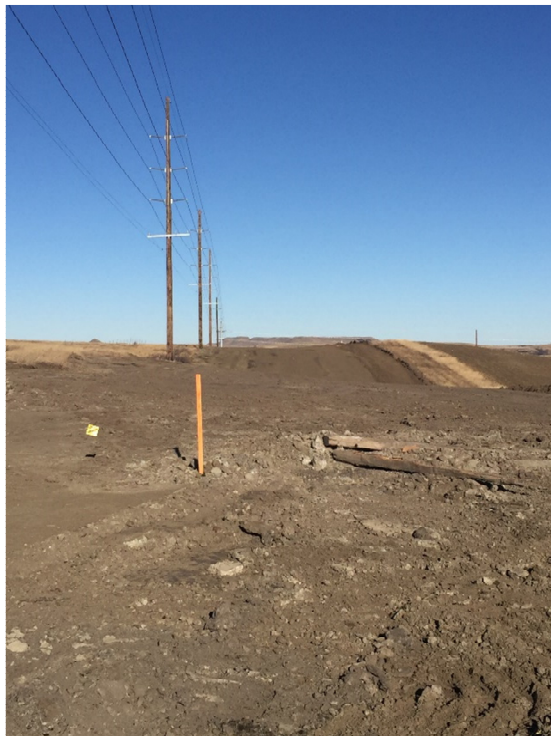
Picture 29: Grading and cleanup in progress

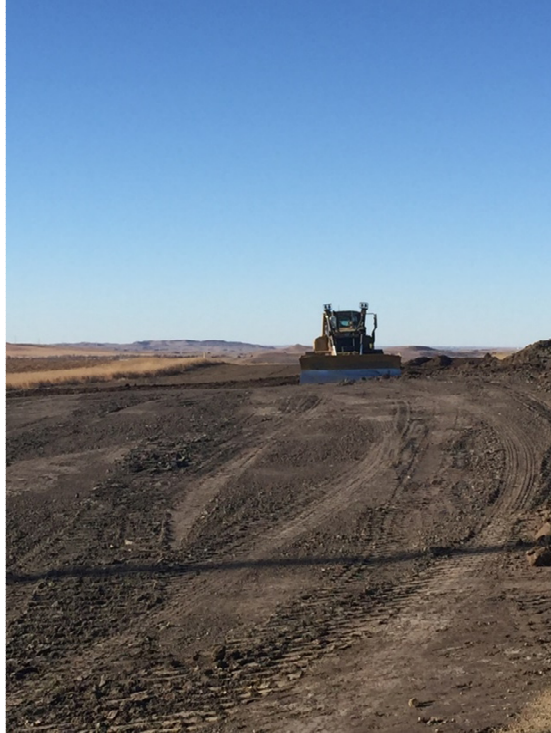
Picture 30: Topsoil spreading in progress, looking west

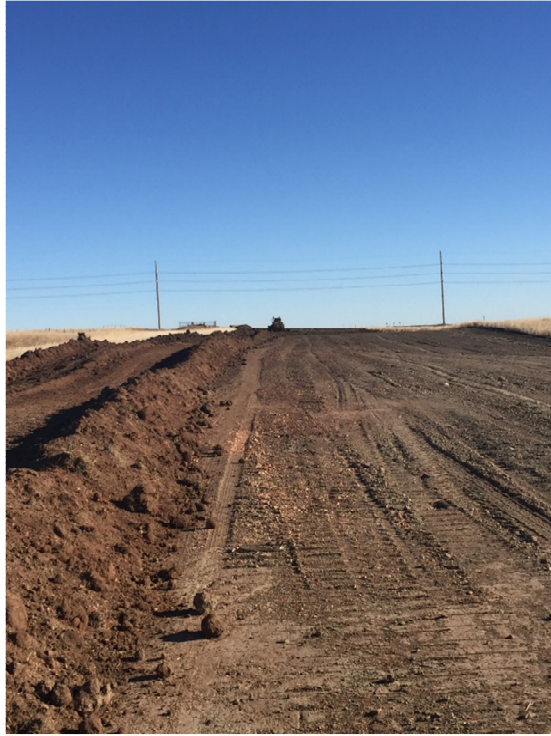
Picture 32: Begin spreading topsoil berm, looking east

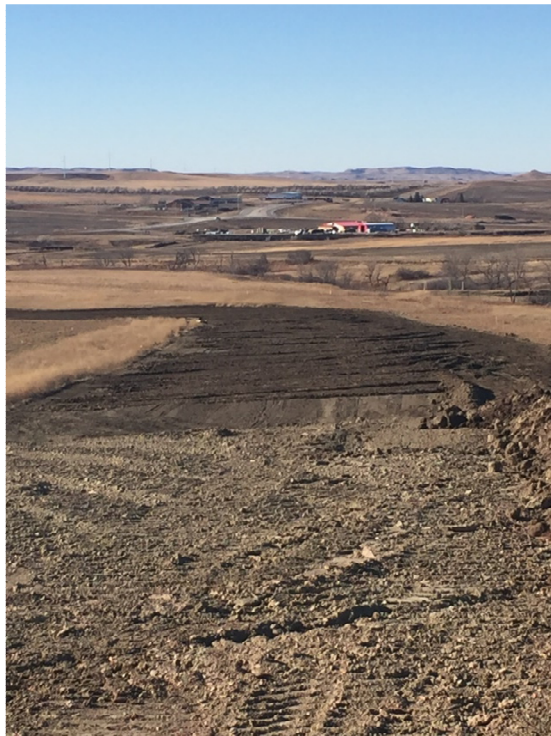
Picture 33: Topsoil spreading completed, looking west

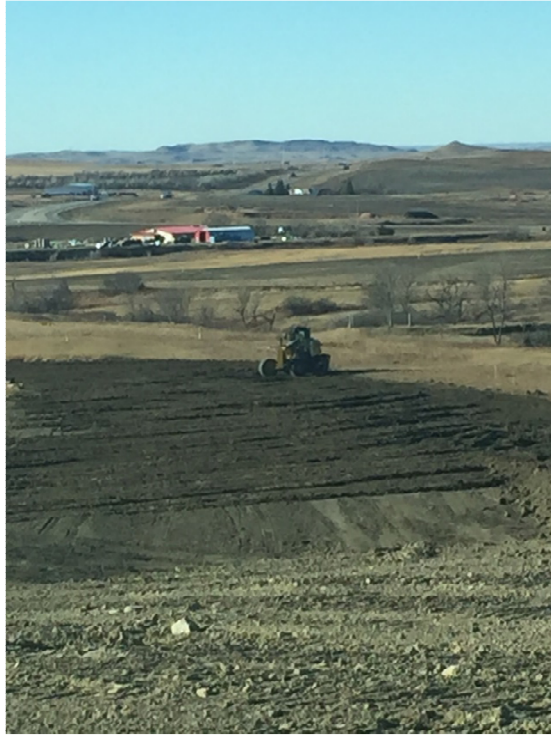
Picture 34: Finish grading of topsoil in progress, looking west
