# PU-16-140 CONSTRUCTION INSPECTION

Plains Terminal 24-Inch Crude Oil Pipeline – McKenzie Co.  
Johnson's Corner to Dakota Access Pipeline

*October 24, 2017*

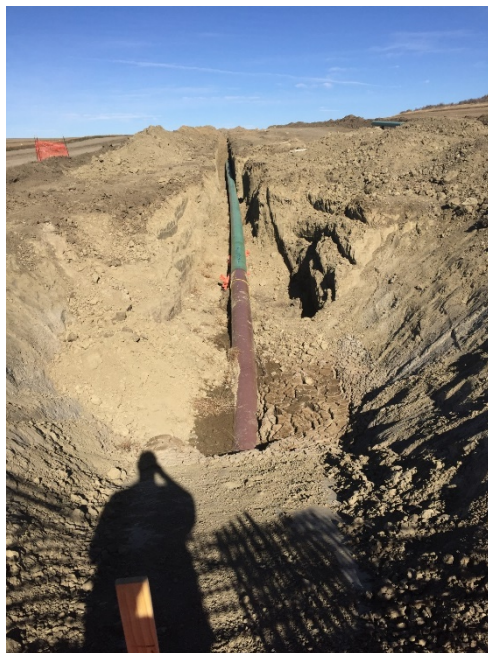
Picture 2: Pipe bore/trench. Depths checked at 4 feet or greater cover in trench.

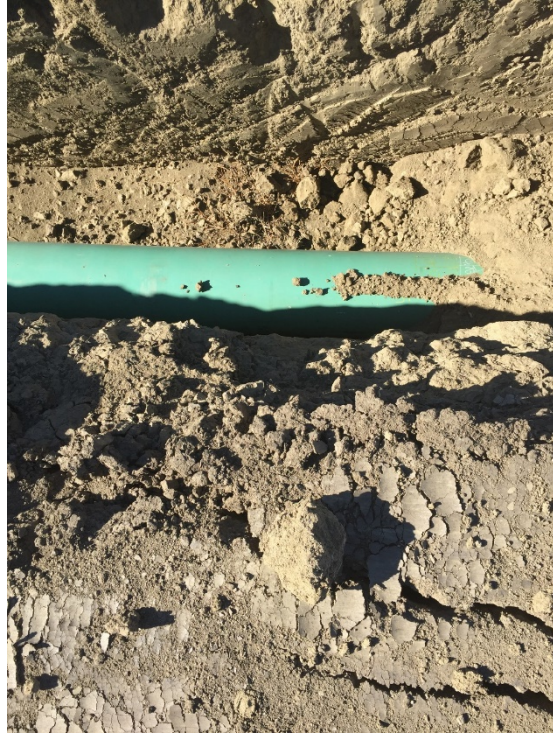
Picture 3: Pipe backfill

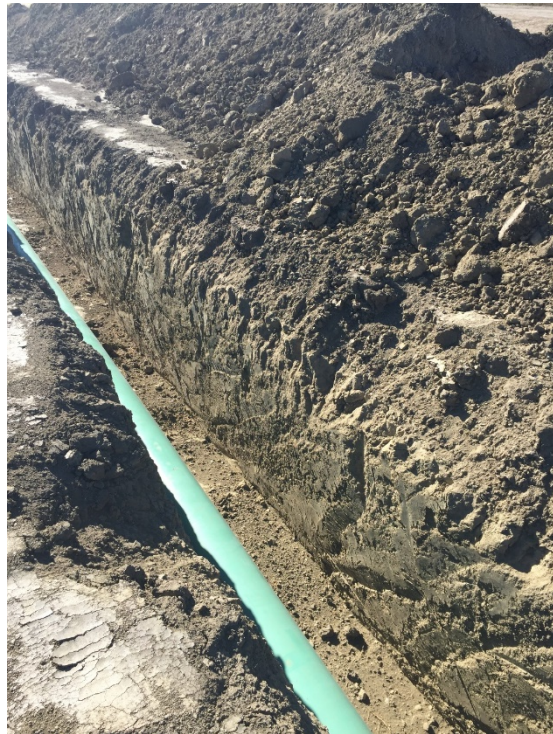
Picture 4: Laying pipe, cover verified greater than 4 feet.

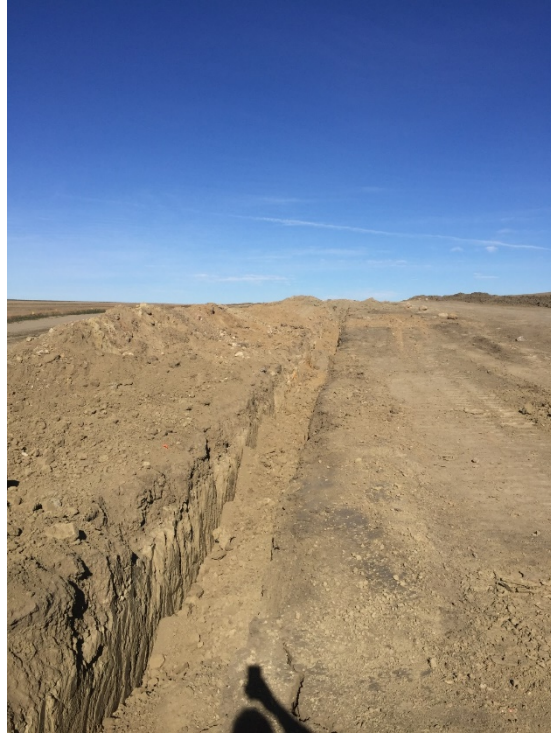
Picture 5: Backfilling pipe

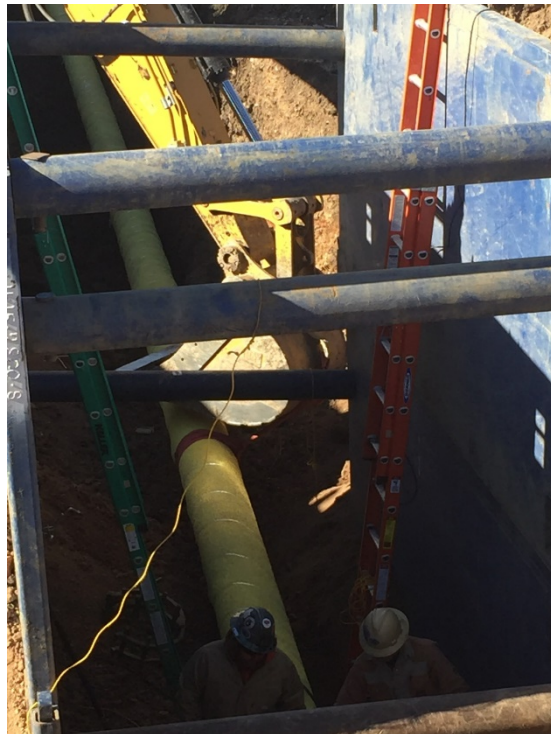
Picture 6: Trench box and installation of pipe at utility crossing

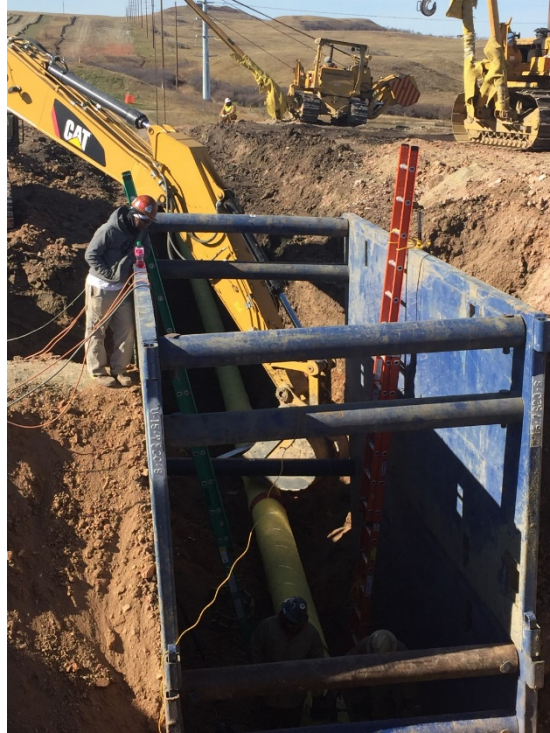
Picture 7: Utility crossing

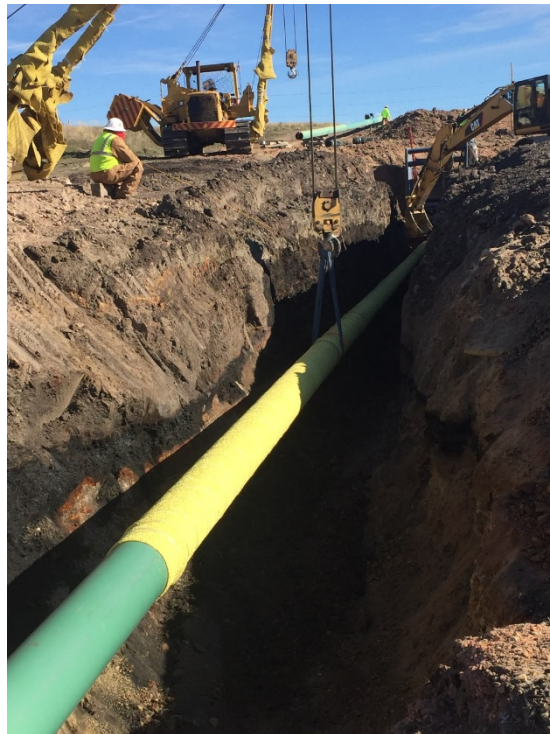
Picture 8: Placing pipe near utility crossing

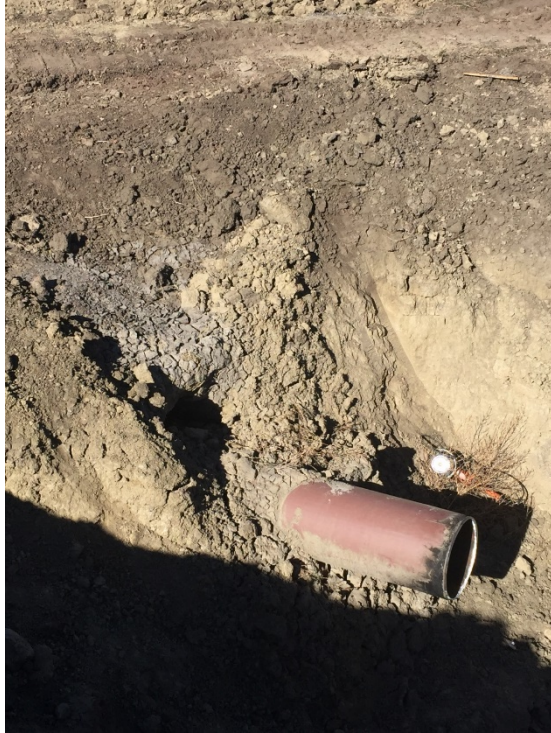
Picture 9: Location of bore tie-in

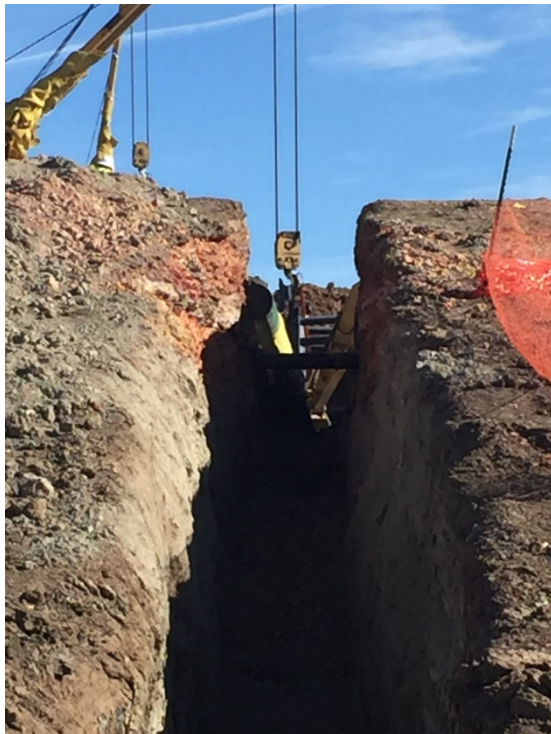
Picture 10: Installing pipe at utility crossing

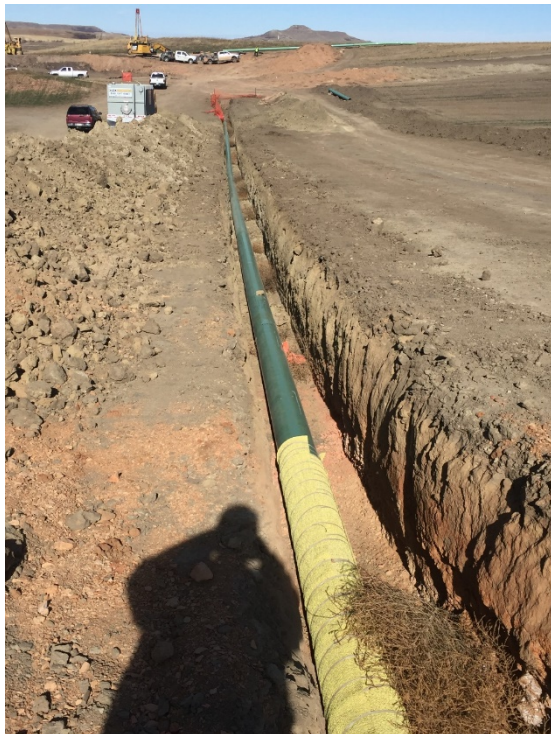
Picture 12: Pipe laid in trench, preparing for backfill

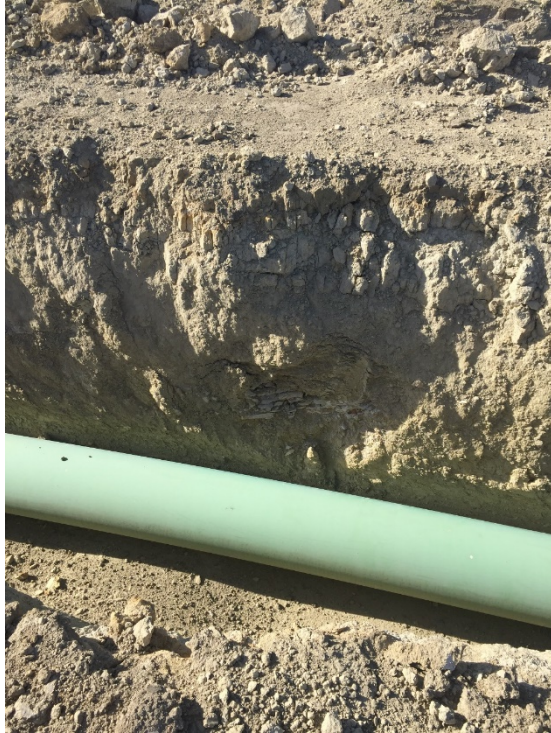
Picture 13: Pipe recently placed in trench

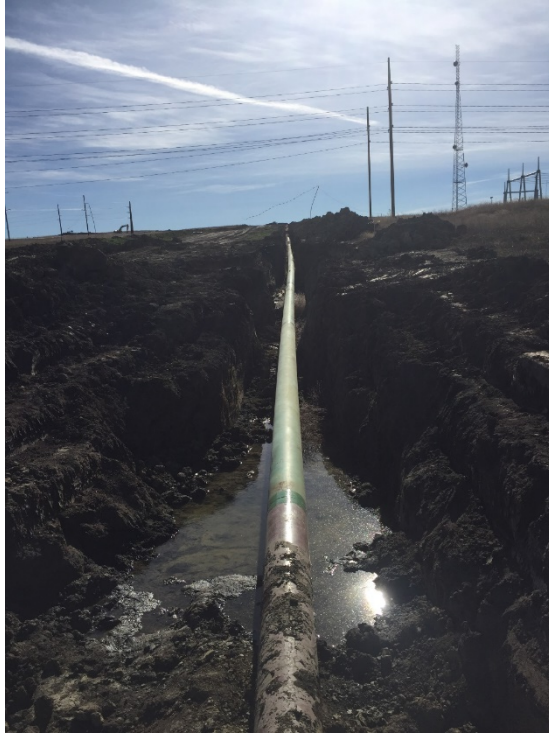
Picture 15: Pipe placed in trench, some water collecting in low area

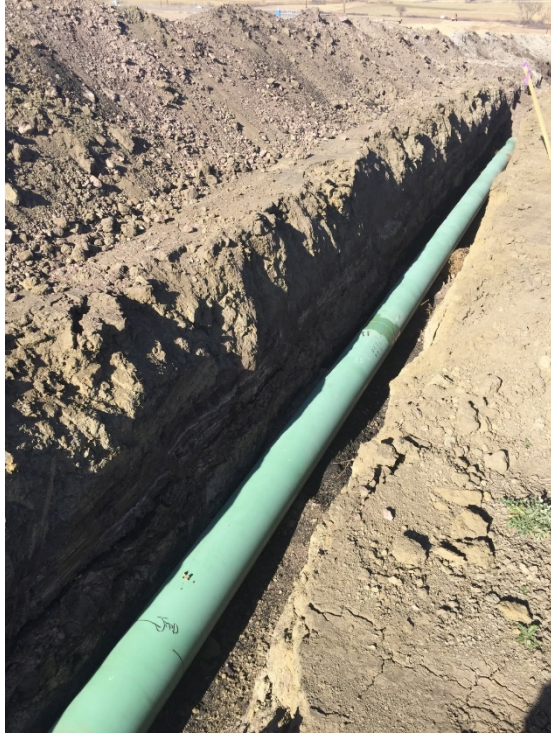
Picture 17: Pipe ready for backfill, minimum depth requirements verified

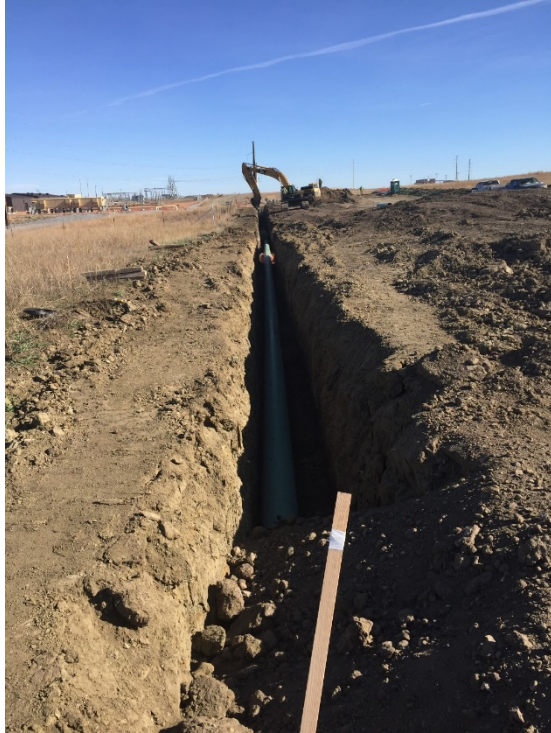
Picture 19: Backfill in progress

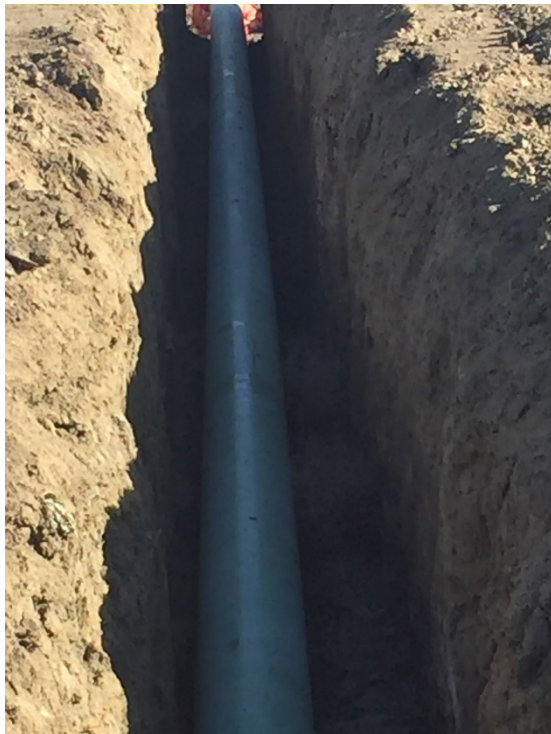
Picture 20: Backfill in progress

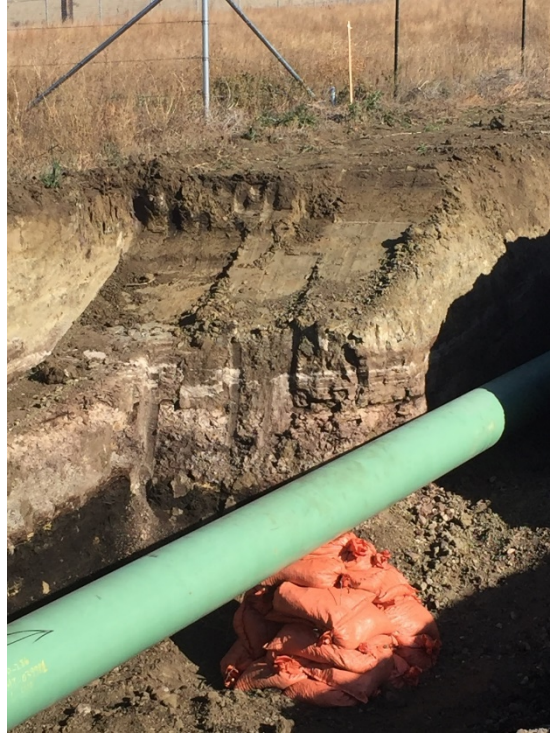
Picture 21: Pipe leveled on sandbags to make connection at PI

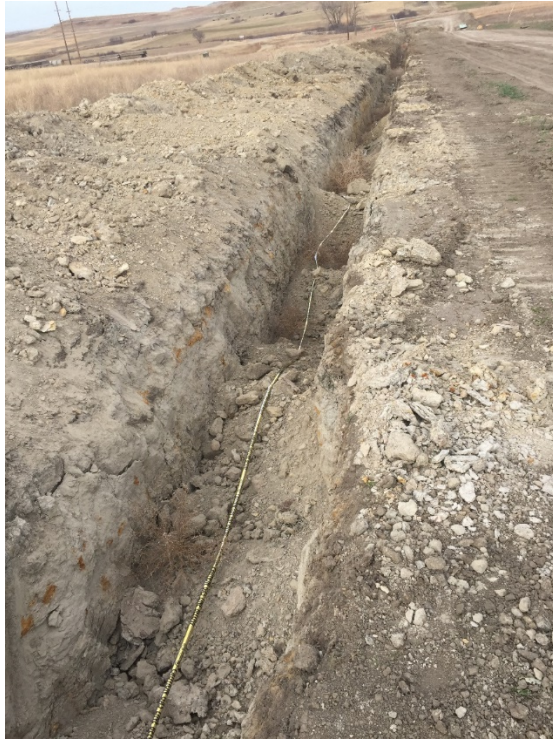
Picture 22: Backfill pipe trench, warning tape placed in trench

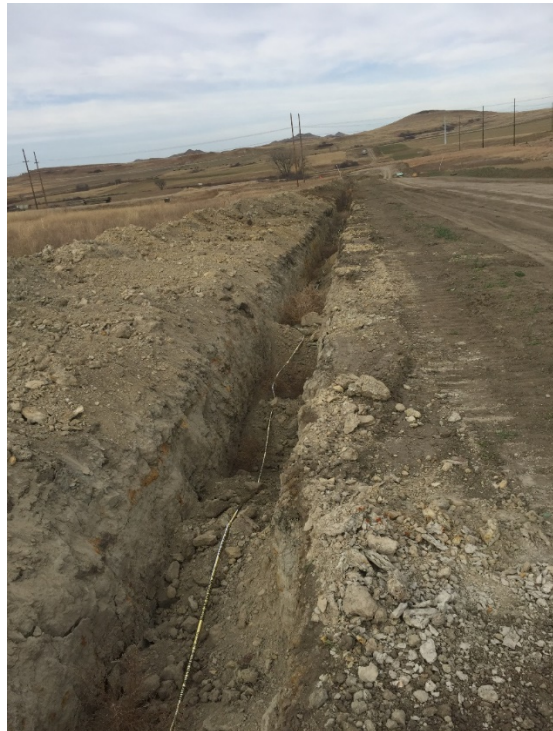
Picture 23: Backfilling, warning tape placed in trench

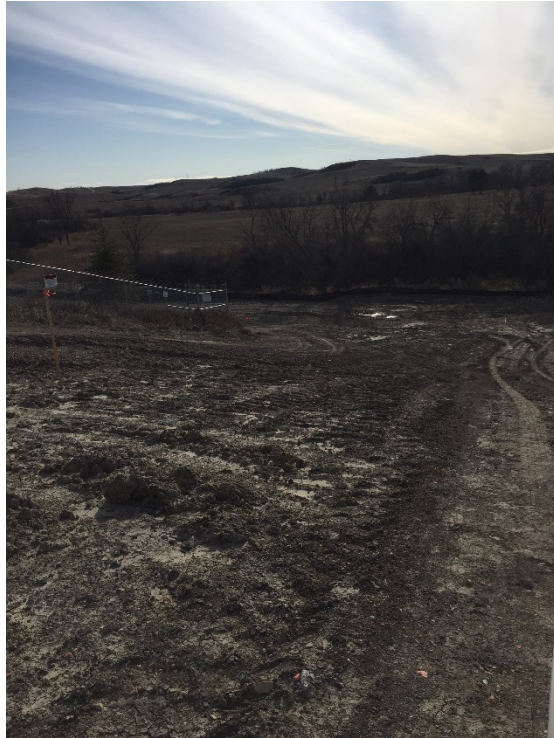
Picture 24: PI near Johnsons Corner Terminal backfilled

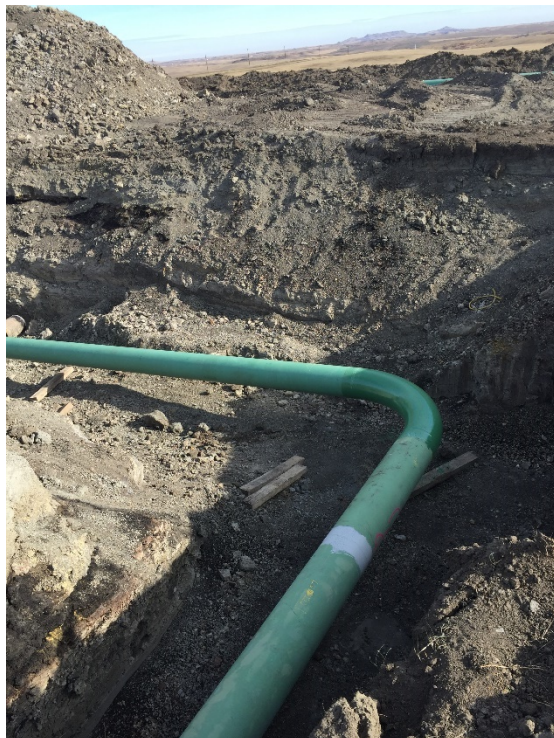
Picture 25: Point of intersect west of Johnsons Corner Terminal

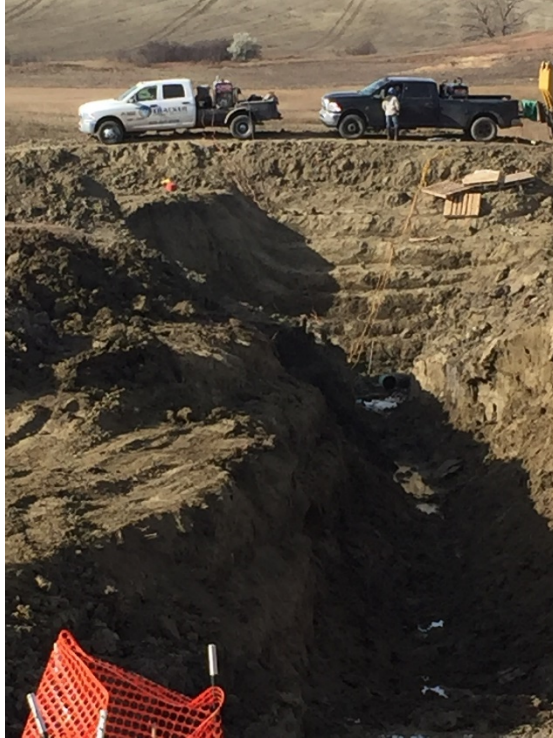
Picture 26: Excavating for trench near Highway 73 bore

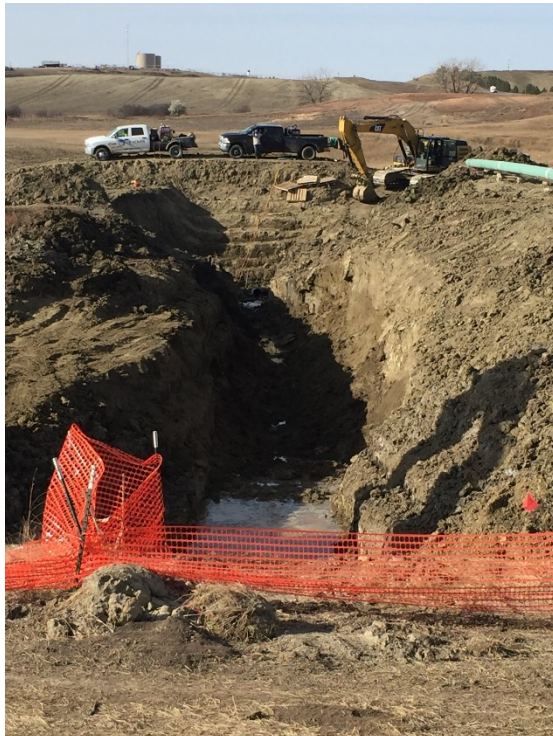
Picture 27: Excavating for trench near Highway 73 bore

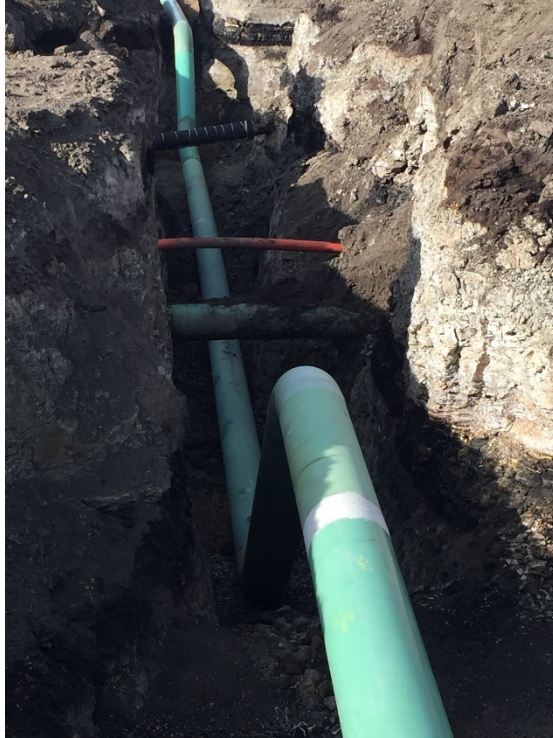
Picture 28: Utility crossing completed west of PI near station 60+00

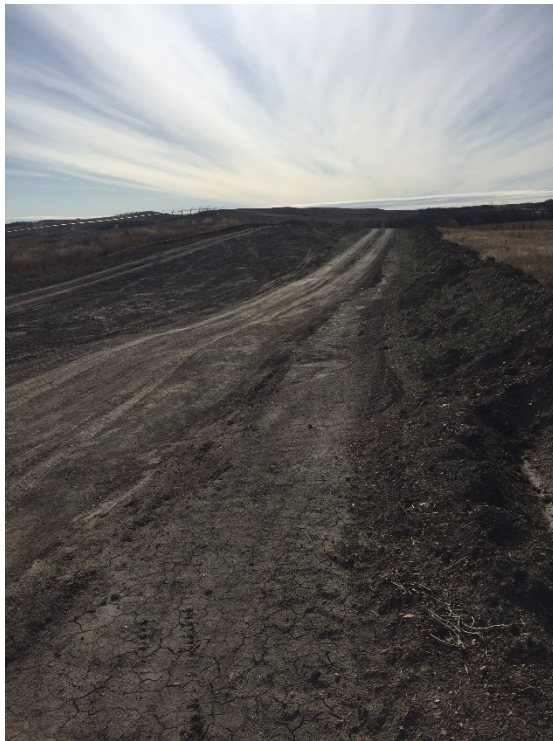
Picture 29: Backfill completed, prior to topsoil placement

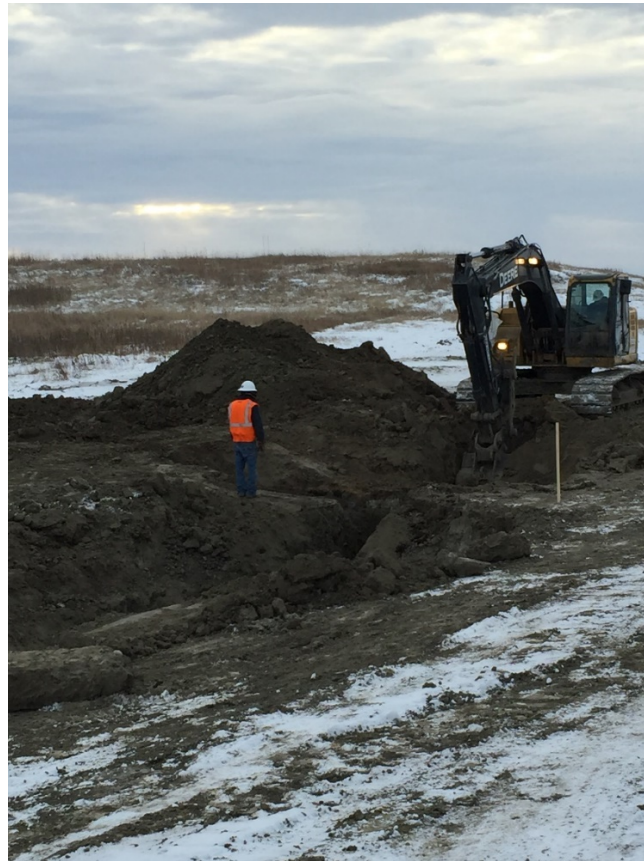
Picture 31: Excavation
