# PU-16-140 TOPSOIL INSPECTION

Plains Terminal 24-Inch Crude Oil Pipeline – McKenzie Co.  
Johnson's Corner to Dakota Access Pipeline

*August 22, 2017*

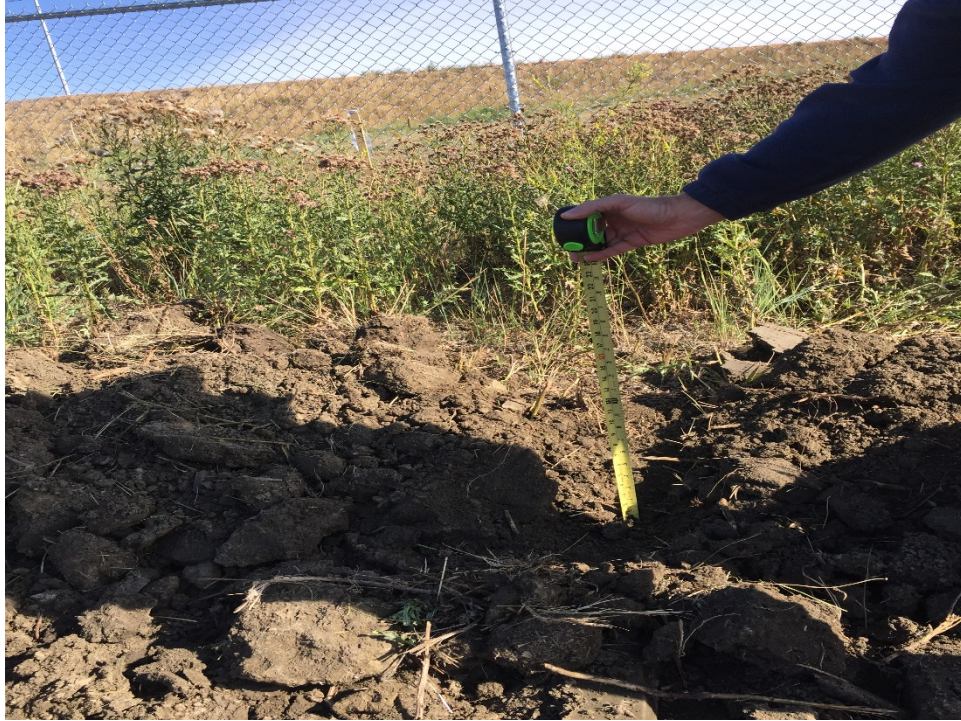
*Photo 3: Sta. 3+00 showing 8 inches topsoil removal*

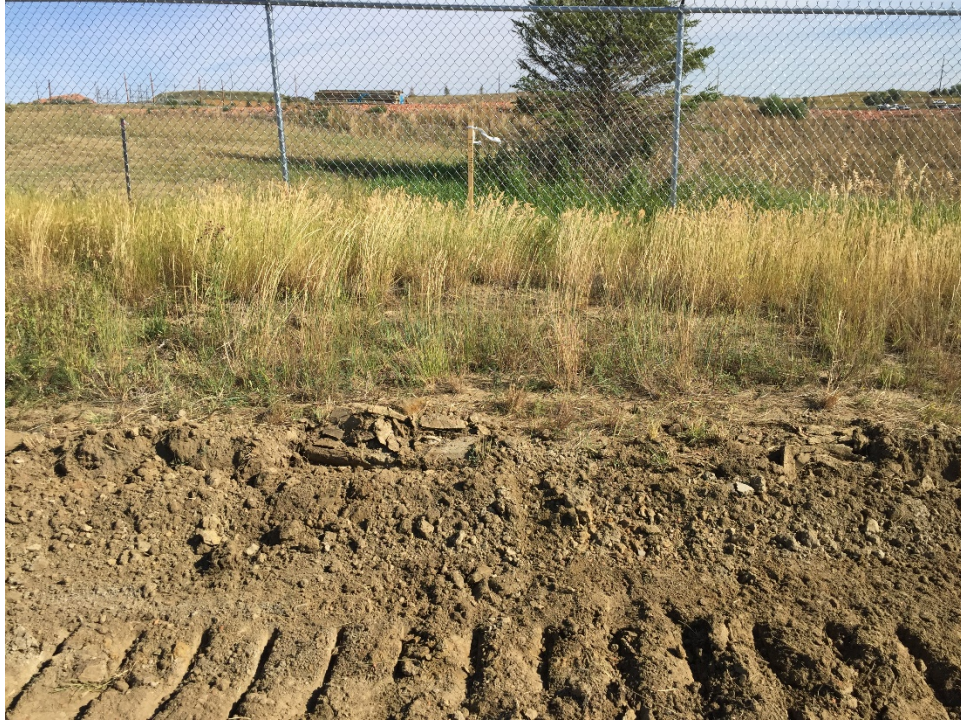
*Photo 5: Sta. 4+00 showing top soil removal depth*

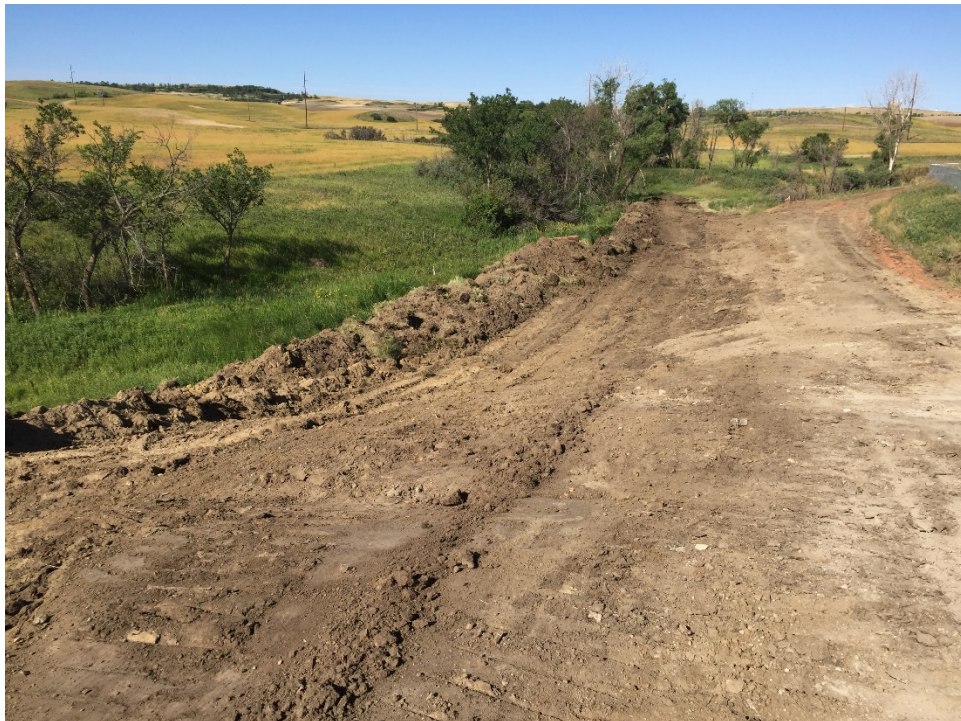
On August 4<sup>th</sup>, 2017 Paul Lee visited the worksite for approximately 5 hours. During inspection, the work activities include mowing within the ROW and topsoil stripping. Depth of topsoil varied but was observed to typically be in the range of 4" to 5" with low areas containing up to 12". Procedures of topsoil removal and stockpile were discussed while on site in order to determine the best places to stockpile. Efforts were made to reduce the risk of erosion or pooling of water due to the pile locations.

*Photo 6: Sta. 5+50 looking west showing top soil pile along drainage area.  
See photo 10 on August 8 showing replacement of topsoil stockpile with silt fence.*

Construction was monitored to insure the Certificate of Corridor Compatibility and Route Permit was followed. This included verification of work locations, width of right-of-way, topsoil stripping depth, segregation of topsoil, and erosion and sediment control. Two on-site inspections were performed and documented during the topsoil removal phase. Prior to beginning earthwork, the ROW was cleared/mowed in order to assist in stripping. In the areas observed, all distinguishable amounts of topsoil (4-12 inches typical) was being cleared and placed at the edge of the ROW or in alternative locations on the project if necessary. Per discussion with contractor, some topsoil stockpiles were kept clear of low areas, where heavy drainage would be likely to cause issues with erosion along the stockpiles. Silt fence was installed in these locations to prevent erosion outside of the work area. This resolution is documented in pictures 6 and 10.

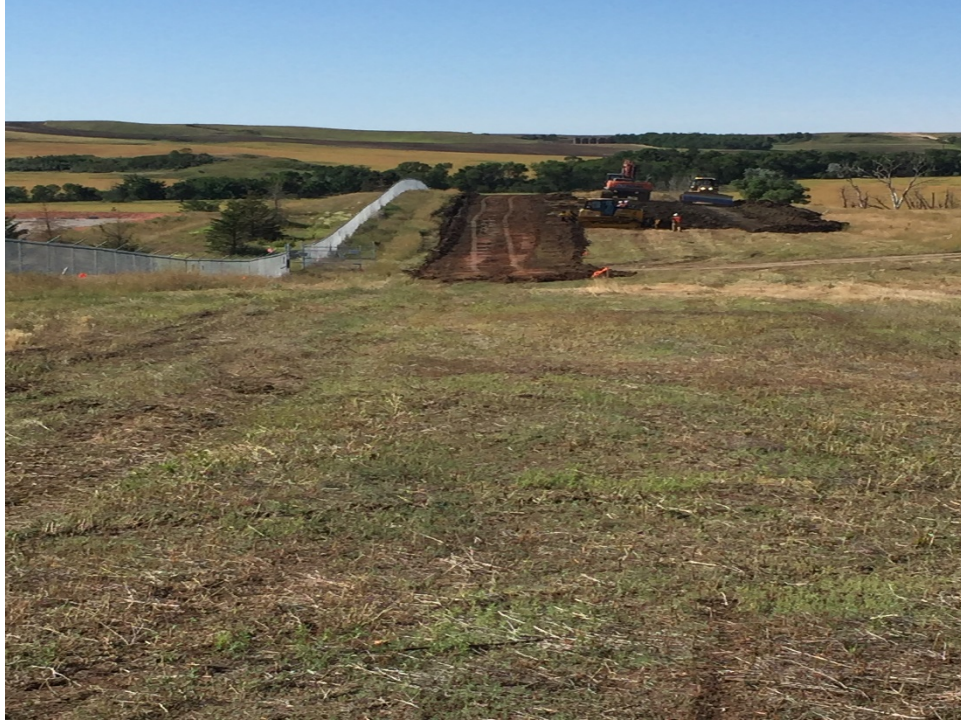
*Photo 7: Sta. 13+00 looking south showing stripping operation and equipment*

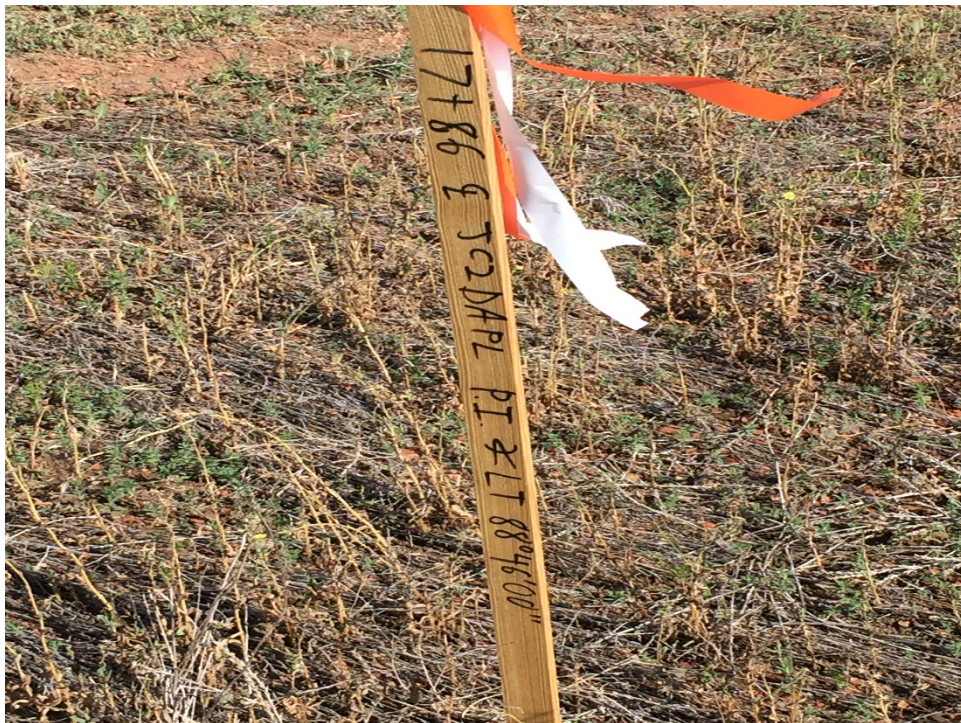
*Photo 8: Sta. 17+86 point of intersection angle Lt. 88°46'00"*

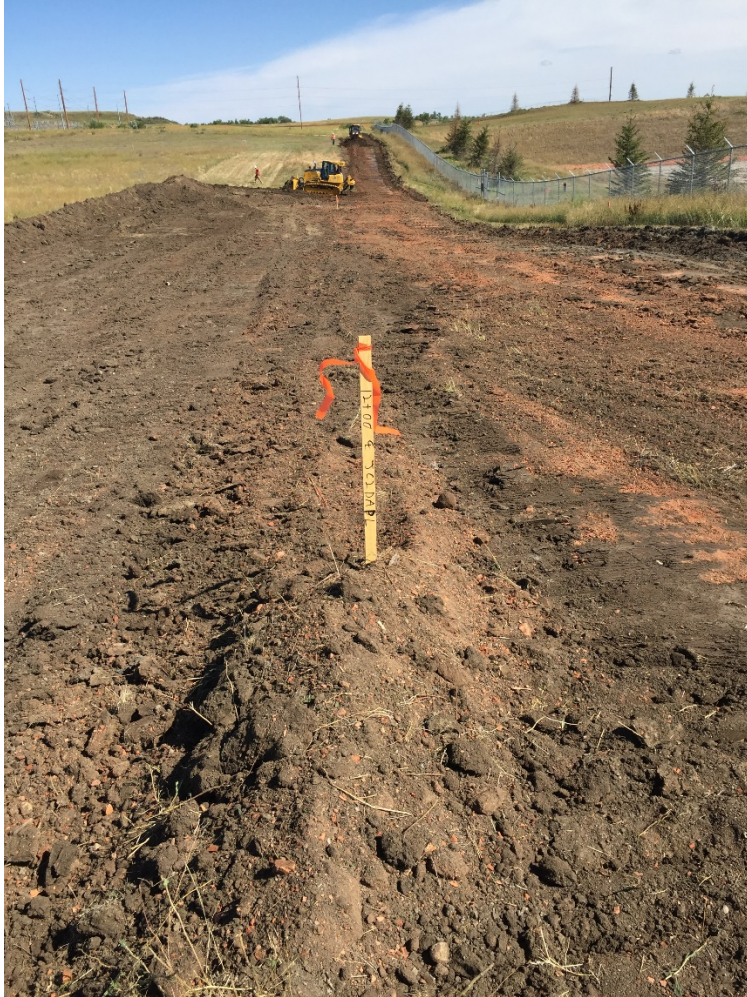
*Photo 9: Sta. 12+00 looking north showing an old road under the stripping of limited top soil*

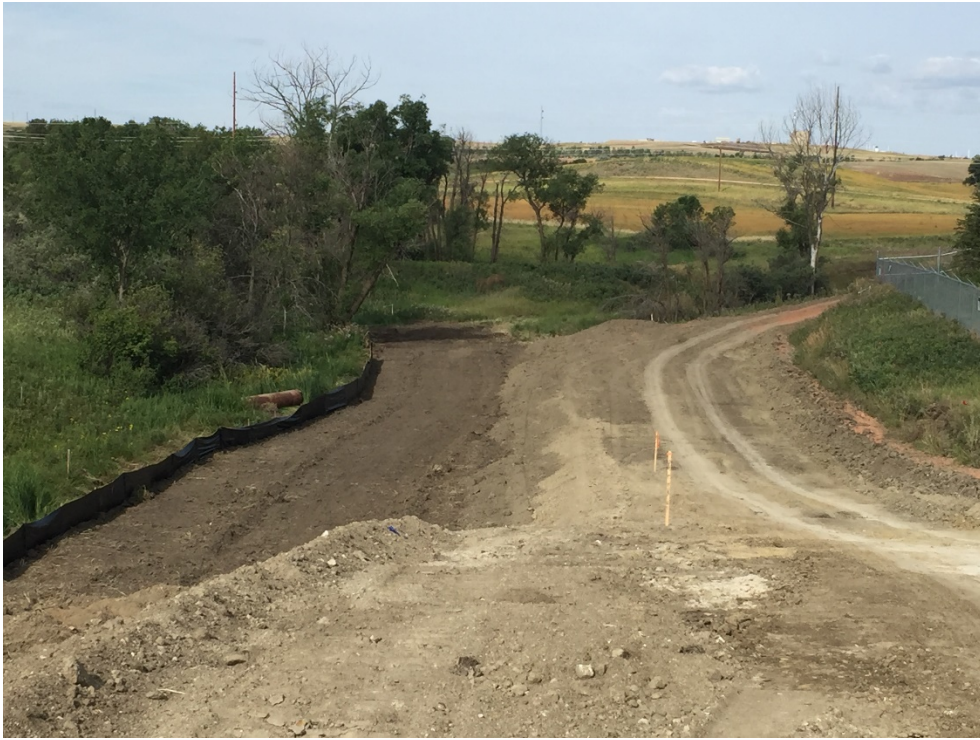
*Photo 10: Sta. 7+00 looking west at the channel with topsoil removed to safe location and silt fence installed as previously committed to on site.*

Photos (See previous page 1)	
Photo 10, Sta. 7+00 looking west at the channel with topsoil removed to safe location and silt fence installed as previously committed to on site.	
Photo 11, Sta. 14+00 7 inches topsoil removed. Photo 12, Sta. 19+00 looking west pipe being delivered. Photo 13, Sta. 22+00 looking west.	
Photo 14, Sta. 92+00 showing back side of tops of top soil pile along R/W the previous pipe installation is to the north or left with no vegetation.	
Photo 15, Sta. 92+00 looking east. Photo 16, Sta. 92+00 looking west. Photo 17, 18, Sta. 92+00 showing 4-5 inch top soil removal. Notice soil is same from previous pipe installation on the left out side of R/W. Photo 19, facing west Sta. 100+00 area to right is previously installed pipe line left side is R/W.	
Photo 20, 21 Sta. 108+00 8-10 inch. Topsoil. Photo 22, Angle pt. Sta. 106+00. Photo 23, Sta. 113+00 area to be bored. Photo 24, Sta. 126+00 8-9 inches top soil.

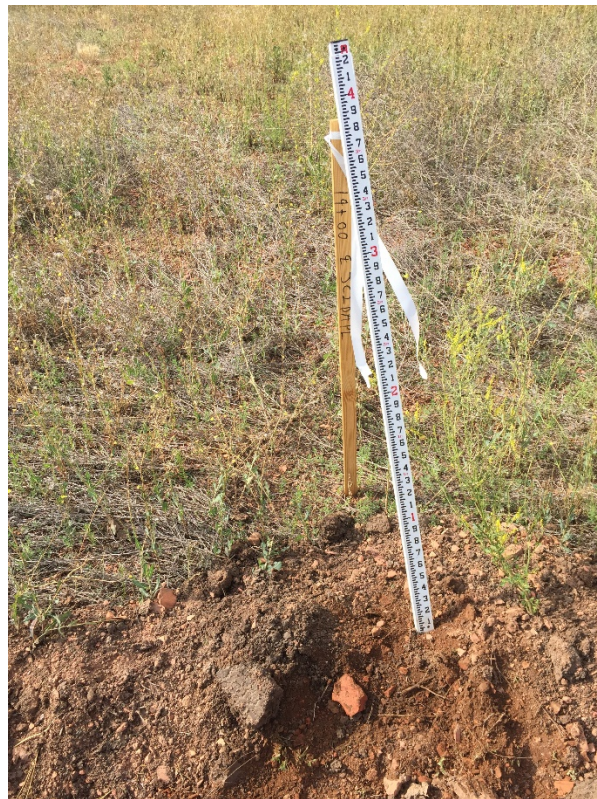
*Photo 11: Sta. 14+00, 7 inches topsoil removed.*

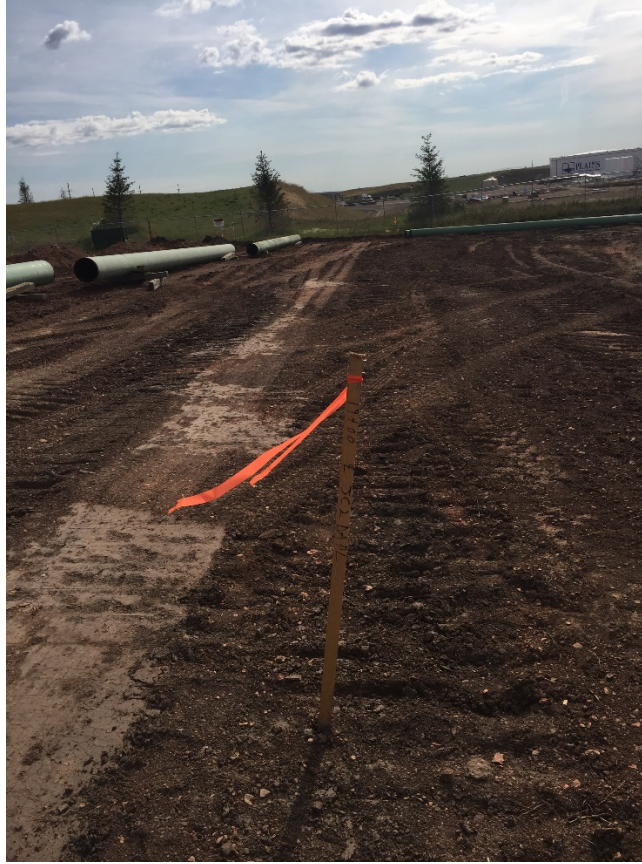
*Photo 12: Sta. 19+00 looking east, pipe being delivered.*

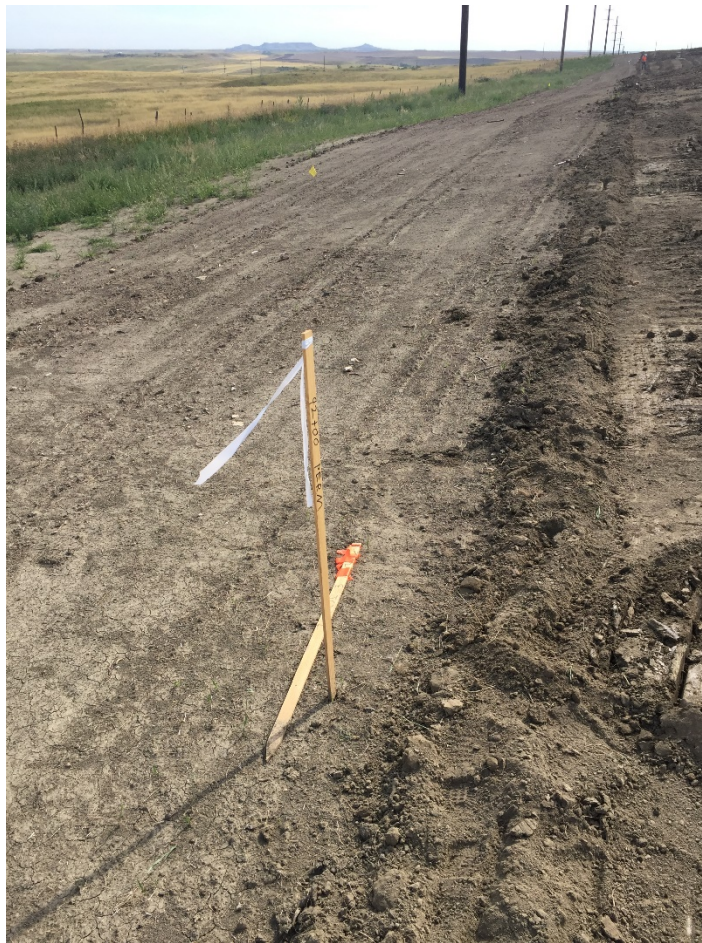
A second visit to the site took place on August 8<sup>th</sup>. Paul Lee spoke with Joe Pease to discuss some areas of thin or mixed topsoil where other pipeline installations had previously taken place. The contractor agreed to salvage whatever topsoil they could distinguish in these locations.

*Photo 14: Sta. 92+00 showing back side of topsoil pile along R/W.  
The previous pipe installation is visible to the north or left with no vegetation.*

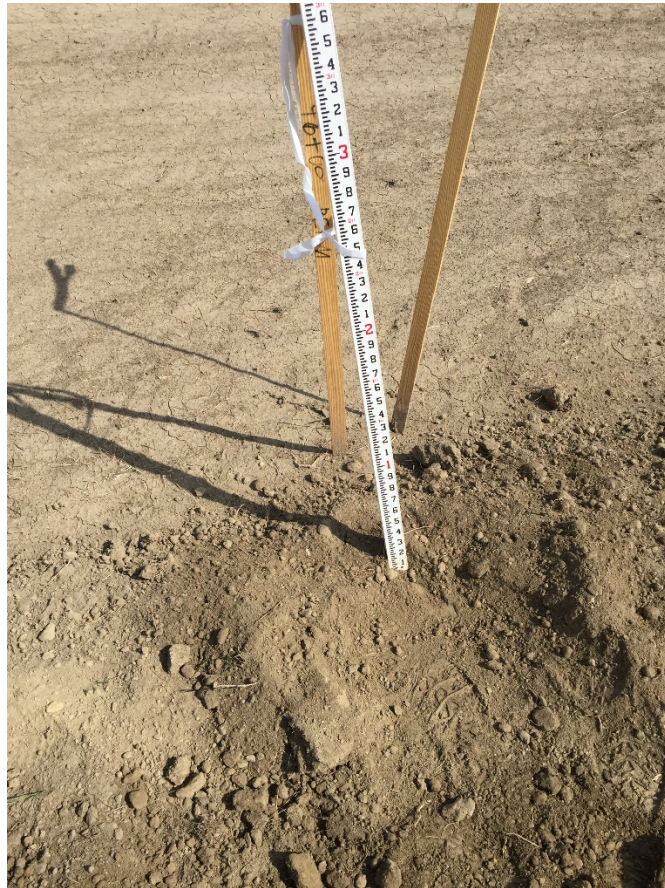
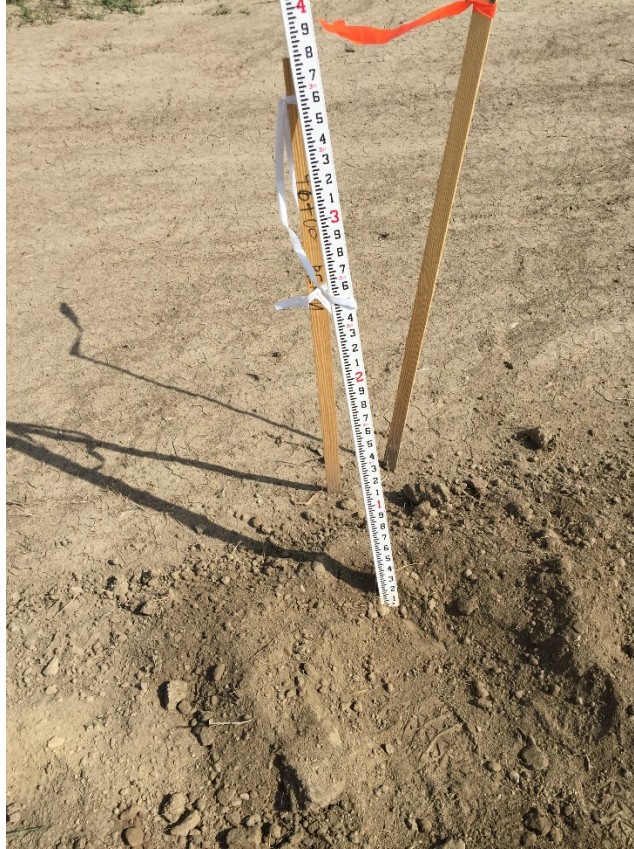
*Photo 17: Sta. 92+00 showing 4-5 inches top soil removal.  
Notice soil is same from previous pipe installation on the left, outside of R/W.*

*Photo 18: Sta. 92+00 showing 4-5 inches topsoil removal.  
Notice soil is same from previous pipe installation on the left outside of R/W.*

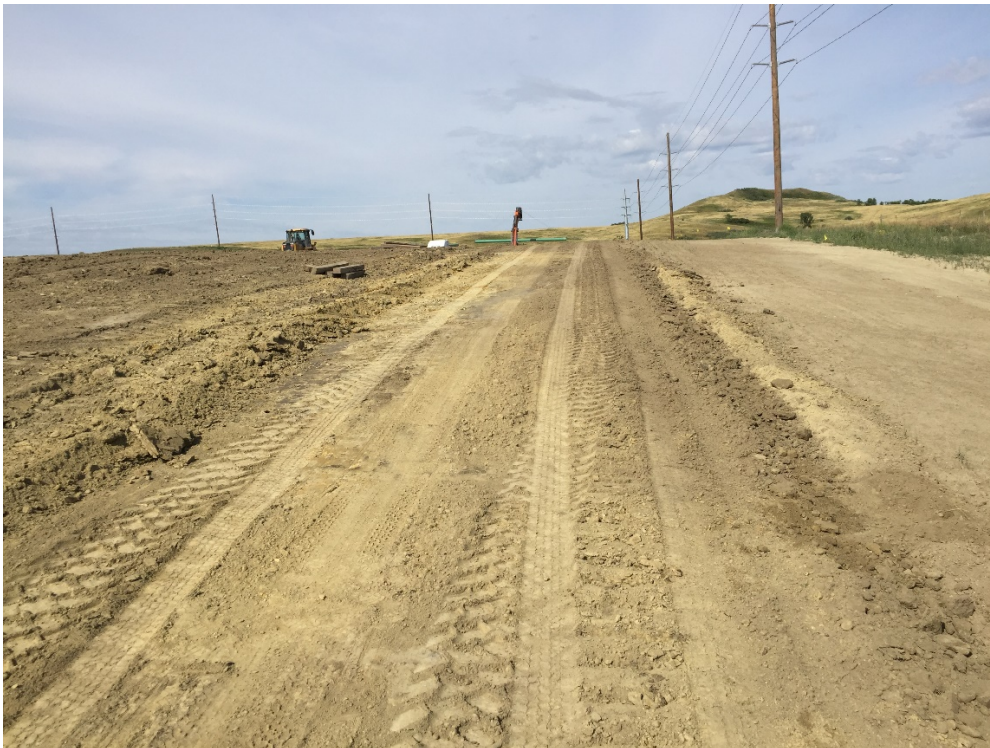
*Photo 19: Facing west, Sta. 100+00. Area to right is previously installed pipeline. Area on the left side is the current project.*

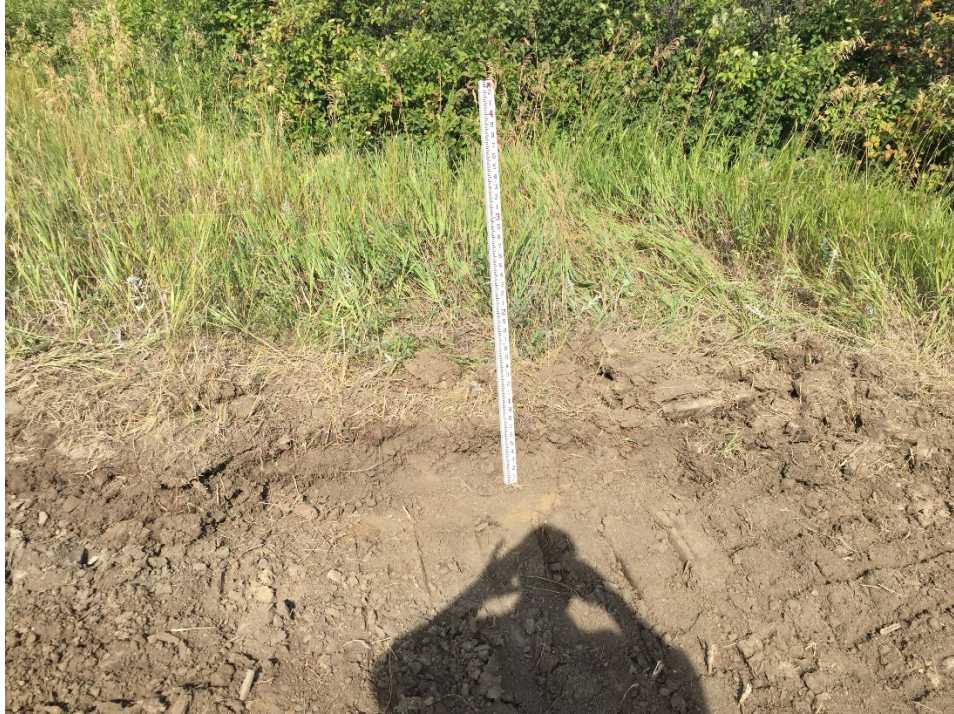
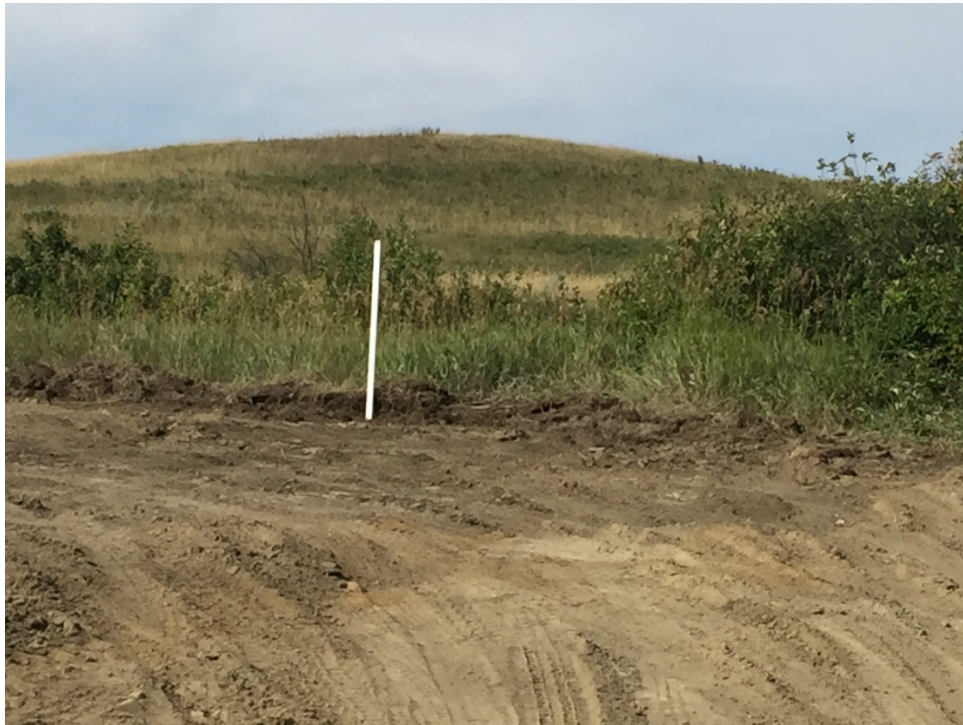
*Photo 20: Sta. 108+00, 8-10 inches of topsoil.*

*Photo 21: Sta. 108+00, 8-10 inches of topsoil.*

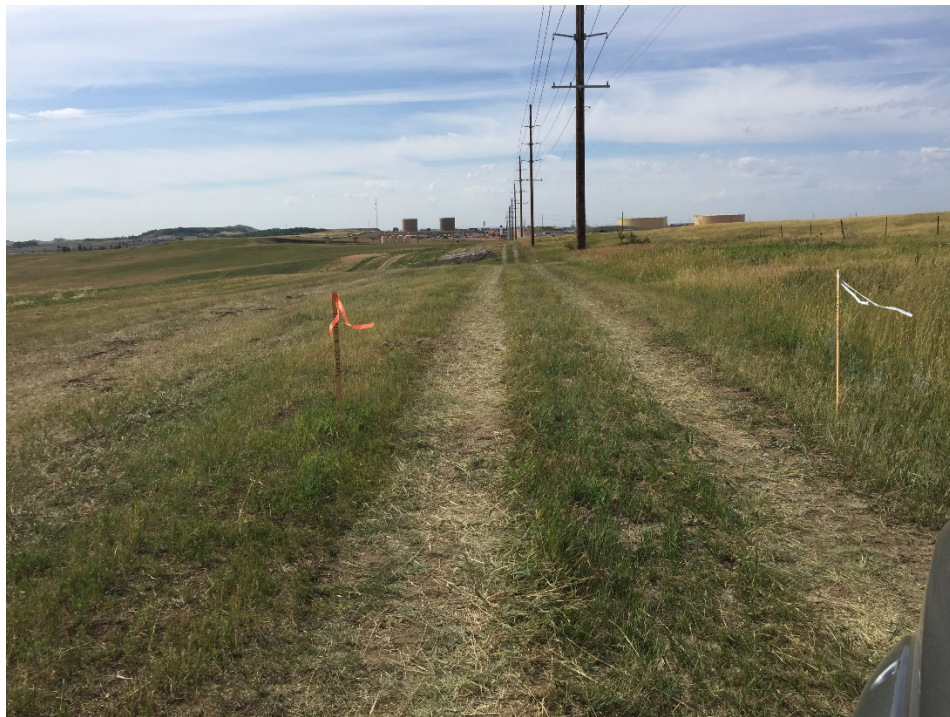
*Photo 23: Sta. 113+00 area to be bored.*

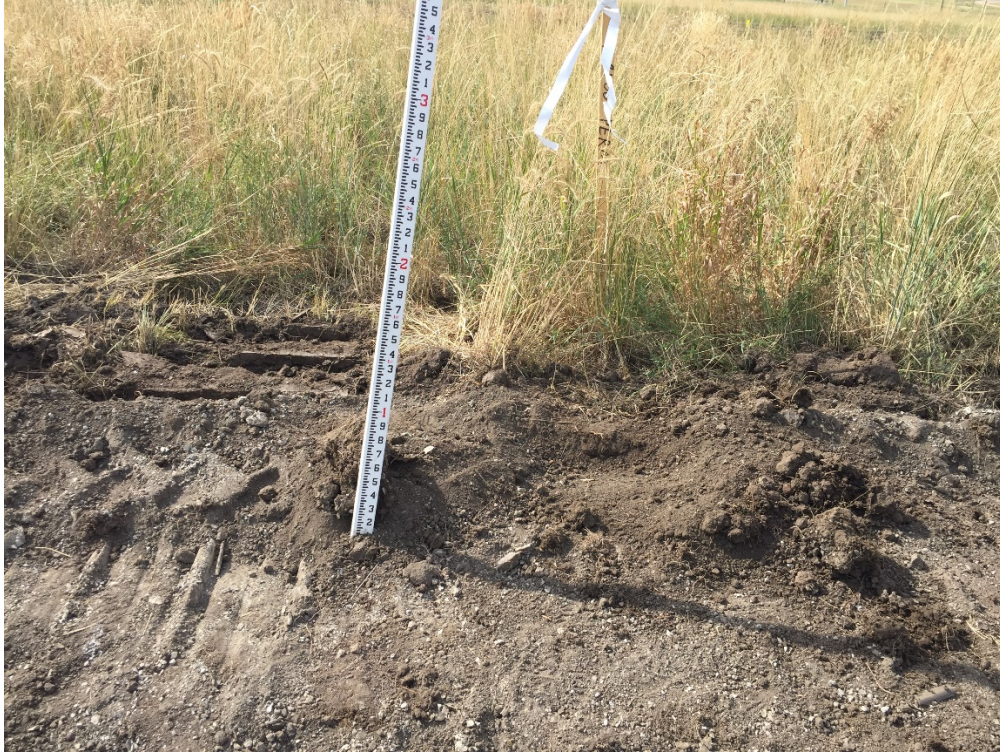
*Photo 24: Sta. 126+00 8-9 inches topsoil.*

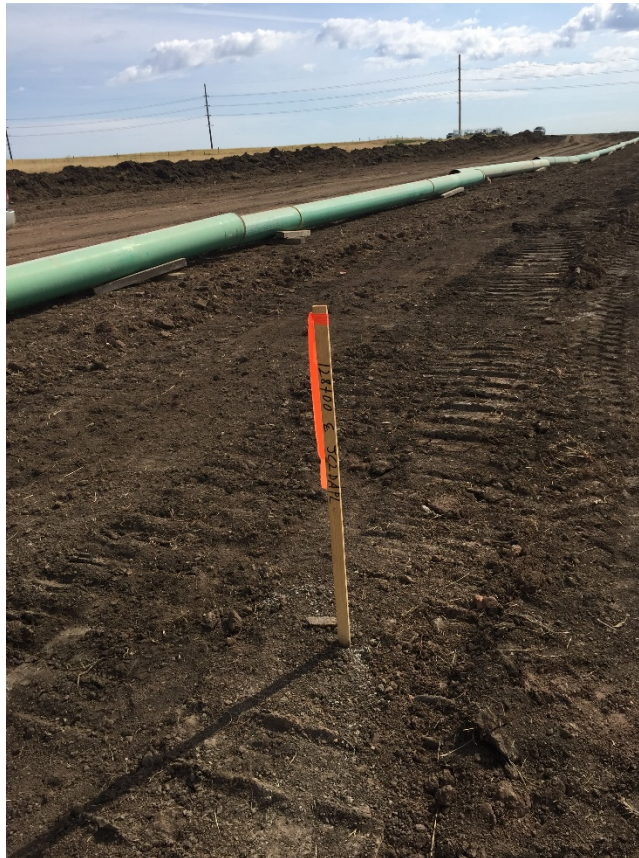
*Photo 25: Sta. 128+00 pipe staged, preparing to weld.*

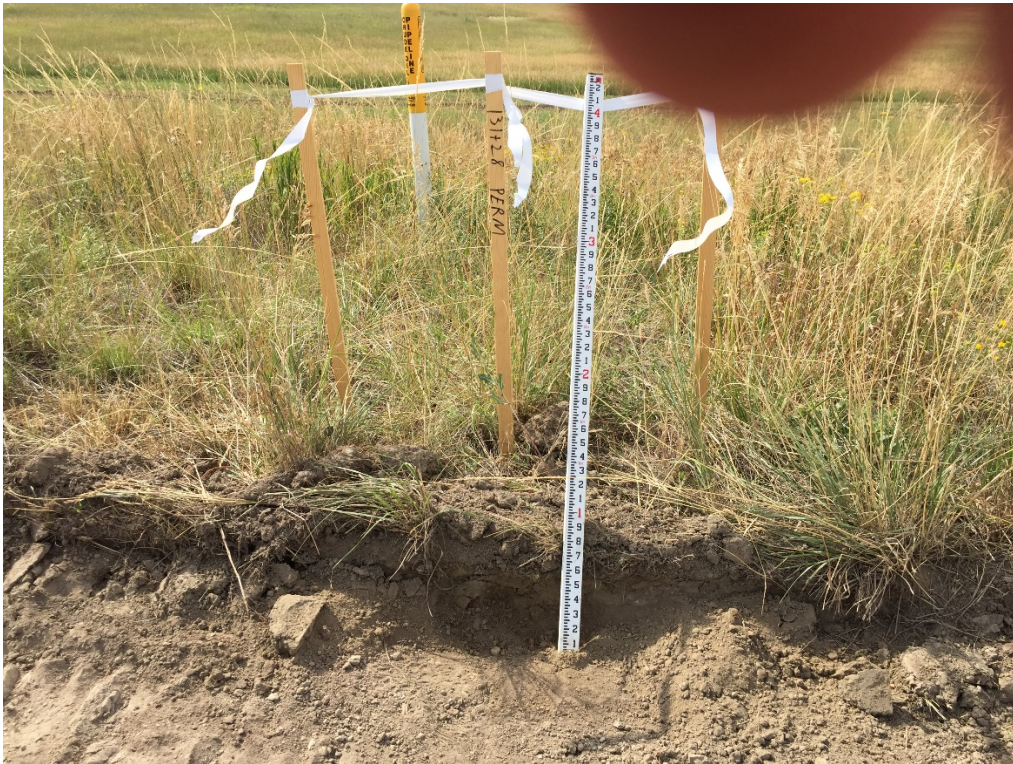
Photo 27: Sta.131+28 8-9 inches of topsoil.

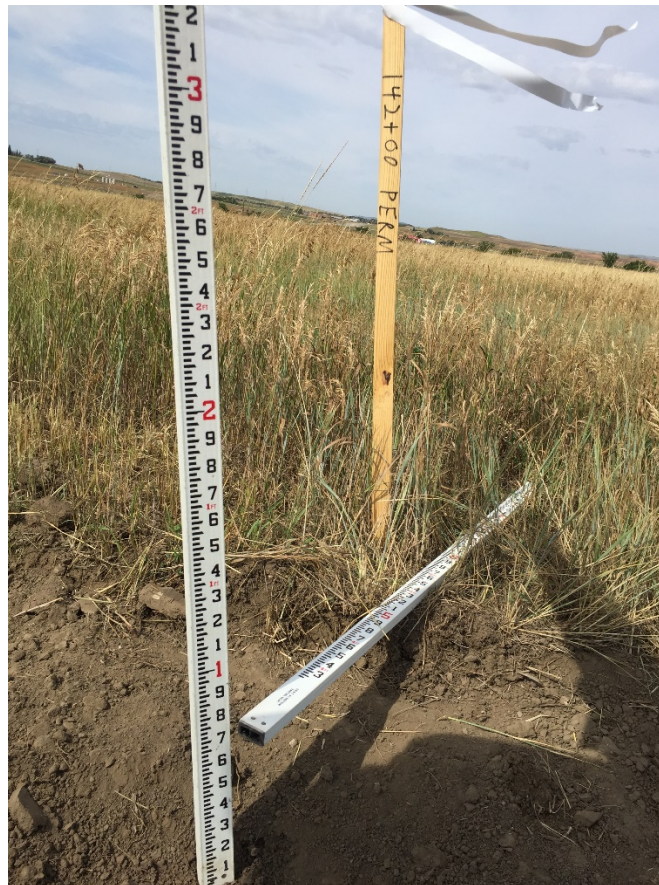
Photo 29: Sta. 142+00 7-8 inches of topsoil.

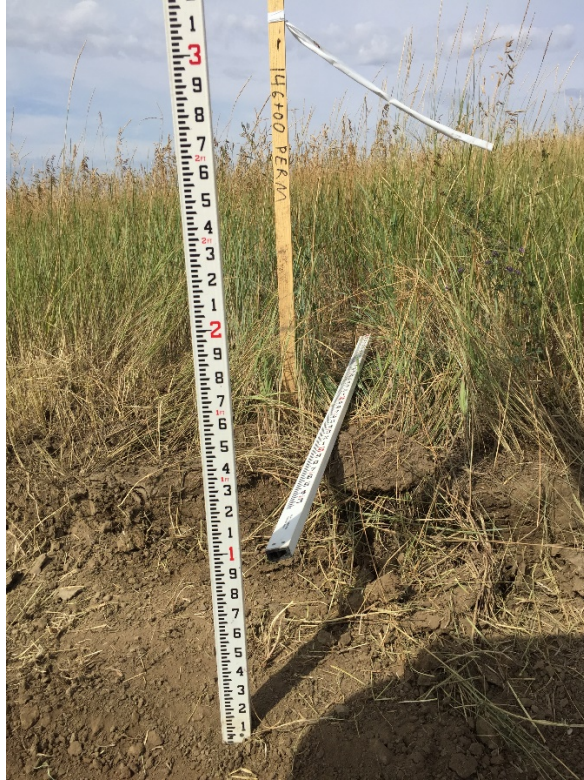
*Photo 30: Sta. 146+00 9-10 inches of topsoil.*
