PU-16-140 AS-BUILT INSPECTION

Plains Terminal 24-Inch Crude Oil Pipeline – McKenzie Co.
Johnson's Corner to Dakota Access Pipeline

November 28, 2017

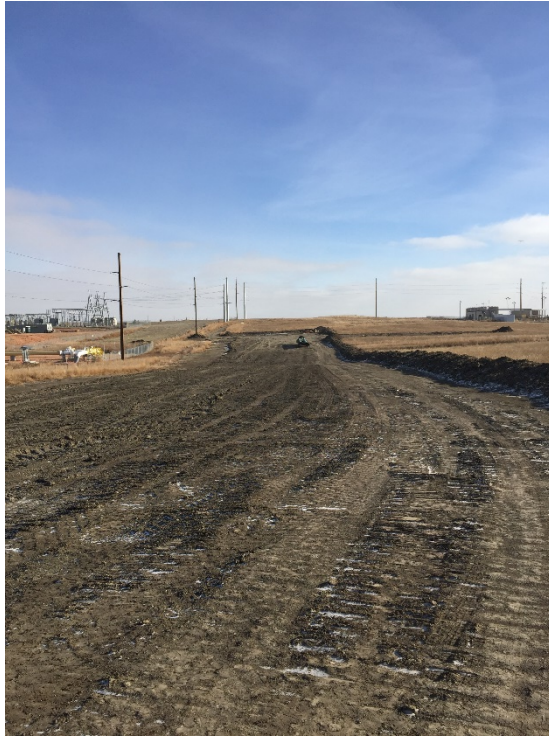
Picture 1: Finish grading, some topsoil remaining to be spread

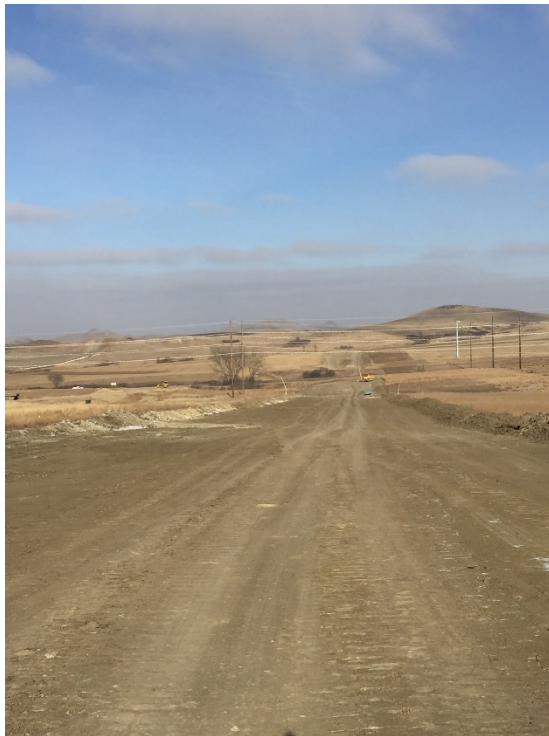
Picture 2: Finish grading subgrade, looking north

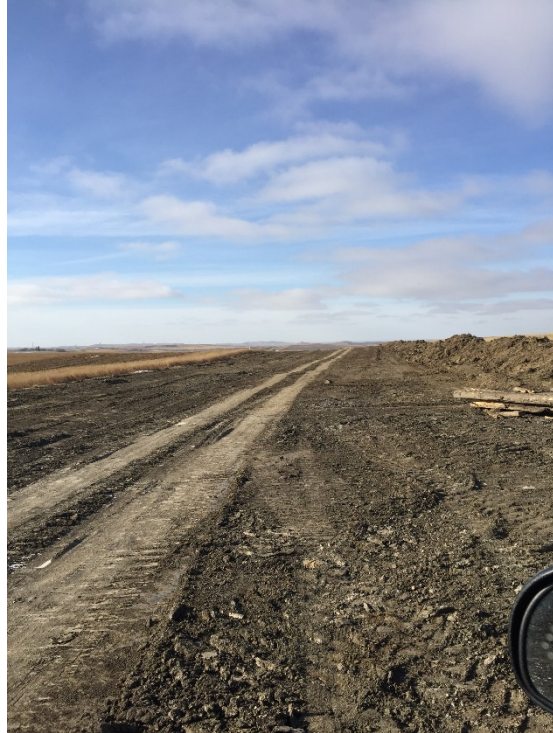
Picture 3: Grading completed prior to topsoil spreading

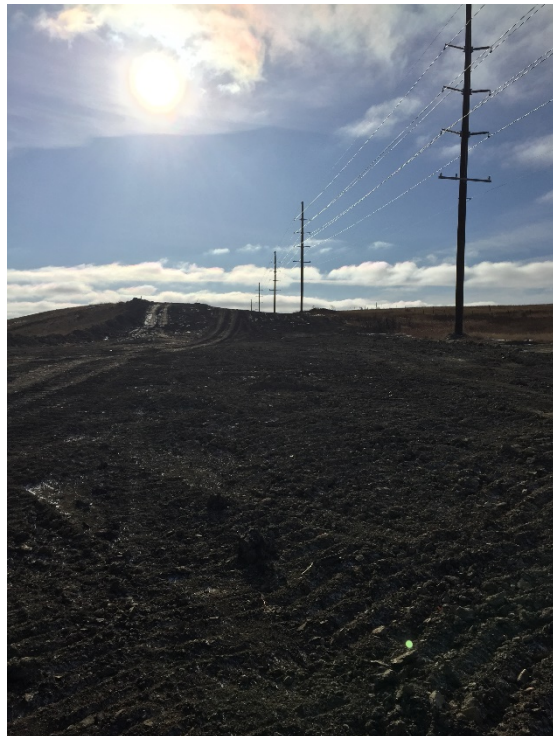
Picture 4: Grade returned to previous contours

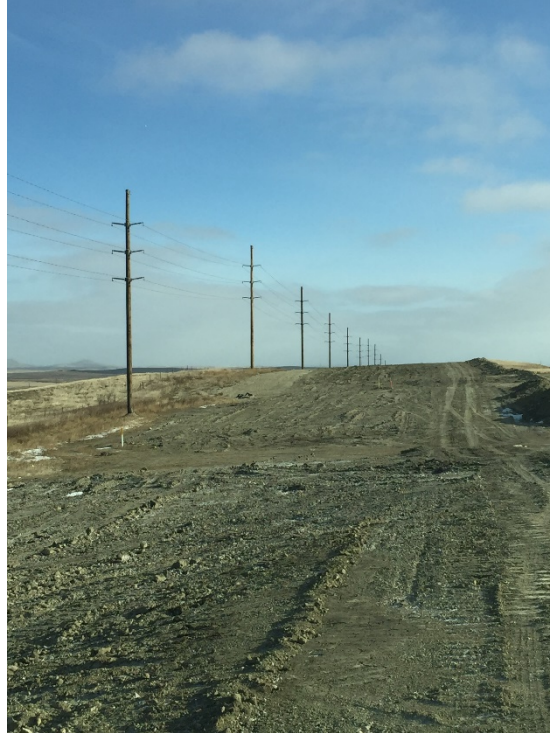
Picture 5: Low area to be graded before topsoil is spread, looking east

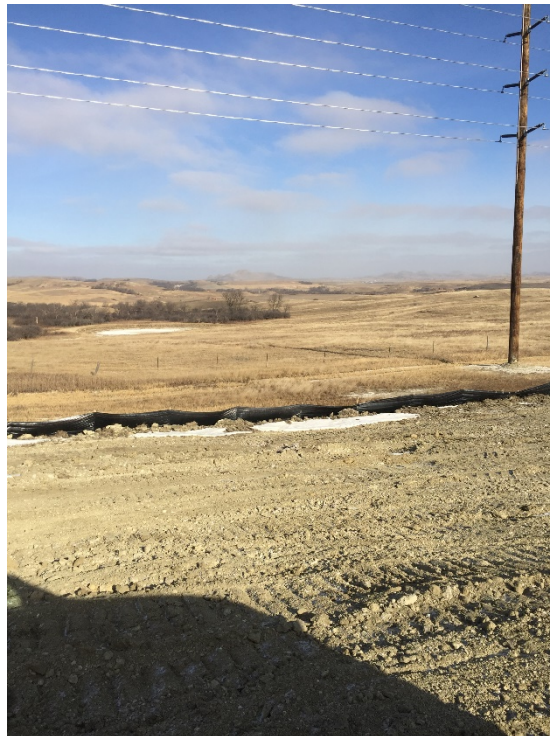
Picture 6: Silt fence at drainage area, finish grading completed

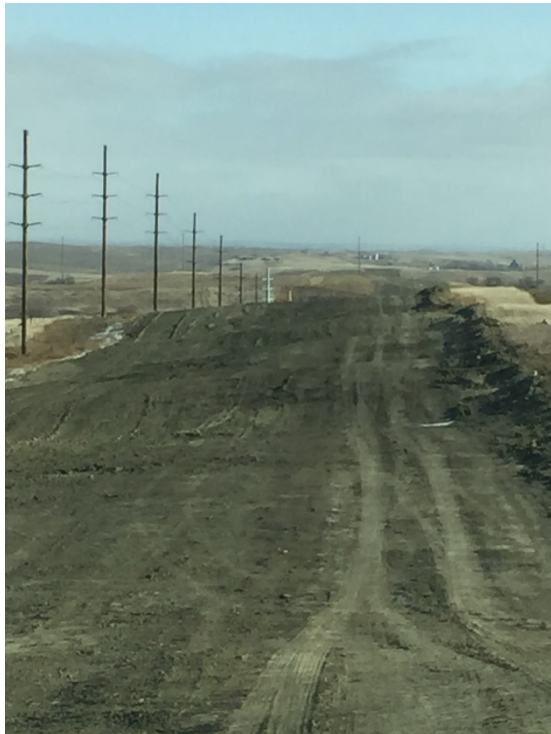
Picture 8: Grade restored to original contours prior to placing topsoil

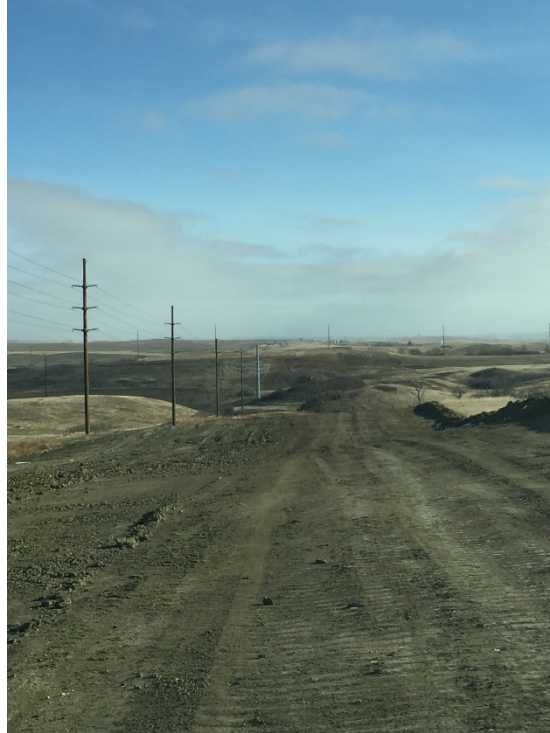
Picture 11: Ready for topsoil to be spread, showing grade returned to existing contours

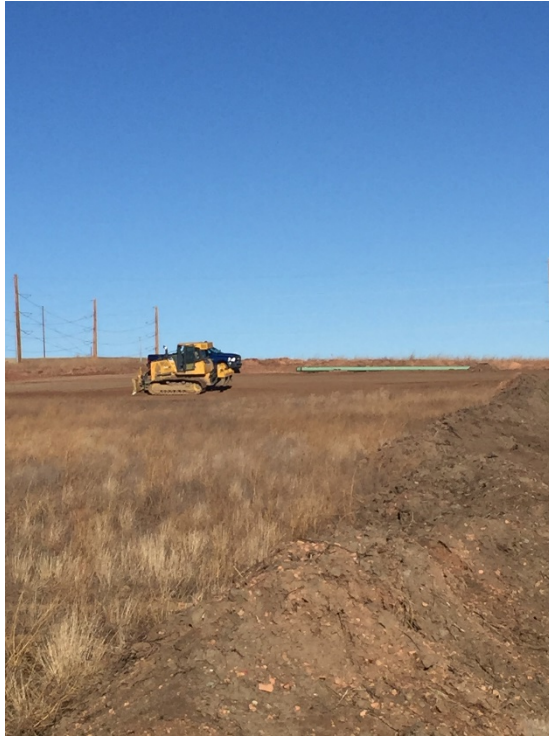
Picture 14: Equipment working on restoring grade

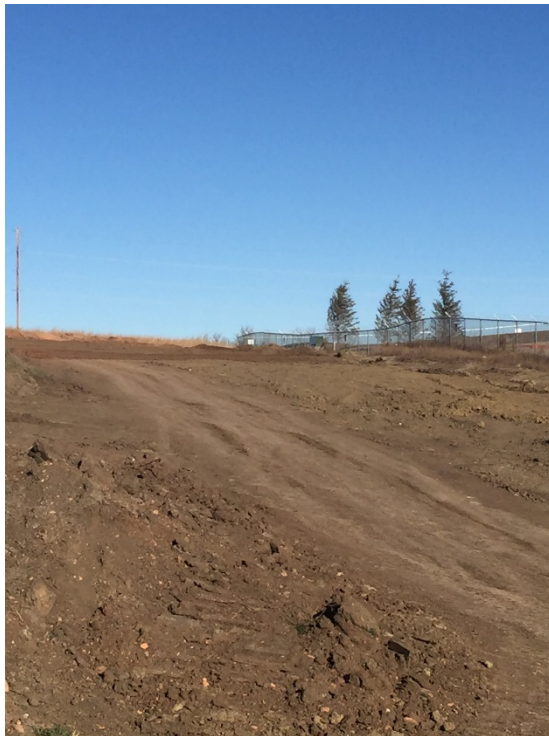
Picture 15: Topsoil spreading beginning near Johnsons Corner Terminal

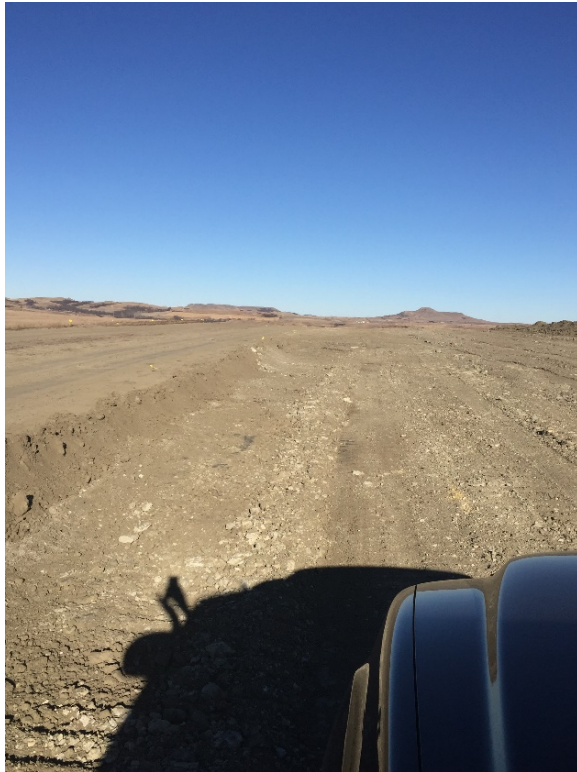
Picture 18: Grading in progress, looking north. Beginning to spread topsoil from berm

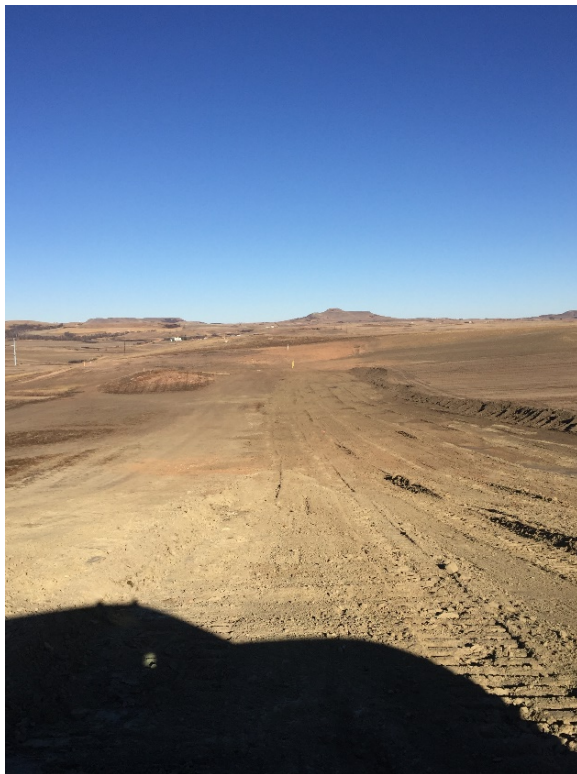
Picture 19: Grading in progress, looking north

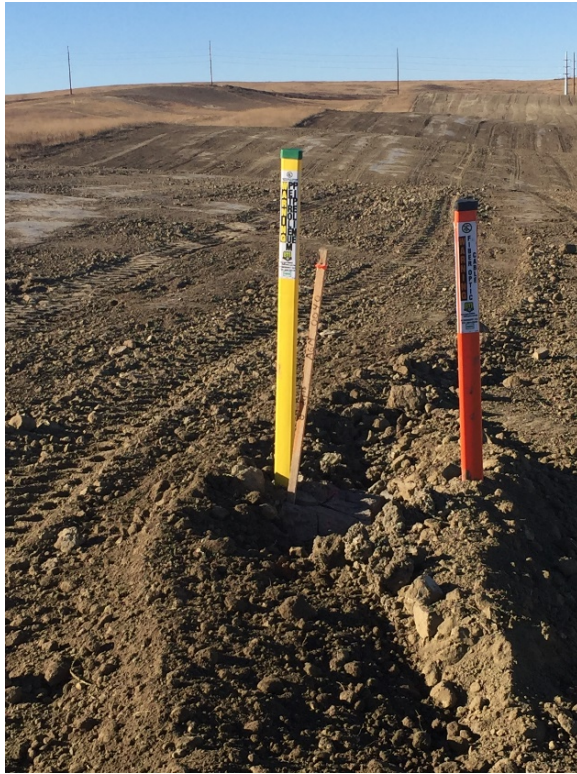
Picture 20: Topsoil completed, looking west

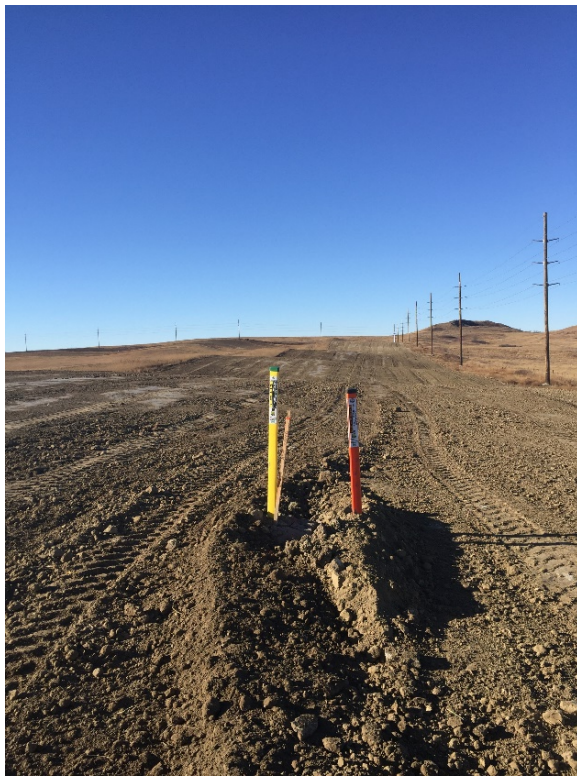
Picture 21: Topsoil spreading completed, looking west

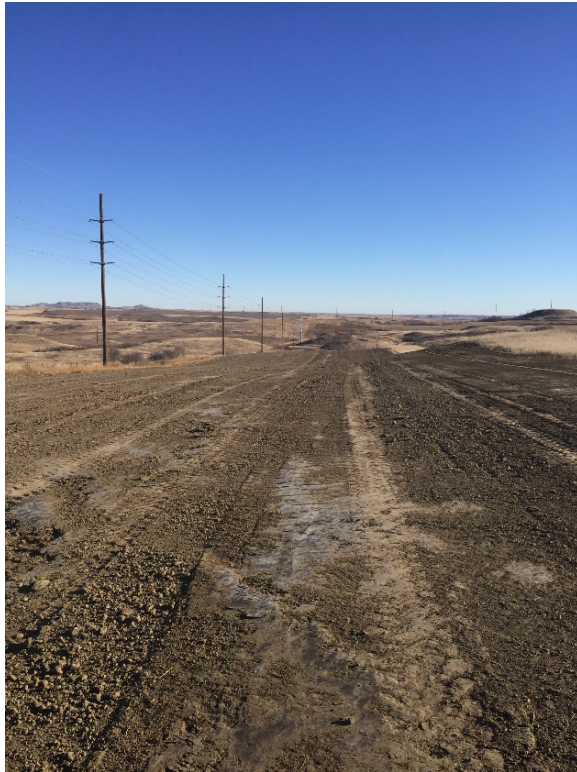
Picture 22: Topsoil spreading completed, looking east

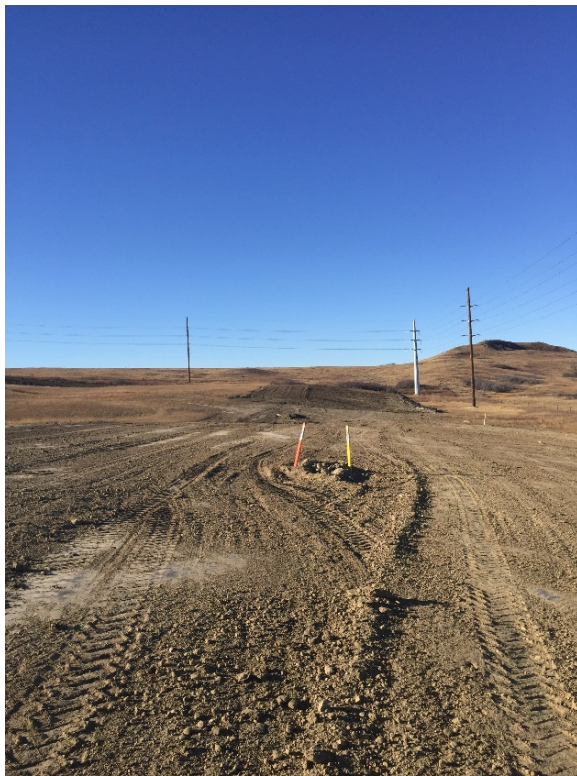
Picture 23: Topsoil spreading recently completed in background, looking west

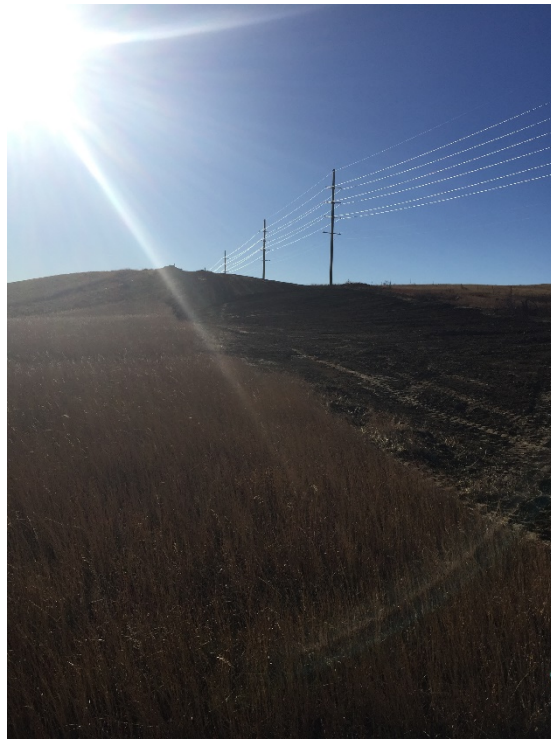
Picture 25: Topsoil spreading completed

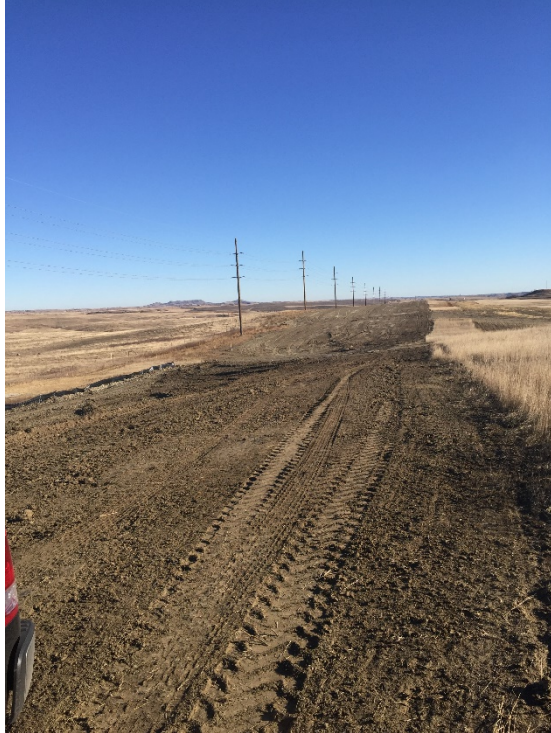
Picture 26: Topsoil spreading completed, looking east

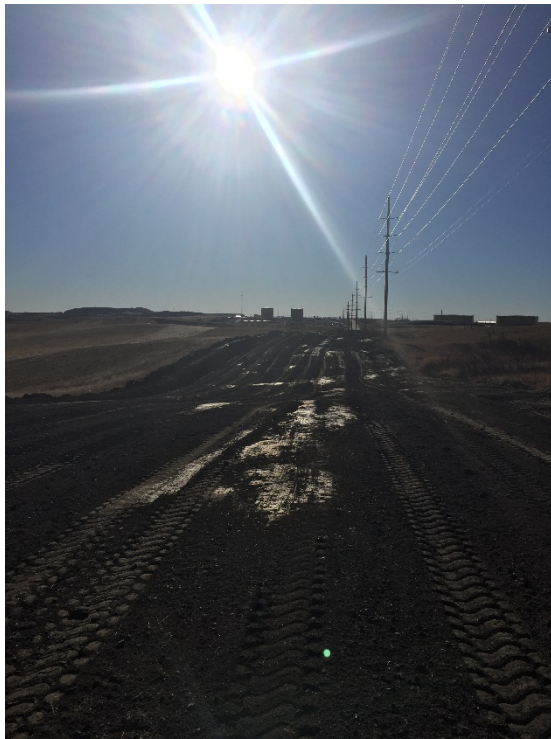
Picture 27: Topsoil spreading completed

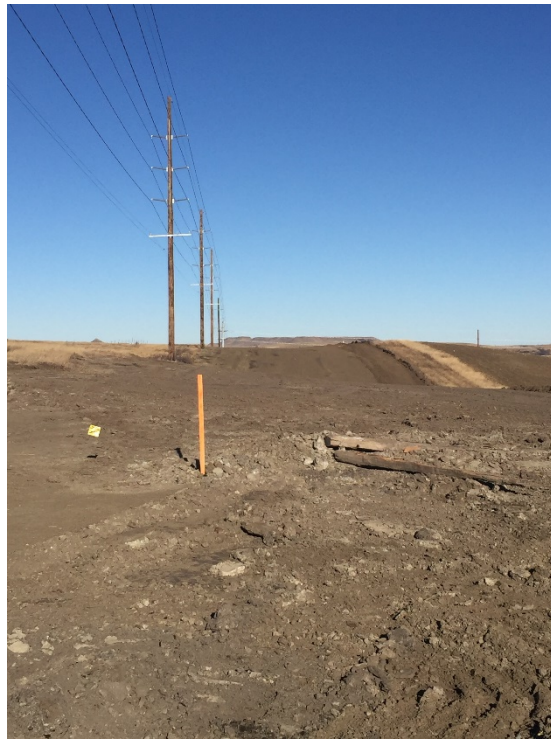
Picture 29: Grading and cleanup in progress

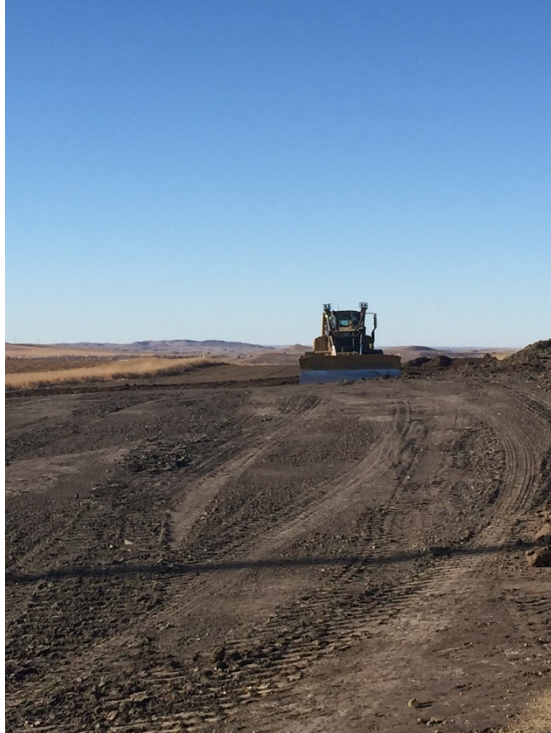
Picture 30: Topsoil spreading in progress, looking west

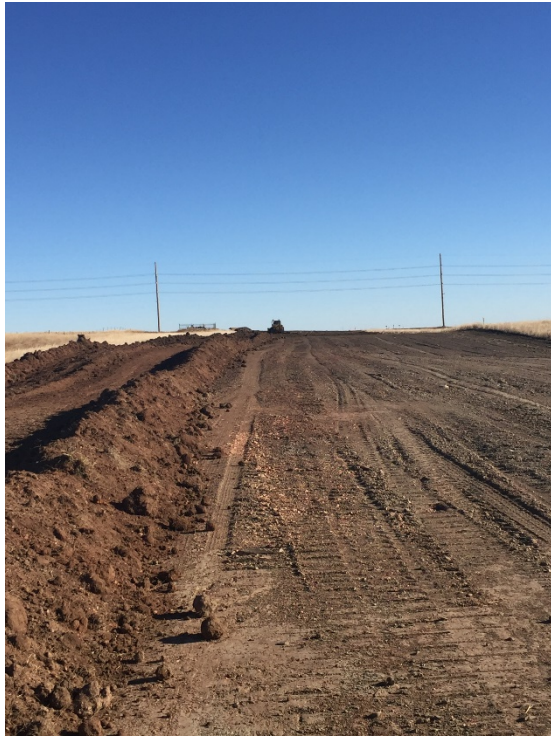
Picture 32: Begin spreading topsoil berm, looking east

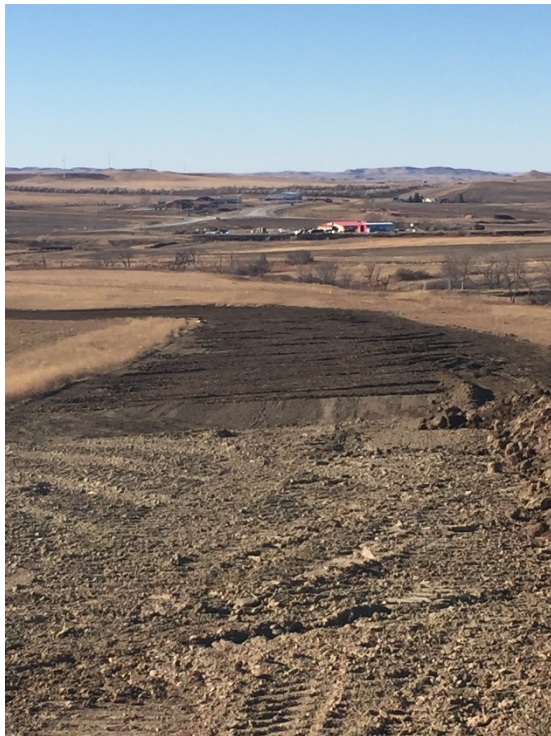
Picture 33: Topsoil spreading completed, looking west

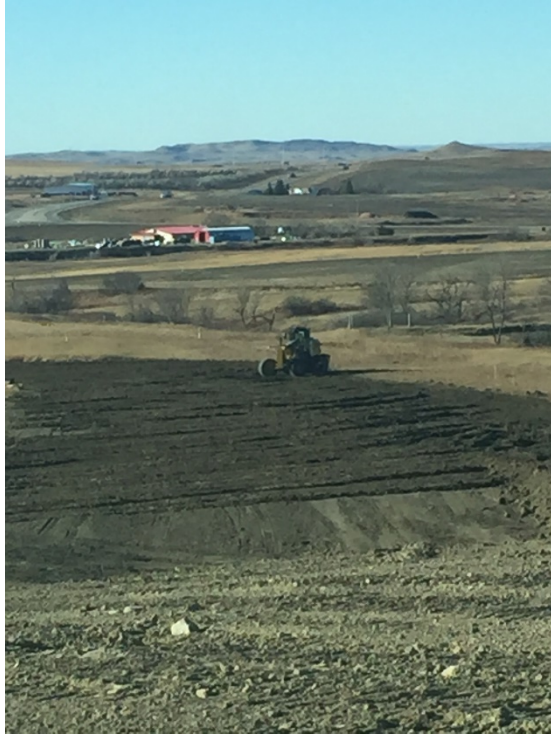
Picture 34: Finish grading of topsoil in progress, looking west
