Plains Terminal 24-Inch Crude Oil Pipeline Johnson's Corner to Dakota Access Pipeline

Reclamation and Revegetation Inspection Report

Case No. PU-16-140

November 20, 2019

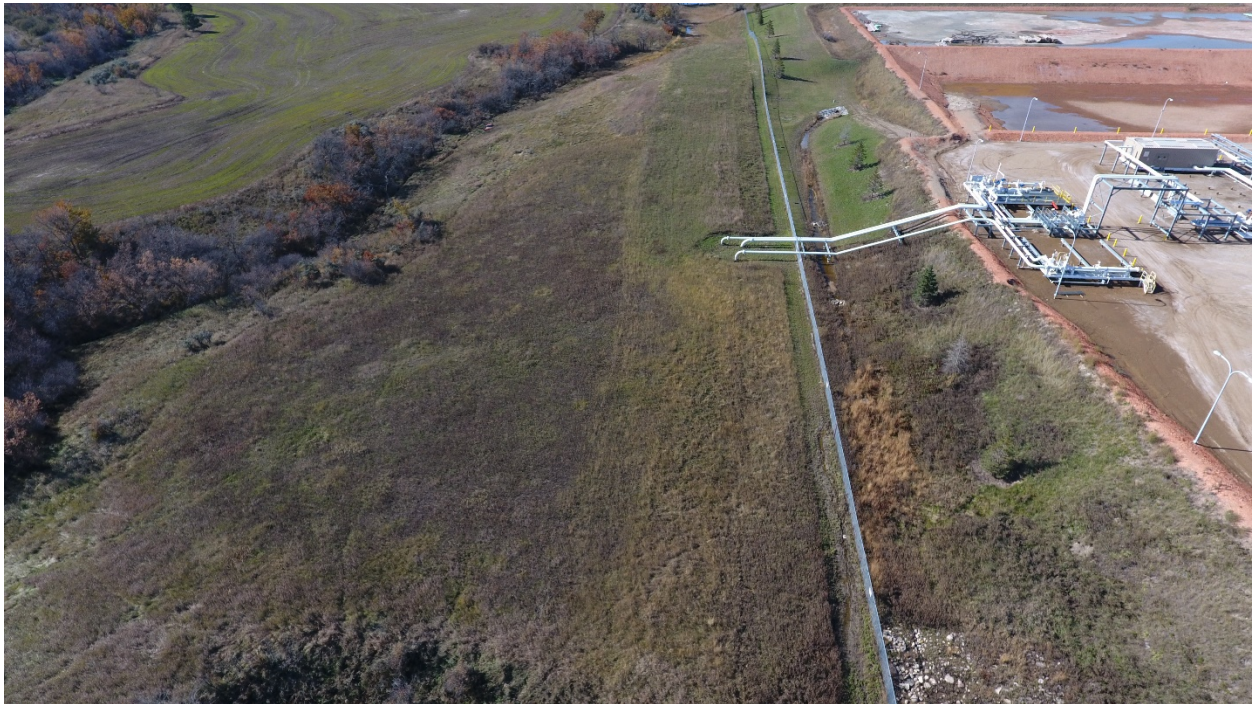
Locations 1 and 2: Location of pipeline is visible but shows native plant life beginning to blend well into the reclaimed area.

Location 1 - Looking west, vegetation well established and matching surroundings

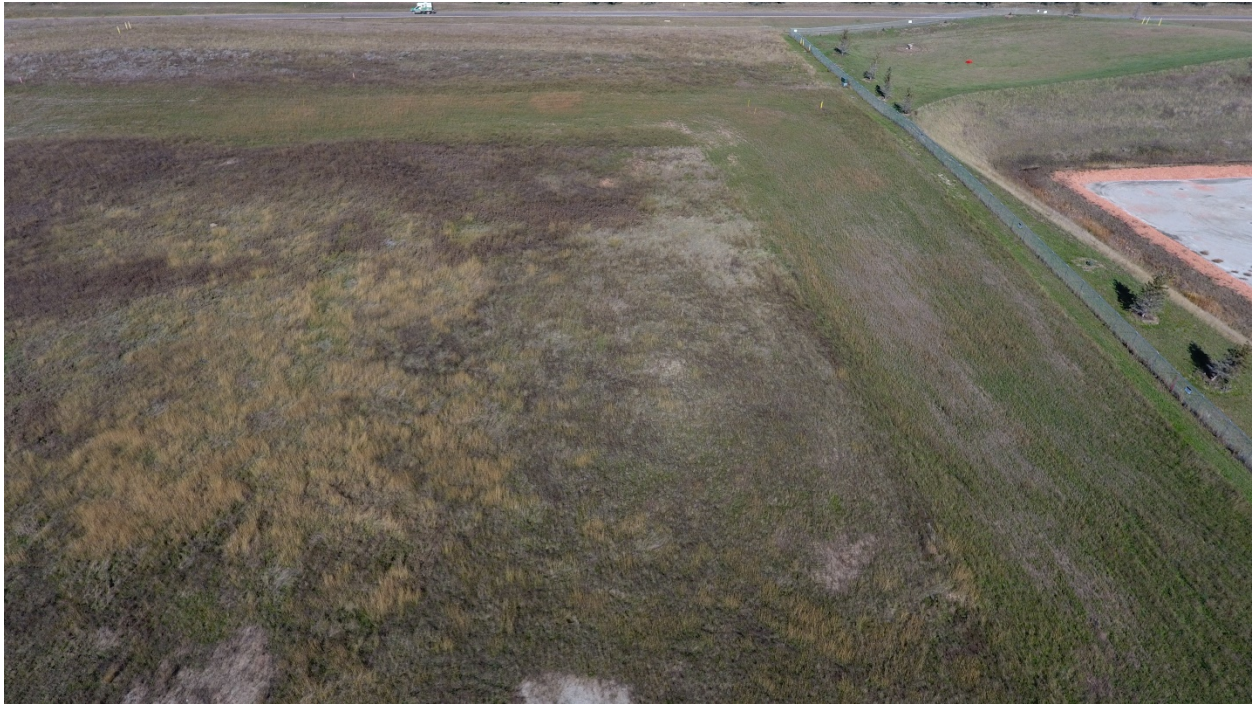
Location 5 and 6: Vegetation has been established to a level matching the surrounding conditions, however the location of the reclamation is still visible. This is likely due to varying varieties of plant life in the surround terrain.

Location 5 - Looking north, vegetation established to a level matching adjacent ground. Different varieties of plant life

Based on our observations, we feel the reclamation efforts have been successful throughout the project. Evidence can be seen in several locations throughout the project where the native grassland is beginning to blend into the reclaimed area. In locations where farm or crop land was planted, little to no evidence of the pipeline exists. We expect areas of concern will continue to improve with time as seen elsewhere in along the pipeline, and in previous projects.

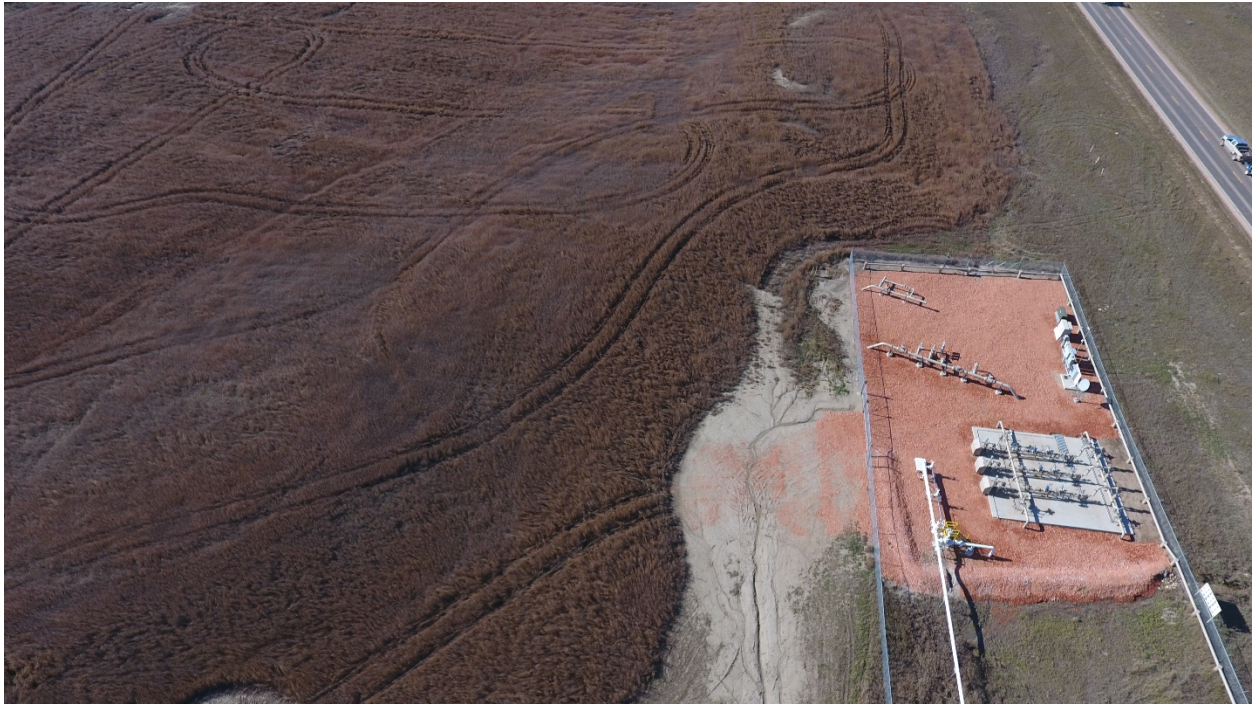
Locations 9-15: Area primarily crop or hay land. In these locations the pipeline is generally undetectable among its surroundings. The reclamation efforts appear to have been fully successful at returning the land to its original condition.

Location 9 - Looking west. Pipeline not detectable in farmland

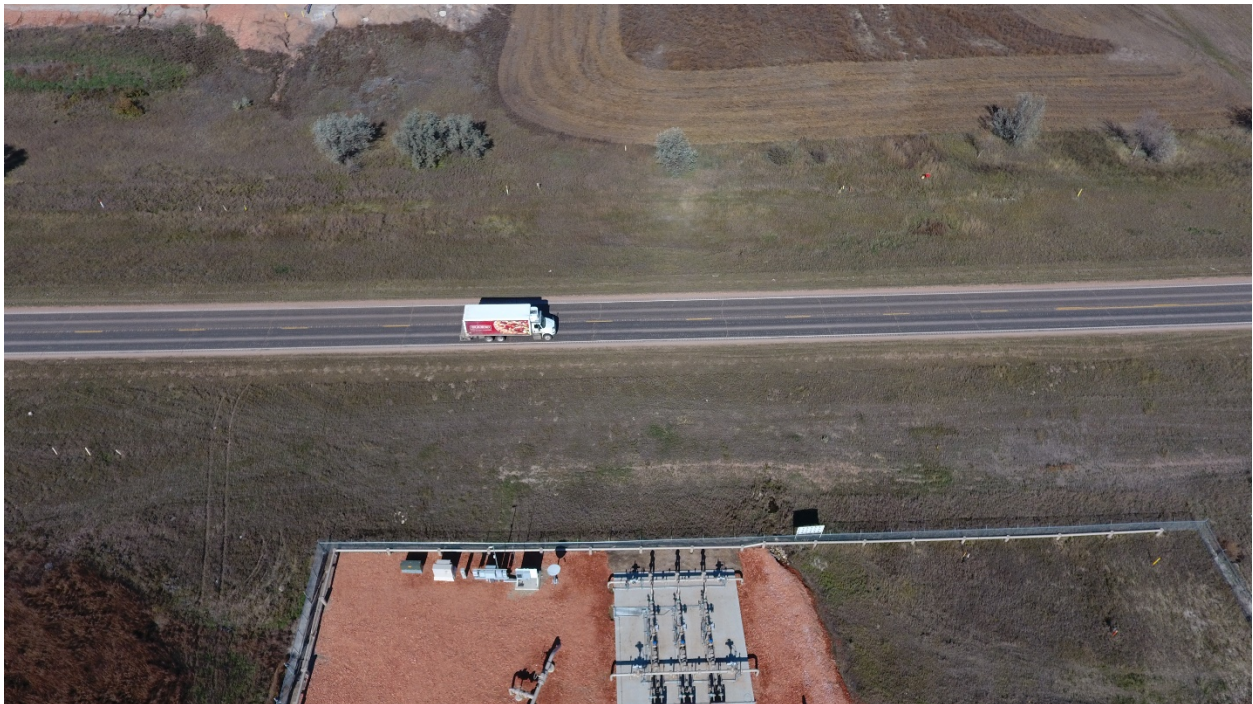
Location 10 - Looking north, bore area, pipeline not detectable

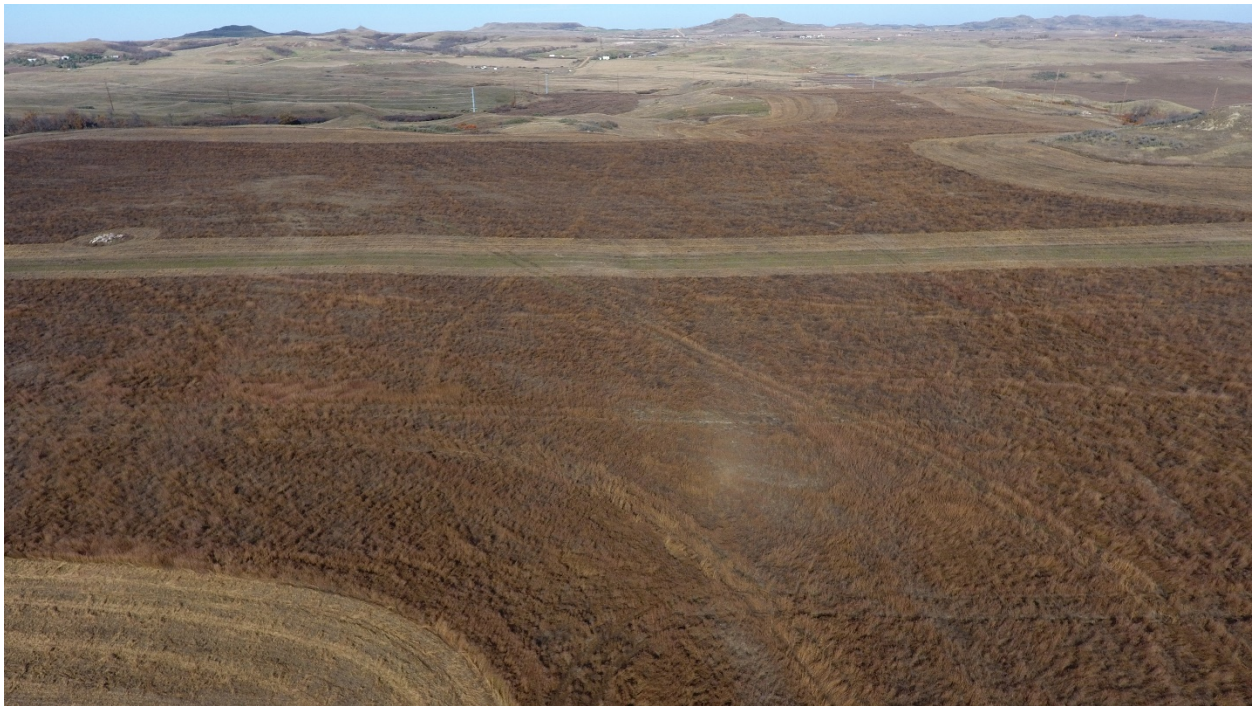
Location 13 - Looking north, no evidence of pipeline

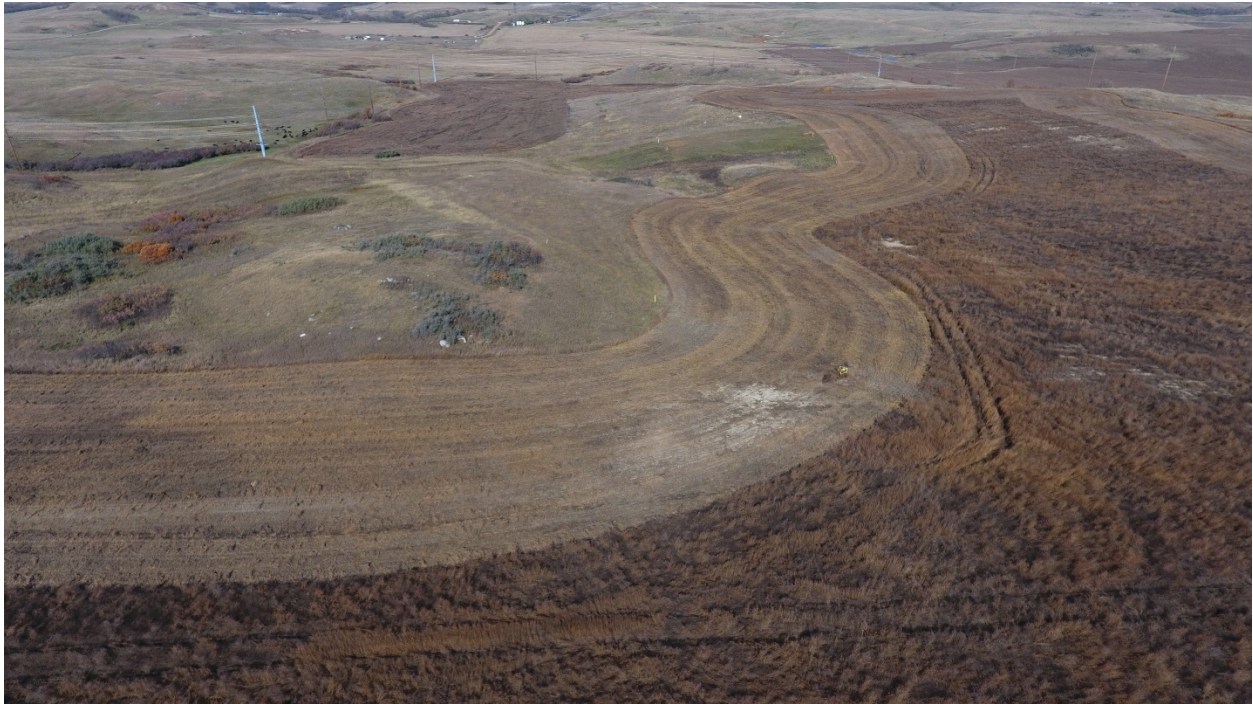
Location 15 - Looking north, no evidence of pipeline in cropland

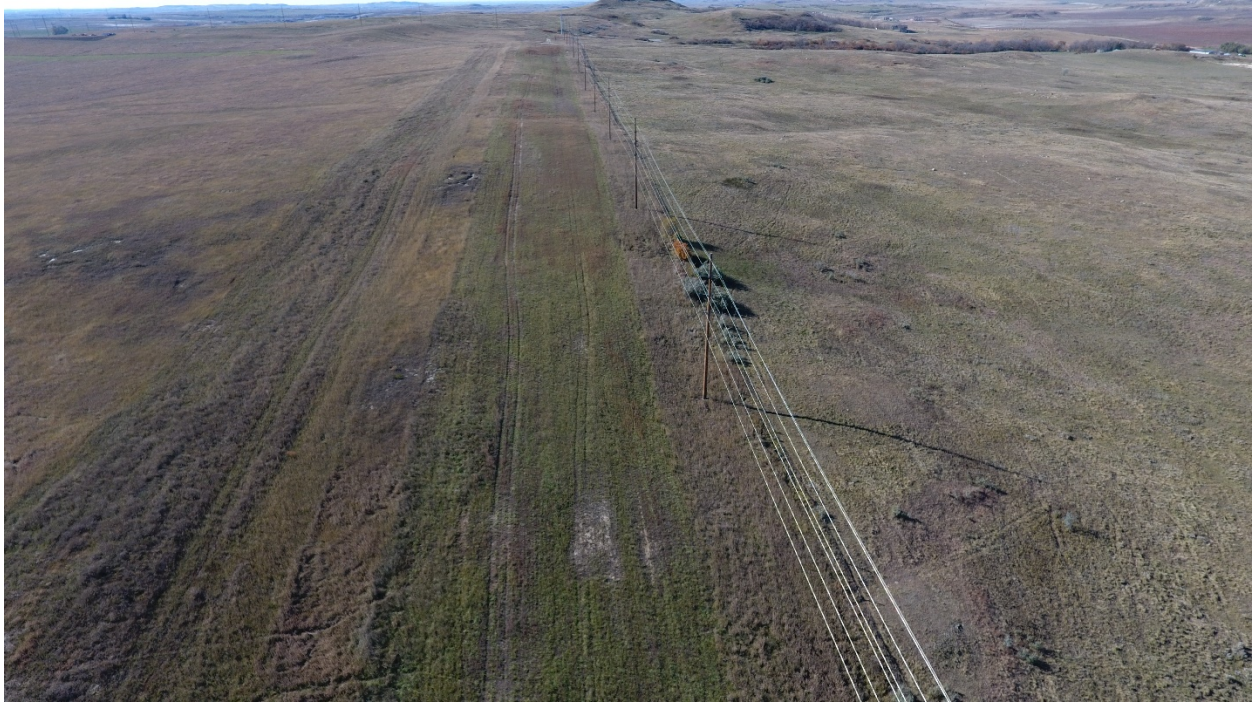
Locations 17-22: Areas showing good signs of growth throughout reclaimed area.

Location 17 - Looking west, vegetation well established

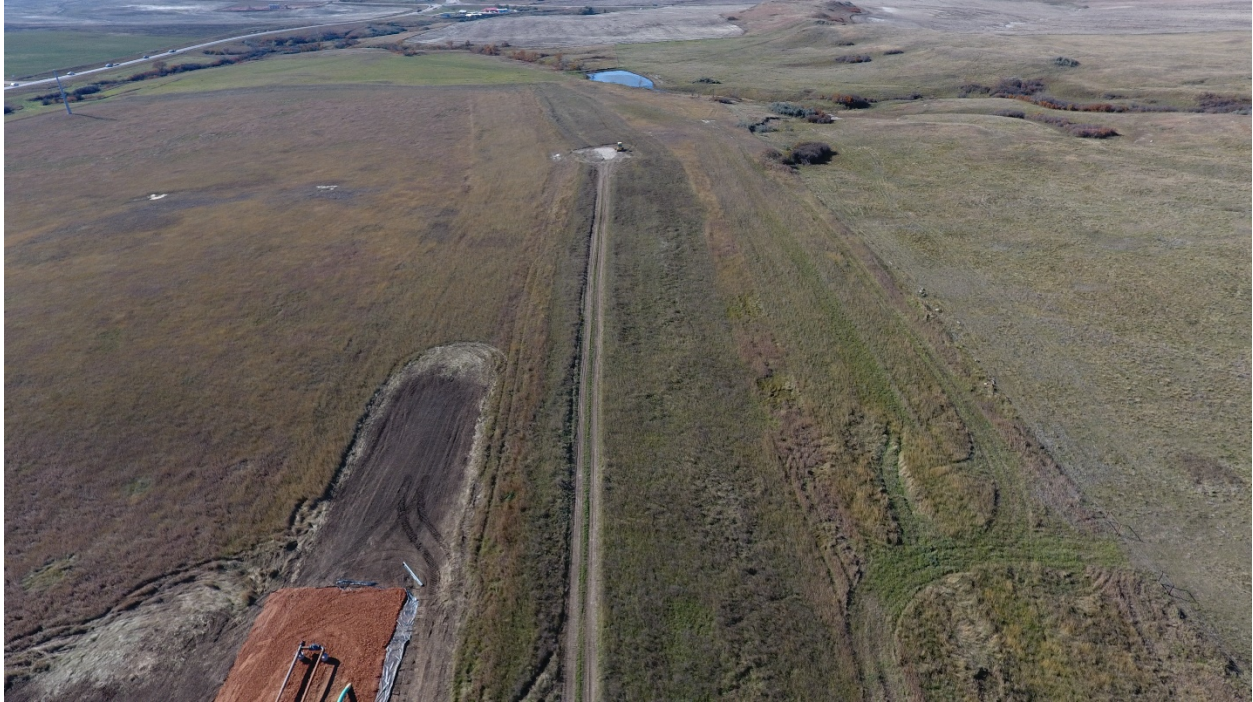
Location 23 - Looking west, vegetation well established, and blending into surrounding conditions

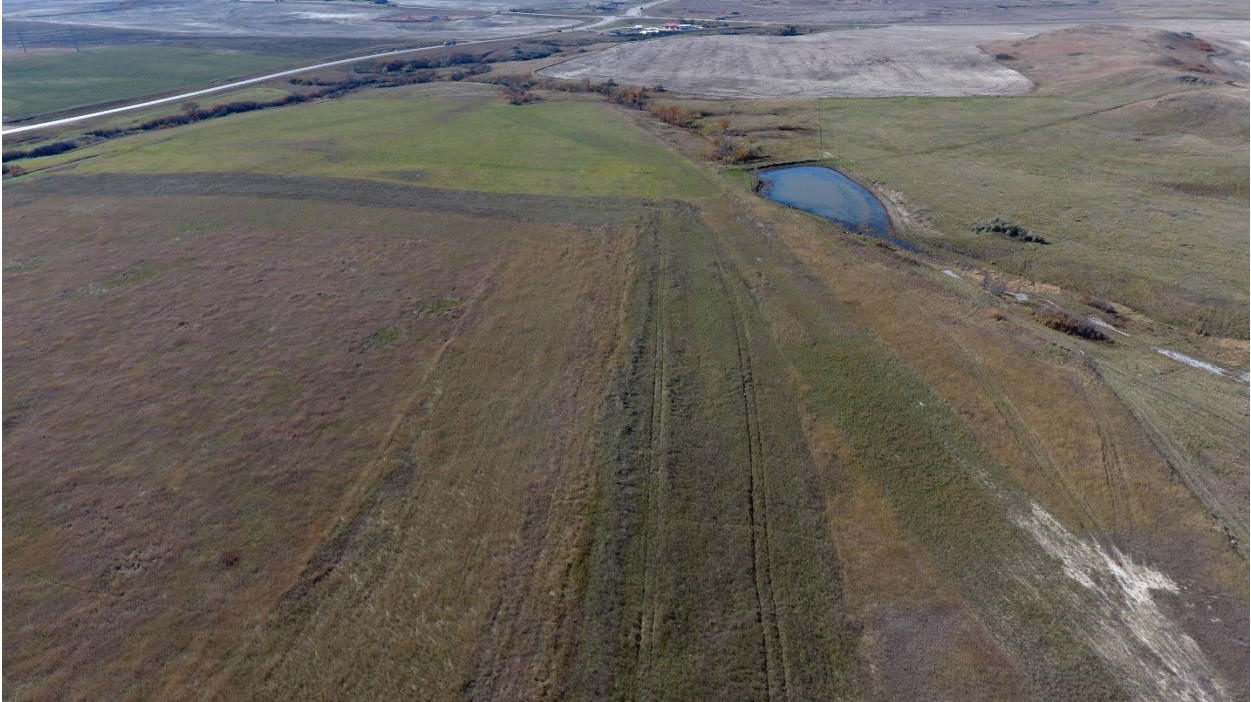
location 25 - Looking west

Locations 25-29: Vegetation beginning to blend into surroundings. We believe the area of reclamation is still detectable due to the land being planted and/or cut at different times than the adjacent land. The differences in vegetation will likely minimize in future growing seasons.

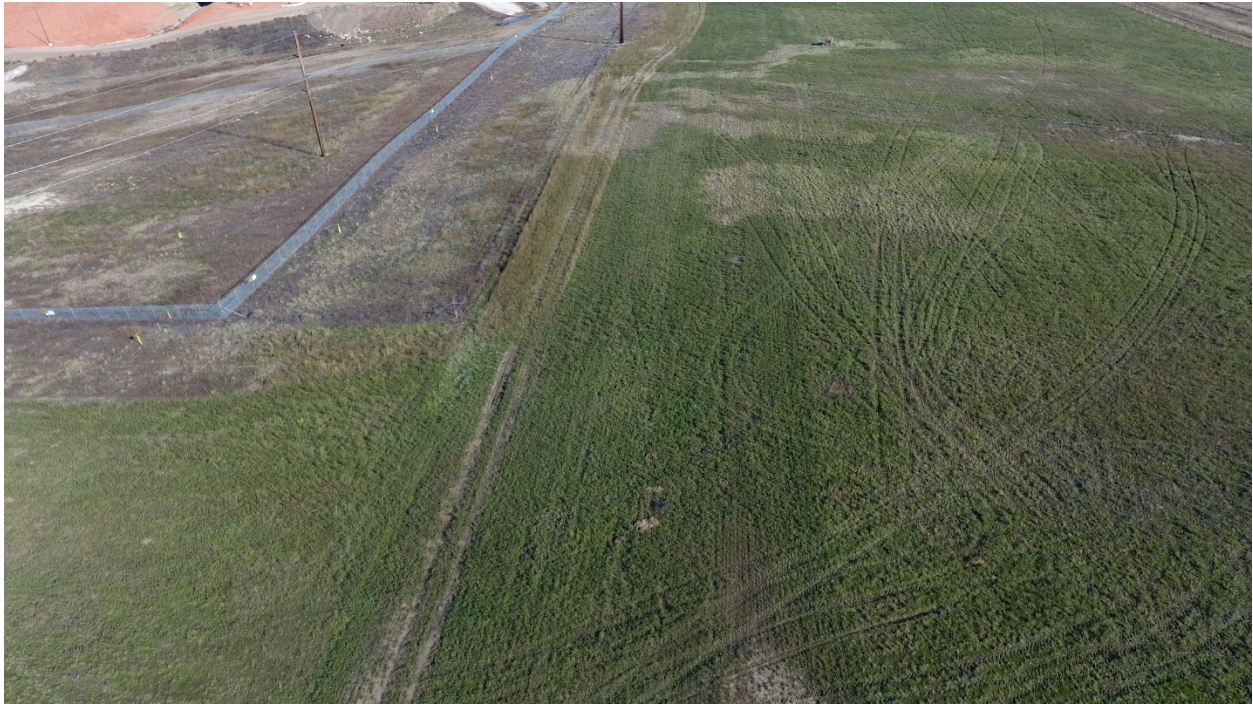
Locations 32-24: Vegetation well established. Reclaimed areas nearly undetectable among its surroundings.

Location 33 - Looking east, vegetation blending well into surrounding conditions
