Carlson McCain, Inc. (CMI) conducted a construction inspection at the Hess ETP Pipeline – Williams County (Case No. PU-16-189) on October 7, 2016, on behalf of the North Dakota Public Service Commission (PSC). The project consists of installing a 12-inch diameter, 1.1-mile crude oil pipeline.

45 **PU-16-189** Filed: 10/10/2016 Pages: 9
Construction Inspection Report

Construction Inspection
PSC Case No. PU-16-189

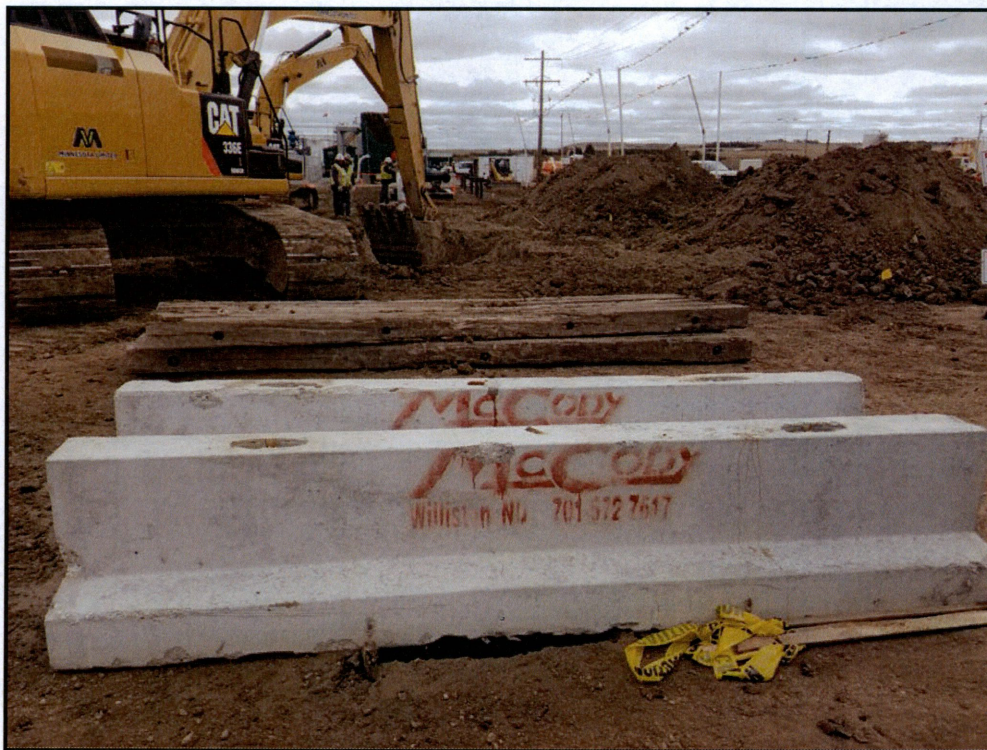
Figure 2. Photo taken facing south from the RFT access road. Construction of ditch to the RFT facility was underway.

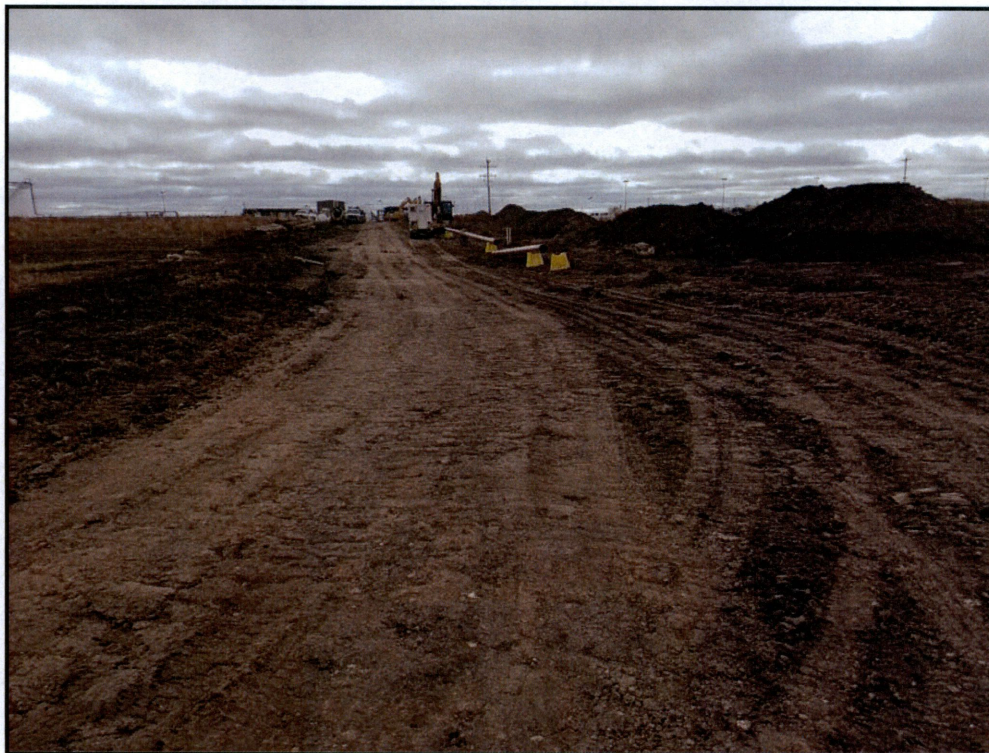
Figure 3. Photo taken looking north. Pipeline has been installed and trench filled. Pipe strung in photo is for the RFT tie-in.

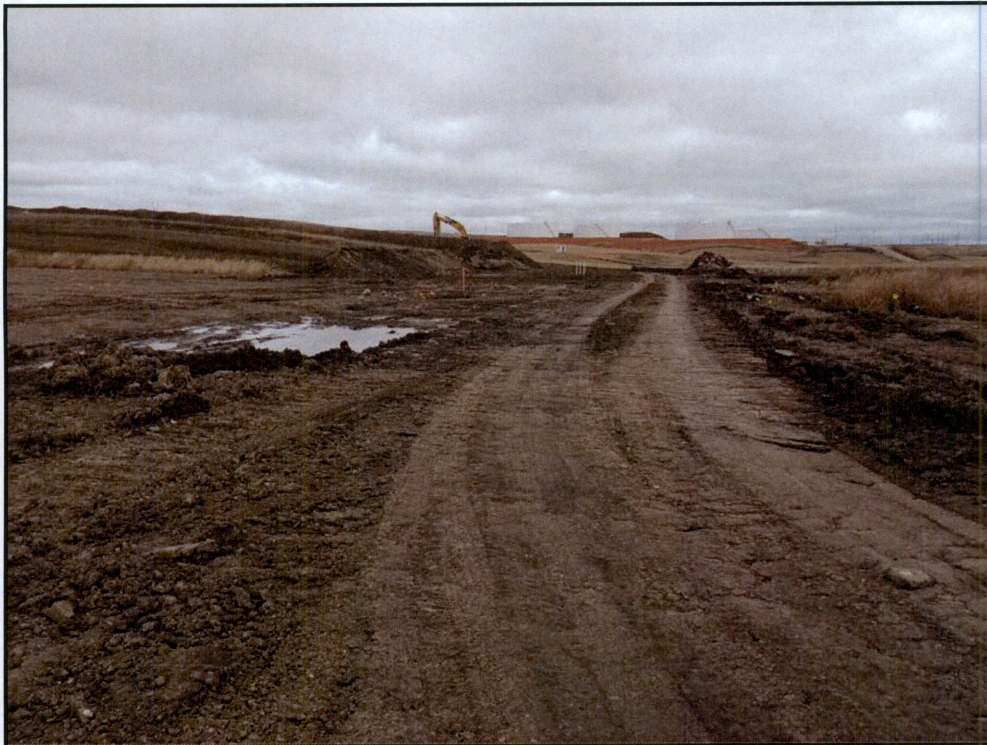
Figure 4. Photo taken looking northeast. Pipeline has been installed and backfilled.

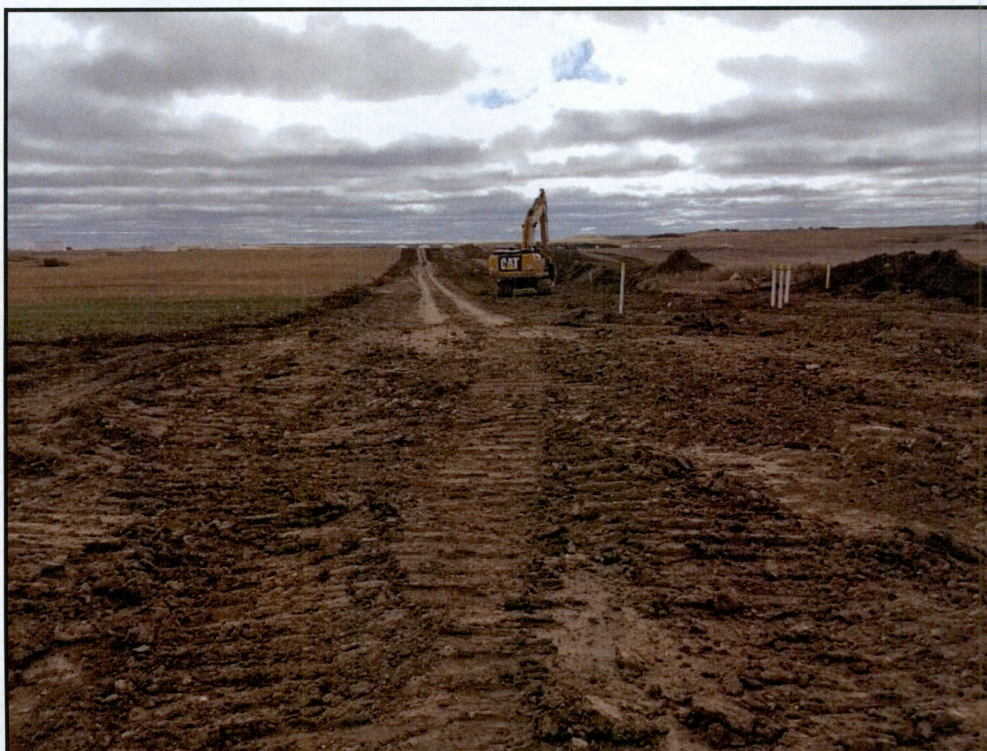
Figure 5. View looking south down the pipeline corridor.

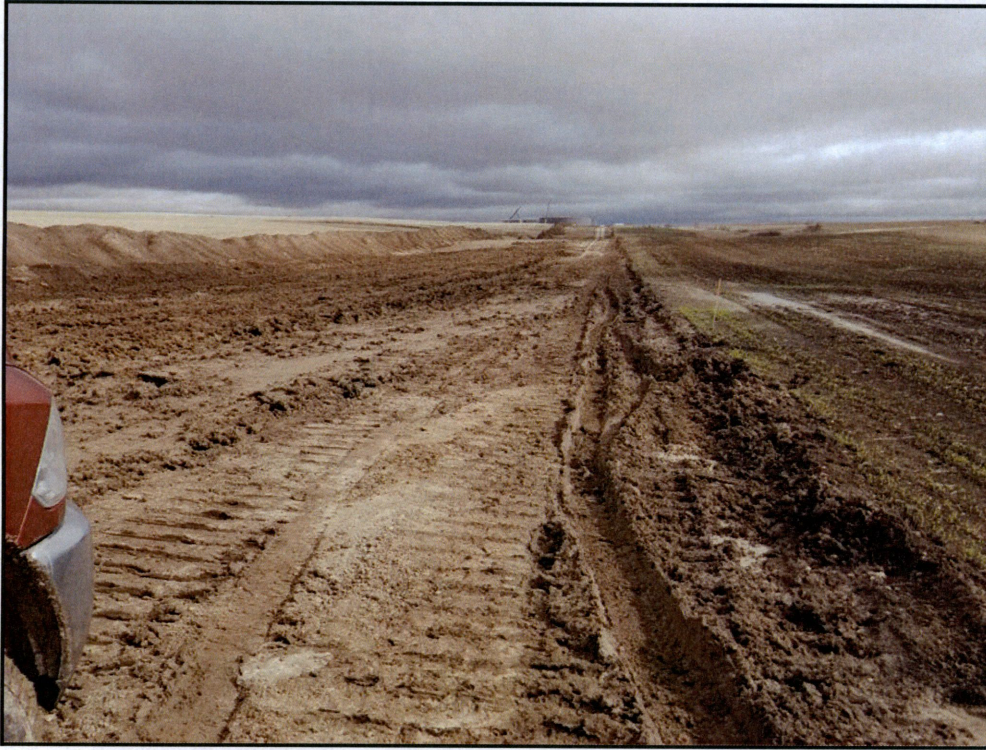
Figure 6. Photo taken looking east down the pipeline corridor.

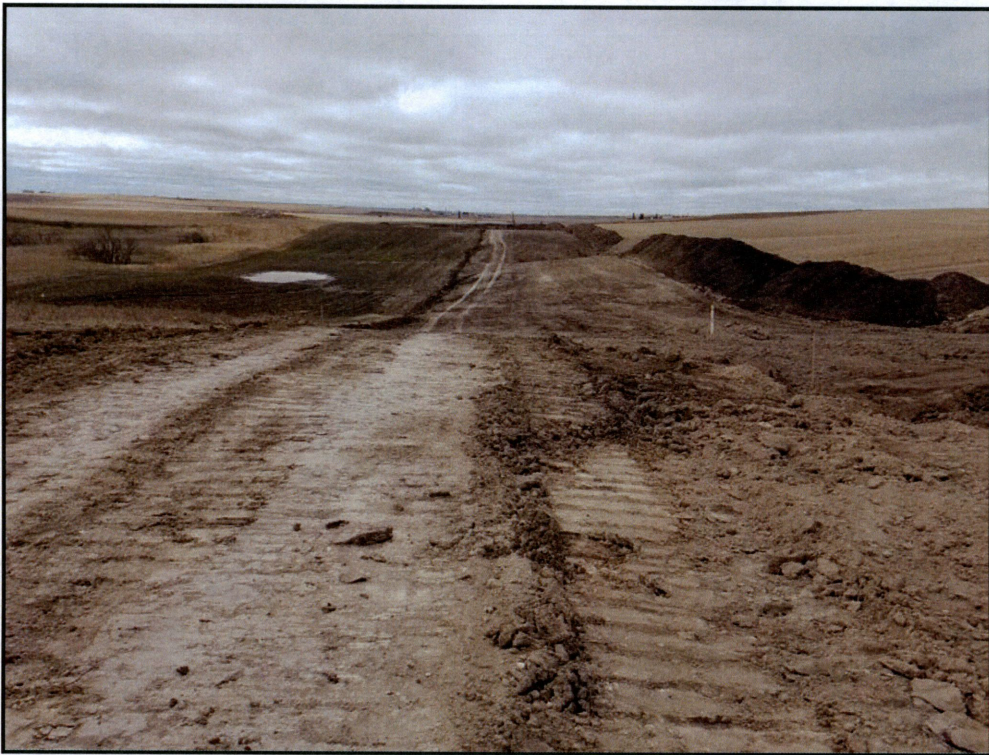
Figure 7. Photo taken looking west down the pipeline corridor. Pipeline has been installed and backfilled. Topsoil has not been re-spread.

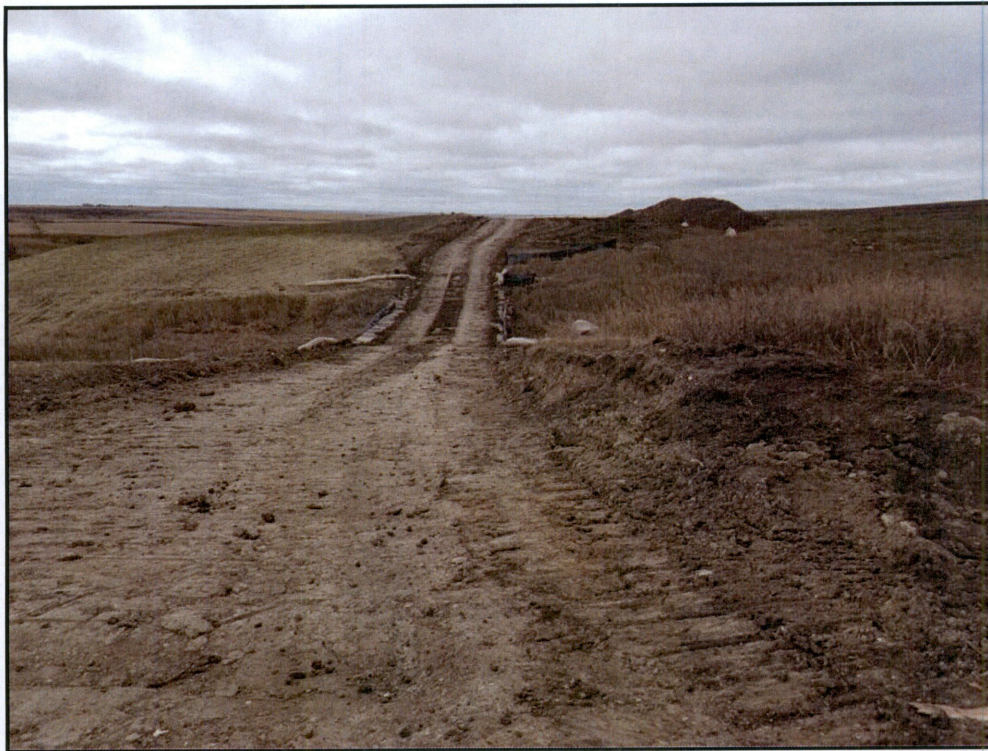
Figure 8. Photo taken looking west across matting installed in upland drain. Silt fence and straw waddles are properly installed and functioning.

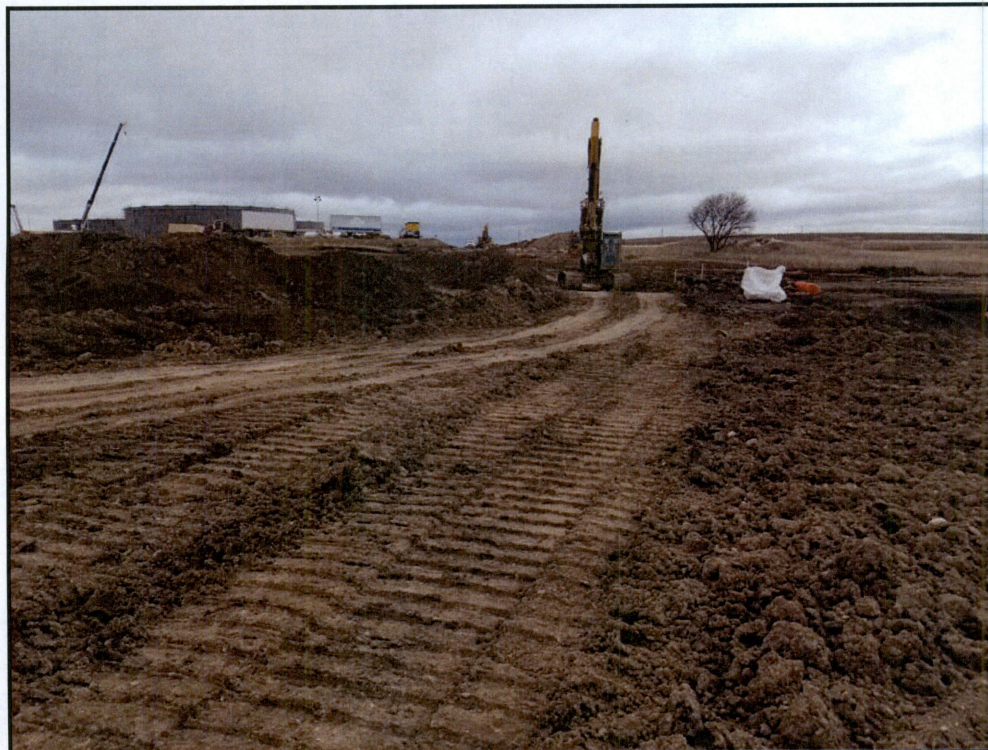
Figure 9. Photo taken, facing east, of construction corridor at dogleg near ETP facility.

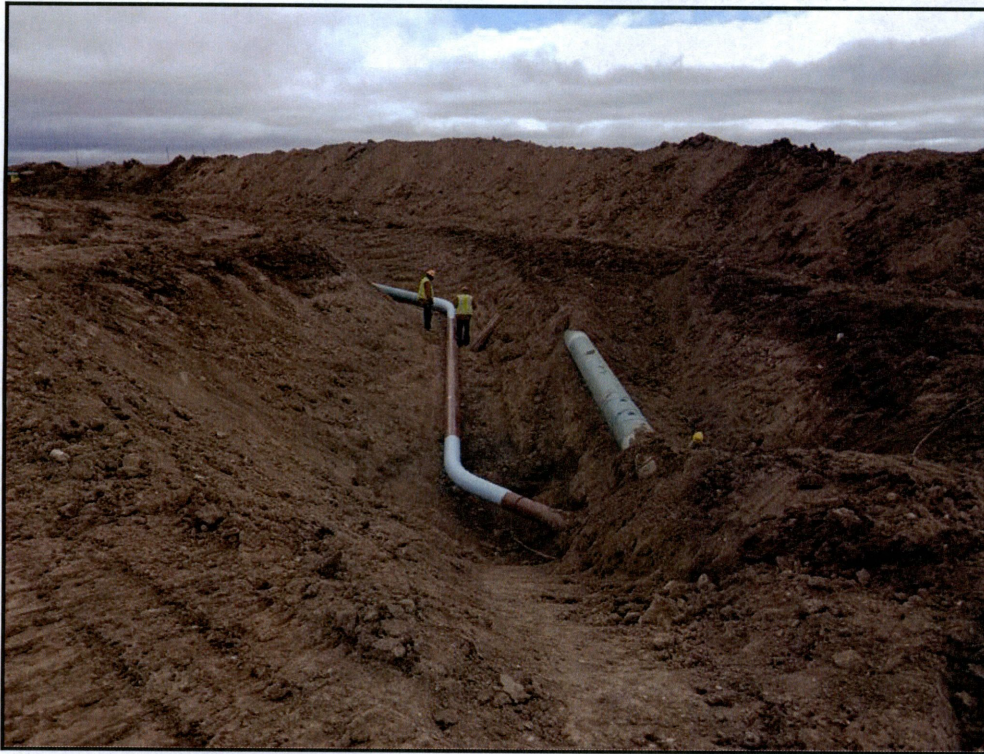
Figure 10. Photo of ETP Pipeline crossing under Dakota Access Pipeline. Pipeline construction is currently underway from this point to the ETP Facility.
