November 17, 2017

Carlson McCain, Inc. (CMI) conducted a construction inspection at the Hess Energy Transfer Partners (ETP) Pipeline – Williams County (Case No. PU-16-189) on October 22, 2017, on behalf of the North Dakota Public Service Commission (PSC). The project consists of installing a 12-inch diameter, 1.1-mile crude oil pipeline.

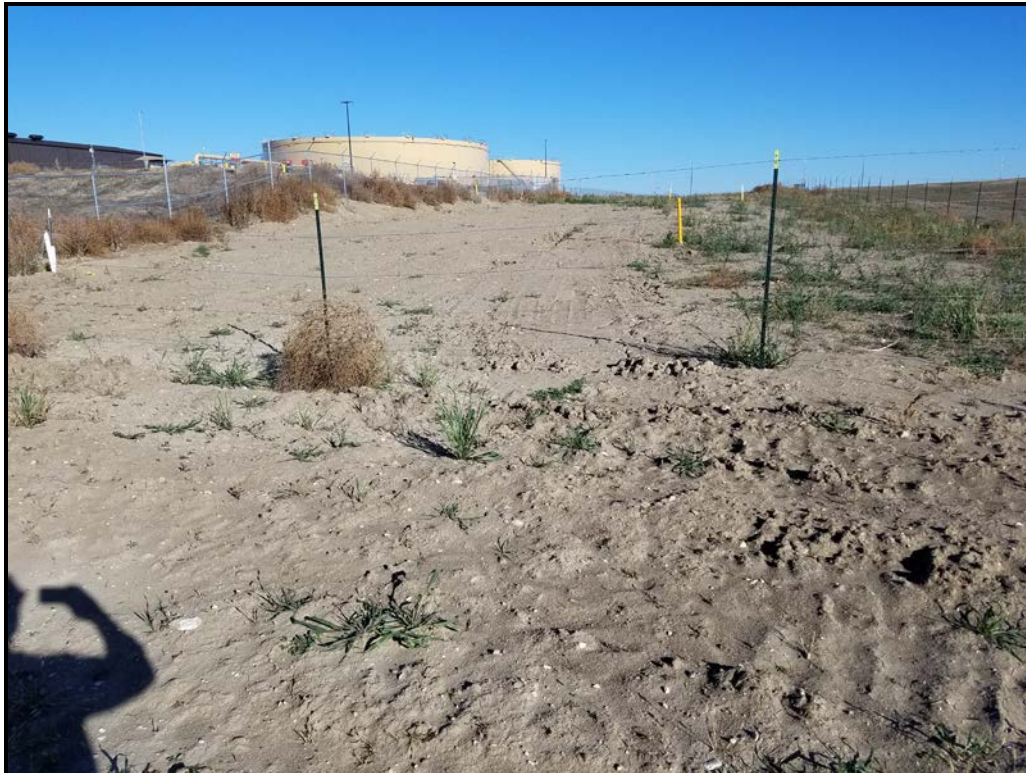
The ground is mostly barren just outside of the Hess ETP Facility with some weedy species present (Figure 2). A rockpile was noted, just off the southwest corner of the Facility, within the pipeline corridor. Barren, eroded soil and noxious weeds, Canada thistle (*Cirsium arvense*), are present around the rockpile (Figure 3). The survey continues west, across the cultivated portion of the corridor. The wetland/waterbody crossing was inspected and found to have ECD's in place and functioning. Vegetation at the crossing was poorly established with Canada thistle common (Figure 4 and 5). The grassy area west of the crossing also had poorly established vegetation with smooth brome (*Bromus inermis*), black medic (*Medicago lupulina*), kochia (*Bassia scoparia*), and Russian thistle (*Salsola tragus*) common (Figure 6). The reclaimed ROW in the cultivated areas had been planted in row crop and had no erosion issues.

Figure 2. Photo taken facing east towards where the ETP Pipeline enters the ETP Facility.

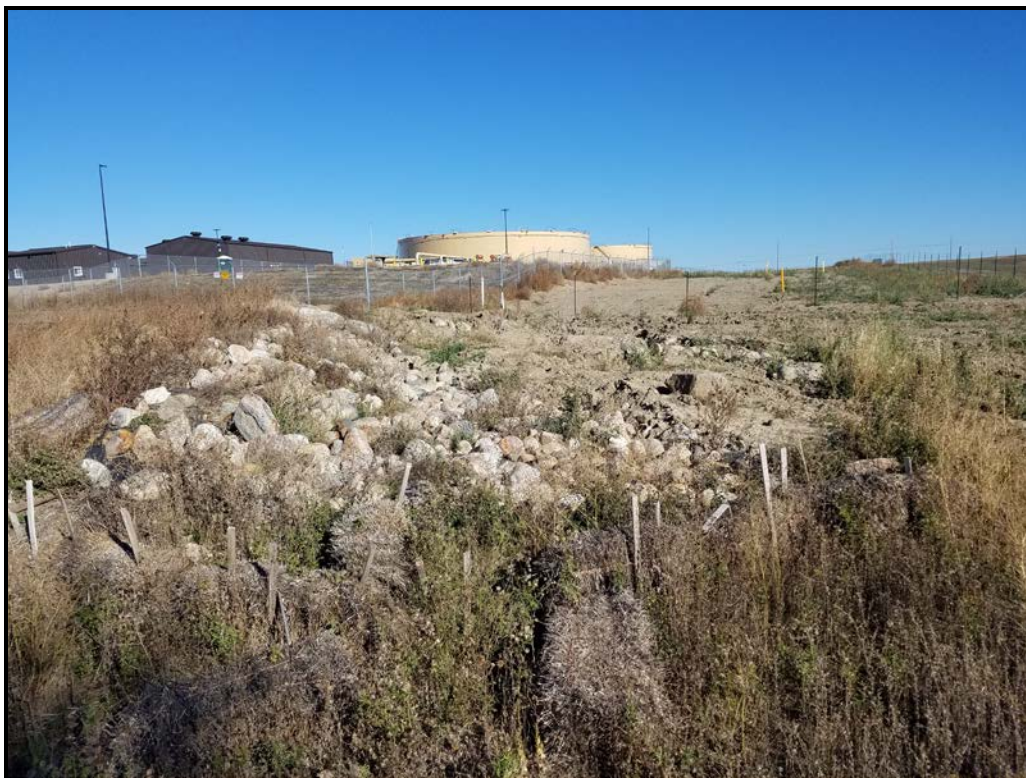
Figure 3. Photo taken looking east. A rockpile lies within the ROW with unlevel bare earth and noxious weeds.

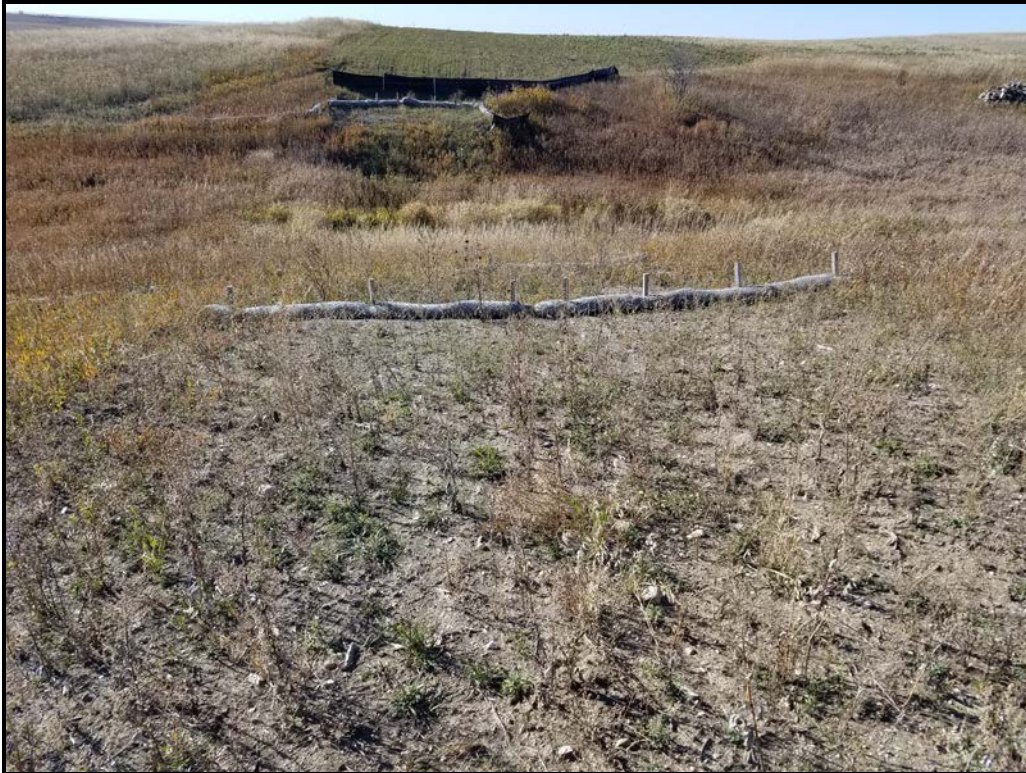
Figure 4. Photo taken looking west at the wetland/waterbody crossing. Vegetation is poorly established with noxious weeds present.

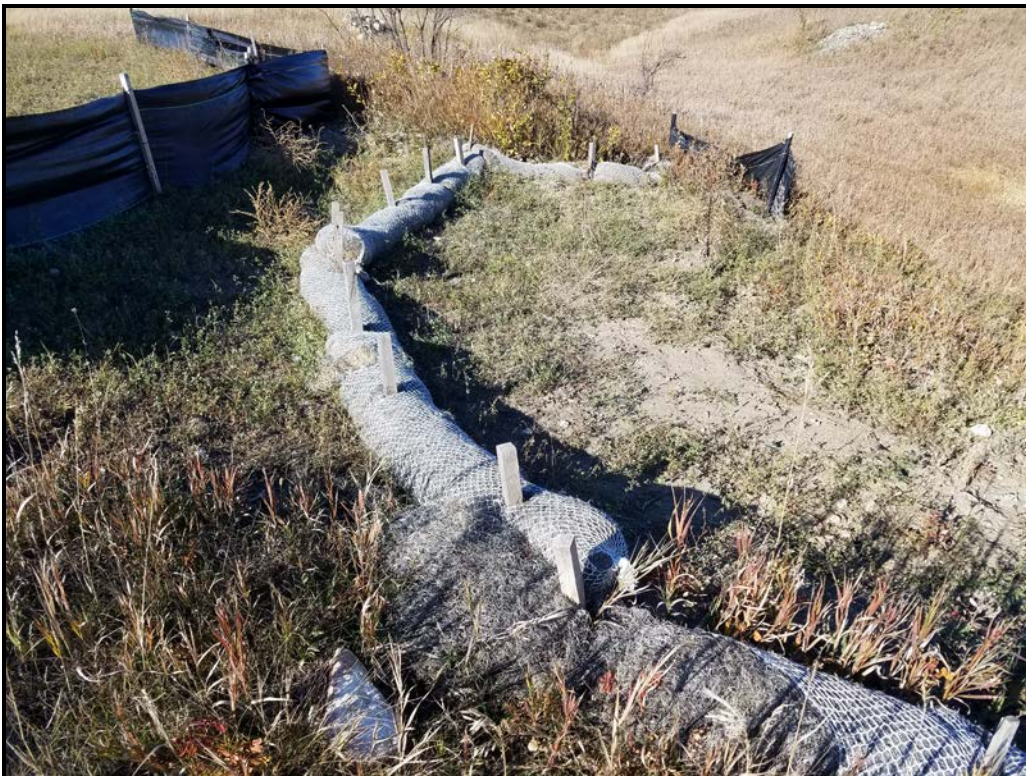
Figure 5. View of ECD's in place and functioning on the west side of the wetland/waterbody crossing.

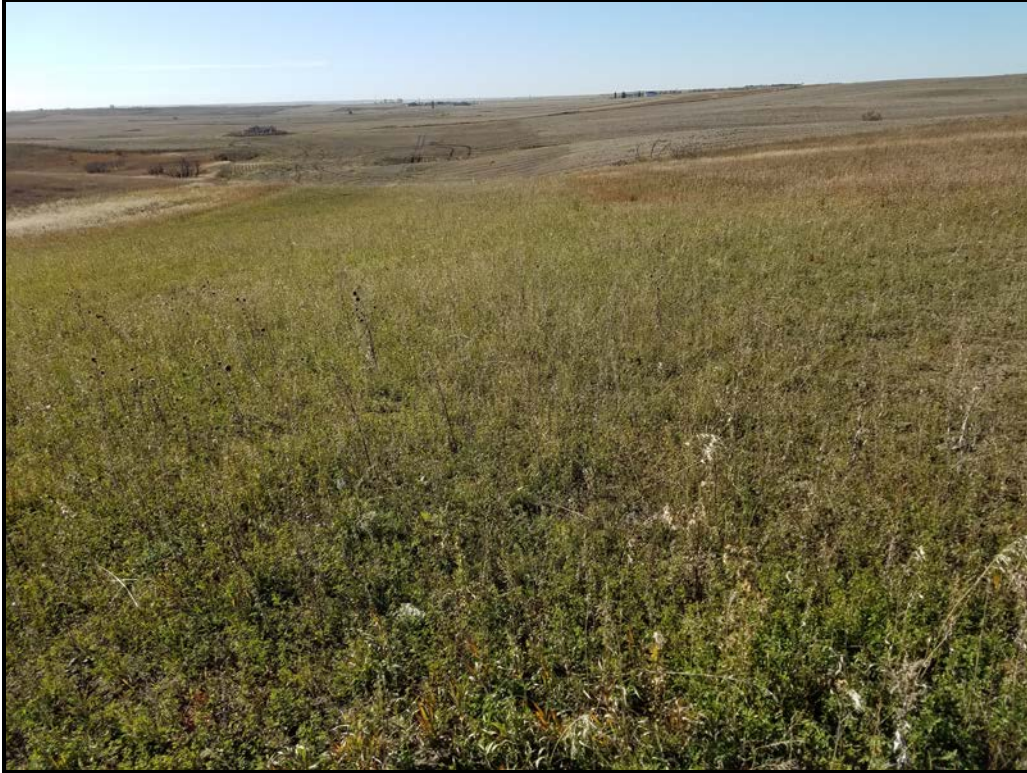
Figure 6. Photo taken looking west at the uncultivated portion of the ROW. Vegetation is present here, however, species present are primarily “weedy” species.

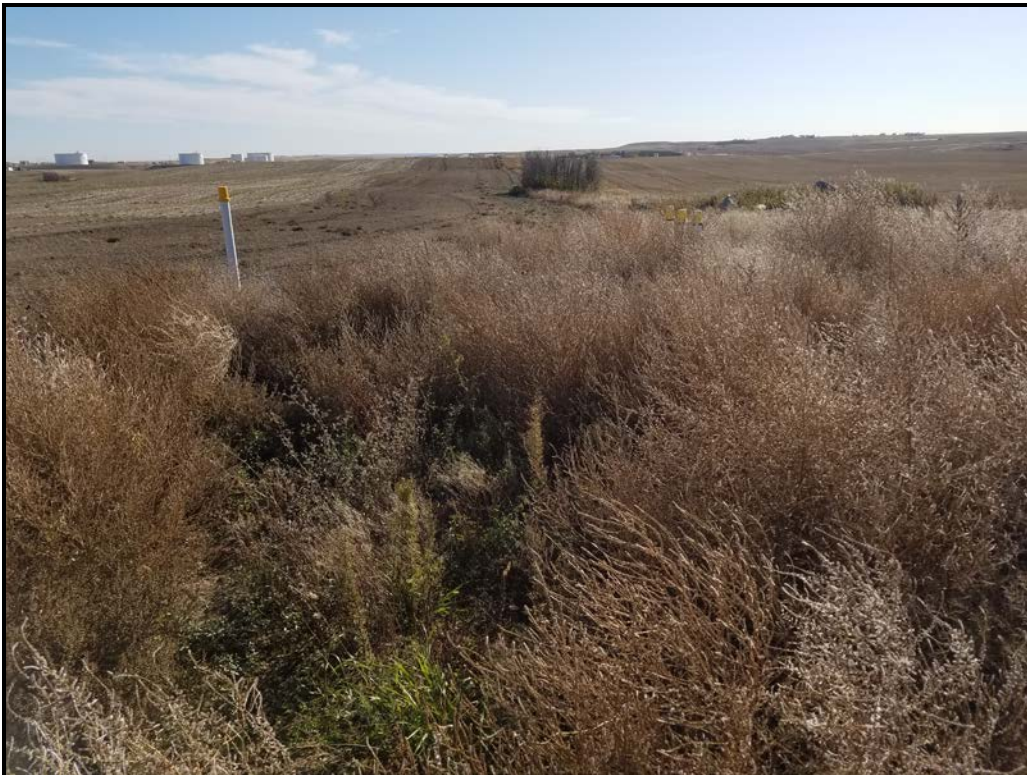
As the ROW turns south, kochia (*Bassia scoparia*), is present (Figure 7). Further to the south, Canada thistle is common along the west edge of the ROW (Figure 8 and 9). As the Pipeline enters the Rhamberg Trucking Facility ground cover is sparse with kochia being common (Figure 10).

Figure 7. Photo taken looking south from the where the Pipeline turns to the south. Kochia is common in this area.

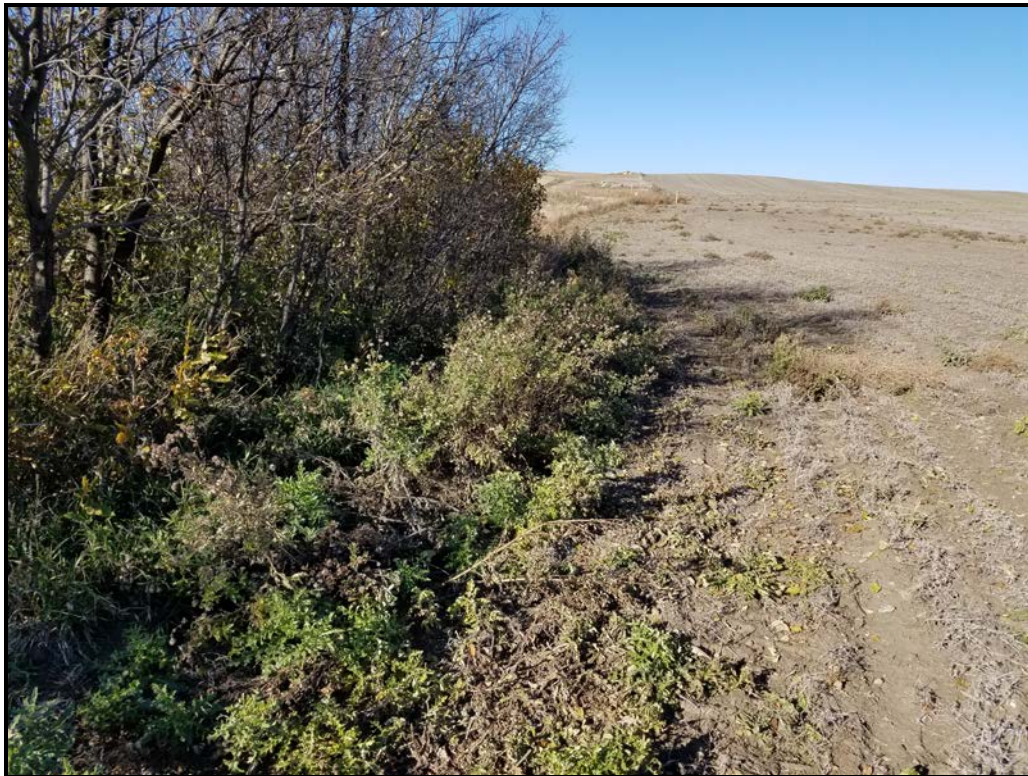
Figure 8. Photo taken looking north. Canada thistle is common on the edge of the ROW in this area.

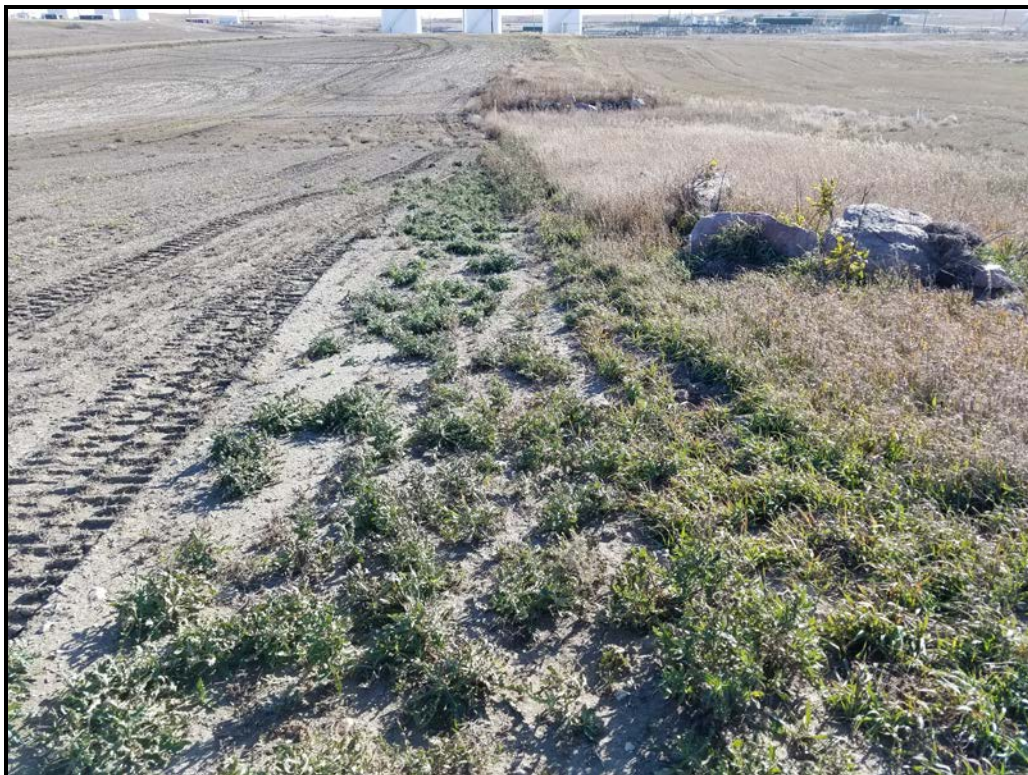
Figure 9. Photo taken facing south towards the Rhamberg Truck Facility. Canada thistle can be seen on the edge of the Pipeline ROW.

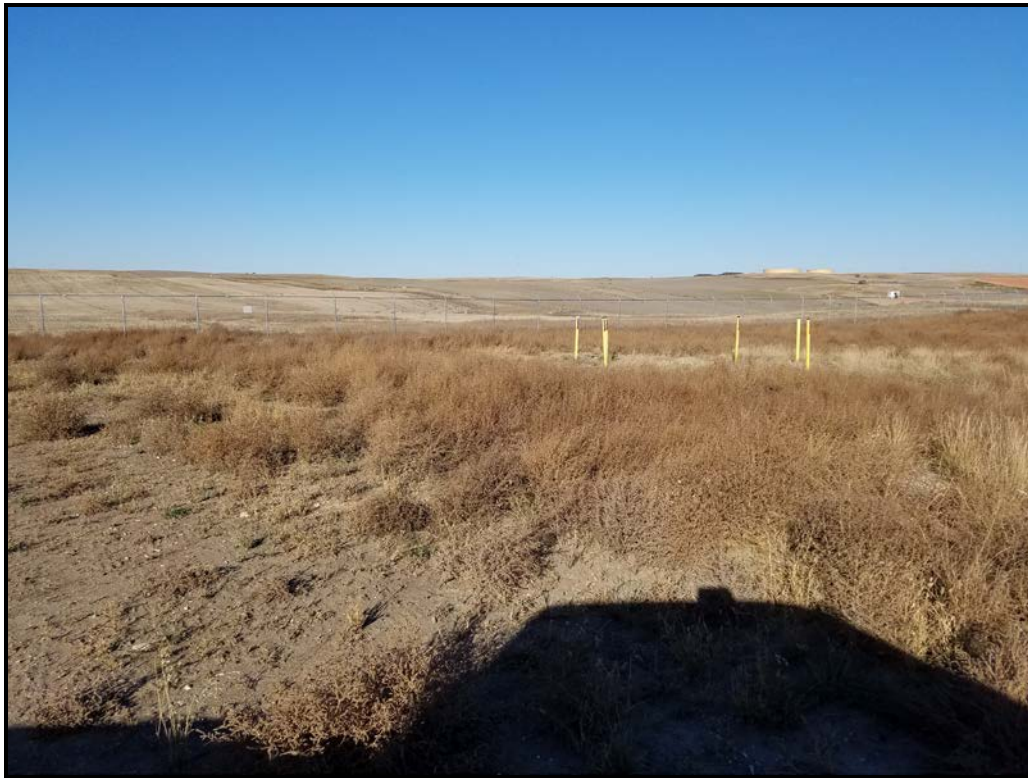
Figure 10. Photo taken facing north from inside the Rhamberg Trucking Facility. Vegetation is poorly established here with kochia being common.

Overall the reclamation planting appears unsuccessful, likely due to the abnormally dry conditions throughout the 2017 growing season. The vegetation should be monitored and replanted if ground cover does not improve during the spring of 2018.
