To: Patrick Fahn, North Dakota Public Service Commission
From: Samantha Swanberg, Wenck Associates, Inc.
Copy: Kevin Magstadt, P.E., Wenck Associates, Inc.
Date: May 10, 2017
Subject: PU-16-420 Caliber Bear Den Pipeline Project - Construction Inspection Report

Construction Inspection Report

Site Visit: April 25, 2017

Caliber Bear Den Pipeline Project – 12.75-inch Crude Oil Pipeline – PSC Case No. PU-16-420

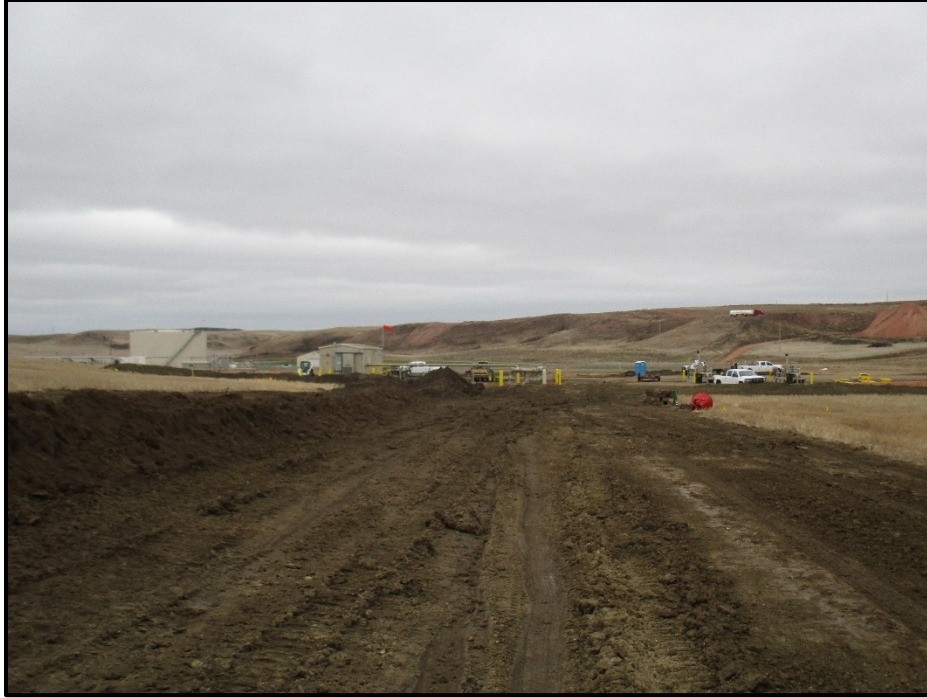
- This area along the ROW had a small amount of soil subsidence, it was bladed and re-contoured. Topsoil pile to the left of the photo. The ROW connects to the South Loadout Facility (Photo #1, Point 508).

Photo 1. (GPS Point #508) – This area along the ROW had a small amount of soil subsidence, it was bladed and re-contoured. Topsoil pile to the left of the photo. The ROW connects to the South Loadout Facility. Direction: South.

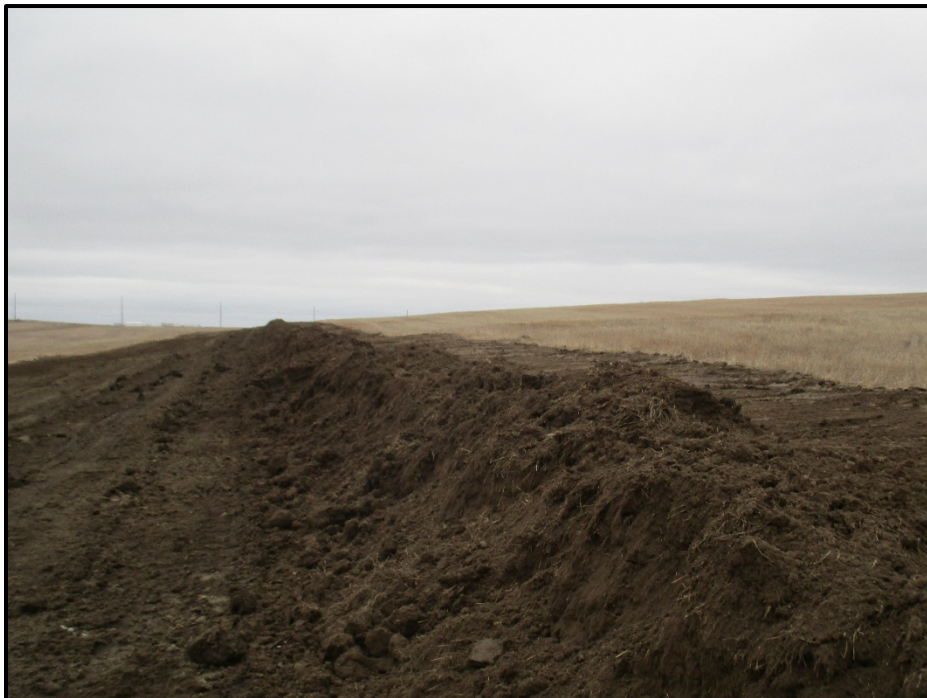
- Topsoil pile has been pushed into the center of the ROW and is no longer along the edge. This gives the dozer access to spread out the topsoil pile (Photo #2, Point #508).

Photo 2. (GPS Point #508) – Topsoil pile has been pushed into the center of the ROW and is no longer along the edge. This gives the dozer access to spread out the topsoil pile. Direction: North.

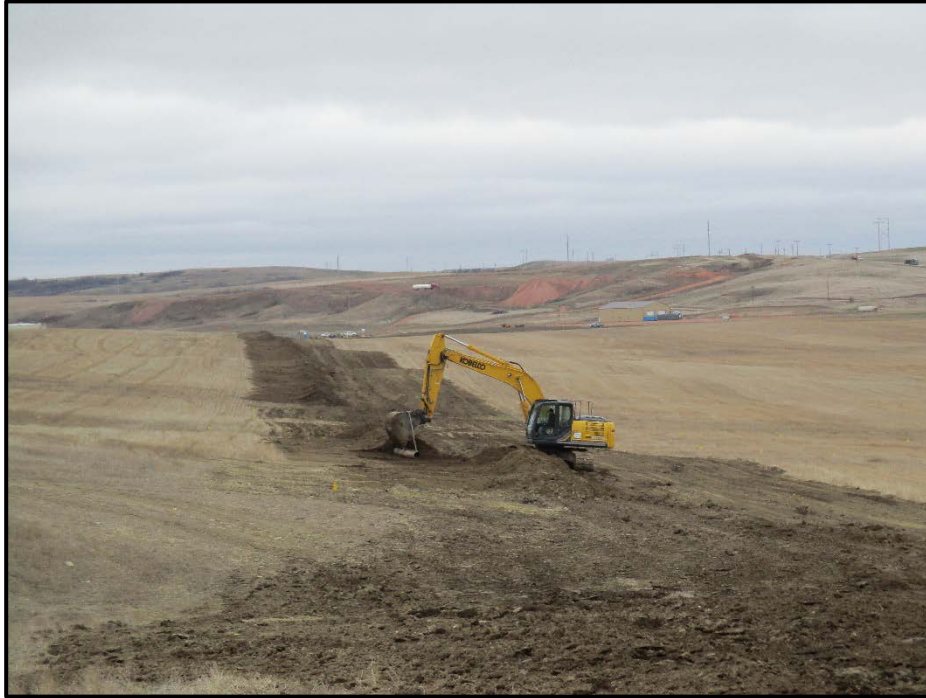
- Equipment shown pulling back topsoil, notice the claws on the bucket are not being used. Topsoil is pulled to center of ROW so dozer can easily spread it over the ROW (Photo #3, Point #509).

Photo 3. (GPS Point #509) – Equipment shown pulling back topsoil, notice the claws on the bucket are not being used. Topsoil is pulled to center of ROW so dozer can easily spread it over the ROW. Direction: South.

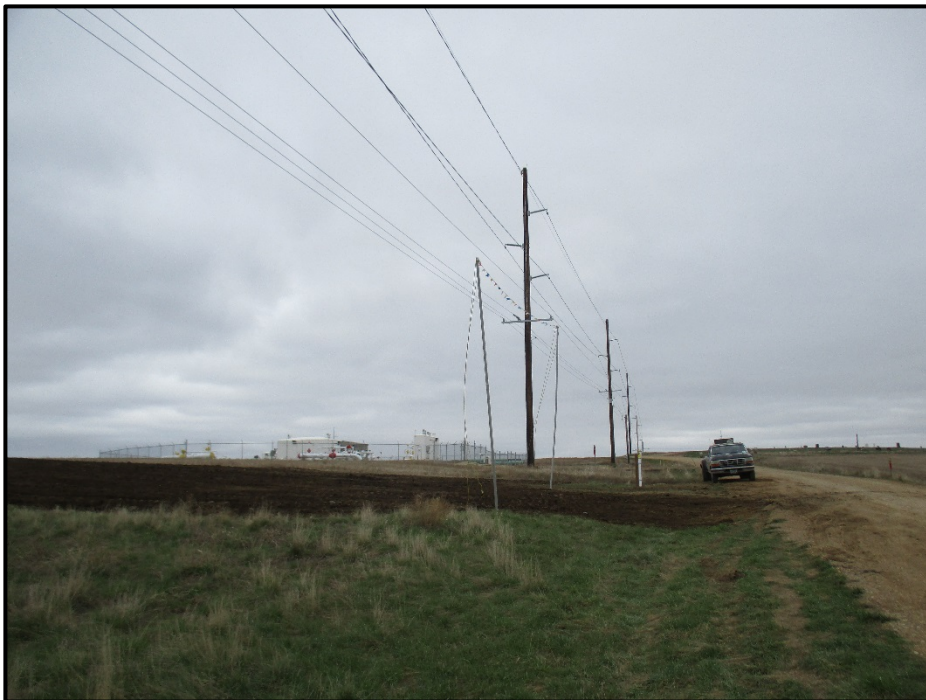
Photo 4. (GPS Point #509) – Flags shown to mark overhead lines. Topsoil has been replaced on the ROW. Direction: West.

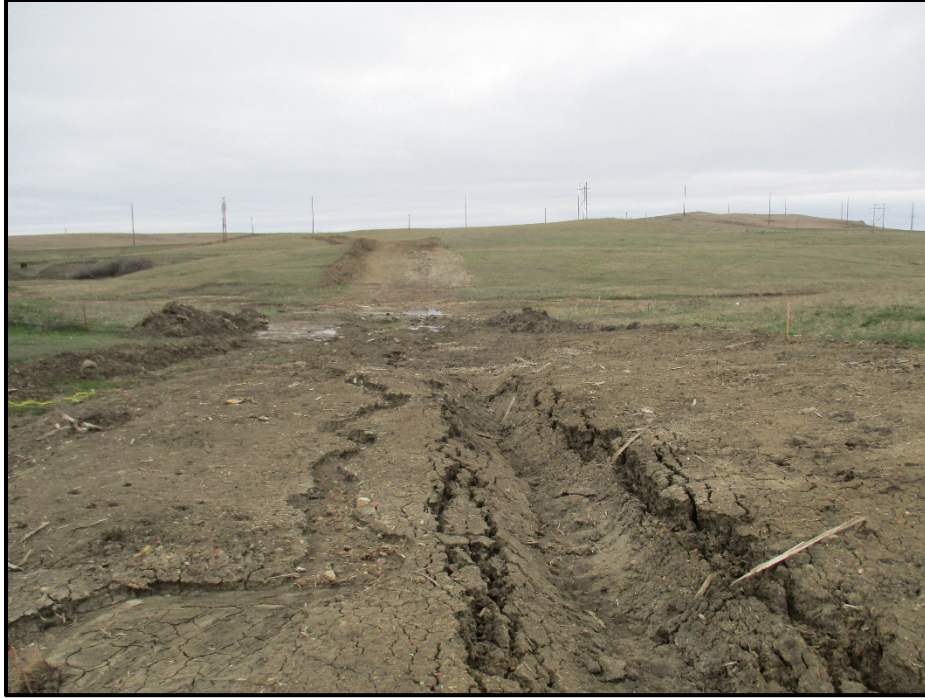
Photo 5. (Near GPS Point #510) – There is soil subsidence along the trench and some erosion forming near it. This is leading to a wetland area that was double ditched. Direction: East.

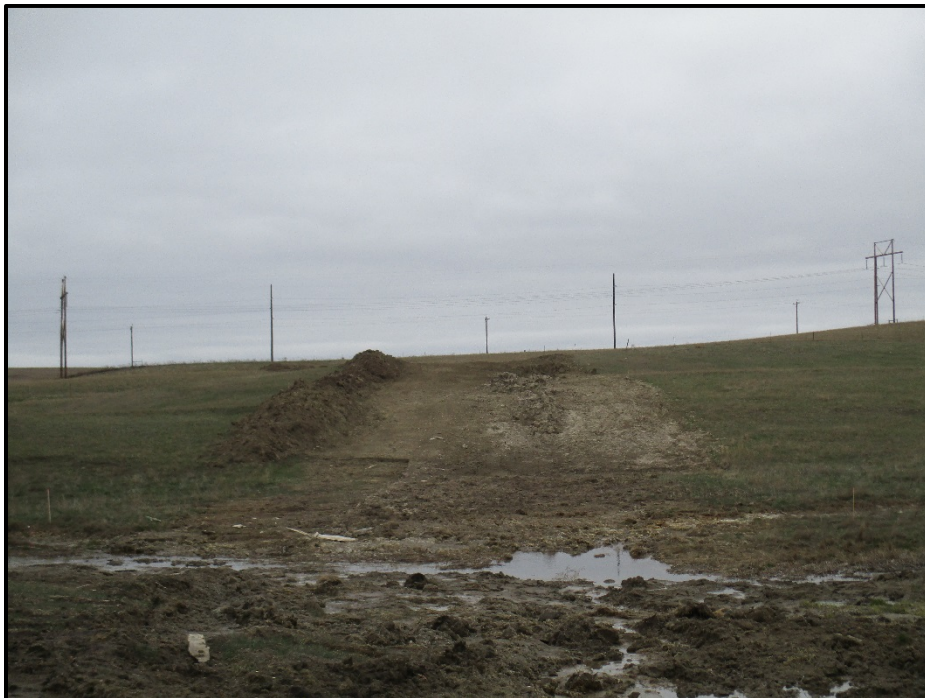
- This is a wetland area that was double ditched (same area as photo #6). Caliber stated at this wetland location they will be installing wattles, Curlex erosion control blanket, and silt fences as needed and will make additions as needed (Photo #6, Point #510).

Photo 6. (GPS Point #510) – This is a wetland area that was double ditched (same area as photo #6). Caliber stated at this wetland location they will be installing wattles, Curlex erosion control blanket, and silt fences as needed and will make additions as needed. Direction: East.

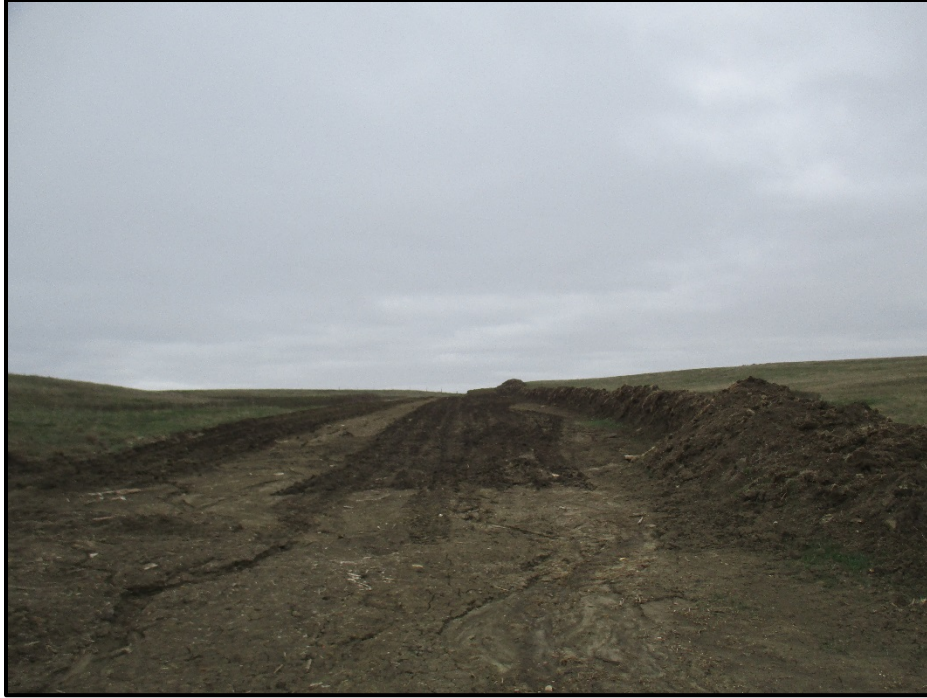
Photo 7. (GPS Point #510) – This area along the ROW has been ripped with the exception of the centerline where the trench was. Direction: West.

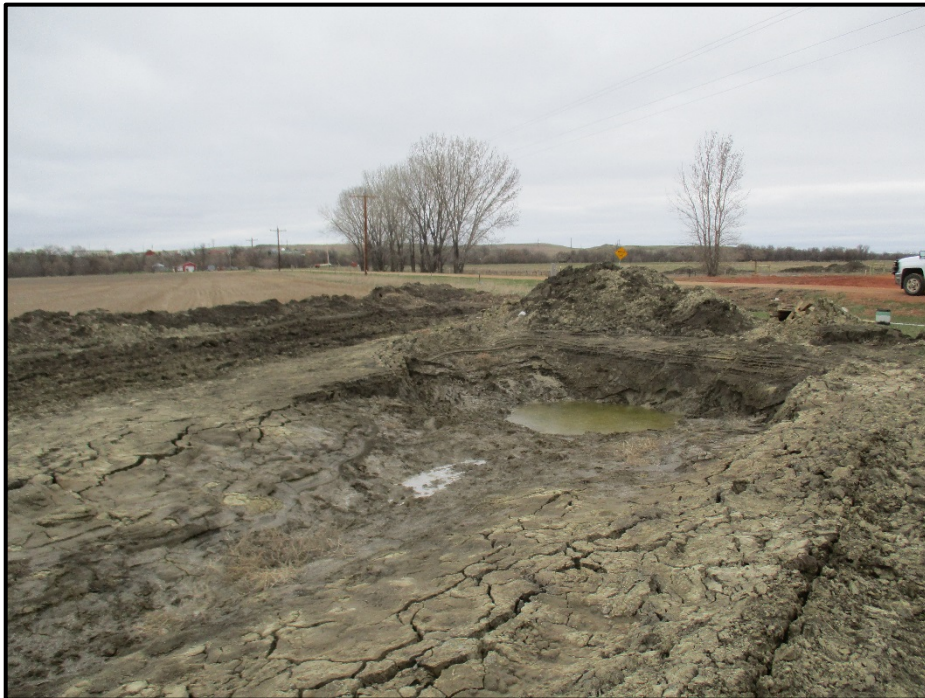
Photo 8. (GPS Point #512) – Sunken bell hole and trench, due to extensive snow in the area and the backfill material. This will be rectified during reclamation work. Direction: South.

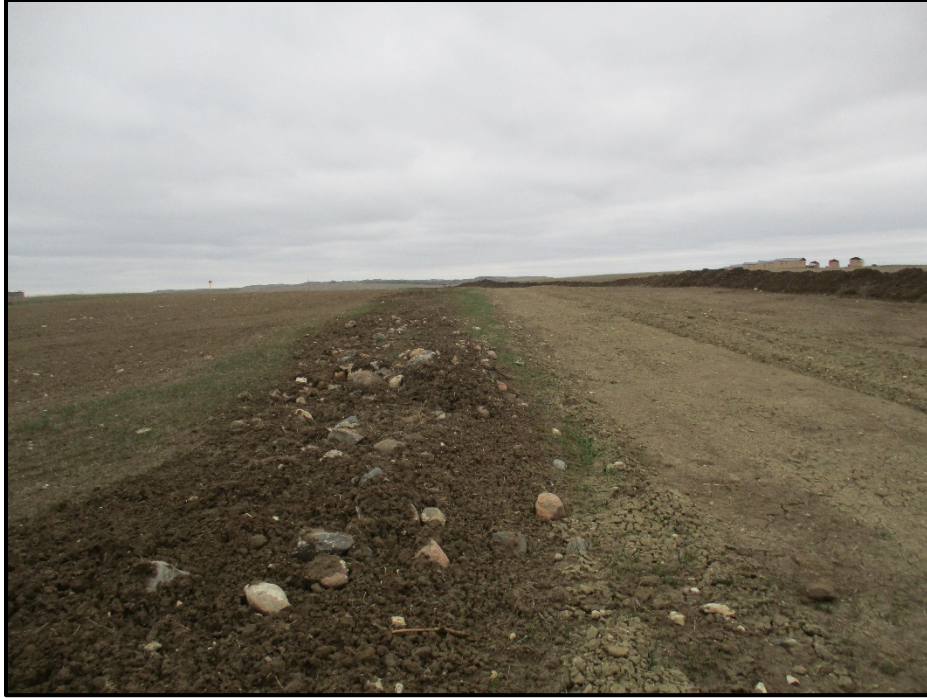
- Area shows rocks that have been picked from the ROW they will be piled up, per landowner request. Topsoil (to the right of photo) has not been replaced along the ROW. Dakota Access Pipeline (DAPL) ROW is to the left of photo (Photo #9, Point #514).

Photo 9. (GPS Point #514) – Area shows rocks that have been picked from the ROW they will be piled up, per landowner request. Topsoil (to the right of photo) has not been replaced along the ROW. Dakota Access Pipeline (DAPL) ROW is to the left of photo.
Direction: East.

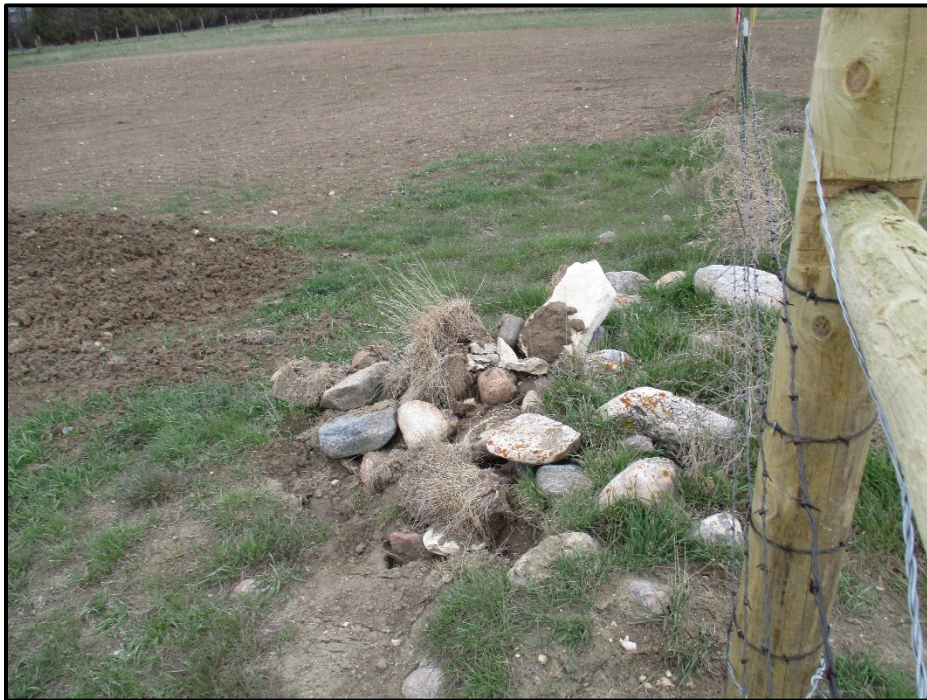
Photo 10. (GPS Point #514) – This is a rockpile that was moved when Caliber shifted their pipeline ROW. It was not culturally significant.

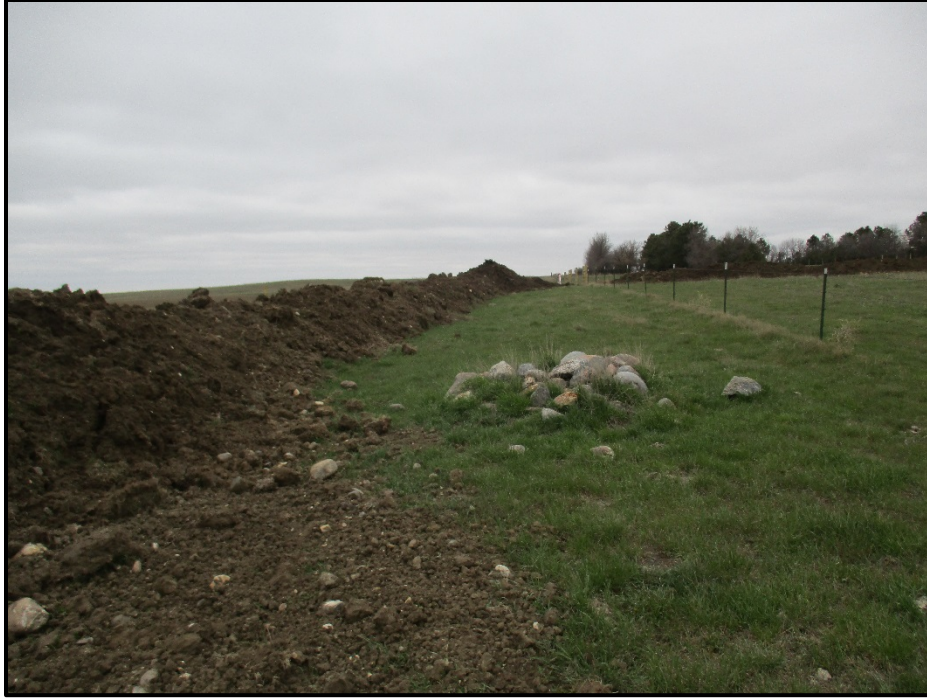
Photo 11. (GPS Point #515) – Topsoil pile along edge of ROW, with untouched rock pile on adjacent land, one of a few in the area. Direction: North.

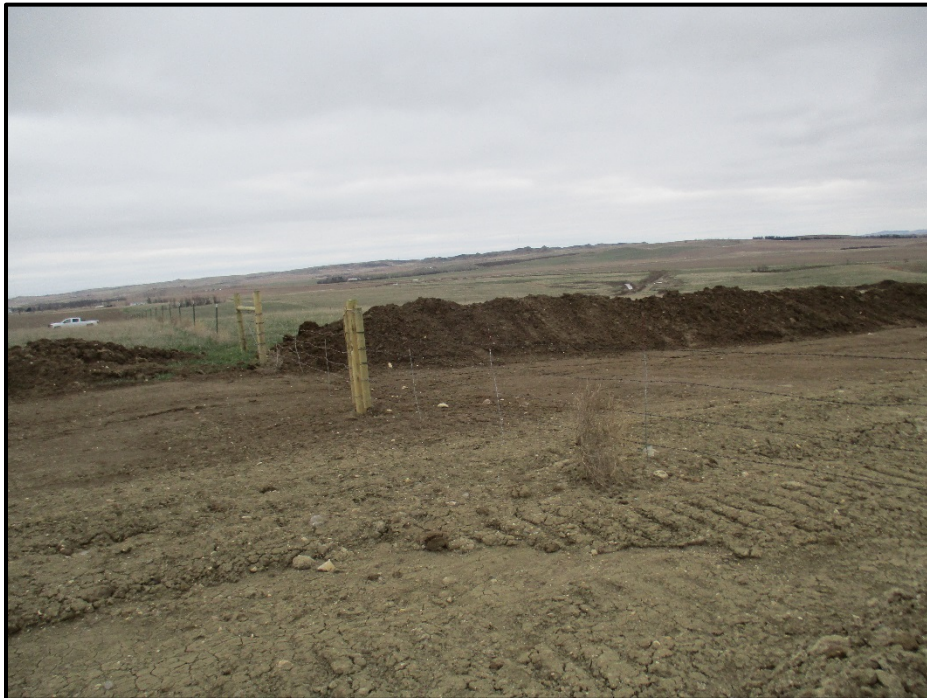
- Gate and fence installed by Caliber, it currently has two gates on it but will be re-done to only have one gate when construction is finished (Photo #12, Point #514).

Photo 12. (GPS Point #514) – Gate and fence installed by Caliber, it currently has two gates on it but will be re-done to only have one gate when construction is finished. Direction: South.

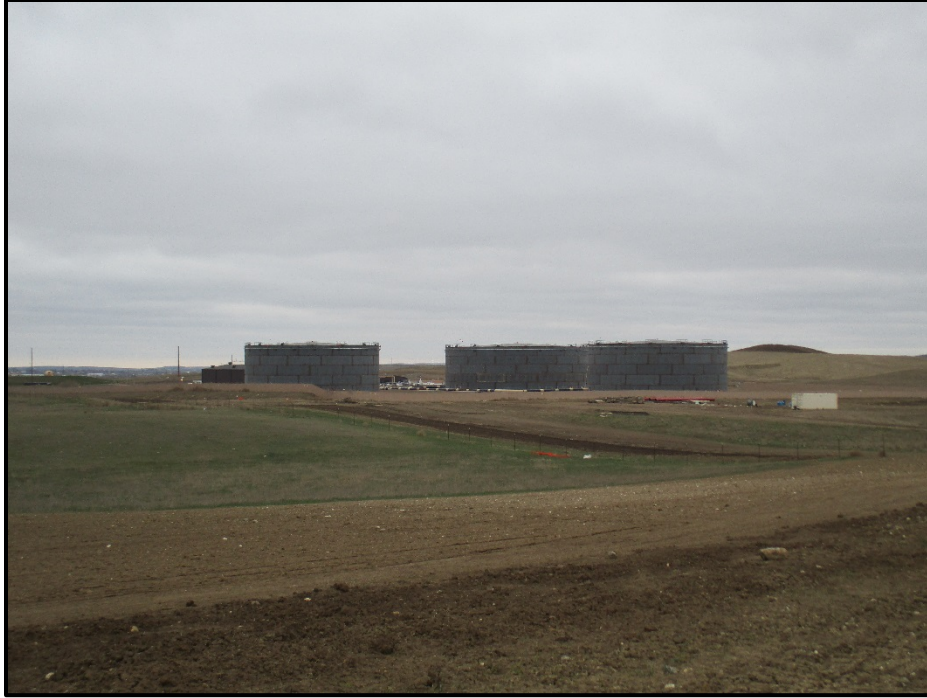
Photo 13. (GPS Point #513) – View shows northern portion of the pipeline where it connects to DAPL. Direction: Northwest.

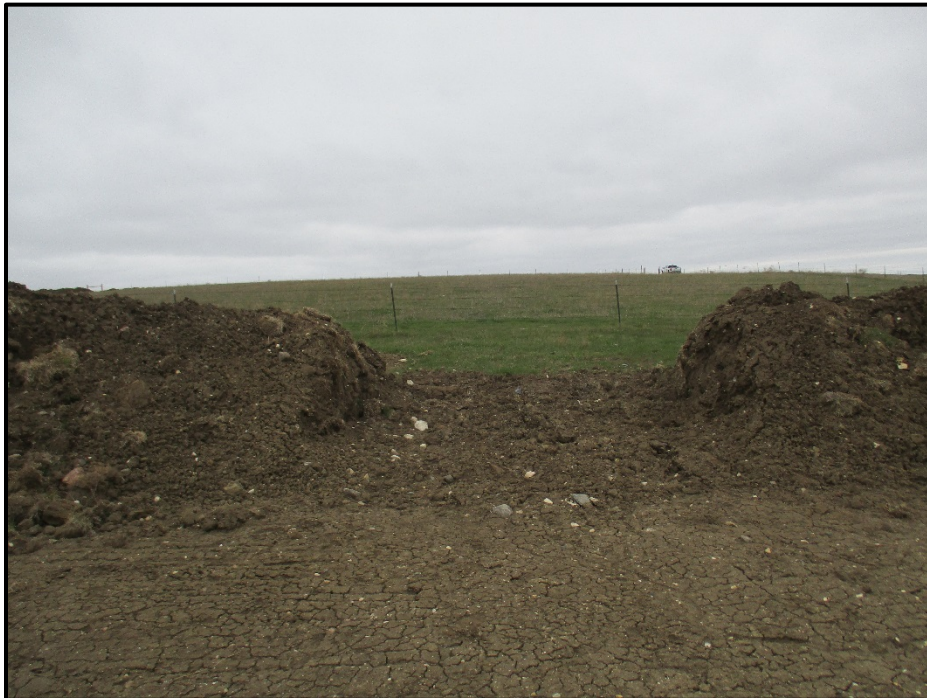
Photo 14. (GPS Point #515) – Open space along piled topsoil. Space was left open for drainage.

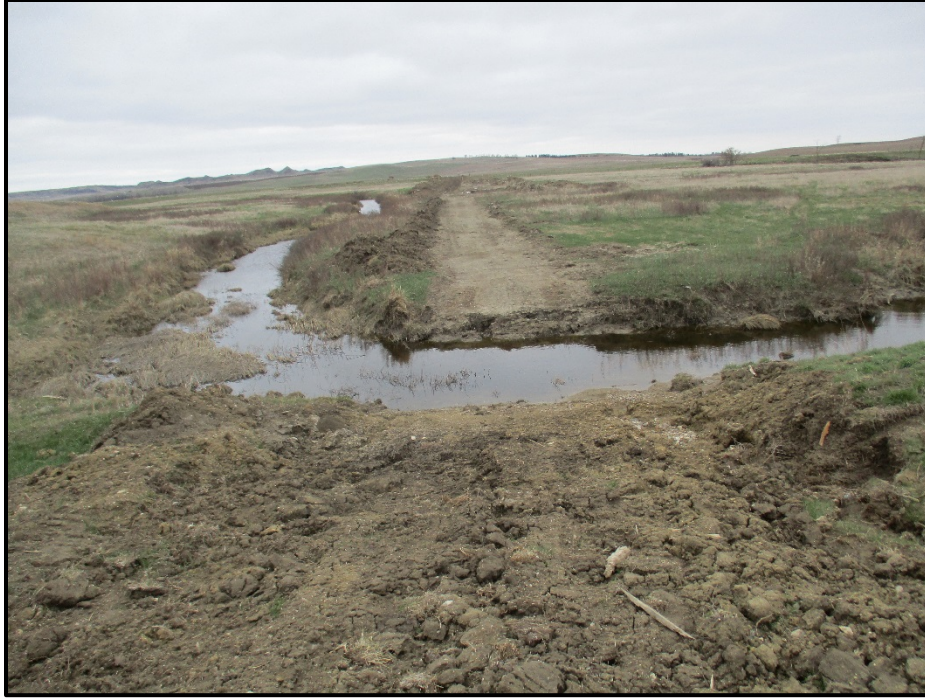
- The stream crossing along the ROW was bored. There were mats along this area which were used by vehicles to cross the stream, but they have since been removed (Photo #15, Point #517).

Photo 15. (GPS Point #517) – The stream crossing along the ROW was bored. There were mats along this area which were used by vehicles to cross the stream, but they have since been removed. Direction: Southwest.

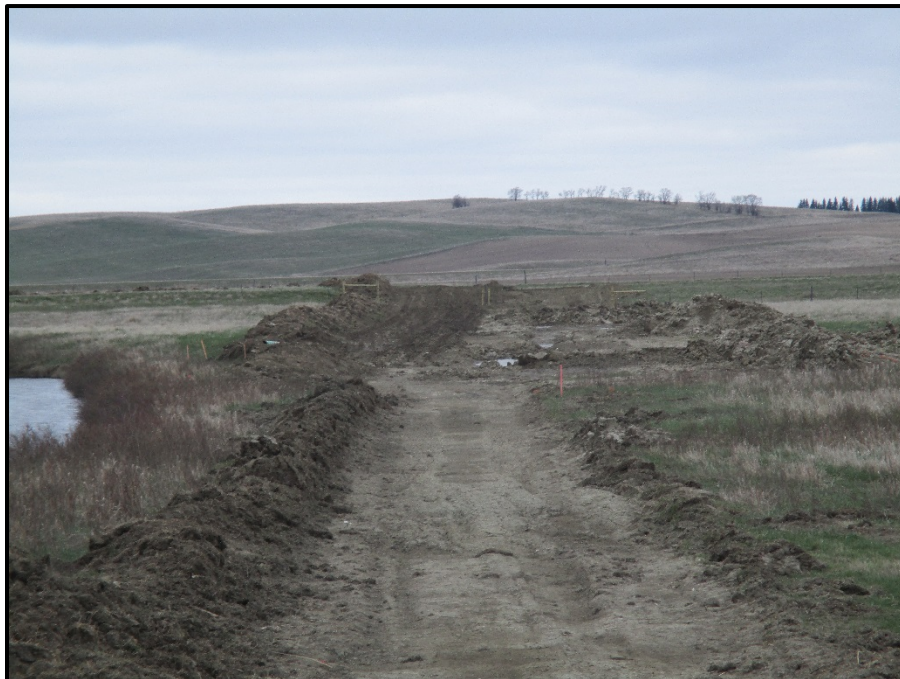
- Bore location for stream crossing (on south side of stream). Area in the lower portion of the photo was used as a travel lane, topsoil was removed for temporary road. The area in upper portion of the photo is the bore location with the extended ROW (for the bore) (Photo #16, Point #517).

Photo 16. (GPS Point #517) – Bore location for stream crossing (on south side of stream). Area in the lower portion of the photo was used as a travel lane, topsoil was removed for temporary road. The area in upper portion of the photo is the bore location with the extended ROW (for the bore). Direction: Southwest.

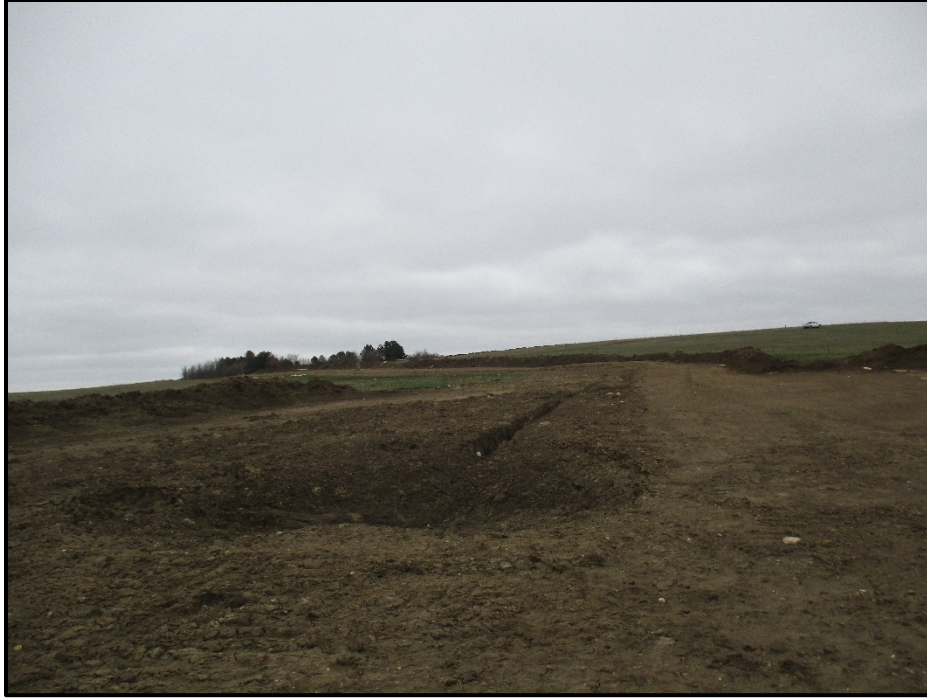
- Bore location for stream crossing (on north side of stream). There is soil subsidence along the trench and bell hole area. Area will be re-contoured and likely ripped before topsoil is replaced (Photo #17, Point #516).

Photo 17. (GPS Point #516) – Bore location for stream crossing (on north side of stream). There is soil subsidence along the trench and bell hole area. Area will be re-contoured and likely ripped before topsoil is replaced. Direction: Northwest.

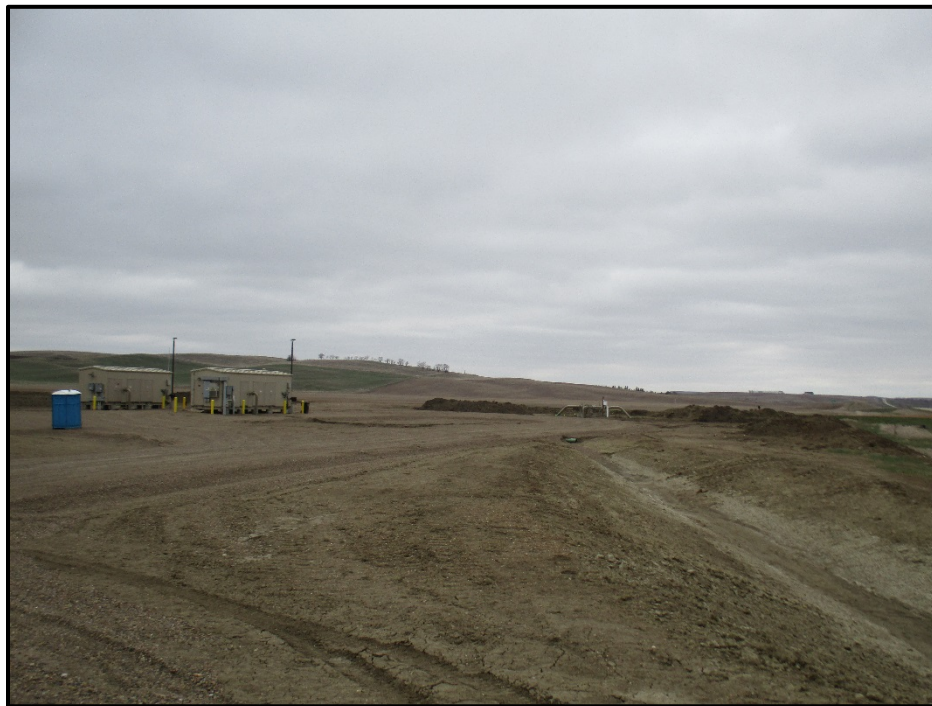
- View of North Load-In Facility. Area will be fenced and gated (Photo #18, Point #518).

Photo 18. (GPS Point #518) – View of North Load-In Facility. Area will be fenced and gated. Direction: West.
