# Caliber Bear Den Interconnect Pipeline Revegetation Inspection Report PU-16-420

Prepared for:  
**North Dakota  
Public Service Commission**

**WENCK Associates, Inc.**  
301 1st Street NE, Suite 202  
Mandan, ND 58554  
Phone: 701-751-3370  
Fax: 763-479-4242

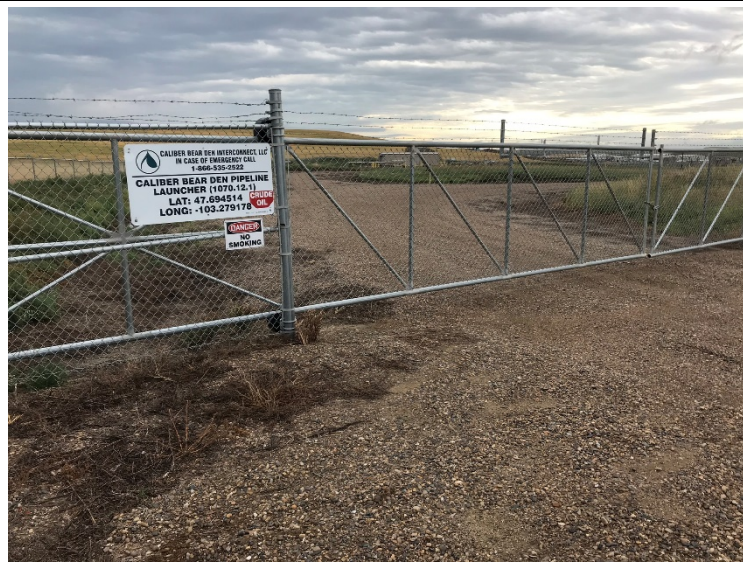
**Image #:1077**

Photo Description: Start of interconnect pipeline at the interconnect valve site. Site was maintained in good condition.

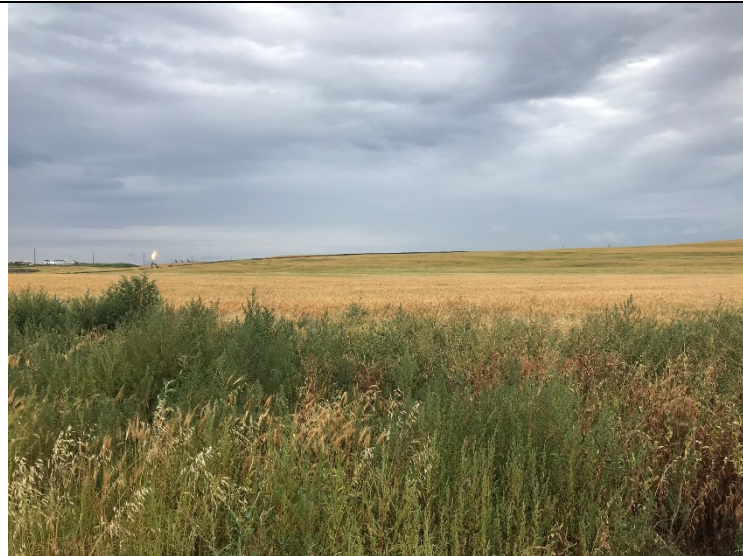
**Image #:1078**

Photo Description: Route begins north from interconnect, through a wheat field. The ROW was not visually distinguishable in the field.

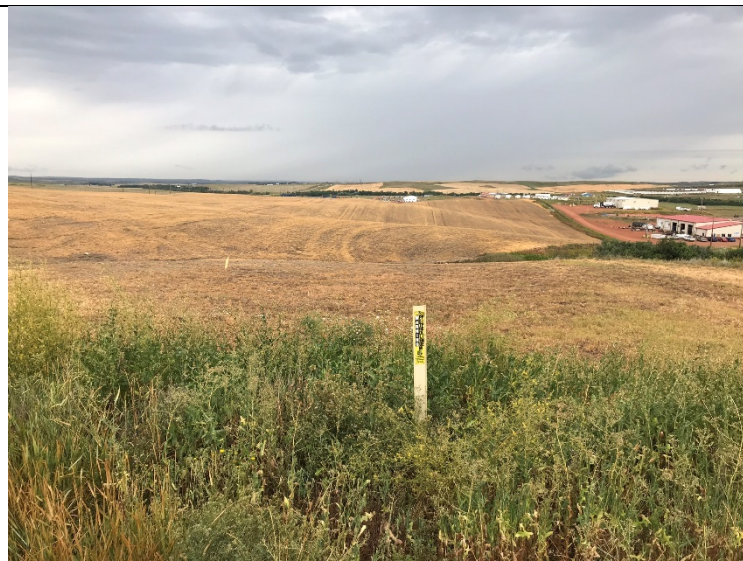
**Image #:1079**

Photo Description: ROW through fallow crop field. No visual difference within and outside of ROW. Pipeline marker in place.

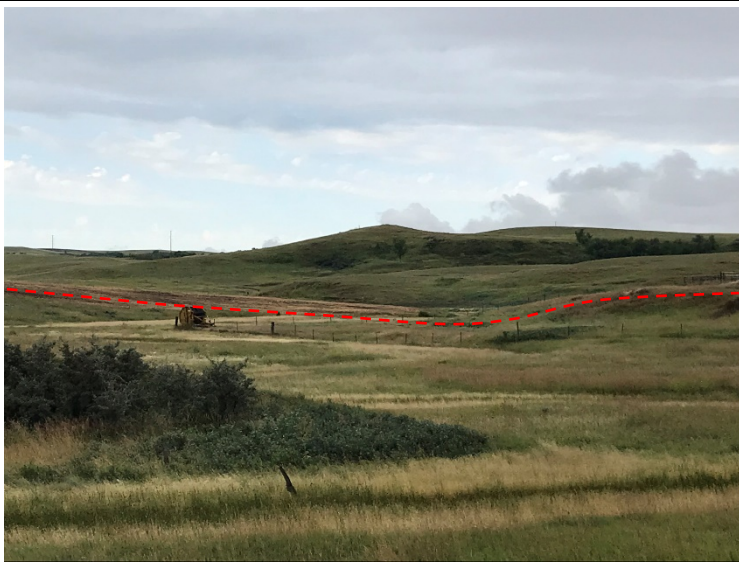
**Image #:1080**

One open cut stream/drainage crossing was observed from a distance (**Appendix B; Observation Point 696/Photo 1080**). A recently installed line was adjacent to the Caliber ROW which was seeded and mulched and overlapped with the width of previous disturbance from the Caliber line, such that it was difficult to assess revegetation of the Caliber line specifically.

Photo Description: The Caliber ROW is routed from left to right of photo between a drainage between hillsides (indicated by red dashed line). A recently installed line is adjacent to the Caliber ROW which was seeded and mulched, overlapping with the width of previous disturbance from the Caliber line.

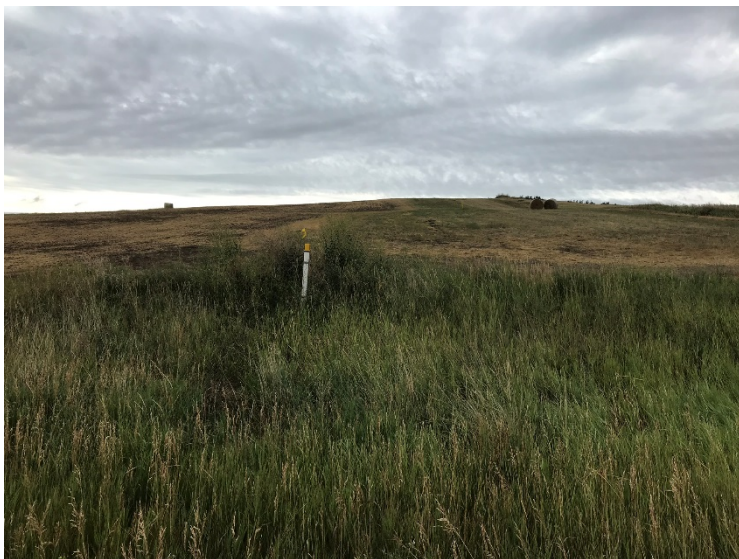
**Image #:1083**

Photo Description: Caliber ROW indicated by pipeline marker in the foreground. ROW goes through hayland visible on hill slope.

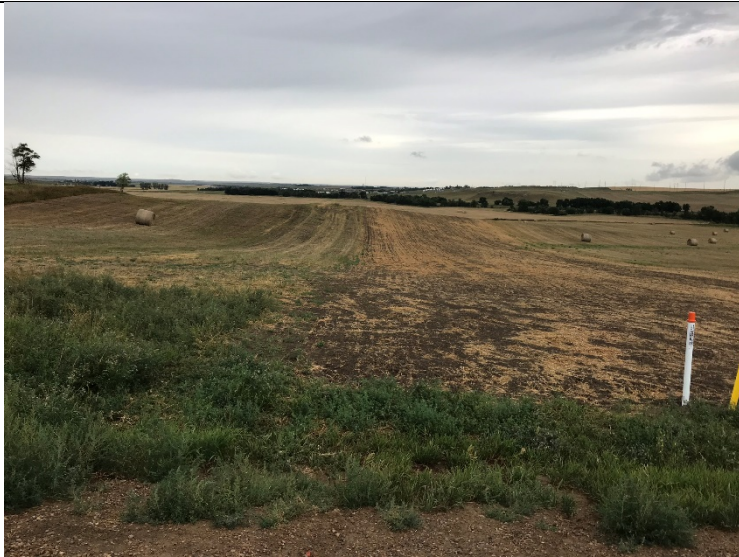
**Image #:1081**

Photo Description: Continuation of ROW across road (bored underneath) and through hayland. Caliber ROW is on left, recently seeded and mulched ROW is on right and partly overlaps with Caliber ROW. Reclaimed ROW consists of about 20% alfalfa, 20% seeded grasses, 20% Russian thistle, and 40% bare ground.

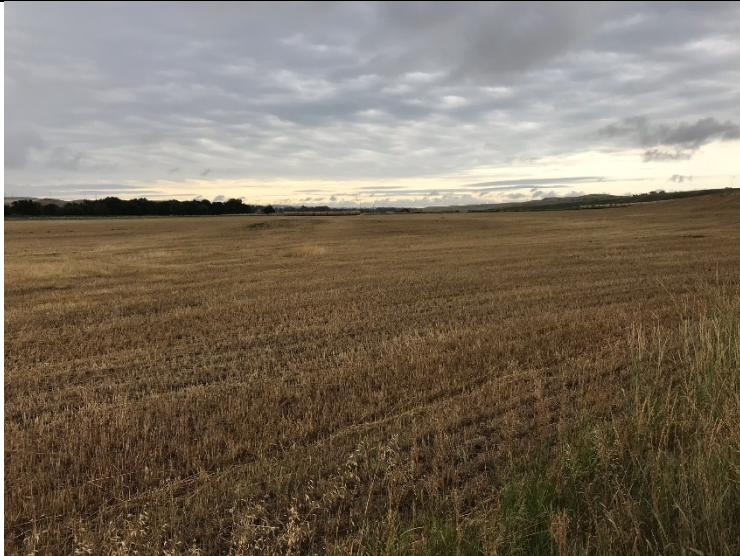
**Image #:1084**

The areas of subsidence discussed in the as-built inspection had been corrected at the time of the revegetation inspection. Re-contouring matched adjacent topography and no significant depressions were observed within the ROW. One area in a crop field appeared to have a few areas of shallow subsidence that were noticeable but were not deep or problematic (**Appendix B, Observation Point 699/Photo 1084**).

Photo Description: ROW diagonal across a field of harvested oats. Stubble density was visibly similar within and outside of ROW. A minor cover of annual weeds and a few areas of shallow subsidence were noticeable in the ROW.

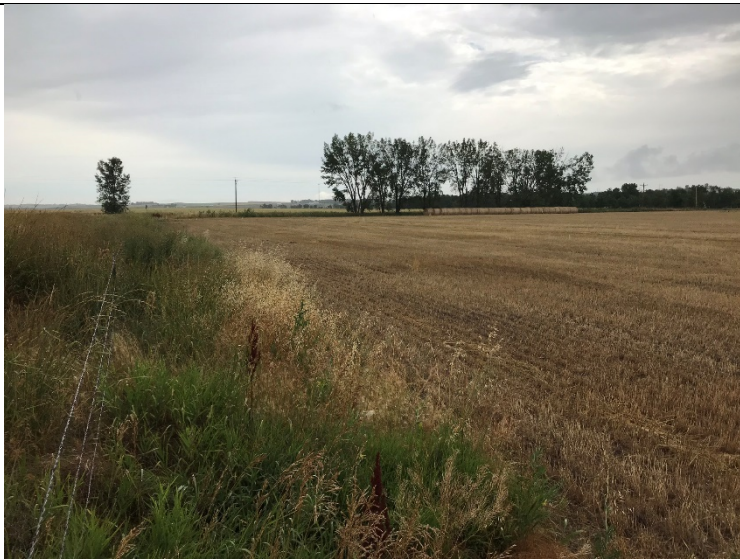
**Image #:1085**

Photo Description: ROW turns straight north along edge of access road and well pad (on left of photo out of view). No concerns noted.

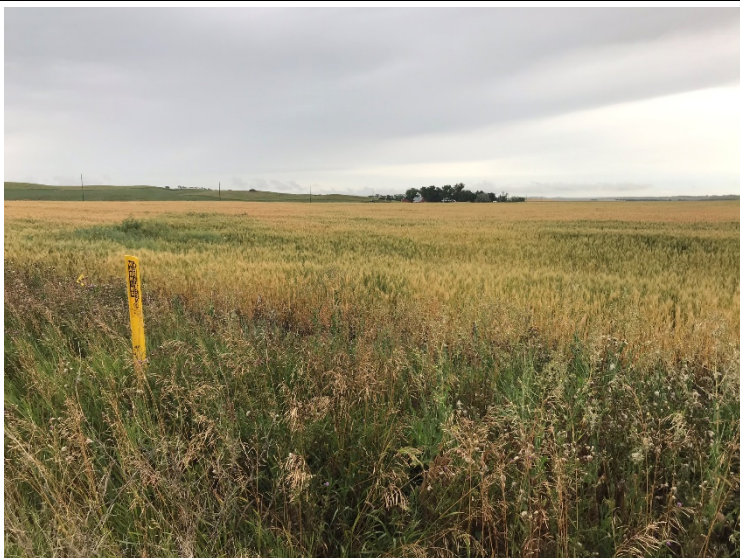
**Image #:1086**

Photo Description: Short diagonal through wheat field which appeared to have similar crop growth within and outside of the ROW. Pipeline marker in place. Crossing was bored under gravel road on south edge of field shown in photo. Canada thistle was noted on the field edge within the ROW.

Caliber has been treating known locations of noxious weeds. Two locations of Canada thistle were observed within the ROW which should continue to be monitored and treated, along with any other locations along the ROW (**Observation Points 700, 703/Photo 1089**).

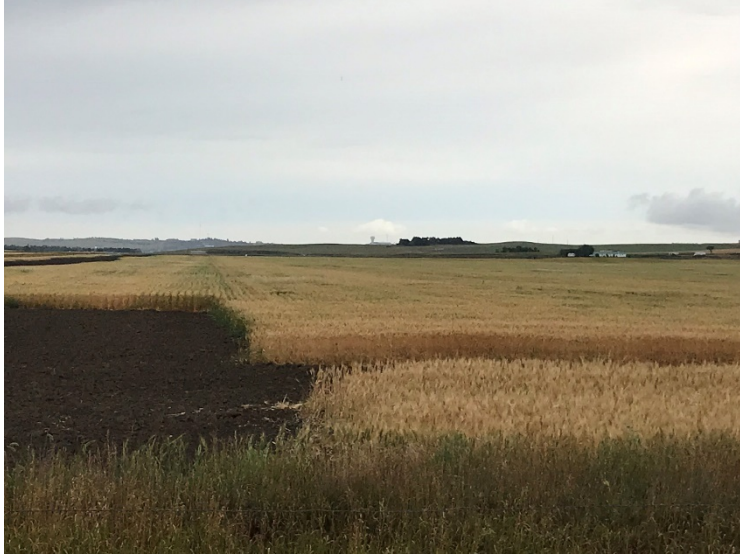
**Image #:1087**

Photo Description: ROW runs straight north through wheat field with no noticeable concerns. Bare soil in foreground is associated with another project.

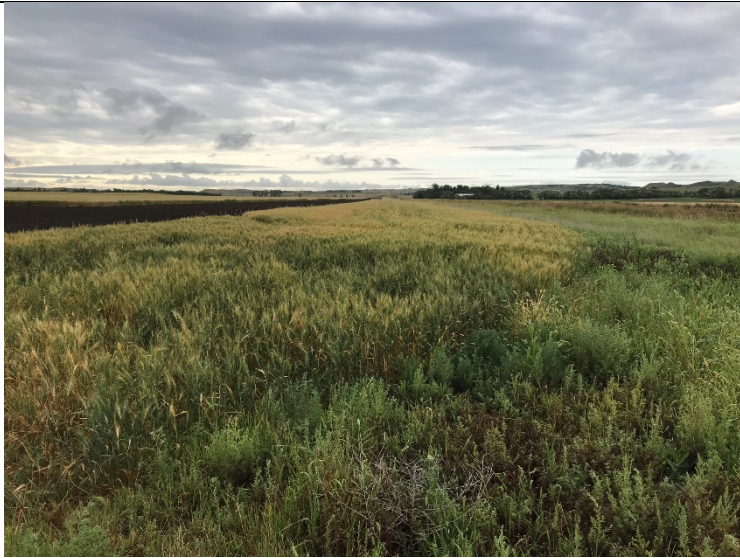
**Image #:1088**

Photo Description: North end of wheat field shown in Photo 1087. At this point the ROW runs between the gravel road on right of photo and a recently installed ROW on left of photo. Wheat stand had variable heights within the ROW.

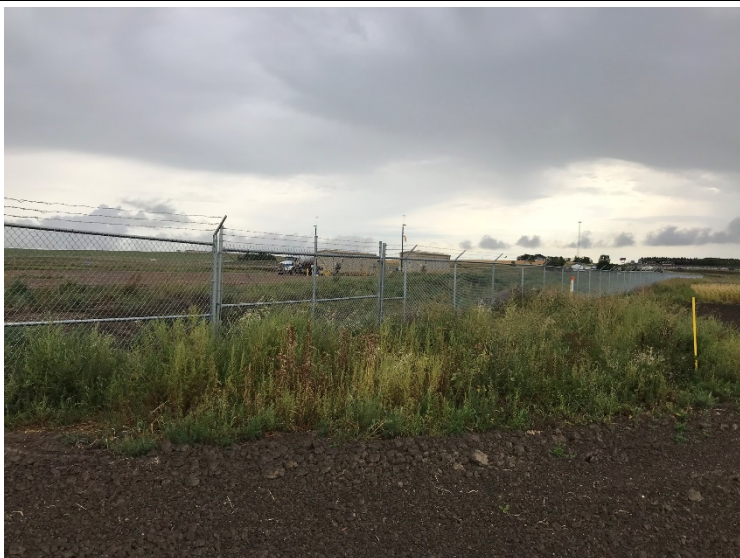
**Image #:1089**

Gravel roads crossed by the ROW had been bored underneath to avoid impacts and were in good condition. No temporary access roads were associated with the Project. The ROW was being maintained in good condition. No trash or equipment was observed. Valve sites were fenced, secure, and maintained well. Annual weeds had been sprayed and were under control (**Appendix B; Observation Points 694, 703**). One valve site had Canada thistle outside of the security fence which needs control (**Appendix B; Observation Points 703/Photo 1089**).

Photo Description: Dense Canada thistle patches noted around the edge of the wheat field and surrounding a valve site/interconnect fence.

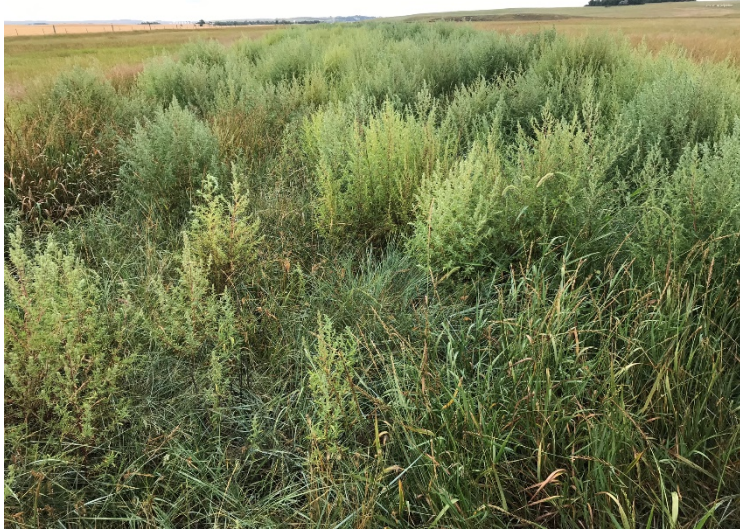
**Image #:1091**

Photo Description: ROW through parcel of hayland or CRP land comprised of Kentucky bluegrass, crested wheatgrass, and smooth brome. No grazing or haying had occurred this season. The ROW vegetation consisted of about 50% cover of the annual weeds kochia and pigeongrass; with about 50-75% cover underneath the weed cover of vigorous seeded grass growth. Grasses included western wheatgrass, crested wheatgrass, slender wheatgrass, green needlegrass, and quackgrass.

Annual weeds should be monitored along the route in hayland per landowner preferences. One portion of the ROW on the north end of the route crossed through a parcel of hayland or CRP (**Observation Points 704, 706/Photos 1091, 1094, 1095, 1096**). This portion includes a necked down crossing of a stream which had areas of bare ground. The ROW vegetation consisted of good cover and vigorous growth of seeded grasses at 50-75% cover; however, annual weed cover of kochia and pigoongrass was between 10-50%. Wenck recommends one or two years of mowing in June prior to seed ripening. This would reduce the annual weed seed bank within a year or two and allow the grass cover to establish further.

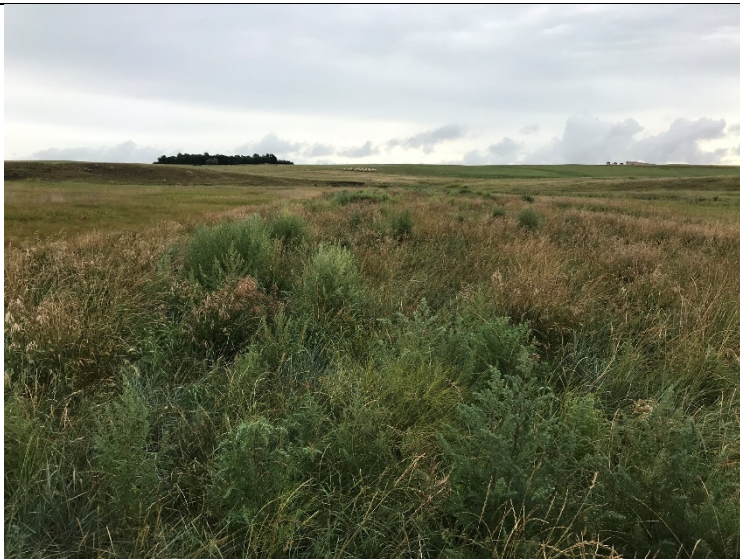
**Image #:1094**

Photo Description: ROW continues past fence separating hayland/CRP in Photo 1091 with the adjacent parcel of land that appeared to be used as rangeland, though had not been grazed this season. The ROW vegetation consisted of about 10% kochia, and about 90% cover of the grasses smooth brome, western wheatgrass, slender wheatgrass, and Kentucky bluegrass.

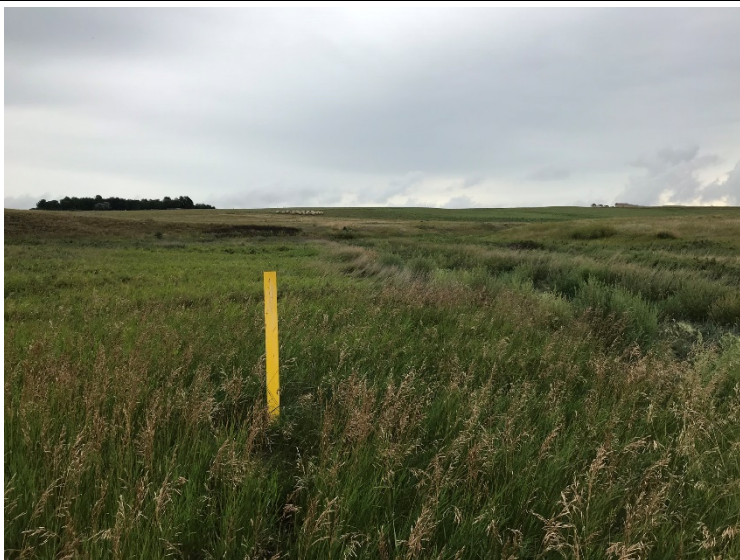
**Image #:1095**

Another stream/drainage was observed where the pipeline was horizontally bored underneath stream (**Appendix B; Observation Point 706/Photos 1095, 1096**). The ROW was necked down to a narrow width adjacent to the bore route; however, the surface of this area had been disturbed during construction and used for an access road, according to the Caliber representative. Seeded grasses were not as well established along this drainage crossing, with more bare ground.

Photo Description: Crossing of intermittent stream in distance of photo. Pipeline route is indicated by marker in foreground. Pipeline was bored underneath stream, and the adjacent ROW was necked down to a narrow width. The surface of the necked down ROW had been disturbed during construction and used for access, despite the pipeline itself being bored, according to the Caliber representative.

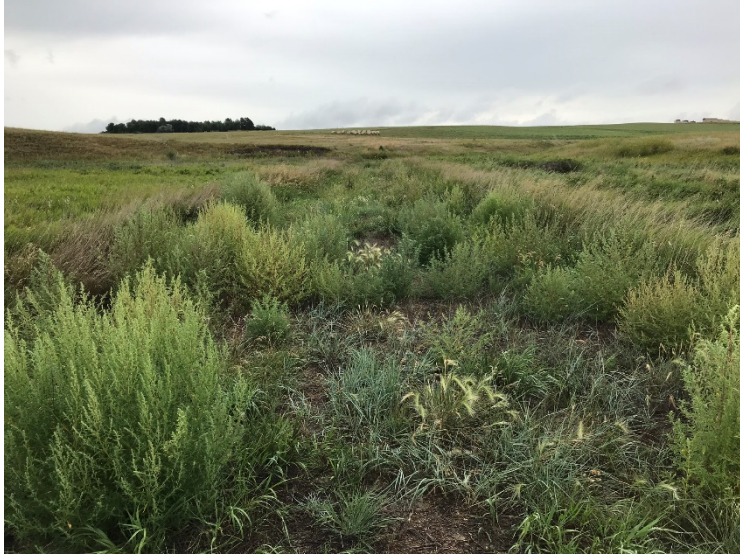
**Image #:1096**

Photo Description: View of vegetation within the necked down portion of the stream crossing. Vegetation consisted of about 10% kochia, 50-60% grasses, and 30-40% bare ground.

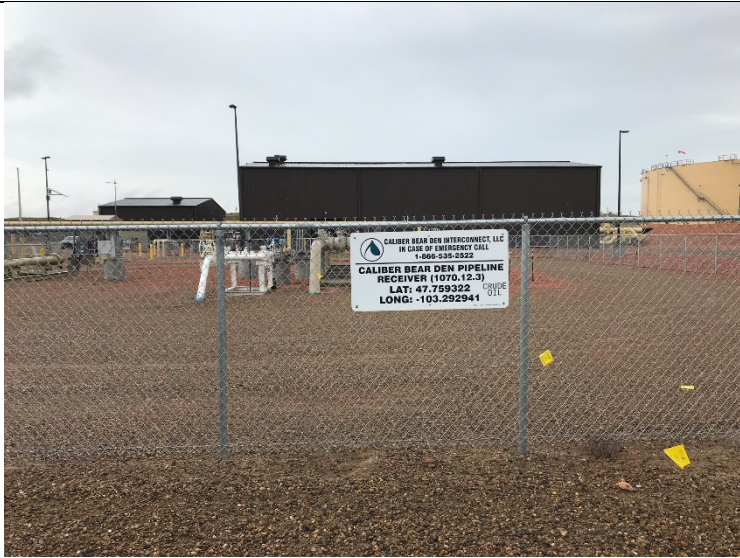
**Image #:1097**

Photo Description: View of valve setting where the Caliber line interconnects with the Dakota Access Pipeline.
