**Topsoil Inspection Report - Glacier Ridge Wind Farm
Barnes County, ND
ND PSC Case No. PU-16-539**

103 **PU-16-539** Filed: 1/18/2017 Pages: 5
Topsoil Removal Inspection Report

Site/Project Location: Glacier Ridge Wind Farm Project

Date of Inspection: 14 December 2016

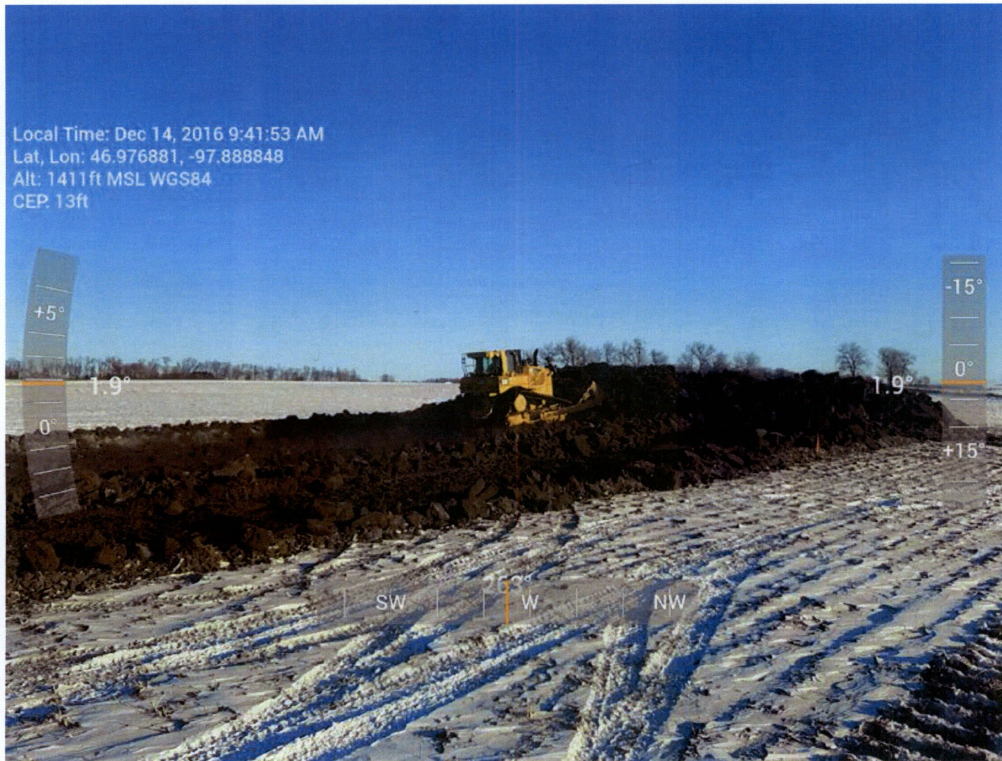
Topsoil removal began at the T15 turbine site. Topsoil was removed to a depth of approximately 12 inches, at which time subsoil was encountered. Topsoil removal and segregation then began at the T14 turbine site. The topsoil at both T15 and T14 was sufficiently thawed to allow proper segregation from the subsoil.

Report Photo #1 "Topsoil Removal and Segregation at Turbine Site T15"

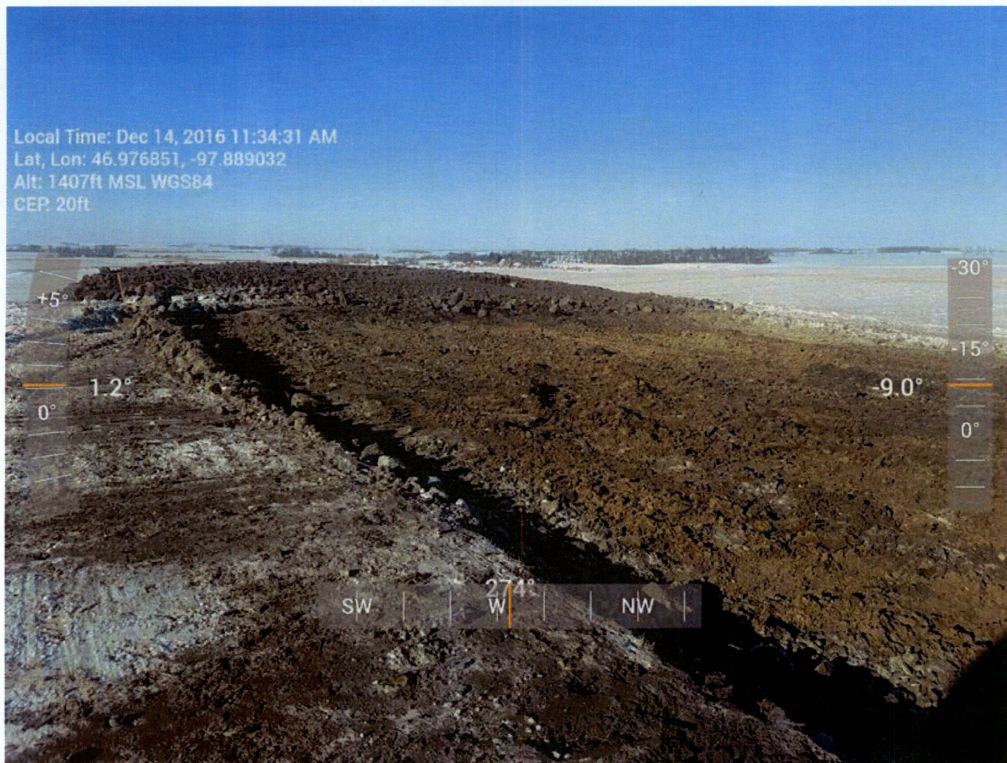
Report Photo #2 "Initial Topsoil Removal and Segregation at Turbine Site T14"

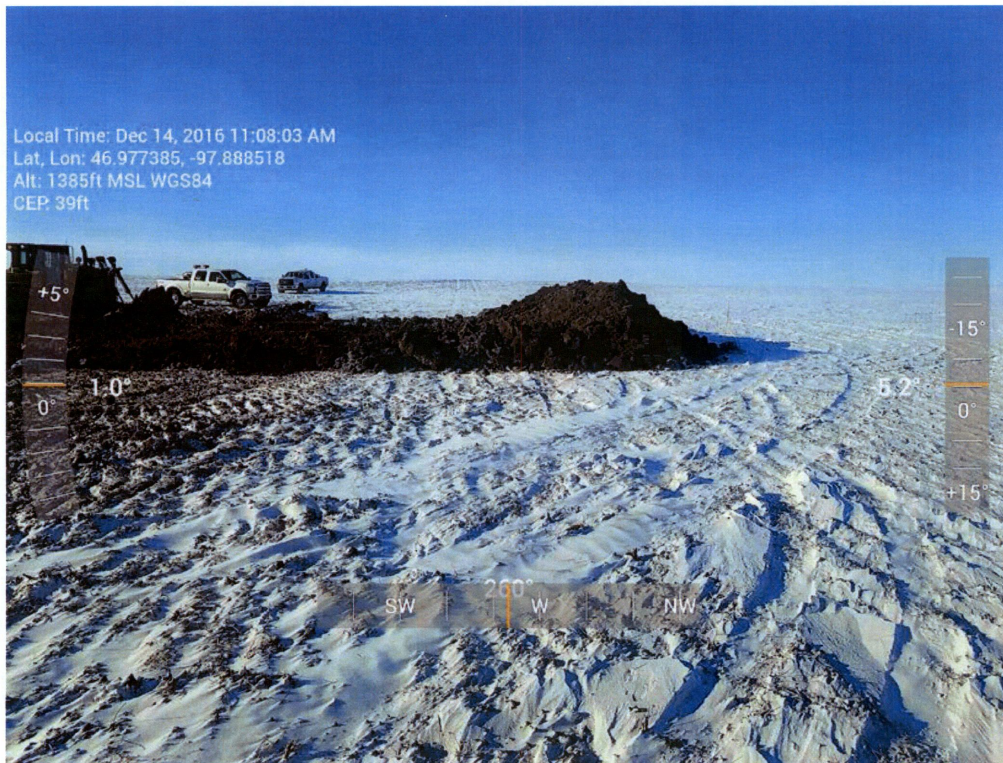
At the T15 pad area, a loader operator began excavating subsoil and depositing it directly onto the surface of the cultivated field. The loader was also mixing topsoil and subsoil in the process.

Report Photo #3 Subsoil Staged on Topsoil

Eric Ryan, Safety Supervisor for RES Group, was informed of the issue and work was stopped.

Keitu's staff ensured that all on-site contractors fully understood the requirements of the Commission's Orders, regarding topsoil segregation, and that topsoil needed to be removed and segregated from any subsoil staging areas.
