**Revegetation and Remediation Inspection Report - Glacier Ridge Wind Farm
Barnes County, ND
ND PSC Case No. PU-16-539**

Reclamation and Revegetation Inspection Report

Glacier Ridge Wind Farm

ND PSC Case No. PU-16-539

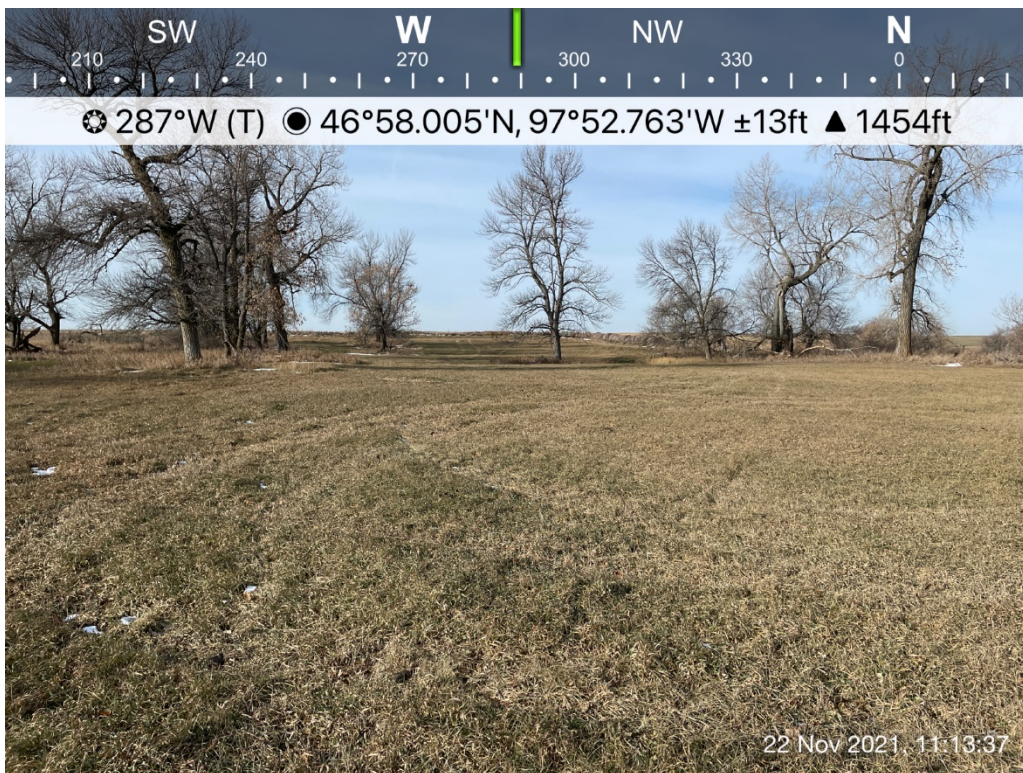
Report Photo #4: Turbine Site T4

Of the 19 total turbine site locations, 18 sites had been returned to active crop production, and 1 site located in non-tilled pastureland (Turbine Site T4) had over 70% established vegetation at the time of inspection. No further action is recommended.
