INSPECTION REPORT

DATE OF INSPECTION: July 12, 2016

PERMITTEE - MINE: Coyote Creek Mine

PERMITS INSPECTED: NACC-1301, NACC-1302

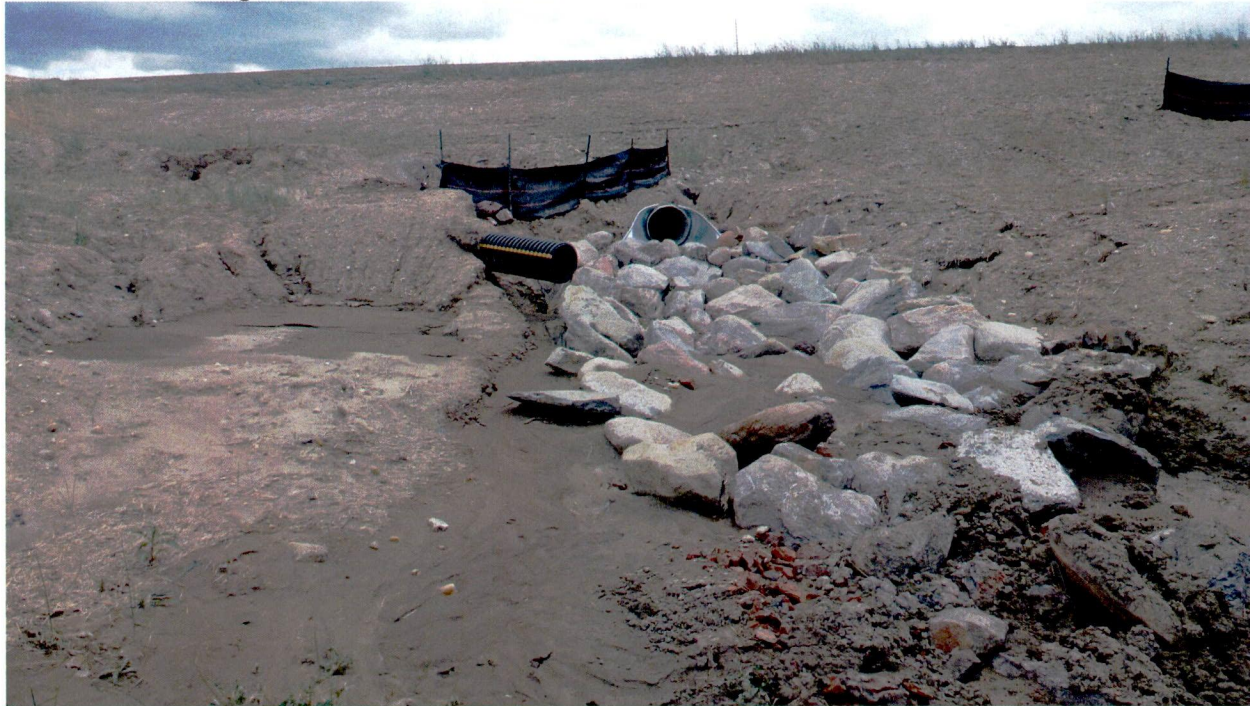
Haul road Discharge Point 8 in SE1/4 Section 8

The erosion and sediment controls along the haul road north of County Road 12 took heavy damage from the recent rain events. At several locations it appeared that significant erosion occurred at discharge outlets during the runoff events resulting in the loss of material from erosion at pipe outlets and the loss of silt fences and sumps located near the outlet. We reviewed and extensively photographed the erosion at haul road storm water discharge point 6 in the SE1/4 of Section 9. Similar damage was observed at storm water discharge points 4, 8 and 9. The other storm water discharge points were affected but to a lesser degree. A contract crew was removing sediment at discharge point 3 in the SW1/4 of Section 10.

We walked a portion of the drainage below Discharge Points 8 and 9 located on State land in the SE1/4 of Section 8. The sediment material in this area is very sandy in texture and appeared to settle-out mostly upstream of the point where the drainage from point 8 joins the drainage below point 9. About 150 to 200 yards downstream of where point 8 joins the drainage below point 9, the sediment deposits appeared to be minimal.

The design, arrangement and erosion protection armoring used at the culvert and slope drain outlets must be reevaluated and improved to provide a stable transition for water from the outlets to the undisturbed channel downstream of the haul road. The discharge points that appeared to experience the most off-site sediment deposition also had substantial erosion damage at the outlets. We discussed several possible modifications to be made at discharge point 6 and others with similar damage.
