RE: Sacagawea Pipeline

**RE: Sacagawea Pipeline Company, LLC
(PU-16-582) - Response Regarding
Compliance for Case No. PU-15-114**

Construction Inspection Report

Sacagawea Pipeline, LLC – 16-inch Crude Oil Pipeline – PSC Case No. PU-15-114

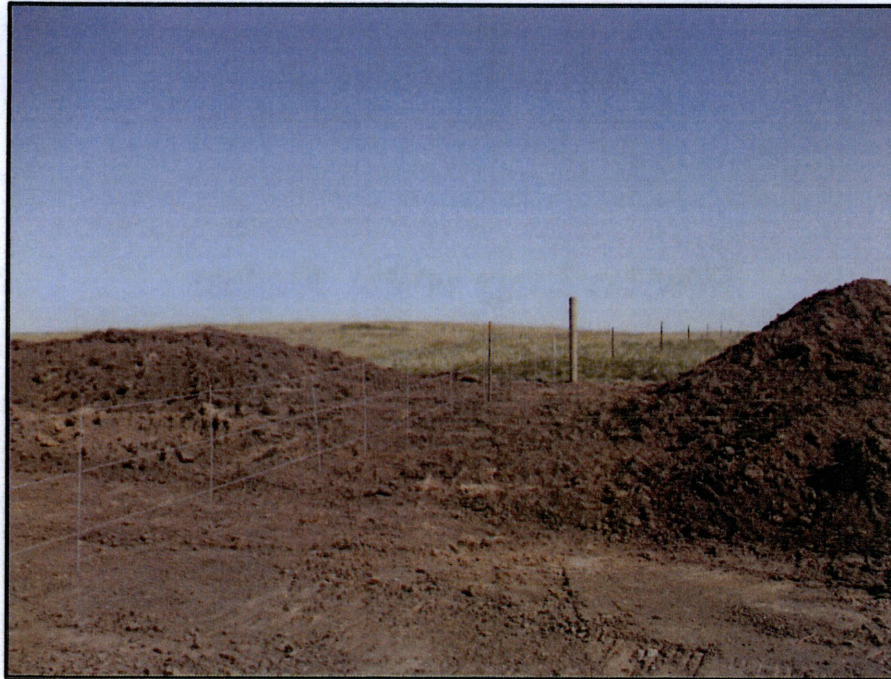
Photo 1. (GPS Point #443) – Temporary gate for fence put up across the ROW. Site visit 7/21/2016.

Photo 1 of the Report notes that a temporary gate was erected across a ROW. SPC's agreement with landowners requires the installation of gates in any fence gaps to facilitate construction.

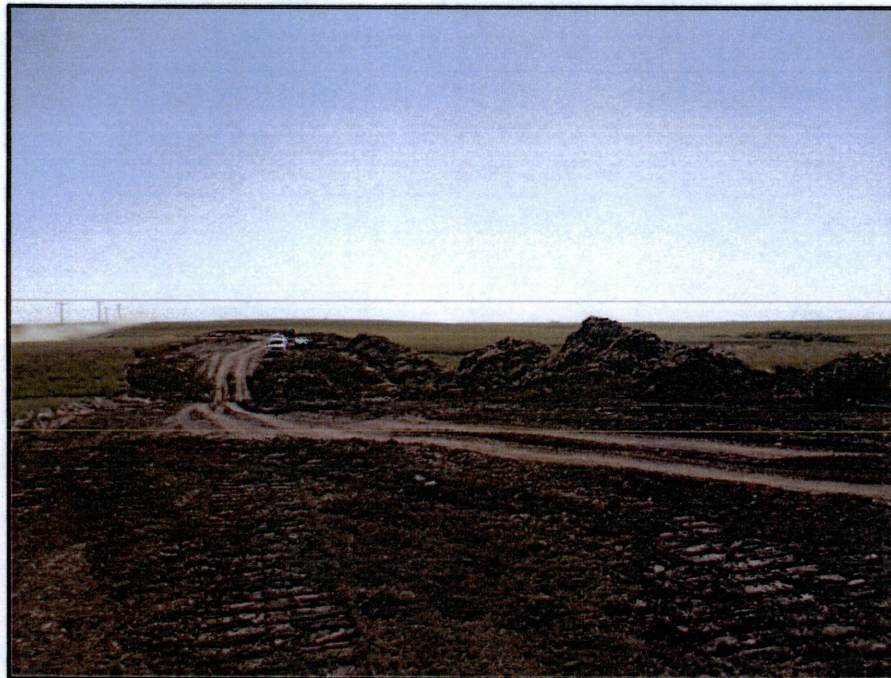
The comments associated with photos 2, 3 and 4 imply erosion control and drainage area deficiencies. *See* Report 1, 12-13. For example, Photo 2 states "the corridor had not been necked down in this area to reduce disturbance." *See* Report 1. However, as outlined in the Project's environmental mitigation plan, waterway disturbance areas are to be narrowed where practical, but are not applicable to every swale or other type of drainage areas. Furthermore, the depicted site is in excess of 25 feet of vegetative cover to open water. Even on high slope areas, 50 feet of vegetative

Photo 2. (GPS Point #446) – Drainage area intersected by ROW. No erosion control devices were in place and the corridor had not been necked down in this area to reduce disturbance. Direction: East.

BMP's can include existing vegetative cover. In this case there is more than 50 feet of vegetative cover between the disturbance and any surface water and the drainage in question is not a designated wetland.

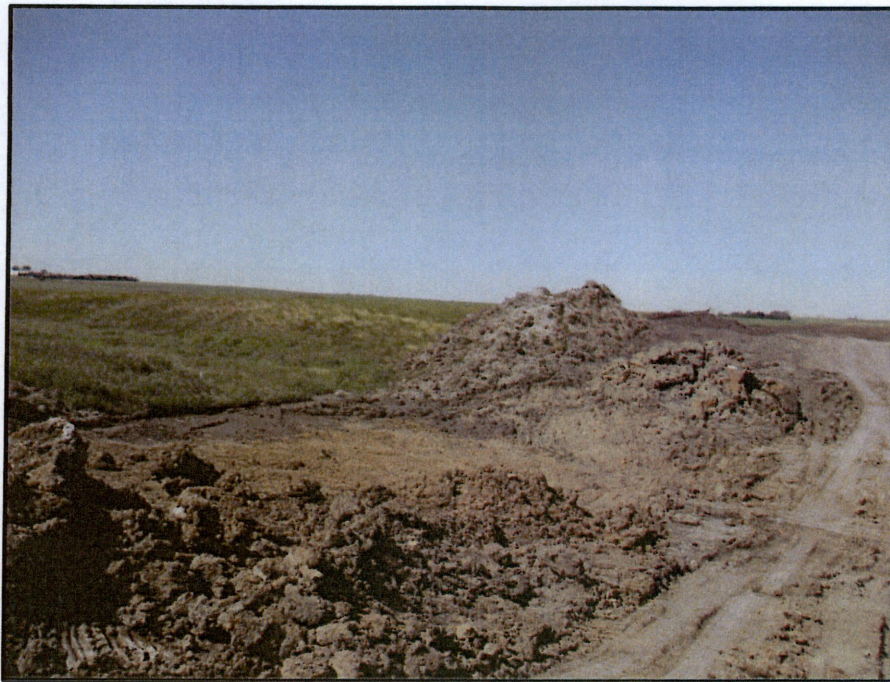
Photo 3. (GPS Point #446) - Drainage area along ROW, which appeared to be a potential wetland based on the topography, moist soil (along ROW edge) and change in vegetation. Topsoil pile along the left of photo. Drainage area looks like a potential wetland area.

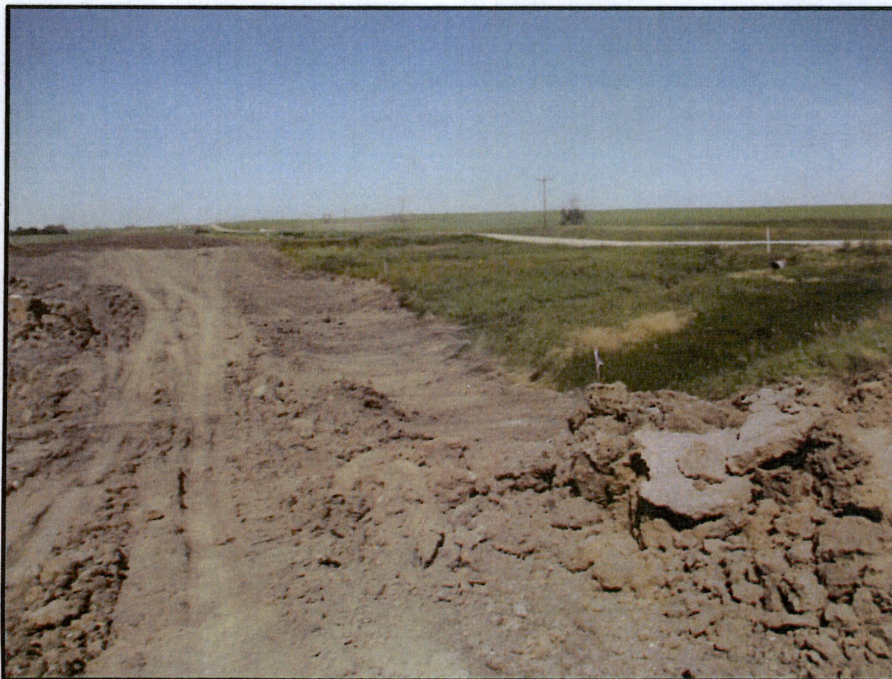
- Drainage area intersected by ROW. Pipe trenched and backfilled along the edge of the ROW. The drainage area appeared to be a potential wetland. Notice the vegetation change. However, the environmental inspector stated it was not a wetland. No erosion control devices were observed. The PSC was informed of this site the day after the inspection (Photo #4, Point #446);

Photo 4. (GPS Point #446) - Drainage area intersected by ROW. Pipe trenched and backfilled along the edge of the ROW. The drainage area appeared to be a potential wetland. Notice the vegetation change. However, the environmental inspector stated it was not a wetland. No erosion control devices were observed. The PSC was informed of this site the day after the inspection.

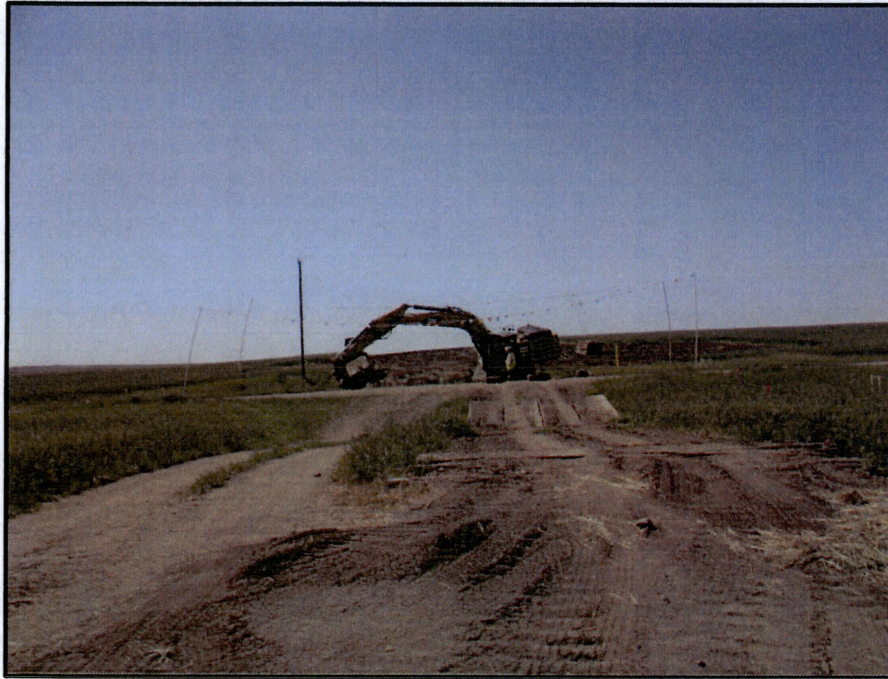
- Excavator removing mats from road ditch (far side of the road), which was used for access to the ROW. Most of the topsoil had been replaced in this area (Photo #5, Point #447);

Photo 5. (GPS Point #447) – Excavator removing mats from road ditch (far side of the road), which was used for access to the ROW. Most of the topsoil had been replaced in this area. Direction: South

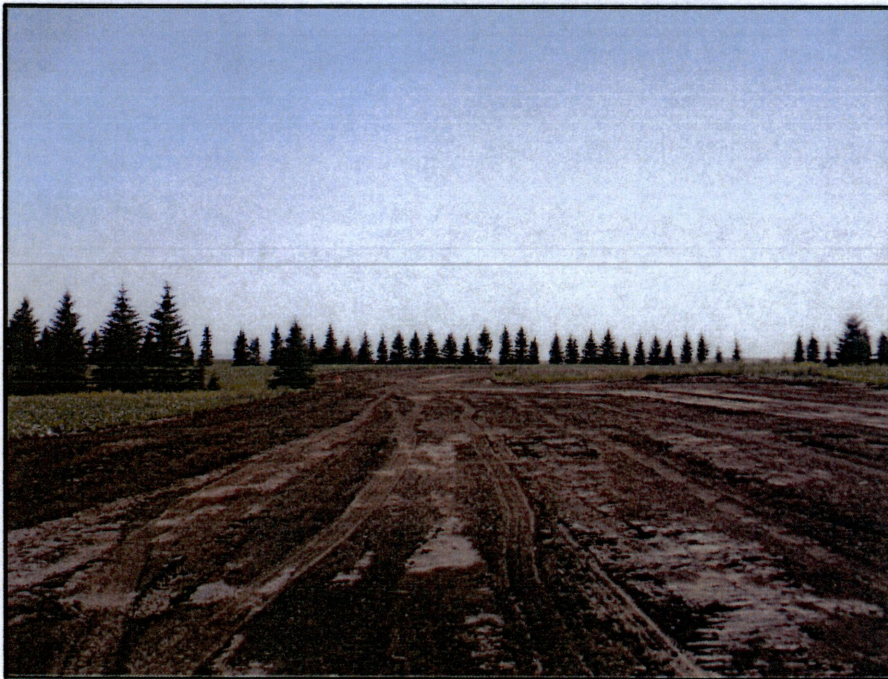
- ROW necked down to 50 ft width through tree rows. Unknown if or how many trees were taken out in this area. Topsoil replaced back on the ROW (Photo #6, Point #448);

Photo 6. (GPS Point #448) – ROW necked down to 50 ft width through tree rows. Unknown if or how many trees were taken out in this area. Topsoil replaced back on the ROW. Direction: East.

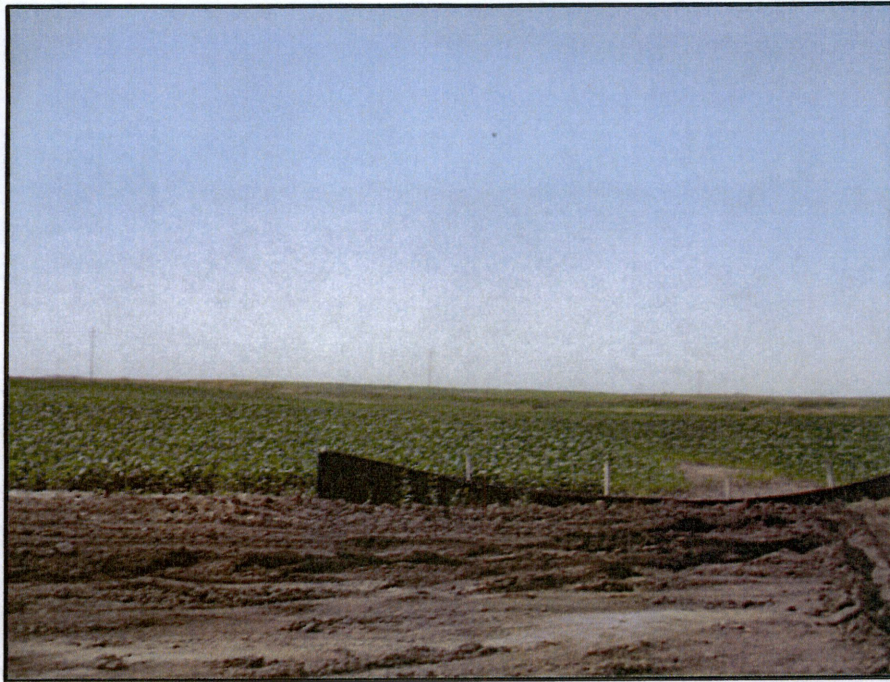
Photo 7 depicts a silt fence requiring repair and was taken during the July 21, 2016 inspection. *See Report 2, 15.* The depicted area received multiple storms, traditional for the July season. The noted fence was likely repaired prior to the next event. Furthermore, it is unlikely that the depicted area was in violation of storm water regulations due to visible vegetative cover which prevents sediment from entering surface waters.

- Silt fence observed in drainage area near crop field, which needs maintenance. The area was rutted up and needs to be smoothed out again. Topsoil had been replaced back on the ROW (Photo #7, Point #448);

Photo 7. (GPS Point #448) - Silt fence observed in drainage area near crop field, which needs maintenance. The area was rutted up and needs to be smoothed out again. Topsoil had been replaced back on the ROW.

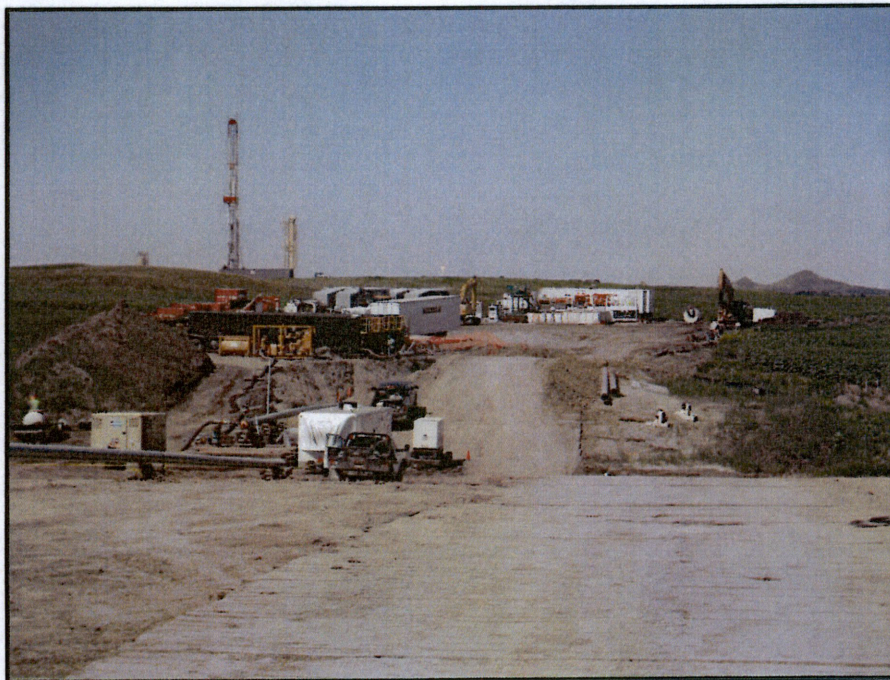
Photo 8. (GPS Point #449) - Lake Sakakawea bore area. Direction: West

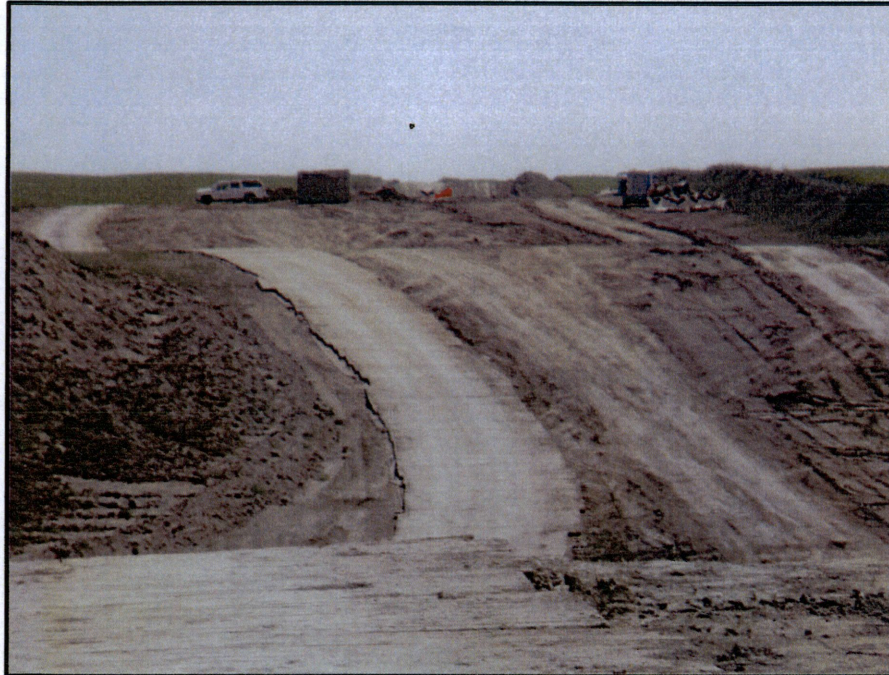
Photo 9. (GPS Point #449) – ROW going up to Lake Sakakawea bore area. The bore contractor wanted mats placed on ROW up to bore area. Mats are observed on the left side of the ROW. Direction: East

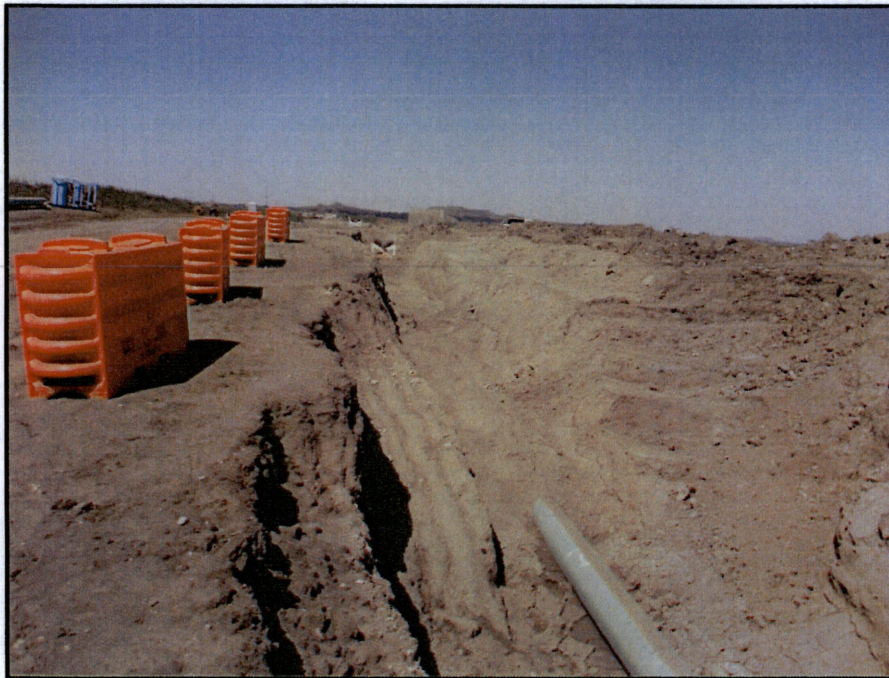
The Report indicates photos 8 through 12 were taken at the east side of the Lake Sakakawea HDD bore location on July 21, 2016. *See Report 2.* The accompanying photos imply an inadequate safety marking of the excavation hazard. *See Report 15-17.* Note that it is atypical for open pipeline trenches to be marked in their entirety.

Photo 10. (GPS Point #450) - Open trench with partially covered pipe in trench. Orange safety blockades to the left of photo. White and black pipe rollers (visible in trench in far distance of photo) were used to guide the bore pipe into bore hole. Direction: West

Regardless, SPC recognizes the hazards associated with open trenches. SPC limits construction site access to authorized personnel, workers who have completed the requisite project safety orientation, and workers escorted by project personnel. When there are specific hazards, such as unstable soils, large excavations, or nonobvious excavations from the designated rive lanes, these limited areas will be marked with barriers. Photos 10 through 12 are consistent with this practice.

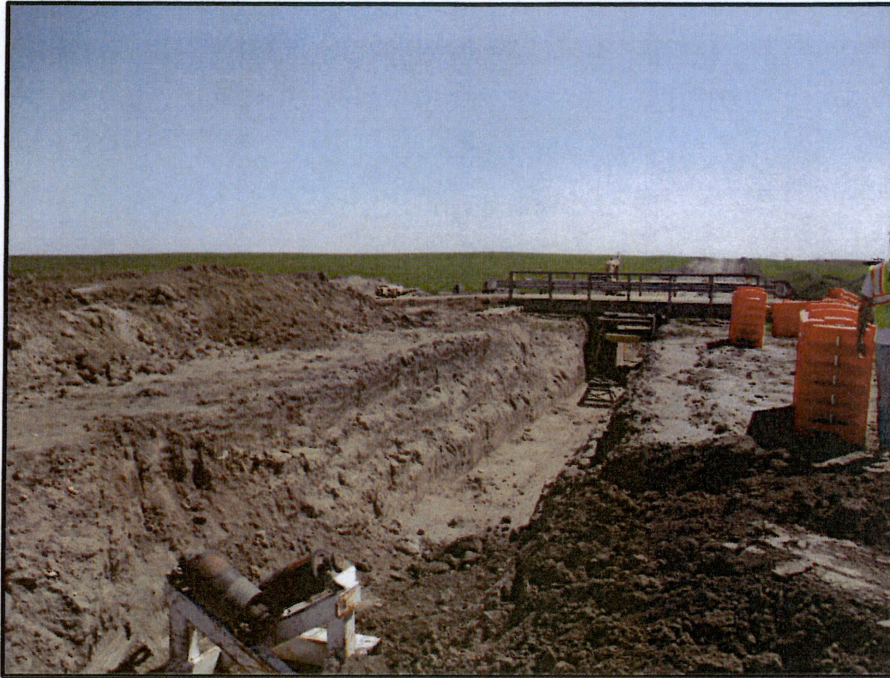
Photo 11. (GPS Point #450) - Open trench with orange blockades to the right of photo, trench spoil to the left. White and black pipe rollers in foreground were used to guide bore pipe. Bridge was used for a vehicle crossing to get to the bore area. Direction: East

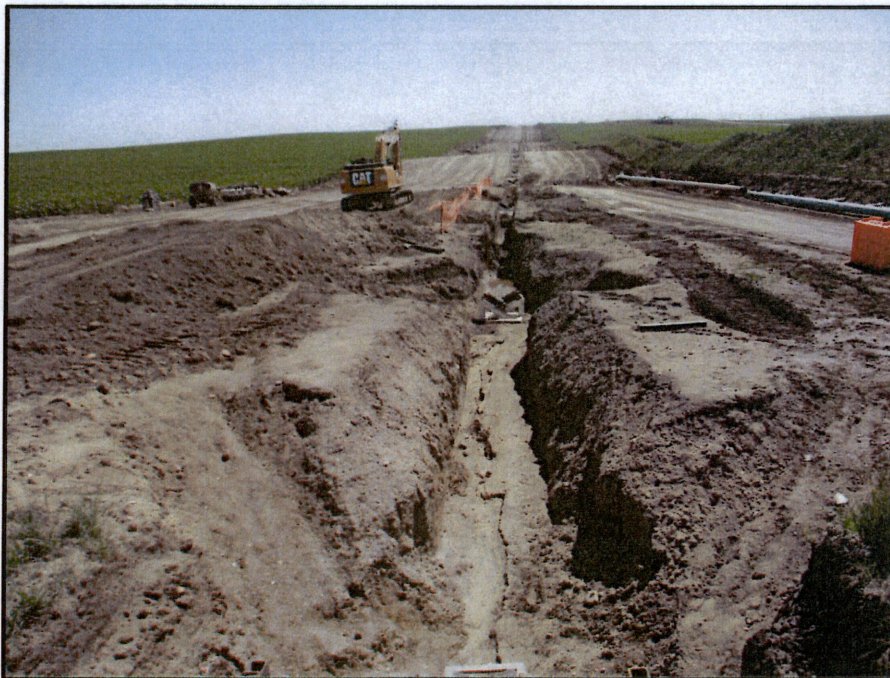
Photo 12. (GPS Point #450) - Open trench with few orange blockades ending to the right of photo, and only partial orange fence to the left of trench. White and black pipe rollers in trench were used to guide bore pipe. Photo taken from bridge shown in photo #11.
Direction: East

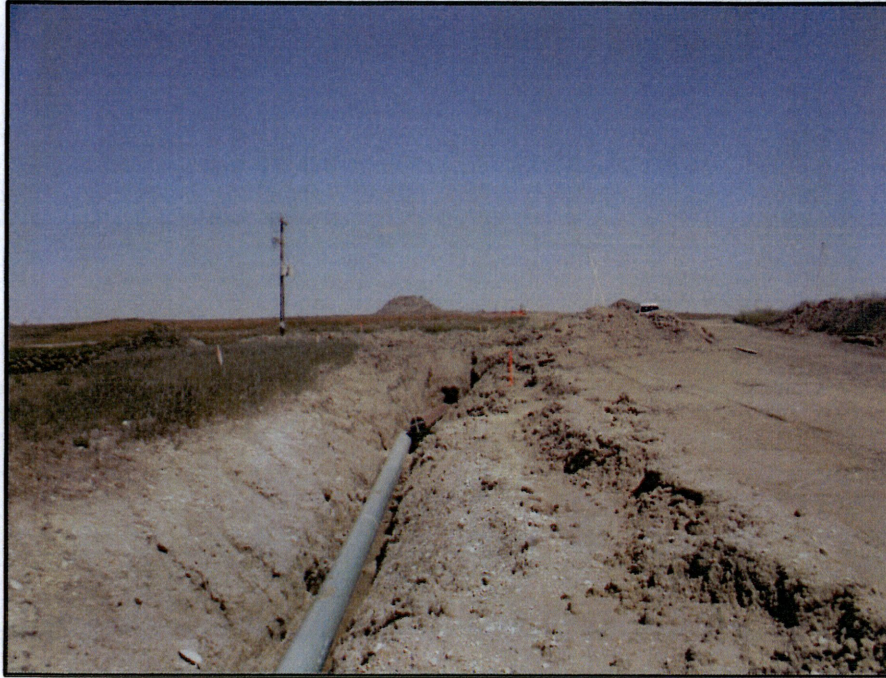
Photo 13 of the Report depicts an open trench. *See Report 2, 18.* The trench was open to complete the tie-in of the bore section to the mainline. SPC's primary concern is safety and inspections for BMP and safety measures are routine. When potential violations and/or concerns are raised, SPC takes prompt remedial measures.

- Area near rural water line break. Open trench to the left of photo. No standing safety fence observed, unknown how long there has been an open trench, no work going on in the area. Environmental inspector thought they hit the rural water line while they were doing boring activities (Photo #13, Point #444);

Photo 13. (GPS Point #444) - Area near rural water line break. Open trench to the left of photo. No standing safety fence observed. Environmental inspector thought they hit the rural water line while they were doing boring activities. Direction: North

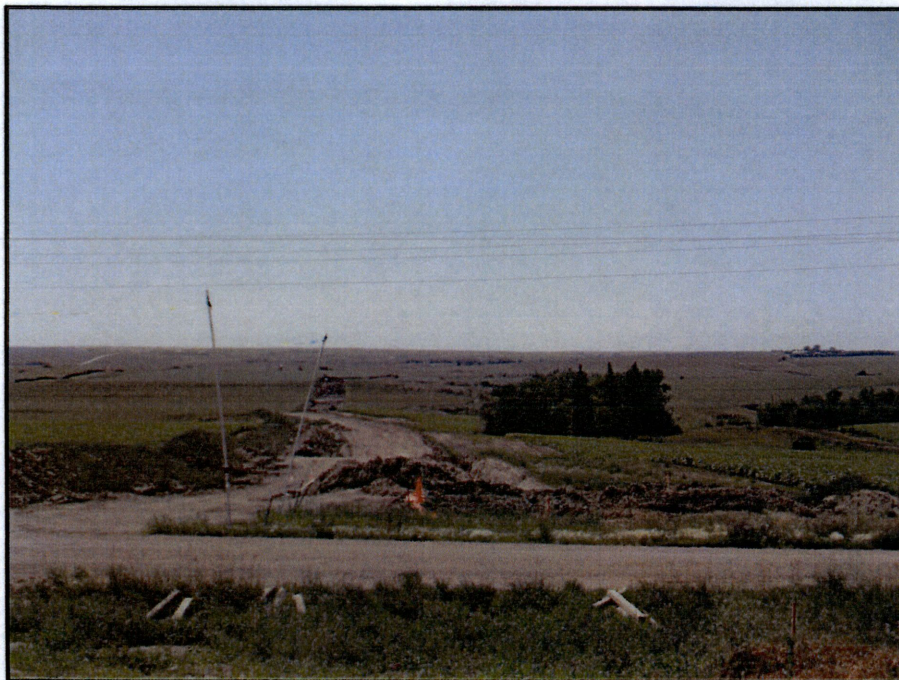
Photo 14. (GPS Point #444) - Area near rural water line break. Extended ROW for bore area. Topsoil pile to the left of photo on left side of ROW with vegetation growing on it. Direction: South

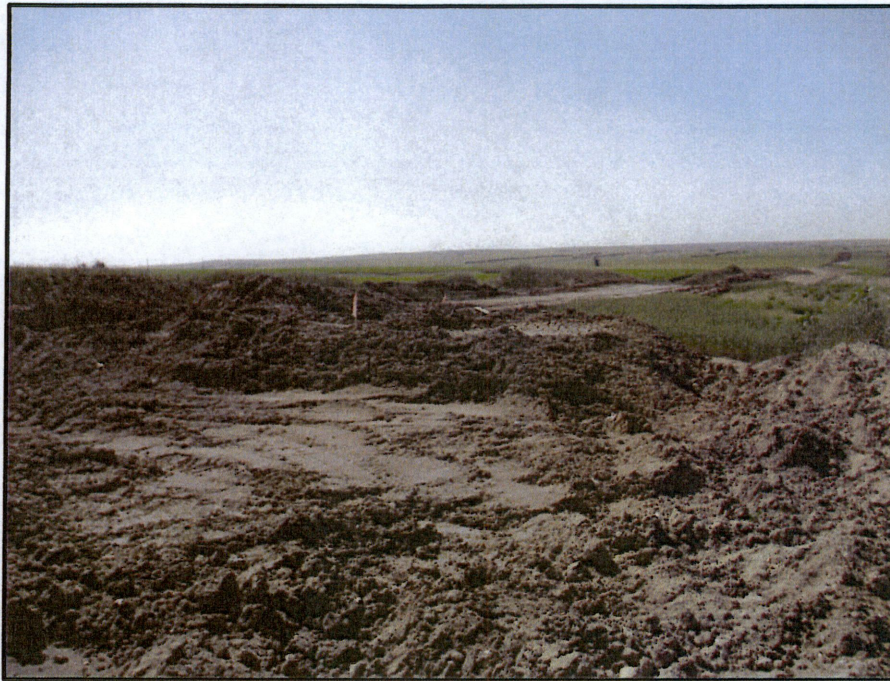
In addition, Photo 13, along with Photos 14 and 15 of the Report, depict an area near a rural water line break. *See Report 2, 18-19.* The photos show "pushed around" soil and pooled water. *See Report 18-19.* However, the images are expected due to the associated land events. Consistent with PSC requirements, construction activity halted to allow for the soil to dry and to avoid unnecessary damage.

Photo 15. (GPS Point #444) - Area near rural water line break. Looks like subsoil had been pushed around, there was some ponded water in back of photo. Direction: South

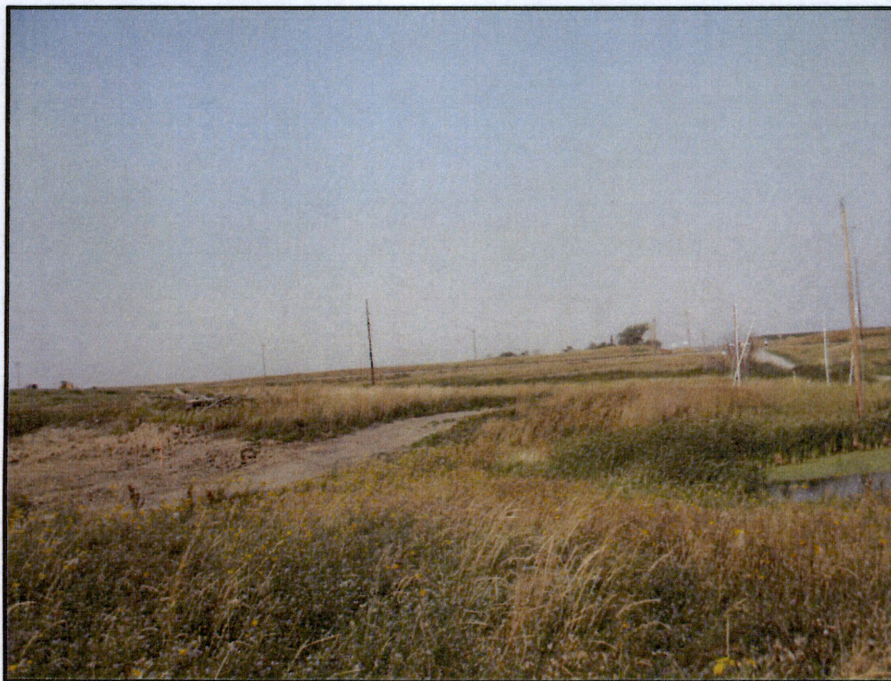
Photo 16 of the Report alleges insufficient erosion control devices. *See Report 2, 19.* The photo shows a bored wetland with an adjacent bypass road to move traffic around the area. The bare dirt road is without a control fence; however, no visible sediment is flowing into the wetland and the road slopes back away from the water. Also note that sufficient vegetative cover between surface waters and the disturbance may be considered a BMP.

Photo 16. (GPS Point #481) - ROW and access road next to wetland. No erosion control devices observed. Site visit 9/1/2016. Direction: West

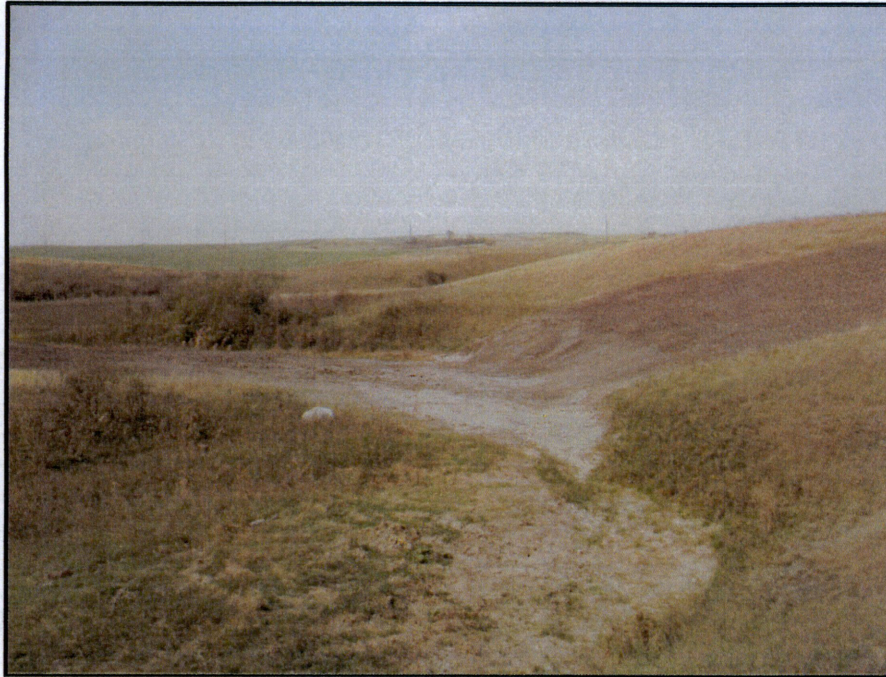
Photo 17 of the Report shows a drainage area allegedly lacking an erosion control device. *See Report 2, 20.* The area depicted is a restored ROW and as such, any BMPs were intentionally removed. While the foreground appears to have some soil mixed into the vegetation off of the ROW, the foreground also appears to be “upstream” of the ROW location. The photo’s background indicates that an adequate vegetative cover exists beyond the ROW, thus preventing sediment from reaching surface waters until vegetation in the ROW is re-established. Photo 17 is an example of a drainage path continuing to exist following the completion of pipeline construction. Any issues that potentially exist with respect to this photo are being addressed by construction and environmental personnel.

Photo 17. (GPS Point #482) - Drainage area, no erosion control device. Area along the drainage pathway looks light in color, possibly due to topsoil erosion. Direction: West

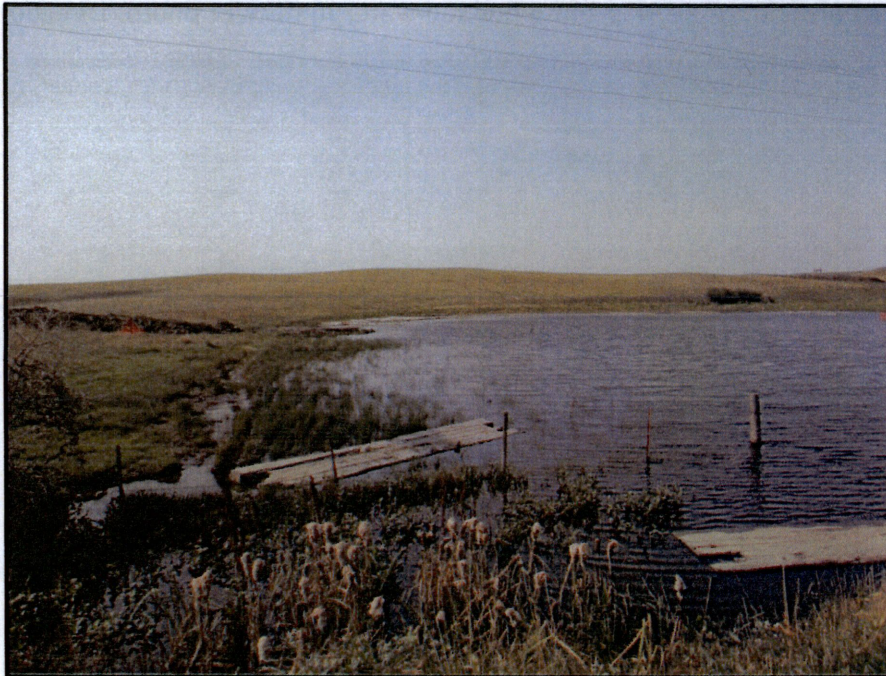
Photos 18 through 20 of the Report depict wood mats used to protect property next to a wetland. *See Report 3, 20-21.* Large amounts of rain from May through July led to a rapid expansion of the surface water which has been slow to drain in this area. The wood mats likely floated and were carried by wind or wave action to the other side of the pool. The depicted fenced pothole demonstrates the relatively large impact/pond boundary shift of the prior rain events. The photos also indicate that the pool is at the bottom of a rather large size drainage area which would be subject to wide seasonal fluctuations in size. The submerged vegetation boundary speaks to the rarity of the event. Further, the landowner requested that SPC delay reclaiming the area until it had dried.

Photo 18. (GPS Point #483) - Swamp mats floating all around wetland. ROW is next to the wetland/open water. Wetland appears it may have had an influx of water at some point, reason for this is unknown (there has been little to no rain in the last couple of weeks).
Direction: South

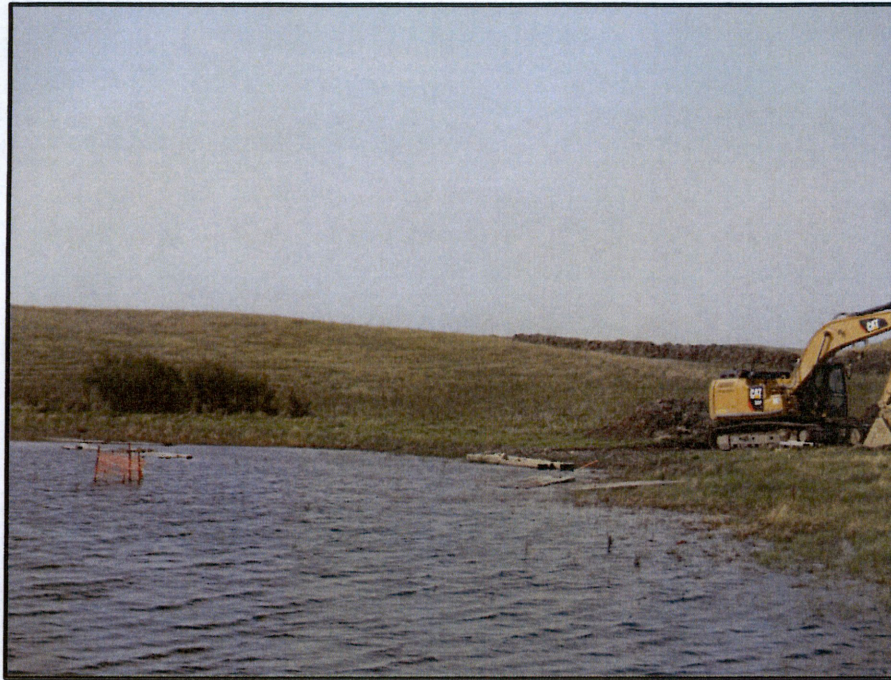
- Swamp mats floating in wetland, no erosion control devices observed. Small orange fenced in area, possible pot holing site, under water (Photo #19, Point #483);

Photo 19. (GPS Point #483) - Swamp mats floating in wetland, no erosion control devices observed. Small orange fenced in area, possible pot holing site, under water. Direction: South

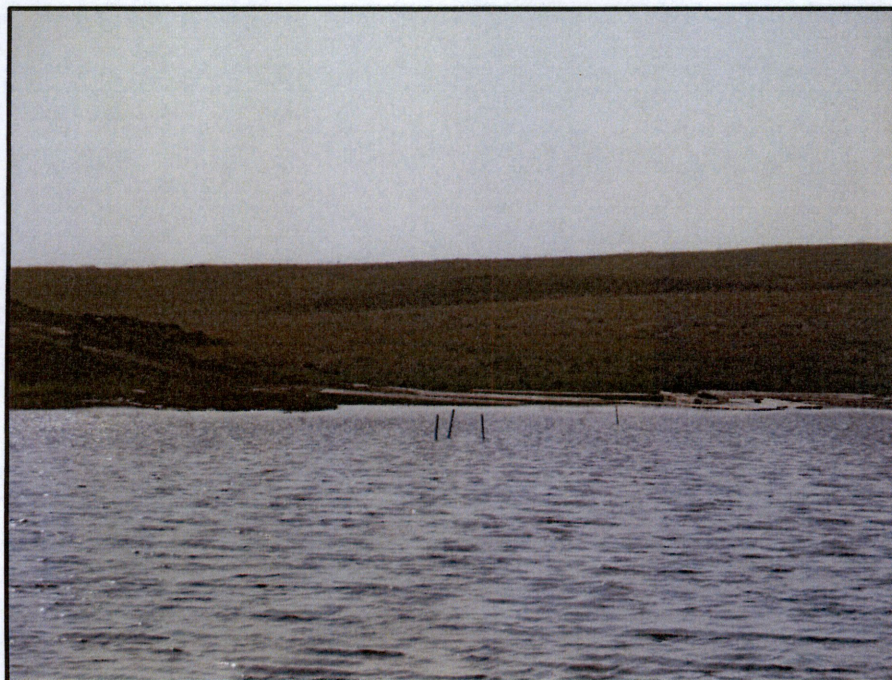
- Swamp mats floating in wetland. Dirt pile in water seen to left of photo on wetland edge. No erosion control devices observed (Photo #20, Point #483);

Photo 20. (GPS Point #483) - Swamp mats floating in wetland. Dirt pile in water seen to left of photo on wetland edge. No erosion control devices observed. Direction: South

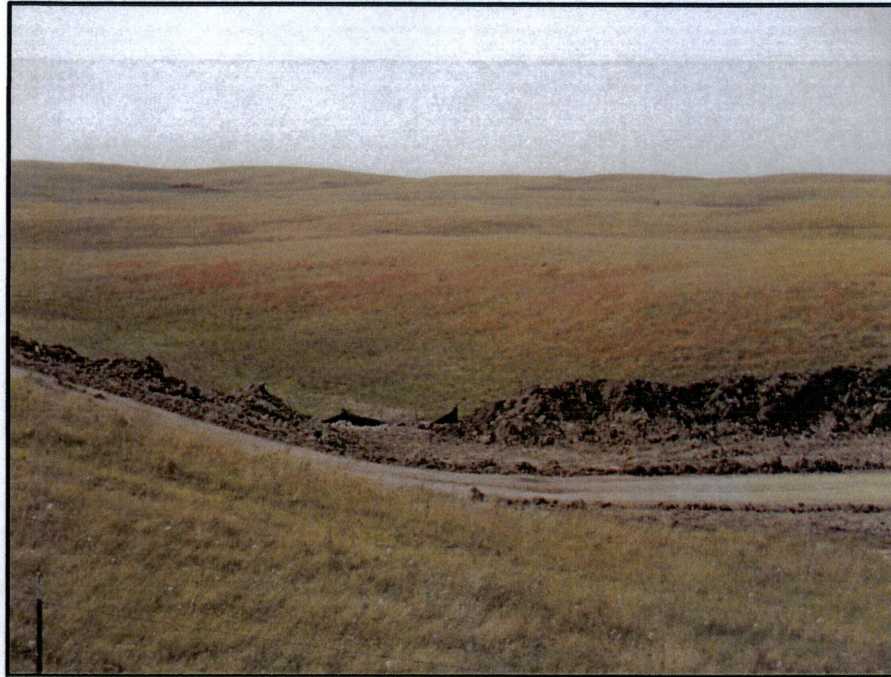
Photo 21. (GPS Point #484) - Silt fence in drainage area, needs maintenance. Direction: South

The area detailed in photo 21 has already been addressed as a result of a SWPPP inspection conducted on September 6, 2016 by SPC Environmental Inspectors. *See Report 3, 22.* The maintenance was completed by a contractor on September 8, 2016 in accordance with the provisions of the existing stormwater management plan. Furthermore, the existing vegetation served to prevent sediment from being discharged into the nearest surface water.

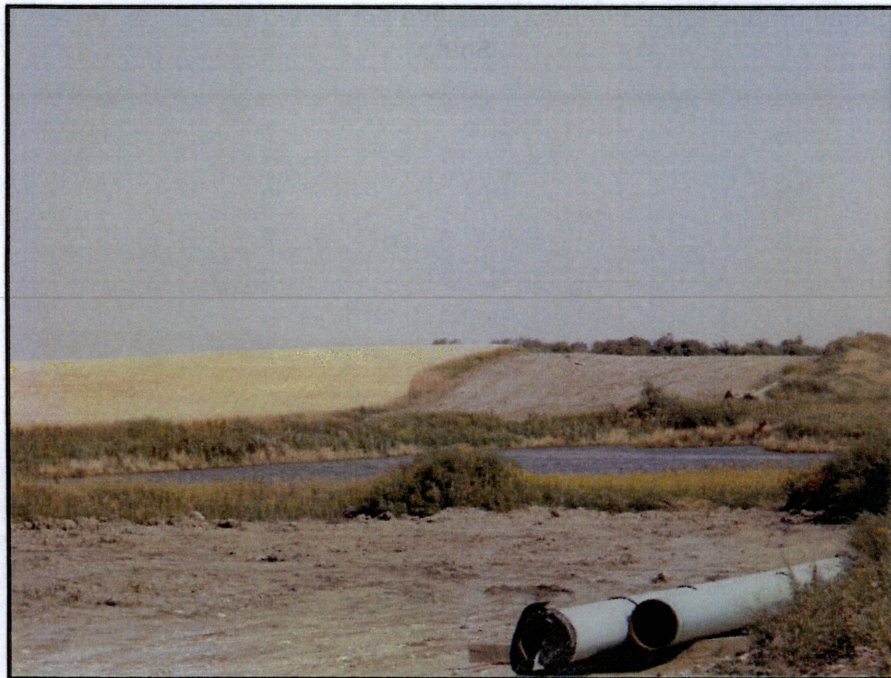
Photo 22 of the Report depicts a “rough” topsoil surface restoration with BMPs intentionally removed. *See Report 3, 22.* The vegetative cover between the surface water and the disturbance serves as a BMP.

Photo 22. (GPS Point #485) - Pipeline ROW goes down the hill in the distance and wetland was bored under. No erosion control devices observed. Direction: North

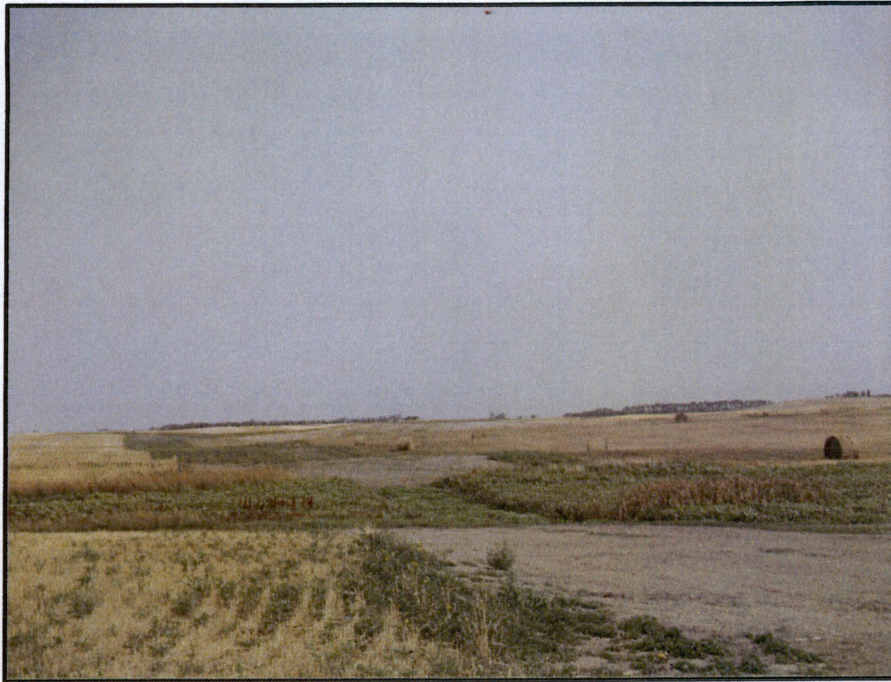
Photo 23 of the Report does not present a surface disturbance as alleged. *See Report 3, 23.* The area is a final ROW restoration with a sole, low travel lane to allow revegetation.

Photo 23. (GPS Point #488) - No erosion control devices observed. Area appears to have been bored but it looks like the wetland was driven through.

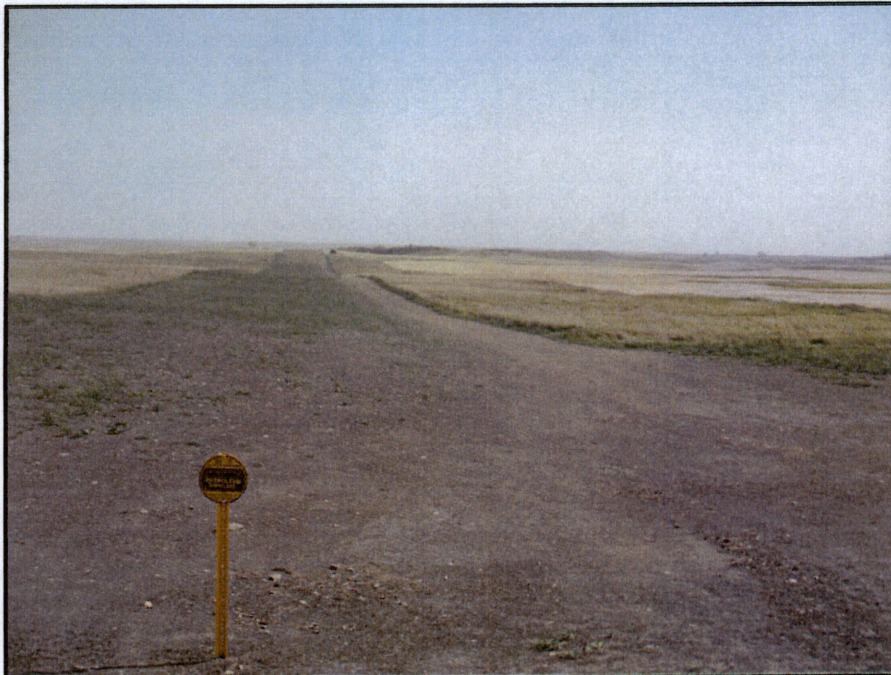
Photo 24. (GPS Point #490) - Pipeline ROW has vegetation growing. Looks like the right side of the ROW, where no vegetation is growing, has been/or is being used as a travel lane. Direction: East
