Enclosed are copies of two complaints recently filed with the North Dakota Public Service Commission concerning the Sacagawea Pipeline, a crude oil transmission pipeline being constructed by Sacagawea Pipeline Company, LLC in McKenzie and Mountrail Counties, North Dakota. Siting of this pipeline was approved by the Commission's January 5, 2016 Order (Case No. PU-15-114).

**Re: Notice of Potential Violation
Sacagawea Pipeline Company, LLC
16-inch Crude Oil Pipeline – McKenzie & Mountrail
Case No. PU-15-114**

RE: Construction Inspection Report for the Sacagawea 16-inch Pipeline Project

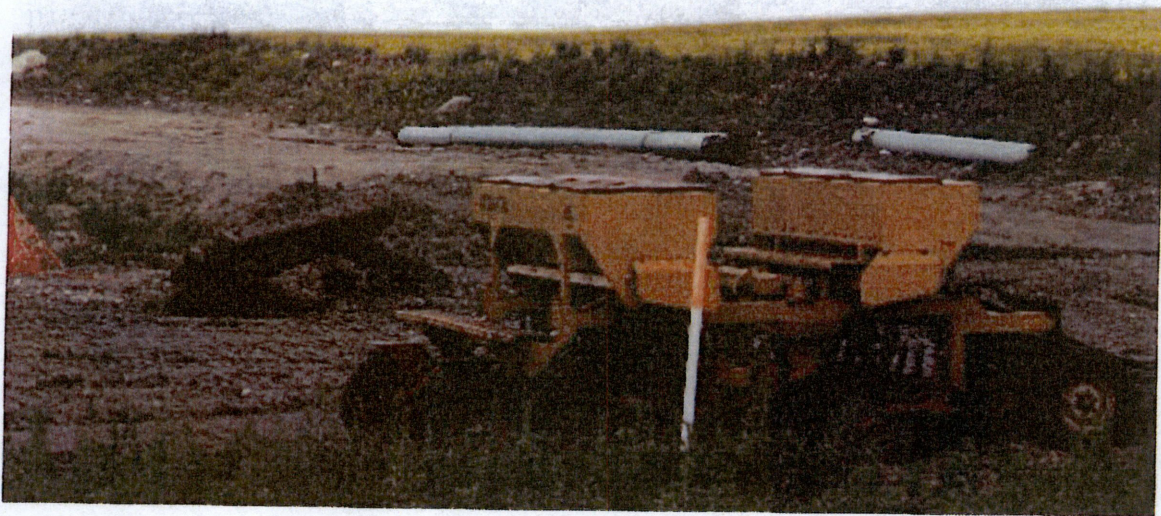
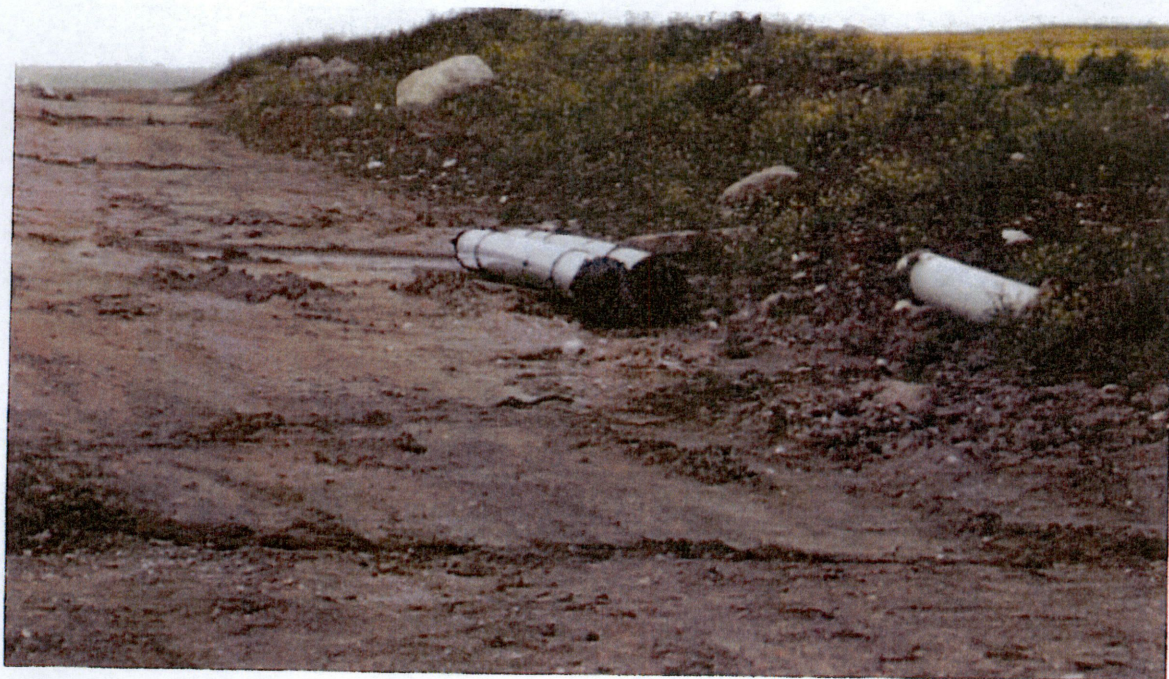
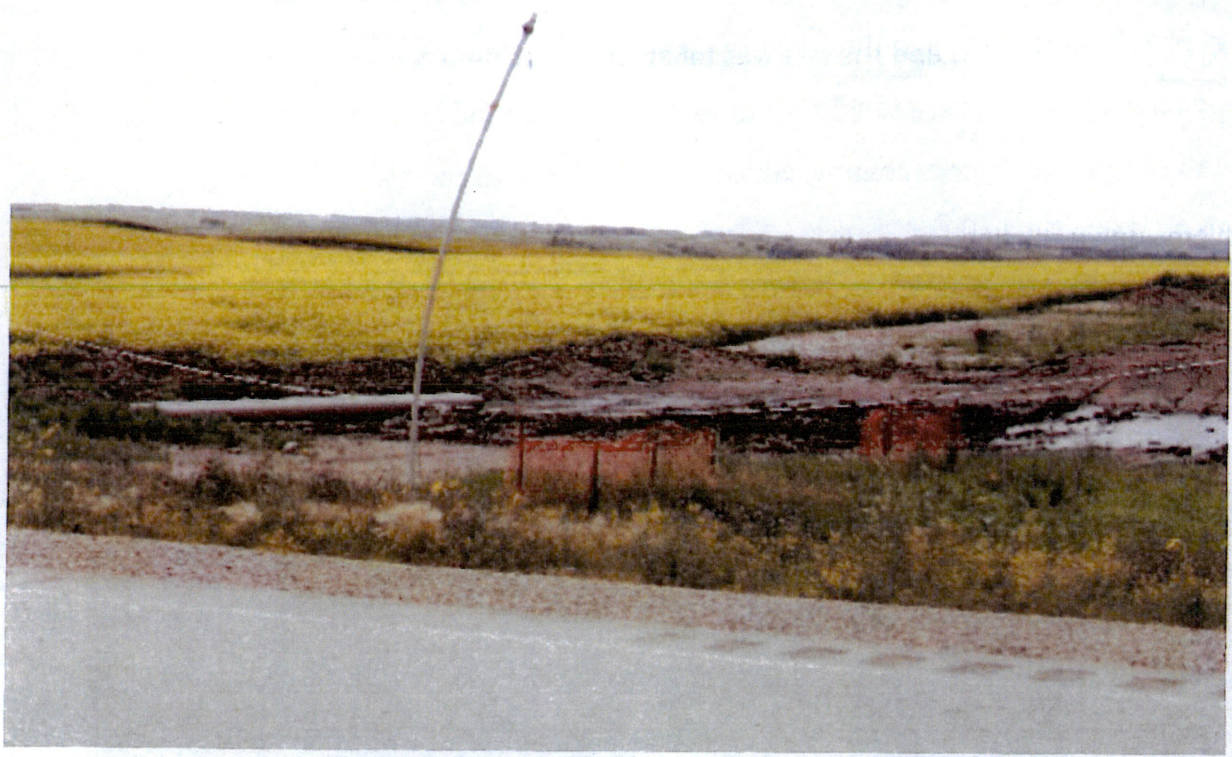
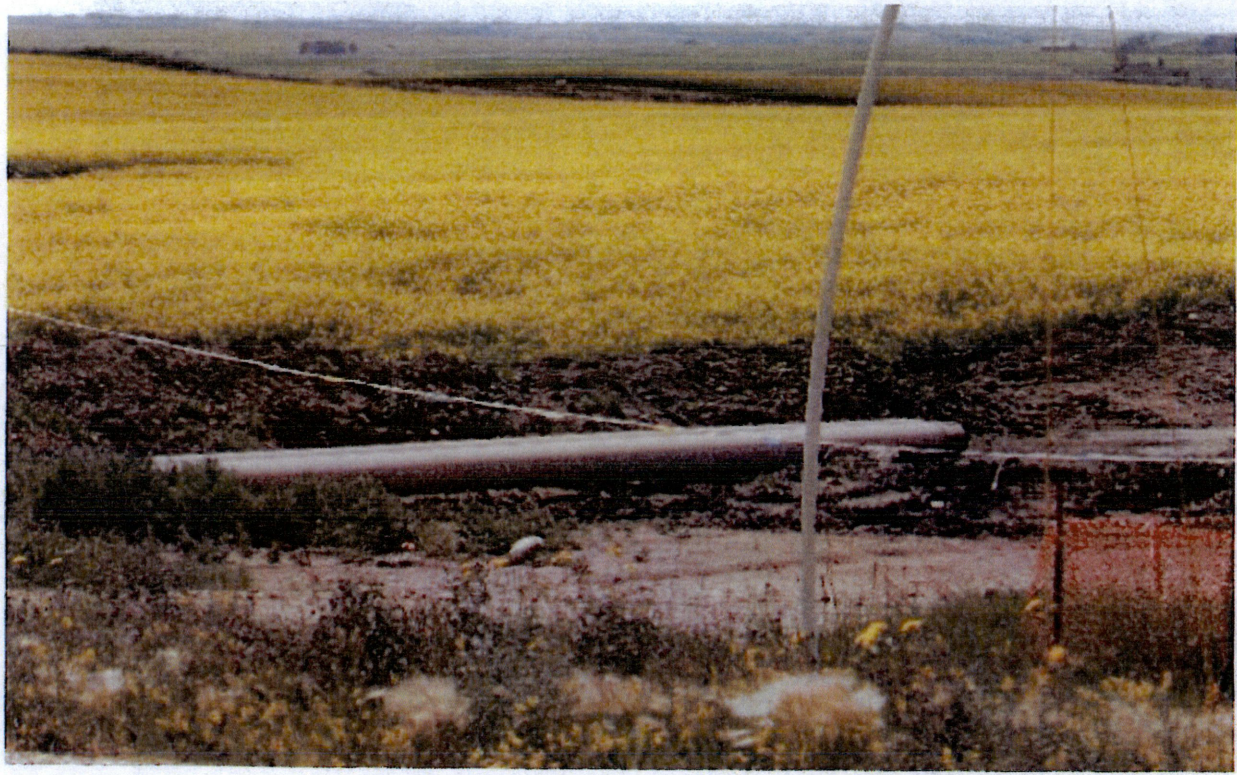
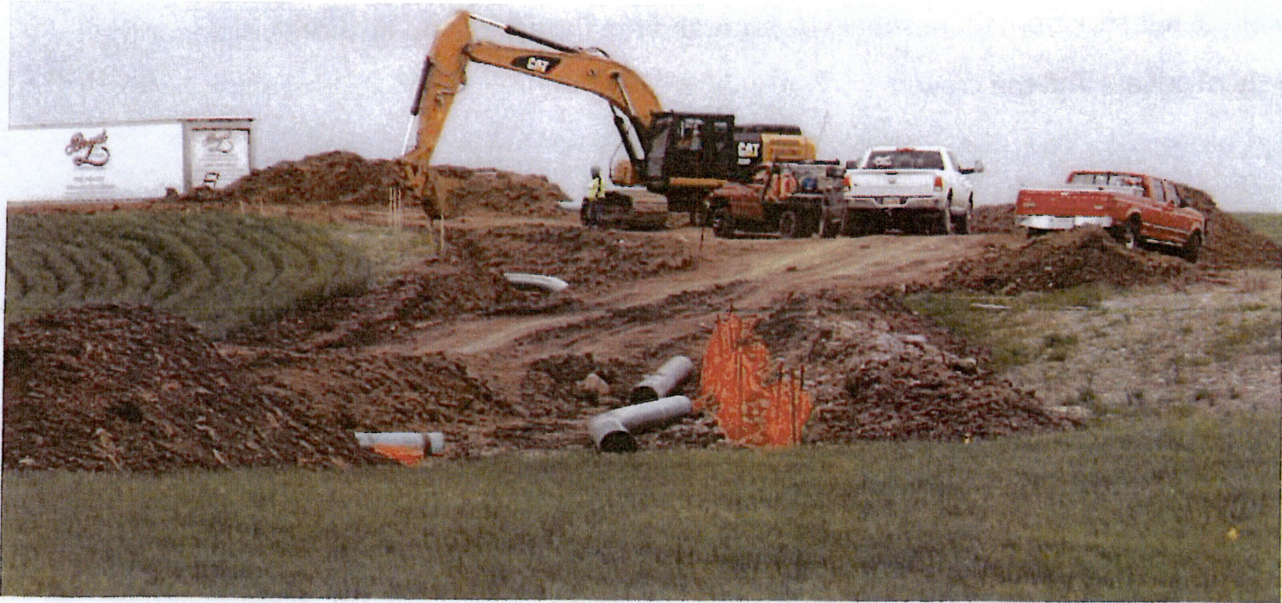
The photos below show locations along the Sacagawea Pipeline right-of-way where sections of pipe were left lying on the ground. The first two were taken near 49th Street

approximately two miles west of Highway 8, the second two were taken near Highway 8 south of 53rd Street NW, and the last was taken at 59th Street west of 80th Avenue NW. Skilled pipeline workers are taught never to place pipe on the ground because rocks and dirt can scratch the factory coating, which can contribute to corrosion and integrity problems down the line.

affidavit were likely pipeline “pups,” i.e. short lengths of pipe, or partial joints that had been cut as part of the construction process. The photos indicate that stringing, welding, trenching, lowering and backfilling were completed. *See* Whiteford Aff. 2-4. However, the photos were likely taken prior to topsoil replacement/final restoration. Consequently, the pipes depicted are likely surplus waiting to be retrieved prior to final topsoil preparation. The seeder (machine for mechanically sowing seed) on page 2 confirms this speculated phase of the project. Furthermore, even if any of the depicted pipes were not surplus and instead used after the photos were taken, their coatings would have been inspected and any defects remedied prior to subsequent use.

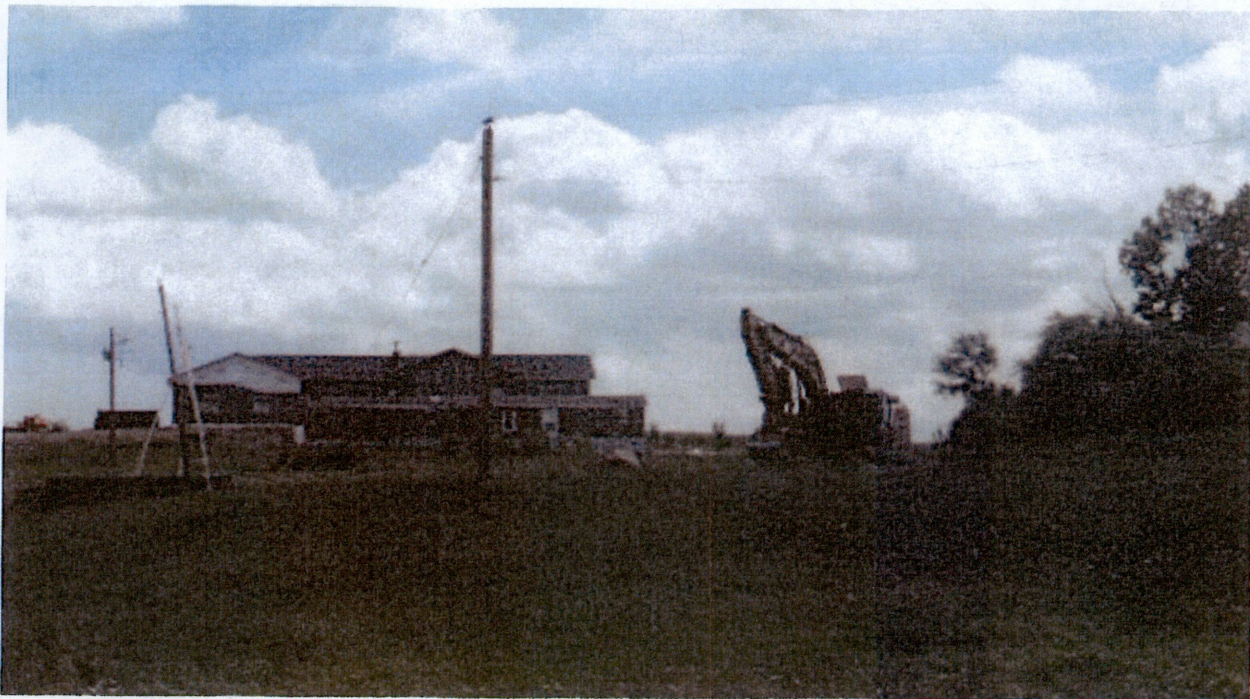
The photo below, taken near 53rd Street NE east of Highway 8 in Mountrail County, shows an excavator working near overhead power lines without a spotter. In my experience a responsible contractor will not allow use heavy equipment in the vicinity of a live power line without a spotter because contact with the line can injure or kill the operator in addition to the potential for damage to the equipment and the power system.

Second, Whiteford notes that an excavator was “working near overhead power lines without a spotter.” *See* Whiteford Aff. 4. Again, this photo is undated and it is impossible to tell whether work is actually occurring at the time the photo was taken. There was one incident whereby an excavator was discovered working near a powerline without a spotter. The responsible excavator was terminated for unsafe work practices.

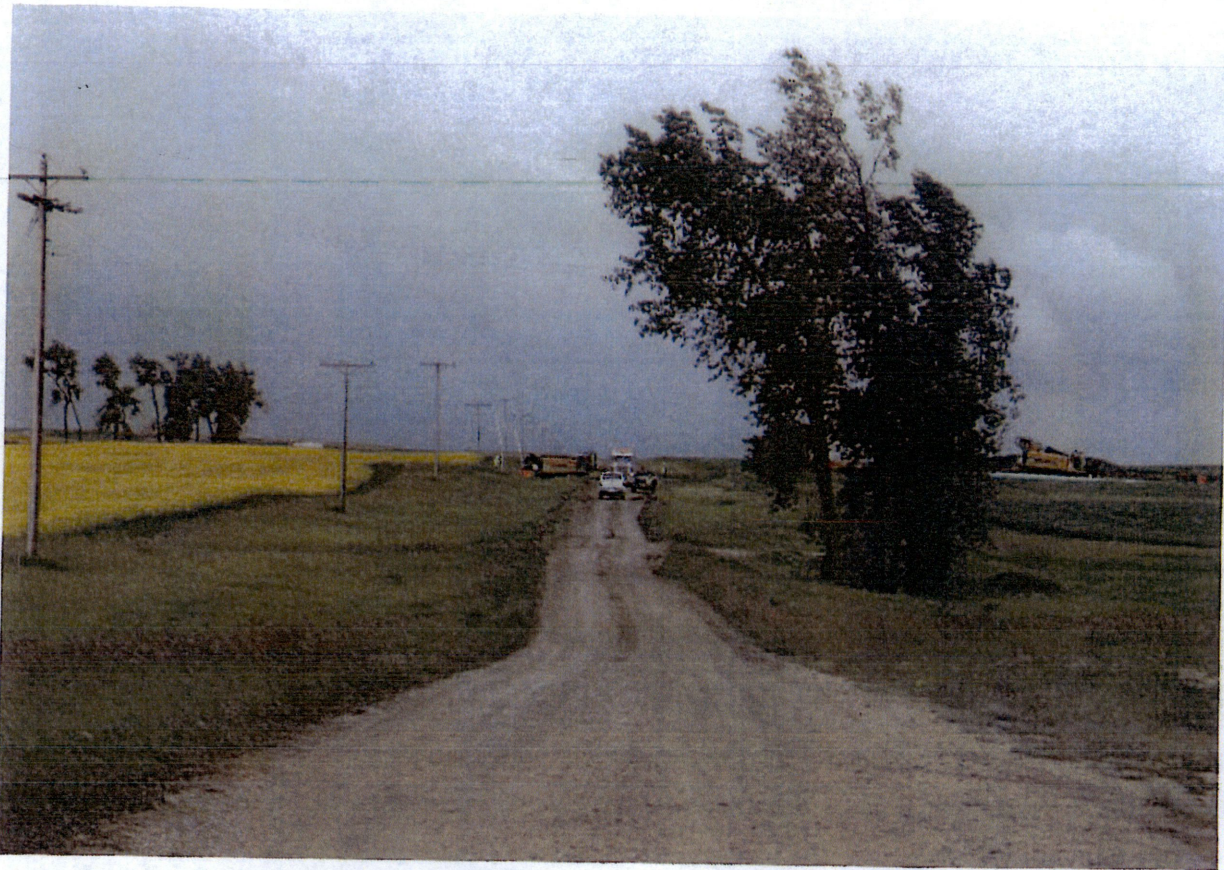
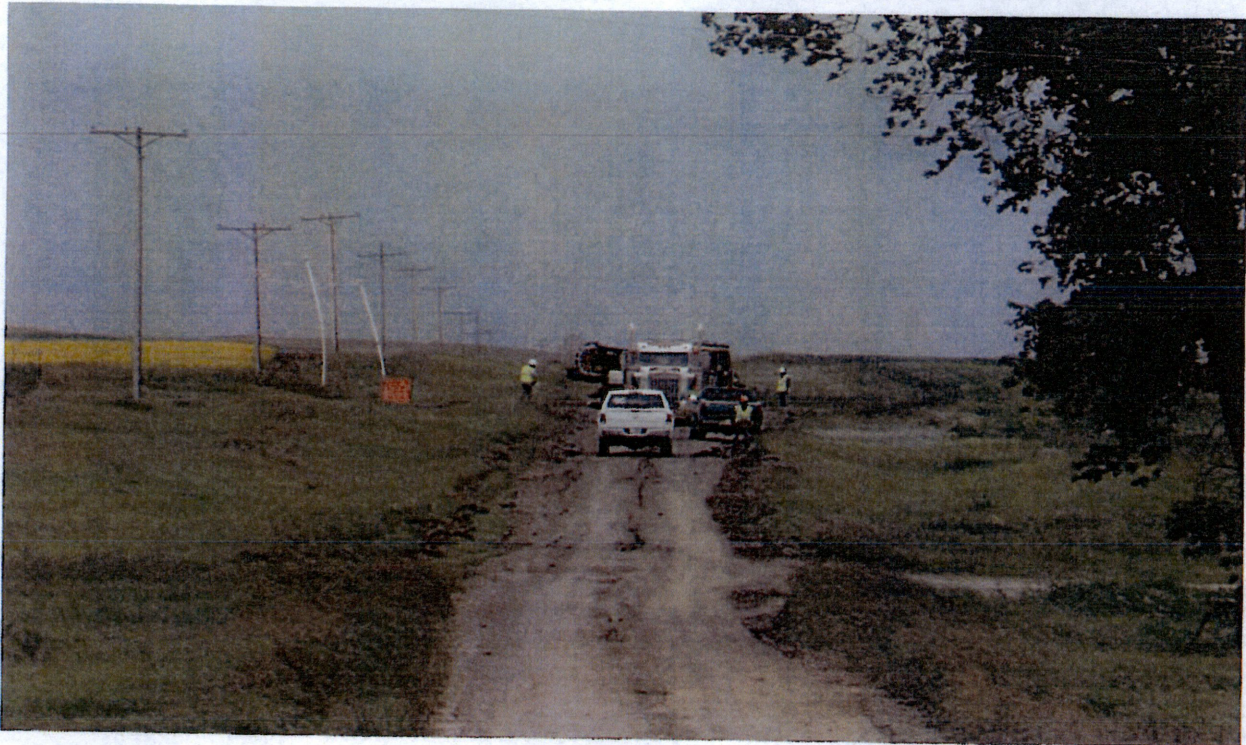
The next two photos, taken near 59th Street west of 80th Avenue NW, shows construction activity along a road that has not been adequately posted to warn drivers of potential hazards

ahead. In this situation, there should be signs and the flagger should be more visible for the safety of drivers and the crew.

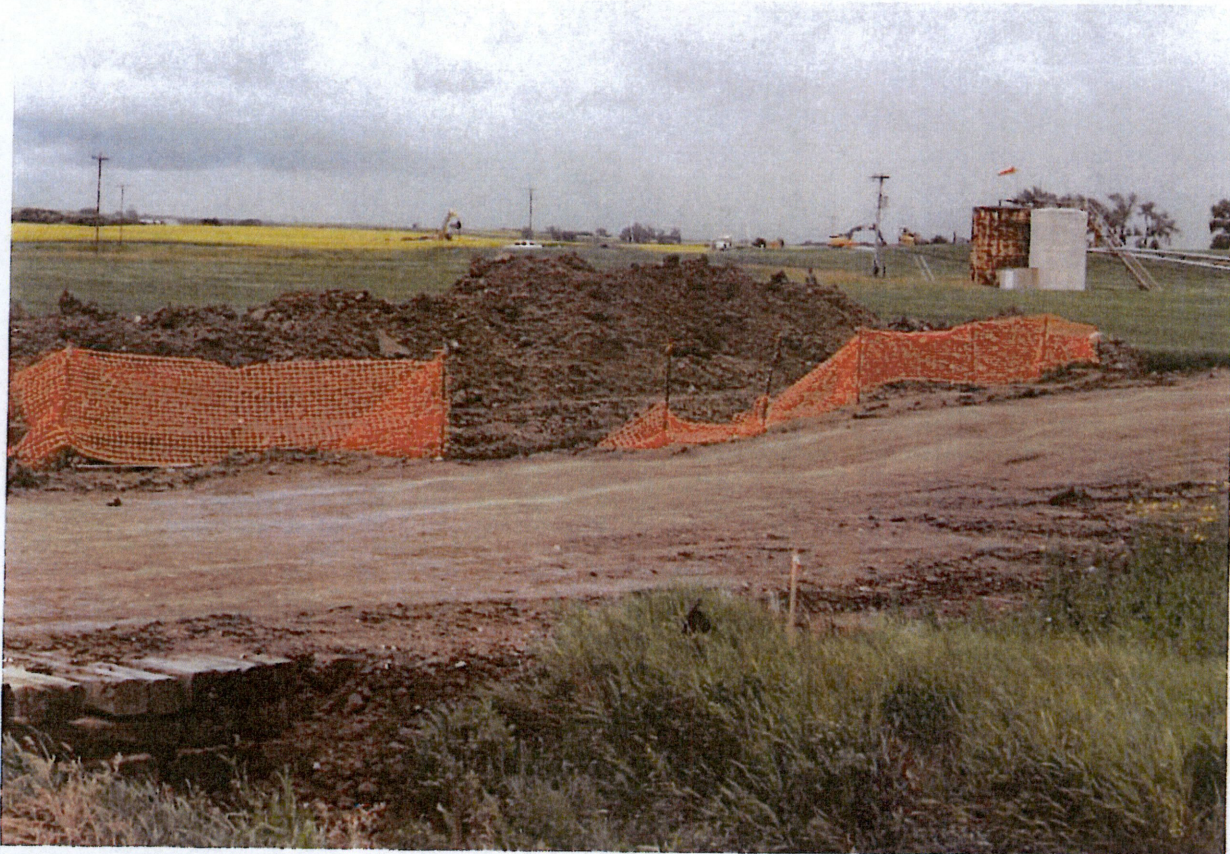
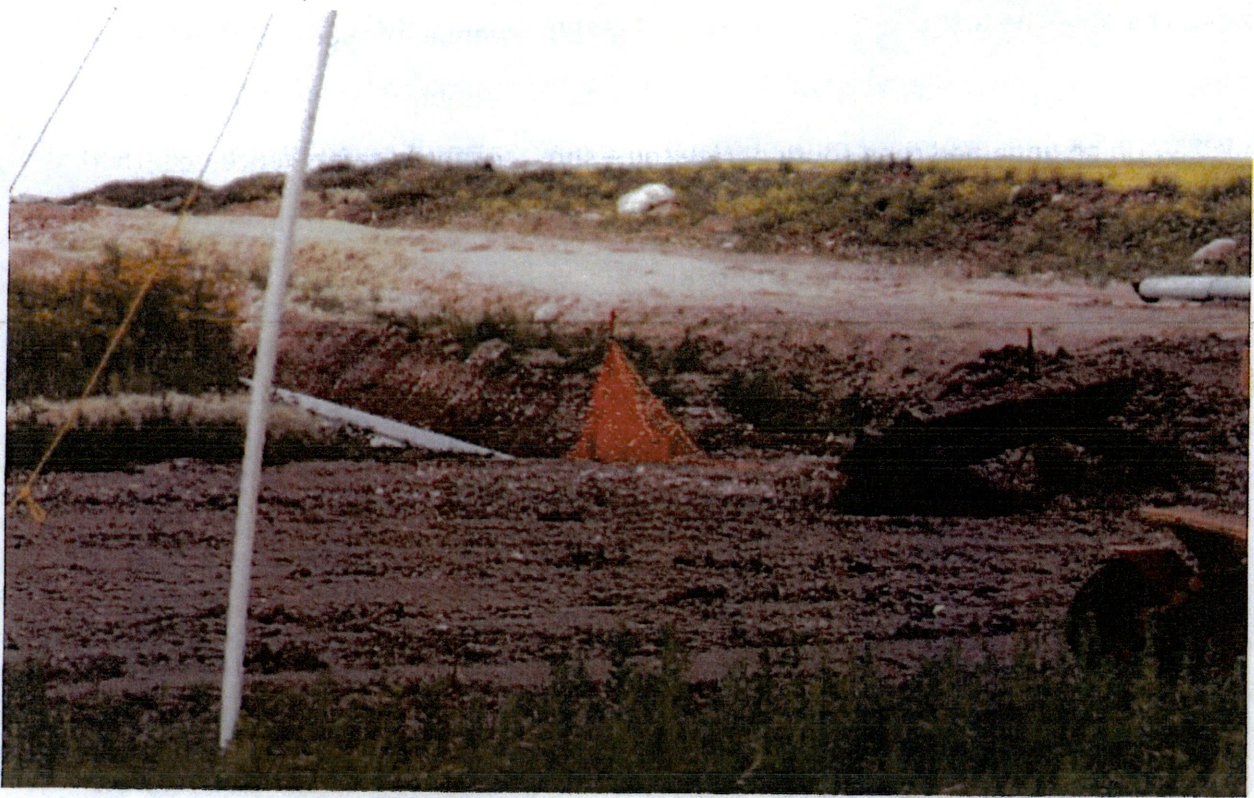
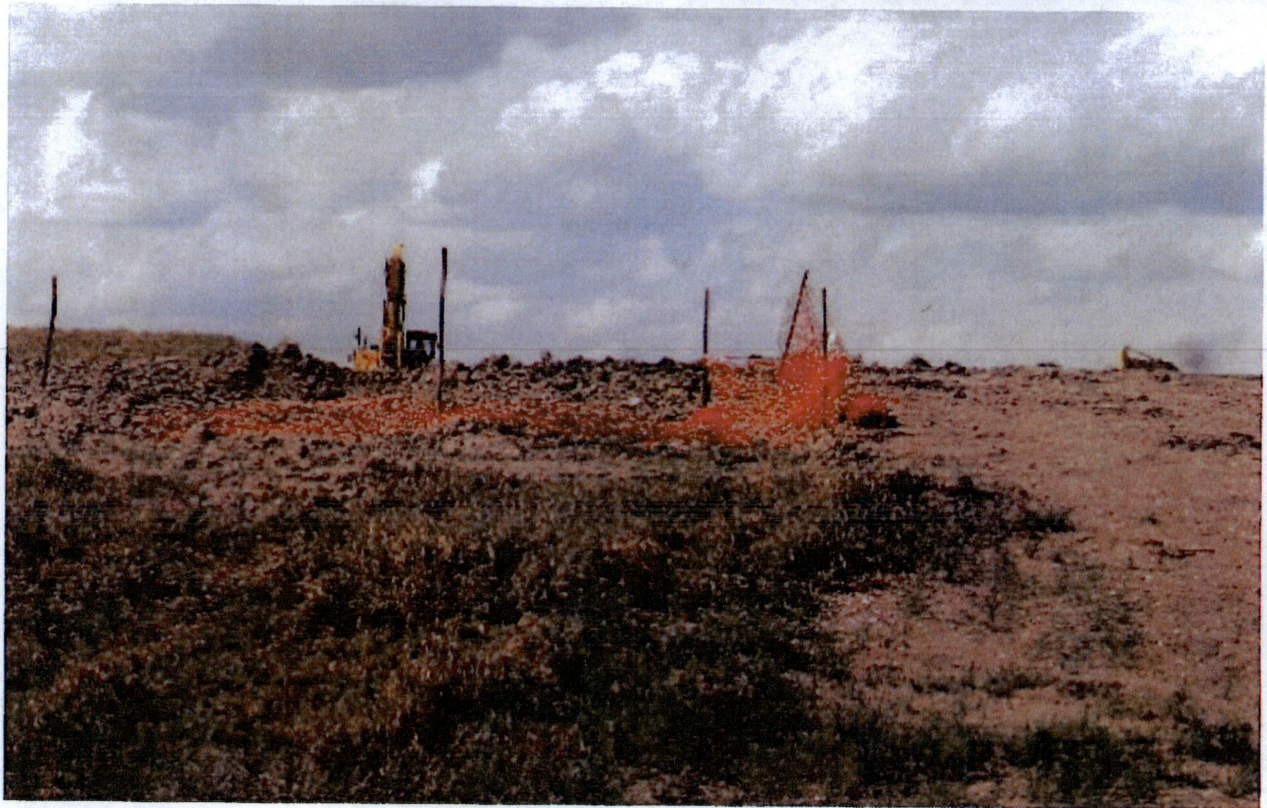
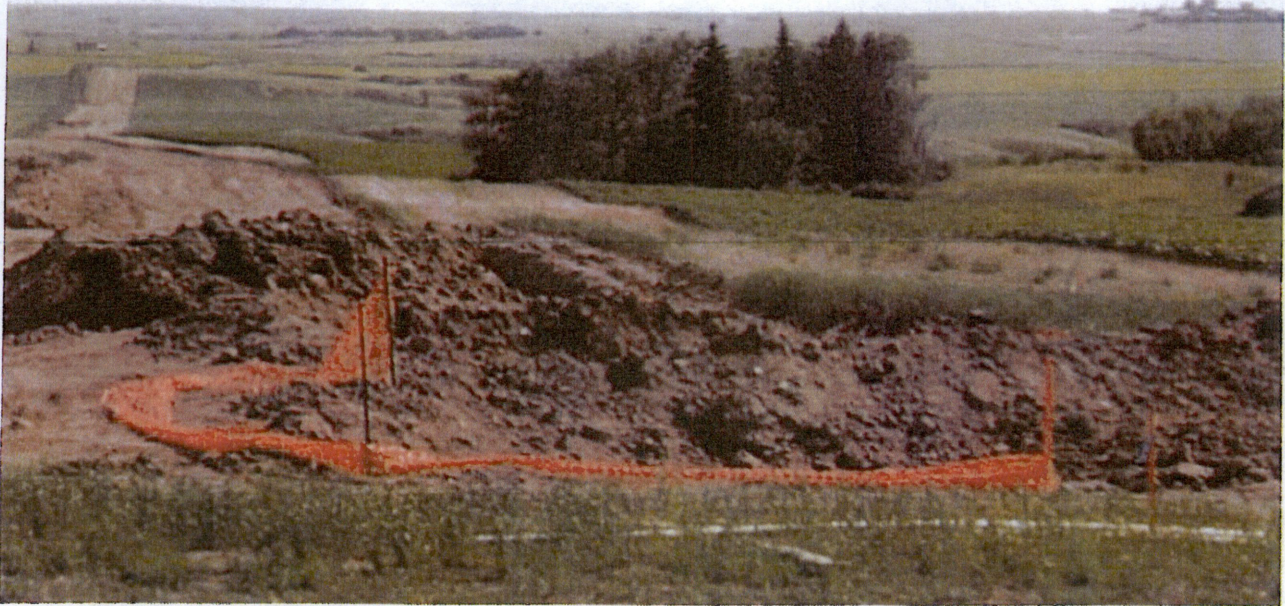
The photos below – the first taken 59th Street west of 80th Avenue, the second taken near 49th Street approximately two miles west of Highway 8, and the rest taken two miles west of 92nd Avenue NW on an unnamed road south of Newton – show collapsed safety fence near road crossings that is no longer helping to protect people, animals, or vehicles from injury or damage that can result from a fall into a bore pit.

Fourth, Whiteford describes collapsed safety fences near road crossings. *See* Whiteford Aff. 6-8. Safety fences are components used to prevent passage into dangerous areas and mitigate risk. Due to the windy weather conditions in North Dakota, the maintenance of safety fences is ongoing. At times, portions of safety fences are intentionally removed to facilitate work in a specified area. Other times, safety fences are intentionally removed during clean-up or to facilitate revegetation during early stages of restoration. Without specifics regarding the timing of these photos, it is impossible to identify the exact circumstances with respect to any safety fences.

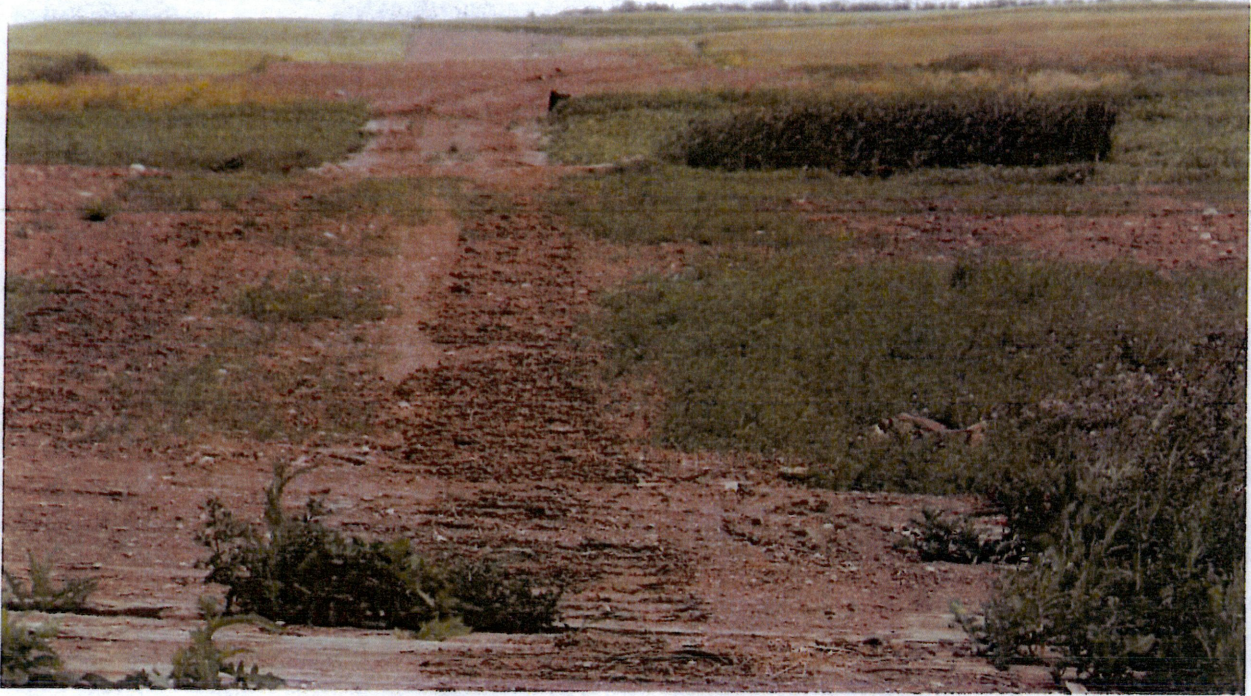
The next photo, taken in the vicinity of 60th Street a mile west of 79th Avenue, shows a section of the right-of way where heavy equipment has obviously been moved across unprotected wetland, leaving a clear set of tracks. Heavy equipment can permanently damage fragile wetland soil and vegetation, which is why a responsible contractor will use a mat bridge when wetland crossings are unavoidable.

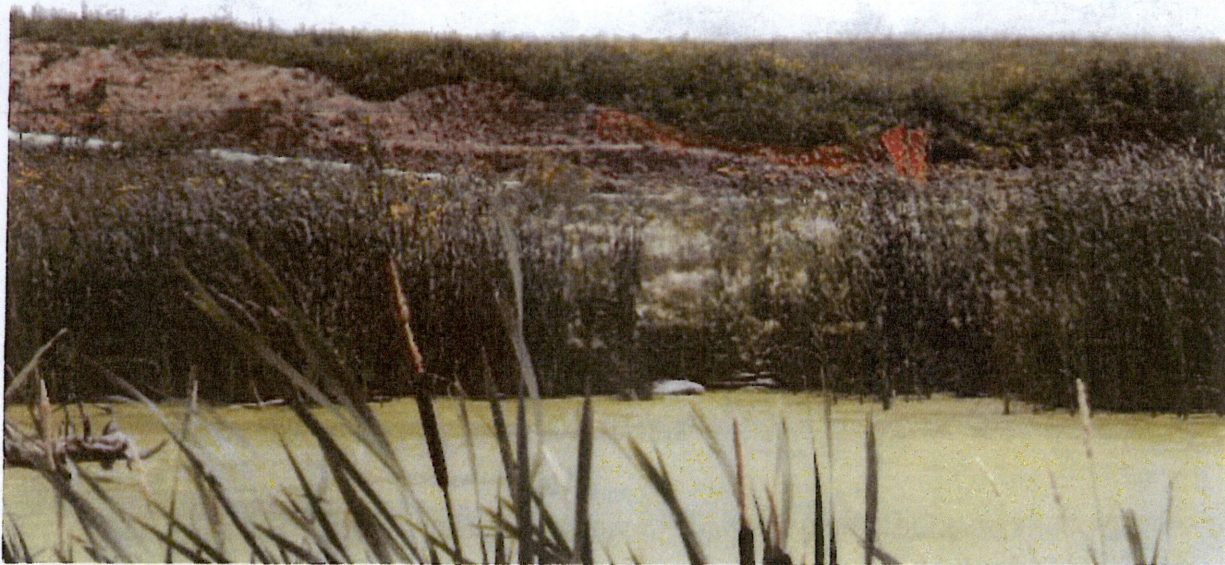
The photos below show areas where the contractor has failed to properly install or maintain silt fence or other erosion controls. Skilled pipeliners are trained to install and maintain proper erosion controls, because erosion can kill wetland vegetation, while removing topsoil necessary to sustain native plant life or cultivation on exposed areas. The following photo shows a section of the right-of-way on 53rd Street NW East of Highway 8 in Mountrail County where no silt fence has been put in place to prevent runoff into a wetland.

Sixth, Whiteford alleges a failure to properly install or maintain silt fences or erosion control measures. *See* Whiteford Aff. 9-14. SPC, per the Storm Water Pollution Prevention Plan (“SWPPP”), requires the inspection of erosion control devices after precipitation events. However, inspectors and work crews are proscribed from driving on muddy right-of-ways (“ROW”) to further avoid erosion.

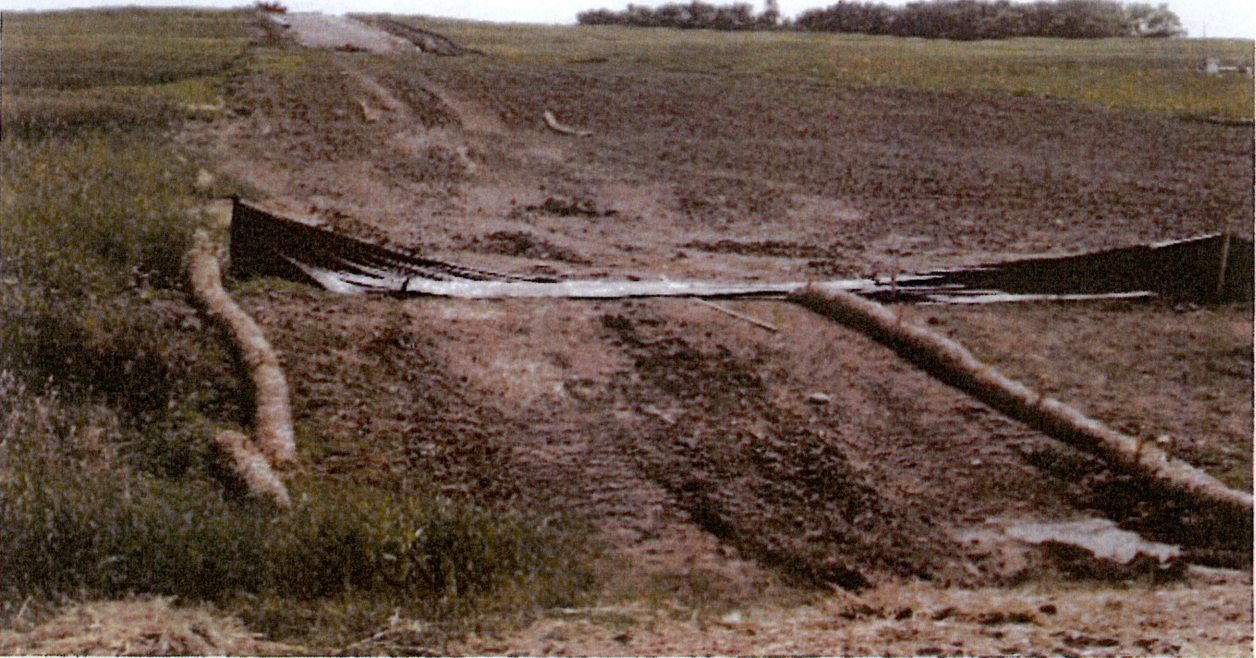
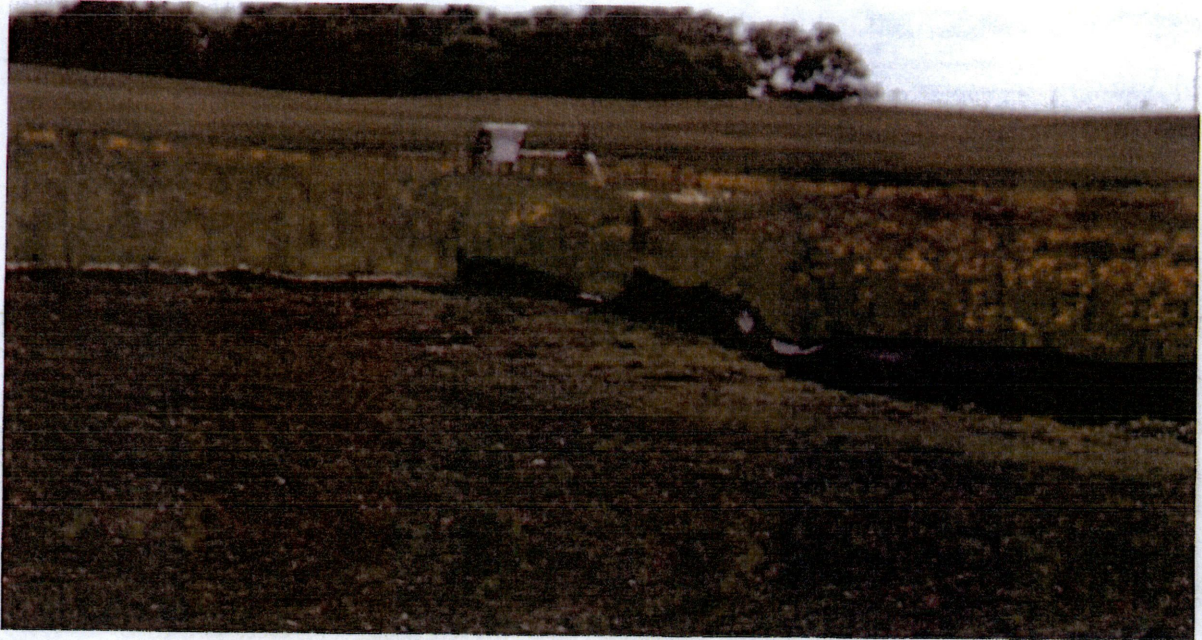
The next two photos, taken at a location east of 87th Avenue on an unnamed road in Mountrail County, show an area where silt fence was installed but then evidently run over and neglected.

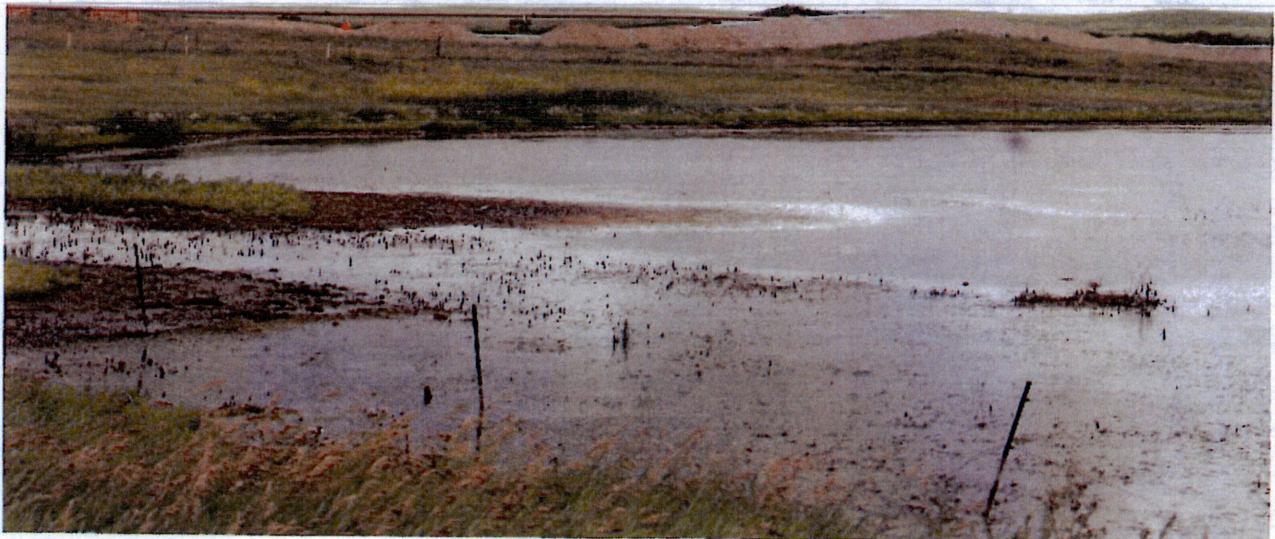
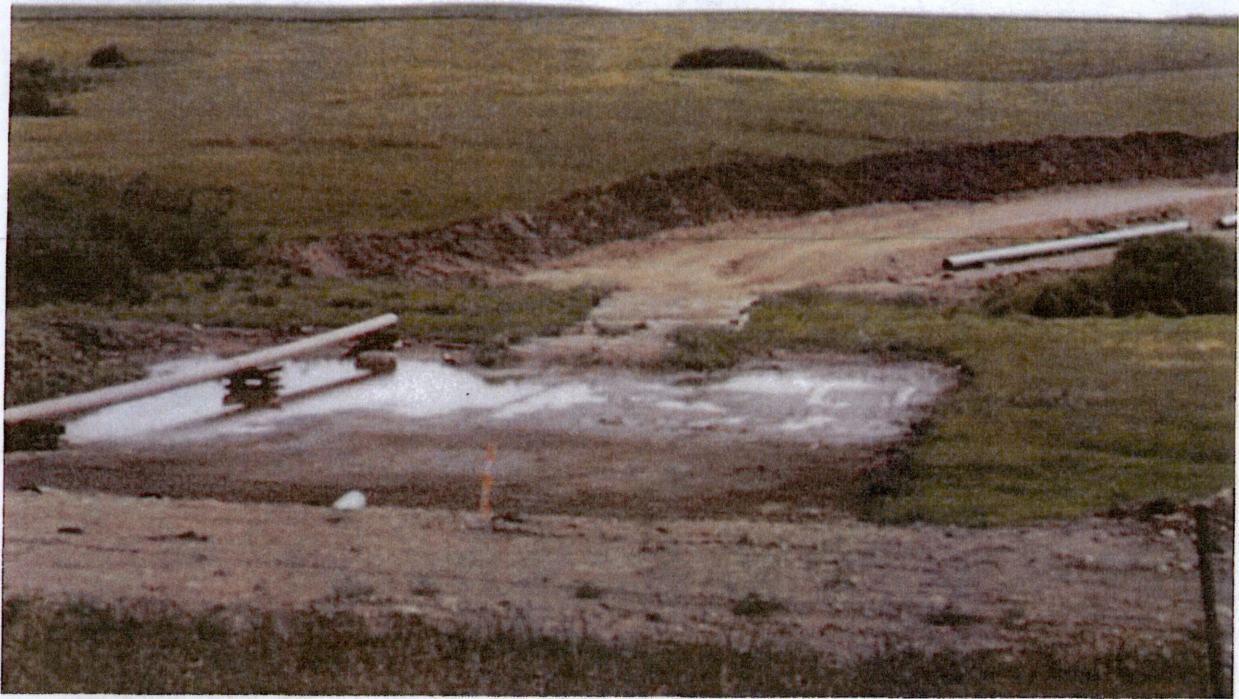
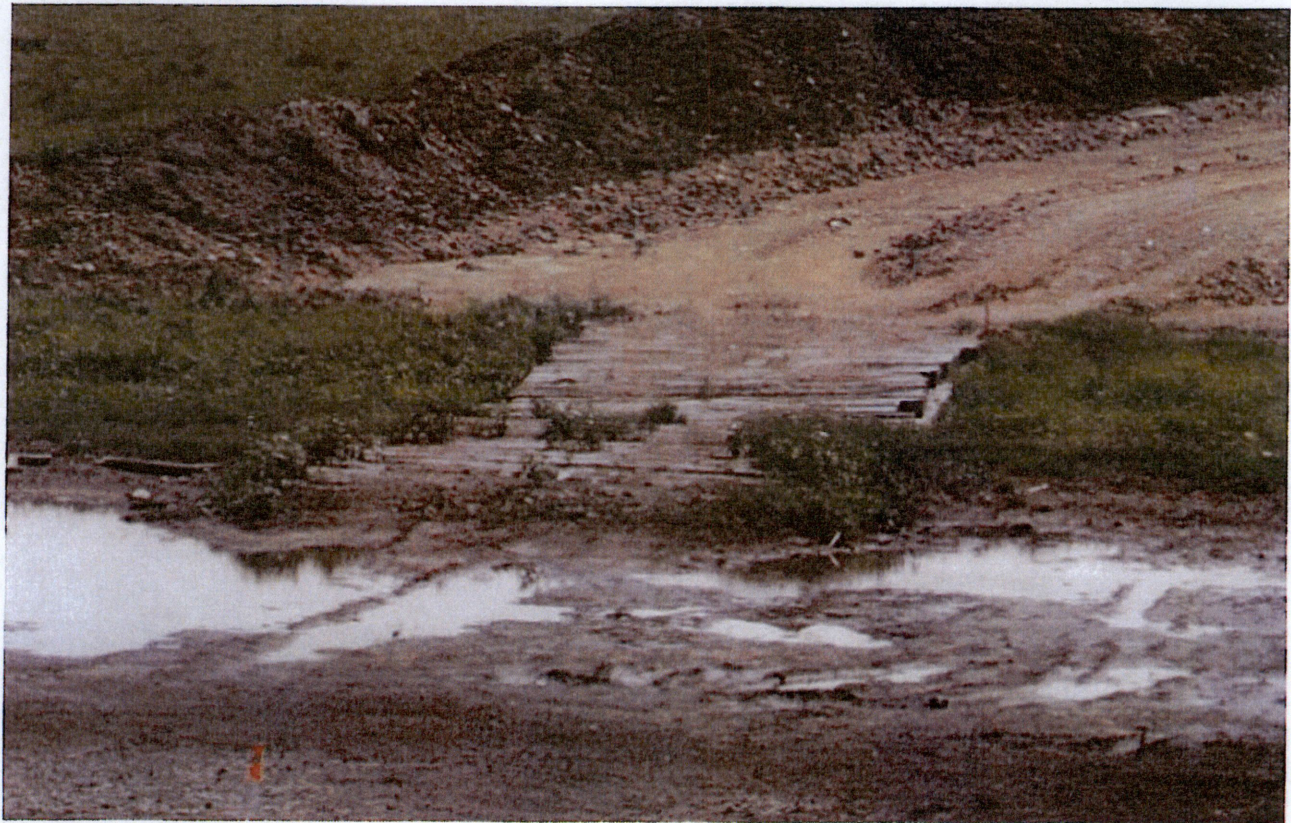
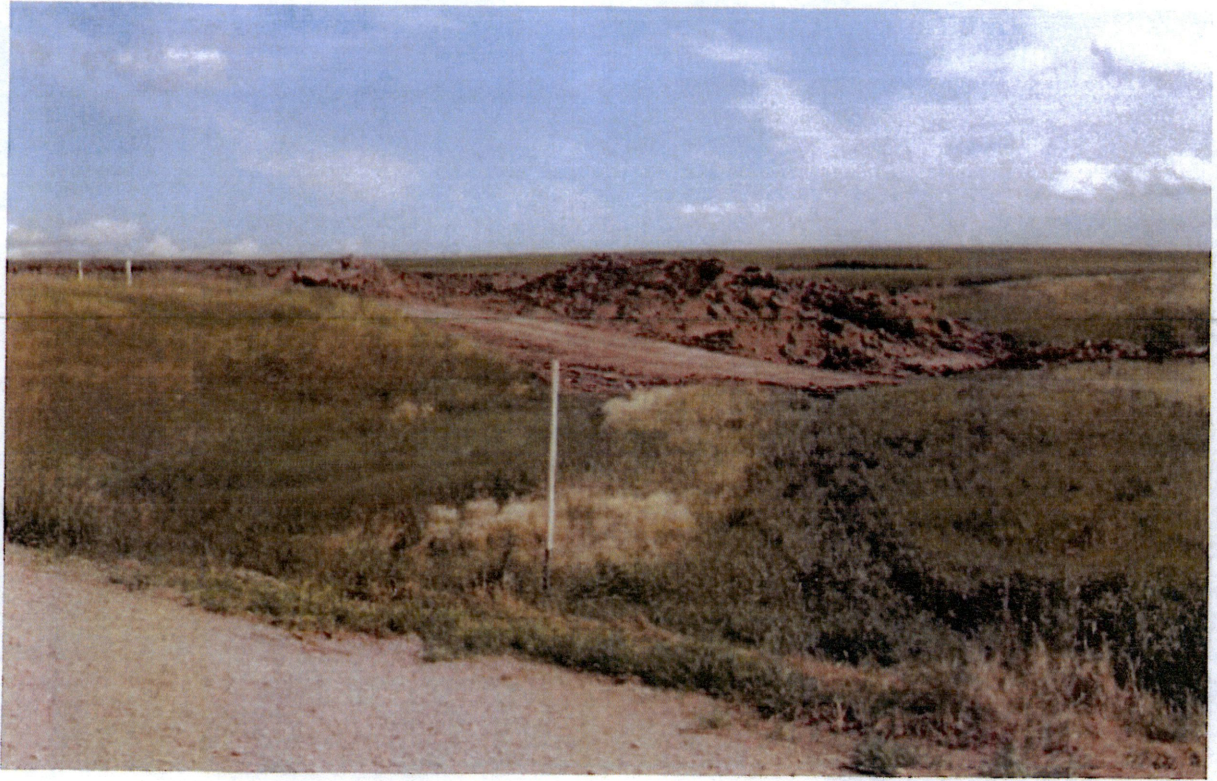
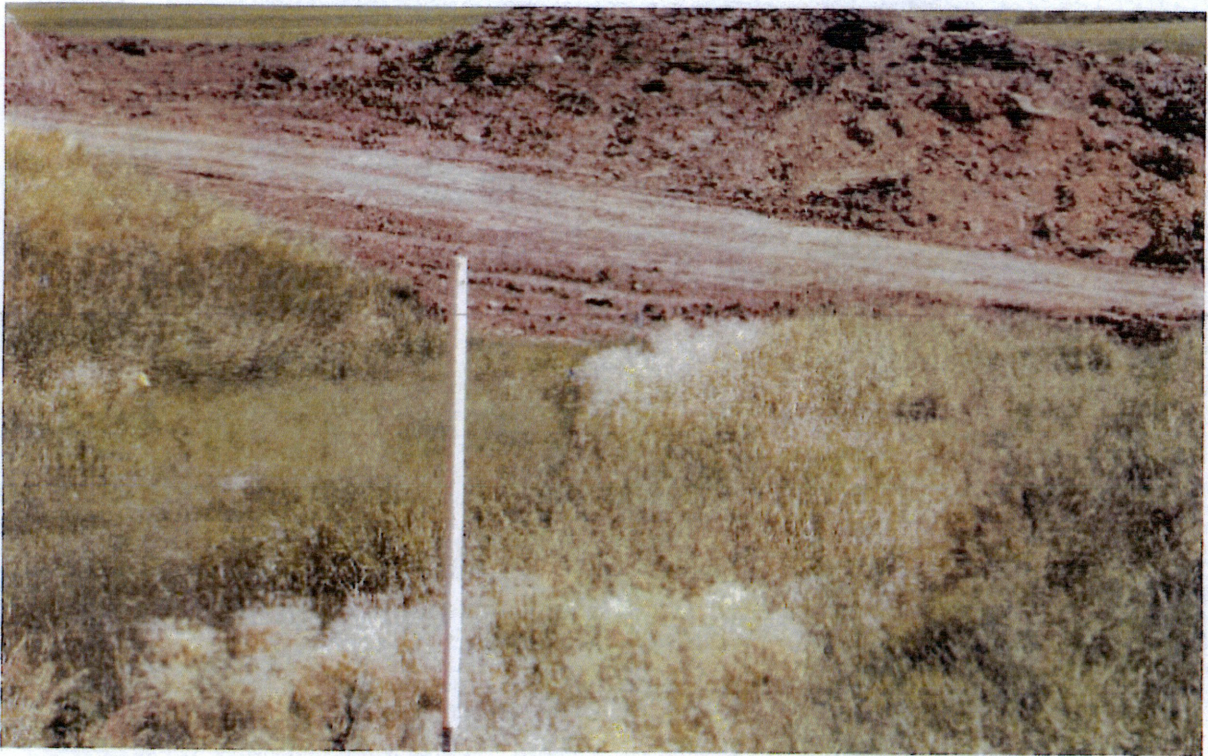
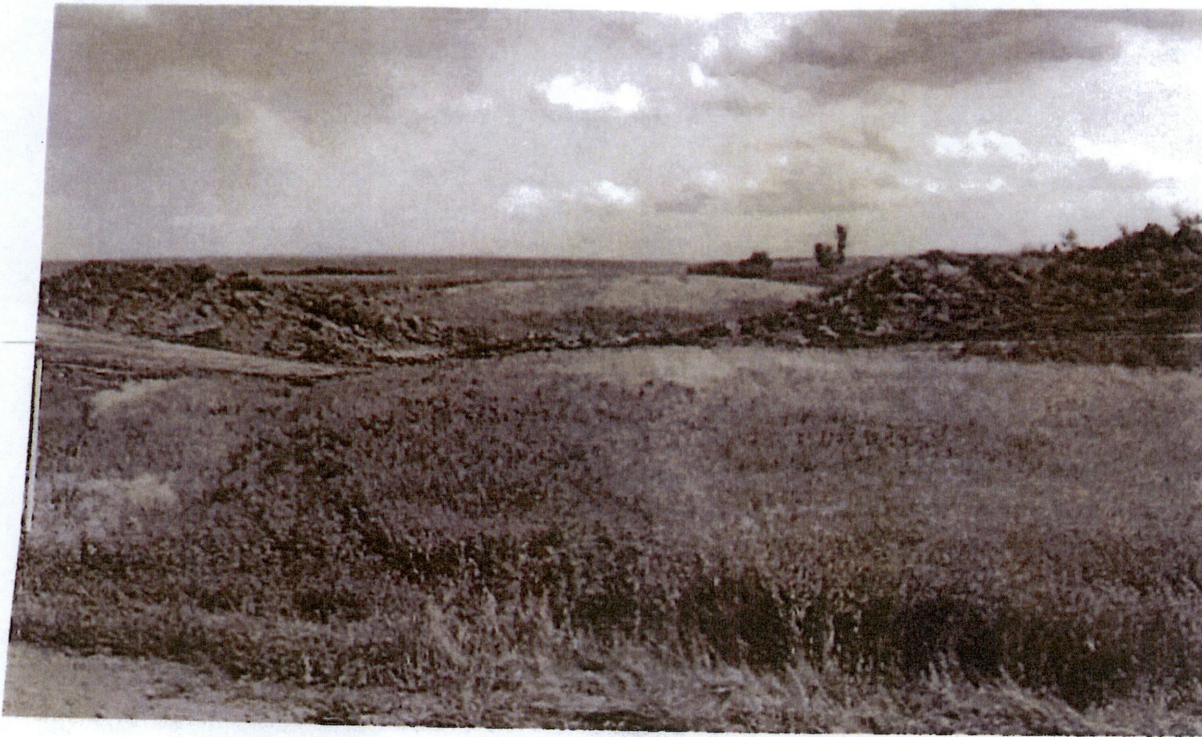
The photos below show locations along the right-of-way where there is clearly no silt fence in place to protect a wetland area. The first photos was taken near 80th Avenue NW north of 59th Street NW; the second two were taken approximately a half-mile west of 87th Avenue NW along an unnamed road north of Newtown; and the remainder were taken about two miles west of 9nd Avenue NW on an unnamed road soth of Newtown.

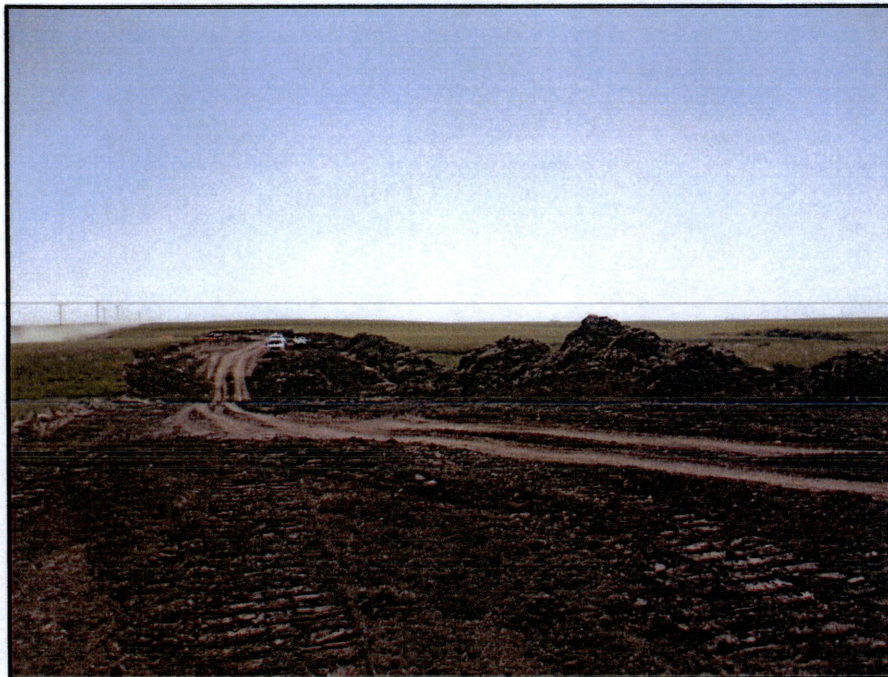
Photo 2. (GPS Point #446) – Drainage area intersected by ROW. No erosion control devices were in place and the corridor had not been necked down in this area to reduce disturbance. Direction: East.

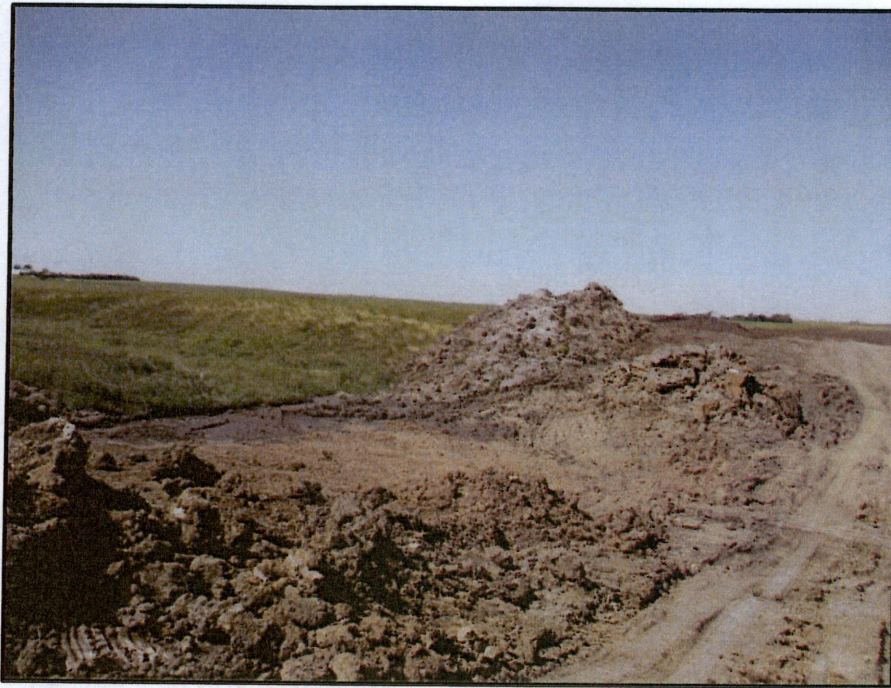
Photo 3. (GPS Point #446) - Drainage area along ROW, which appeared to be a potential wetland based on the topography, moist soil (along ROW edge) and change in vegetation. Topsoil pile along the left of photo. Drainage area looks like a potential wetland area.

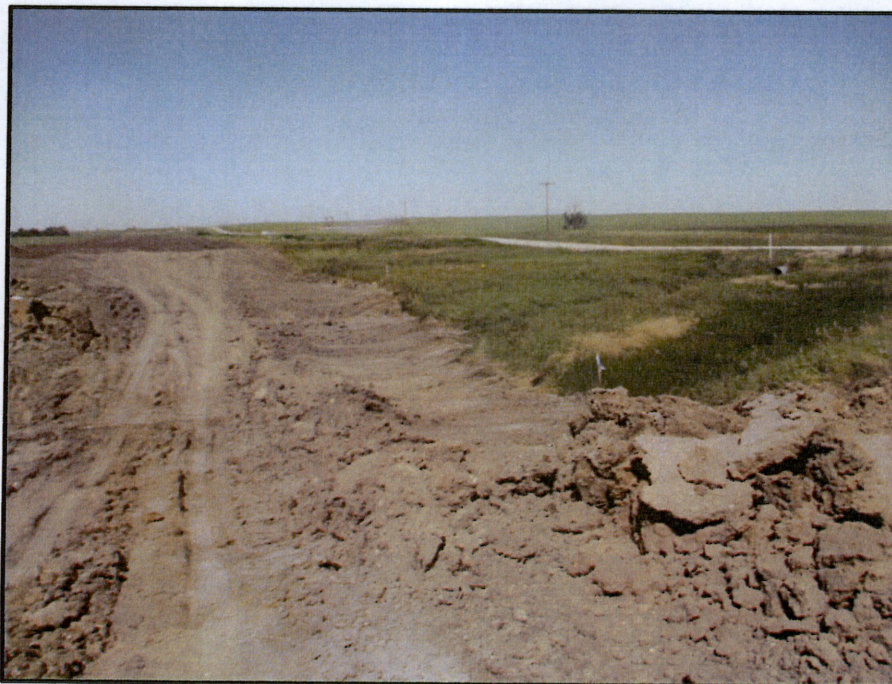
- Drainage area intersected by ROW. Pipe trenched and backfilled along the edge of the ROW. The drainage area appeared to be a potential wetland. Notice the vegetation change. However, the environmental inspector stated it was not a wetland. No erosion control devices were observed. The PSC was informed of this site the day after the inspection (Photo #4, Point #446);

Photo 4. (GPS Point #446) - Drainage area intersected by ROW. Pipe trenched and backfilled along the edge of the ROW. The drainage area appeared to be a potential wetland. Notice the vegetation change. However, the environmental inspector stated it was not a wetland. No erosion control devices were observed. The PSC was informed of this site the day after the inspection.
