Enclosed are copies of two complaints recently filed with the North Dakota Public Service Commission concerning the Sacagawea Pipeline, a crude oil transmission pipeline being constructed by Sacagawea Pipeline Company, LLC in McKenzie and Mountrail Counties, North Dakota. Siting of this pipeline was approved by the Commission's January 5, 2016 Order (Case No. PU-15-114).

**Re: Notice of Potential Violation
Sacagawea Pipeline Company, LLC
16-inch Crude Oil Pipeline – McKenzie & Mountrail
Case No. PU-15-114**

RE: Construction Inspection Report for the Sacagawea 16-inch Pipeline Project

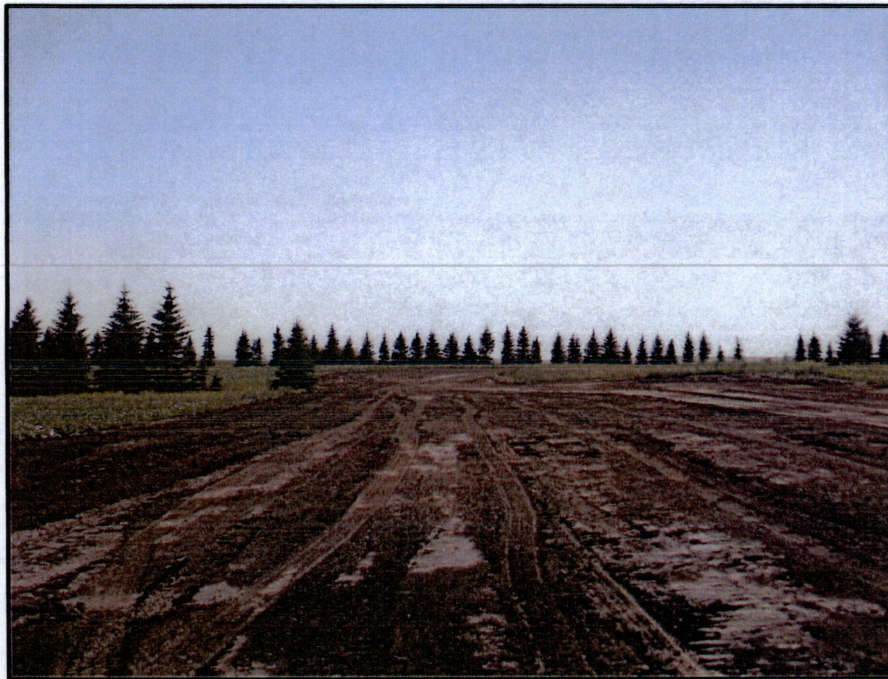
- ROW necked down to 50 ft width through tree rows. Unknown if or how many trees were taken out in this area. Topsoil replaced back on the ROW (Photo #6, Point #448);

Photo 6. (GPS Point #448) – ROW necked down to 50 ft width through tree rows. Unknown if or how many trees were taken out in this area. Topsoil replaced back on the ROW. Direction: East.

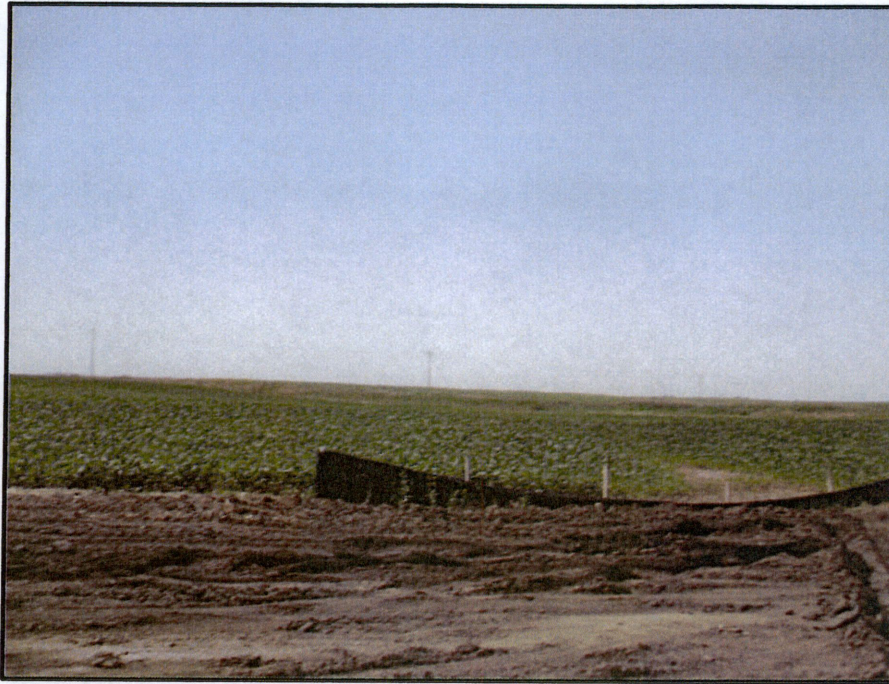
- Silt fence observed in drainage area near crop field, which needs maintenance. The area was rutted up and needs to be smoothed out again. Topsoil had been replaced back on the ROW (Photo #7, Point #448);

Photo 7. (GPS Point #448) - Silt fence observed in drainage area near crop field, which needs maintenance. The area was rutted up and needs to be smoothed out again. Topsoil had been replaced back on the ROW.

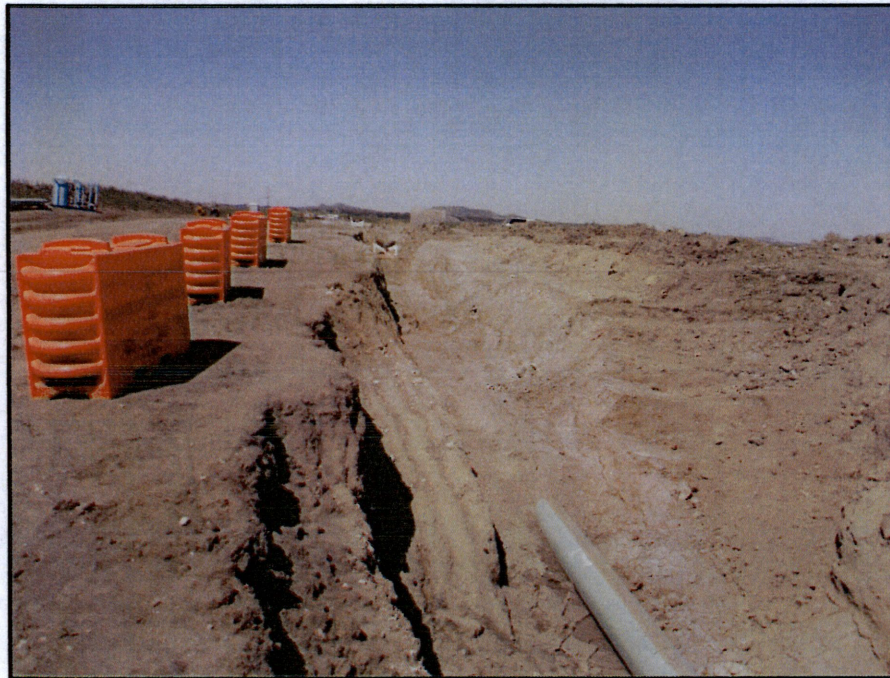
Photo 10. (GPS Point #450) - Open trench with partially covered pipe in trench. Orange safety blockades to the left of photo. White and black pipe rollers (visible in trench in far distance of photo) were used to guide the bore pipe into bore hole. Direction: West

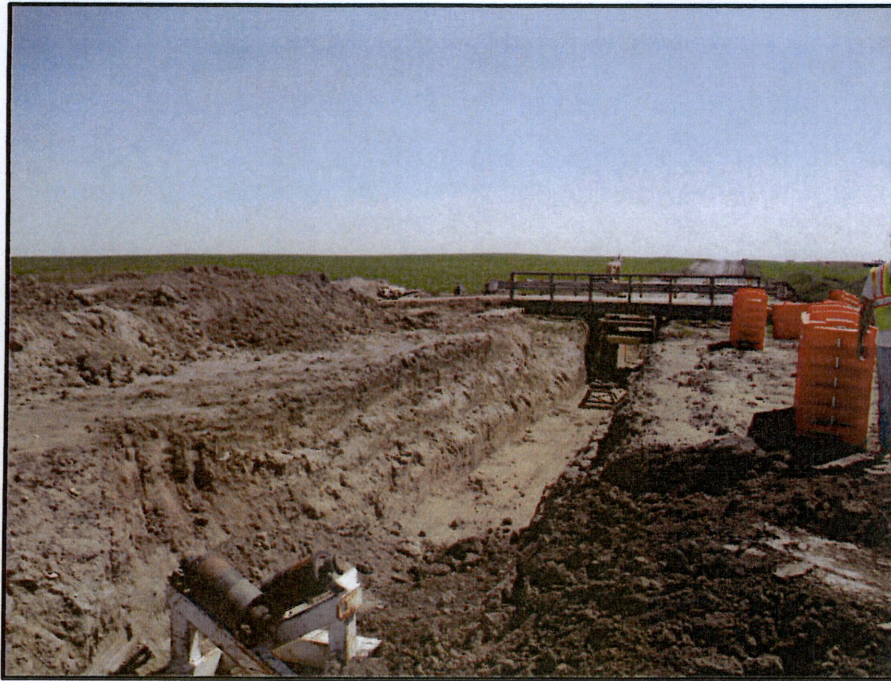
Photo 11. (GPS Point #450) - Open trench with orange blockades to the right of photo, trench spoil to the left. White and black pipe rollers in foreground were used to guide bore pipe. Bridge was used for a vehicle crossing to get to the bore area. Direction: East

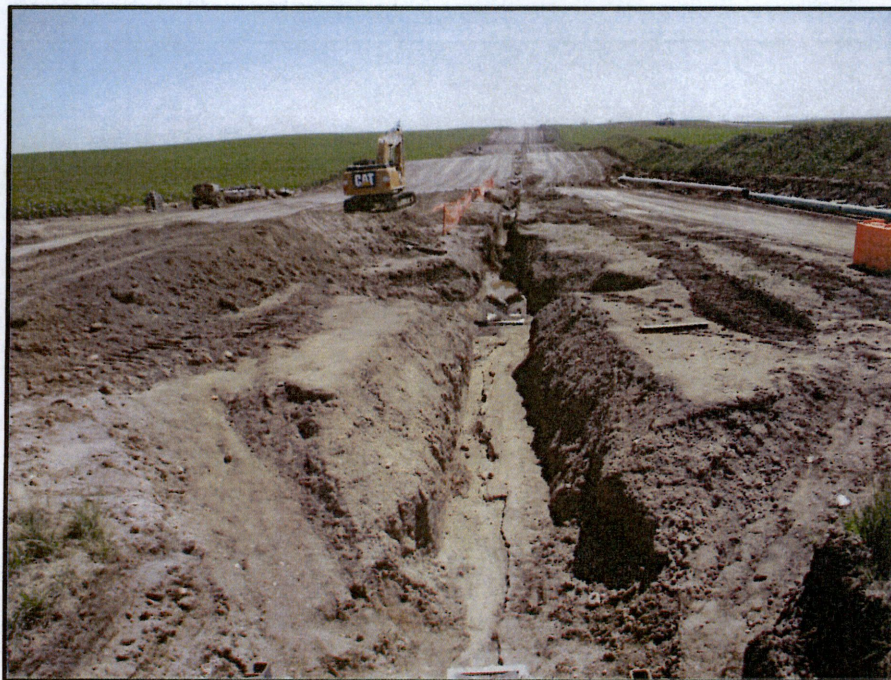
Photo 12. (GPS Point #450) - Open trench with few orange blockades ending to the right of photo, and only partial orange fence to the left of trench. White and black pipe rollers in trench were used to guide bore pipe. Photo taken from bridge shown in photo #11. Direction: East

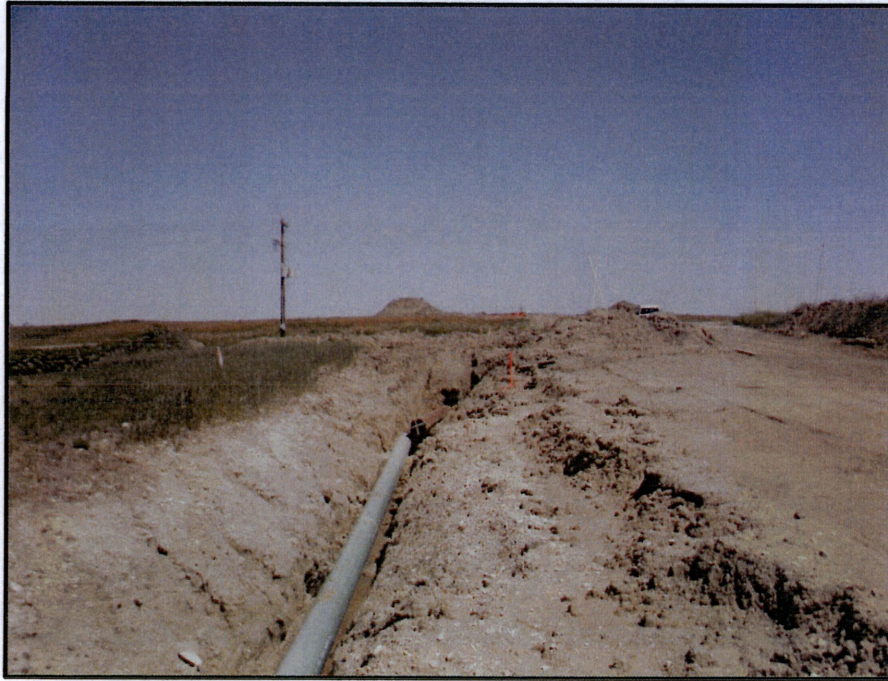
- Area near rural water line break. Open trench to the left of photo. No standing safety fence observed, unknown how long there has been an open trench, no work going on in the area. Environmental inspector thought they hit the rural water line while they were doing boring activities (Photo #13, Point #444);

Photo 13. (GPS Point #444) - Area near rural water line break. Open trench to the left of photo. No standing safety fence observed. Environmental inspector thought they hit the rural water line while they were doing boring activities. Direction: North

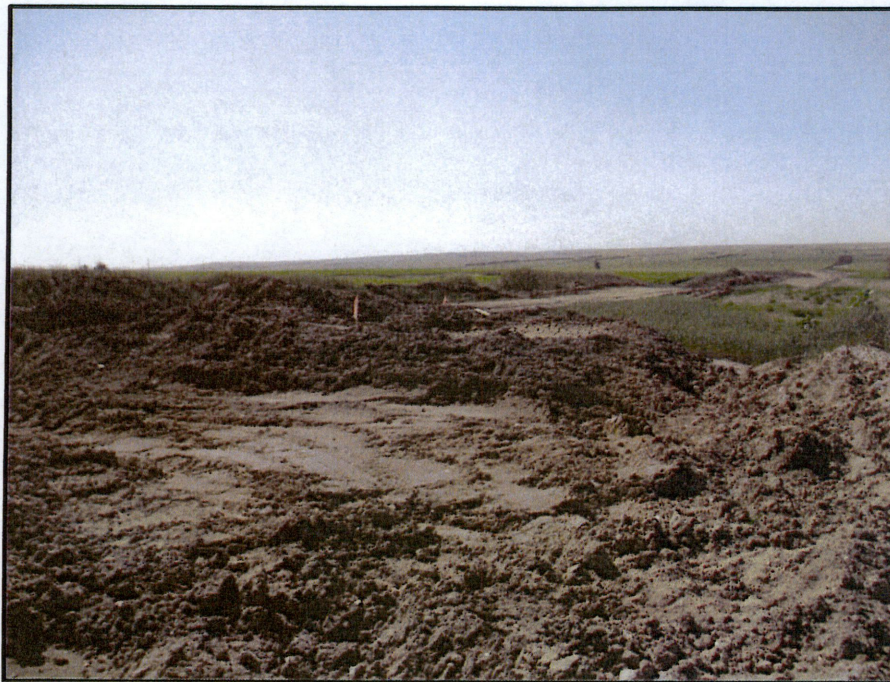
Photo 15. (GPS Point #444) - Area near rural water line break. Looks like subsoil had been pushed around, there was some ponded water in back of photo. Direction: South

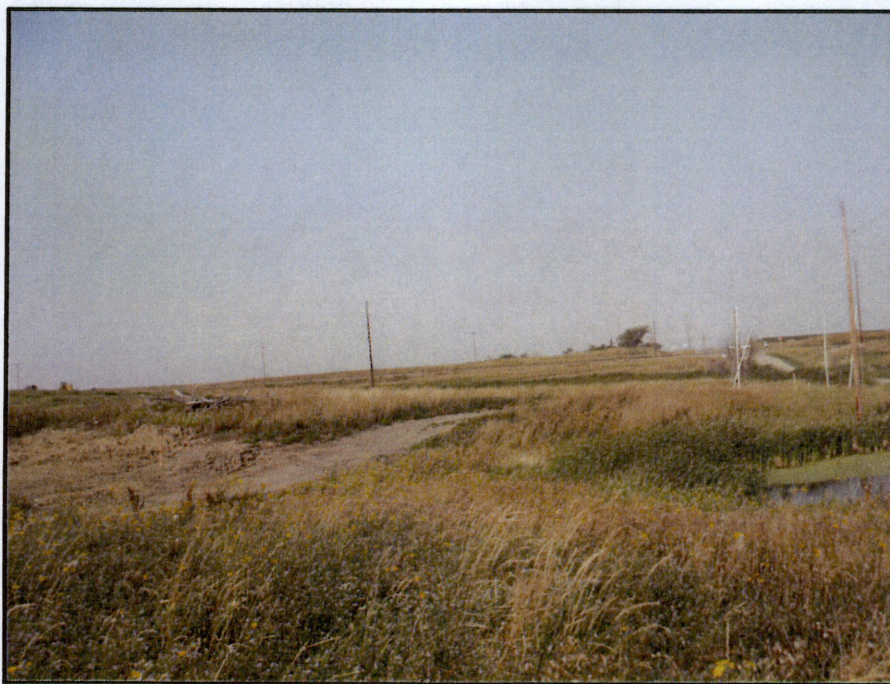
Photo 16. (GPS Point #481) - ROW and access road next to wetland. No erosion control devices observed. Site visit 9/1/2016. Direction: West

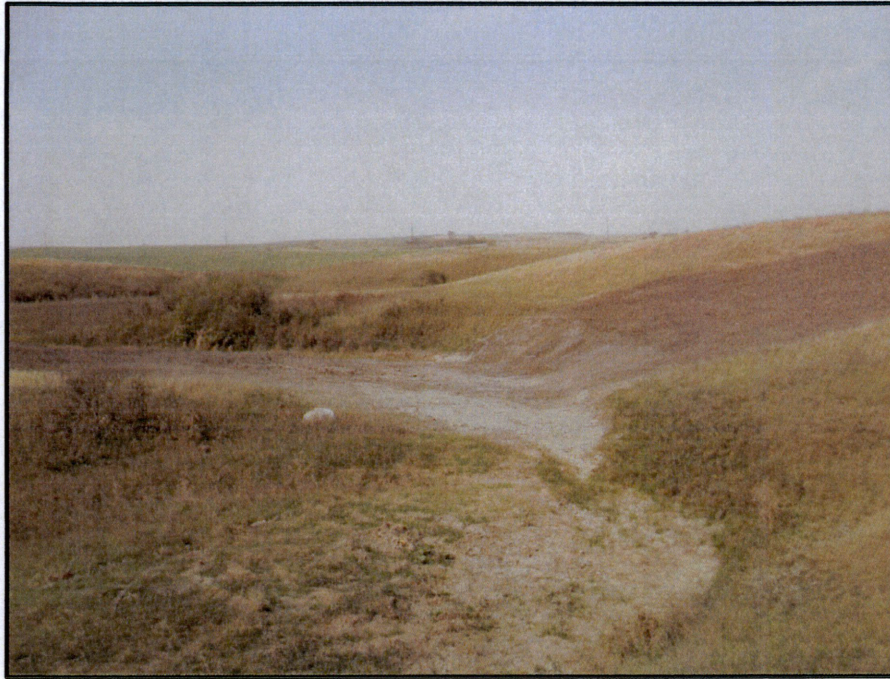
Photo 17. (GPS Point #482) - Drainage area, no erosion control device. Area along the drainage pathway looks light in color, possibly due to topsoil erosion. Direction: West

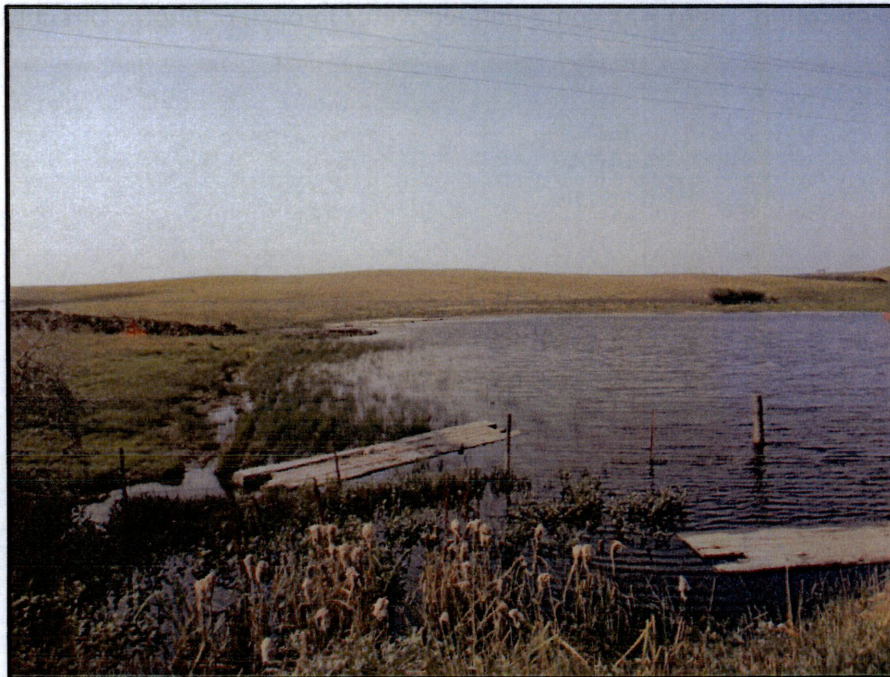
Photo 18. (GPS Point #483) - Swamp mats floating all around wetland. ROW is next to the wetland/open water. Wetland appears it may have had an influx of water at some point, reason for this is unknown (there has been little to no rain in the last couple of weeks).
Direction: South

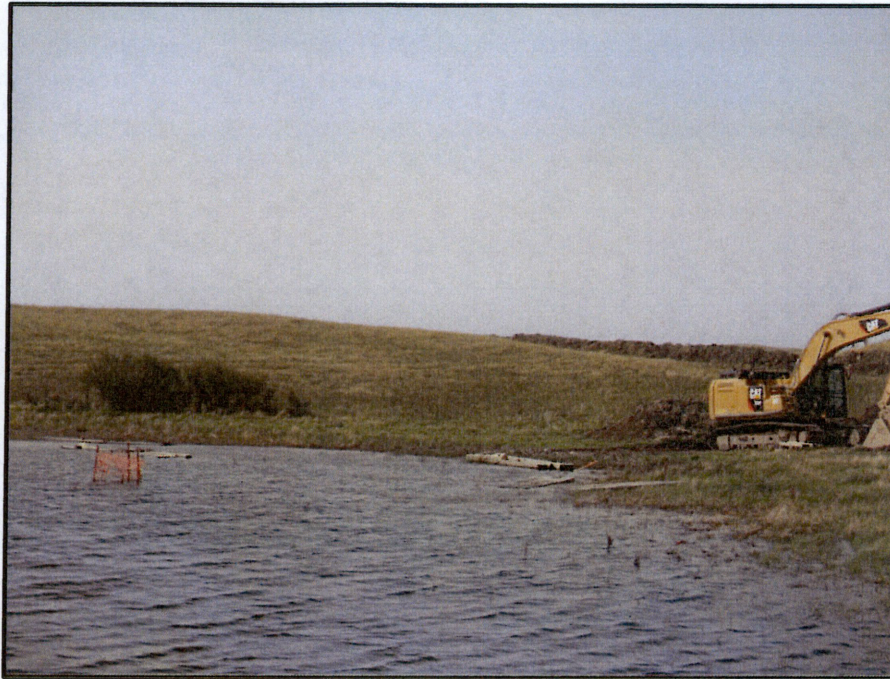
- Swamp mats floating in wetland, no erosion control devices observed. Small orange fenced in area, possible pot holing site, under water (Photo #19, Point #483);

Photo 19. (GPS Point #483) - Swamp mats floating in wetland, no erosion control devices observed. Small orange fenced in area, possible pot holing site, under water. Direction: South

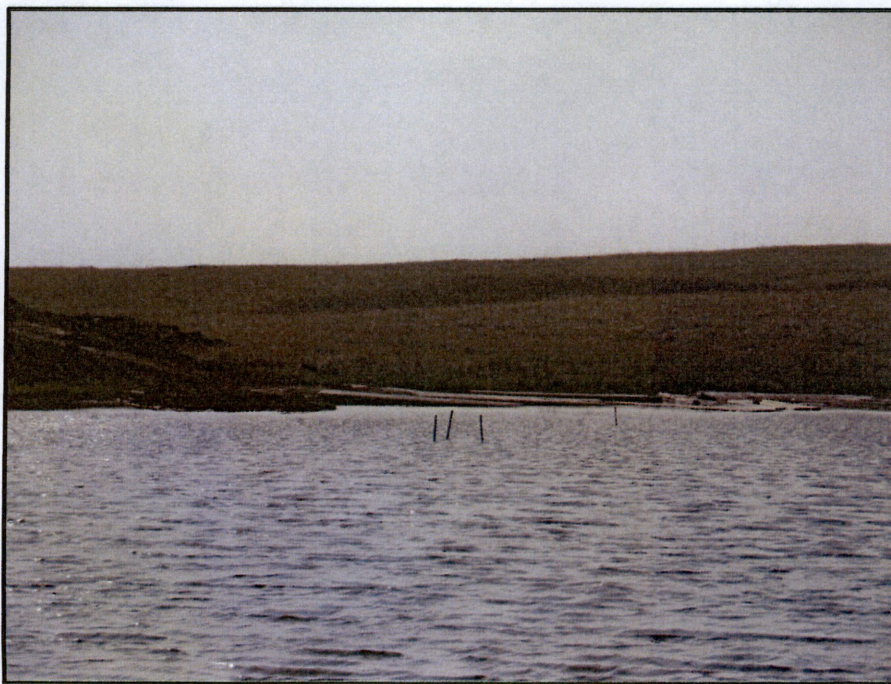
- Swamp mats floating in wetland. Dirt pile in water seen to left of photo on wetland edge. No erosion control devices observed (Photo #20, Point #483);

Photo 20. (GPS Point #483) - Swamp mats floating in wetland. Dirt pile in water seen to left of photo on wetland edge. No erosion control devices observed. Direction: South

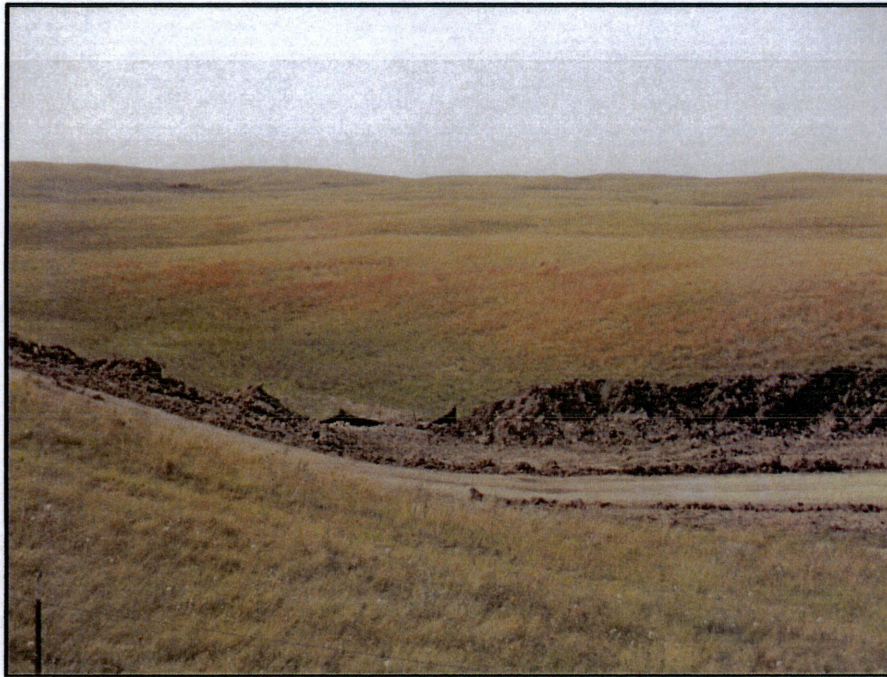
Photo 21. (GPS Point #484) - Silt fence in drainage area, needs maintenance. Direction: South

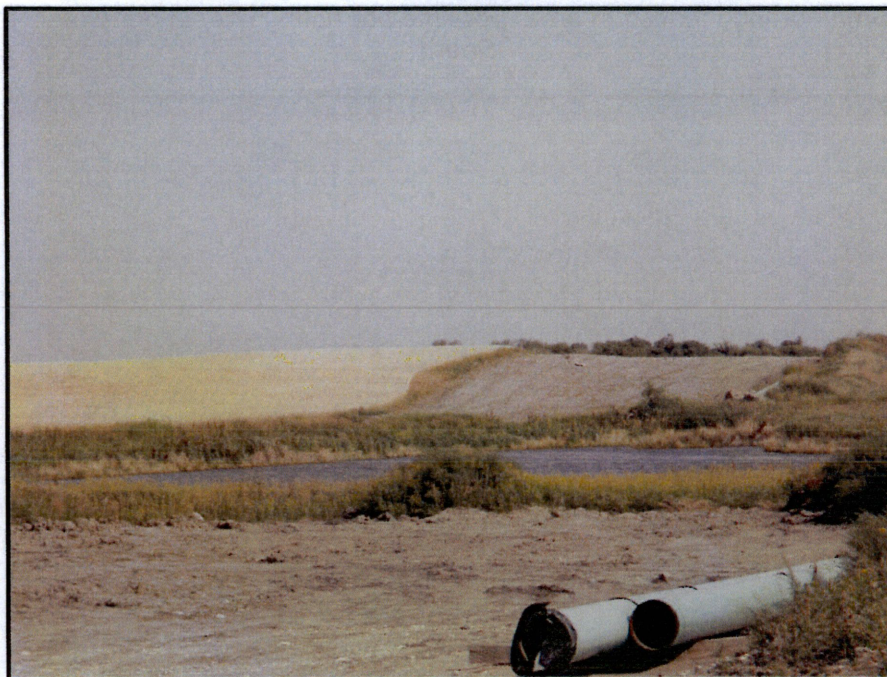
Photo 22. (GPS Point #485) - Pipeline ROW goes down the hill in the distance and wetland was bored under. No erosion control devices observed. Direction: North

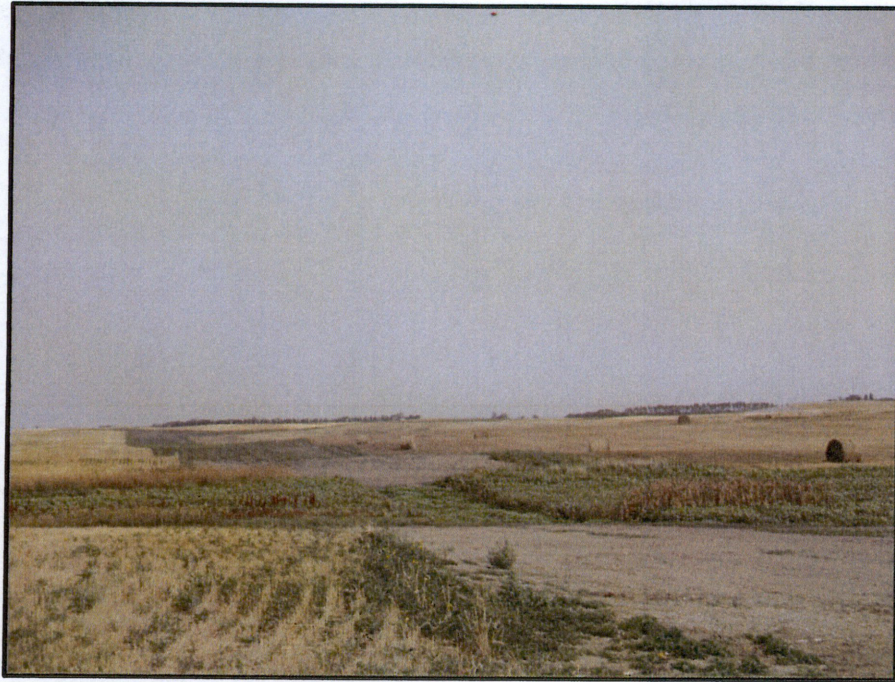
Photo 23. (GPS Point #488) - No erosion control devices observed. Area appears to have been bored but it looks like the wetland was driven through.

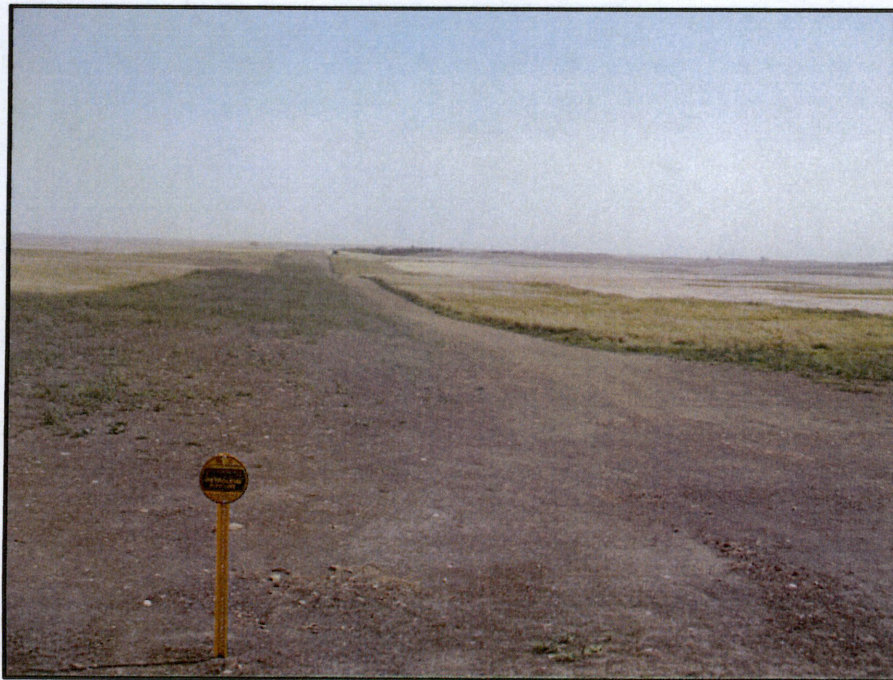
Photo 24. (GPS Point #490) - Pipeline ROW has vegetation growing. Looks like the right side of the ROW, where no vegetation is growing, has been/or is being used as a travel lane. Direction: East
