**Re: Sacagawea Pipeline Company, LLC
16-inch Crude Oil Pipeline – McKenzie & Mountrail
Case No. PU-16-582**

**Response to Sagawea Pipeline Company Supplemental Response Letter (ND PSC Docket
No. PU-16-582)**

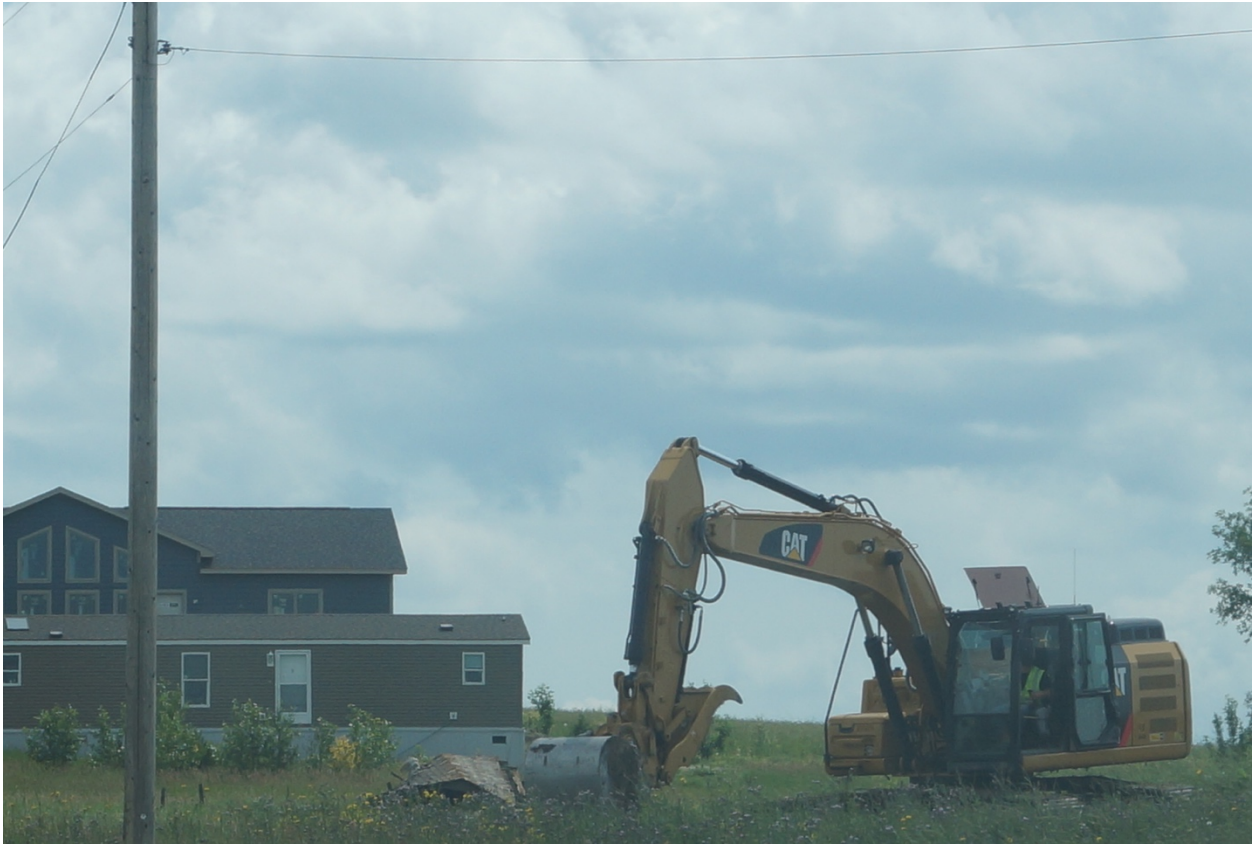
In addition to providing evidence of excavations with missing or poorly-maintained safety fence, LDC also provided evidence of apparent failures in the area of traffic control and unsafe operation of an excavator near overhead power lines. Further, Mr. Crase observed that the project had safety problems including the use of “incredibly steep, unsafe bore pits”.

In order to clarify the matter, we have provided a better version of the photo, which was taken on July 14 and clearly shows that the operator is in his machine (see below). We encourage the Commission to request that SCP clarify the matter by providing details and evidence regarding the excavator who was terminated, including dates and locations that would make it possible to determine whether the excavator in the photo is the one who was terminated, and how long he was allowed to operate unsafely.

Photo of Sacagawea Pipeline construction near 53rd Street NE east of Highway 8 in Mountrail County on July 14, 2016

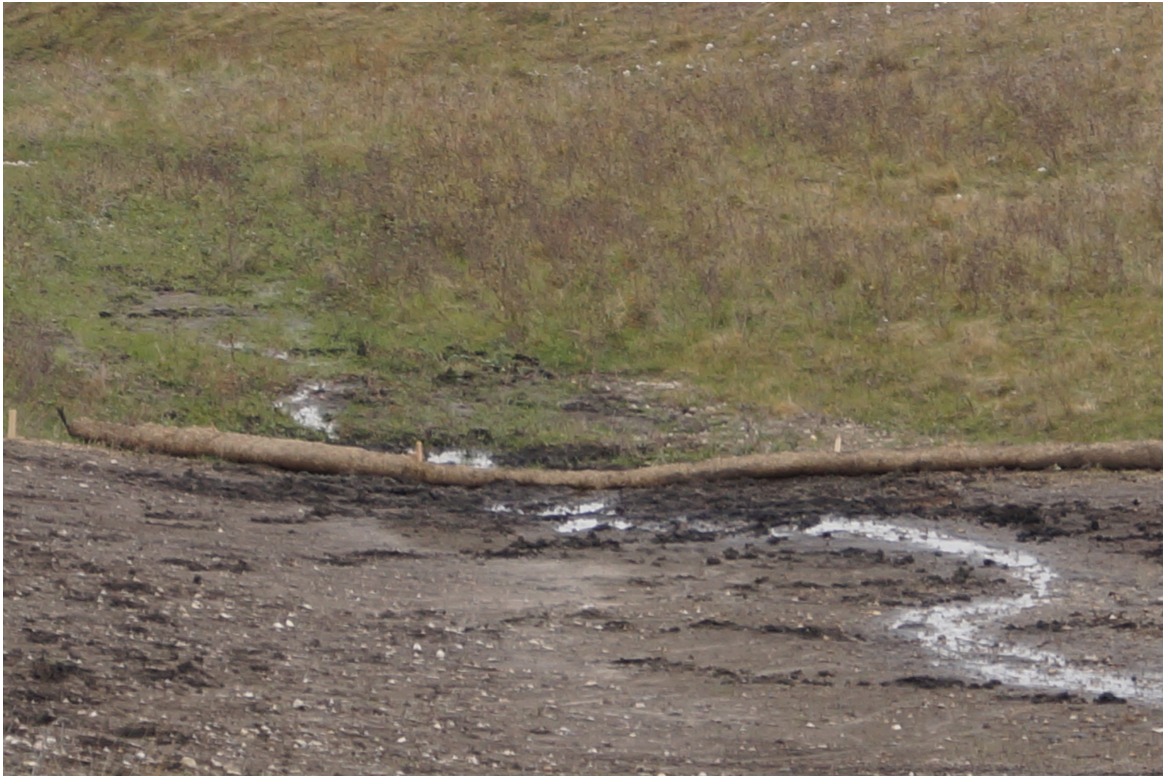
The photo below, taken in the vicinity of 47th Street NW east of 82nd Avenue Northwest, shows an area where it is evident that sediment has clearly run off the right-of-way into a drainage, likely because the straw log was installed too late and/or was insufficient to contain erosion. In our view, a silt fence should have been in place, and we think the Commission will find that this photo corresponds to photo 21 of the Wenck's Construction Inspection report where the lack of adequate erosion control is noted.

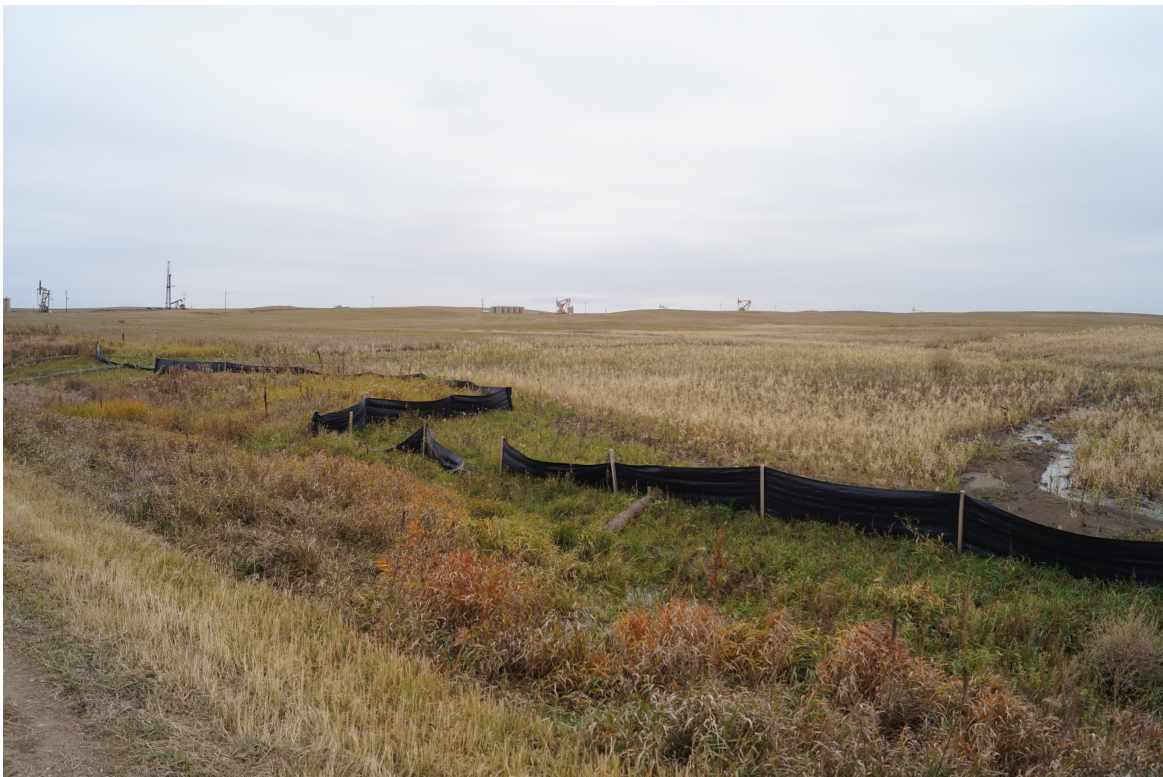
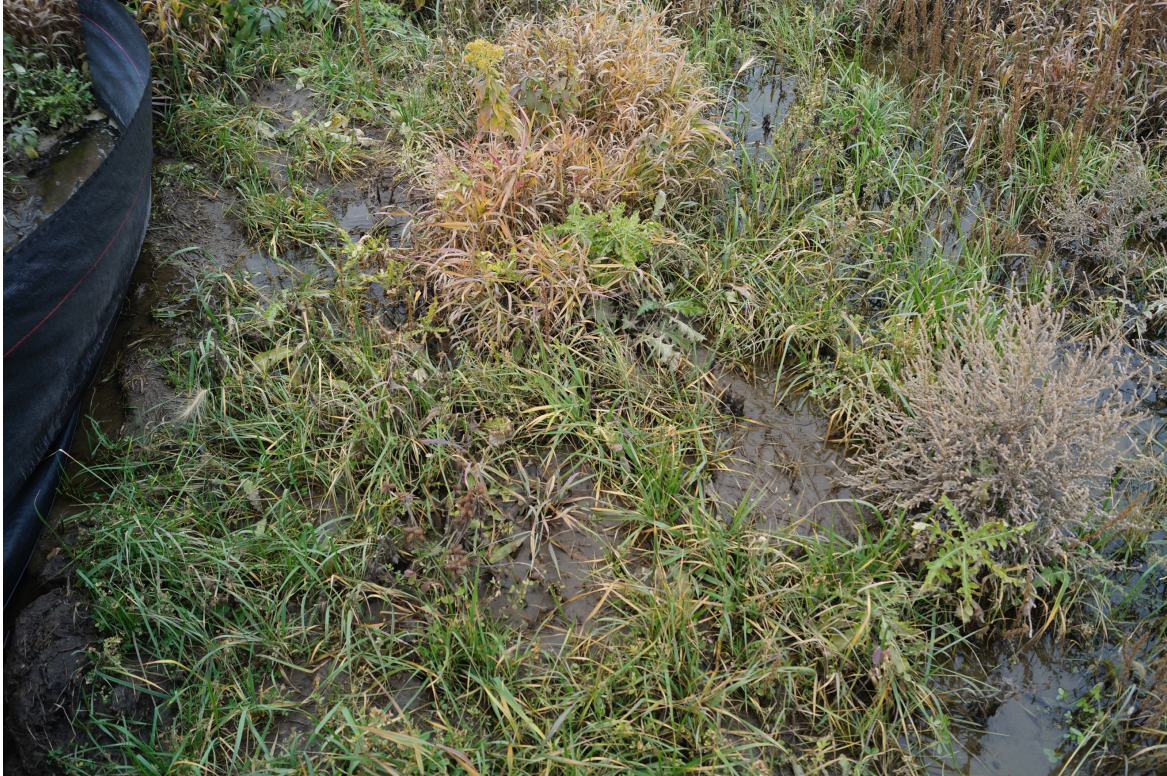
The two photos below show the same area east of 87th Avenue NW where poorly maintained silt fence was documented in the Whiteford affidavit (p. 9-10). The photos show not only that the silt fence is still poorly-maintained, but worse, that sediment is apparently running under it.

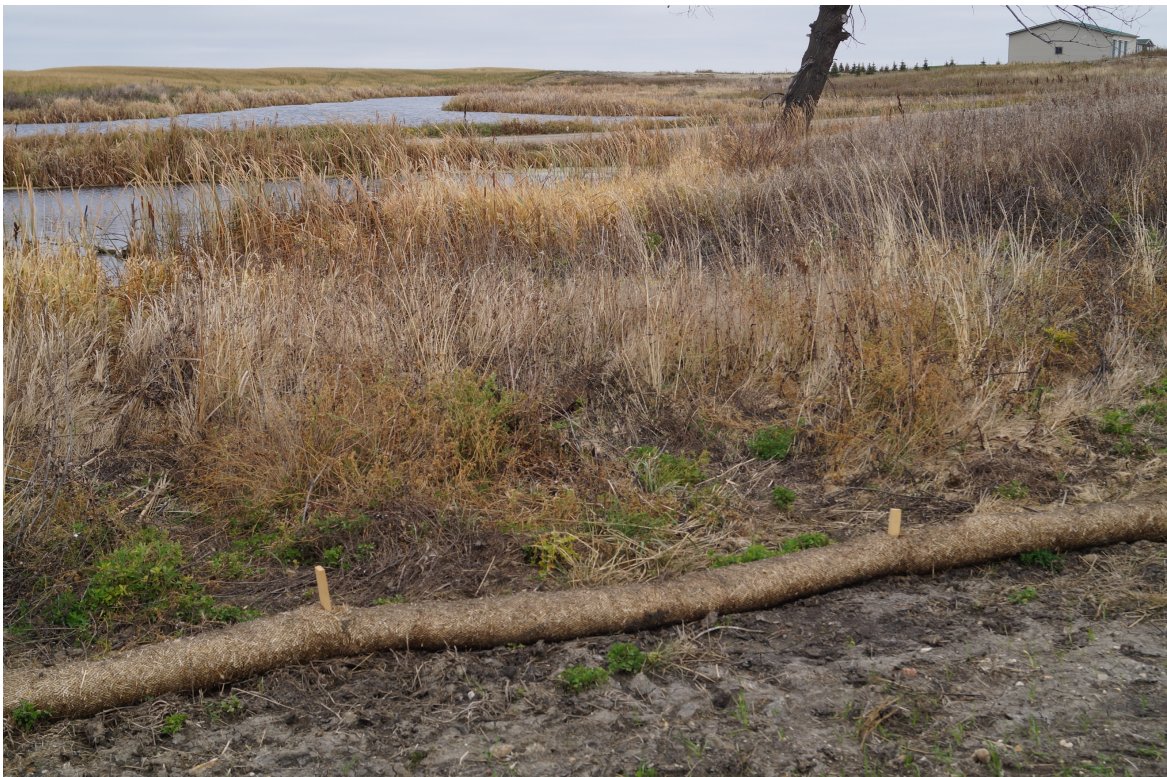
The photo below was taken in the vicinity of 53rd Street NW east of Highway 8, and we believe that it is the same area depicted in Wenck Construction Inspection report Photo 16, which identified a lack of erosion control devices. The photo shows that a straw log has been installed (recently judging by the color), but apparently only after equipment was tracked through the area based on the crushed vegetation under and in the background of the log. In our view, a silt fence would have been more appropriate, and construction equipment should always be kept on the right-of-way and off vegetation.

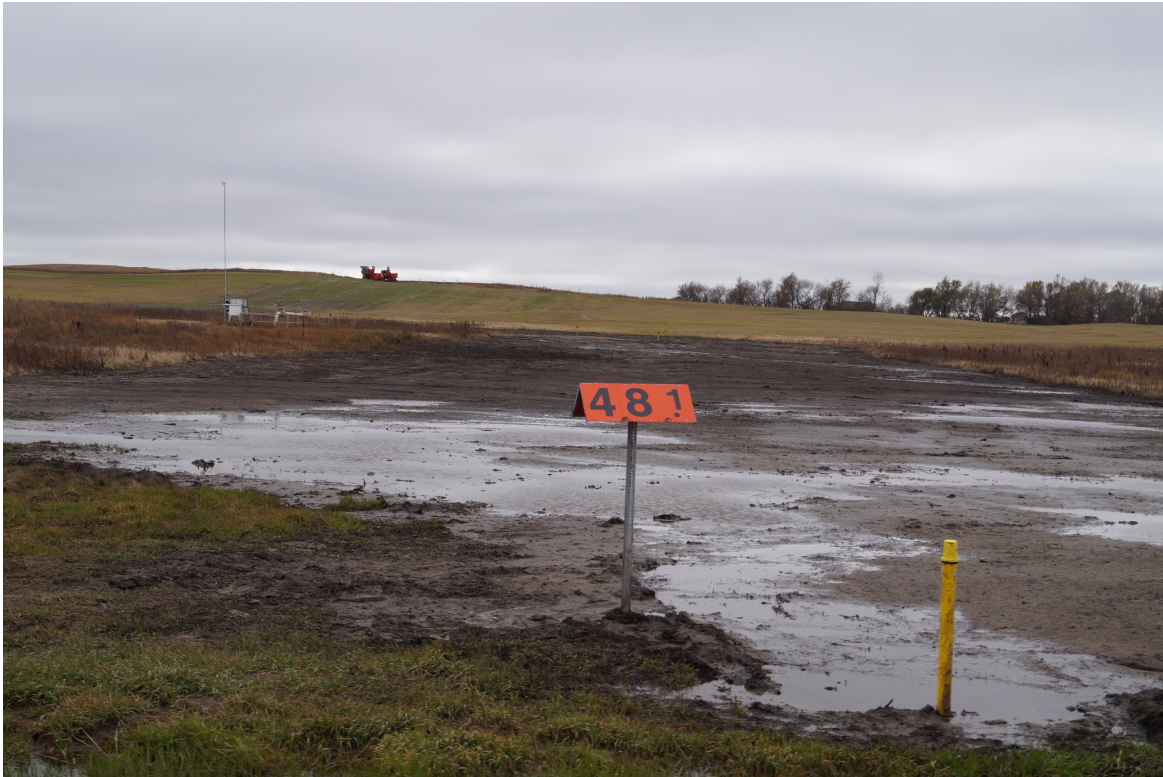
The last photo, which was taken near the location where the right-of-way crosses 49th Street NW, shows a new cause for concern where construction activity appears to have disturbed a significant wetland area. The right-of-way does not appear to have been routed or necked-down in a manner that might have minimized the environmental impact.
